SRMC-CWDA-2023-00032
Revision 0

**Conceptualization of Potential Leak Paths
Associated with Saltstone Disposal Unit 6 (SDU 6)**

April 2023

Prepared by: Savannah River Mission Completion LLC
Closure and Waste Disposal Authority
Aiken, SC 29808

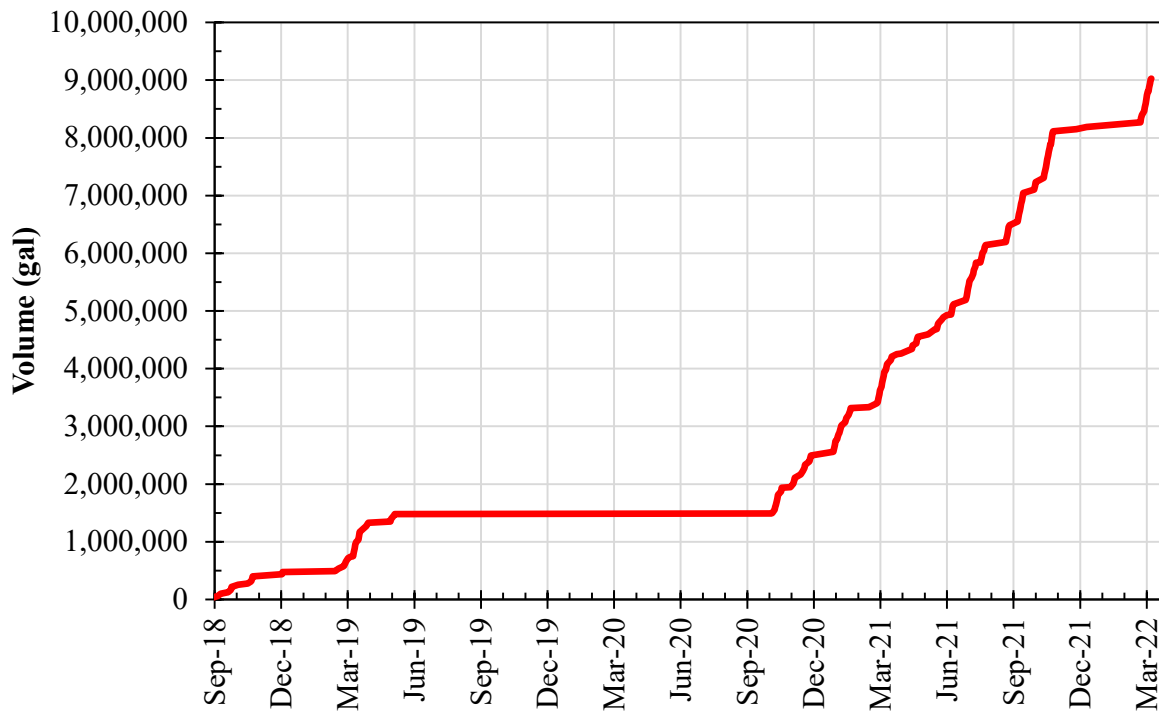
Figure 3.1-1: Fill Volume History for SDU 6 (Based on DSS Transfers)

Disposal operations continued until March of 2022 when contamination was detected in the East Sump of SDU 6. As of March 2022, SDU 6 had already been filled with approximately 9M gallons of saltstone (Figure 3.1-1), with a maximum fill height of approximately 13.25 feet.

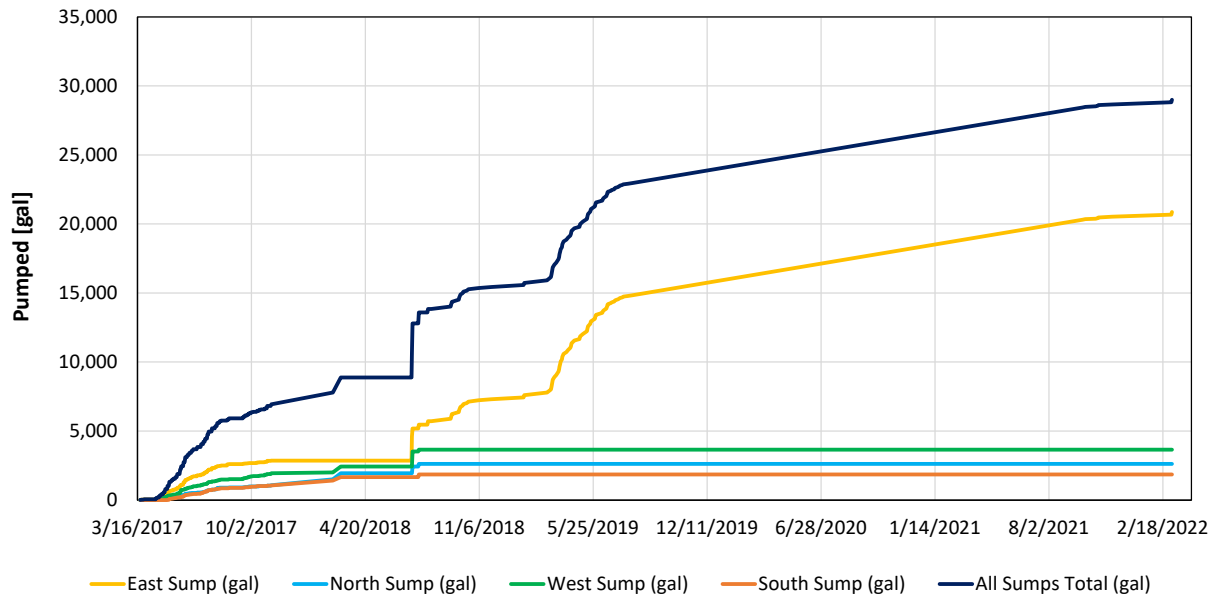
Figure 3.2-3: Cumulative Volume of Water Pumped from SDU 6 Sumps through March 2022

When the contamination of the East Sump occurred, an investigation was performed to better understand how the water became contaminated. As part of the investigation, the cumulative volume of water pumped out of the SDU 6 sumps was estimated (Figure 3.2-3) (SRMC-2022-WSE-0010). Based on pump data it was estimated that a maximum of 29,000 gallons had been pumped out over the 5-year period.

Note, however, that this estimate was not based on measuring the actual volumes but, instead, was based on the number of minutes that the pumps were run for, then multiplied by the flow rate of each pump (11 gallons per minute (gpm)) (McCoy, 2022). If the pumps were run continuously, even after the sump ran dry, then these estimates have the potential to be high. For example, it was noted that one day from this data set reported 5,480 gallons pumped out of the East Sump in a single day; coincidentally, this is approximately equal to the volume that could be pumped over an 8-hour shift at the set rate of 11 gpm. However, this volume is much higher than the approximately 10-gallon capacity of the sump. With this insight, the 29,000-gallon estimate over this five-year period is expected to be a bounding estimate. It is very likely that a smaller volume than this has actually been removed from the sumps.

It is likely that the sump water has multiple sources: pre-existing construction water trapped when the system was initially enclosed, rainwater from the SDU roof and the soils external to the HDPE entering through a potential leak site, or from inside the SDU itself. In the absence of reliable flow totalizer data from the sump transfers, material balance around the system cannot be accurately determined. If only a portion of the water is from the inside of SDU 6 (which seems almost certain given the process history prior to the disposal of radioactive materials), then assuming that the estimated volume of 29,000 gallons comes entirely from inside of SDU 6 is likely to be an overestimate.

Using the bounding volume of 29,000 gallons over the 5-year period (from March 2017 to March 2022) along with the approximately 18,000-gallon volume (from late August 2022 through February 2023), the long-term average pump rate (from March 2017 through February 2023) is estimated to be less than 22 gal/day pumped from the leak detection system. This value is less than the approximately 100 gal/day shown by the green curve on Figure 3.2-4; however, because no water was pumped out of the sump while the modification was being deployed, there were approximately 5 months with no pumping. Figure 3.2-4 also shows that in February 2023, water was only pumped out twice (for a total of less than 500 gallons), suggesting that the leak rate might now be slowing down, which should be expected as the saltstone within SDU 6 cures and as excess

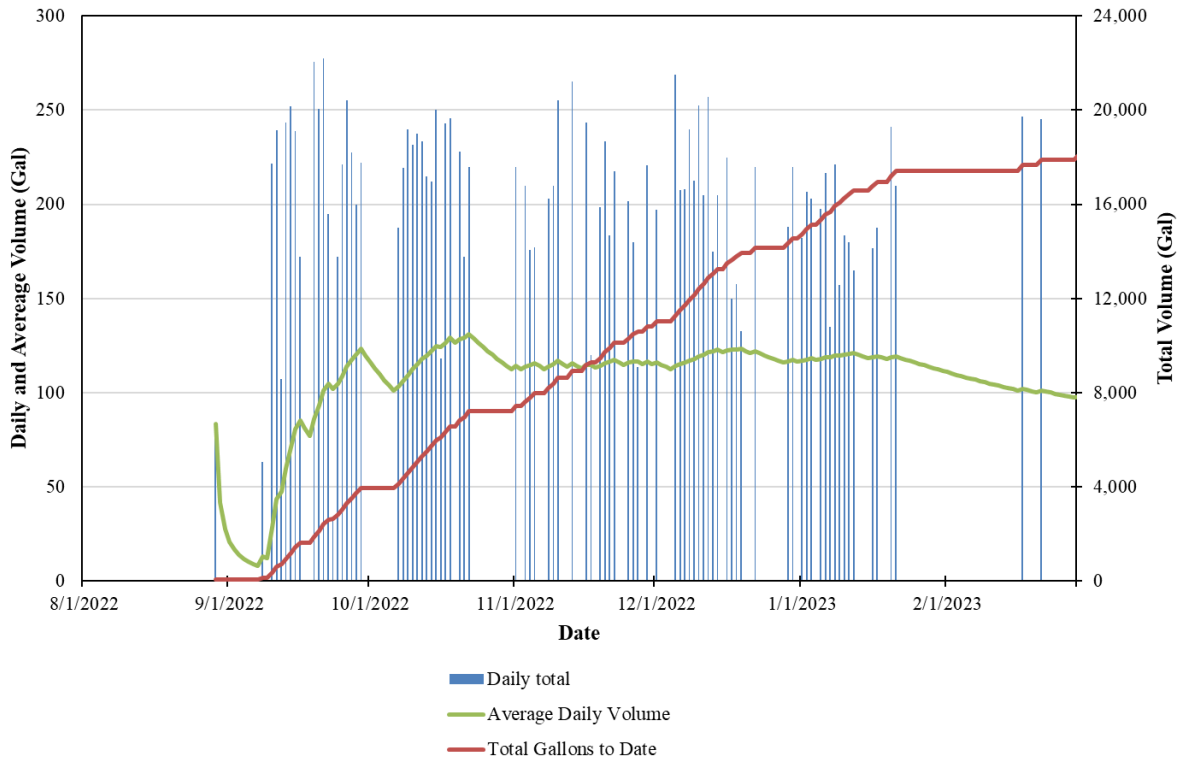
Figure 3.2-4: Cumulative Volume of Water Pumped from the SDU 6 East Sump Back into SDU 6 since August 2022

Starting in late August, the temporary modification (M-TMOD-Z-00002) was deployed and drain water from the East Sump was pumped back into SDU 6 per procedure WS-Z-1055: *Pumping SDU 6 East Sump into SDU 6*. This modification provides a reliable method for removing water from the sump and sending it to SDU 6, consistent with the recommendations of the Site Tracking, Analysis, and Reporting (STAR) issue: 2022-CTS-004583. Sending the liquid back to the SDU will maintain the contamination in the system while allowing ongoing processing.

the largest volume ever pumped in a single day was approximately 275 gallons; however, on more than half of the days no water was pumped. The average over this period was approximately 100 gallons a day.

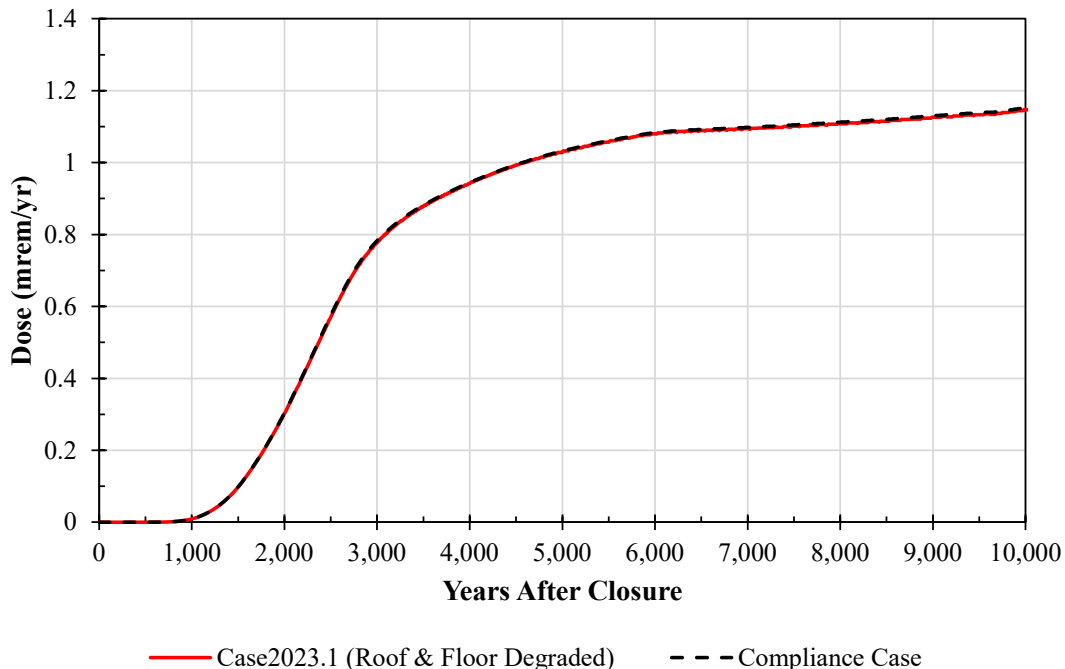
Figure 6.2-1: Dose Results Comparing the Compliance Case Against Case2023.1

As expected, the impact was still negligible (see Figure 6.2-1). This is because the SDU concrete is only a secondary containment system. The primary containment of the waste in the SDUs is the saltstone waste form itself, which was intentionally designed to immobilize the waste.

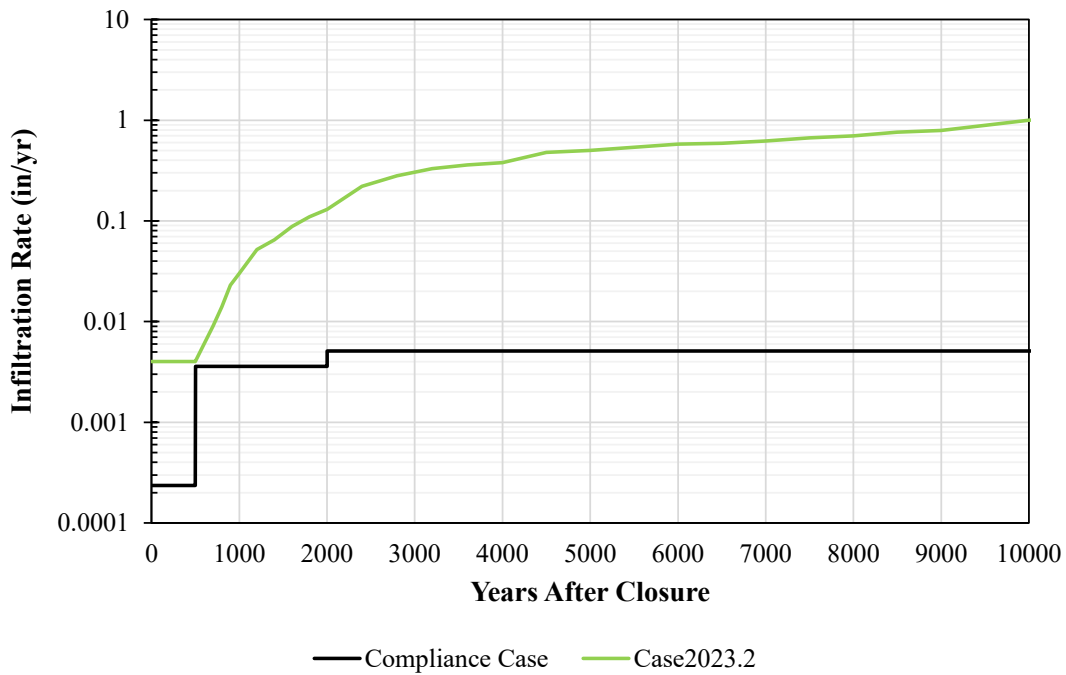
Figure 6.3-1: Comparison of Infiltration Rates: Compliance Case Versus Case2023.2

Next, Case2023.2 was developed by modifying Case2023.1 to use a significantly higher infiltration rate, as shown in Figure 6.3-1. Because dose results are sensitive to infiltration rates, these dose results were significantly higher than the Compliance Case. Figure 6.3-2 shows that Case2023.2 had a peak of approximately 6.3 mrem/yr at approximately 3,300 years after closure. Within the 1,000-year Compliance Period, the doses remained very low (less than 0.05 mrem/yr).

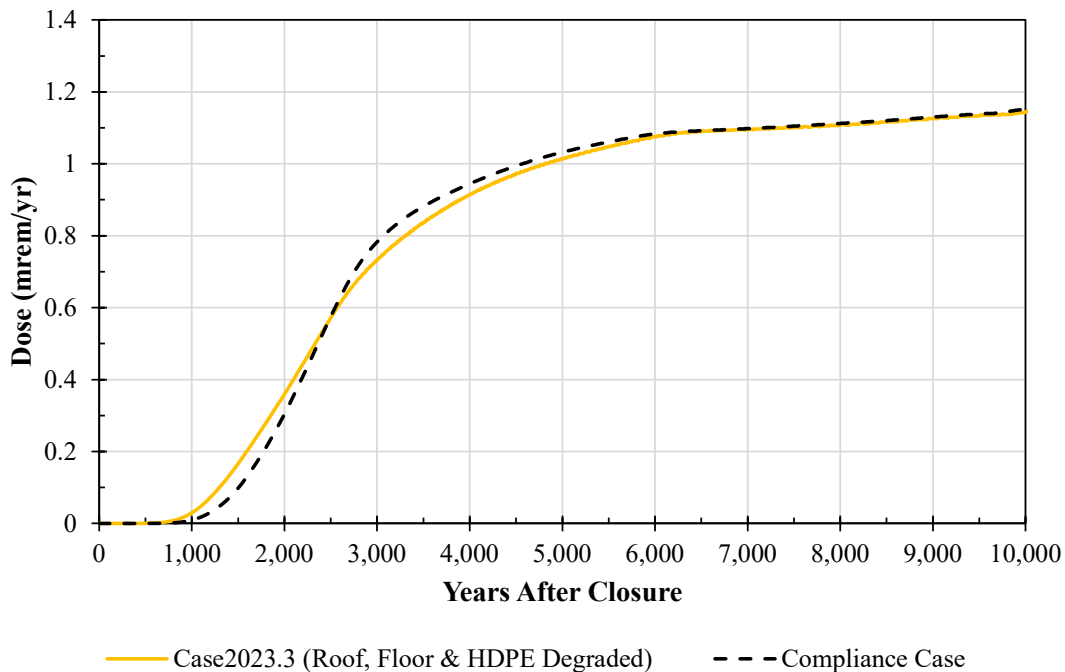
Figure 6.4-1: Dose Results Comparing the Compliance Case Against Case2023.3

Next, Case2023.2 was developed by modifying Case2023.1 to assign initially degraded properties to the HDPE and GCL of the exterior liner system (i.e., backfill properties were assigned to these materials). Figure 6.4-1 shows that this change had a minor impact on the dose result. The doses were slightly higher than the Compliance Case within the first 2,500 years and then from approximately 2,500 years to almost 6,000 years, the doses were slightly lower than the Compliance Case. However, there was not a significant impact on the magnitude or timing of the peak dose within the first 10,000 years.

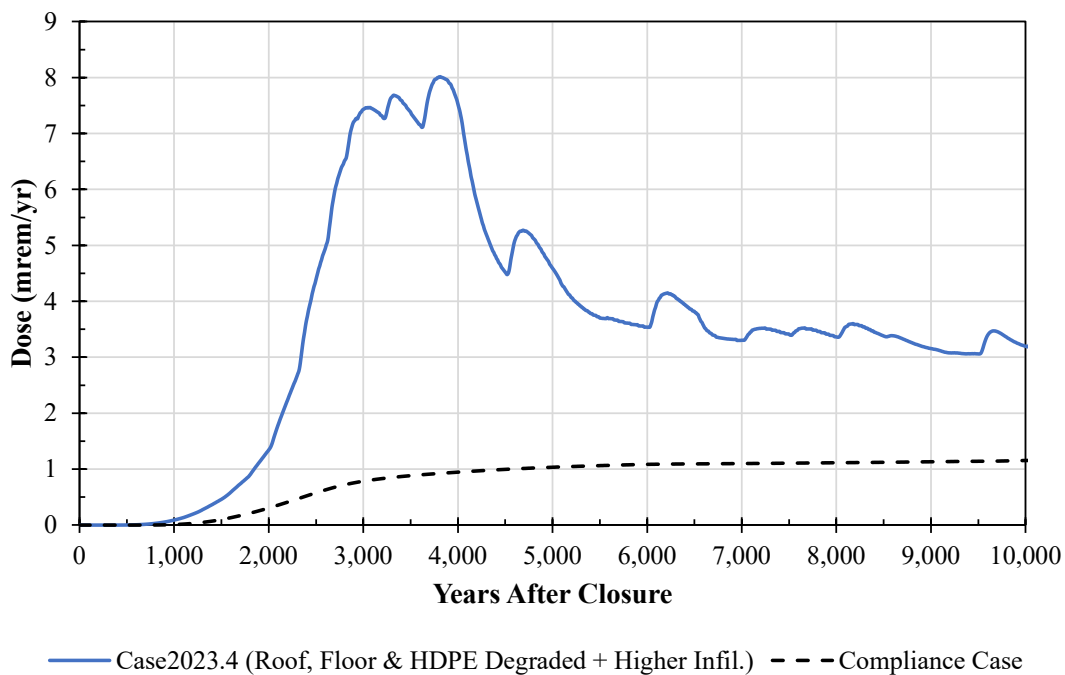
Figure 6.5-1: Dose Results Comparing the Compliance Case Against Case2023.4

Finally, Case2023.4 combines the increased infiltration rate from Case 2023.2 with the initially degraded HDPE and GCL from Case 2023.3. As expected, the combined affects from all of these conditions resulted in the highest peak dose among the sensitivity cases considered within this report. The peak dose in Figure 6.5-1 is approximately 8 mrem/yr at approximately 3,800 years after closure. While this peak dose is nearly seven times higher than the Compliance Case dose, it is still a factor of three lower than the 25 mrem/yr performance objective. Further, within the 1,000-year Compliance Period, the dose remains less than 0.1 mrem/yr, which may be considered a negligible dose.
