Technical Letter Report
TLR-RES/DE/MEB-2025-04
PNNL-37055

Alloy 690/152(M)/52(M) SCC Initiation Test 5.7-Year Summary Report

September 2025

Pacific Northwest National Laboratory

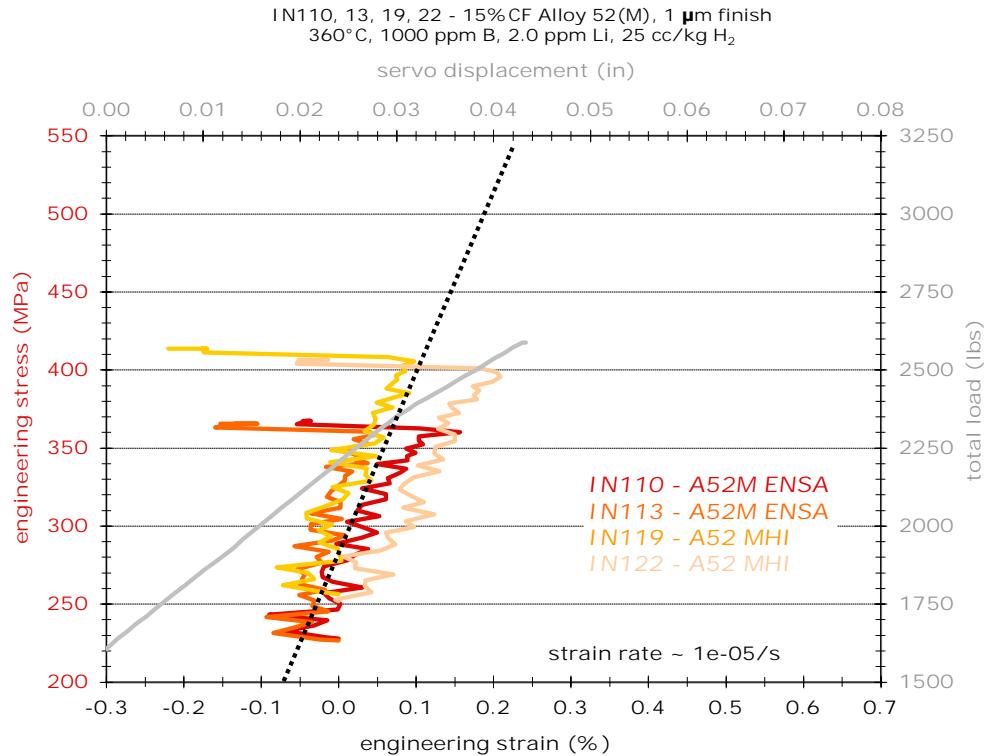
Figure 3. DCPD-indicated strain repositions of the Alloy 52(M) specimens during the initial attempt at the first load-up.

During the first load-up, unexpected, negative DCPD-indicated strain response was observed on 4 of the 12 instrumented specimens as shown in Figure 3. The load on the specimens was approximately 860 lb which was well below the target yield load of 1,000 lb, so there was little concern that something undesirable was happening with these specimens. However, this type of behavior had not been previously observed, and because the cause could not be immediately determined, the specimens were unloaded. After finding no issues with the test setup outside the autoclave, another load-up attempt was performed the next day.

The same behavior was observed during the second attempt, but this time, it happened with all 12 specimens. Load-up was continued to approximately 930 lb to see if the strain response would change, but it did not, so the test was stopped again.

This time the test was completely stopped, and the autoclave was opened to examine the load line, the specimens, and the DCPD wiring. No issues were observed with the specimens or the load line. However, several of the DCPD current wire spot welds to the specimens were found to have failed. The cause was determined to be inadequate spotwelding voltage.

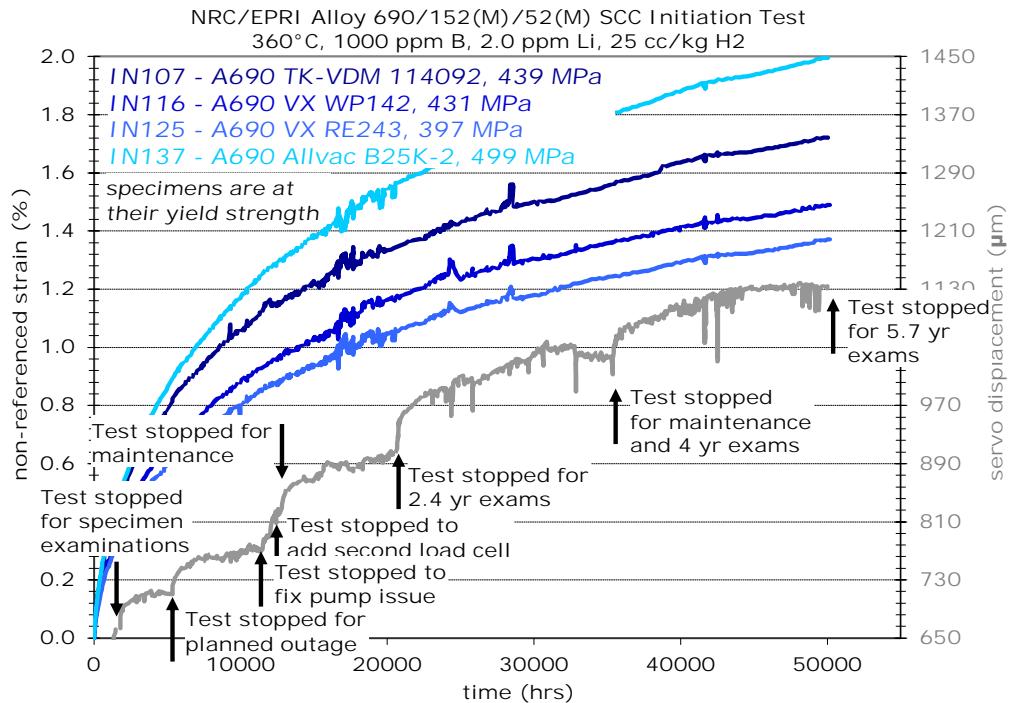
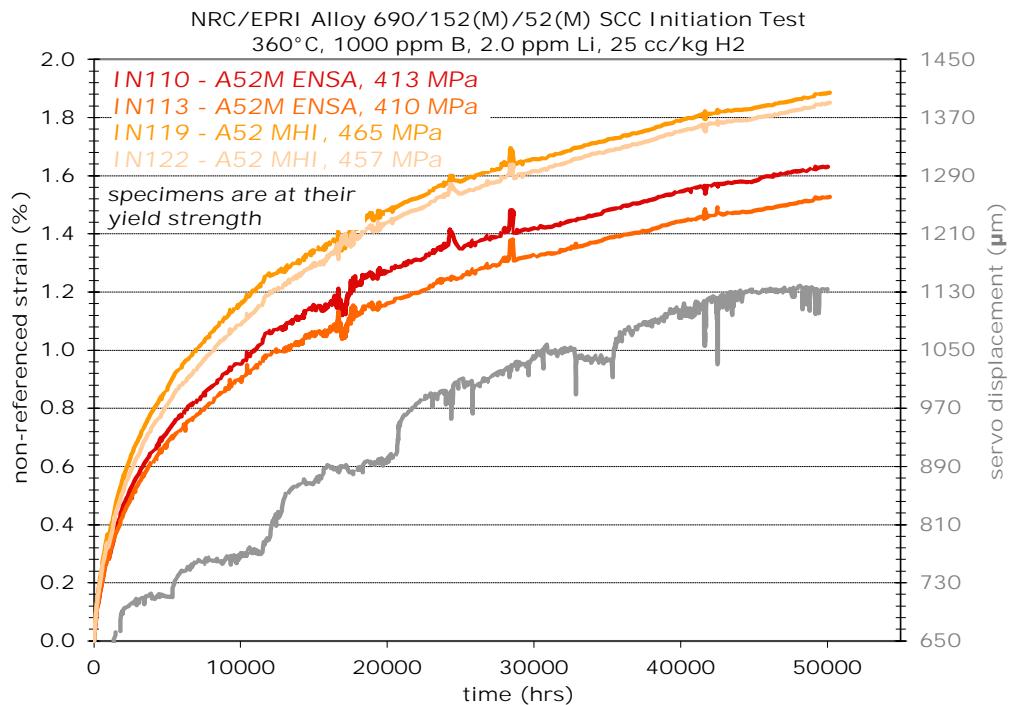
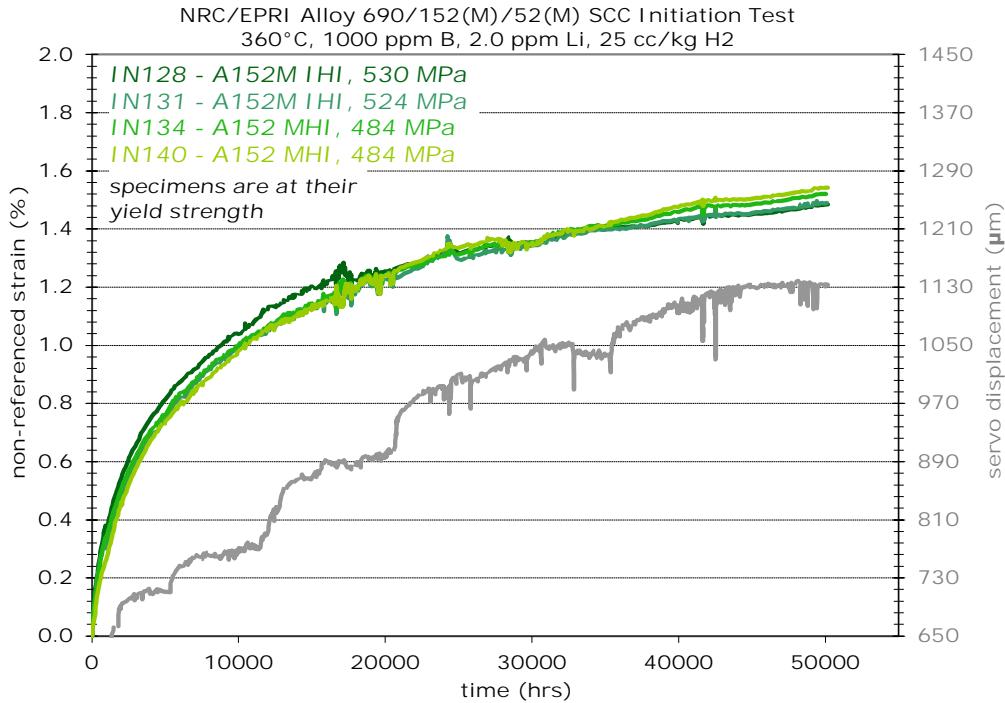
The responses of the 12 DCPD-instrumented specimens are presented in Figures 7–9 up to the current test time of 50,163 hours (5.7 years).. All twelve of the DCPD-monitored specimens exhibited a non-referenced strain response that is primarily due to resistivity evolution and creep of the materials and is not indicative of SCC initiation, in particular, none of the specimen traces exhibited a shift to a positive rate of curvature that is indicative of SCII.

Portions of the traces contain spikes in the values or periods of increased noise levels. These are primarily due to changes in DCPD system performance during the test and are not representative of specimen behavior. A few of the spikes are also due to building operational excursions that affected test temperature (DCPD readings change with test temperature) and room temperature (the output of the DCPD electronics have a slight room temperature sensitivity).

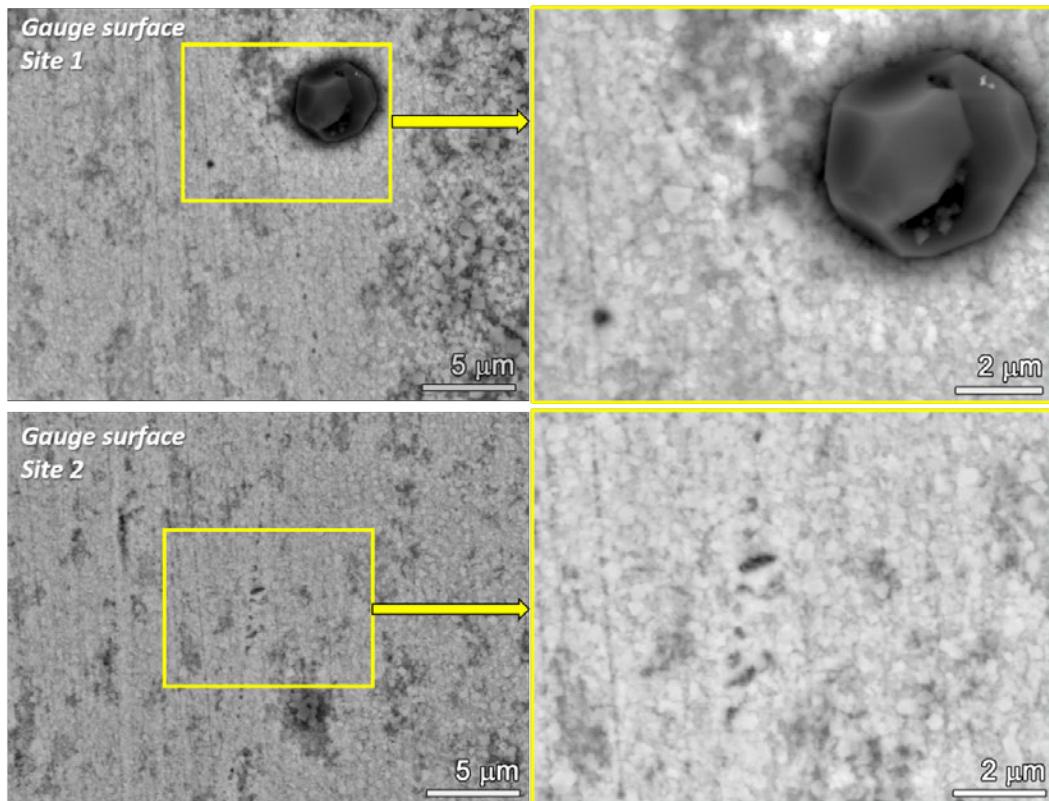
The 15% CF Alloy 690TT Valinox heat WP142 specimen IN118 exhibited “postage stamp” features at GBs on the gauge surface after 2.4 years of exposure with examples at two locations provided in Figure 12. After a total of 4.0 years of exposure, the entire gauge surface

Figure 12. Representative SEM-BSE images of the gauge surface of the 15% CF Alloy 690 CRDM Valinox WP142 specimen IN118 after 2.4 years of exposure.

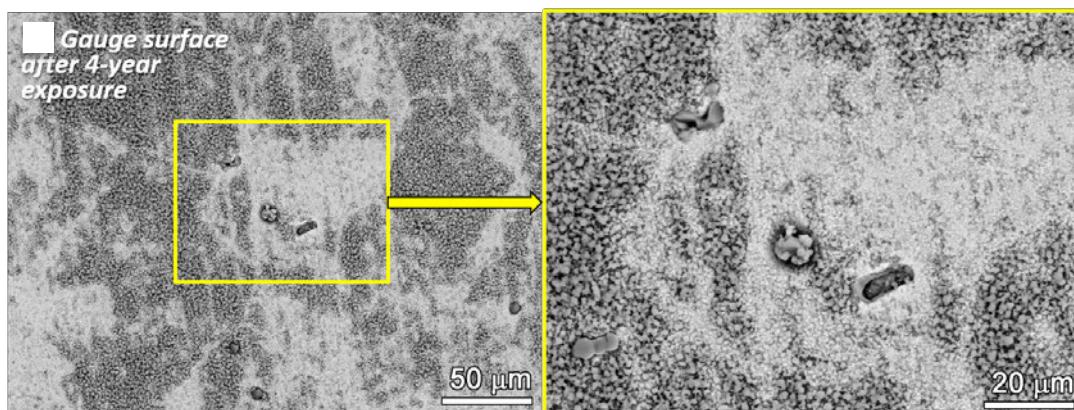
was covered by thick spinel oxides, obscuring detailed examination of the exposed grain boundaries as exemplified in Figure 13. This heat has a similar GB carbide distribution to the Valinox RE243 heat. Since the cavity distribution is believed to be similar to the Valinox RE243, no FIB trench cross-section examinations were performed on this specimen after 2.4 or 4.0 years of exposure.

Figure 13. SEM-BSE images of typical gauge surface appearance in the 1 μm finish of the 15% CF Alloy 690TT CRDM heat WP142 specimen IN118 after 4.0 years of exposure.

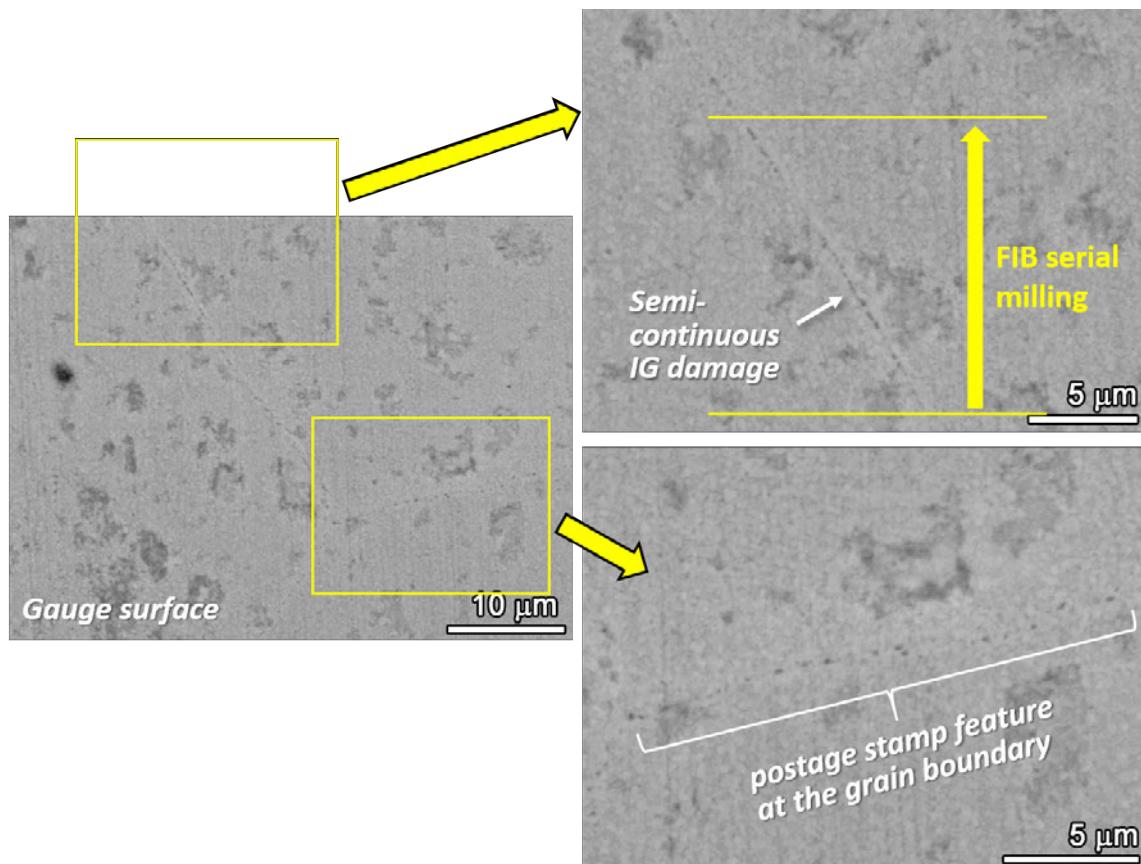
Coupled surface and FIB trench cross-section examinations were performed on one specimen of the Valinox RE243 CRDM heat after 2.4 and 4.0 years of exposure. As shown in Figure 15, “postage stamp” features were commonly observed at GB intersections with the surface of this specimen after 2.4 years. Serial FIB milling was performed along the GB over a distance of about 18 μm with examples showing the cross-section morphology in Figure 16. The cavities observed on the surface were found to be no more than 100 nm in depth, and as with the Valinox RE243 specimen, no GB cavities were found below the surface.

Figure 15. Representative SEM-BSE images of the gauge surface of the 15% CF Alloy 690 CRDM Valinox RE243 specimen IN126 after 2.4 years of exposure.

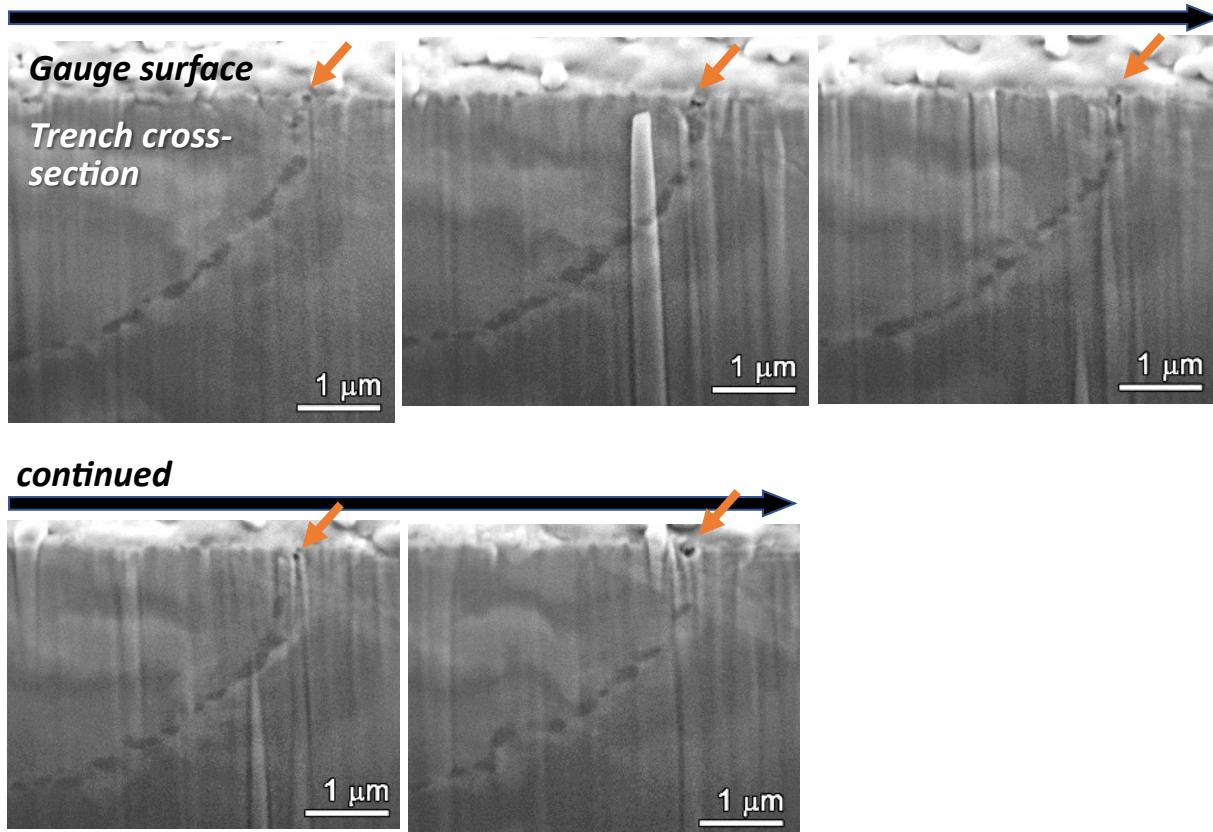
Sequential FIB serial milling images at 2.4 yrs

Figure 16. Selected FIB-SE serial trench cross-section images of IN126 after 2.4 years. These were taken along a selected portion of a GB highlighted in Figure 15. The small holes revealed at the GB intersecting the surface are highlighted by orange arrows.

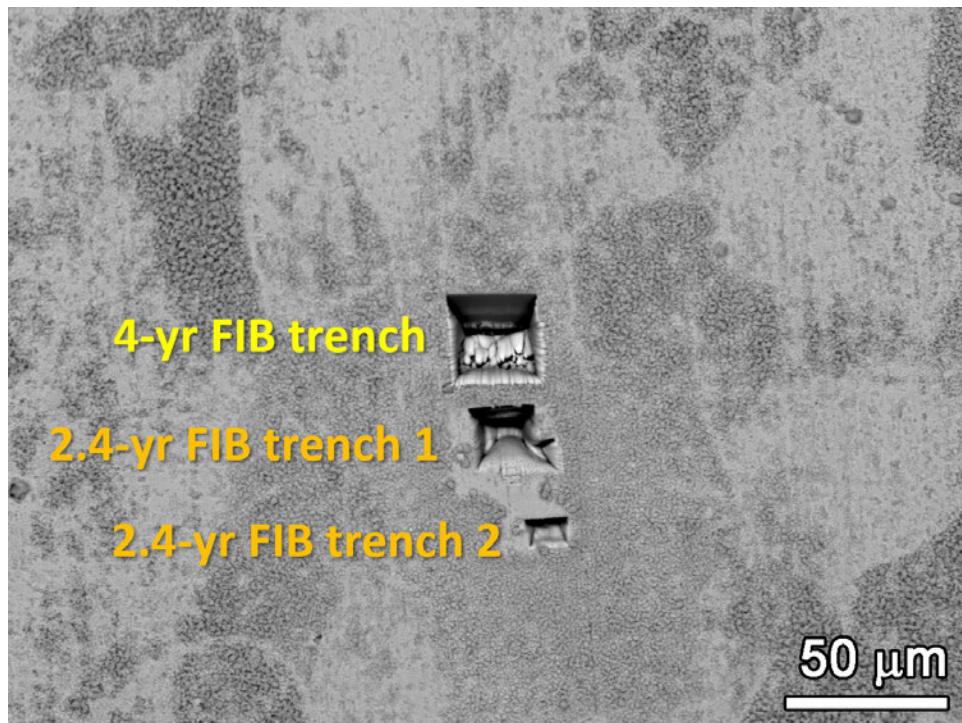
The same region was examined again after 4.0 years of exposure. Similar to IN108 (TK-VDM 114092) after 4.0 years, this specimen was covered by thick spinel oxides that prevented observation of the GBs intersecting the surface (Figure 17b). While no GB cavities were observed in FIB trench cross-sections after 2.4 years, serial FIB trench cross-sections at two different GBs after 4.0 years in the same specimen consistently revealed a small number of GB cavities in multiple cross-sections with some examples provided in Figure 18. This suggests that the formation of GB cavities appears to be possible in Alloy 690TT at near-service relevant CW levels after long-term testing; however, the overall density at this point in time is inconsequently low and may simply be growth of cavities produced during cold forging. It should also be noted that this heat exhibited a higher areal density of GB carbides than the Alloy 690TT TK-VDM plate heat. High densities of GB cavities have been found to promote GB cavity formation and growth. This led to crack initiation of two 31% CF specimens from the same heat of Alloy 690 after 3.2–3.7 years of exposure [23,26].

Figure 17. SEM-BSE images of typical gauge surface appearance in the 1 μm finish of the 15% CF Alloy 690TT CRDM heat RE243 specimen IN126 after 4.0 years of exposure in the same region shown in Figure 15.

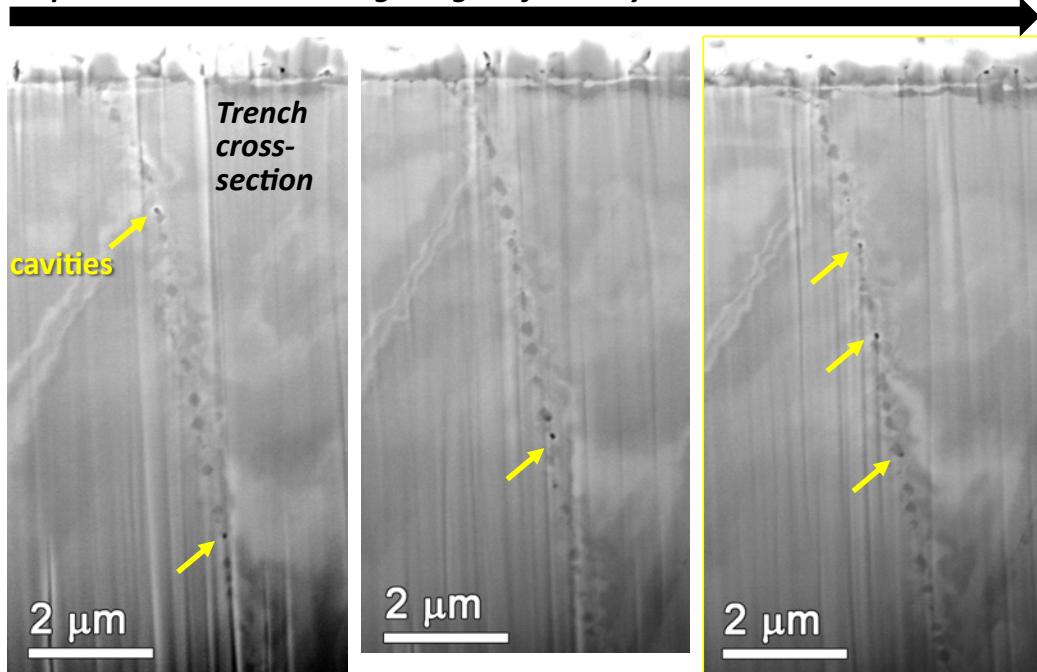
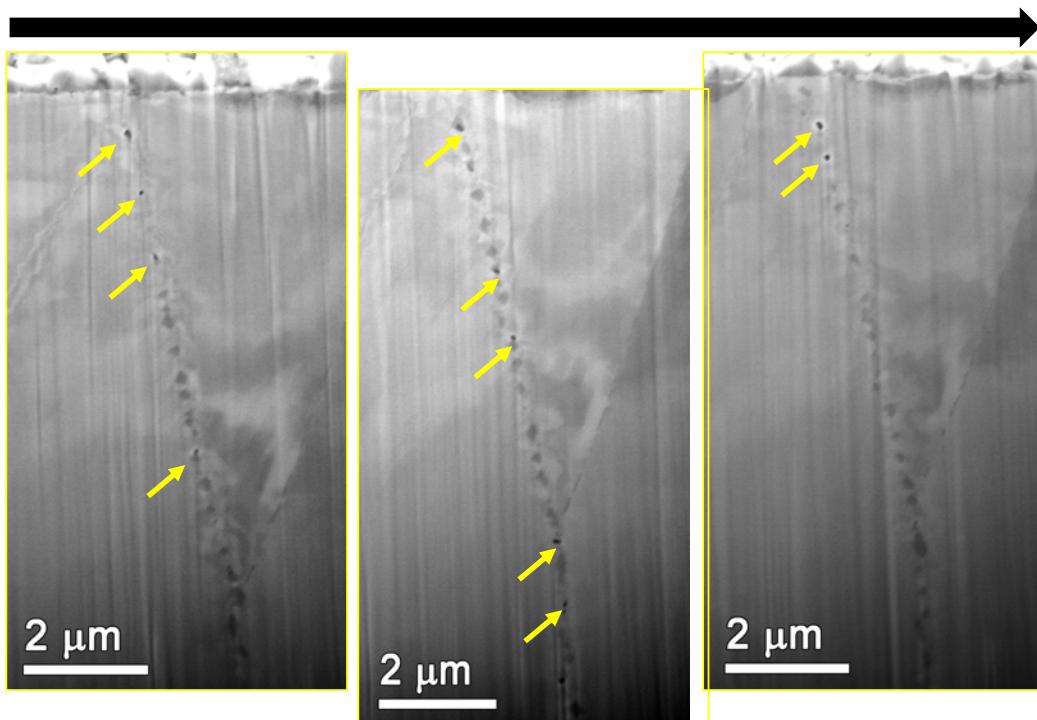
Sequential serial FIB milling images after 4.0 years

Figure 18. Selected FIB-SE serial trench images taken of IN126 along a randomly selected GB after 4.0 years of exposure. Cavities revealed in the cross-sections are highlighted in yellow.

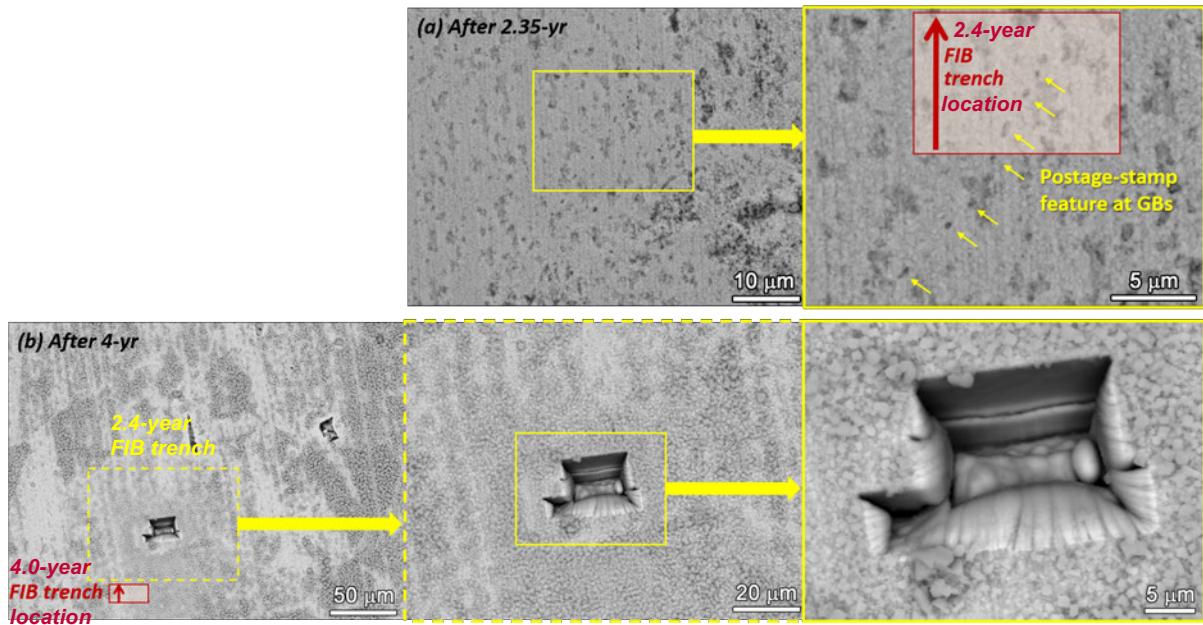
As shown in Figure 20a, no obvious cracks were observed on the surface of IN108 after 2.4 years, but many of the visible GBs in this specimen exhibited a “postage stamp” appearance whereby the GBs intersecting the surface of the specimen are decorated with what appear to be nano-sized, discrete holes or cavities. To better understand the nature of these features, serial FIB trenching was performed as shown in Figure 21 to reveal cross-sections of a portion of the GB highlighted in the red box in Figure 20a for examination of the subsurface morphology of these “postage stamp” features. A total of approximately 100 images were taken of serially obtained cross-sections over a distance of approximately 10 μm along the GB with representative images shown in Figure 22. Small cavities were only found on the surface where the GB exhibits the “postage stamp” features. This same heat of material in a 21% CF condition was examined under the DOE LWRS program at PNNL after approximately the same exposure duration and found to contain not only surface cavities but also a very limited number of nano-sized cavities in cross-section [23].

Figure 20. SEM-BSE images of typical gauge surface appearance of IN108 after (a) 2.4 and (b) 4.0 years of exposure. The images at 2.4 and 4.0 years were taken at similar locations.

SEM surface examination was again performed on the same specimen after 4.0 years of exposure as presented in Figure 20b. The observation was in the same location as the 2.4-year examination with the 2.4-year FIB trench noted in the image. After 4.0 years of exposure, the “postage stamp” features revealed above and below the 2.4-year trench are no longer visible due to formation of a thicker spinel oxide layer. While this thick surface oxide layer obscured the examinations of the surface, the 20 kV SEM accelerating voltage should be sufficient to resolve any open, small cracks despite the presence of the thick surface oxide. Thus, it is believed that no significant cracks were present after 4.0 years of exposure.

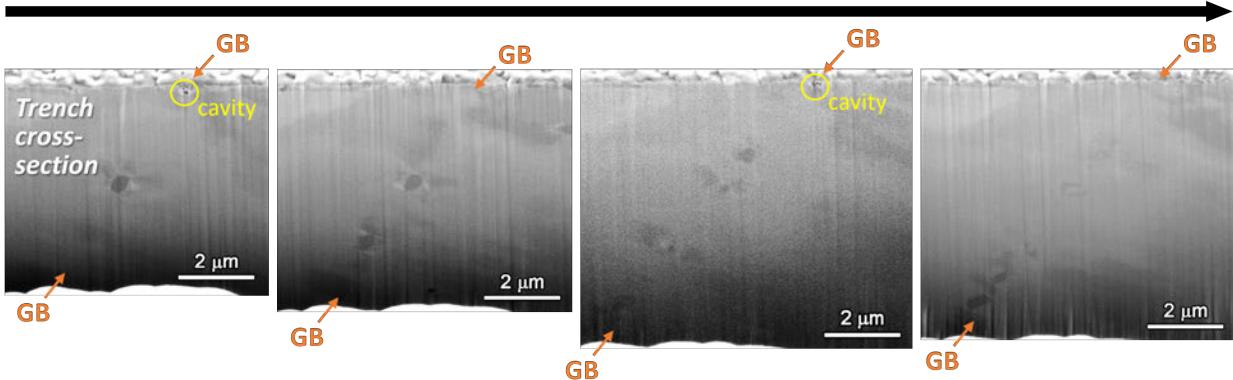
FIB serial milling (after 2.4-yr exposure)

Figure 22. Selected FIB-secondary electron (SE) serial trench cross-section images taken along a selected portion of a GB highlighted in the red box in Figure 20(a) after 2.4 years of exposure in IN108.

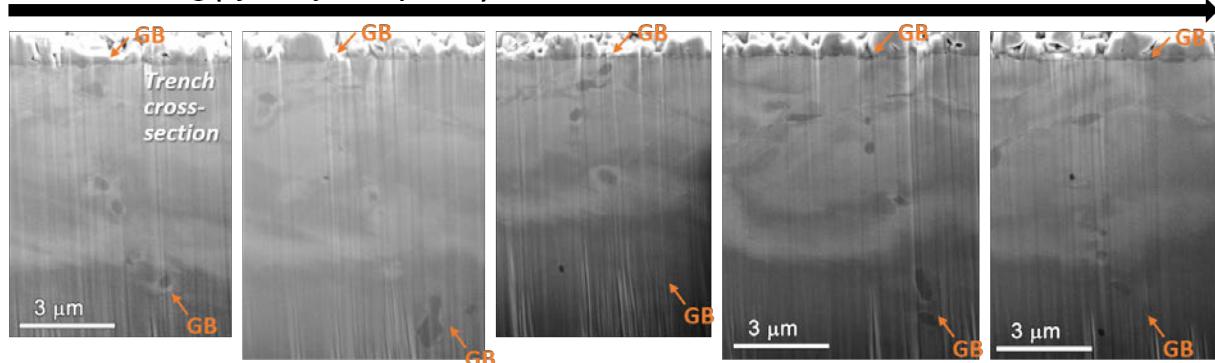
FIB serial milling (after 4-year exposure)

To investigate whether cavities had grown or increased in quantity, serial FIB trenching was again performed along the same GB at the site marked by a red box in Figure 20b (left image) with representative images of the cross-sections shown in Figure 23. Although the orientation of the GB examined after 4.0 years (Figure 23) is different than the one observed at 2.4 years (Figure 22), the carbide density and size are similar between the two observations. No cavities were observed in the multiple cross-sections revealed during serial FIB milling, suggesting little or no cavity formation or growth in this material after a total exposure of 4.0 years. In comparison, the same material tested under DOE LWRS program in the 21% cold rolled condition exhibited multiple obvious short cracks at the surface associated with cavity evolution after 4.0 years of exposure [23]. Increased cavity formation and coalescence also led to macro-sized crack formation and DCPD detection of crack initiation at approximately 3.7 years of exposure in a 31% CF specimen from the same material [26].

Figure 23. Selected FIB-SE serial trench cross-section images taken after 4.0 years of exposure of IN108 along the same GB trenched after 2.4 years. The GB included in this serial milling is highlighted in the red box in Figure 20(b).

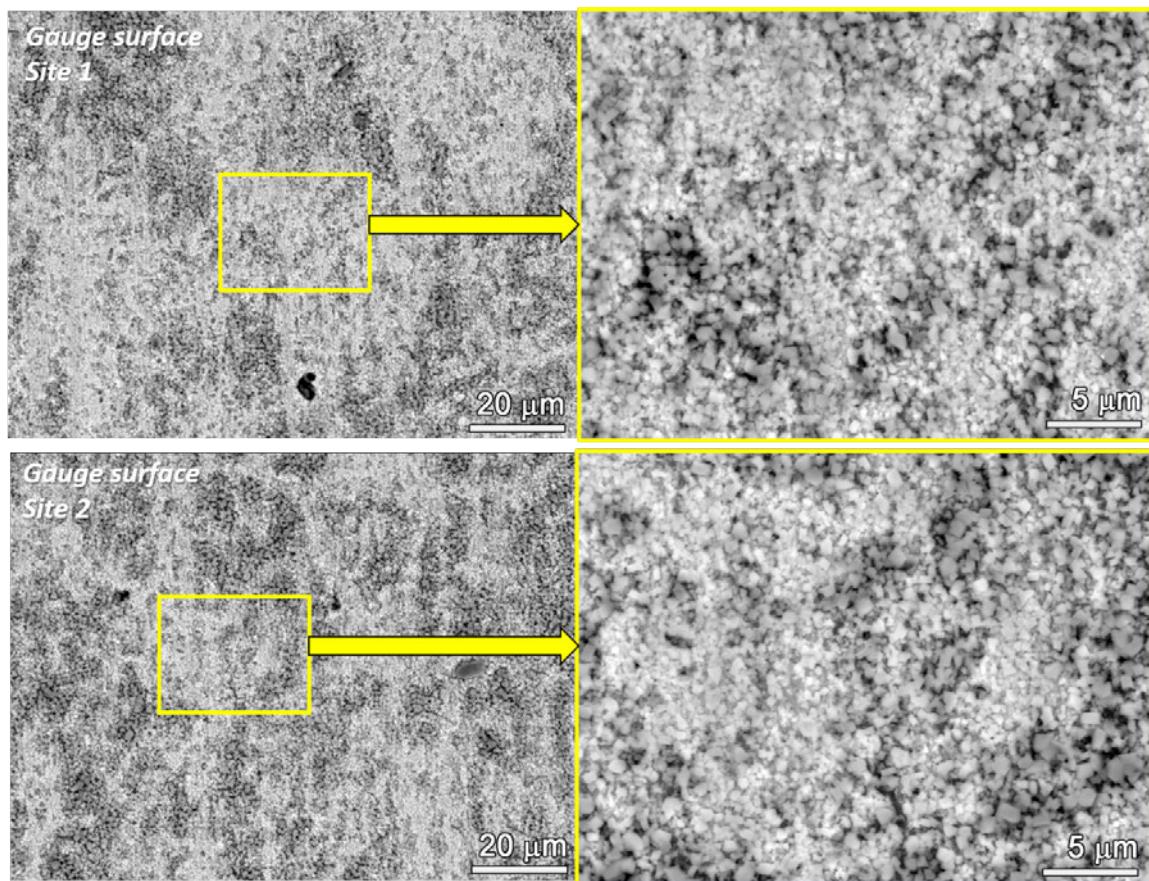
As shown in Figure 25, after 2.4 years, the IN137 specimen exhibited a thick spinel oxide layer on the gauge surface, obscuring a clear examination of GB features. As expected, the surface was even more heavily covered in spinel oxides after 4.0 years with an example of the specimen surface provided in Figure 26. No FIB trenching or serial milling were performed on this specimen during the test interruptions.

Figure 25. Lower and higher magnification SEM-BSE images of the gauge surface of the 15% CF Alloy 690MA bar Allvac B25K-2 specimen IN137 after 2.4 years of exposure.

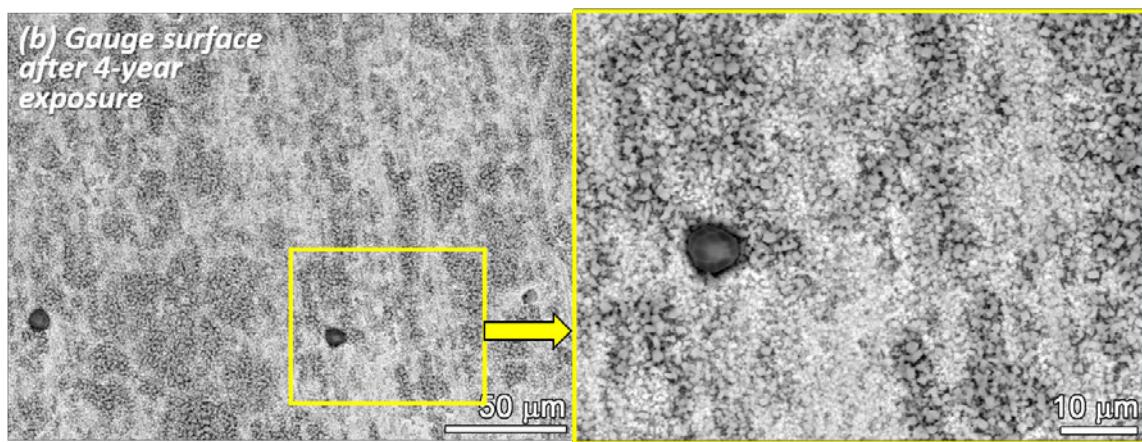
Figure 26. Lower and higher magnification SEM-BSE images of typical gauge surface appearance of the 15% CF Alloy 690MA bar Allvac B25K-2 specimen IN137 after 4.0 years of exposure.

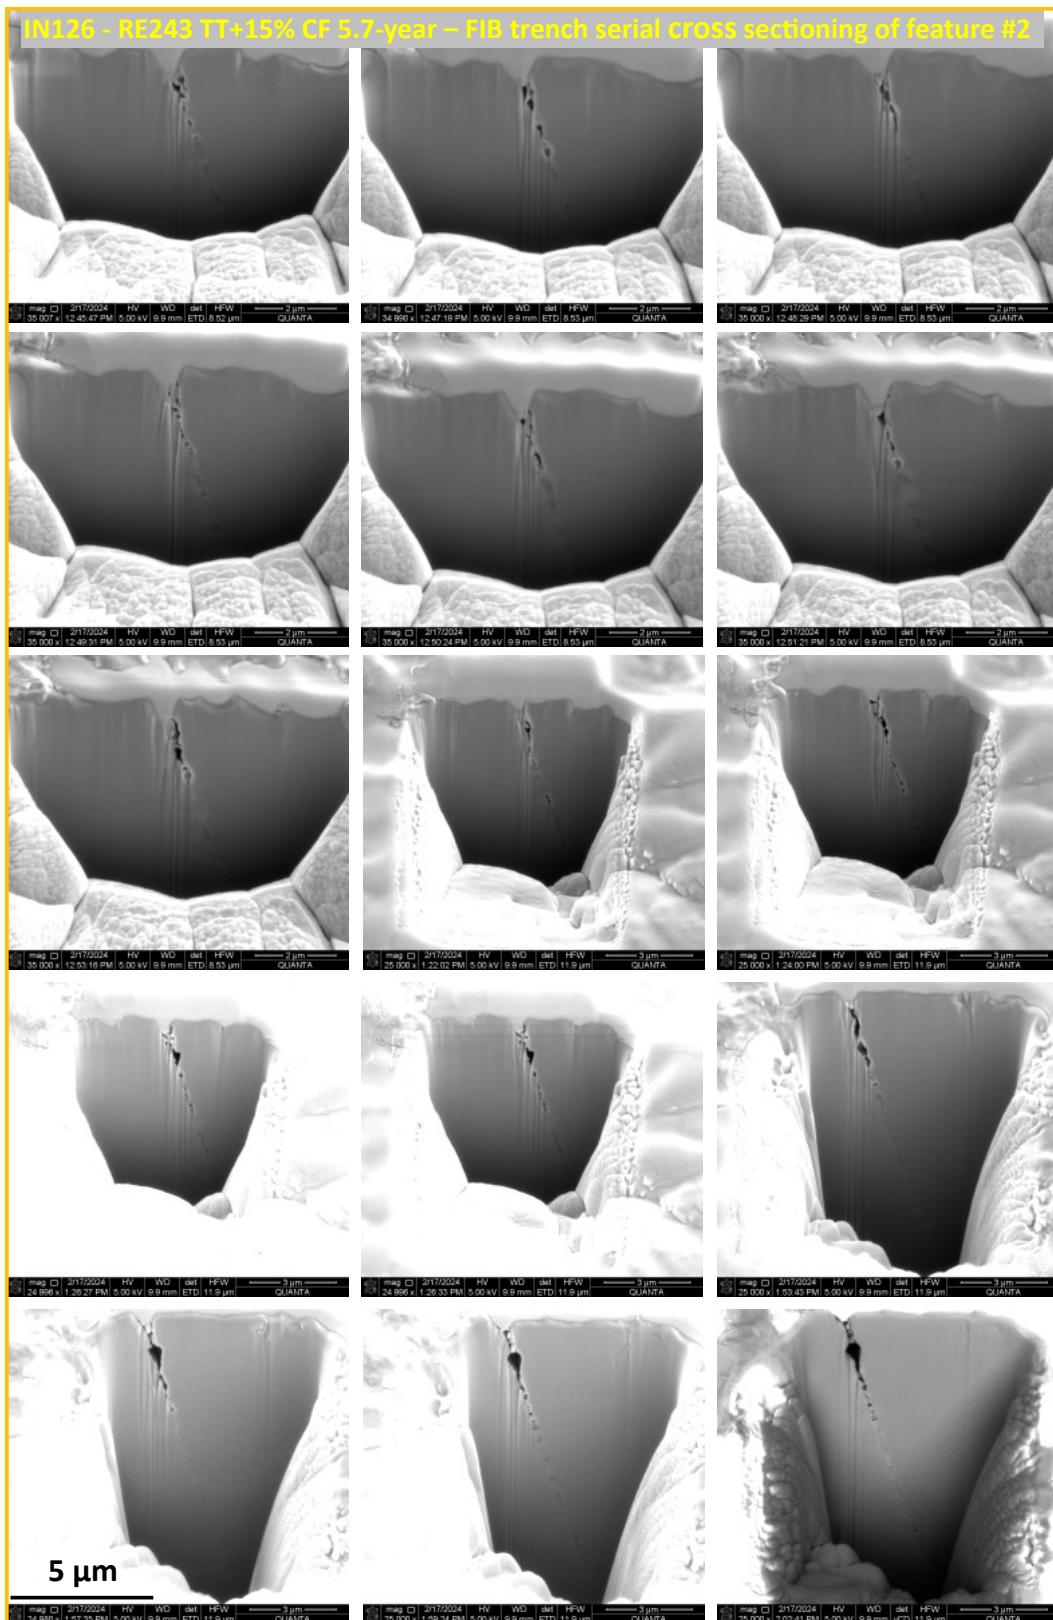
It is notable that even in the RE243 with the highest density of GB carbides and therefore the highest likelihood for GB cavity formation that there were only three suspect GBs. Detailed serial FIB trench cross-sectioning was performed on feature #2 with a subset of the cross-section images provided in Figure 31. A high density of large GB cavities is present down to a depth of 5 μm or more in many of the images, and higher resolution images such as shown in Figure 32 reveal that small cavities are present to a depth of >15 μm . The serial FIB trench images indicate that feature #2 is a shallow, 5 μm deep crack that formed as a result of GB cavity formation and coalescence. This is far too shallow of a crack to be of practical significance, but the rate at which the depth of the crack may be extending due to additional creep cavity formation cannot be determined from these images. Subjecting the specimen to additional SCCI testing would be the best means to accomplish this. Despite the formation of this shallow crack, which suggests that SCCI has the potential to occur in 15% CF material, it is important to keep in mind that this was the only obvious crack in all 12 of the Alloy 690 SCCI specimens.

Figure 31. IN126 (RE243) feature #2 FIB trench serial cross-section image series. The progression of the images is to the right and then down.

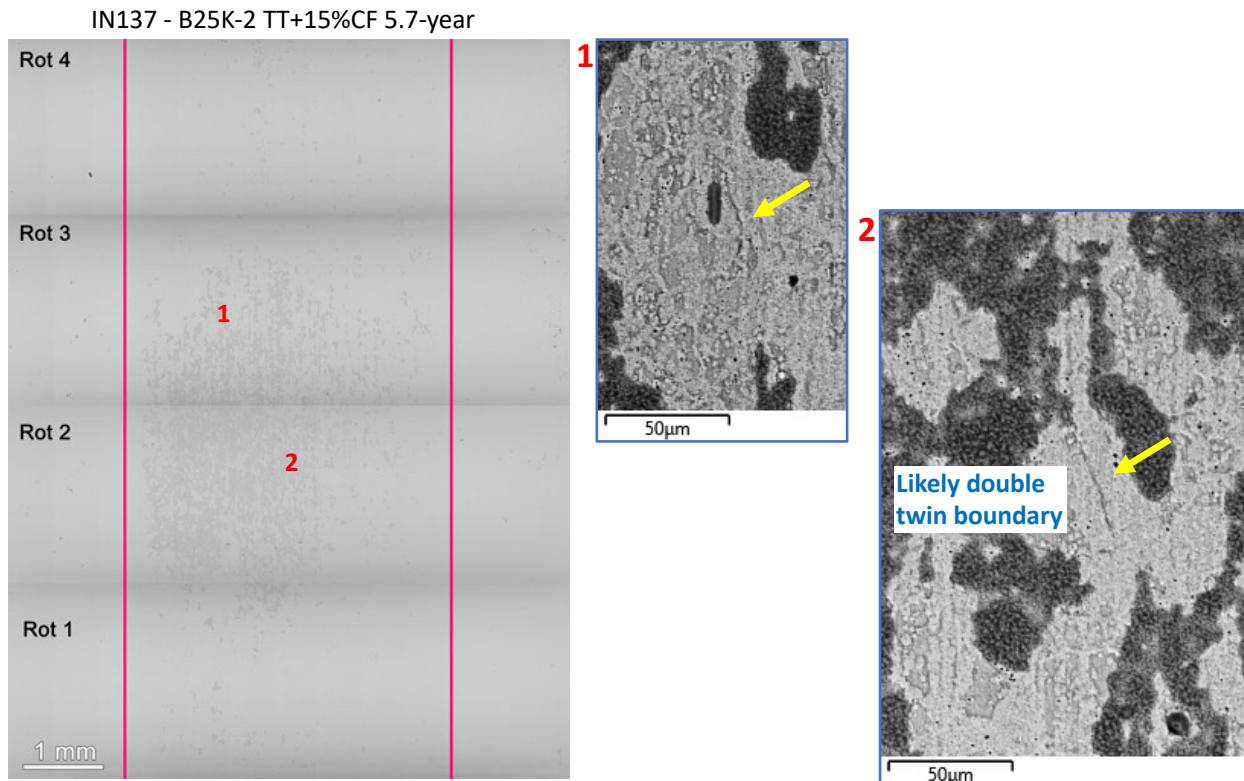
As previously mentioned, the heat B25K-2 specimens exhibited the least SCC susceptibility to high temperature water exposure. The only boundaries with dark contrast appeared to be double twin boundaries as shown, for example, in Figure 33 which is a gauge surface summary of the IN137 B25K-2 specimen. Both features are straight lines running across a clear region surrounded by mostly darker (more heavily oxidized regions). This is highly suggestive that these are double twin boundaries, and FIB trench cross-sectioning confirmed that feature #2 is a double twin boundary. To obtain information from a high angle GB, one such boundary aligned to the stress was selected for FIB trench serial cross-section imaging. Within the 34 images that were obtained over tens of micrometers along the crack, no carbides or cavities were observed. Typical example images are shown in Figure 34. Note that in image 29 (right-hand image in Figure 34), two GBs are intersecting, confirming that this is not a twin boundary.

Figure 33. IN137 B25K-2 specimen 5.7-year gauge surface summary.

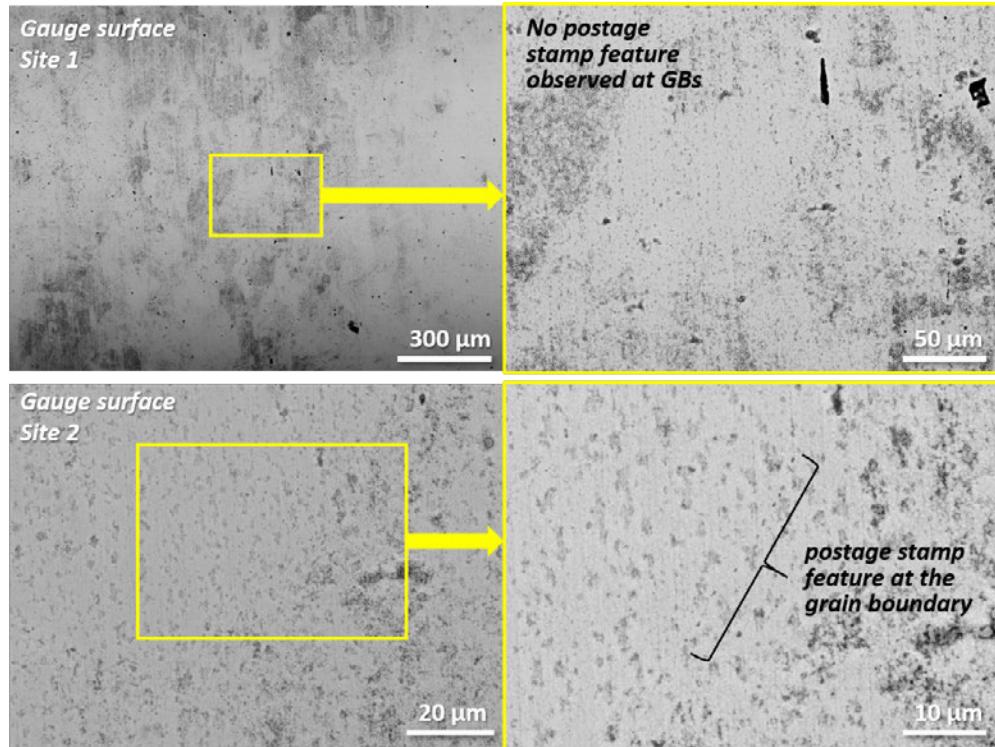
Similar to the three Alloy 690TT specimens (IN108, IN118, and IN126), GBs in the 15% CF Alloy 52M ENSA DPM specimen IN112 also has some “postage stamp” features on the surface after 2.4 years of exposure (Figure 35), but these features were not as extensive as seen in the Alloy 690TT specimens. Two nearby regions along a GB were examined in cross-section by serial FIB trenching after 2.4 years on a GB that did not have a clear indication of postage stamp features (Figure 36). Serial milling along the direction of the GB covering a distance of approximately 5 μm was performed in one of the trenches as illustrated by the sequence of images in Figure 36b, and the other trench was made for a quick examination of the cross-section morphology of the investigated GB. A high density of IG precipitates was revealed in both locations, but no IG defects were observed in either of them.

Figure 35. Representative SEM-BSE images of the gauge surface of the 15% CF Alloy 52M ENSA DPM specimen IN112 after 2.4 years of exposure.

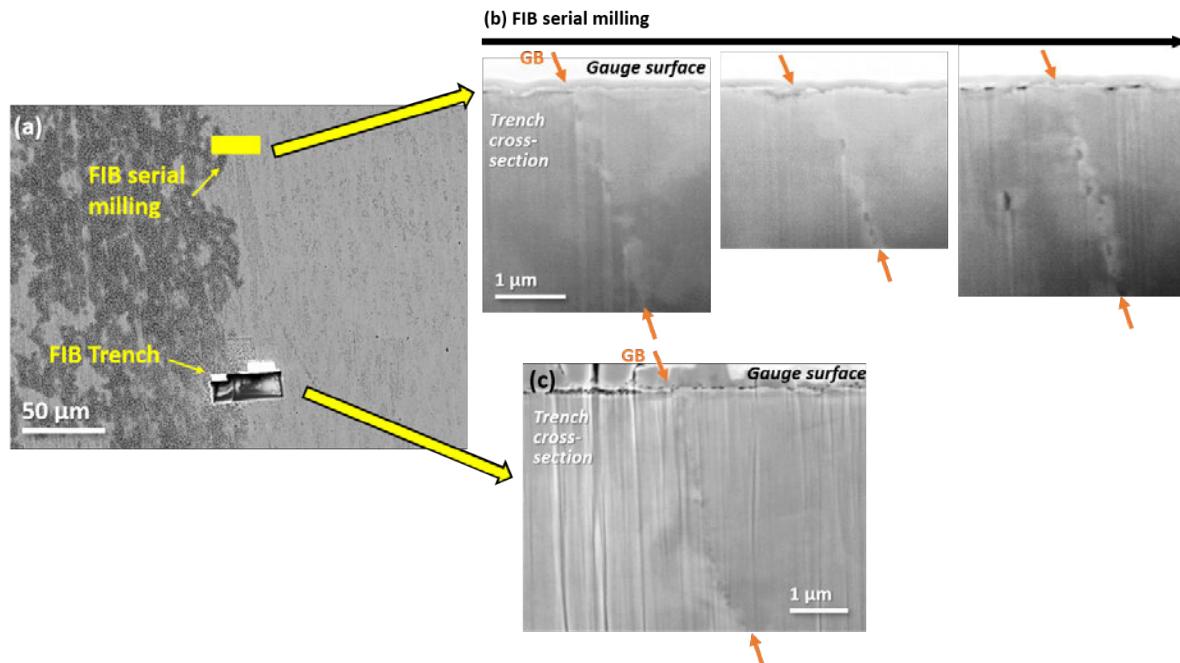
Figure 36. (a) SEM-BSE image showing the location of the two FIB trenches in IN112 made at the 2.4-year test interruption, (b) examples of the FIB-SE images taken during the serial FIB milling along the selected portion of a GB identified in (a), and (c) FIB-SE image showing the cross-section of the trench at the location identified in (a).

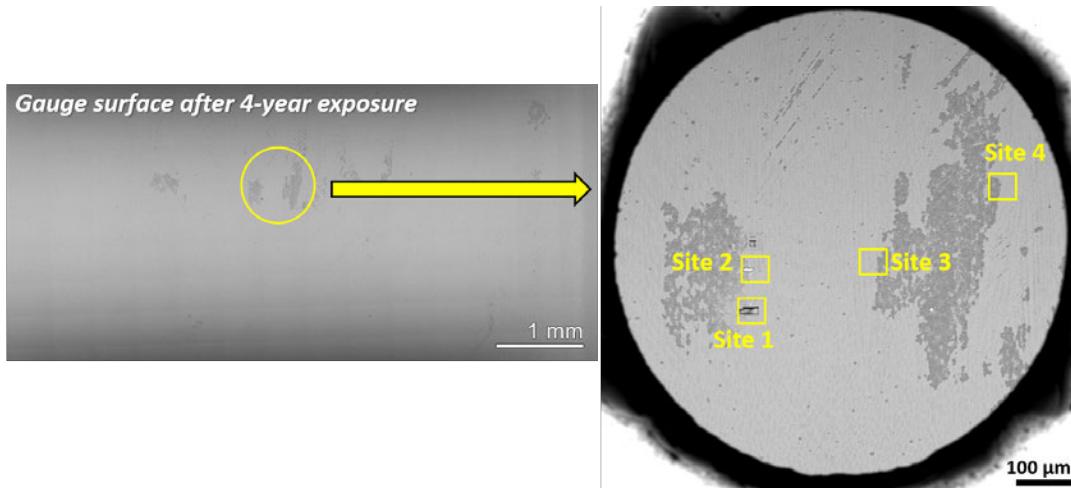
This specimen was examined again at the 4.0-year test interruption. Four sites were examined in detail in the vicinity where the FIB trenches were made after 2.4 years of exposure (Figure 37).

Figure 37. Representative SEM-BSE images of the gauge surface of the 15% CF Alloy 52M ENSA DPM specimen IN112 after 4.0 years of exposure.

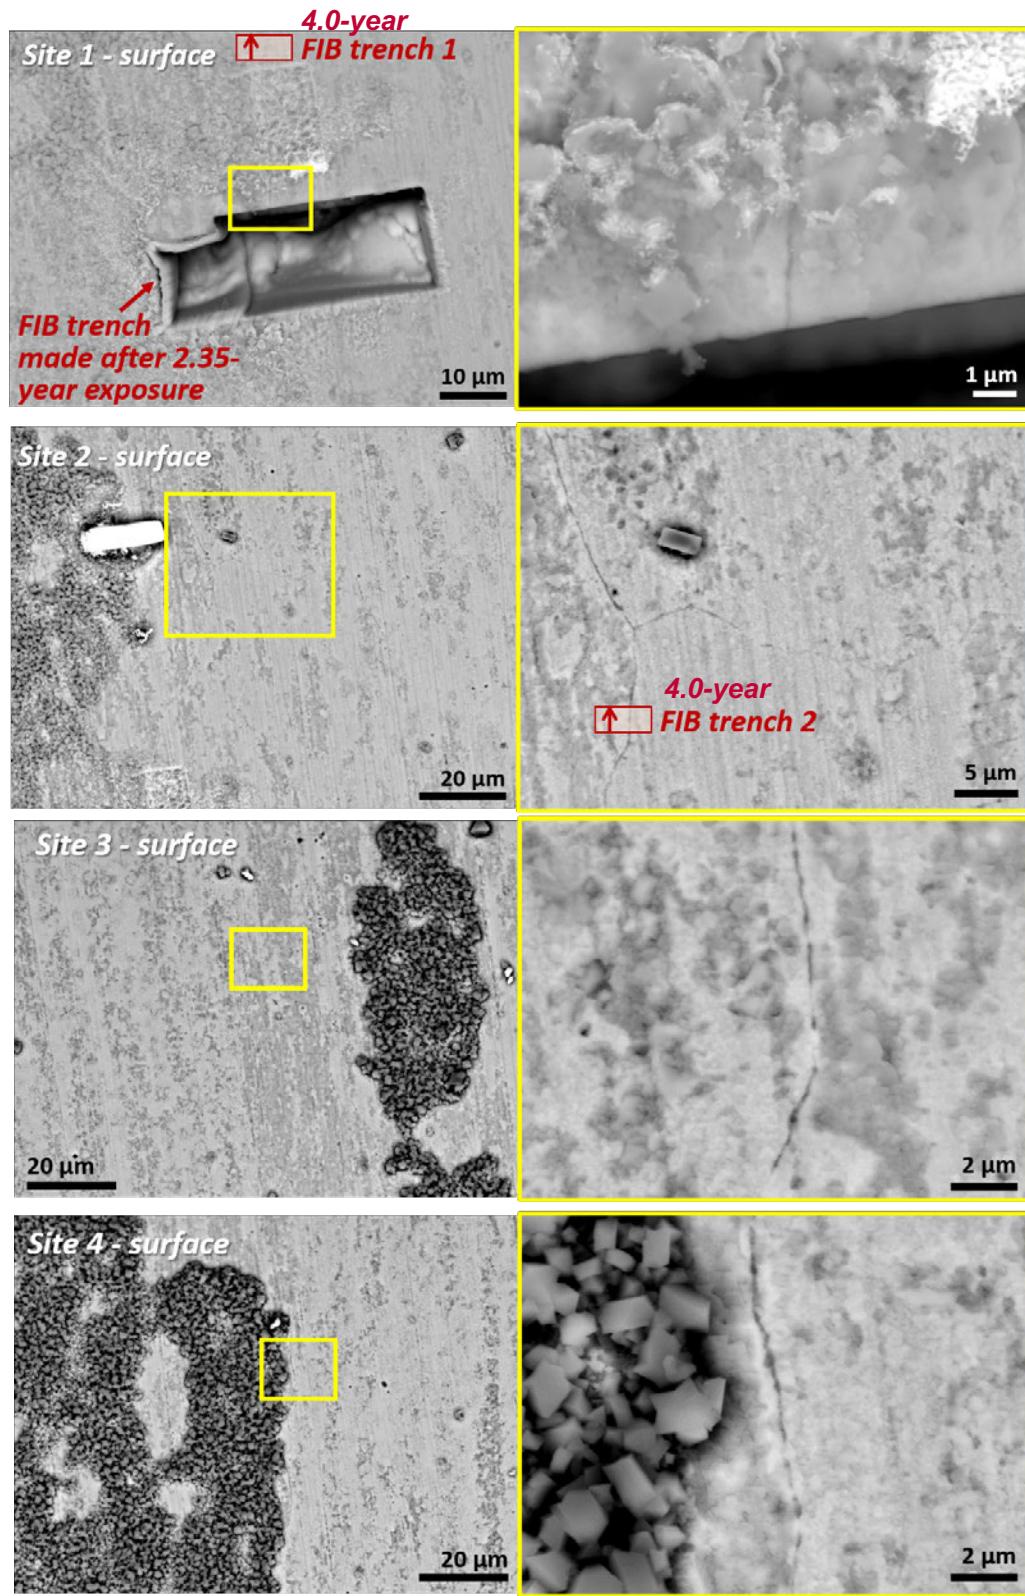
In general, the surface oxide in this specimen is thin enough to allow the SEM to probe the GB appearance at the surface of the specimen. As shown in Figure 38, the GBs appeared as a dark line of contrast at all four sites. This is different from the occasional, discrete postage stamp-like features observed after 2.4 years, indicating a progression in GB microstructure, at least near the surface of the specimen.

Figure 38. Detailed examination of surface morphology at the four sites highlighted in Figure 37 in IN112 after 4.0 years of exposure.

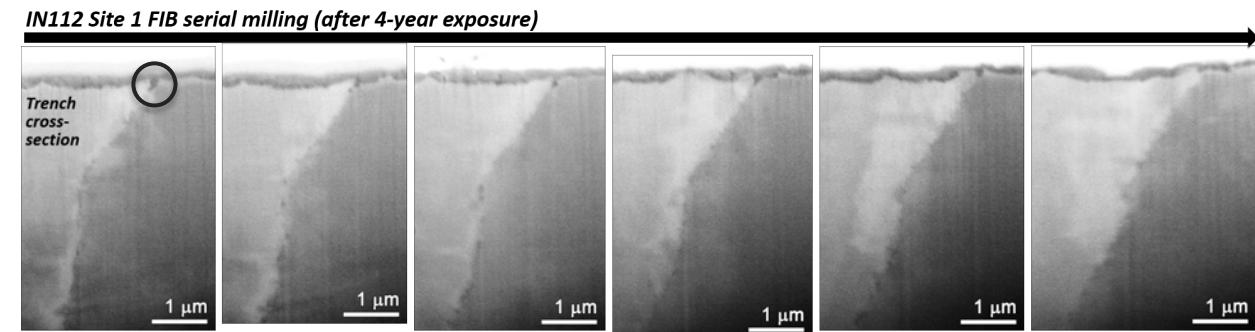
To better understand this continuous dark line contrast, two small FIB trenches were made at locations marked at Sites 1 and 2 in Figure 38, and serial milling was performed in both trenches with results shown in Figures 39 and 40, respectively. The dark contrast appears to be due to very shallow GB oxidation to a depth of no more than 100 μm . Both GBs feature a high density of very small, nm-sized IG precipitates, but no cavities or cracks are present.

Figure 39. Selected FIB-SE images taken during the serial FIB milling along a trench made after 4.0 years of exposure along the same GB where the first trench was made after 2.4 years of exposure in IN112 (Figure 38 Site 1). An example of the shallow GB oxidation is within the black circle.
