Technical Letter Report
TLR-RES/DE/MEB-2025-04
PNNL-37055

Alloy 690/152(M)/52(M) SCC Initiation Test 5.7-Year Summary Report

September 2025

Pacific Northwest National Laboratory

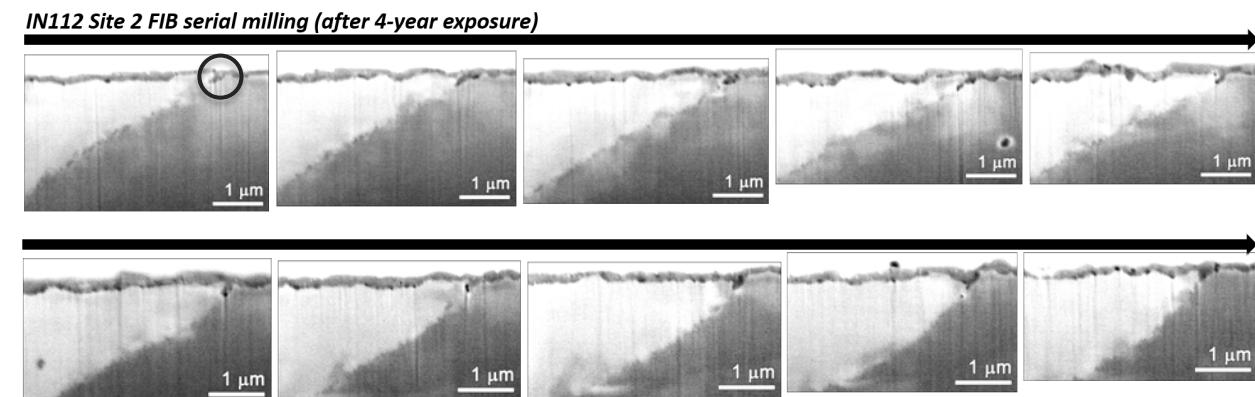
To better understand this continuous dark line contrast, two small FIB trenches were made at locations marked at Sites 1 and 2 in Figure 38, and serial milling was performed in both trenches with results shown in Figures 39 and 40, respectively. The dark contrast appears to be due to very shallow GB oxidation to a depth of no more than 100 μm . Both GBs feature a high density of very small, nm-sized IG precipitates, but no cavities or cracks are present.

Figure 40. Examples of the FIB-SE images taken during the serial FIB milling along a randomly selected GB at Site 2 (the exact region is marked in Figure 38) after 4.0 years of exposure in IN112. An example of the shallow GB oxidation is within the black circle.

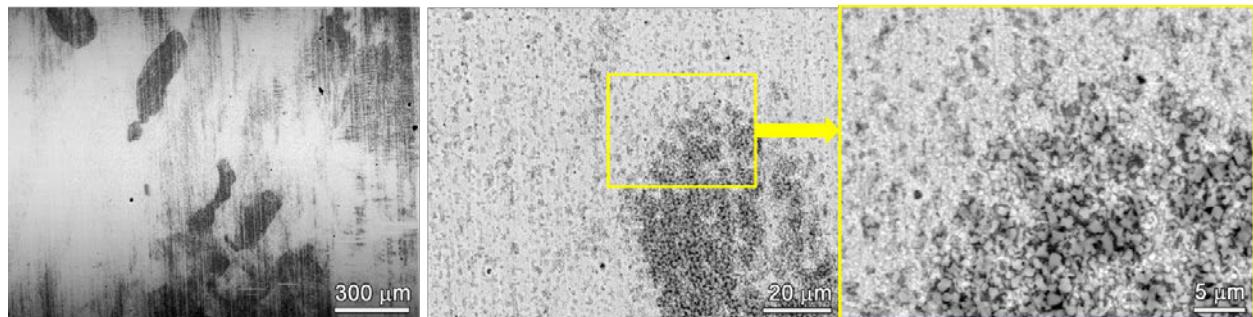
Only gauge surface examinations were performed on this specimen. A non-uniform distribution of surface oxides was present on the gauge surface after both 2.4 and 4.0 years of exposure. As shown in both Figures 41 and 42, the grains were partially revealed possibly due to grain orientation-dependent formation of spinel oxides, and potential location of GBs could be traced by identifying the edge between regions of spinel oxide with significant difference in contrast such as those presented in higher magnification images in these two figures. However, even at regions where GBs likely reside with thinner surface oxides, IG damage were not identifiable after either 2.4 or 4.0 years of exposure.

Figure 41. Representative SEM-BSE images of the gauge surface the 15% CF Alloy 52 MHI specimen IN124 after 2.4 years of exposure.

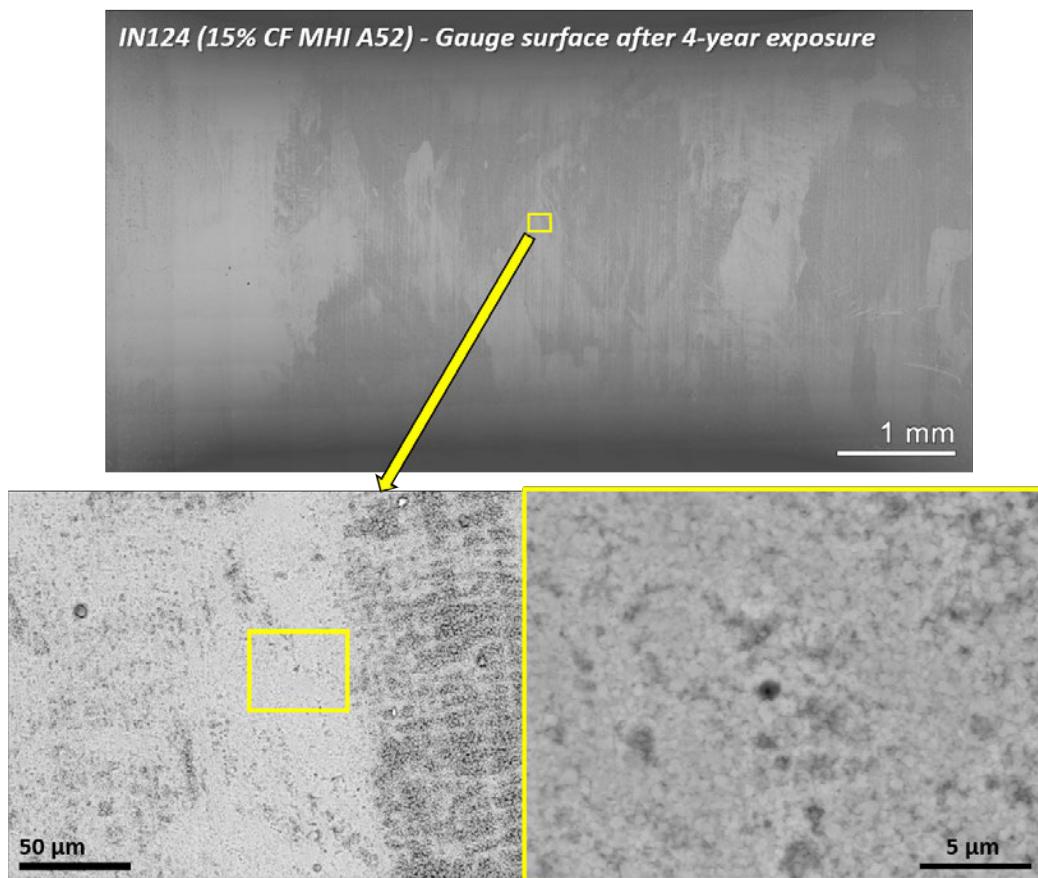
Figure 42. Representative SEM-BSE images of the gauge surface of the 15% CF Alloy 52 MHI specimen IN124 after 4.0 years of exposure.

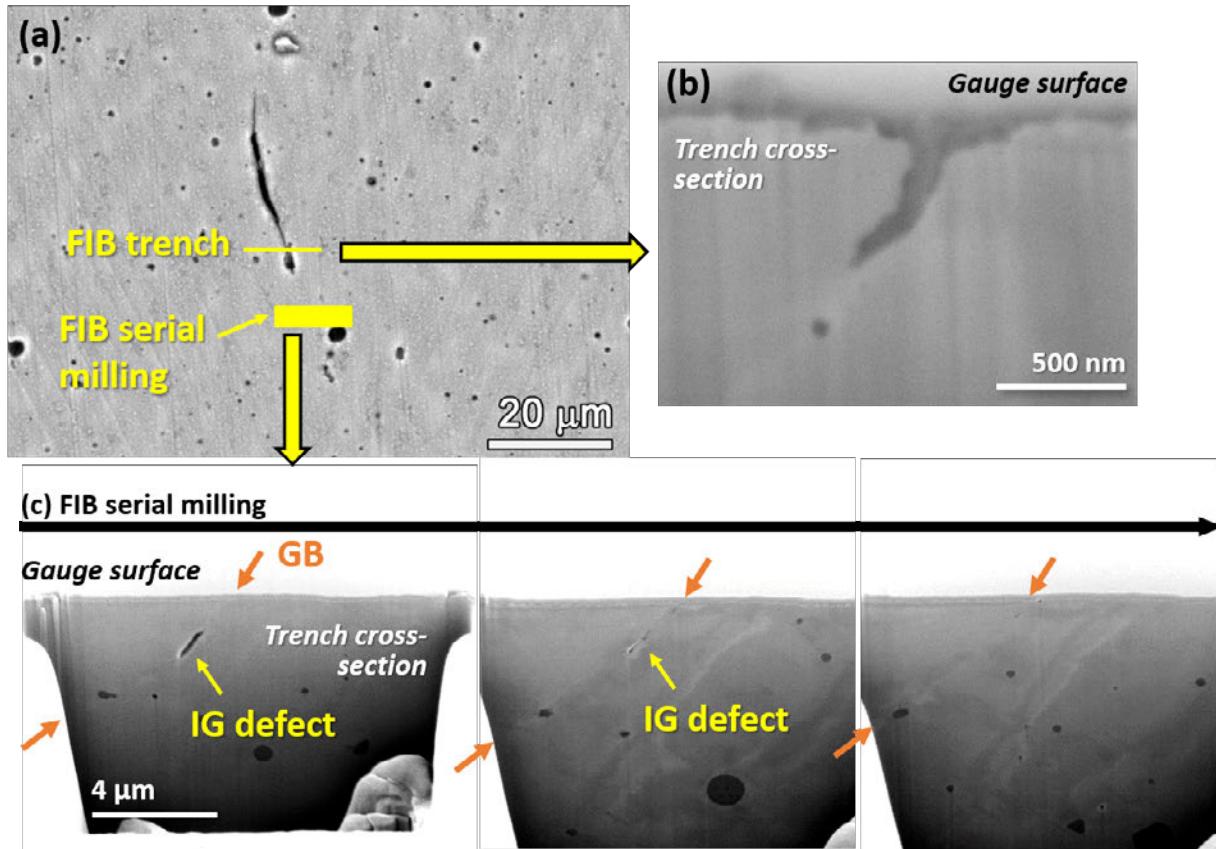
To better understand these IG cracks, FIB was employed to make shallow trenches of approximately 6 μm in depth at two locations on Crack 1 as shown in Figure 44(a). The first trench was made at the lower tip of Crack 1 to examination the cross-section morphology of the crack. As shown in Figure 44(b), no crack opening was observed, and instead only a shallow but wide IG oxidation with a penetration depth of approximately 500 nm from the surface was found. While this depth is extremely shallow, the open nature of this feature suggest that it is a crack. No other IG defects such as cavities were observed in the near-surface region. To preserve this crack-like feature for future exposure and documentation of its evolution over time, a second trench was made approximately 10 μm away from the lower tip of the crack, and serial milling across a span of approximately 5 μm on the surface was performed.

Figure 44. (a) SEM-BSE image showing the location of the two FIB trenches in IN128, (b) FIB-SE image showing the cross-section of the trench at the location identified in (a), and (c) examples of the FIB-SE images taken during the serial FIB milling along the selected portion of a GB identified in (a).

No indication of GB cavities or intergranular oxidation was present in these cross-section images. However, a subsurface, lack-of-fusion type defect was revealed during the serial milling at approximately 2 μm below the surface along the GB (Figure 44c). This suggests that the surface crack may be associated with the subsurface welding defect, thereby making the surface crack a preexisting crack rather than a new crack formed during the long-term exposure. However, more examinations are needed to confirm this deduction.

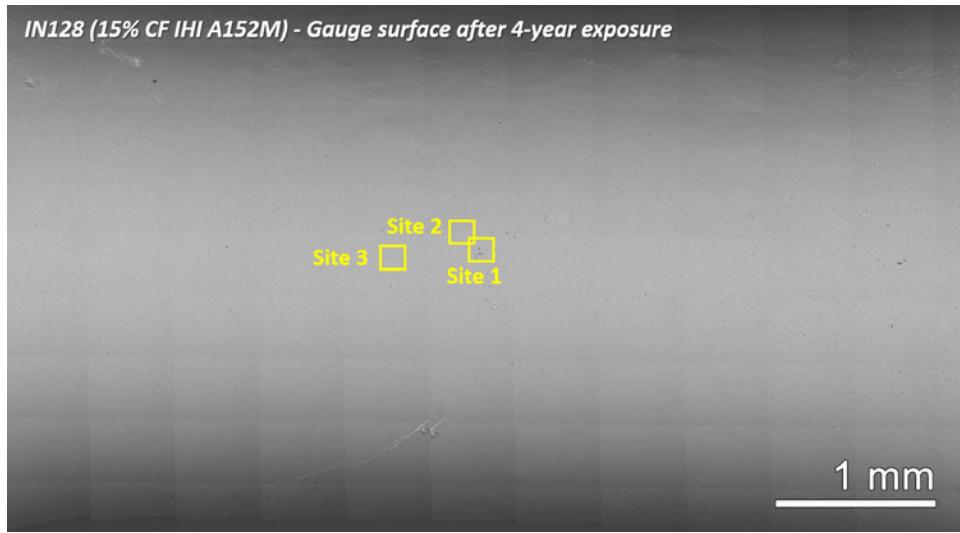
After 4.0 years of exposure, higher resolution imaging was performed at additional sites to see whether more cracks could be identified (Figure 45). As shown in Figure 46, at least one crack-like feature was observed in each site, suggesting that this specimen may indeed exhibit a higher than usual density of cracks. However, it should be noted that all the crack-like features have a very short surface length. The longest crack in this specimen was observed at Site 1 (Figure 46(a)) and had a total surface length of approximately 30 μm. Not all of these cracks were recorded in detail during the 2.4-year test interruption, making it difficult to determine when these cracks formed. Nevertheless, some insights regarding this matter could be obtained by coupled SEM-FIB examinations of the two cracks that were documented at both test interruptions.

Figure 45. SEM-BSE low-magnification montage of the gauge surface of one rotation of the 15% CF Alloy 152M IHI specimen IN128 after 4.0 years of exposure. Sites examined at higher resolution for cracks are highlighted.

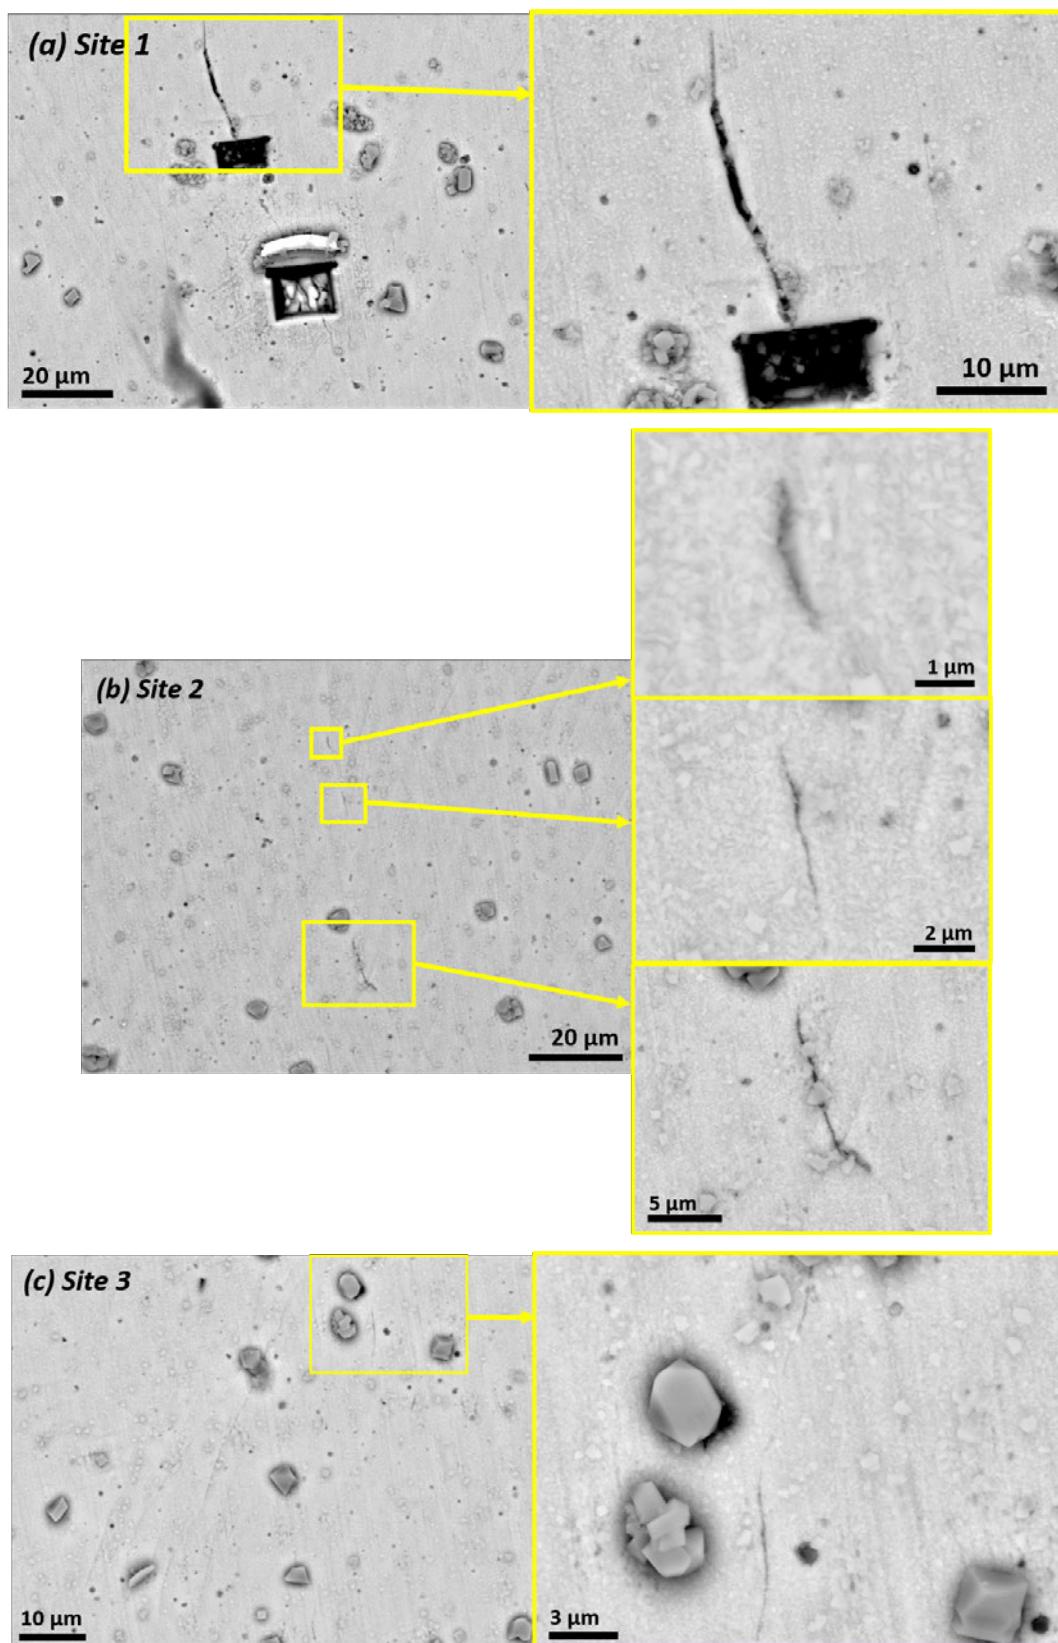
Figure 46. SEM-BSE images of the surface appearance at the three sites after 4.0 years of exposure. These sites are highlighted in Figure 45.

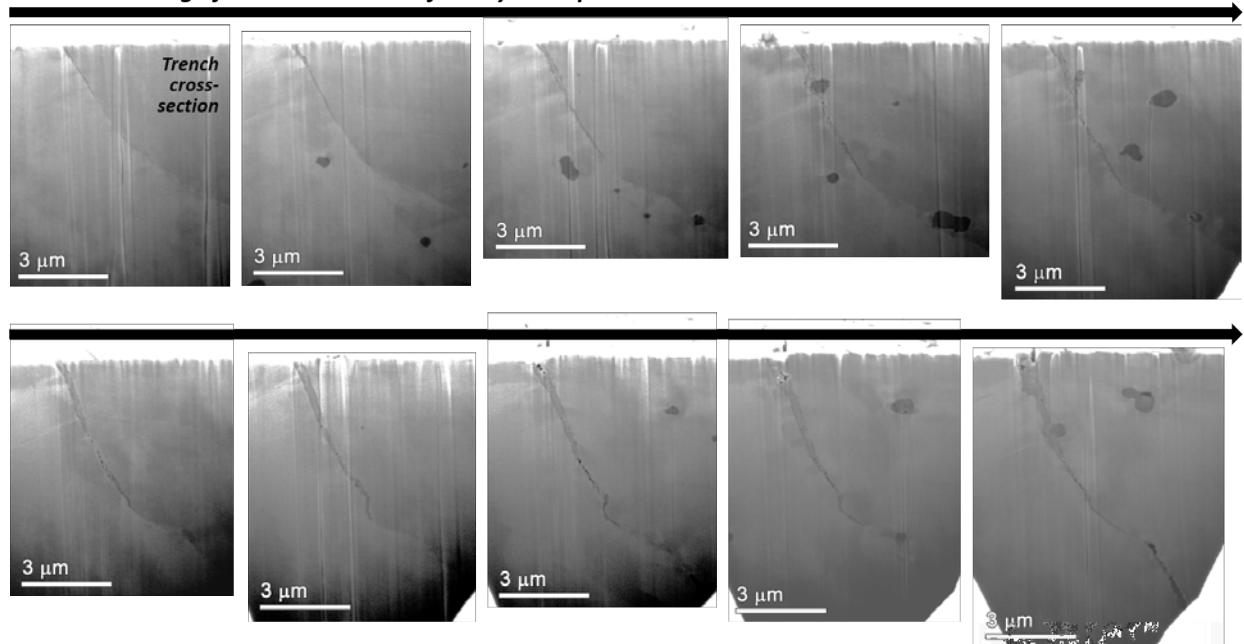
FIB serial milling of Crack 1 in IN128 after 4-year exposure

For Crack 1, the FIB milling started from beyond one end of the crack and traversed through the entire tighter portion of the crack as enclosed in the red box in Figure 47(a), covering a total length of approximately 10 μm . A total of 112 FIB-SE images were taken during the serial milling. Figure 48 illustrates selected images showing the evolution of the subsurface morphology of Crack 1 from the start to the end of the milling. It can be seen that the crack started shallow and gradually grew deeper as the milling moved its way along the tighter portion of the crack to a total depth of approximately 5–6 μm . Interestingly, it appears that once the milling reached the transition between the tighter portion and more open portion of the crack as it appears on the surface, the crack suddenly went deep into the cross-section, and the total depth of the crack reached beyond the extent of the FIB trench. It was decided to stop milling at this point and the final milling face was examined in detail in an SEM for better resolution with results presented in Figure 49. It turns out that on this cross-section, the crack intersecting the surface and the crack at the bottom are not connected, but an examination at higher magnification revealed heavy oxidation around the bottom crack and clear decohesion between the neighboring grains. This is not typical of SCC morphology which usually becomes tighter with increasing depth, often ending with a sharp tip. Based on our experience, the deeper portion of the crack is a weld defect that existed before testing. Since it is heavily oxidized, it is reasonable to assume that the two cracks would link up if we continued milling, and that's how water got its way into the lower defect as we see it on the final milling face.

Figure 48. FIB-SE images taken during serial FIB milling of a portion of Crack 1 at Site 1 after 4.0 years of exposure in IN128. The FIB milling area is marked in Figure 47(a).

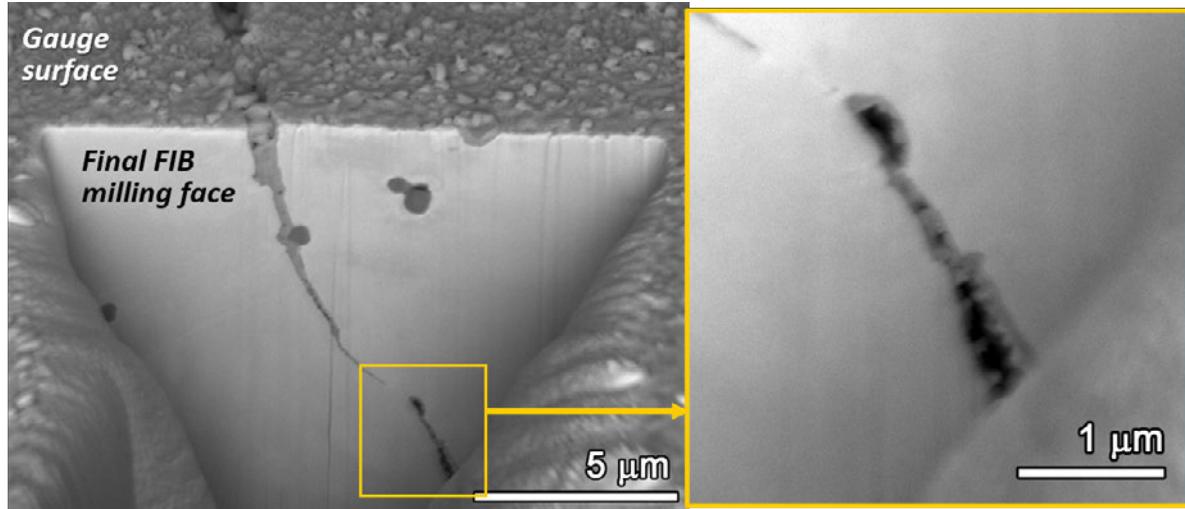
Figure 49. SEM-BSE image of the final milling face of the trench made on Crack 1 in IN128.

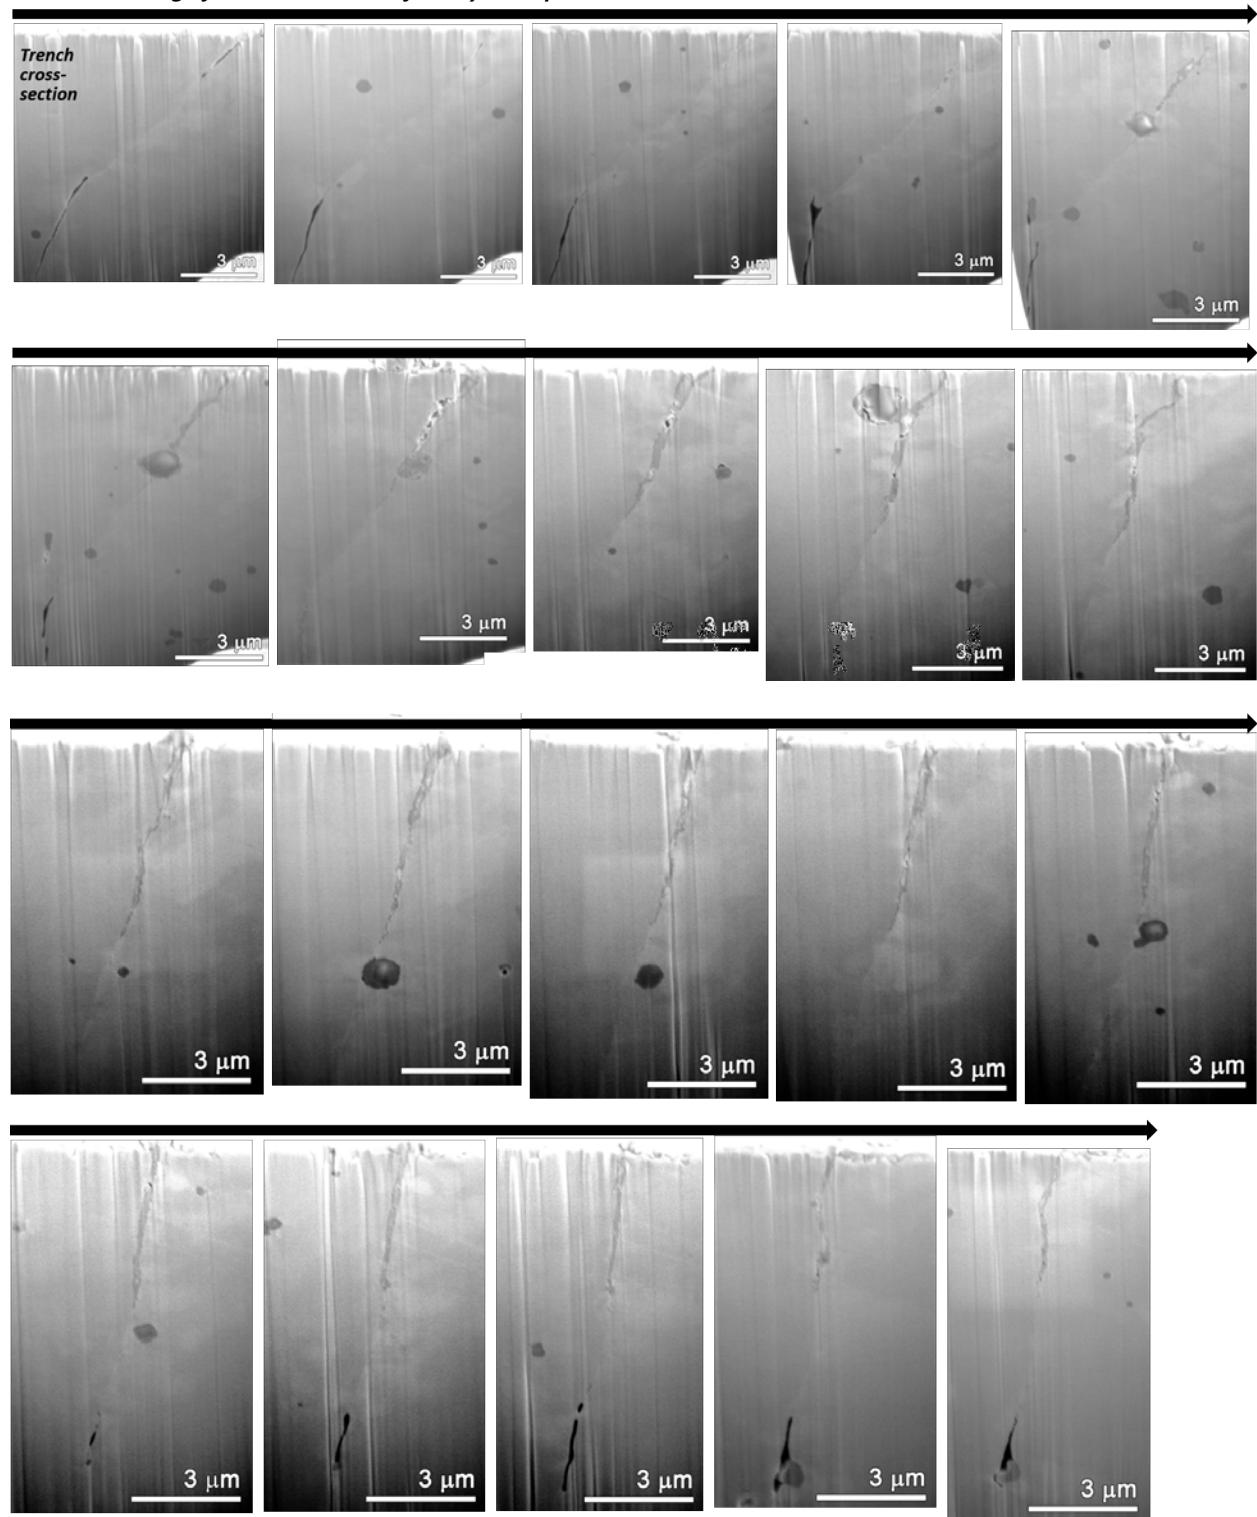
FIB serial milling of Crack 2 in IN128 after 4-year exposure

As shown in Figure 47(b), serial FIB milling was also performed on Crack 2 with images taken across the entire length of this short crack over a distance of approximately 15 μm . A total of 137 images were recorded. As shown in Figure 50, the first few FIB cross-section images revealed unoxidized IG weld defects at portions both near and approximately 6 μm below the surface along the GB where the crack was found. The upper defect disappeared before the oxidized crack was intersected by FIB milling, while the lower defect persisted through a few more FIB milling slices and was never found connecting to the oxidized crack above it. While the oxidized crack encountered a few precipitates as the serial milling progressed, no GB cavities were identified either within or beyond this crack. The deepest section of the crack is presented in the first two images in the third row in Figure 50, showing a depth of approximately 5–6 μm . Towards the end of the milling, another IG defect appeared at a depth of approximately 8–10 μm from the surface. By the time the milling was stopped because almost the entire crack had been trenched away, there was no sign that the defect would link to the crack, especially as the crack depth was getting shorter.

In summary for this Alloy 152M specimen, detailed SEM and FIB examinations after 2.4 and 4.0 years of exposure revealed that the defected GBs were heavily oxidized which is representative of preexisting weld defects. While no direct evidence was found to demonstrate that these subsurface defects are linked to IGSCC cracking, they may contribute to higher IGSCC susceptibility at local GBs due to induced locally higher stresses and possibly because GB chemistry in the vicinity of these defects may be suboptimal, e.g., depleted in chromium or having a high concentration of impurity elements from welding (as evidenced by the significantly oxidized GBs). Additional chemistry examinations via atom probe tomography would be helpful in justifying this hypothesis. The IG cracks remained shallow even after 4.0 years of exposure without observable growth on the surface. These facts suggest that despite containing some very small IG cracks, this heat of Alloy 152M is very resistant to crack initiation, at least during the first 4.0 years of testing.

Figure 50. FIB-SE images taken during serial FIB milling of a portion of Crack 2 at Site 1 after 4.0 years of exposure in IN128. The FIB trench milling is marked in Figure 47(b).

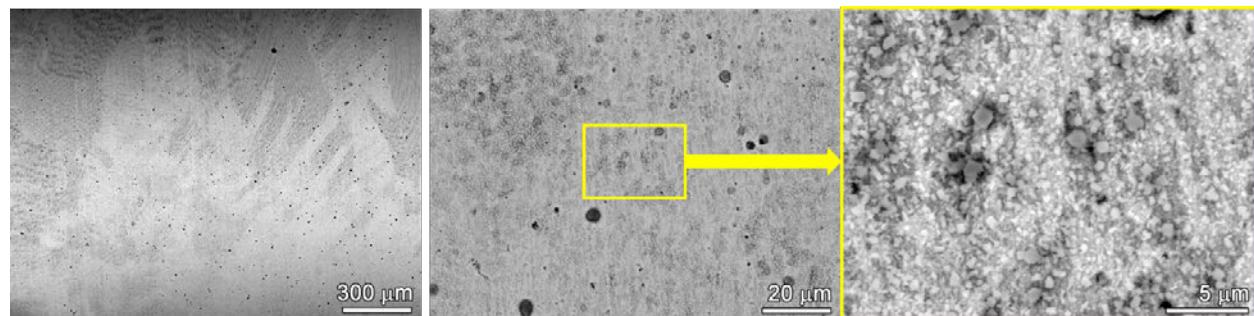
Only gauge surface observations were performed on this specimen. Similar to the 15% CF Alloy 52 MHI specimen IN124, the Alloy 152 MHI specimen IN142 exhibited a thick surface oxide layer at both the 2.4 (Figure 52) and the 4.0-year (Figure 53) test interruptions, which obscured a clear examination of the GBs intersecting the surface of the specimen. Despite some small pits/holes less than a few micrometers in size observed during high-magnification examination after 4.0 years of exposure (Figure 54), no other types of defects were observed. These features appear to be intragranular and could possibly be associated with precipitate drop-outs. Based on our experience with Alloy 182 SCC initiation, these features are considered to have little impact on crack initiation in the weld materials [18].

Figure 52. Representative SEM-BSE images of the gauge surface of the 15% CF Alloy 152 MHI specimen IN142 after 2.4 years of exposure.

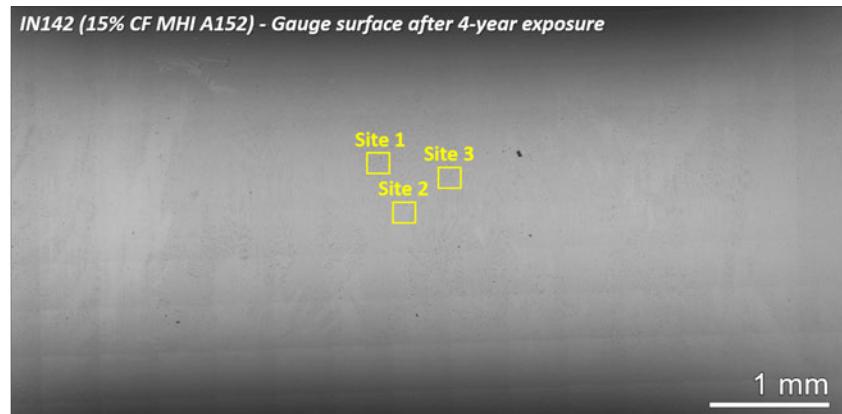
Figure 53. SEM-BSE low-magnification montage of the gauge surface of one rotation of the 15% CF Alloy 152 MHI specimen IN142 after 4.0 years of exposure. Sites examined at higher magnifications are highlighted.

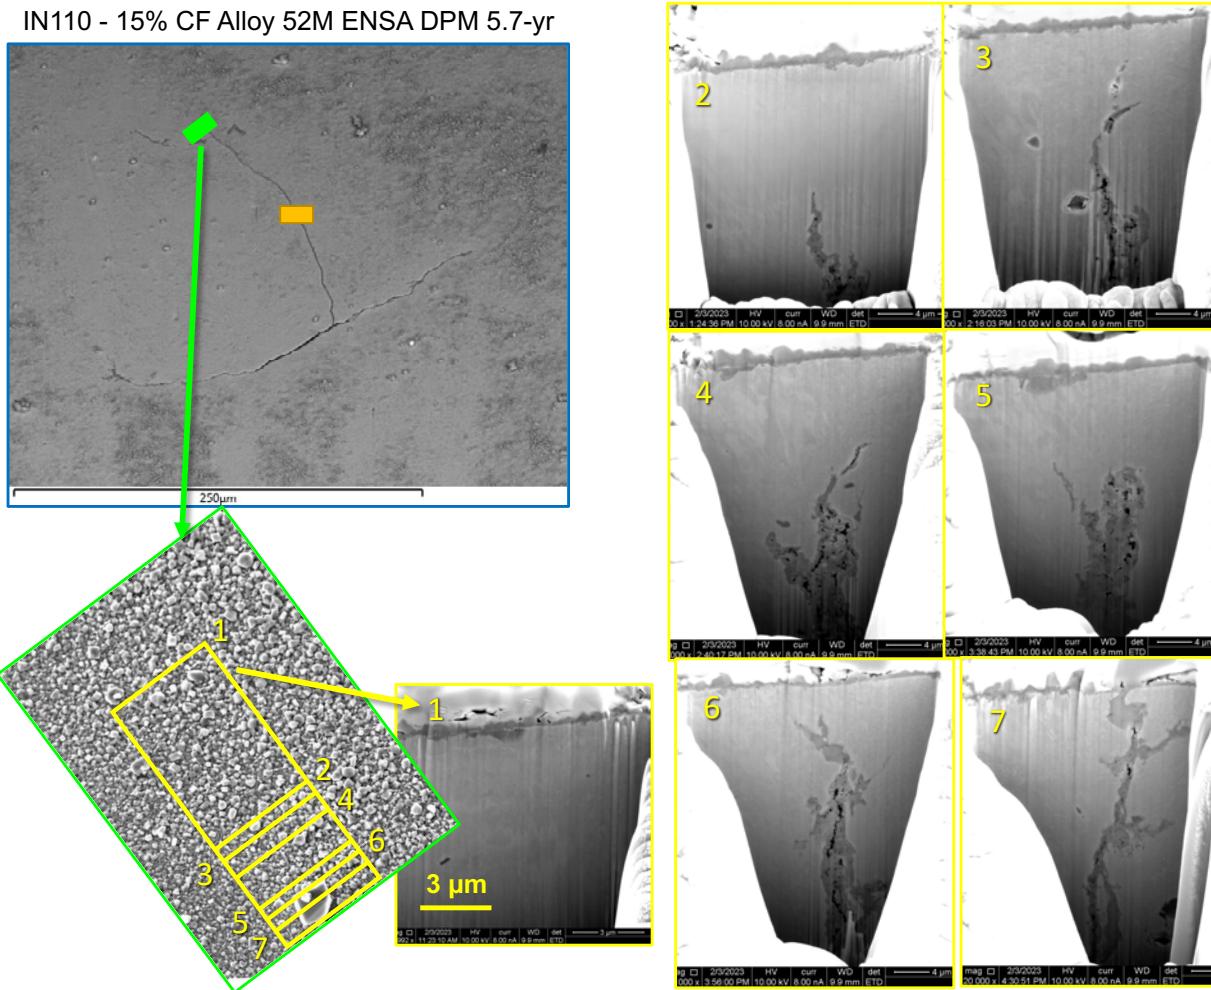
Only one Alloy 52M specimen was examined by FIB trench cross-section at 5.7 years. This specimen has a complex shape crack-like feature located in one of the fillets as shown in Figure 55. A FIB trench cross-section image at the end of one of the branches (Figure 55) revealed a heavily oxidized linear structure with voids away from the surface. A set of cross-section images taken from the middle of the same crack branch (Figure 56) revealed a complexly shaped feature that has no resemblance to a GB. This crack is most likely a weld fabrication defect that may be part GB and part lack-of-fusion structure. It is unclear whether the feature became heavily oxidized as a result of exposure to high temperature water or during weld fabrication.

Figure 56. IN110 Alloy 52M ENSA DPM 5.7-yr FIB trench cross-section images.

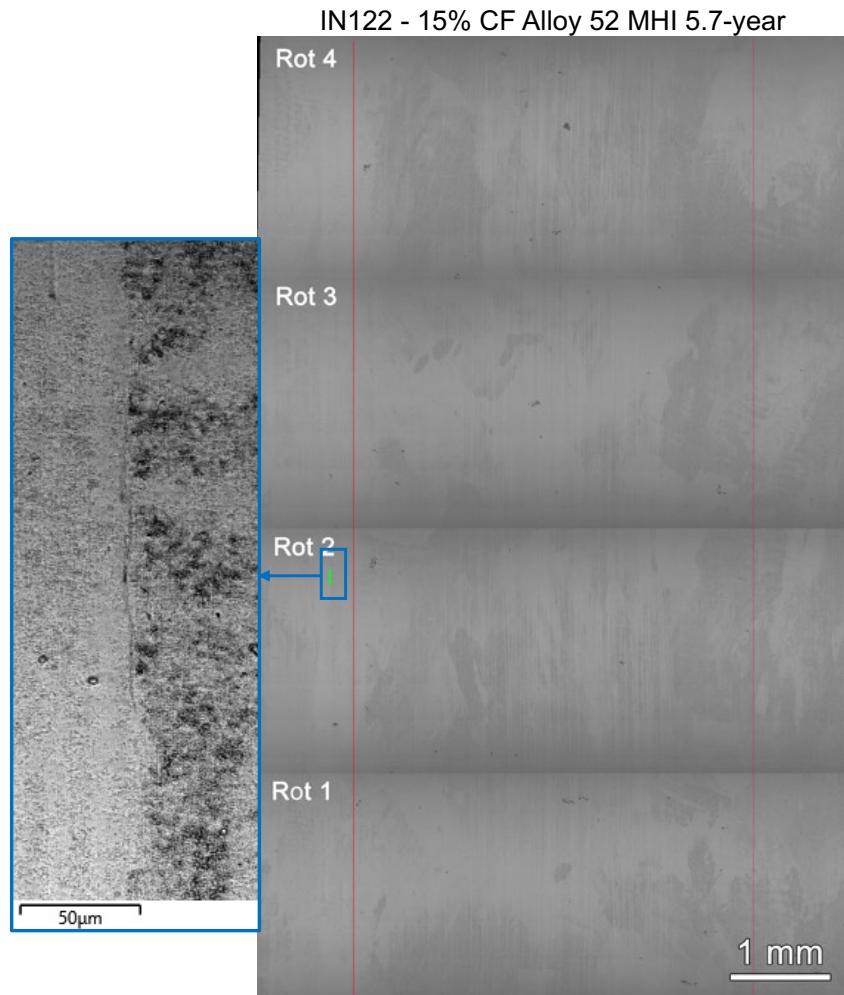
Two Alloy 52 MHI specimens were examined by FIB trench cross-section. The trenched GBs in both specimens had the same appearance, and for the purpose of illustration, IN122 is presented here, first with the gauge surface overview in Figure 57 and the FIB trench cross-section images provided in Figure 58. The GB cross-section has the same general appearance as the Alloy 690 RE243 specimen with significant quantities of GB cavities. There is no thick layer of oxidation on the GB as was observed in crack-like features that were probably weld fabrication defects such as was shown in the IN110 Alloy 52M specimen (Figure 56). The GB cavity in the Alloy 52 specimen has a approximately 150 μm length on the surface, and creep cavities extend to a maximum depth of approximately 10 μm. The degree of cavity formation in this Alloy 52 specimen is less than that of the Alloy 690 RE243 specimen, but a significant number of large cavities are present to a greater depth in this Alloy 52 specimen. While the Alloy 690 RE243 specimen has a 65 μm long, 5 μm deep crack, the feature in this Alloy 52 specimen has not yet become a crack despite having a greater length on the surface and large cavities to a greater depth than observed for the crack in the RE243 specimen.

Figure 57. IN122 Alloy 152M MHI gauge surface after 5.7 years.

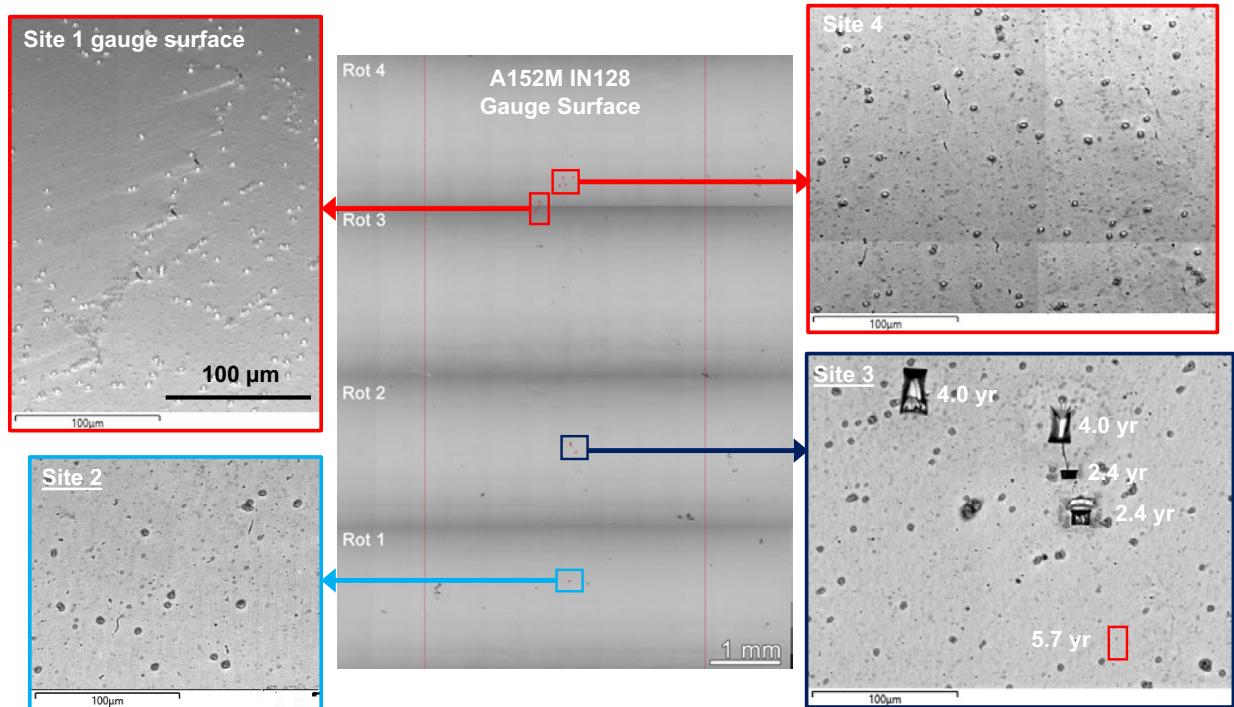
IN128 was the only weld metal specimen that was examined at 2.4, 4.0, and 5.7 years. The gauge surface overview is provided in Figure 59. Four regions (sites) of interest were identified with this specimen. The gauge surface at Site 1 shows a linear set of surface-breaking cavities, likely following a GB. Sites 2–4 show a group of short (approximately 10 μm long) crack-like features. Site 3 was previously examined by FIB trenching at 2.4 and 5.0 years, and it was examined again after 5.7 years.

Figure 59. IN128 Alloy 152M 5.7-year gauge surface overview.

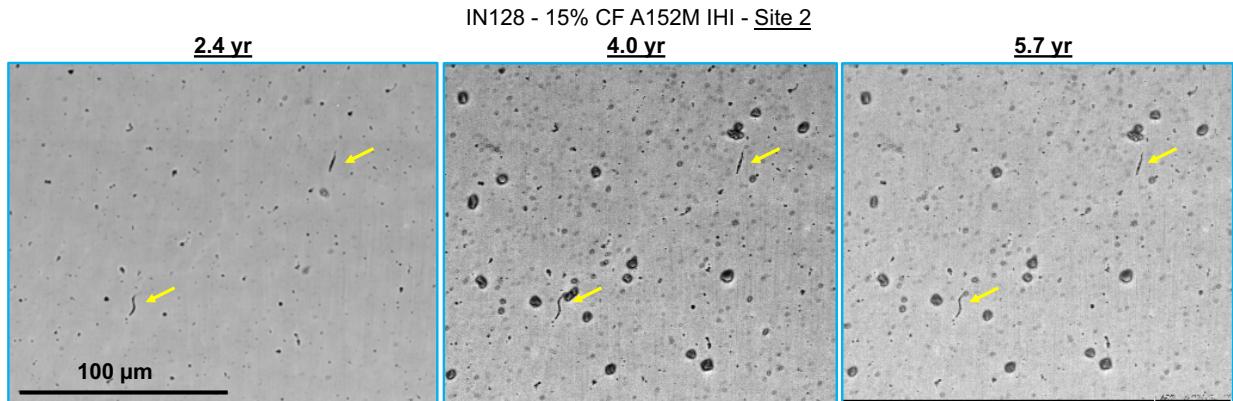
Figure 60. IN128 Alloy 152M Site 2 gauge surface appearance history.

A time evolution image series for Site 2 in Figure 60 shows that the surface appearance of the short crack-like features did not evolve between 2.4 and 5.7 years. The smooth shape of the crack on the surface suggests that it formed during weld fabrication. FIB trench cross-section analysis of this region was only conducted after 5.7 years on one of the features as shown in Figure 61. Cross-section images progressing from the end of the feature towards the middle reveal a GB that becomes progressively more open and filled with oxide. No cavities were present despite the presence of GB precipitates. Although the oxidation of this GB likely occurred during high temperature water exposure, this is most likely a preexisting weld fabrication defect rather than a feature that formed during SCCI testing.

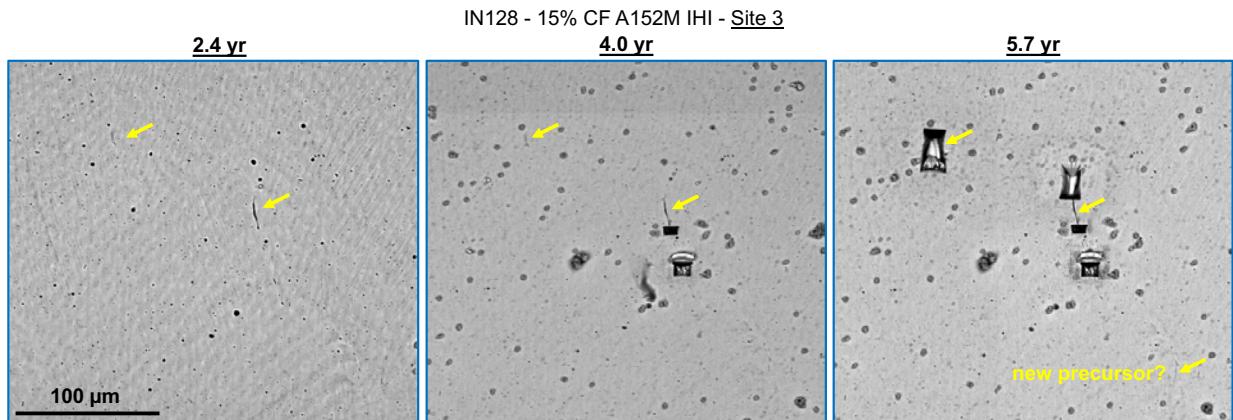
Figure 62. IN128 Alloy 152M Site 3 gauge surface appearance history.

Gauge surface observations of Site 3 (Figure 62) similarly show a lack of time evolution of the linear defects. FIB trench cross-section imaging was performed on one of the features at a location adjacent to where an examination was performed after 4.0 years (Figure 63). The voids that were present have a linear appearance rather than appearing as spherical cavities. In trench #4, the boundary has a very smooth shape and appears to be filled with oxide or possibly some kind of precipitate. FIB serial trenching of this same boundary after 4.0 years is shown in Figure 50; this feature was also judged to be a very small preexisting weld fabrication defect.

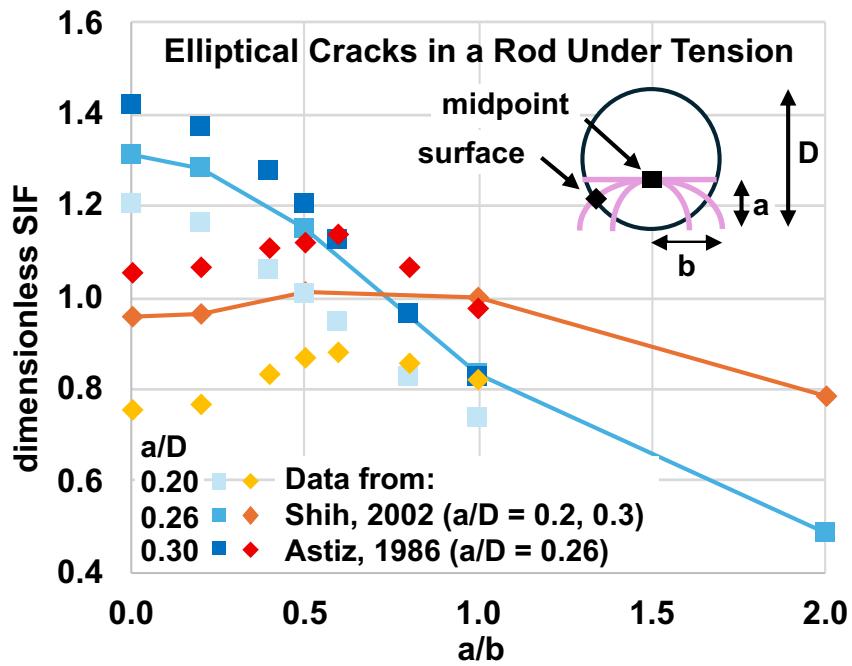
Figure 68. Dimensionless SIF values from Astiz [30] and Shih [31] for an elliptical crack. Note that "a" and "b" values are the ellipse minor and major radii rather than the values corresponding to where the crack meets the specimen surface.

The stress intensity at the middle of the crack and where the crack meets the surface of the specimen can be estimated from stress intensity factor (SIF) solutions in the literature. There are several studies in the literature with most of these based on finite element modelling of a sharp, elliptical shape crack in a linear elastic system [28-32]. Crack depth and shape have a significant effect on the predicted SIF. For elliptical cracks, the depth of the crack is given by the minor radius, a , and the width of the crack is based on the major radius, b . For a round bar of diameter D , the crack depth is given by the ratio a/D . For IN129, $a/D = 0.25$. Crack shape is represented by the ratio a/b . The projected width of the crack at the surface of the round bar is typically less than b . In the case of the crack in IN129, a/b is ~ 2 .

Only one literature study was found to have estimated SIF values for $a/b > 1$ [30], and the data from this work is reproduced in Figure 68 along with SIF values for a/b values up to 1.0 from another study for comparison [31]. A comparison of SIF values for $a/b \leq 1.0$ shows that the two studies are in good agreement for a/b values ≤ 0.5 with the work of Astiz at $a/D = 0.26$ falling between the work of Shih at $a/D = 0.2$ and 0.3. At $a/b = 1.0$, the work of Astiz at $a/D = 0.26$ falls on the work of Shih at $a/D = 0.3$. Some variability among similar studies is to be expected and should be considered part of the uncertainty in the K estimate. For $a/b = 2.0$, the work of Astiz predicts that the K value at the crack front midpoint for this specimen with a test stress of 527 MPa is $13 \text{ MPa}^{\sqrt{m}}$ while at the point where the crack intersects the surface, the estimated K value is $21 \text{ MPa}^{\sqrt{m}}$. Since the crack is not a true elliptical shape, and the crack is somewhat blunted, these K values should be considered approximate.

Low SCCGRs of $\leq 5 \times 10^{-9} \text{ mm/s}$ were measured at PNNL for 360°C tests on this weld metal in the 15% CF condition at $30 \text{ MPa}^{\sqrt{m}}$. Low SCCGRs of $< 5 \times 10^{-9} \text{ mm/s}$ were also measured during testing of 30% CW Alloy 690 at PNNL for K values $\leq 20 \text{ MPa}^{\sqrt{m}}$ [4]. The same 30% CW Alloy

690 materials exhibited SCCGRs of $\sim 1 \times 10^{-7}$ mm/s at 30 MPa $\sqrt{\text{m}}$, indicating a strong K dependence for Alloy 690 which is also likely for Alloy 152(M)/52(M). Thus, this SCCI specimen should be exhibiting SCCGRs well below 5×10^{-9} mm/s despite the very large crack. This would make it unlikely for the crack to grow to this size in 5.7 years.

While the available information suggests that this specimen had a large preexisting crack that did not grow significantly during 5.7 years of SCCI testing, further SCCI testing is recommended to confirm this hypothesis.
