Subject: Response to Request for Additional Information by the Office of Nuclear Reactor Regulation to support Review of TMI-1/ Crane (Cycle 22) Steam Generator Inspection Report

TMI-1/CRANE (CYCLE 22) STEAM GENERATOR INSPECTION REPORT

Condition Monitoring and Operational Assessment of TMI-1 Steam Generators 2024 Inspection

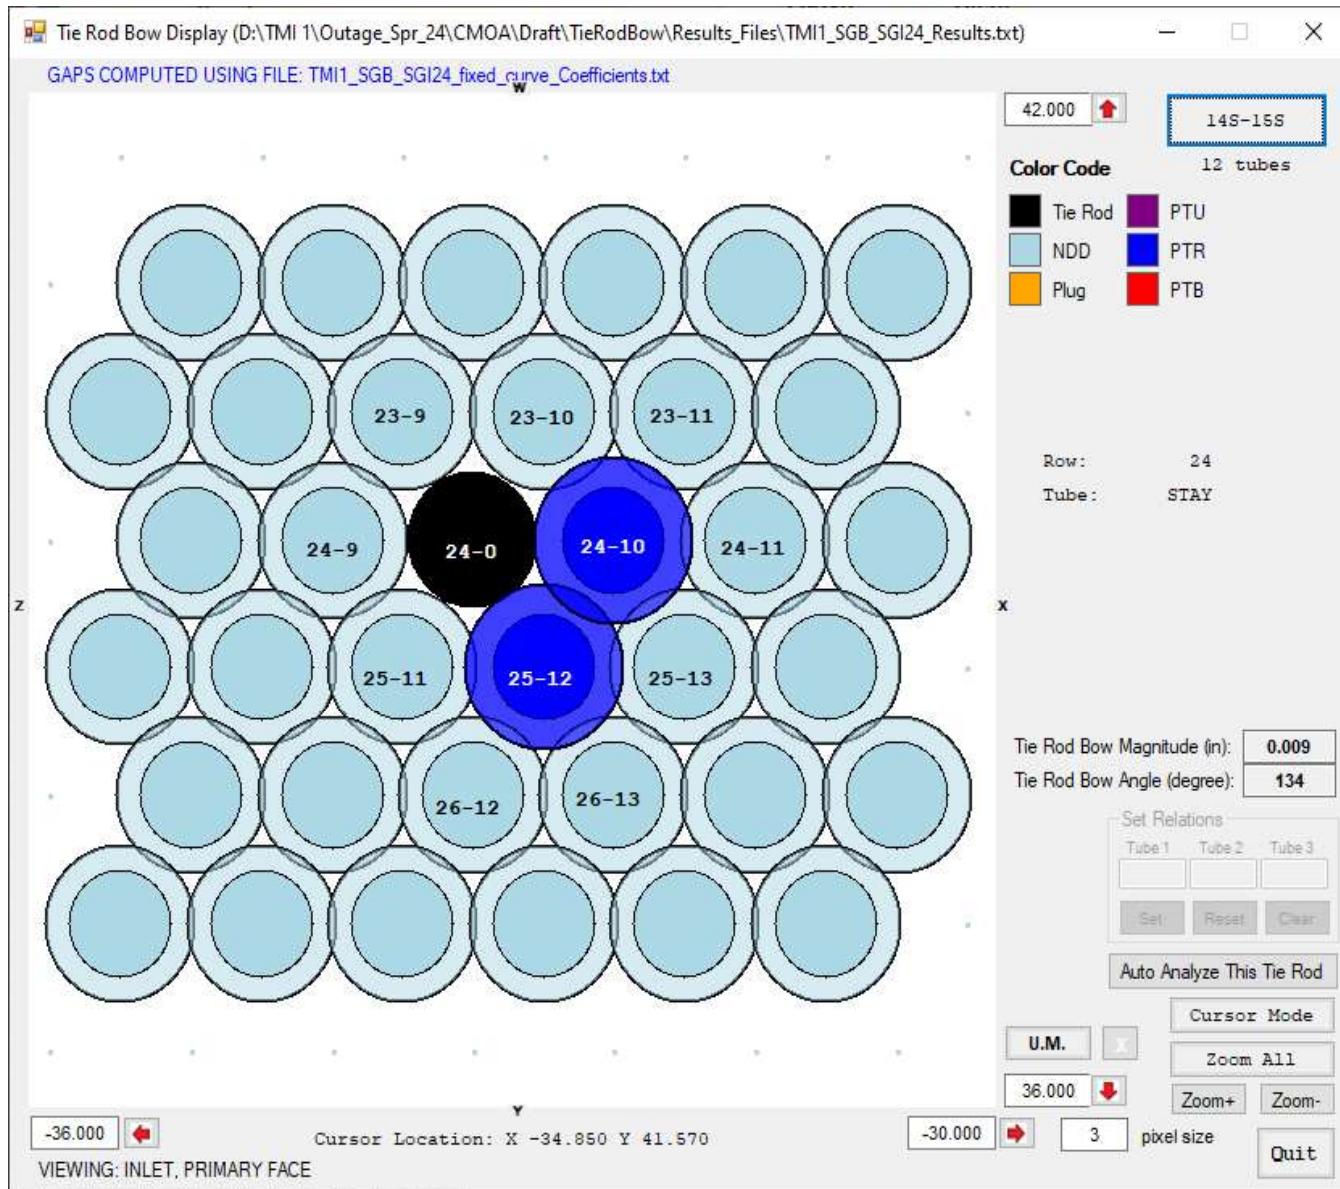
Figure 4-22: Representative Tie Rod Bow Calculation

The Framatome developed methods using a gap calibration standard to measure tie rod displacement with ECT [22] confirmed that none of the tubes are in contact with an adjacent bowed tie rod. Additionally, assuming that the current bowed magnitude has occurred over at least 5 cooldowns since the SGs have been installed, any projected bow over the course of an additional heat-up and cooldown cycle (HU/CD) will be within the 0.2" elastic range as determined from testing of the tie rods [23]. Therefore, there is no potential for contact with an in-service tube during operation. See Table 4-8 for a summary of the Tie Rod Proximity (PTR) indications and calculated tie rod bow. A representative calculation is provided in Figure 4-22.

1. The tie rod bow is conservatively calculated by subtracting the proximity from the maximum possible tie rod displacement of 0.204" for a tie rod to contact the adjacent tube. For example, the tie rod adjacent to tubes R64-T8 and R65-T8 had the smallest proximity of 0.055", resulting in a maximum possible tie rod bow of 0.149".

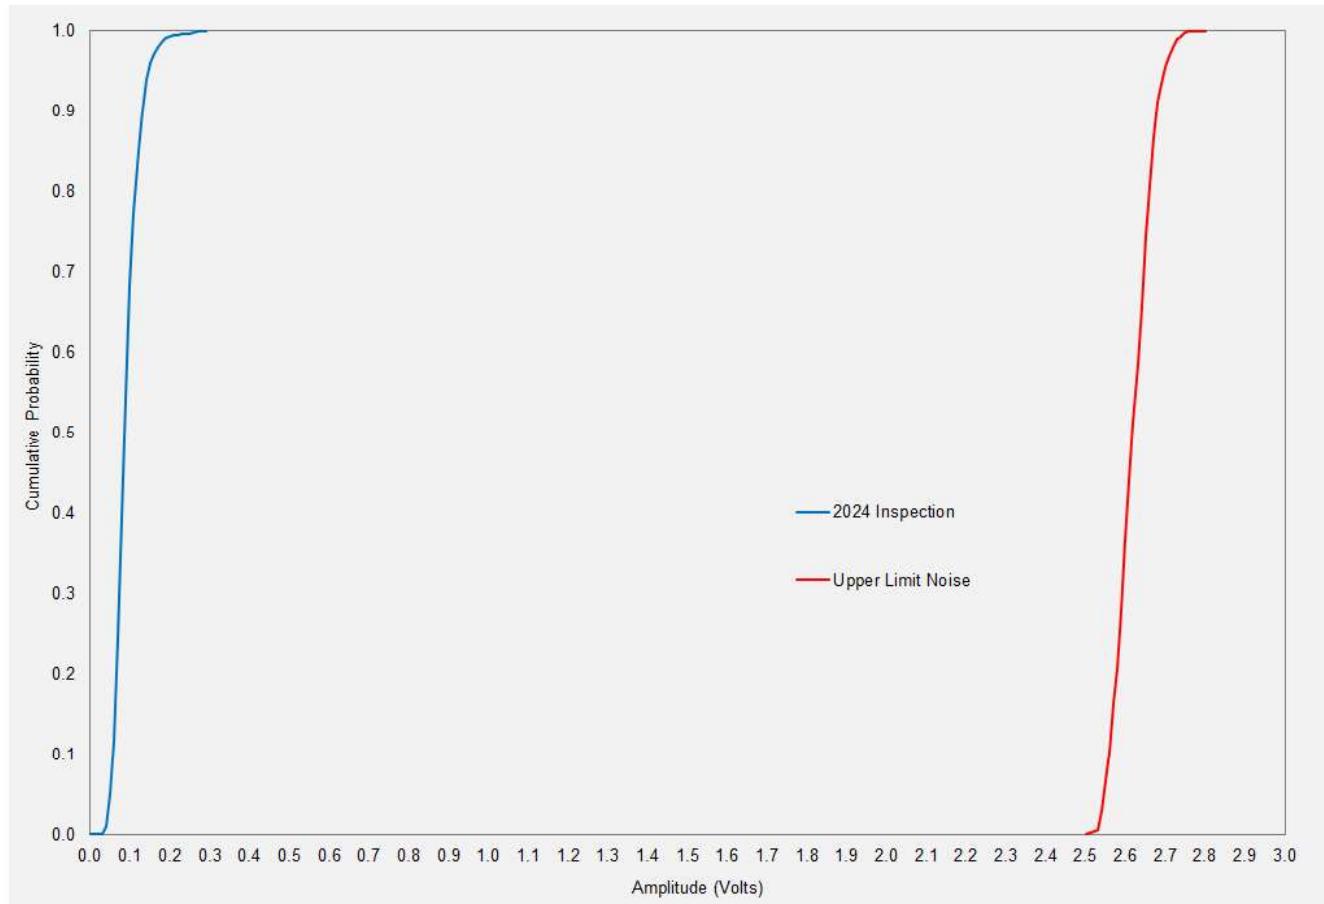
Figure 4-25: SG B Drilled TSP Edge ECT Noise Vs. Upper Limit

In accordance with Revision 8 of the EPRI Examination Guidelines the noise associated with the regions of interest (ROIs) for freespan wear and TSP wear at broached and drilled supports was measured. Figure 4-24 shows that a typical ETSS noise distribution (“baseline noise”). Due to the differing eddy current response at TSP centers and edges, two separate noise groups were created for TSP wear, one for the center of the support and the other for the edges. Noise at all ROIs was measured and compared to the upper limit developed in the DA. Drilled support edge noise was most limiting, but inspection data never approached the upper limit as show in Figure 4-25.

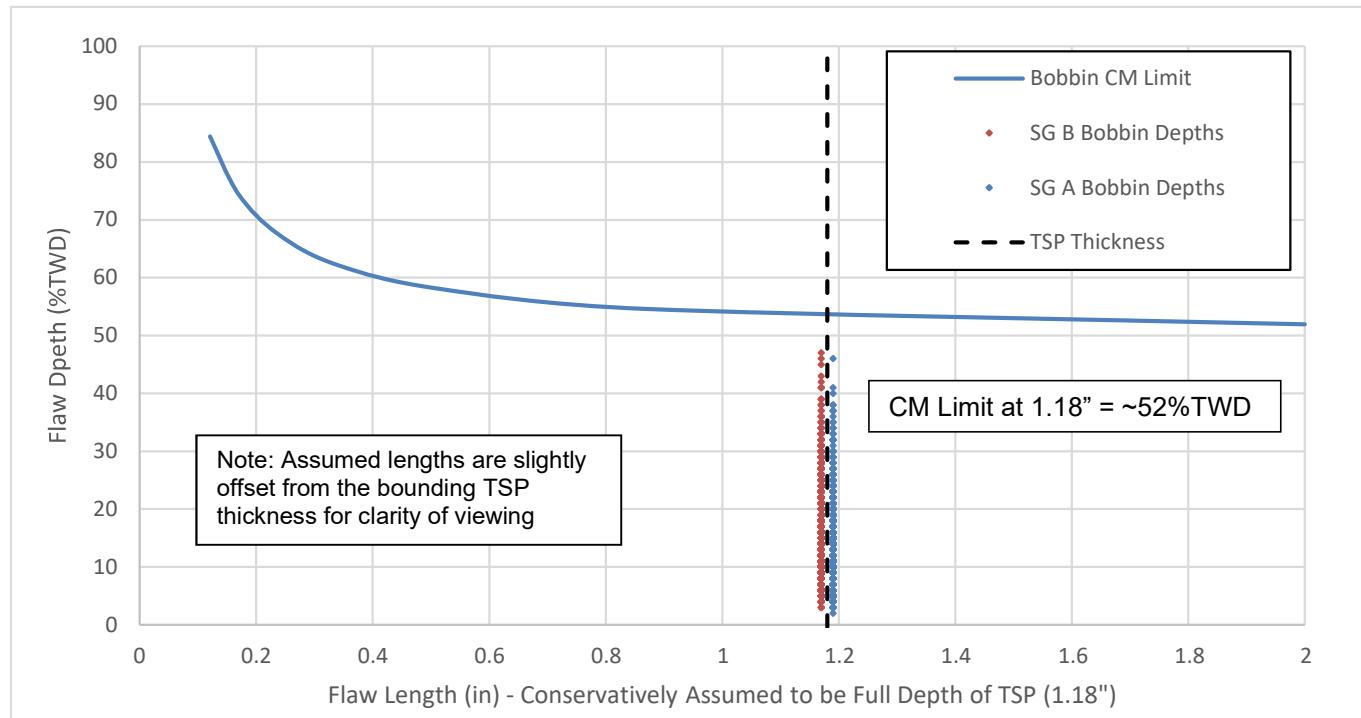
Figure 5-1: Broached TSP Wear Depths vs Bobbin CM Limit (ETSS 96043.1 Rev. 2)

Large Break Loss-of-Coolant Accident (LBLOCA) conditions were also considered during the CM evaluation. For LBLOCA events, the limiting load is the axial load created by the large tube-to-shell temperature differential that develops as the tubes cool faster than the shell. Per [11] structural integrity is satisfied with 100%TWD wear indications at two lands of the support plate. Since none of the detected indications approached 100%TW, structural integrity under postulated LBLOCA conditions is satisfied.

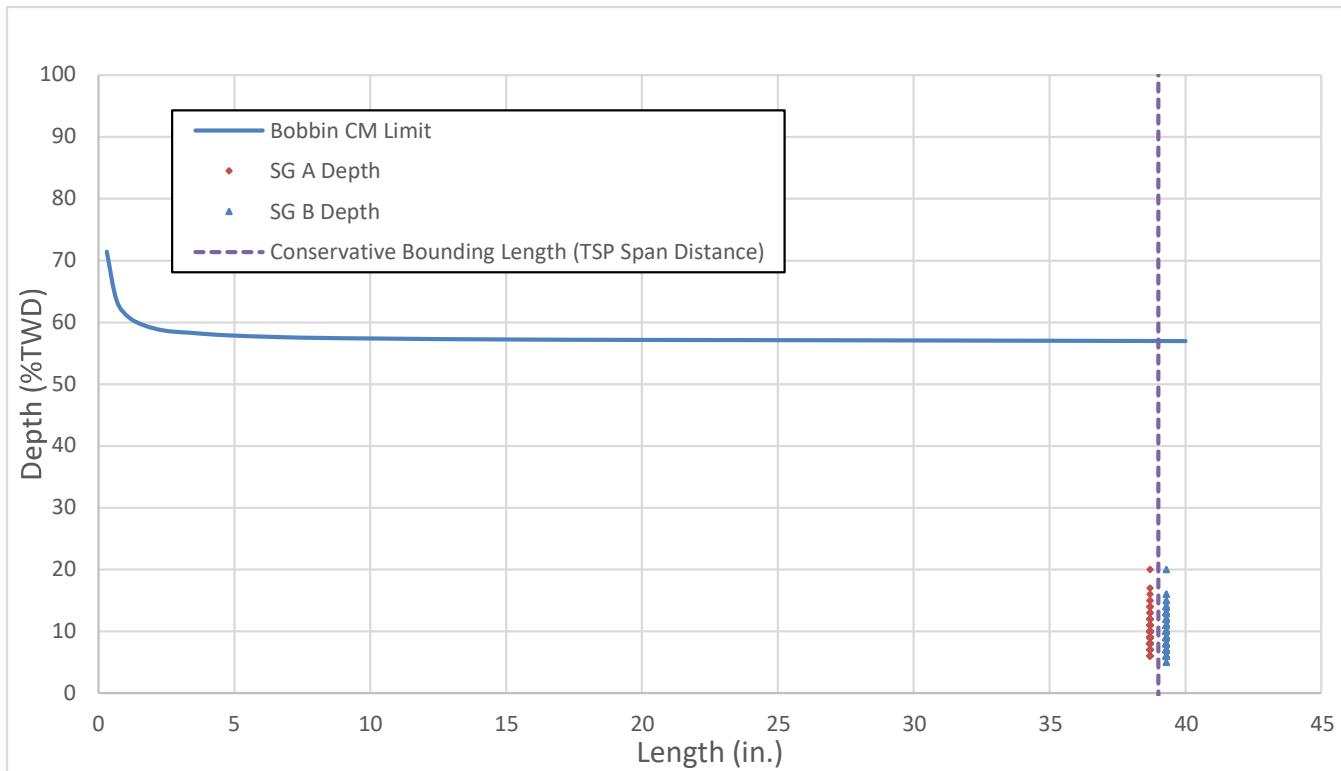
Figure 5-3: 2024 Tube-Tube Wear and CM Limit

Figure 5-3 shows the CM limits as a function of length and depth for the bobbin coil TTW technique. As shown in the figures, the CM limit for an indication with a bounding structural length of 39" is approximately 56%TW. Since the deepest NDE depths were 20%TW (R70-T100 in SGA, and R22-T63 in SGB) all tube-to-tube wear indications passed condition monitoring analytically. In-situ pressure testing was not required for TTW and was not performed.

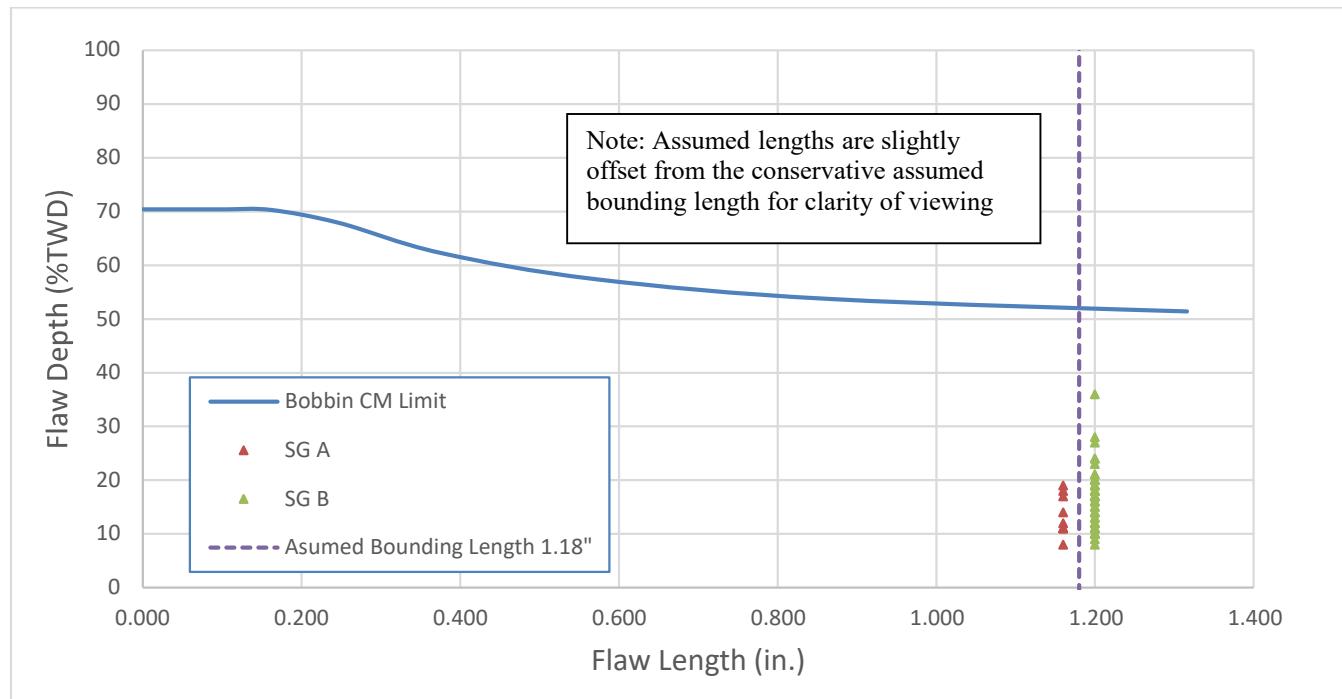
Figure 5-4: Bobbin CM Limit Plot for Drilled TSP Wear

Measured circumferential extents varied from 0.42 to 1.12 inches with the max PDA of any drilled TSP flaw of 8.74 PDA, satisfying the 29.7 PDA LBLOCA acceptance criterion 10]. Since none of the indications approached this depth, the LBLOCA criterion is also met for this mechanism.

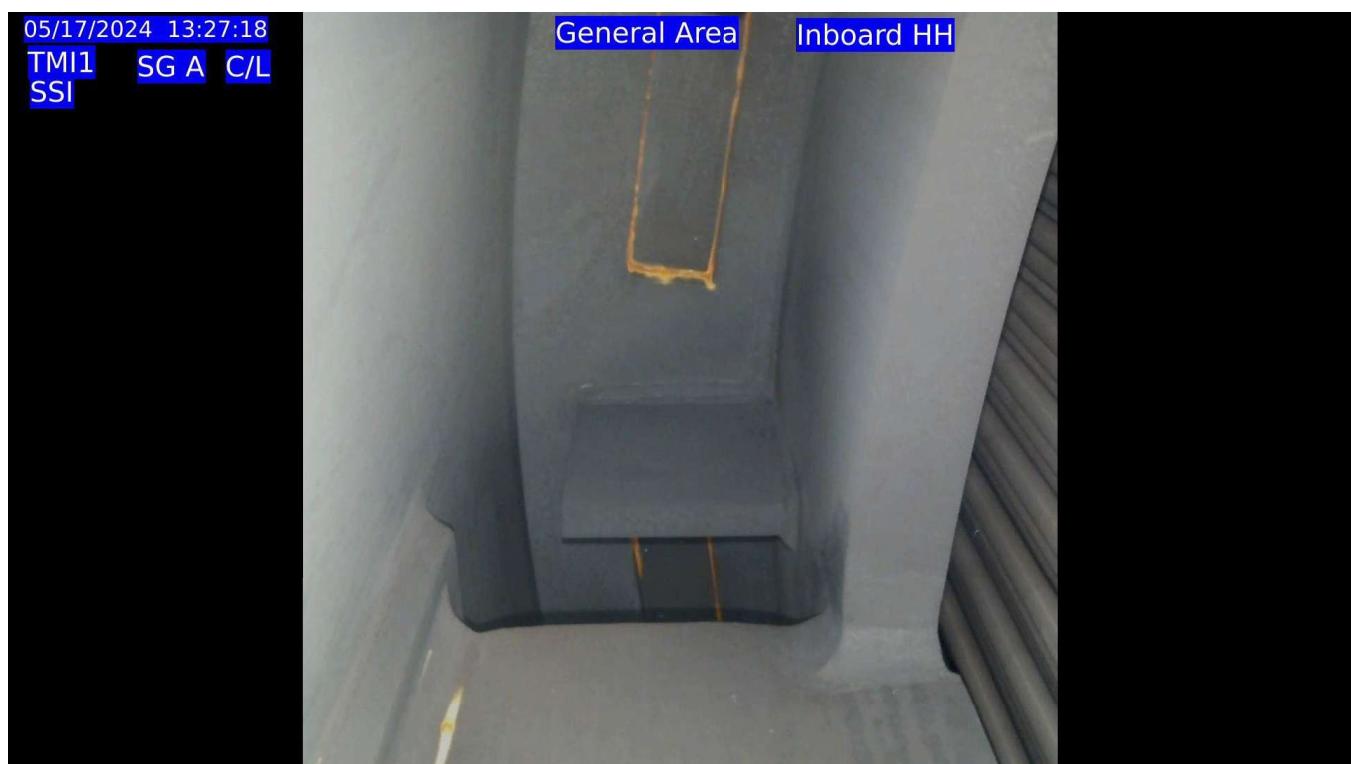
Figure 6-3: TMI-1 2024 Secondary Side Inspection – Upward View at Orifice Plate

No abnormalities were identified during visual inspections looking upward at the orifice plate and other nearby structures. with an example shown in Figure 6-3.

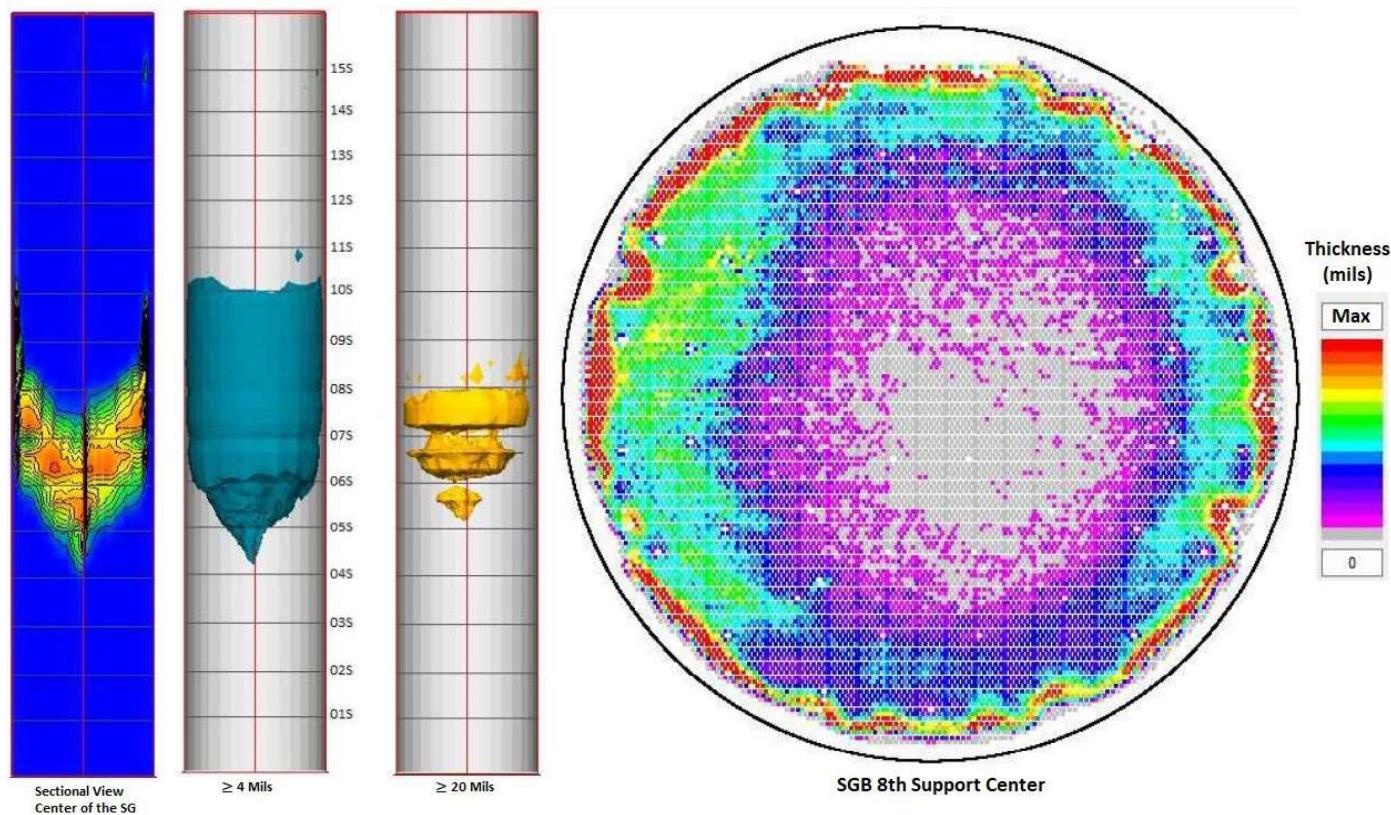
Figure 6-4: Example Bobbin Deposit Mapping – SG B 2024 Results

Deposit mapping of the SGs can be performed using the bobbin ECT data which can provide estimates of the total deposit loading as well as identify elevations the deposit is accumulating and tube locations with potential blockage of the broached support plates. Broach blockage can be a concern as it could alter the secondary side fluid flow or lock a tube against the support plate, influencing wear rates of the tubes. An example of the bobbin mapping is shown in Figure 6-4 for SG B using the Spring 2024 data. For TMI-1 the deposit accumulates primarily between the 4th and 11th support plates in a conical shape typical of OTSGs.

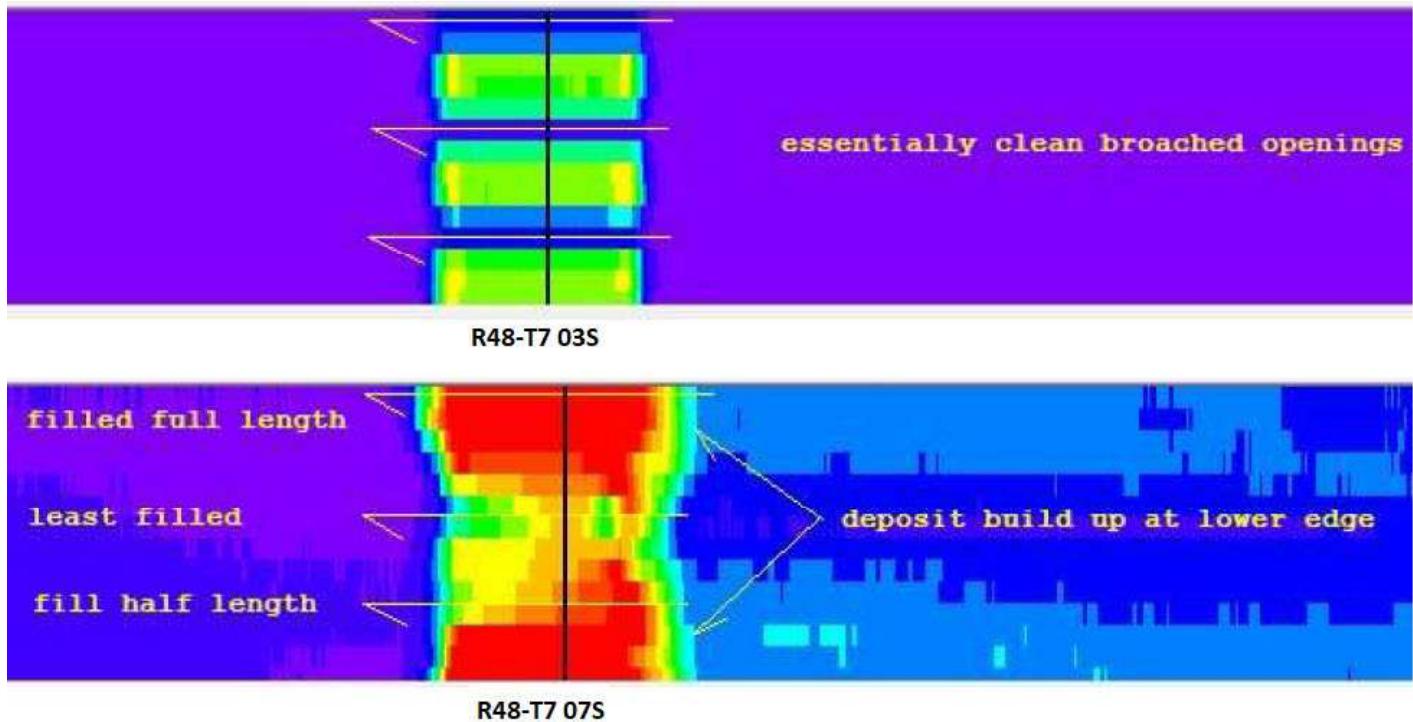
Figure 6-5: Example Array Deposit Mapping – SG B R48-T7 at 3rd and 7th Supports

Full length array ECT data can be used to identify the number of broaches that are blocked as well as the severity of the blockage. An example of the array mapping is shown in Figure 6-5 for SG B R48-T7 at the 3rd support plate, which has no deposit accumulation, and the 7th support plate which has deposit buildup on the lower edge and broaches which are either partially or fully blocked with deposit.

From preliminary review of the data, the largest concentration of deposits for TMI-1 are at the 7th support plate with broached holes of the small sample acquired with array showing partially or fully blocked supports. Currently only one replacement OTSG in the industry has performed chemical cleaning to address broached blockage concerns after approximately 9 years of operation. It is recommended that TMI perform a full deposit mapping analysis to quantify the amount of deposit currently within the SGs, the severity of broach blockage, and trend the rate of accumulation in comparison to other OTSGs.

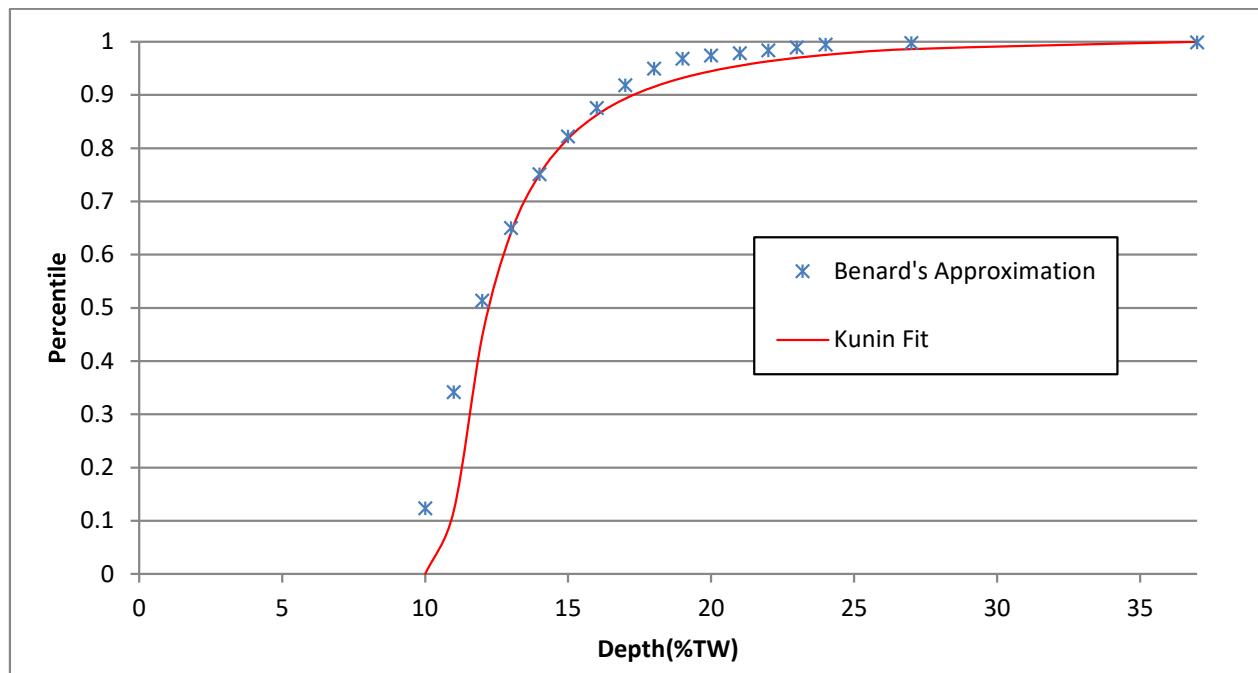
**Figure 7-9: SG A Broached TSP Wear New Flaw Depths and Kunin Fit for OA Calculation**

Parameter	SG B 1-cycle	SG A 1-Cycle
Mean of the sum of yield and ultimate strengths at temperature	114,800 psi	
Standard deviation of the sum of yield and ultimate strengths at temperature	2,448.5 psi	
3 X Normal Operating Pressure Differential	3,830 psid NOTE: Conservatively 5 PSI higher than CM input in Table 5-1 to accommodate the possibility of higher pressure in the future	
Tubing wall thickness	0.0368 inch	
Tubing outer diameter	0.625 inch	
Flaw Parameters	Distributed Properties of profiles from the Spring 2024 Inspection (See Figure 7-15)	Fixed Properties bounding profiles from all inspections (See Figure 7-16)
Growth Rates	Sampled from Bounding Kunin fit (See Figure 7-10, Figure 7-12)	Sampled from Bounding Kunin fit (See Figure 7-8)
ETSS Technique	96043.4 Rev 1	
ETSS NDE depth sizing parameters	Slope = 1.01 Intercept = 2.03 Standard Error = 3.86	
New Indications	Weibull projection based on historical flaws (See Table 7-5) Depth distribution from bounding Kunin fit (See Figure 7-9Figure 7-11)

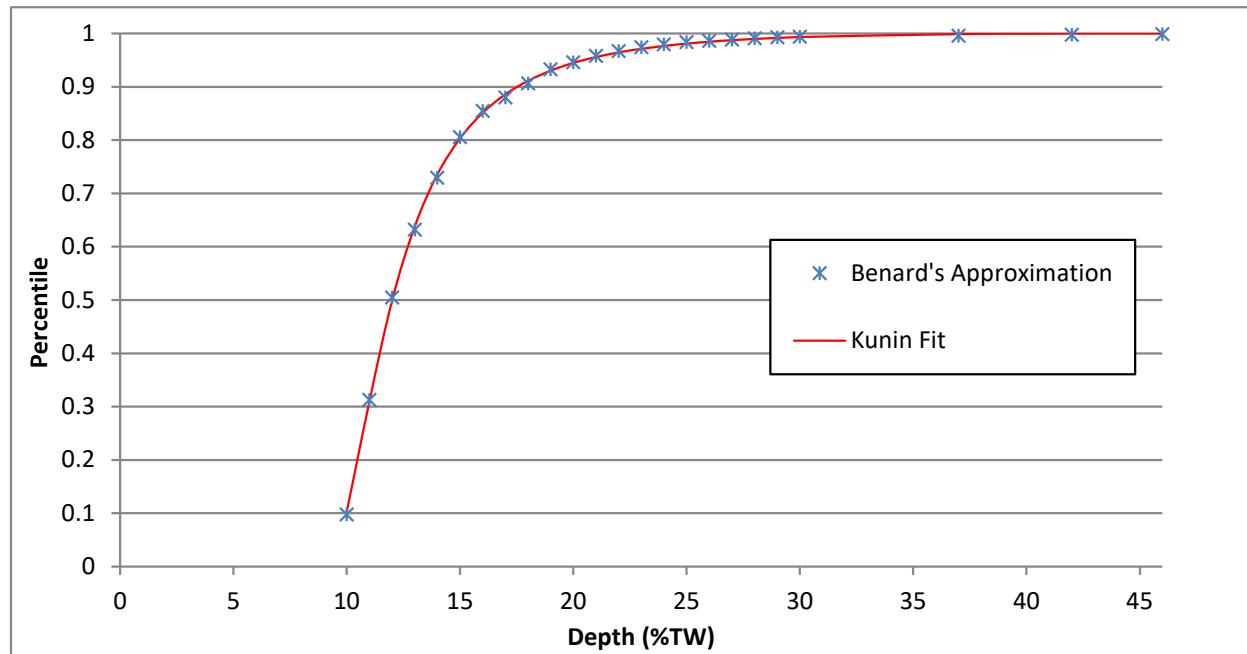
**Figure 7-13: SG B Outer Ring Broached TSP Wear New Flaw Depths and Kunin Fit for OA Calculation**

Independent, fully probabilistic operational assessment models were used for broached TSP wear in each SG. Predictions were made for a single cycle of 2.0 EFPY. The predictions for SG B are illustrated in Table 7-7 below taken from the 2024 CMOA. The predictions are made by zone based on 400 probabilistic trials of all flaws returned to service and picking the highest value. The results for SG B bound SG A. This methodology used to predict the number of new flaws greatly overestimates the number of flaws and is expected to continue to be conservative. New flaws are predicted to initiate following a similar depth distribution to what was observed in 2024 as seen in the example for the outer ring zone in Figure 7-13 below.

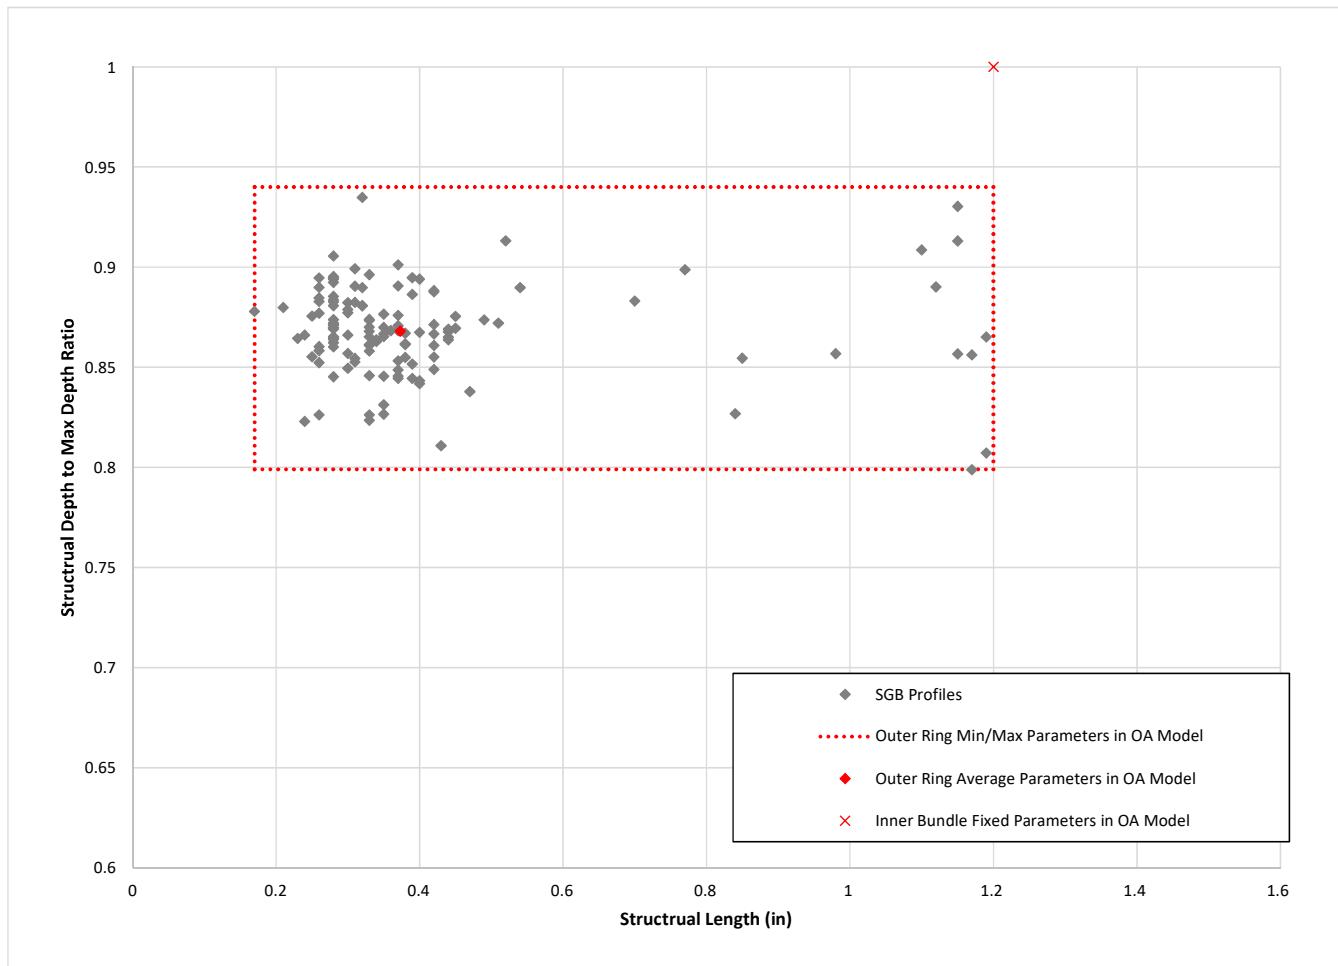
Figure 7-15: 2024 Inspection Broached TSP Wear Flaw Outer Ring Profile Parameters – SG B

Figure 7-14 provides a generic example of a typical wear scar profile and its structural equivalent model. That is, there is a flaw with a rectangular-shaped profiled flaw that has equivalent structural properties (i.e., burst pressure) as the original flaw profile. As all flaws are input into the model as a singular maximum bobbin depth, the probabilistic model essentially evaluates all flaws as their structural equivalence by applying a structural depth to maximum depth ratio (SD:MD) and a structural length to each flaw as sampled from a distribution of profiles for each SG. This same methodology was applied to a representative statistical sample of wear scars using the line-by-line sizing data for both SGs as represented in Figure 7-15 and Figure 7-16 which are the SD:MD ratio plotted vs. the structural length for both SG B and SG A inspection data.

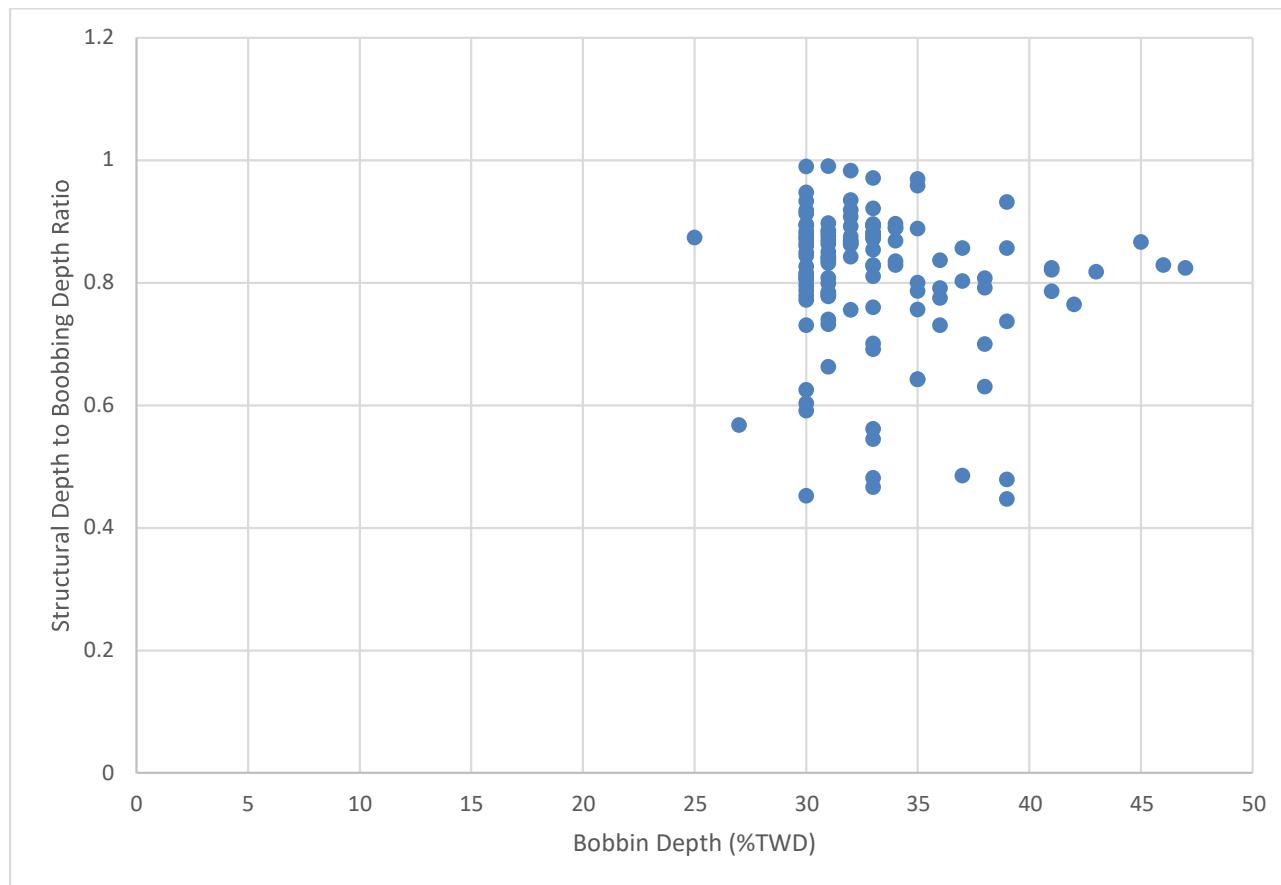
Figure 7-17: SG B TSP Wear Depth Ratio Vs. Bobbin Depth

Because the bobbin coil was used as the technique of record to size TSP wear, the metric of interest for creating length and depth distributions is how the structural depths relate to the depths reported by bobbin. Figure 7-17 shows how the ratio of structural depth to bobbin depth changes as bobbin depth increases. Because flaws less than 30%TWD do not present a challenge to tube integrity, depth sizing distributions were based on the flaws sized by bobbin 30%TWD and deeper.

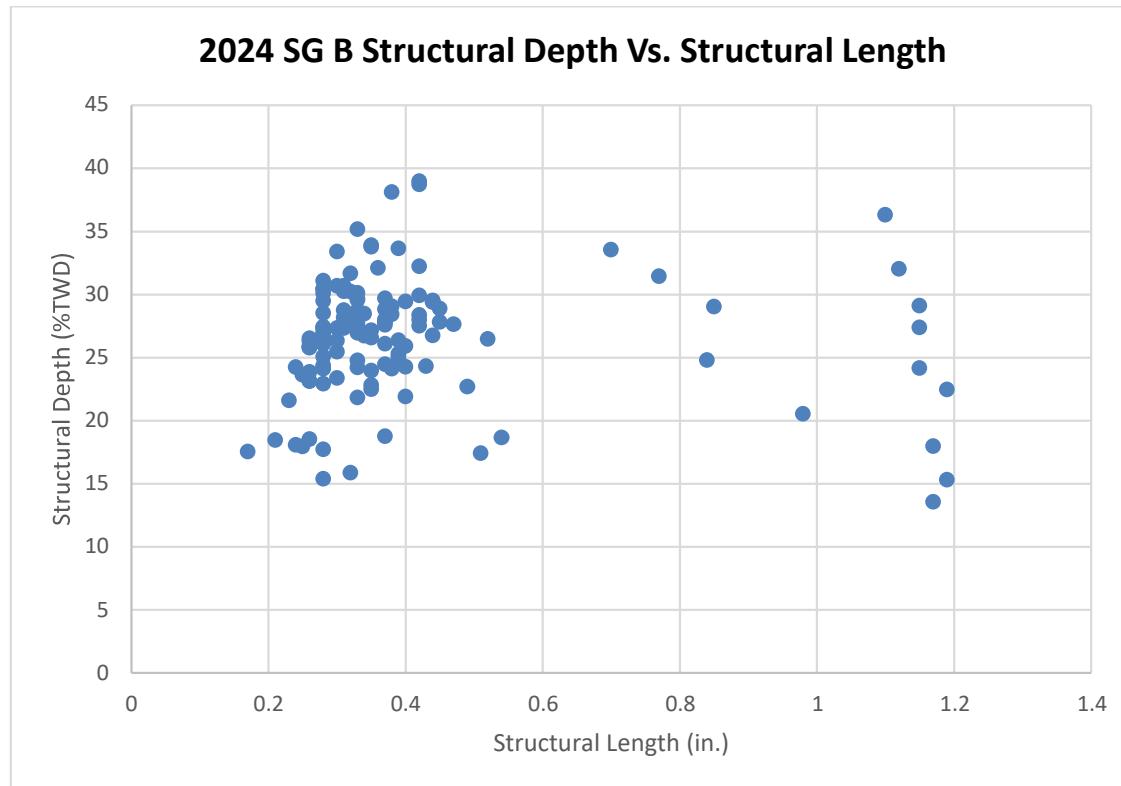
Figure 7-18: 2024 Inspection Broached TSP Wear Distribution of Structural Lengths – SG B

Structural lengths followed the same pattern as that of structural depth ratios. Namely, that structural depth does not appear to be correlated to structural length as shown in Figure 7-18.

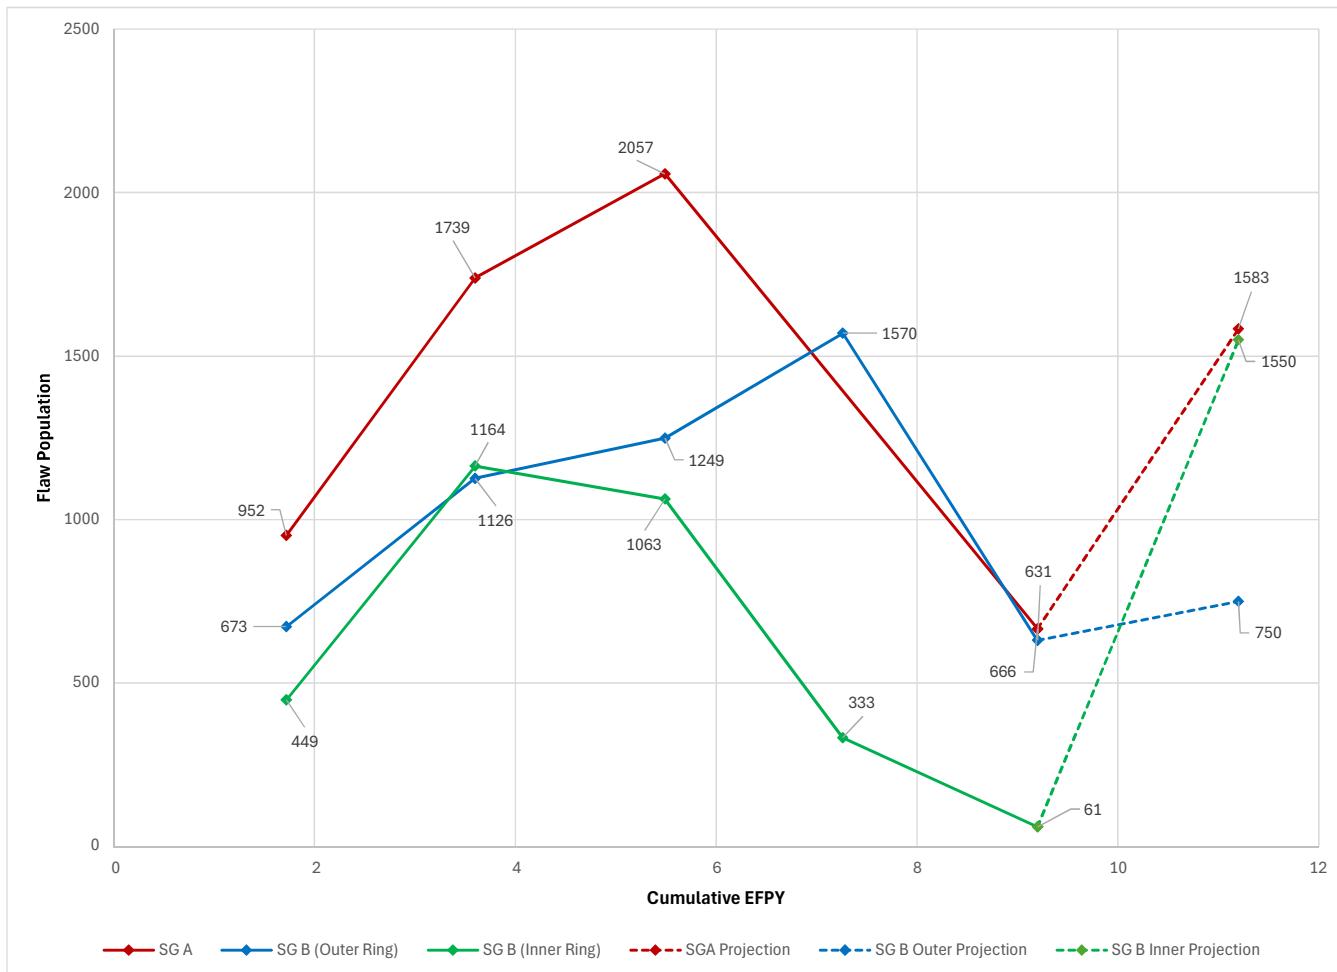
Figure 7-19: TMI New Broached TSP Wear Flaws vs Cumulative EFPY

From the 1R22 OA, a total of 2,914 new wear indications were predicted for SG B. These indications were broken down by each of the two OA zones. The results reported in 2024 showed all zones and the bundle as a whole had fewer new indications than projected in 1R22. The prediction for number of new flaws in 2024 (referred to in the 1R22 OA [21] as “1R23”) is based on a conservative projection of the recent and historical trends in new flaw initiation for each zone. Table 7-5 lists the quantity of new indications (at each cumulative EFPY value) for each OA zone.

New flaws are predicted to initiate following a similar depth distribution to what was observed in 2024. The maximum depth new indication was sized with bobbin at 47%W, which does not challenge tube integrity.

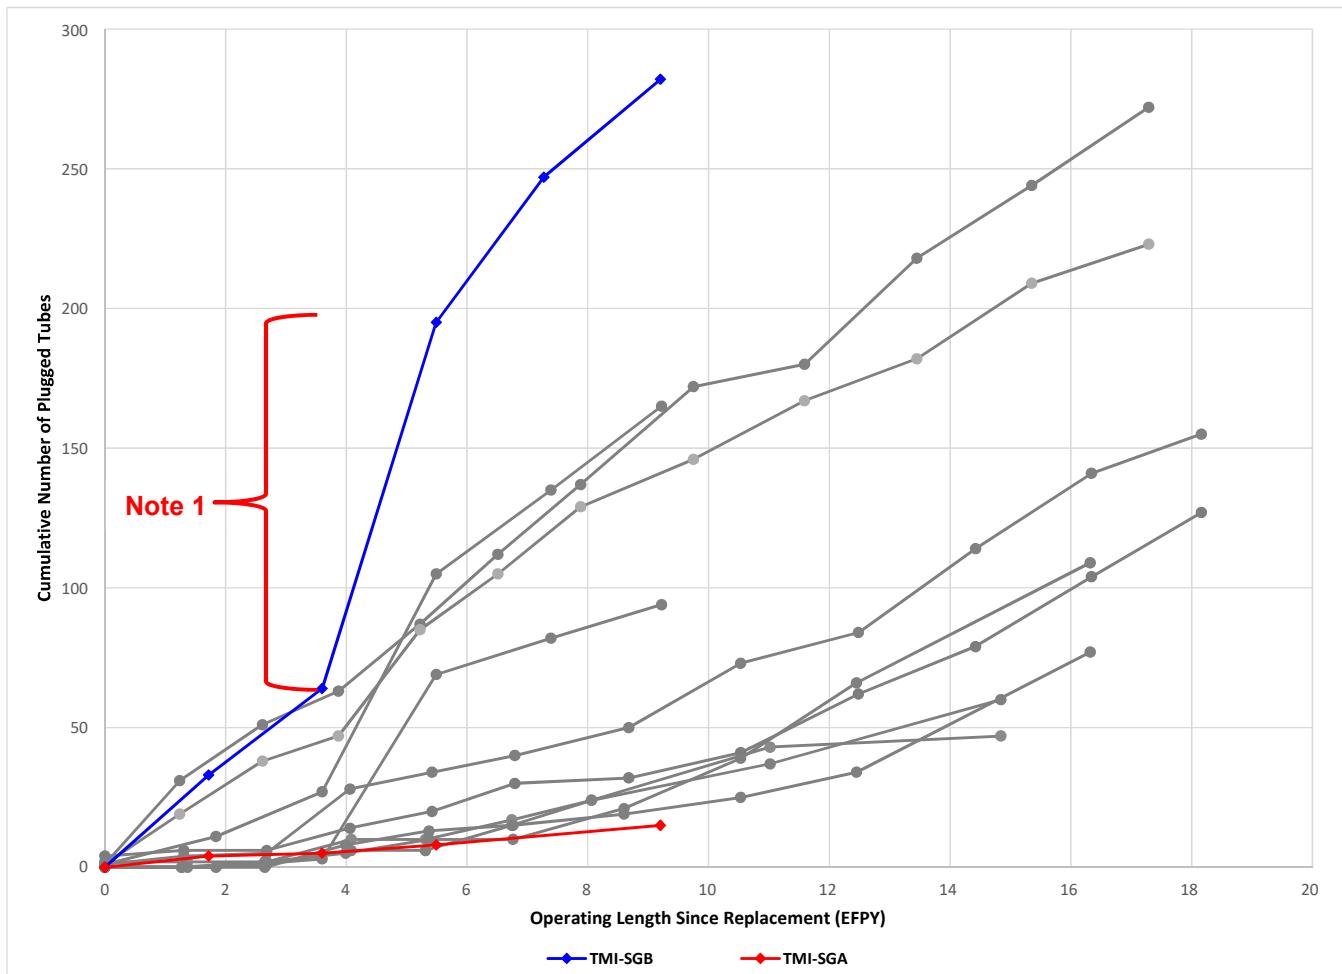
Figure 8-1: Cumulative Tube Plugging of all US OTSGs as of Spring 2024

As an additional comparison to operating experience of US OTSG experience, Figure 8-1 provides the cumulative tube plugging for the TMI-1 SGs alongside all 10 operational OTSGs (5 OTSG Units) as of the Spring 2024 inspection.

1. The large number of tubes plugged in SGB is primarily attributed to the preventative plugging of 86 W-axis tubes in 1R21, only 18 of which contained flaws $\geq 40\%$ TW.
