DEPARTMENT OF MECHANICAL ENGINEERING
THE UNIVERSITY OF TEXAS AT AUSTIN

Nuclear Engineering Teaching Laboratory • (512) 471-5787 • FAX (512) 471-4589

Subject: Report on Technical Specification violation at The University of Texas

Reference: The University of Texas Reactor License, Docket 50-602

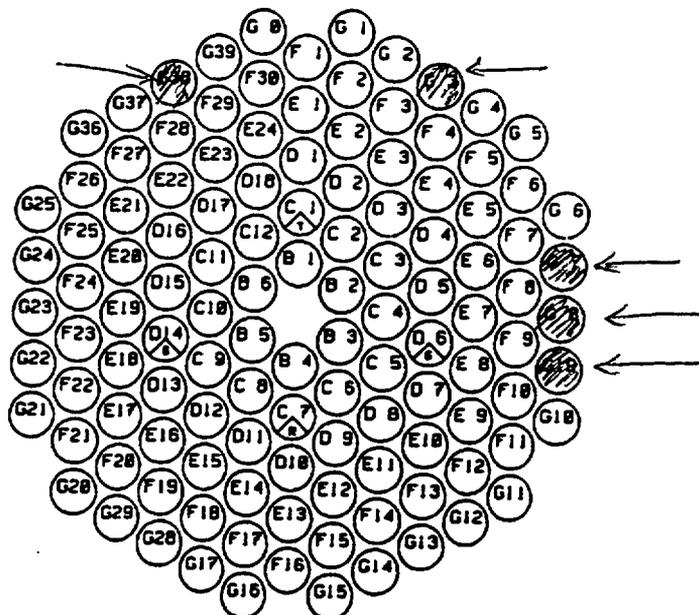
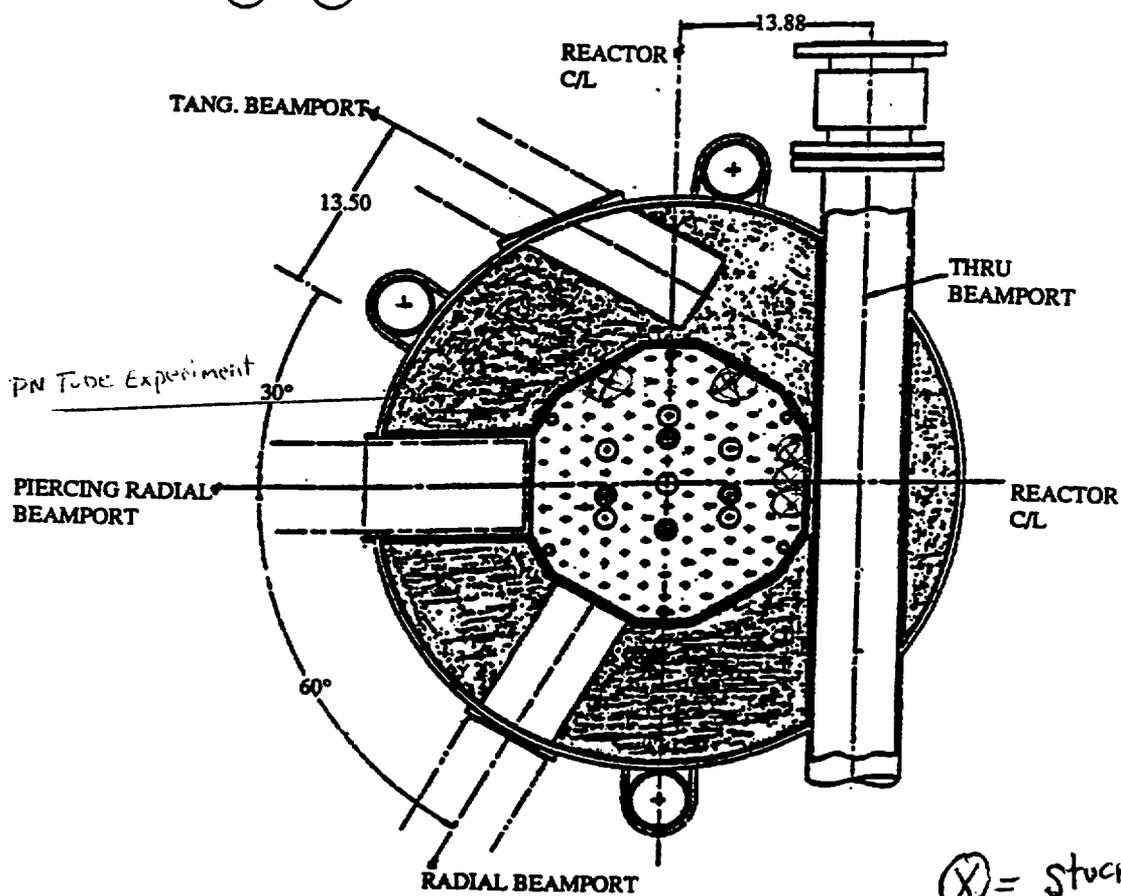
Figure 4-25

Repeatable (in size and location but spread in time) bubbles were eventually noticed while unloading the fuel from the reactor at a rate of one per 1.5 hours. At this point it became clear there had been a failure of the Reflector outer boundary producing a leakage into the system and gas venting. Plans were made for draining the reactor pool and installing a continuous vent or purge system to compensate for the leak. It was hoped that the Reflector could remain dry and not compromise the Reflector characteristics or several experiment locations.

Later calculations resulted in higher pressures to account for the deformation of the aluminum Reflector. Dr. Karl Frank of the UT Department of Civil Engineering calculated it would take approximately 200 psi to cause the displacements in the 0.25 inch aluminum plate. Calculations using this pressure and an equivalence provided by a 1987 EPRI report on Hydrogen Water Chemistry (1000 scf H₂ = 27.1 lbs TNT) would make the total Hydrogen explosive material to be 6203 times the 25 mg limit or 155 gms of TNT.

The NETL has been consulting with various experts in hydrogen, gaseous fuels and explosives to determine the best method of venting the flammable gases. At this time, it is believed that a controlled venting of the internal gases by slowly drilling or piercing the aluminum container is the most likely means of correcting the present conditions.
