**Subject: Beaver Valley Power Station, Unit No. 1  
Docket No. 50-334, License No. DPR-66  
Completion Report for Generic Letter 87-02,  
USI A-46 Program**

### Beaver Valley Power Station Unit 1 (BV-1) Generic Letter 87-02, USI A-46 Completion Report

### **Updated Outlier Completion Tabulation**

JOB NO. 250540 JOB BEAVER VALLEY A-46 OUTLIER RESOLUTION  
 CALC. NO. C-021 SUBJECT OUTLIER RESOLUTION FOR DAMPERS

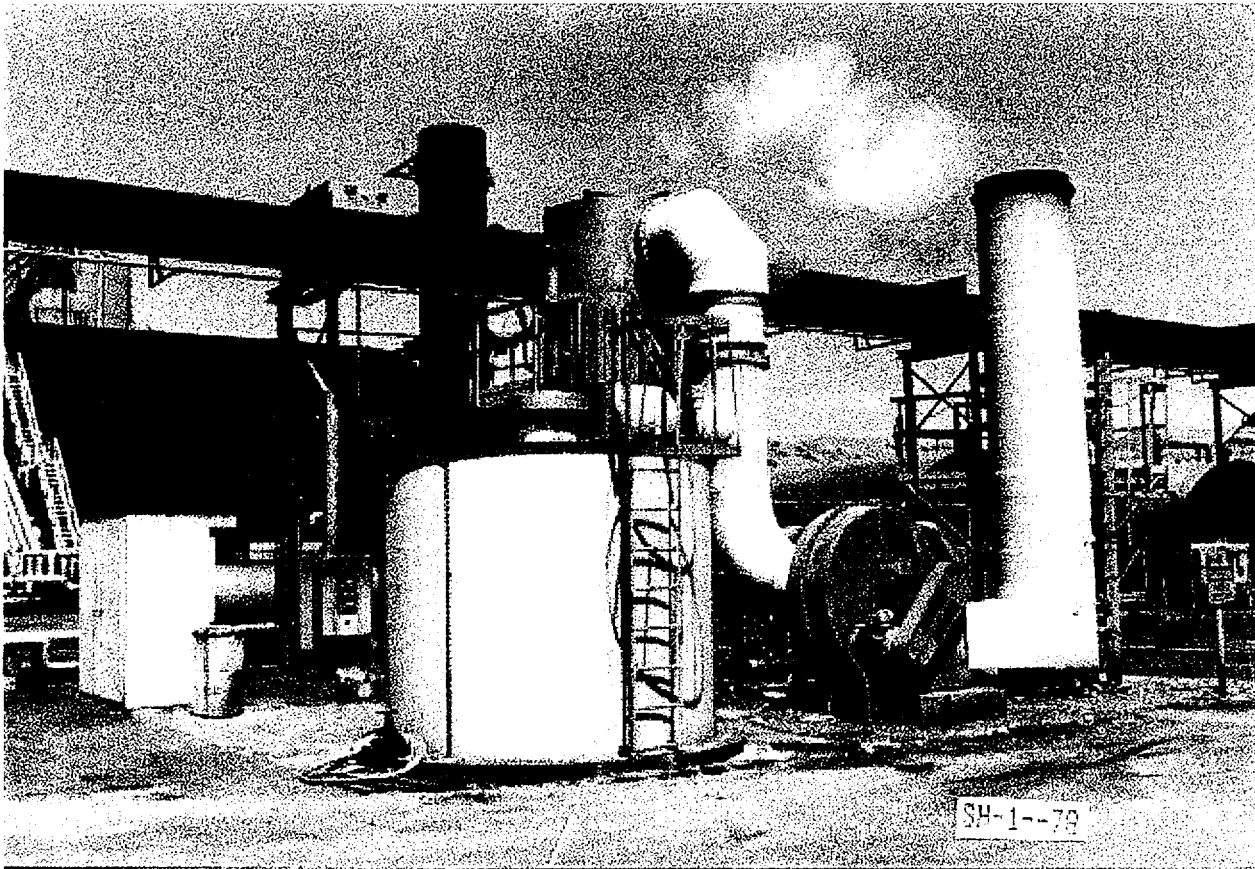
FIGURE A-12: PNEUMATICALLY CONTROLLED DAMPER AT UC SANTA CRUZ APPLIED SCIENCE BUILDING SUBJECTED TO 1989 LOMA PRIETA EARTHQUAKE (0.46G).

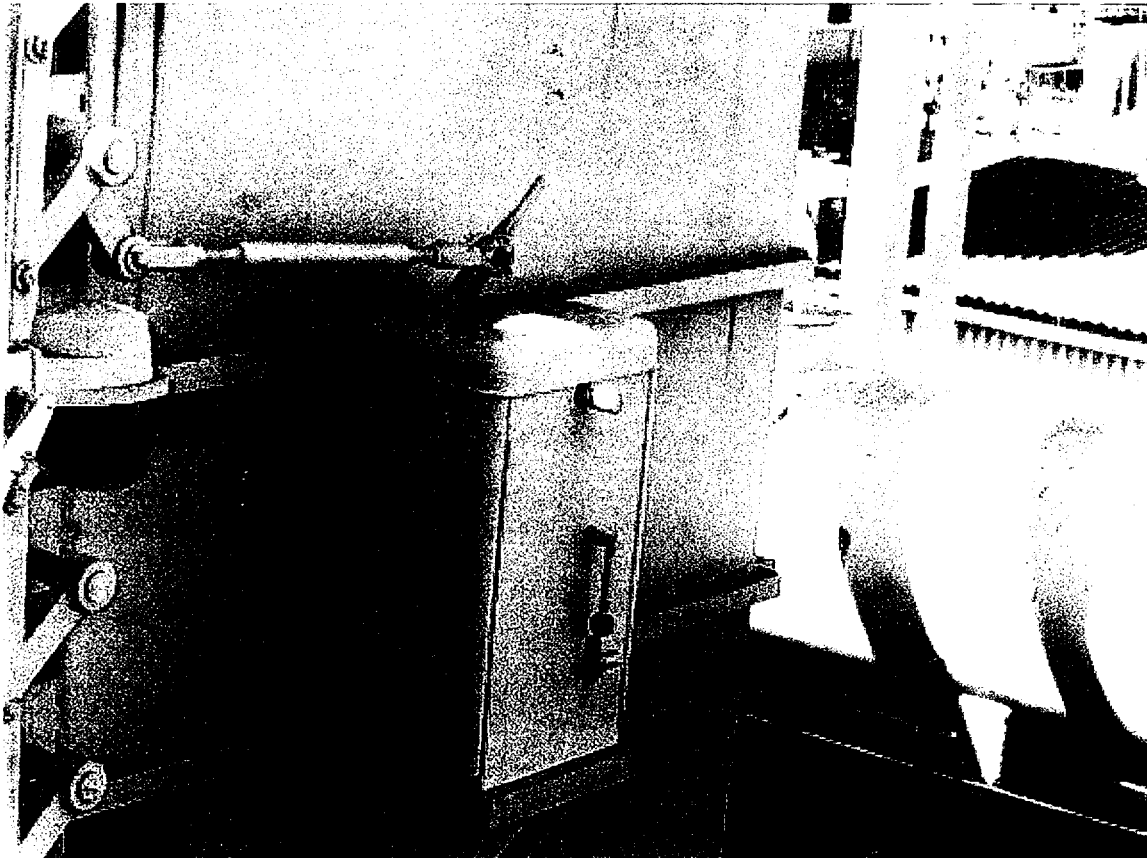
FIGURE A-15: PNEUMATIC LOUVER CONTROL DAMPER AT PASADENA POWER PLANT WHICH EXPERIENCED SEVERAL DATABASE EARTHQUAKES WITH PGA'S OF 0.20G.

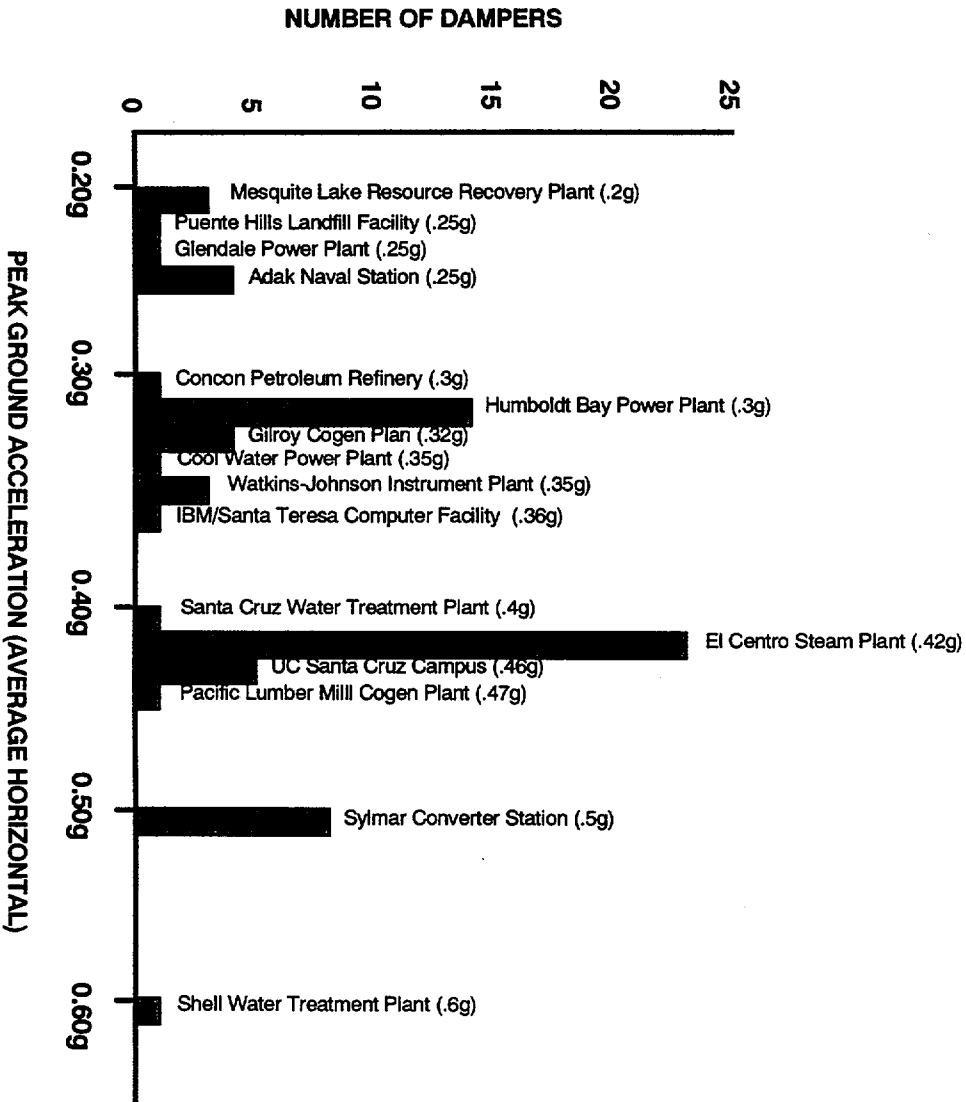
FIGURE A-19: INVENTORY OF DAMPERS WITHIN EXPERIENCE DATABASE

Figure A-19 presents a bar chart that illustrates the inventory of dampers at various database sites as a function of estimated PGA. It should be noted that much attention has recently focused on the existence and verification of ground motion records at sites within the SQUG Seismic Experience Database. Although the PGA level has been used traditionally within the A-46 program to rate the level of the earthquakes at database facilities, concerns have been expressed by the Nuclear Regulatory Commission regarding use of this single parameter to measure earthquake damage. The NRC's position is that a better measure is the ground response spectrum developed from the ground motion recorded at or near a facility. At this date only a limited number of the SQUG database sites meet this requirement. A list of those sites is included in Appendix G of this calculation. Of the database dampers presented in this calculation 47 are located at six of those sites that meet the ground motion requirement and have been accepted by the NRC (Reference 5). They are also presented in Appendix G. On this basis of representation, it is considered acceptable to use the SQUG Reference Spectrum as a basis for comparison of the air handler database equipment. Additional examples within the inventory in Figure A-19 at sites that presently do not meet the ground motion requirements cited by the NRC are also presented to demonstrate that additional dampers are known to have been subjected to significant earthquake motion with no damage, underscoring the inherent ruggedness of the equipment class. It should be noted that activities are currently under way to document the ground motion at currently unapproved sites, thus allowing a greater number of database sites to meet the NRC's requirements in the future.
