NUREG/CR-5280
BNL-NUREG-52178
Vol. 2

Age-Related Degradation of Westinghouse 480-Volt Circuit Breakers

Mechanical Cycling of a DS-416 Breaker
Test Results

Brookhaven National Laboratory

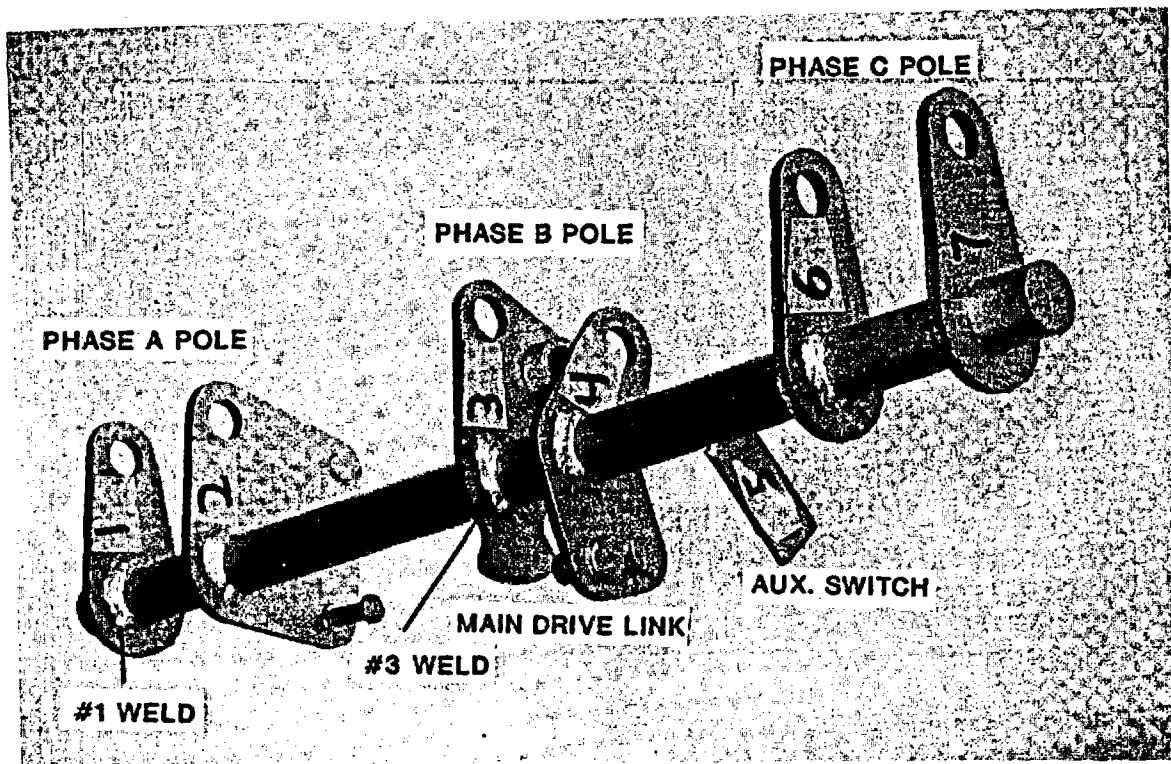
Figure 3-1. Pole Shaft with Seven Levers Welded on to it

The pole shaft is constructed of a round steel shaft and seven levers welded on to it. With exception to the levers 4 and 5 (see Figure 3.1), the other five levers are connected to the moving contact assemblies for the three poles. The #3 and #4 levers are also connected to the main drive link which, in turn, is connected to the operating mechanism via the main roller and cam assembly. The #5 lever is for the auxiliary switch drive link. Thus, when the breaker is closed, or tripped, the stored energy in the closing and/or opening springs rotates the pole shaft to the appropriate positions. Therefore, the welds on the shaft are subjected to torsional forces; weld #3 being the only lever connected to the charging mechanism and the pole, has the worst stress.

The first shaft with a 60 degree weld at the center pole lever (#3 in Figure 3.1) had a life of 3000 mechanical operating cycles. At the end of the test, the pole lever was completely detached from the shaft, as shown in Figure 4.8. A crack was first noted at one end of the weld where the weld material was taken out for experimental purposes. At that time the breaker had undergone 1000 operating cycles. Up until 2500 cycles, the effect of this crack was not noticed; at this point the pole shaft was bent. From then, until the end of the test, several problems associated with the

The second pole shaft with a 120 degree weld size lasted for 13,593 cycles. Two cracks appeared at the levers #1 and #3 welds (see Figure 3.1) simultaneously after the shaft had undergone 8,970 operating cycles. Both cracks grew at almost same rate and reached to sizes of 2.5mm – 3.5mm before the misalignment between the five levers shown in Figures 4.9 and 4.10 caused the end of the shaft life. The event occurred when this pole shaft experienced 12,941 cycles. Problems associated with this misalignment caused the phase A pole pin to break. In between the period when the first cracks were noticed and the misalignment (8,970 to 12,941 pole shaft cycles), the first operating mechanism failed to operate and the motor burned out. In evaluating the data, we attributed these problems to the aging in the operating mechanism rather than to the two cracks on the shaft. These cracks never grew big enough to suggest that there was any change in the torque on the shaft, as was the case in the first shaft, nor did they induce problems with other components attached to the shaft. However, the misalignment caused by the shaft finally fractured the pin.

The No. 3 weld (60 degrees weld) shown in Fig. 3.1 in the main text failed causing the No. 3 lever to loose after 3000 test cycles. EDAX analysis of the weld shows that it is carbon steel.

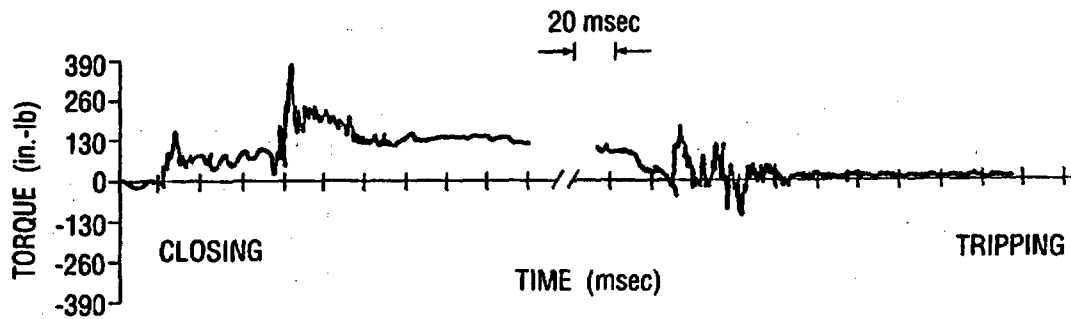
Figure 4-2. First Pole Shaft Torque Signature at 287 Test Cycles (Sequence I - Beginning)

Table 4.2 summarizes torques on the first pole shaft for the beginning and before failure cycles of the test breaker. The average closing torque range remained almost unchanged at 340 to 373 inch-lbs in the later part of the shaft life, while the opening torque range averaged more than doubled from 400 to 840 inch-lbs. This change in the tripping torque occurred at about 2000 cycles on the shaft and the crack in the weld separation had grown to 3.18mm in circumference. Figures 4.2 and 4.3 illustrate the strain gage signatures for the torque on the shaft representing the beginning and final part of its life, respectively. Comparing these two figures, a change in

The failure of the pole shaft weld, which recently received a great deal of attention, is analysed separately. The strain-gage plots shown in Figures 4.2 through 4.7 suggest that the peak torques experienced by the pole shaft and the tripping time spans change with the age of the breaker. These torque signatures are influenced both by the pole lever weld cracks and aging of various parts within the operating mechanism assembly. Analysing the test results for the three test shafts, the following two failure modes are associated with pole shaft failures:

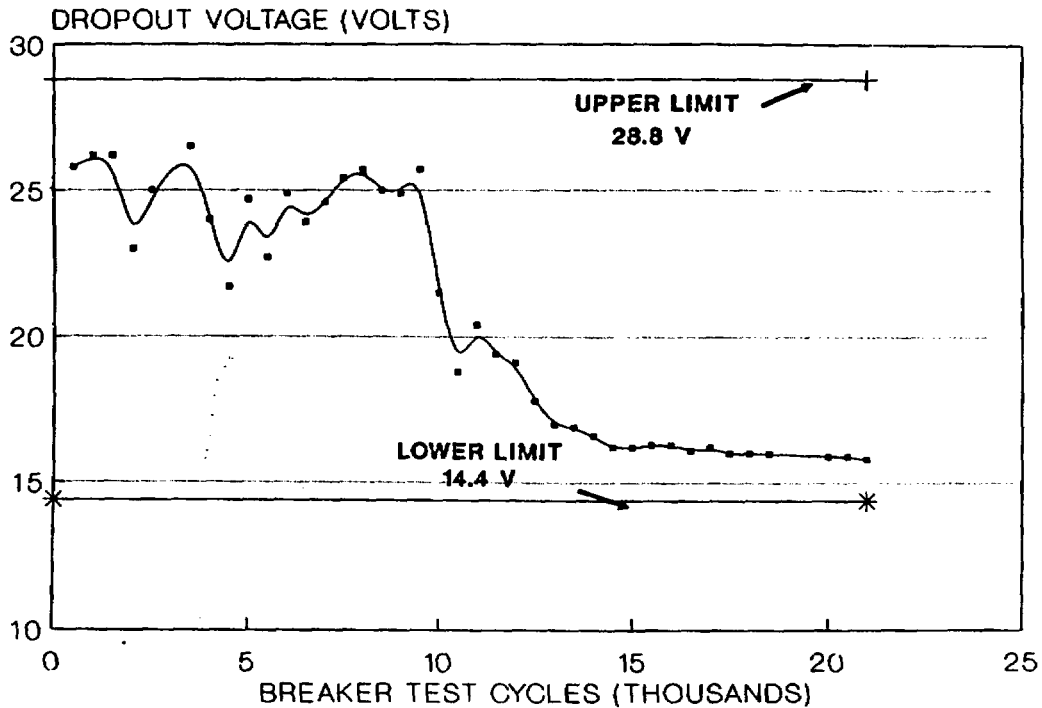
Figure 4-18. Dropout Voltage for the UVTA

Finally, the test results of the dropout voltage of the UVTA coil were examined. Figure 4.18 shows the trend of this parameter with the breaker test cycles. Each data point represents the average of three measurements performed according to the maintenance procedure. The upper and lower limits for a successful operation of this device are also illustrated. It is interesting to note that for the entire life of this device all the measured values remained within these limits; for the first 10,000 cycles it was closer to the upper limit of 28.8 volts, while for the remaining life it was closer to the lower limit of 14.4 volts. The drop in dropout voltage at 10,000 cycles is not understood. However, degradation within the coil insulation by the ohmic heat may be the cause. Again, after this drop the trend remained unchanged for the rest of the coil life.

We conclude that aging in any of these three coils has minimal effects on breaker operation. However, the STA and closing coils are vulnerable to quick burnout due to excessive heat generated by an extended operation, which is primarily caused by the aging of various elements in the operating mechanism and the associated linkages whose binding or sluggish motion caused the coils to burn out instantly.

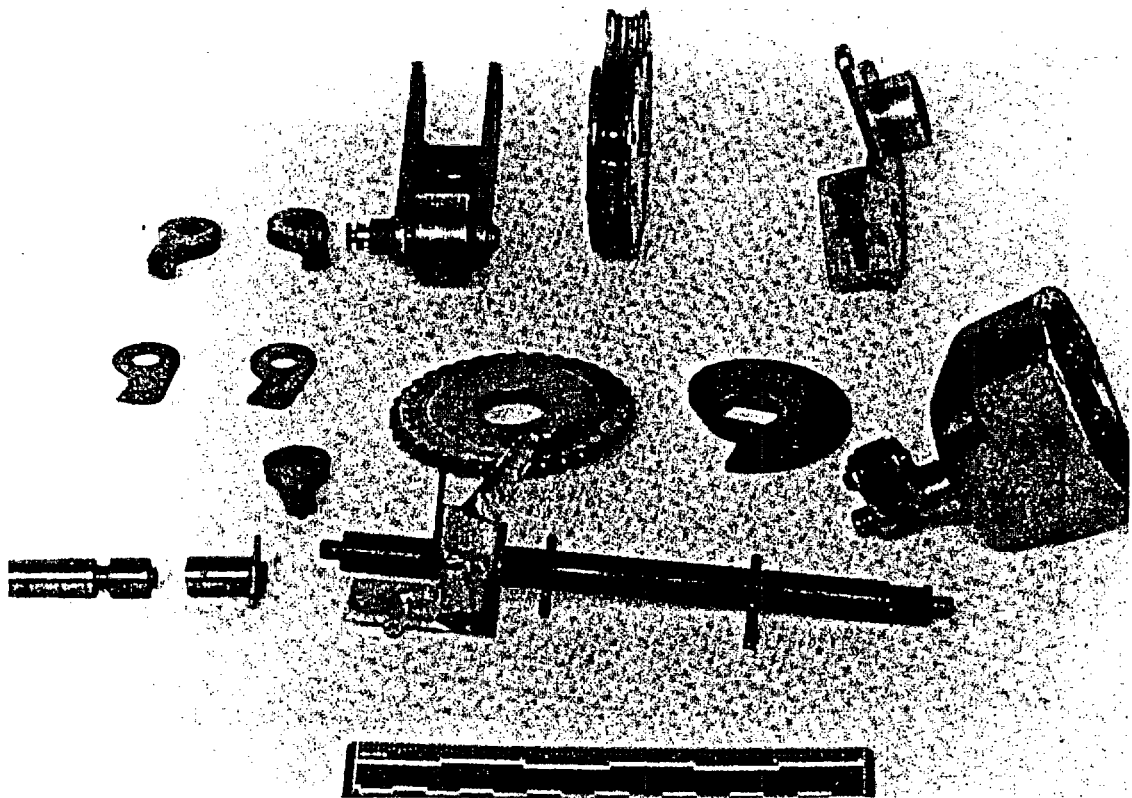
Figure 4-25. Aging in Various Breaker Components

Several other components associated with the operating mechanism failed during this test. Figure 4.25 illustrates the conditions of some of these components taken from the first mechanism that exhibited significant aging after 13,609 cycles. These include worn pawls (emergency charge, hold, and oscillator) for the ratchet wheel, aged drive plate, and fractured pole shaft pin. Other components shown in this figure were discussed earlier.

The second pole shaft with a 120 degree weld in the #3 lever developed cracks in the #1 and #3 lever welds at about the same time. When these cracks became large at about 13,000 cycles, misalignment of the first two levers was noticed, as shown in Figure 4.10. This probably caused higher torque and bending moments on the phase A pole shaft pin which broke (see Figure 4.26) at 13,593 cycles. The metallurgical examination of the fractured surface revealed that the cracking of this pin was primarily due to an improper heat treatment of the stainless steel. Improper machining might have left raisers which initiated the crack under excessive bending moment and finally the crack propagated intergranularly to break the pin (see Appendix C, section C.2.3).

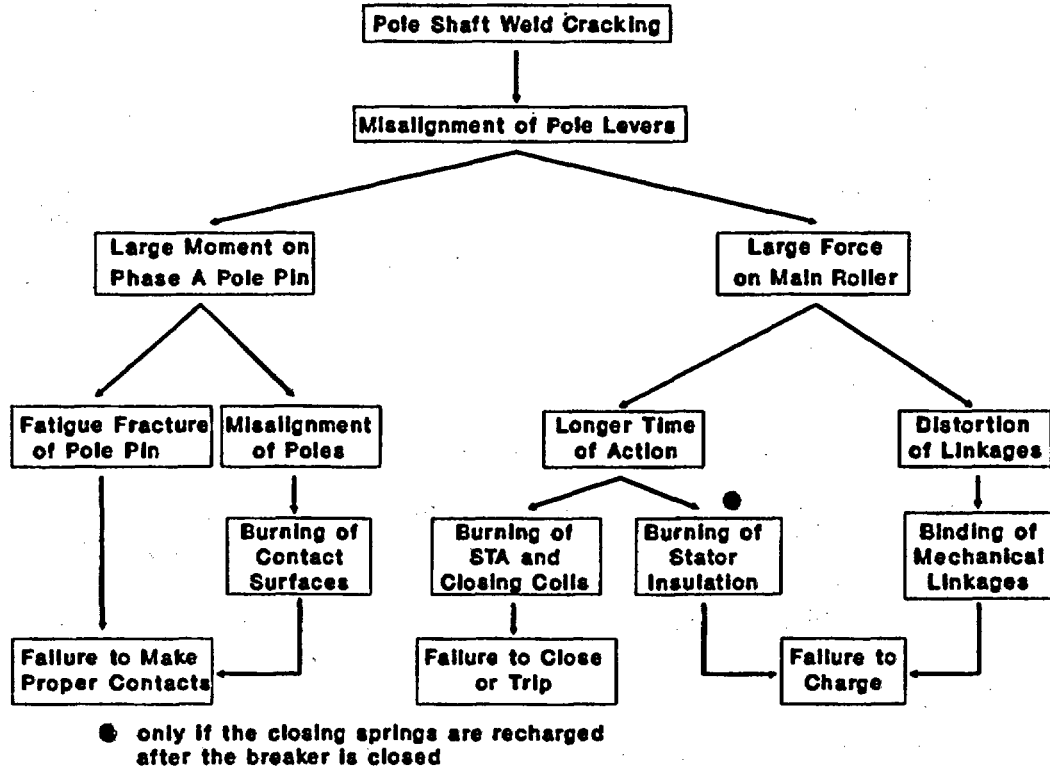
Figure 5-2. Cause and Effect Analysis of Failure of Pole Shaft Weld

- (1) If the quality of the weld in the lever #3 is very bad (i.e. an effective weld size less than 90 degree, or the presence of cleavages or slags in the weld), complete separation of the lever will occur.

- (2) If the quality of the weld in the lever #3 is normal (i.e. an effective weld size is at least 90 degree with some level of imperfection such as porosity), cracks in the #1 and #3 welds will develop.

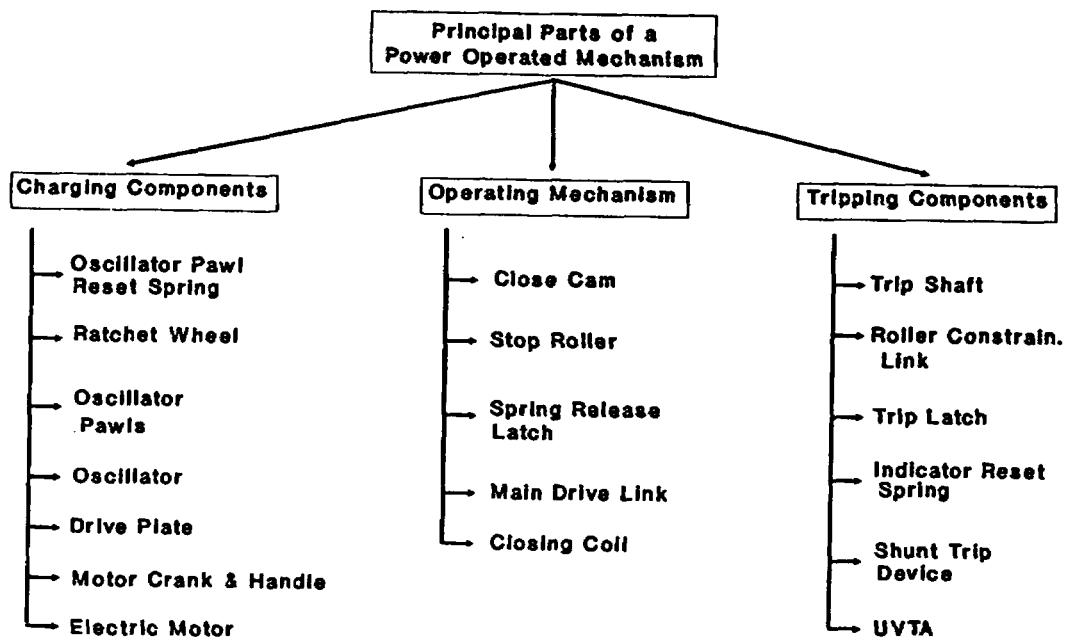
Figure 5-3. Principal Parts of a Power Operated Mechanism Vulnerable to Aging

The principal parts of a power-operated mechanism assembly, that have shown some aging due to mechanical cycling, are listed in three groups (Figure 5.3). Others, not included in this list, such as the closing and opening springs, crank shaft performed their design functions throughout the test. Group 1 components are responsible for charging the unit while the closing springs store the potential energy for closing the contacts, group 3 components are responsible for tripping the breaker, and group 2 components are responsible for closing the contacts and also providing controlled motion for the three operations (i.e. charging, closing, and tripping) of the breaker.

crank shaft which prevented the breaker from charging. Based on the test results, the average life of this assembly is about 12,000 cycles. However, indications of aging were observed somewhere around 9500 cycles. These indications are presumed to reflect the synergic effects of parts of this assembly and the cracking of the pole shaft welds. Therefore, for the second mechanism where the pole shaft contained good welds, no particular early sign was noted until the final 500 cycles.

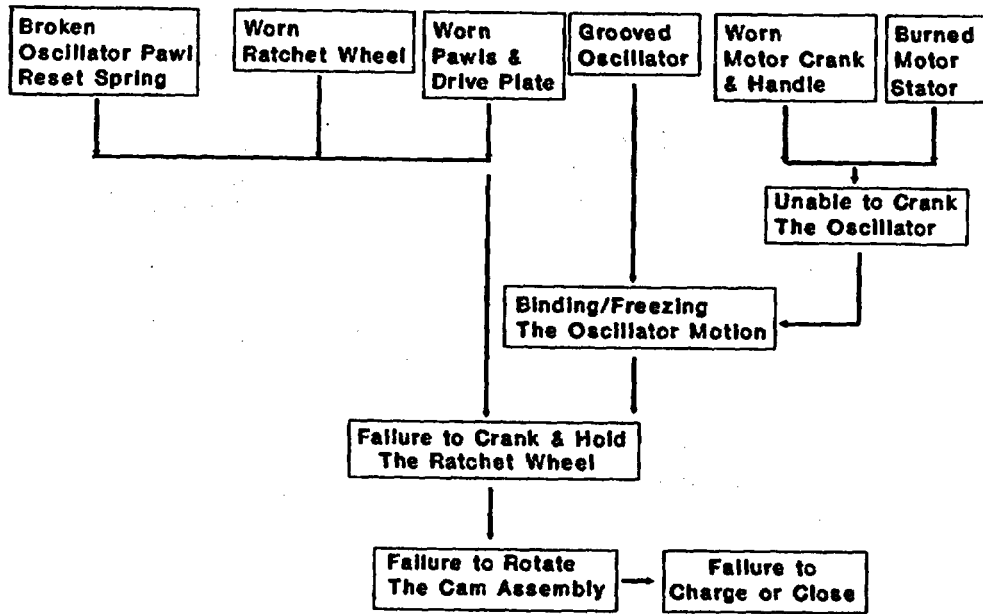
Figure 5-4. Cause and Effect Analysis of Parts Responsible for Charging the Breaker

tions. Figure 5.4 illustrates the root-cause analysis of parts associated with components responsible for charging the breaker.

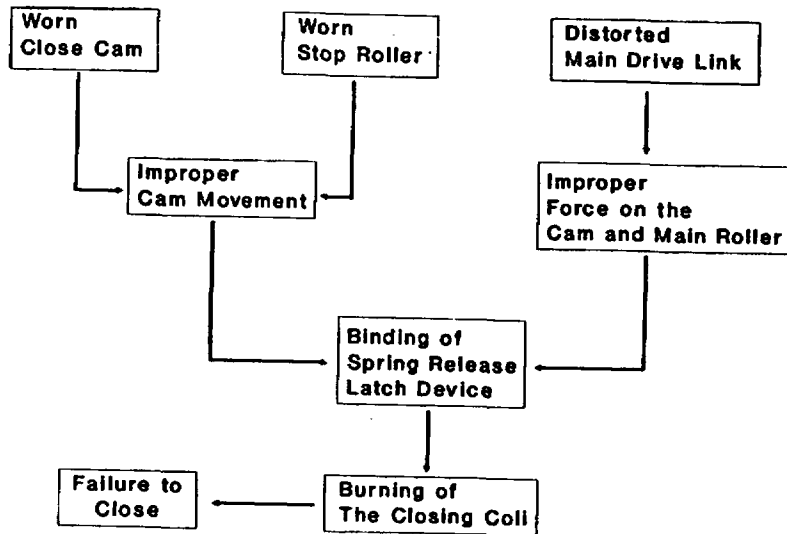
Figure 5-5. Cause and Effect Analysis of Parts in the Operating Mechanism

For the parts within the operating mechanism, wear in the cam assembly and the stop roller reduced the ability of the cam to transfer appropriate control to the main drive link. The constant rolling action of the main roller over the cam surfaces, which can be further accentuated by the redistribution of forces on the main drive link by either failure of the pole shaft weld or misalignment, is primarily responsible for wear on the cam. The main roller attached to the main drive link showed some wear and distortion. Aging in all these components often leads to a binding force on the spring release latch which, in turn, leads to burning of the closing coil. Figure 5.5 shows the cause and effect analysis for this group of components.

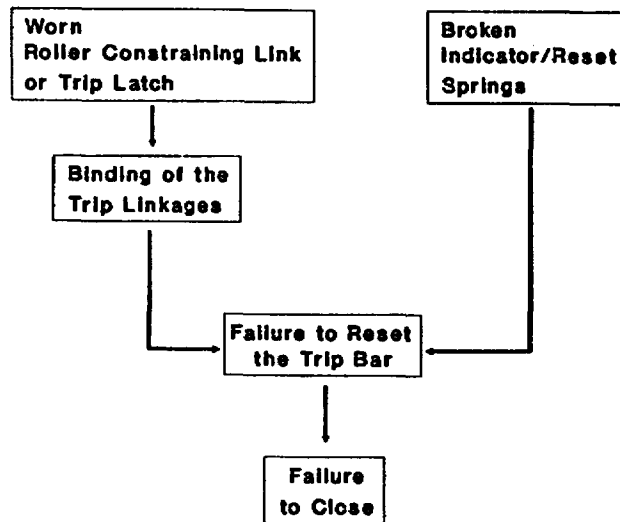
Figure 5-6. Cause and Effect Analysis of Parts in the Tripping Assembly

Finally, among all parts within the tripping assembly, the roller constraining link or the trip latch indicated some wear. In addition, there are two small springs, one attached to the left end of the trip shaft, and the other linked to the 'trip' indicator plate. Both springs are used to reset the trip bar. Metallurgical examination of the fractured surfaces of the broken trip indicator spring revealed that because of the sharp bend at the ends, a high stress probably initiated the crack, which grew under cyclic action of this spring. Under these conditions, the trip shaft failed to reset the breaker. Although this never happened in this test program, dwelling of the trip shaft in one position could lead to burning of the STA coils. Figure 5.6 shows the root cause analysis for this group of breaker components.

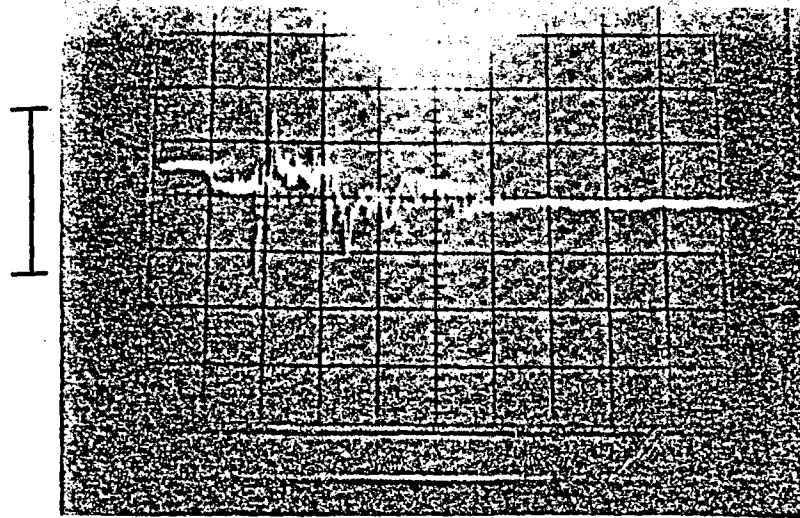
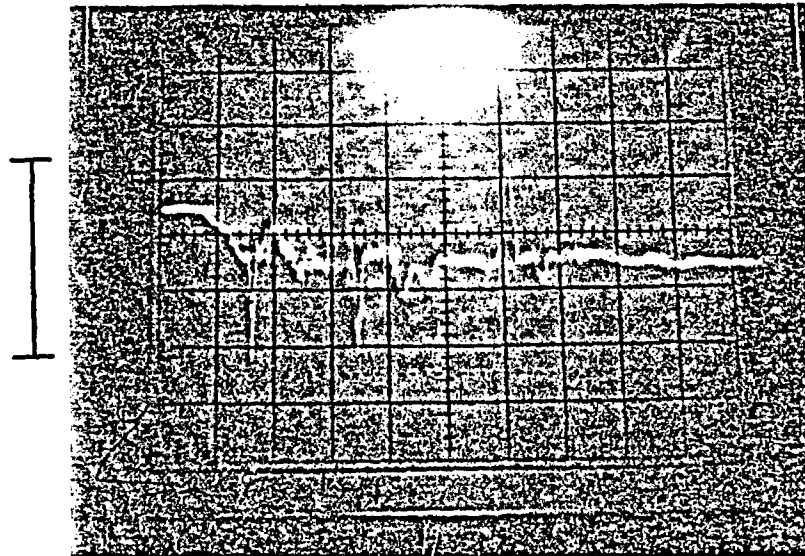
Figure B-3. Tripping Forces – Pole Shaft 1

A characteristic change in the waveform was observed as a function of accumulated opening and closing cycles to the point of failure. The first pole shaft failed at 3027 cycles on July 21, 1989. At 2015 cycles, the oscilloscope photographs indicated a doubling of the "tripping forces" during the opening of the circuit breaker. These higher dynamic torques, in the range of 780 to 910 inch-pounds, remained high until the pole shaft failed.

Figure B-3 shows the tripping forces on June 15, 1989, at 180 cycles; this oscilloscope photograph shows ± 390 inch-pounds of torque and is typical of the results from June 15 to July 10, 1989. Figure B-3 also shows a photograph at 2735 cycles on July 19, 1989; the torque is ± 830 inch-pounds which is typical of all photographs taken from July 11, 1989 until failure.

6/15/89 TRIPPING FORCES = + 390 in. lbs

7/19/89 TRIPPING FORCES = + 830 in. lbs

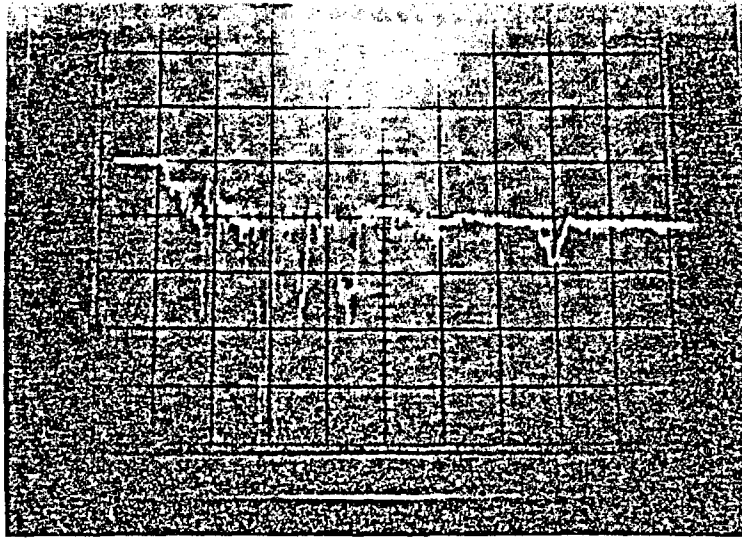
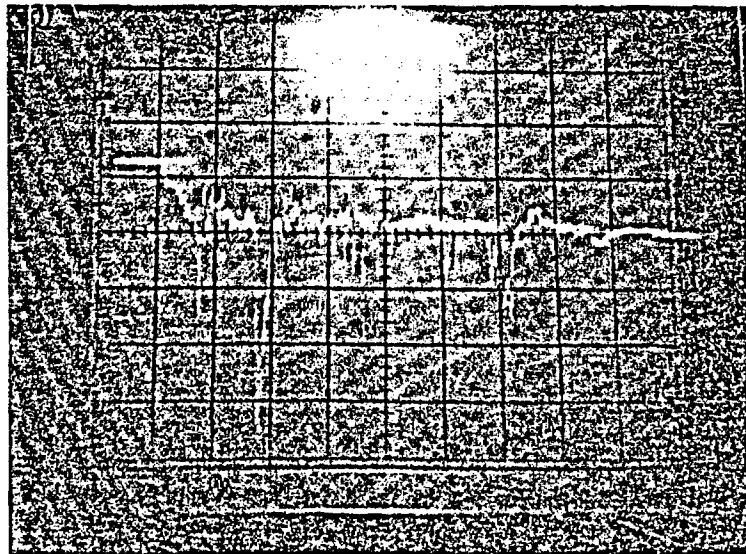
Figure B-4. Tripping Forces – First Mechanism

The first complete failure of the entire first mechanism occurred at 13,609 cycles on November 8, 1989. Before failure, dramatic changes occurred in the pole shaft torque as shown in the oscilloscope photographs. Figure B-4 shows a typical photograph of the torque prior to

TYPICAL WAVE FORM - 10/31/89 - 12, 289 CYCLES

WAVE FORM - 11/8/89 - 13, 227 CYCLES

November 8, 1989. The end of the circuit breaker closing indicates a relatively stable torque waveform. The lower photograph shows a more ragged wave shape, typical of the pattern leading to failure.

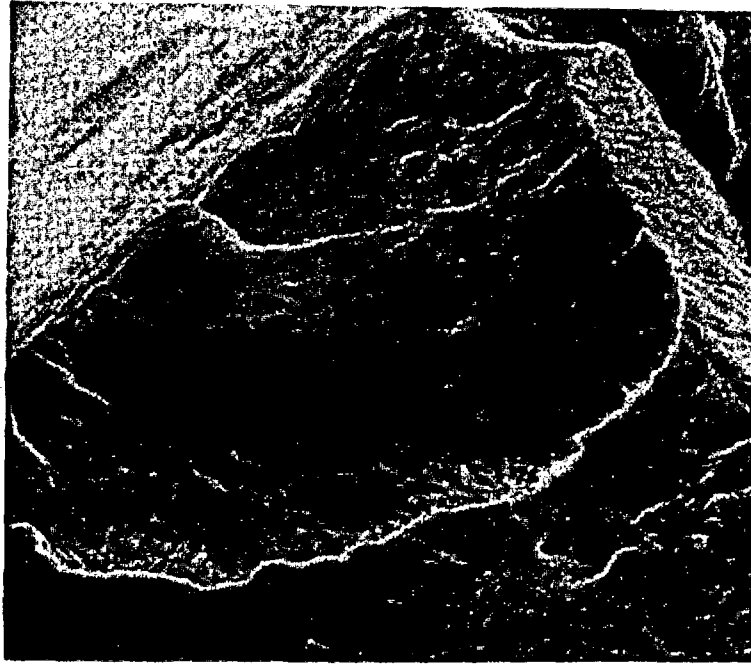
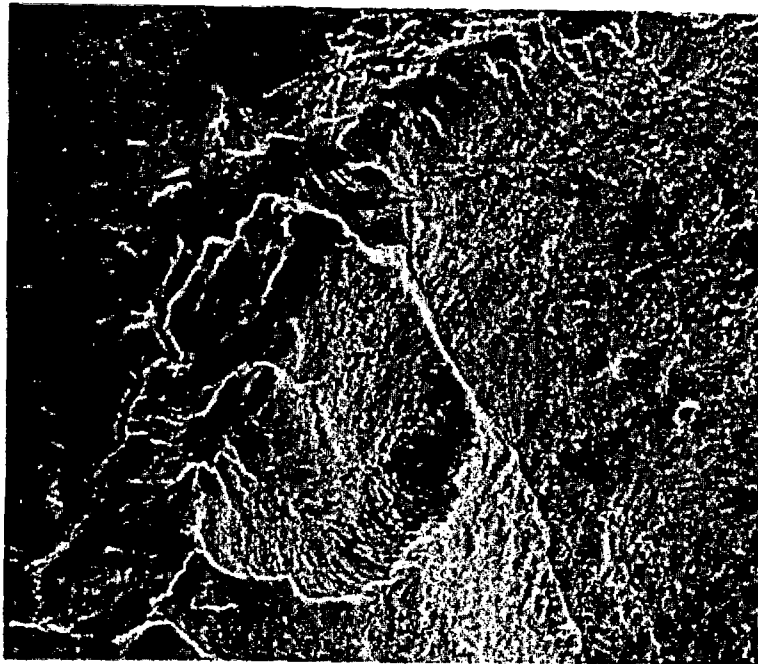
**Figure C-4. a)SEM micrograph shows a crack initiation site. Mag: 2,000 x.
b)SEM micrograph shows a secondary crack formed from the same origin. Mag: 1,000 x.**

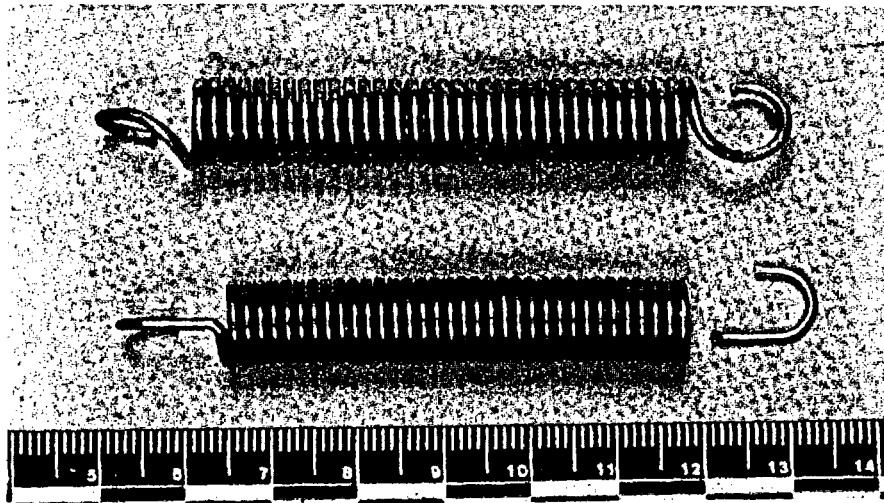
Figure C-5. Oscillator pawl reset springs

The function of this spring is to reset the oscillator pawl after each cycle of testing. It should be noted that this spring experiences a large number of vibrations in the process of resetting. One oscillator pawl reset spring failed after 2,286 test cycles, while the other spring did not fail even after 13,000 cycles. Both springs are shown in Fig. C-5.

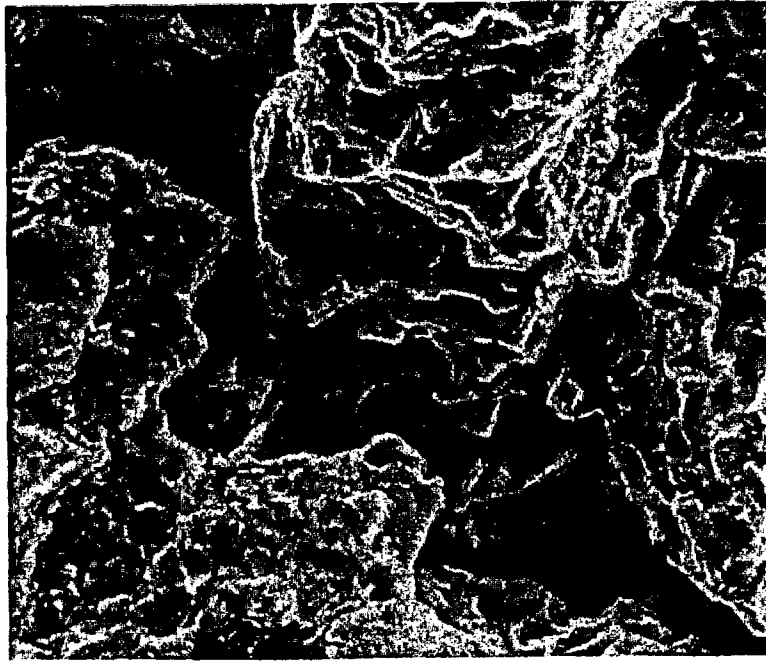
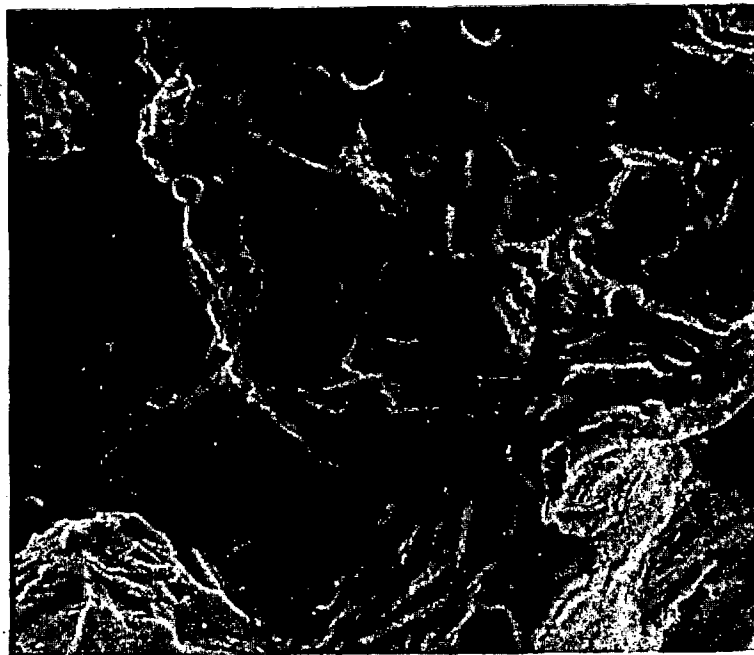
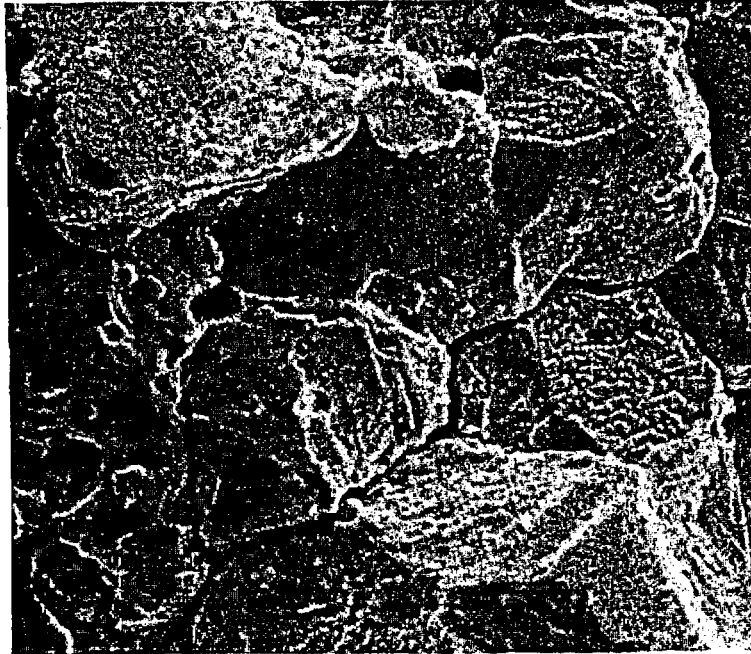
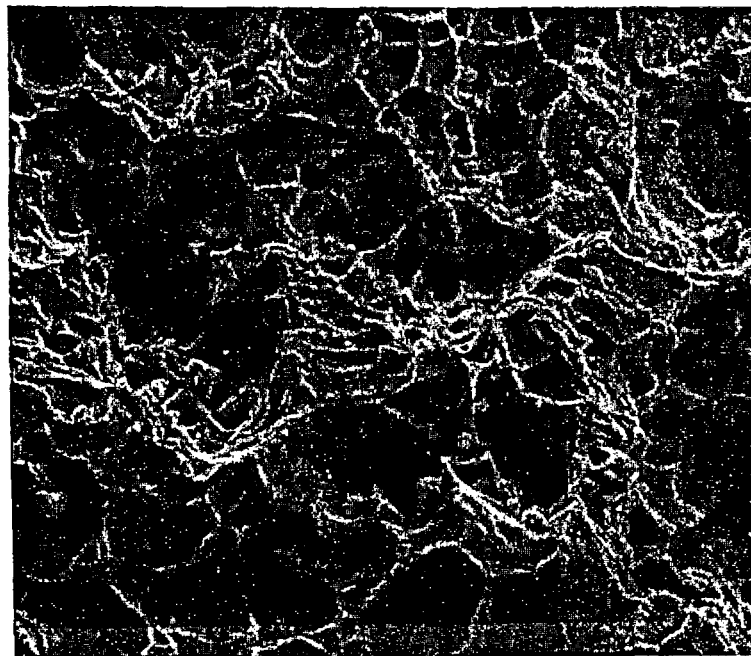
Figure C-12. SEM micrographs of the fracture surface of the drive link pin. Mag.: 2,000 x.

Figure C-12. SEM micrographs of the fracture surface of the drive link pin. Mag.: 2,000 x. (Cont'd)
