Susquehanna Siphon and Vent Block Leak

John Wise
Division of Spent Fuel Management
Regulatory Conference
November 18-19, 2015

Susquehanna spent fuel loading campaign – Nov. 2014

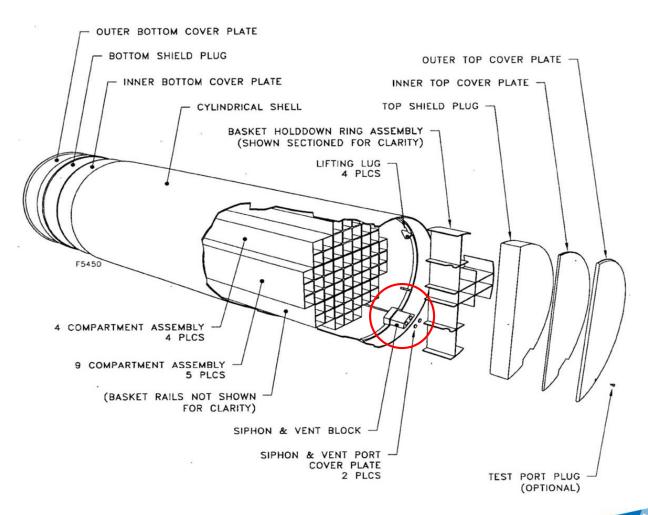
NUHOMS 61BTH Type 1 DSC

- NUHOMS 61BTH Type 1 dry shielded canisters (DSCs)
- During closure operations on one DSC, a liquid penetrant examination of a closure weld identified indications in the base metal of the syphon and vent block
