## What we could learn from the Forsmark unit 1 event 25 July 2006

Per Bystedt  
Swedish Nuclear Power Inspectorate

RIC 2008

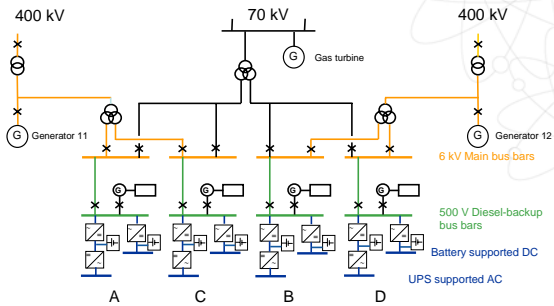
## Electrical diagram – Forsmark 1

- A short circuit in 400kV switchyard occurred during maintenance. Protection on low voltage was delayed
- A voltage transient (between 60% and 120%) was distributed into the onsite-power system
- The protective settings of the UPS were not sufficiently selective. 2 out of 4 UPS stop. CCF
- Connection of EDG was depending on bus bar powered from UPS. 2 out of 4 EDG do not connect
- Essential information lost or ambiguous in MCR
- Excessive steam blow-off from RPV. Some relief valves stayed open. Level turned at +1,9 meter at 20 minutes
- Unit cooled with 2 out of 4 ESF trains with AFW, LHSI and CS powered by EDG:s
- Offsite power to safety bus bars restored at 22 minutes

- Design weaknesses
  - UPS were not set to cope with a "design basis" transient
  - EDG connection were depending on power from UPS
  - Information in MCR effected by power loss
  - Unclear "fail safe state" at power loss
- Administrative weaknesses
  - Deficient routine at switchyard maintenance
  - Generator breaker low frequency protection (47,5Hz) not properly installed
  - Start of local gas turbine failed. Testing omissions
