South Texas Project Electric Generating Station P.O. Box 289 Wadsworth, Texas 77483

July 11, 2003  
NOC-AE-03001557  
10CFR50

South Texas Project  
Units 1 & 2  
Docket Nos. STN 50-498, STN 50-499  
Additional Information Regarding STP's Commitment to Investigate and Repair  
Bottom Mounted Instrumentation Penetration Indications

# South Texas Project Status Report on Resolving the Unit 1 BMI Issue

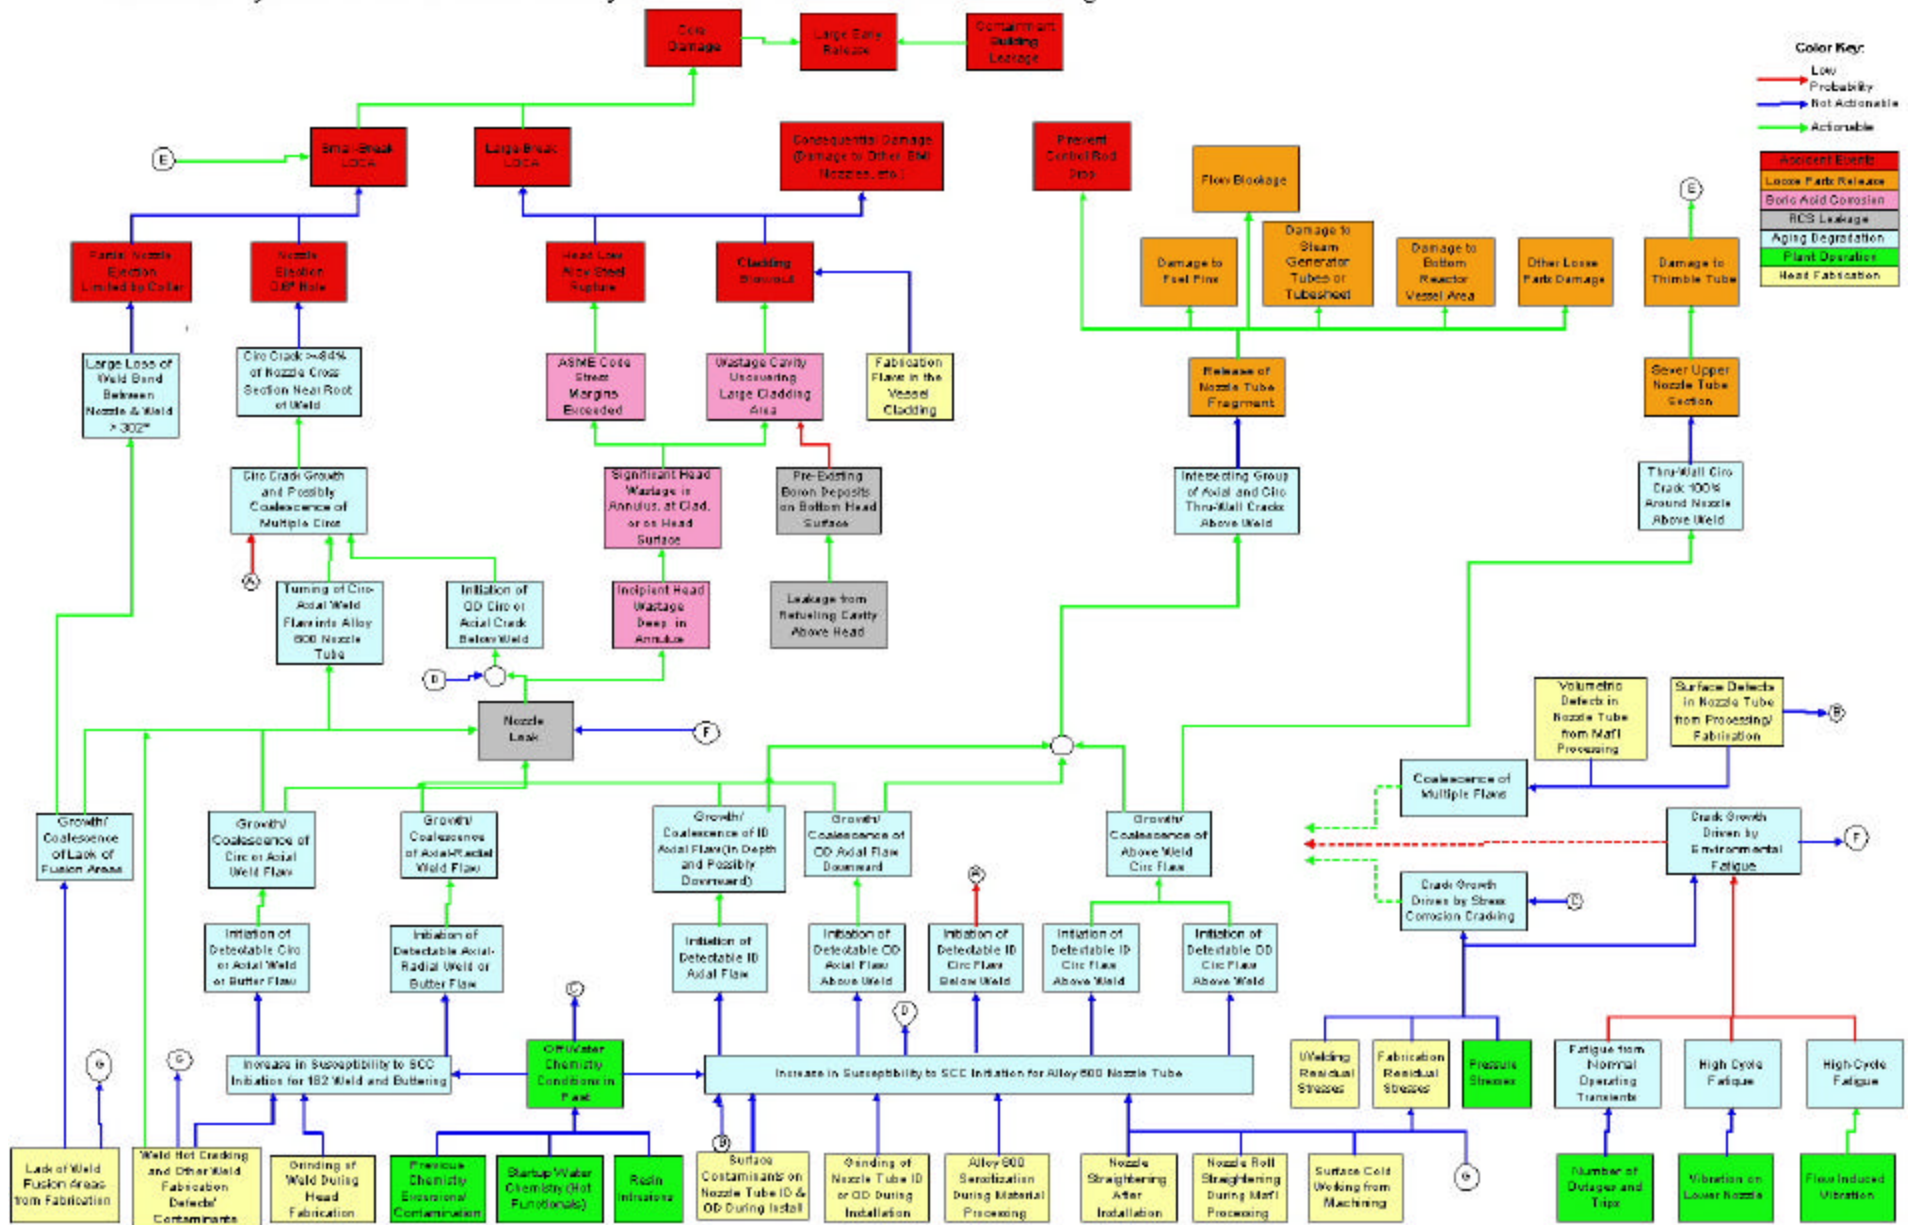
# South Texas Project Status Report on Resolving the Unit 1 BMI Issue – Attachment 1 Failure Modes and Effects Analysis Chart

South Texas Project's Failure Modes and Effects Analysis for Bottom Mounted Instrument Nozzle Leakage

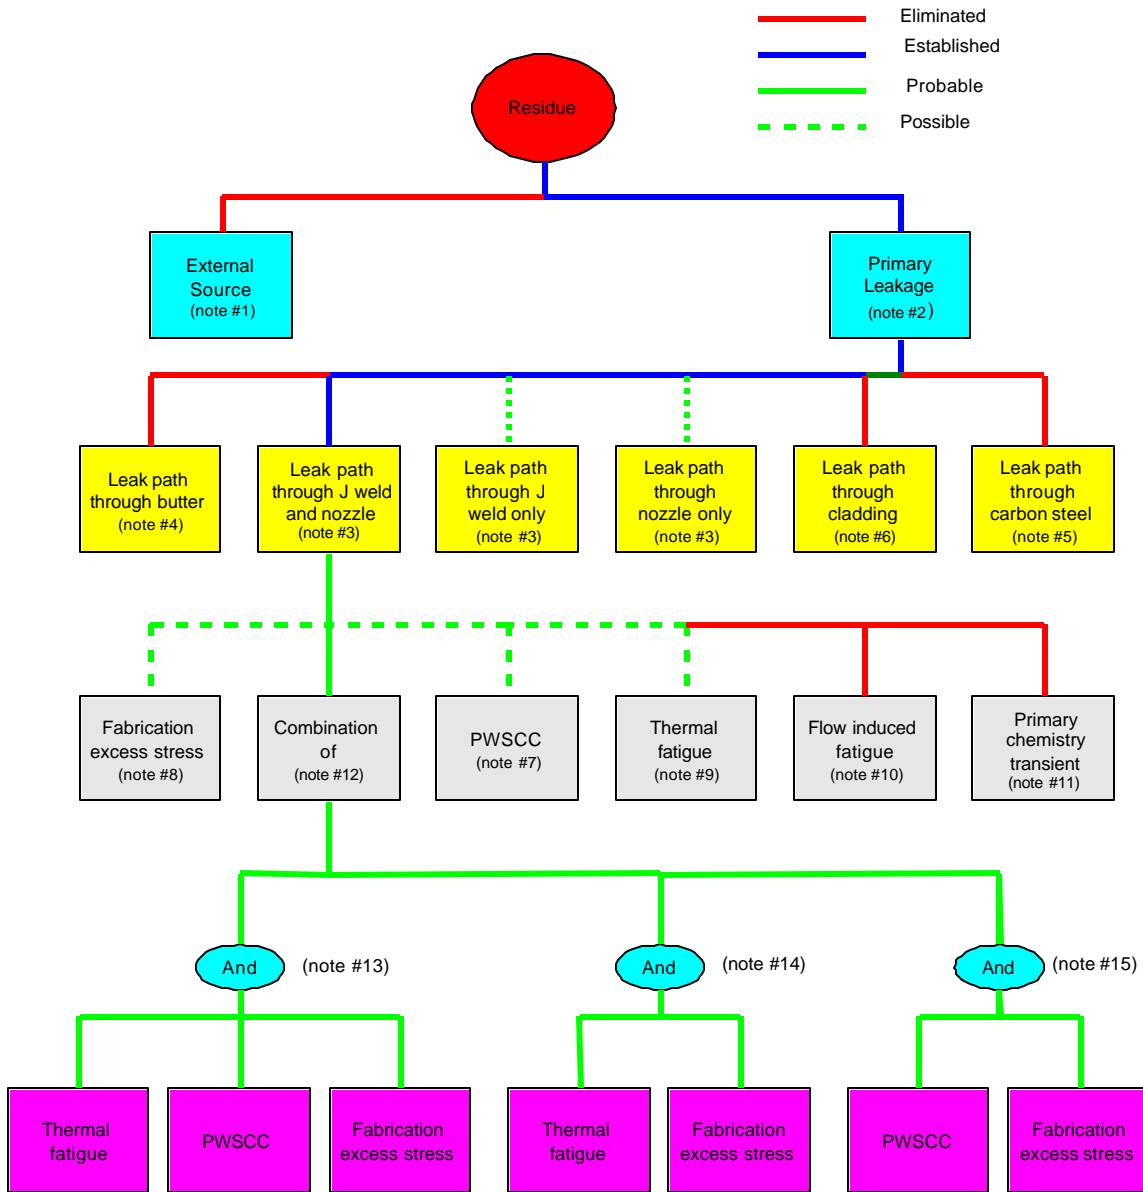
# South Texas Project Status Report on Resolving the Unit 1 BMI Issue – Attachment 3 Fault Tree Analysis

Note #1: Swipes and visual inspection of the outside surface of the RPV do not support outside source for the boron residue.

Note #3: UT examination and the pressure test identified a leak through the weld and nozzle 1. UT examinations suggest the cracks in nozzles 1 and 46 originated at the nozzle weld interface. A crack originating at this location most likely involves both the nozzle and the weld. The investigation path for nozzle, weld and combined nozzle and weld is the same. The boat sample result will be the best opportunity to separate between the nozzle and the weld.

Note #7: PWSCC requires three things; 1) susceptible metal, 2) residual stress, and 3) an aqueous environment. Only two of five nozzle cracks are confirmed to be in contact with primary water. Although these cracks appear to have their origin within the welded zone, it is possible, but unlikely, they could exist by PWSCC alone.

Note #9: This is low cycle fatigue due to temperature and pressure changes. If fatigue alone were responsible for the flaws there should be more flaws in other nozzles. Fatigue is a possible source of the cracks but more likely in combination with pre-existing fabrication defects.

Note #11: There are no records of significant RCS chemical transients. STP experience with the Alloy 600 steam generator tubes, which are much thinner, have not indicated any degradation due to RCS chemical contaminants.

Note #12: Cracks that do not extend beyond the weld zone, (i.e., not in contact with primary water) Are most likely the result of a combination of fabrication flaws

and low-cycle fatigue. However, cracks that are in contact with primary water may be a combination of PWSCC, fabrication flaws, and low-cycle fatigue.

Note #13: Possible for cracks that appear to have their origin within the weld and extend to the point of contact with primary water.

Note #14: Most likely source of cracks totally imbedded in the weld zone but could also be possible for cracks that extend beyond the weld.

Note #15: This postulates a fabrication flaw that was missed by the final PT examination or propagated to the surface during the initial hydro vessel testing and later grew through the weld zone by PWSCC.
