South Texas Project
Units 1 & 2
Docket Nos. STN 50-498, STN 50-499
Additional Information Regarding STP's Commitment to Investigate and Repair
Bottom Mounted Instrumentation Penetration Indications

South Texas Project Status Report on Resolving the Unit 1 BMI Issue

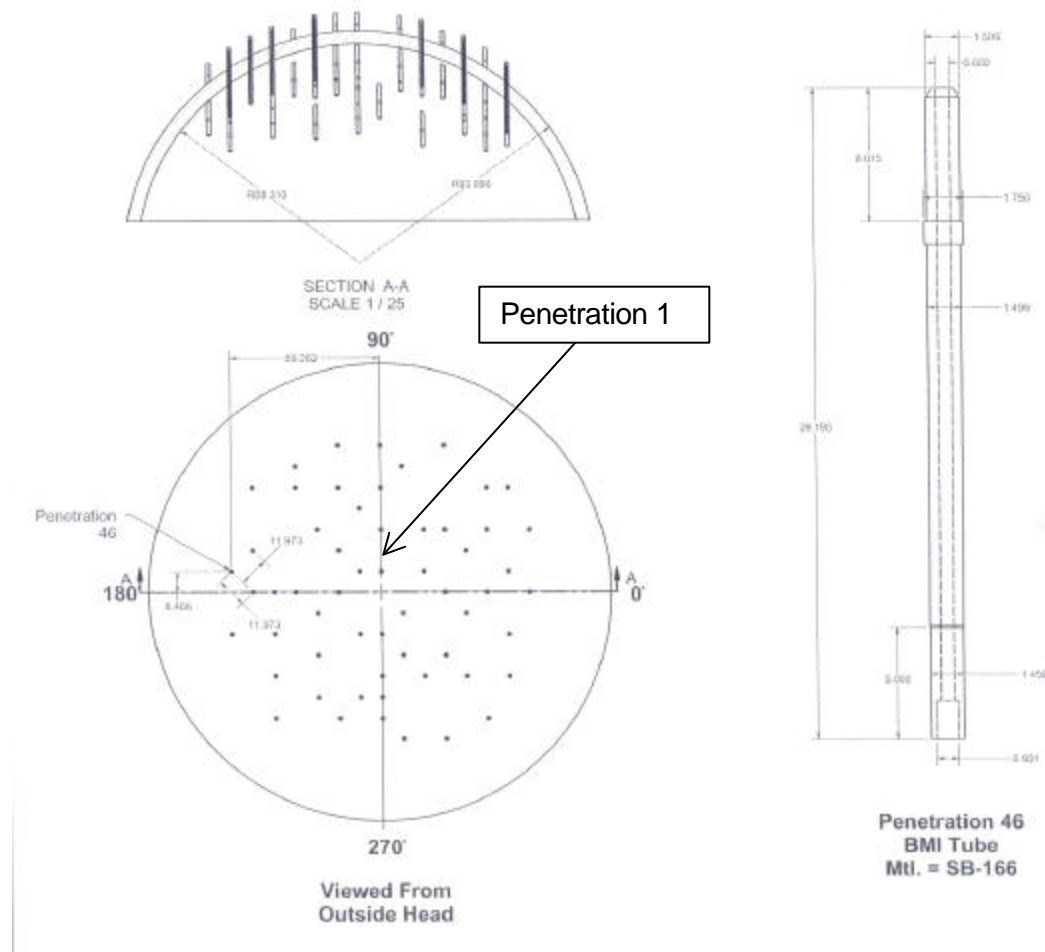
Nozzle number 1 is located about 8.5 inches due north of the center of the bottom head. The nozzle is nearly perpendicular to the reactor bottom head. Penetration number 46 is about 8.5 inches north of the east-west center line and just over 59 inches west of the bottom head center (Figure 3). Nozzle number 46 penetrates the head at 42.6 degrees.

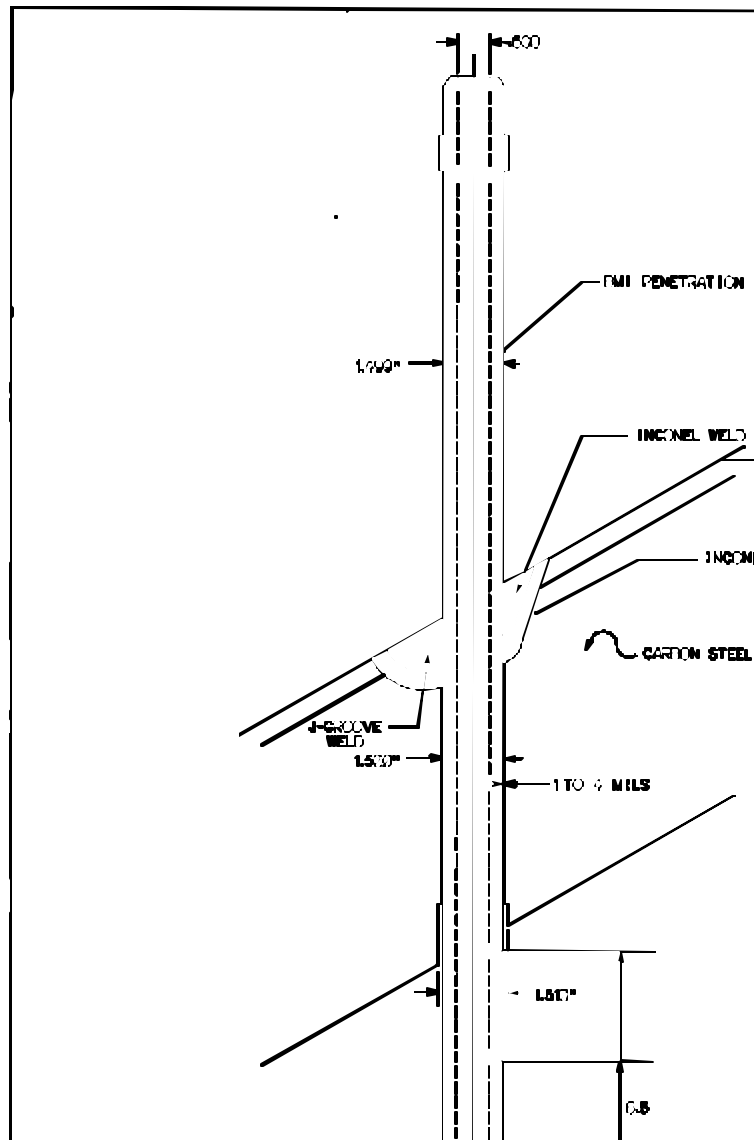
The BMI nozzles are machined from 1.75-inch diameter Alloy 600 bar stock. The nozzles have an outside diameter of 1.499 inches and an inside diameter of 0.600 inches. The BMI nozzles are structurally secured by an interior J-groove weld consisting of Alloy 600 base weld materials designated as 182 with fabrication

weld repairs being made with either 182 or 82 weld material. The vessel itself is 5.38-inch thick low alloy carbon steel with 0.22 inches of stainless steel cladding on the interior surface. Each penetration bore in the reactor bottom head is nominally 1.5 inches in diameter. There is an open annulus between the nozzle and the reactor head below the J-groove weld. Figure 4 provides a simplified view of a typical nozzle configuration

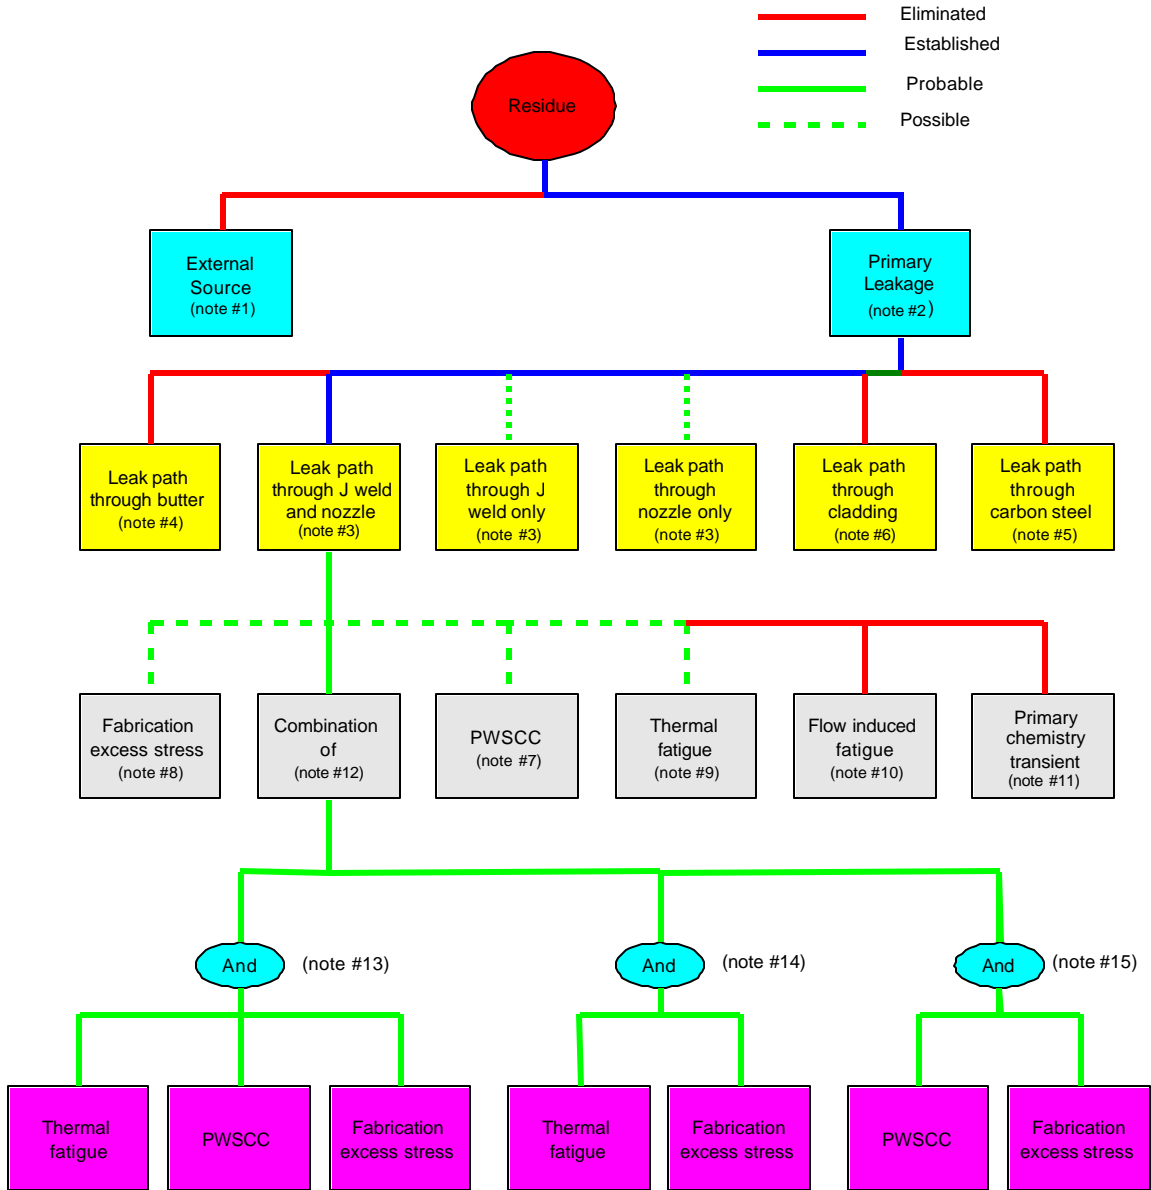
South Texas Project Status Report on Resolving the Unit 1 BMI Issue – Attachment 3 Fault Tree Analysis

Note #1: Swipes and visual inspection of the outside surface of the RPV do not support outside source for the boron residue.

Note #15: This postulates a fabrication flaw that was missed by the final PT examination or propagated to the surface during the initial hydro vessel testing and later grew through the weld zone by PWSCC.
