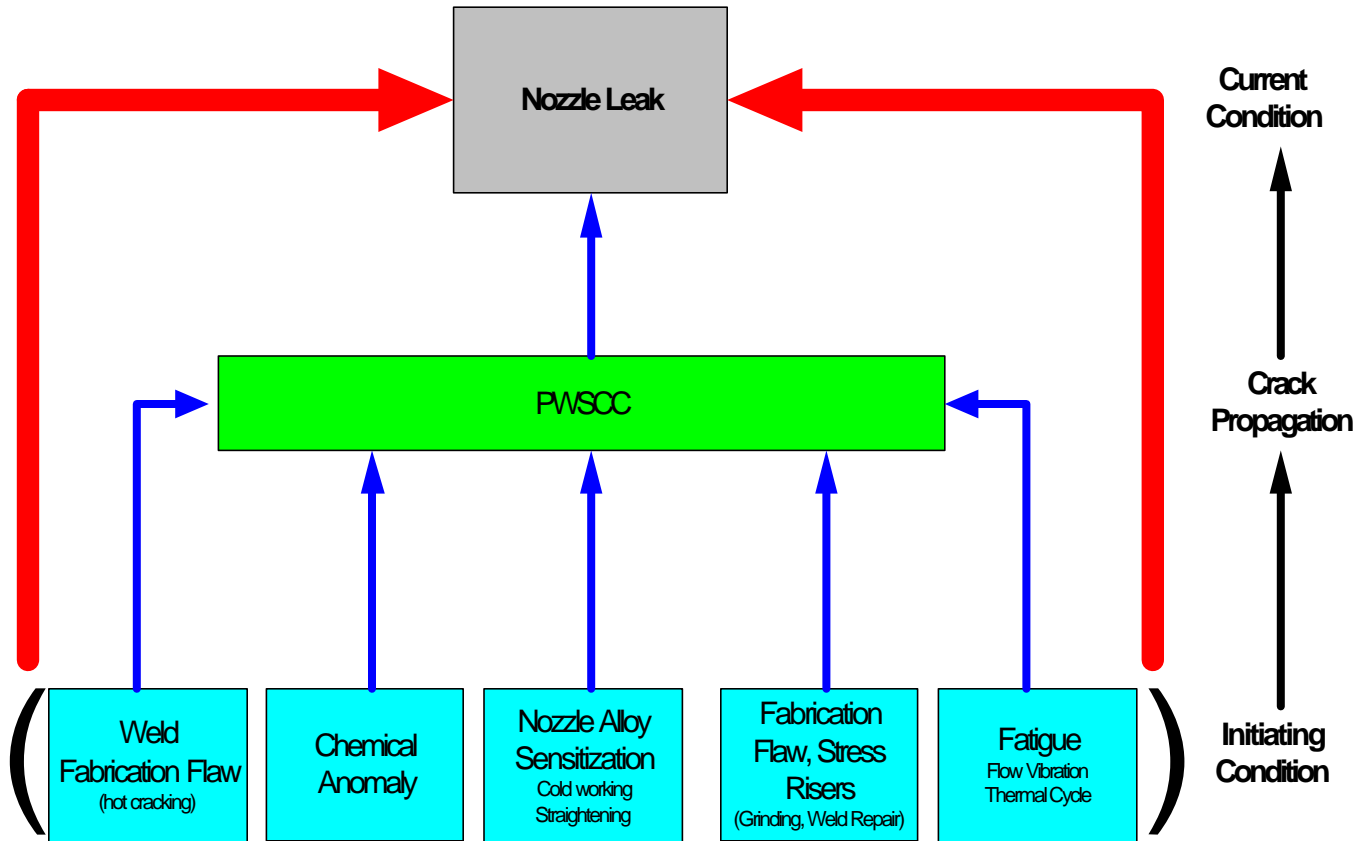
Root Cause Focus

Most Likely Causes

- Residual fabrication stresses
 - J-groove weld grinding, welding, welding rework
- Lack of J-groove weld fusion to nozzle OD
- Weld cracking; fabrication defects / contaminants
- Combination of one or more with PWSCC
