Integrity Assessment for Reactor Vessel Head Penetration Nozzles at B&W-Design Plants

Presented by
S. Fyfitch
Framatome ANP

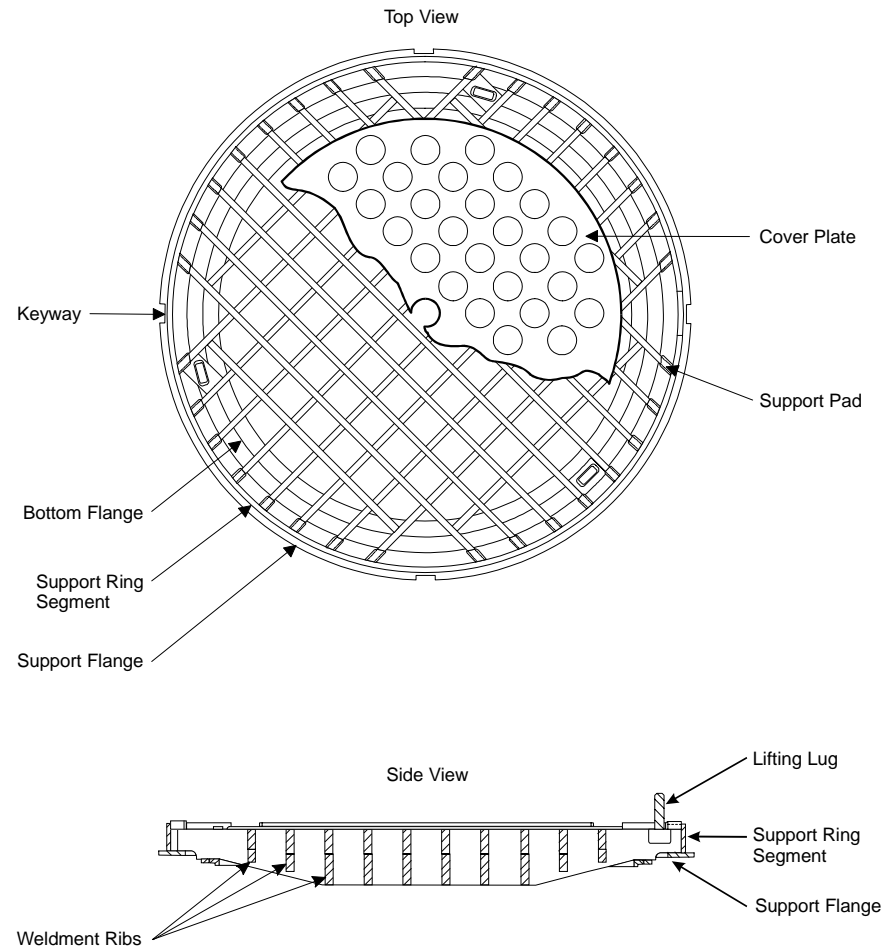
Plenum Cover Assembly.

- Deposited onto the plenum cover plate
 - No impact on safety or plant operation
- Transported through the RCS piping and into the steam generator
 - No safety concern
 - Potential equipment damage (S/G tube ends)
- Transported into the column weldments
 - Potential safety concern
 - Could preclude complete control rod insertion
