# Davis-Besse Reactor Pressure Vessel Head Degradation

Overview, Lessons Learned, and NRC Actions Based on Lessons Learned

# Davis-Besse Reactor Pressure Vessel Head Degradation: Overview

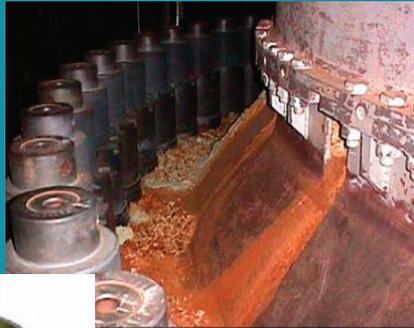
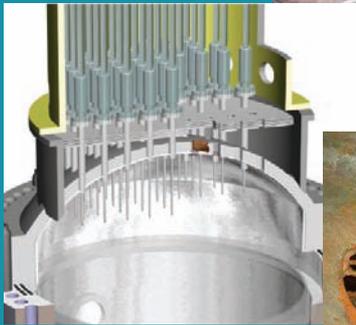
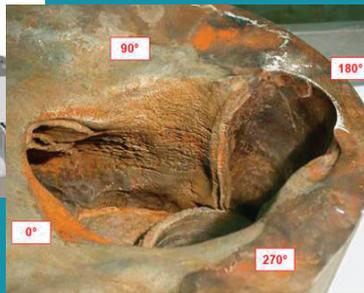
The reactor pressure vessel (RPV) heads of pressurized water reactors (PWR) have penetrations for control rod drive mechanisms and instrumentation systems made from nickel-based alloys (e.g., Alloy 600) and related weld metals (**Figure 1**). Primary coolant and the operating conditions of PWR plants can cause cracking of these nickel-based alloys and weldments through a process called primary water stress corrosion cracking (PWSCC). In response to the detection of PWSCC at several plants, the NRC issued NRC Bulletin 2001-01, “Circumferential Cracking of Reactor Pressure Vessel Head Penetration Nozzles,” which requested information related to licensees’ programs for inspection of vessel head penetration (VHP) nozzles.

The licensee investigated the condition of the RPV head surrounding CRDM nozzle 3. The investigation included removing the CRDM nozzle and removing boric acid deposits from the top of the RPV head. Upon completing the boric acid removal on March 7, 2002, the licensee conducted a visual examination of the area and identified a large cavity in the RPV head on the downhill side of CRDM nozzle 3 (**Figure 2**). The corrosion was caused by borated water that leaked from the reactor coolant system onto the vessel head (**Figures 3 and 4**) through cracks in the nozzle and the weld that attached nozzle 3 to the RPV head (**Figures 5 and 6**). The remaining thickness of the RPV head in the wastage area was found to be approximately 3/8 inch. This thickness consisted of the thickness of the stainless steel cladding on the inside surface of the RPV head, which is nominally 3/8 inch thick. The stainless steel cladding is resistant to corrosion by boric acid, but it is not intended to provide structural integrity to the vessel. Failure of the stainless steel cladding would have resulted in a loss-of-coolant accident (LOCA). The LOCA would have resulted in actuation of the plant's emergency systems.
