To:		From:	Kevin Armstrong
Company:	Nuclear Regulatory Commission	Date & Time:	1-25-02
Fax Number:	301-816-5151	Pages:	10
Subject:	U02O3FBBR-**

The attached analysis indicates a potential 10 CFR Part 21 reportable problem with Automatic Valve part number U02FFBBR-**

AUTOMATIC VALVE TITLE: CORRECTIVE ACTION SUBJ: CORRECTIVE ACTION	NUMBER: D7174-003 LOCN: I:\WORD\DOCUMENT\07174003.DOC TYPE: FORM	PAGE 1 OF 9 DATE: 10-21-1999 REV: F-CN8020
--	--	--

10 CFR Part 21 Report Required: YES - for
U0203FBBR valves when inlet pressure is @ port 1

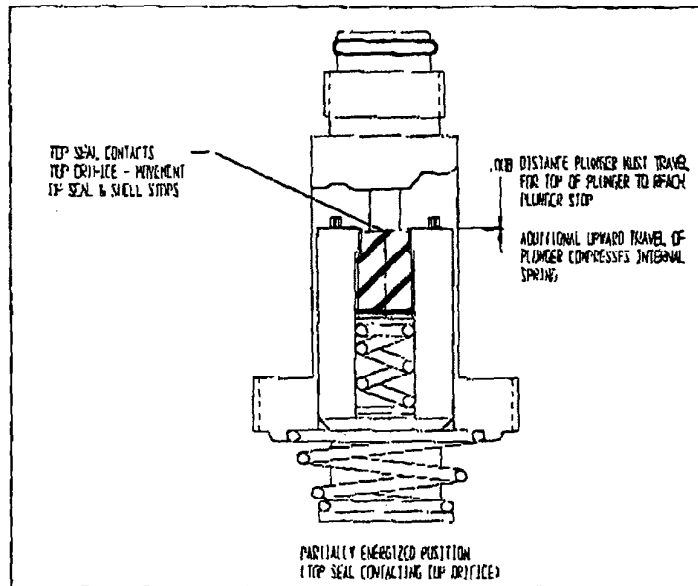
Figure 3B – Partially Energized – Top Seal Contacting Top Orifice

However, when the valve stays in the energized position, the shell creeps upward relative to the top seal over extended periods of time. (Note: Extended periods of time are measured in months. Per Mr. Astbury, the earliest that any valve exhibited leakage from exhaust port 3 was 6 months and this one was one valve out of eight that are currently reported leaking. The remaining seven valves exhibited the leakage after a period of 8 months to a year.) As the creep continues, over a period of months, the shoulder on the shell comes closer and closer to the top of the plunger counter bore thus reducing the amount of compression of the internal spring. That is, the normal compression of .008 shown in Figure 4 becomes less and less. At some point in time, the shoulder on the shell contacts the plunger counter bore and additional creeping of the shell relative to the top seal stops.

When this happens, the top seal is touching the top orifice but is not compressing the internal spring sufficiently to create a good seal and leakage occurs out of port 3. As the leak intensifies, it creates a pressure drop at the top of the plunger as shown in Figure 5. The greater the leak, the greater the pressure drop. At leak rates less than 60 SCFH, all plungers returned.
