UNITED STATES  
NUCLEAR REGULATORY COMMISSION  
OFFICE OF NUCLEAR REACTOR REGULATION  
WASHINGTON, D.C. 20555-0001

NRC INFORMATION NOTICE 2006-01: TORUS CRACKING IN A BWR MARK I  
CONTAINMENT

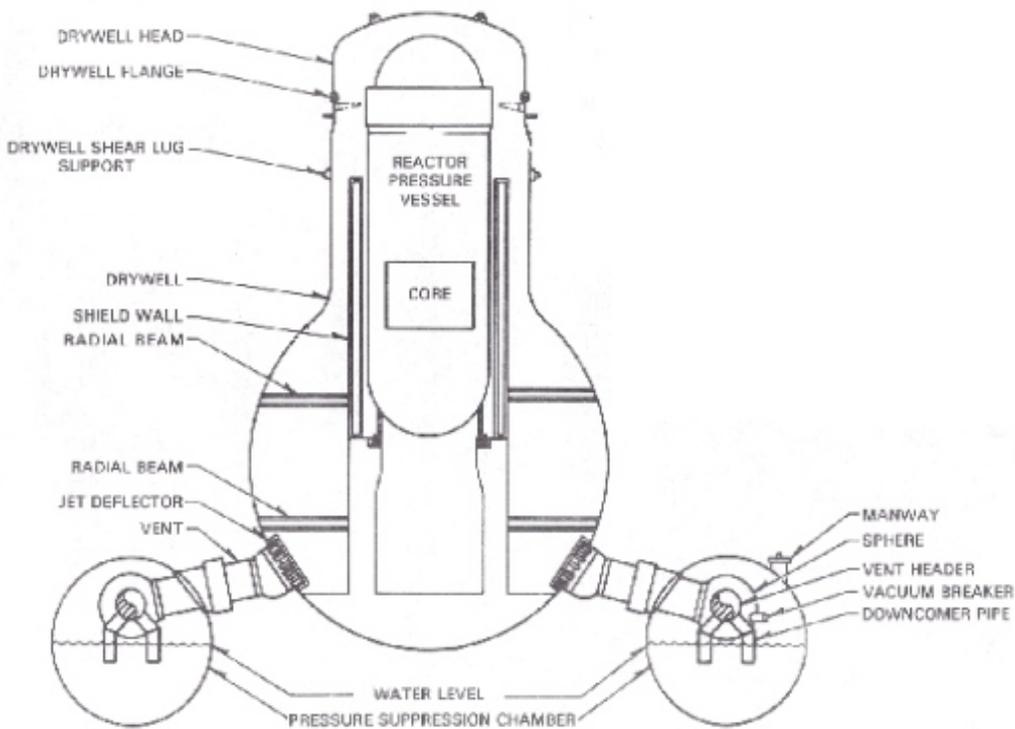
Figure 1 Typical BWR with Mark I Containment

Figure 1 the cross-section of a pressure suppression chamber (or torus) is 29.6 feet wide. The pressure suppression chamber (torus) holds approximately 790,000 gallons of water.
