NUREG/CR-7019
PNNL-18713, Rev. 1

Results of the Program for the Inspection of Nickel Alloy Components

Manuscript Completed: April 2010

Pacific Northwest National Laboratory

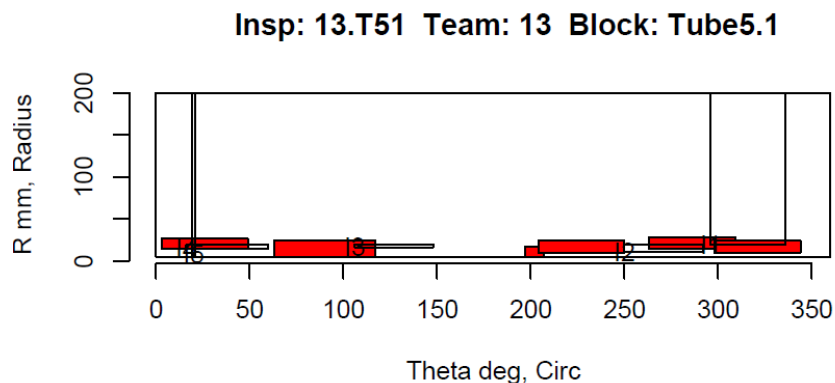
Figure 4.6 Test Block 5.1 –Individual Flaws

One can see from Figure 4.6 that test block 5.1 has six individual flaws that are very close in proximity. Figure 4.7 shows that using the rules of IWA-3400, the six individual flaws in test block 5.1 could be considered as two.

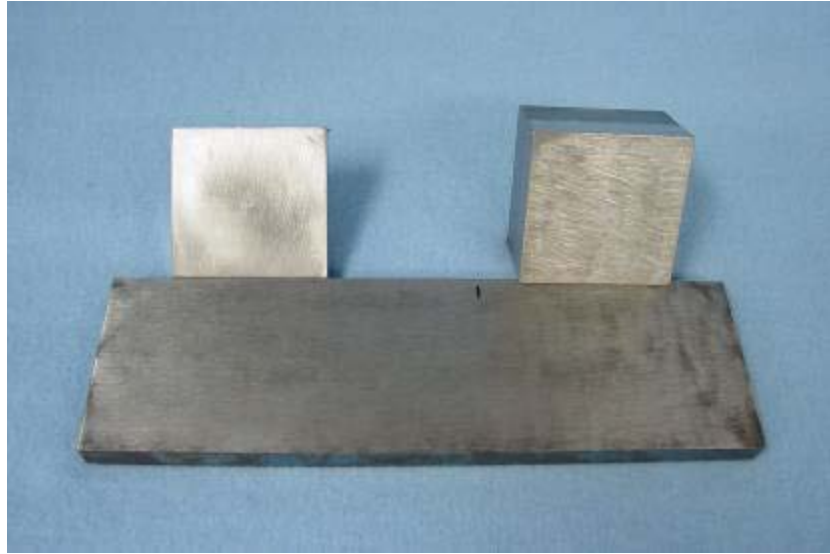
Figure 7.1 Three Cracked Weld Metal Coupons with Thermal Fatigue Crack on the Left, Weld Solidification Crack on the Right, and Laboratory Stress Corrosion Crack at Center

Before PNNL ordered the Alloy 182 weld metal mockup, a simple parametric study was performed. The study was used to refine specifications and quality requirements for the cracks and coupons, especially the selection of appropriate lengths for the cracks to be used in the blind test. Figure 7.1 shows the three cracked Alloy 182 weld metal coupons received at PNNL. The coupon on the right has a thermal fatigue crack that is 5.3-mm long and 2.3 mm deep. The thermal fatigue crack was introduced into the coupon with controlled thermal fatigue loading (Kemppainen et al. 2003). The crack was grown with natural thermal fatigue introduced by cyclic application of high-frequency inductive heating coils and water cooling jets. In this process, the typical heating time is 2–5 seconds and typical cooling time 5–10 seconds. Because the crack is introduced directly into the test material, the crack shape and form are affected by local properties, especially inhomogeneities or stress risers. The cracks tend to grow in the weakest locations in discontinuous segments or with some branching. Figure 7.2 shows the image of the artificially grown stress corrosion crack on the surface of the coupon.

Although not visible at this magnification, the coupon on the left in Figure 7.1 has a weld solidification crack that is 10 mm long and 2 mm deep. Such a crack is introduced by performing a weld and adjusting the weld chemistry to produce a centerline crack that is bounded by the fused metal (Watson and Edwards 1996). The technique uses a machined notch to form a cavity with the length and depth of the desired crack. This cavity is filled with poisoned weld metal that cracks starting at the bottom of the notch. The crack breaks the surface, is interdendritic, and has some branching.

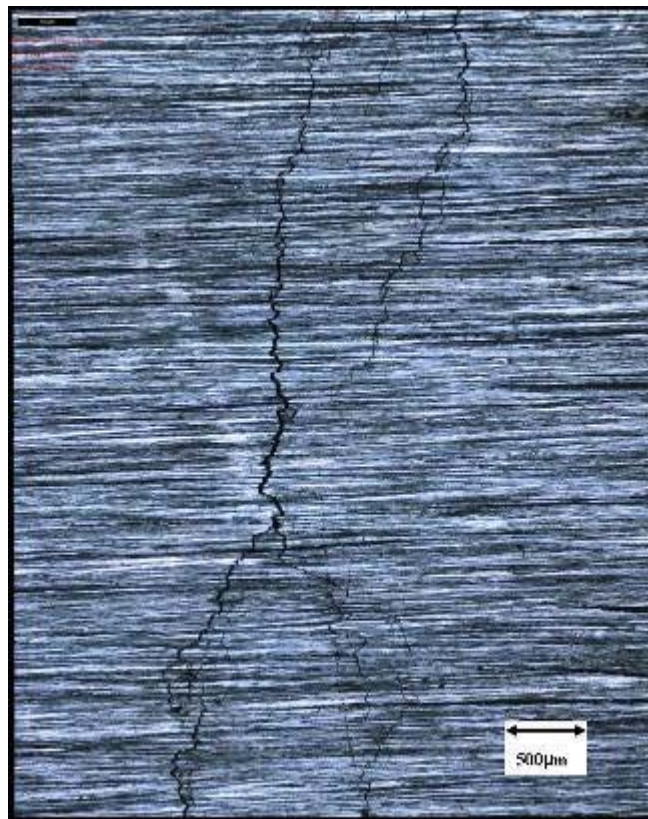
Figure 7.2 Artificially Grown Stress-Corrosion Crack in Coupon of Alloy 182 Weld Metal

A laboratory-grown stress corrosion crack is in the coupon at the center of Figure 7.2. The main crack is 28 mm long with a mean crack opening dimension of 50 microns. Growing SCC (Daniels et al. 2003) involves the manufacture of a test piece that is suitable for the application of tensile stress. The stressed test piece is subjected to a corrosive agent to produce the required crack. Figure 7.4 shows a portion of the laboratory-grown stress corrosion crack purchased by PNNL.

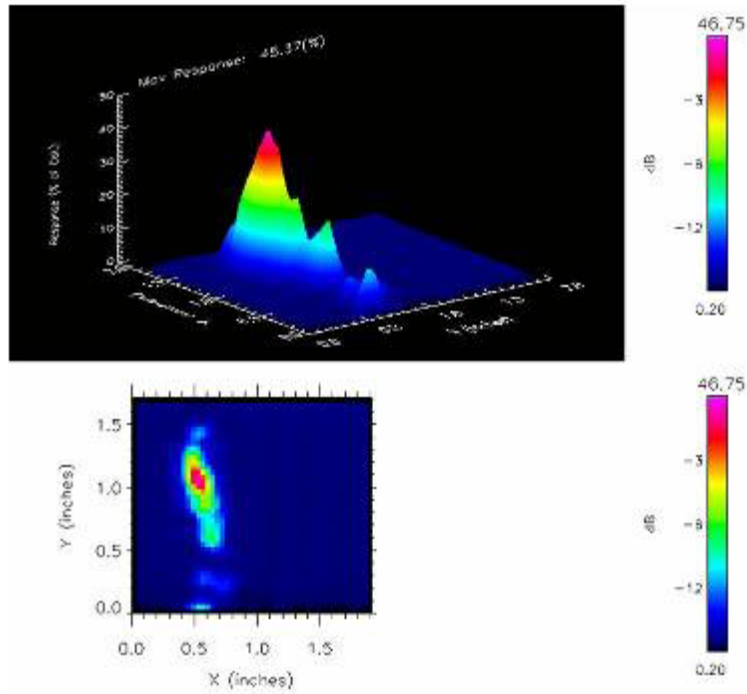
The eddy current responses and noise levels were recorded from the three manufactured cracks at 350 kHz. Figure 7.3 shows eddy current response from the laboratory-grown SCC in Alloy 182 weld metal. The indication is 45% of the calibration electro-discharge machining (EDM) notch. The length of the indication is 25 mm with a secondary crack on the lower edge of the image. The main crack is 28 mm (1.1 in.) long. The depth of the crack is unknown (because the SCC is laboratory-grown with limited control of the cracking process). Figure 7.4 provides a signal-to-noise analysis of eddy current response from the laboratory-grown SCC. The noise level is set to 2.5% of the calibration EDM notch, giving the indication a signal-to-noise ratio of 18.1.

Figure 7.3 Eddy Current Response from Laboratory-Grown Stress Corrosion Crack in Alloy 182 Weld Metal

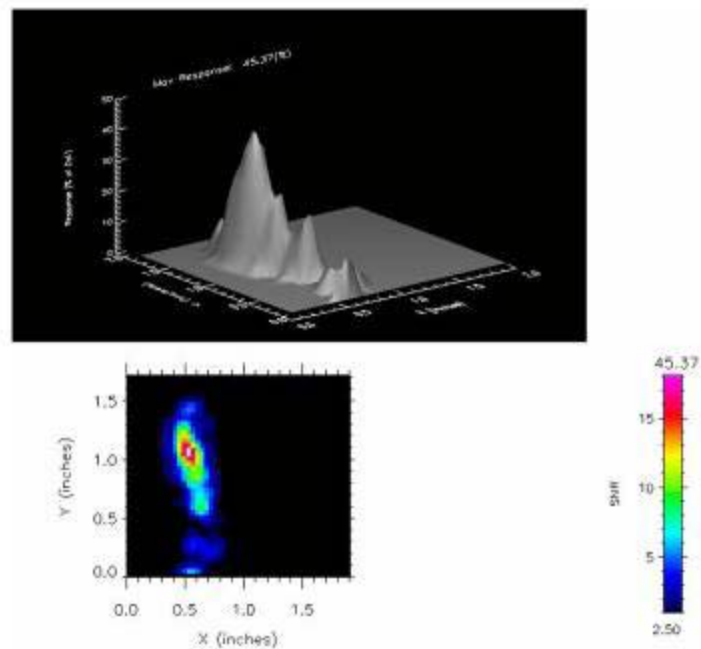
Figure 7.4 Signal-to-Noise Analysis of Eddy Current Response from Laboratory-Grown Stress Corrosion Crack in Alloy 182 Weld Metal

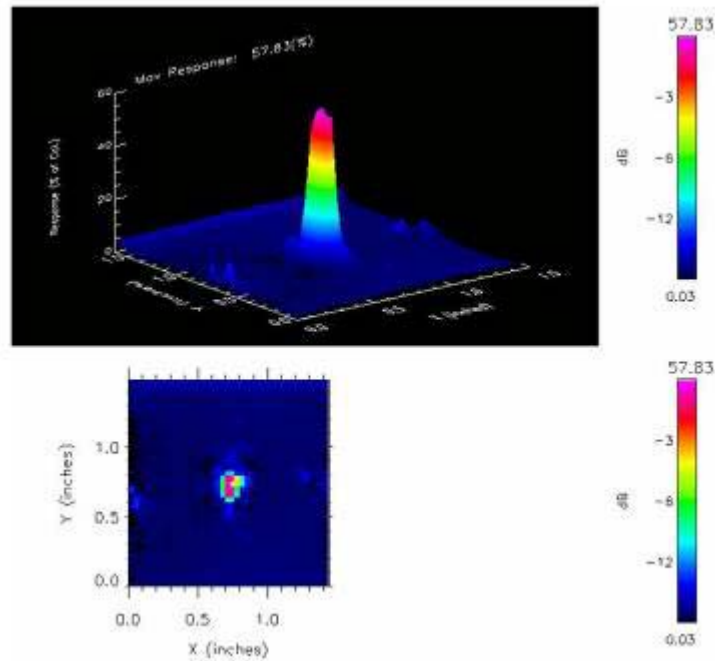
Figure 7.5 shows the eddy current response from a thermal fatigue crack in Alloy 182 weld metal. The indication is 58% of the calibration EDM notch. The length of the indication is 4 mm using loss of signal. The crack is 5.2 mm (0.2-in.) long and 2.3 mm (0.1-in.) deep. Figure 7.6 provides a signal-to-noise analysis of eddy current response from the TFC. The noise level is set to 2.5% of the calibration EDM notch, giving the indication a signal-to-noise ratio of 23.1.

Figure 7.5 Eddy Current Response from Thermal Fatigue Crack in Alloy 182 Weld Metal

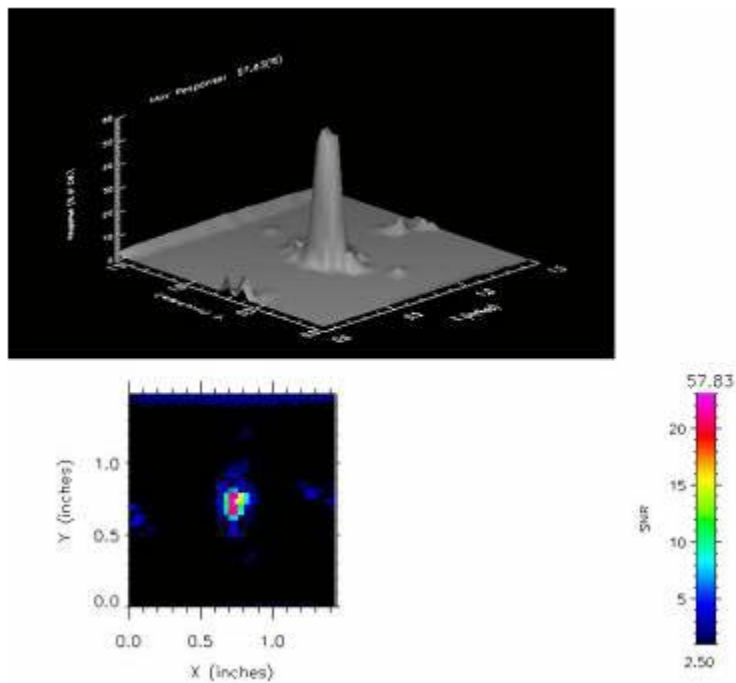
Figure 7.6 Signal-to-Noise Analysis of Eddy Current Response from Thermal Fatigue Crack in Alloy 182 Weld Metal

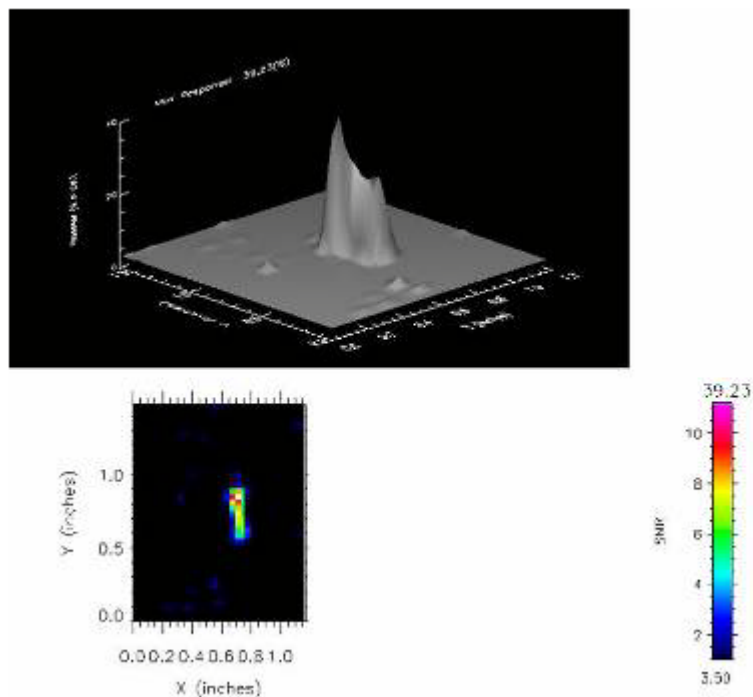
Figure 7.7 shows the eddy current response from a WSC in Alloy 182 weld metal. The indication is 39% of the calibration EDM notch. The length of the indication is 12 mm using loss of signal. Figure 7.8 provides a signal-to-noise analysis of eddy current response from the weld solidification crack. The noise level is set to 3.5% of the calibration EDM notch, giving the indication a signal-to-noise ratio of 11.2.

Figure 7.8 Signal-to-Noise Analysis of Eddy Current Response from Weld Solidification Crack in Alloy 182 Weld Metal

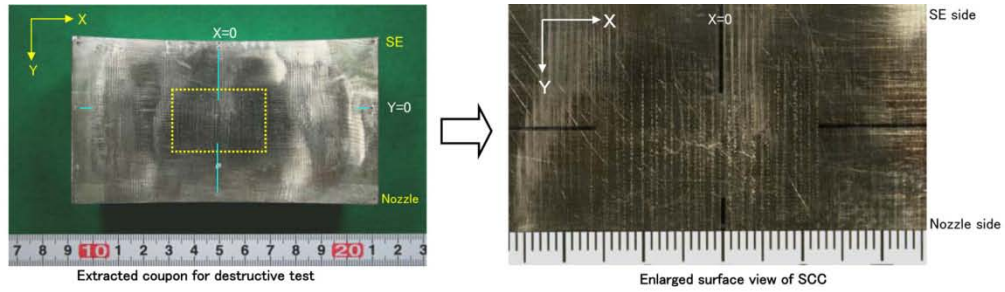
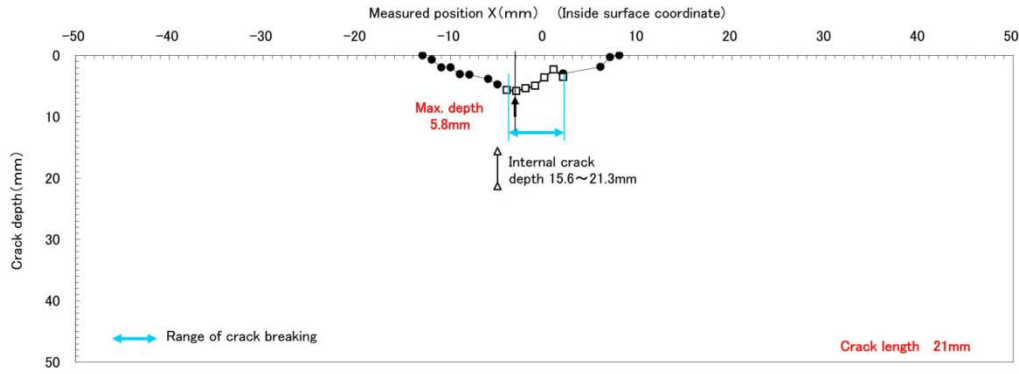
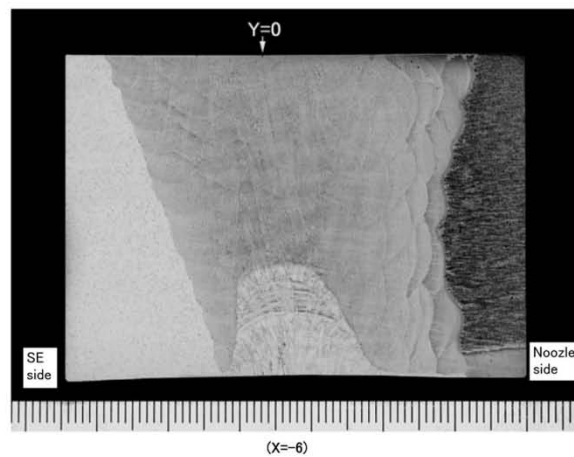
Results of destructive test on PINC2.1 test block (SH-1)

(1) Profile of SCC ● : Measured on sliced cross section □ : Measured on broken crack △ : Internal crack

Measured on sliced cross section											
Position (mm)	X=-13	X=-12	X=-11	X=-10	X=-9	X=-8	X=-6	X=-5	X=2	X=6	X=7
Depth (mm)	0.0	0.7	2.0	2.0	3.1	3.2	3.9	4.8	2.9	1.9	0.3
Opening (μm)	0	<5	<5	<5	<5	<5	30	50	10	<5	<5
Inclination from depth direc.(Deg)	0	-9	16	15	18	6	14	-1	13	10	-8

Measured on broken crack							
Position (mm)	X=-4	X=-3	X=-2	X=-1	X=0	X=1	X=2
Depth (mm)	5.6	5.8	5.4	5.0	3.6	2.3	3.5

Length(mm)	21
------------	----

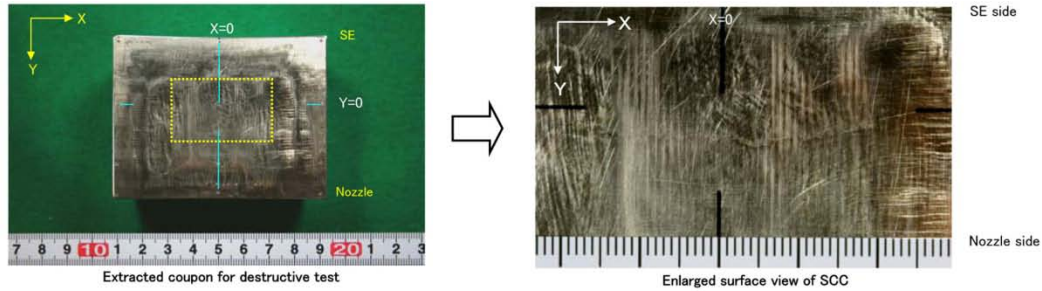
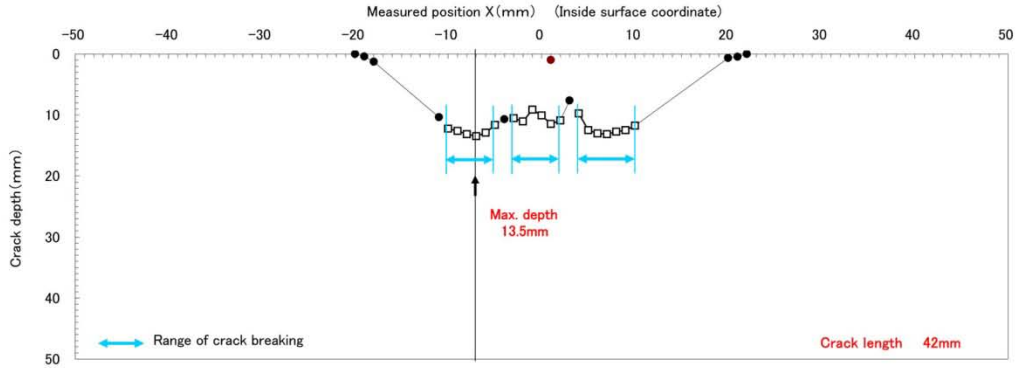
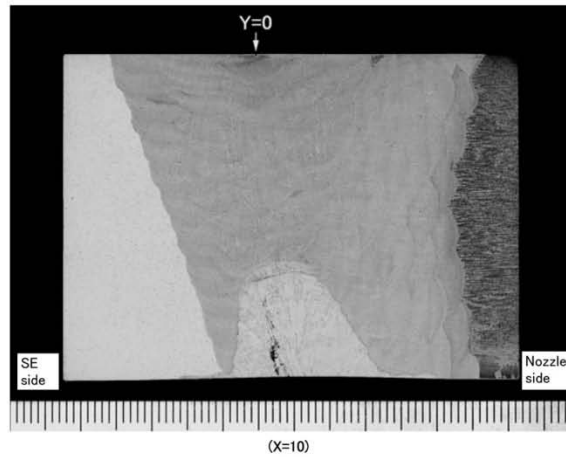
Results of destructive test on PINC2.2 test block (SH-2)

(1) Profile of SCC ● : Measured on sliced cross section □ : Measured on broken crack

Measured on sliced cross section											
Position (mm)	X=-20	X=-19	X=-18	X=-11	X=-5	X=-4	X=2	X=3	X=10	X=20	X=21
Depth (mm)	0.0	0.4	1.3	10.4	10.9	10.7	10.5	7.6	11.7	0.7	0.4
Opening (μm)	0	<5	<5	<5	<5	10	30	<5	10	<5	<5
Inclination from depth direc.(Deg)	0	15	-7	10	12	7	6	15	10	-5	-1

Measured on broken crack				
Position (mm)	X=4	X=5	X=6	X=7
Depth (mm)	9.7	12.5	13.0	13.1

Measured on broken crack		
Position (mm)	X=8	X=9
Depth (mm)	12.8	12.5

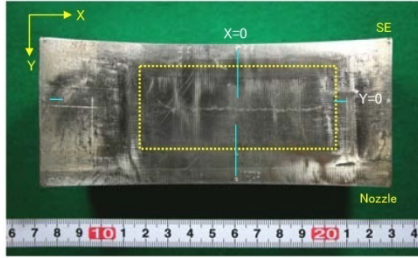
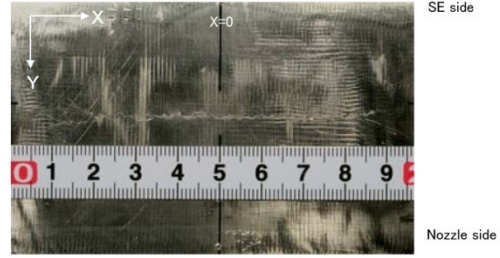
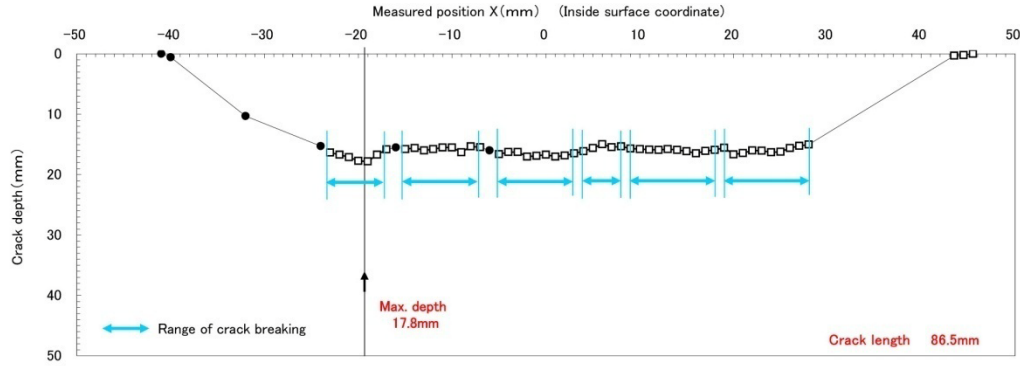
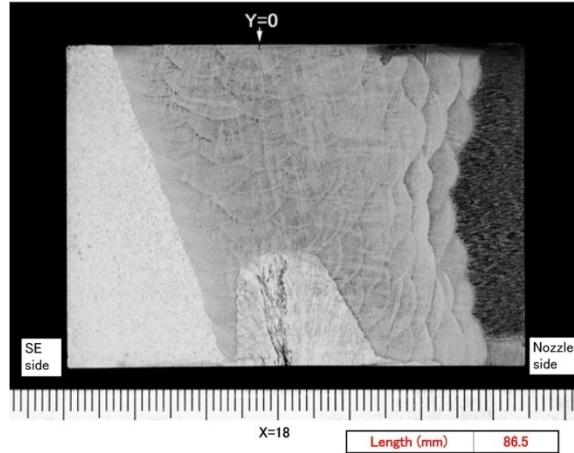
Results of destructive test on PINC2.3 test block (SH-3)

Enlarged surface view of SCC

(1) Profile of SCC ●: Measured on sliced cross section □: Measured on broken crack

Measured on sliced cross section										
Position (mm)	X=-41	X=-40	X=-32	X=-24	X=-17	X=-16	X=-7	X=-6	X=3	X=8
Depth (mm)	無	0.6	10.3	15.3	15.4	15.5	15.3	16.0	15.7	15.3
Opening (μm)	無	<5	25	65(150)	100	100	70	490	790	105(280)
Inclination from depth direc.(Deg)	無	0	0	2	7	7	6	3	9	7
										3

Measured on broken crack			
Position (mm)	X=-14	X=-13	X=-12
Depth (mm)	15.6	16.0	15.8

Measured on broken crack			
Position (mm)	X=-10	X=-9	X=-8
Depth (mm)	15.5	16.3	15.3

Measured on broken crack										
Position (mm)	X=-5	X=-4	X=-3	X=-2	X=-1	X=0	X=1	X=2	X=3	X=4
Depth (mm)	16.6	16.3	16.3	17.0	16.9	16.7	17.0	16.8	16.5	16.1

Measured on broken crack										
Position (mm)	X=7	X=8	X=9	X=10	X=11	X=12	X=13	X=14	X=15	X=16
Depth (mm)	15.5	15.3	15.7	15.8	15.9	15.9	15.8	15.9	16.5	16.5

Measured on broken crack									
Position (mm)	X=19	X=20	X=21	X=22	X=23	X=24	X=25	X=26	X=27
Depth (mm)	15.7	16.7	16.5	16.0	16.0	16.3	16.2	15.6	15.2

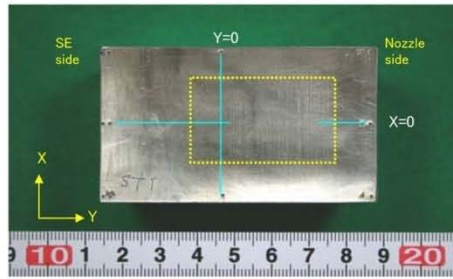
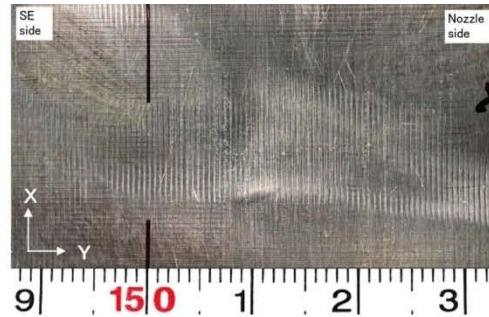
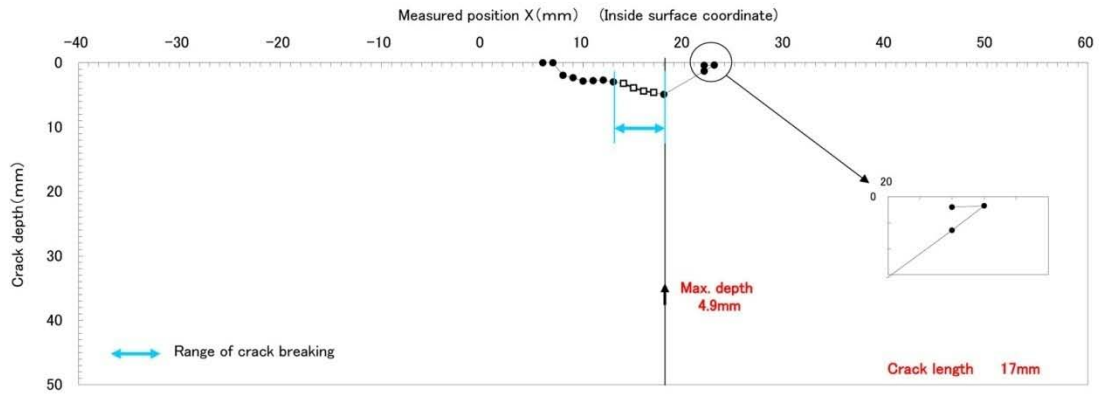
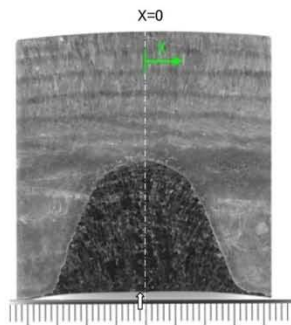
Results of destructive test on PINC2.4 test block (ST-1)

Enlarged surface view of SCC

Measured on sliced cross section										
Position (mm)	Y=6	Y=7	Y=8	Y=9	Y=10	Y=11	Y=12	Y=13	Y=18	Y=22
Depth (mm)	0.0	0.00	2.0	2.3	2.9	2.8	2.7	3.0	4.9	1.3
Opening (μm)	0	0	1	5	2	1	13	2	97	embedded
Inclination from depth direc.(Deg)	0	0	-8	8	7	0	4	0	4	—

Measured on broken crack				
Position (mm)	Y=14	Y=15	Y=16	Y=17
Depth (mm)	3.2	3.9	4.4	4.6

Length (mm)	17
-------------	----

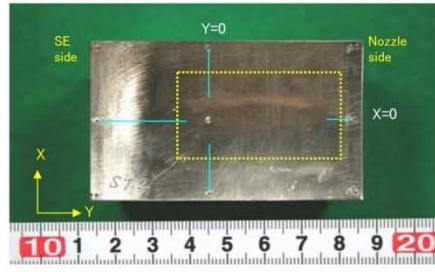
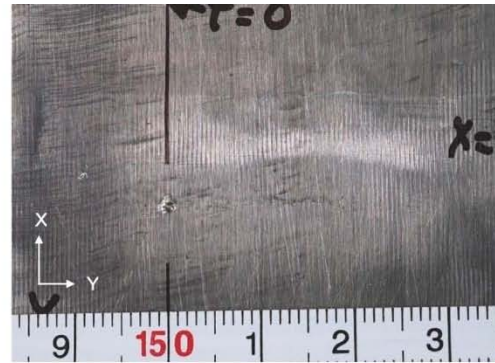
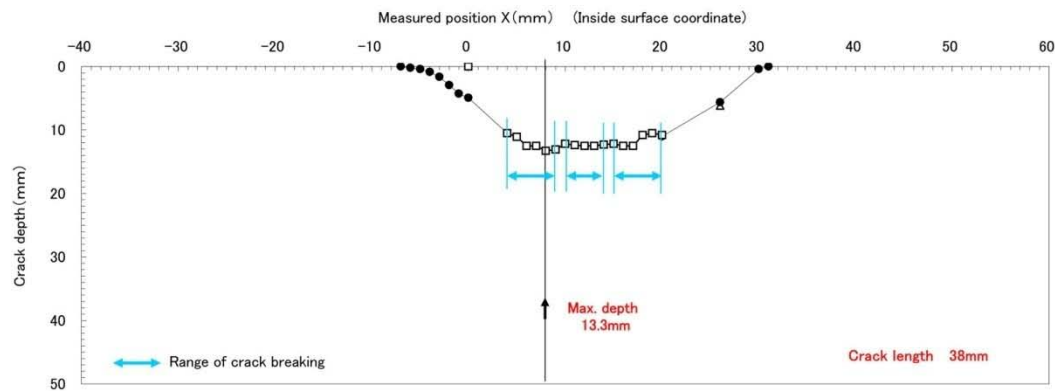
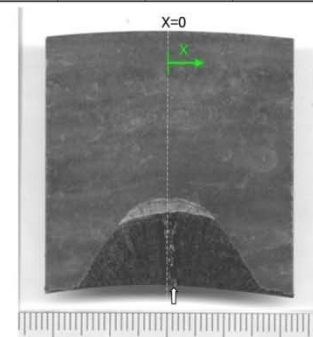
Results of destructive test on PINC2.5 test block (ST-2)

Enlarged surface view of SCC

Measured on sliced cross section										
Position (mm)	Y=-7	Y=-6	Y=-5	Y=-4	Y=-3	Y=-2	Y=-1	Y=0	Y=4	Y=9
Depth (mm)	0.0	0.2	0.4	0.9	1.6	2.9	4.3	4.9	* 10.6/10.5	* 10.6/13.1
Opening (μm)	0	2	2	2	4	2	3	13	361	12
Inclination from depth direc.(Deg)	0	-9	25	-18	-24	-2	-8	9	0	-2

Measured on broken crack						
Position (mm)	Y=15	Y=16	Y=17	Y=18	Y=19	Y=20
Depth (mm)	12.2	12.5	12.5	10.8	10.5	10.8

Length (mm)	38
-------------	----

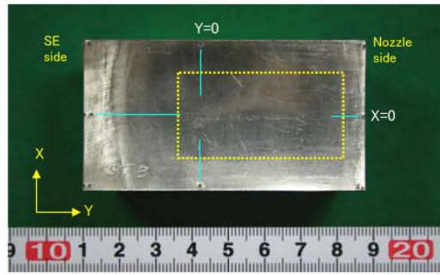
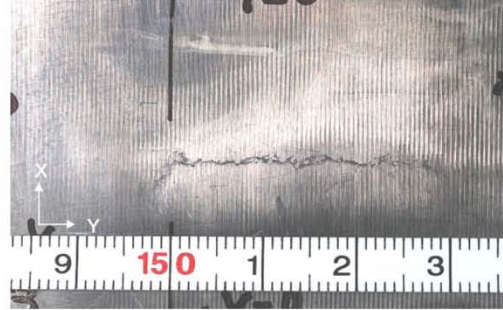
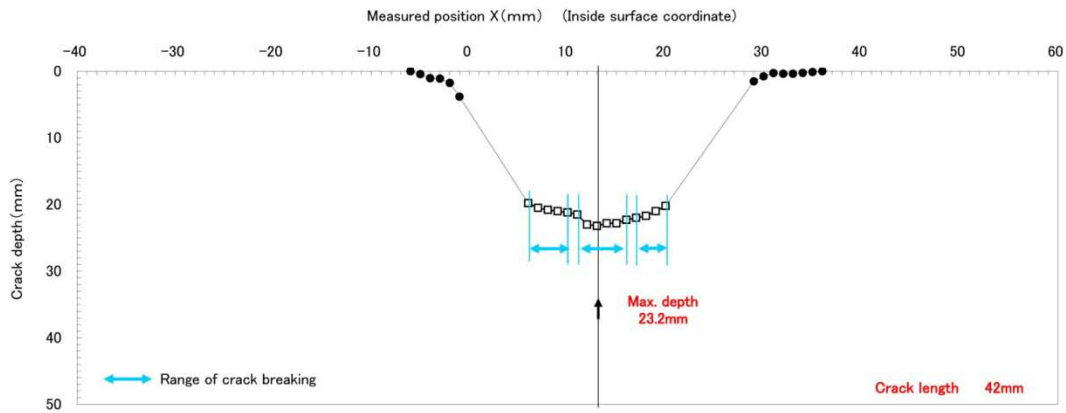
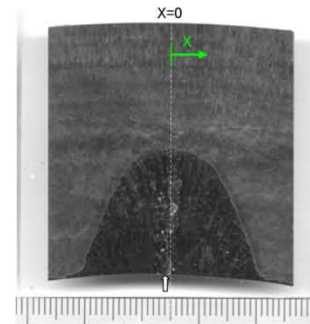
Results of destructive test on PINC2.6 test block (ST-3)

Enlarged surface view of SCC

Measured on sliced cross section										
Position (mm)	Y=-6	Y=-5	Y=-4	Y=-3	Y=-2	Y=-1	Y=6	Y=10	Y=11	Y=16
Depth (mm)	0.0	0.4	1.1	1.1	1.8	3.8	* 19.3/19.8	*20.7/21.2	21.5	*21.4/22.3
Opening (μm)	0	1	59	18	4	18	87	198	45	686
Inclination from depth direc.(Deg)	0	-8	-29	14	-11	1	-1	-3	-5	2

Measured on broken crack				
Position (mm)	Y=16	Y=17	Y=18	Y=19
Depth (mm)	22.3	22.0	21.7	21.0

Length (mm)	42
-------------	----

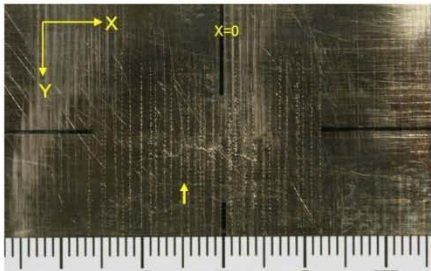
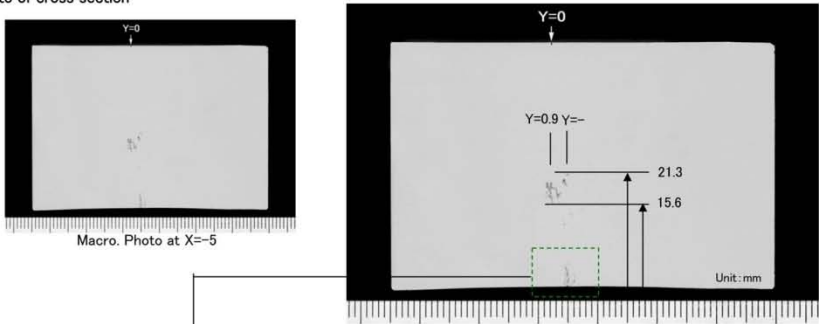
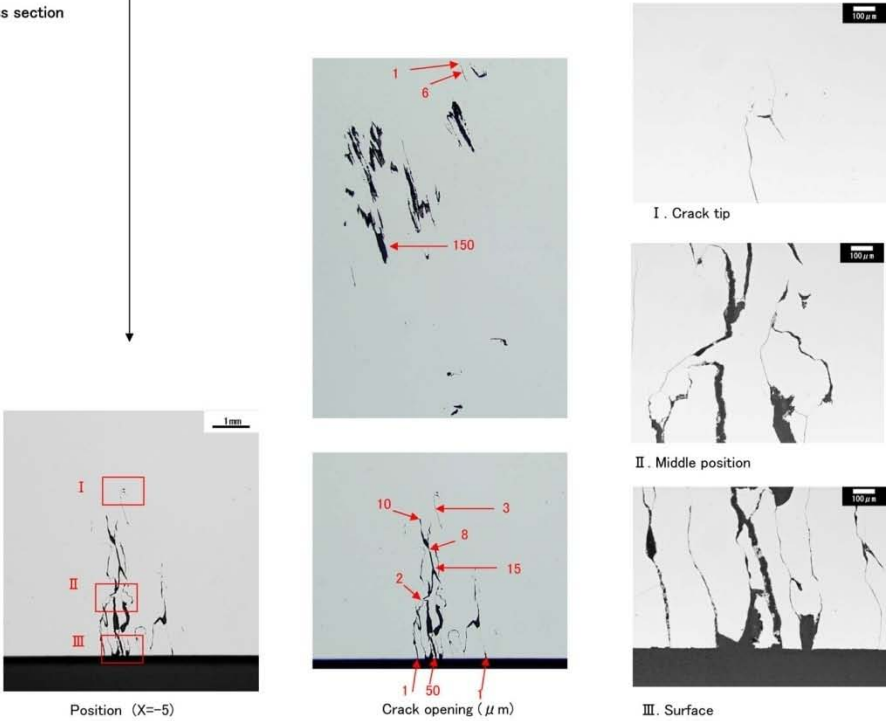
Typical crack opening data of PINC2.1(SH-1) test block at X=-5.

Measured on sliced cross section	
Position (mm)	X=-5
Depth (mm)	4.8
Opening (μm)	50
Inclination from depth direc.(Deg)	-1

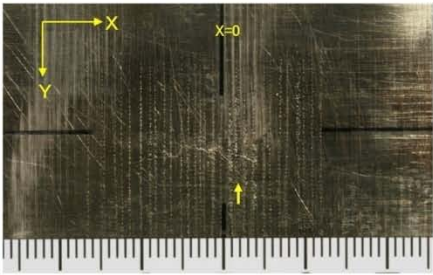
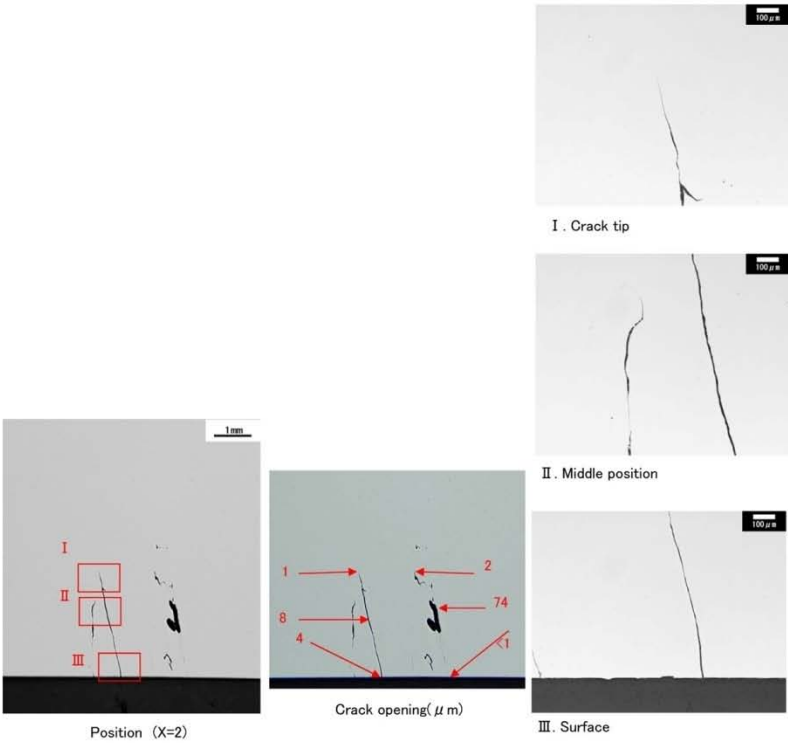
Typical crack opening data of PINC2.1(SH-1) test block at X=2.

Measured on sliced cross section	
Position (mm)	X=2
Depth (mm)	2.9
Opening (μ m)	10
Inclination from depth direc.(Deg)	13

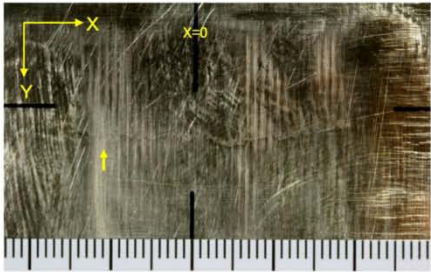
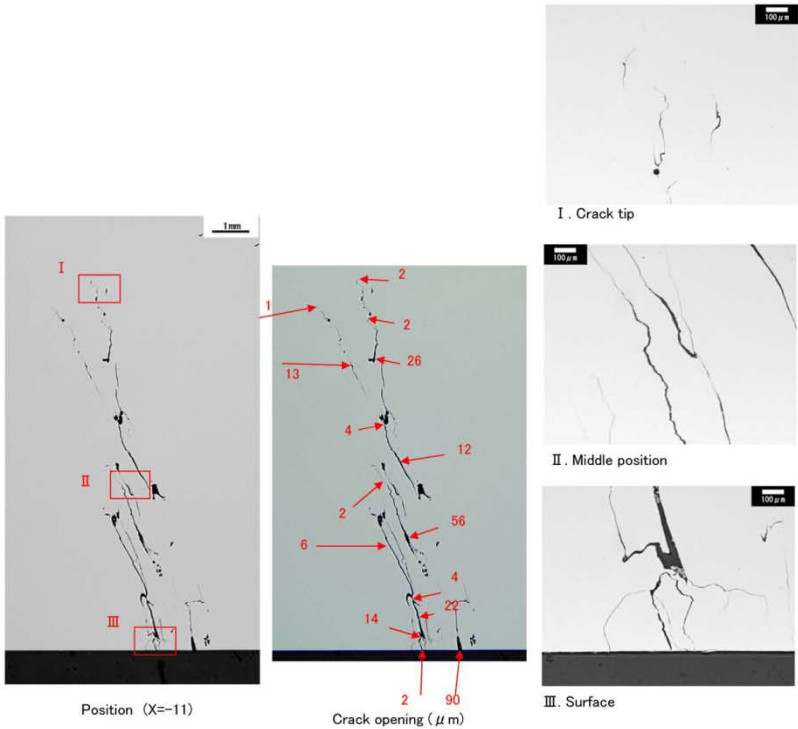
Typical crack opening data of PINC2.2(SH-2) test block at X=-11.

Measured on sliced cross section	
Position (mm)	X=-11
Depth (mm)	10.4
Opening (µ m)	<5
Inclination from depth direc.(Deg)	10

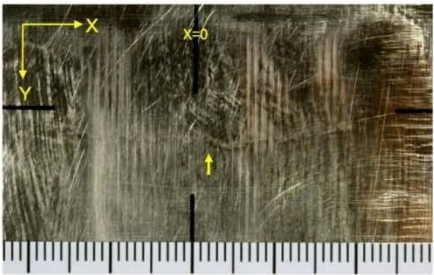
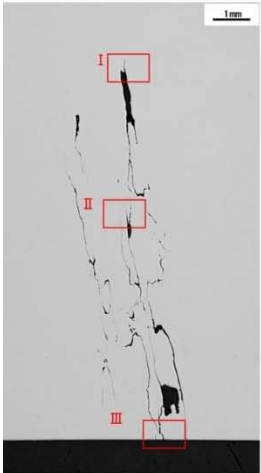
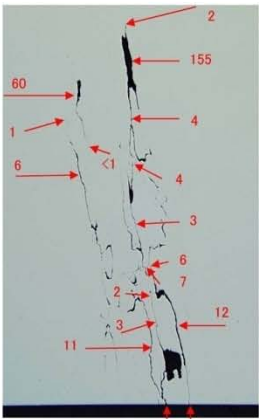
Typical crack opening data of PINC2.2(SH-2) test block at X=2.

Position (X=2)

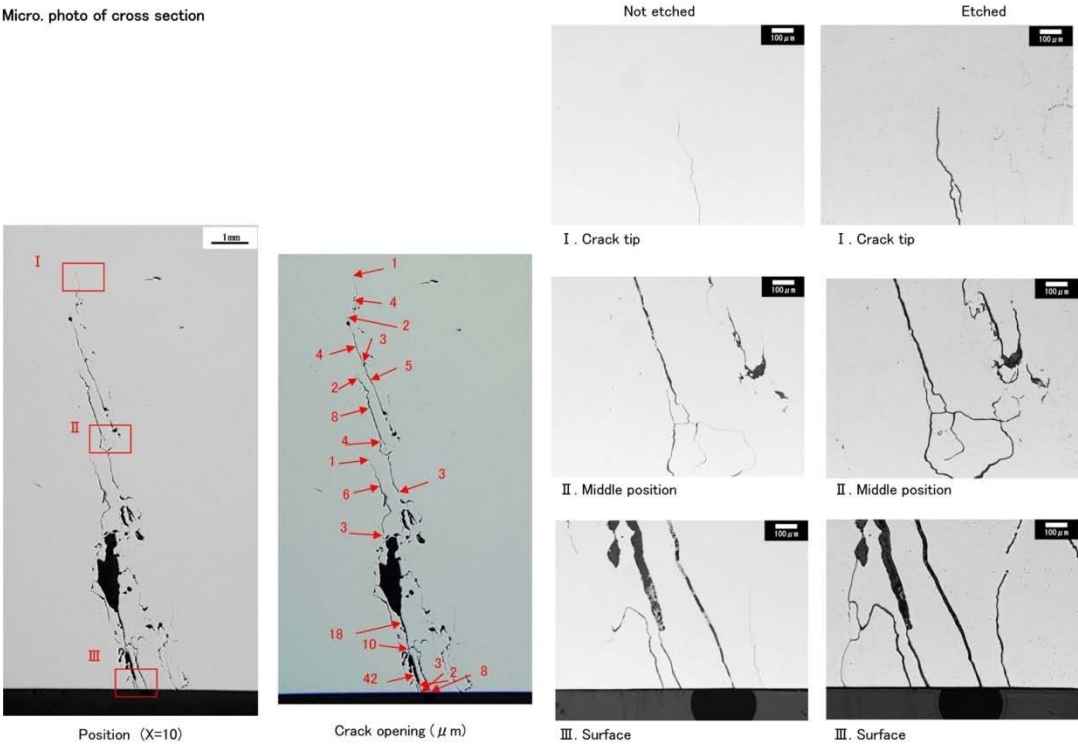
Measured on sliced cross section	
Position (mm)	X=10
Depth (mm)	11.7
Opening (µ m)	10
Inclination from depth direc.(Deg)	10

Typical crack opening data of PINC2.2(SH-2) test block at X=10.

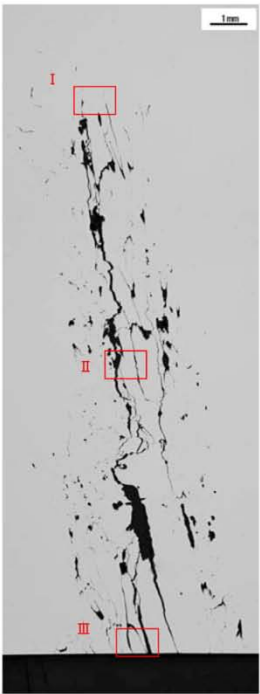
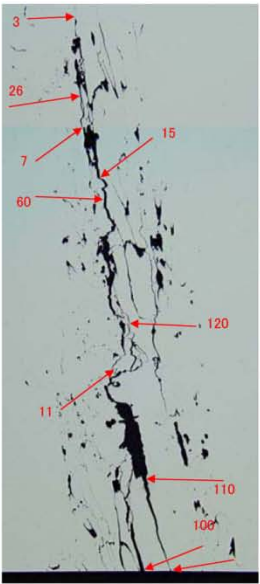
Position (X=-16)

Typical crack opening data of PINC2.3(SH-3) test block at X=-16.

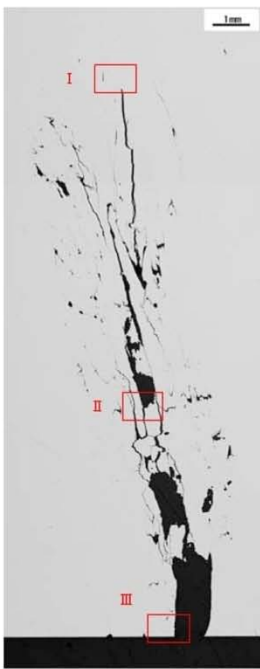
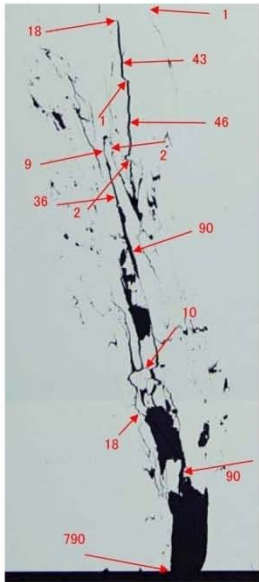
Position (X=3)

Typical crack opening data of PINC2.3(SH-3) test block at X=3.

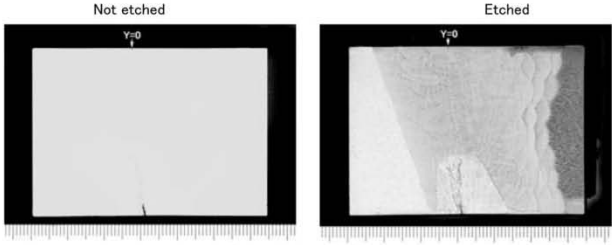
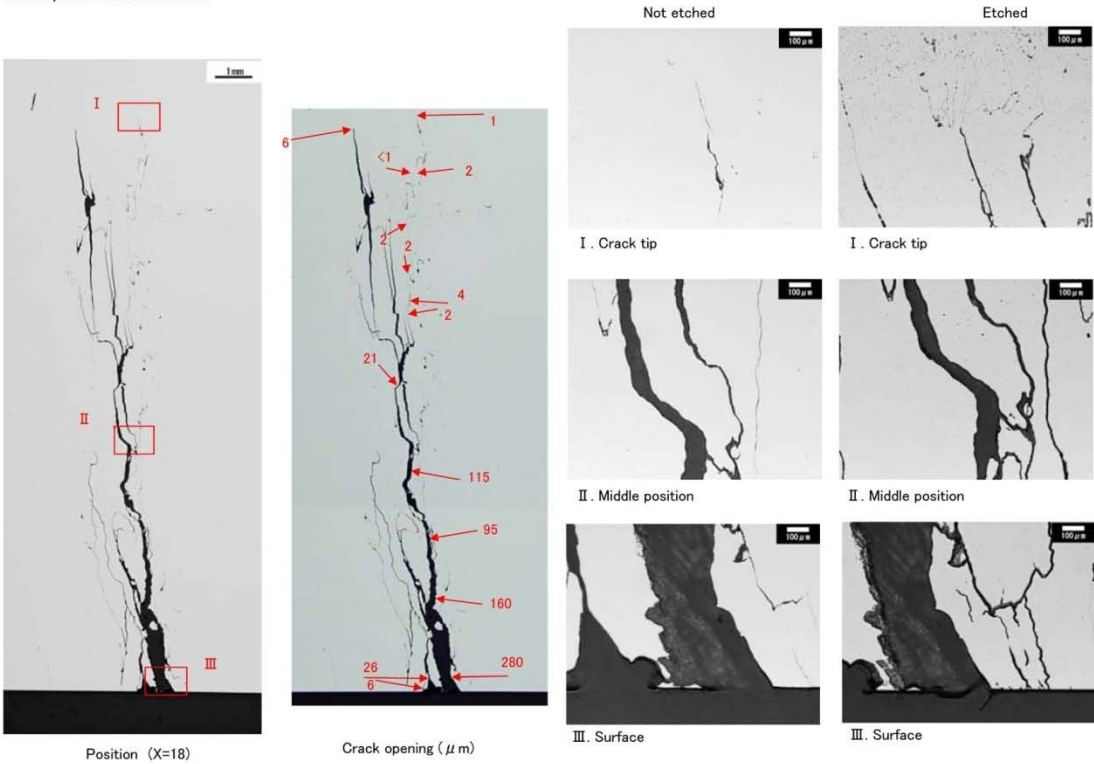
Position (X=18)

Typical crack opening data of PINC2.3(SH-3) test block at X=18.

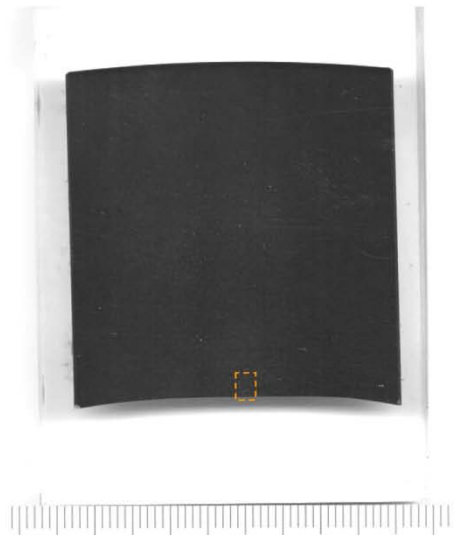
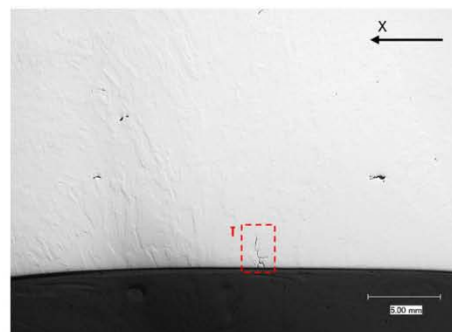
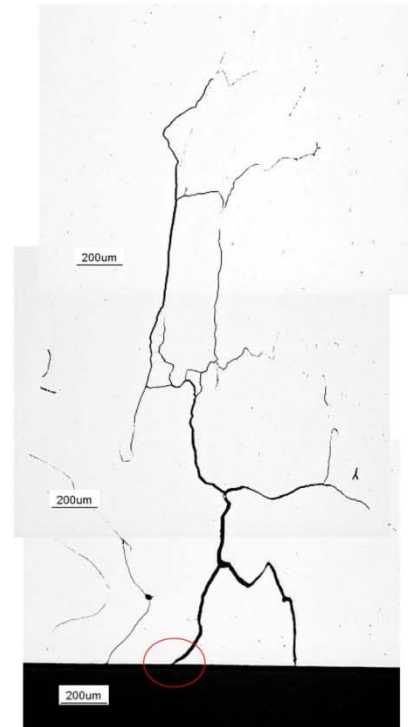
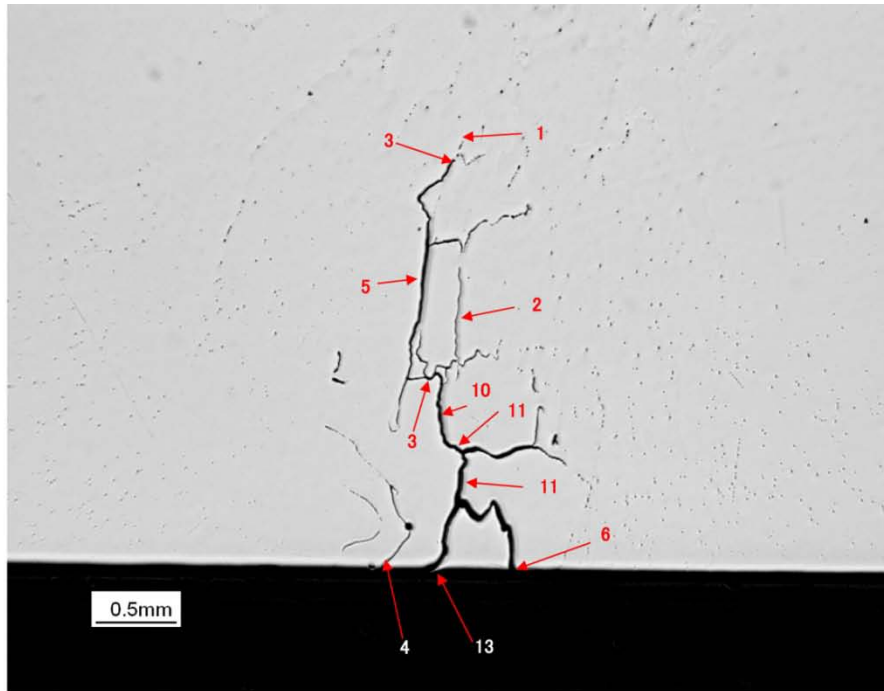
Position (Y=12)

Measured on sliced cross section	
Position (mm)	Y=12
Depth (mm)	2.7
Opening (μ m)	13
Inclination from depth direc.(Deg)	4

Typical crack opening data of PINC2.4(ST-1) test block at Y=12. (Page 1/2)

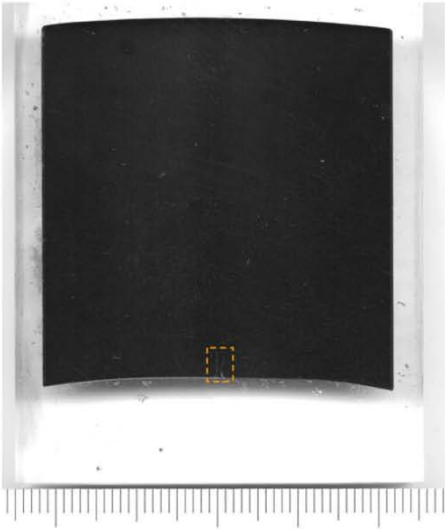
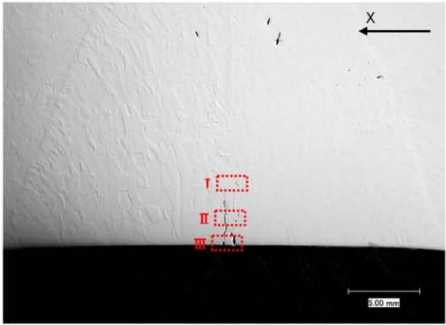
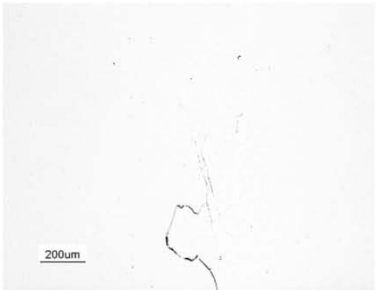
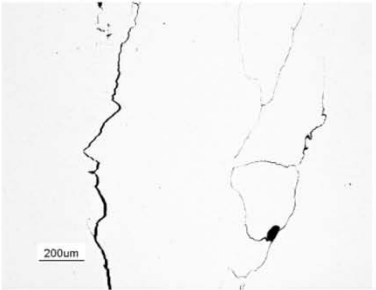
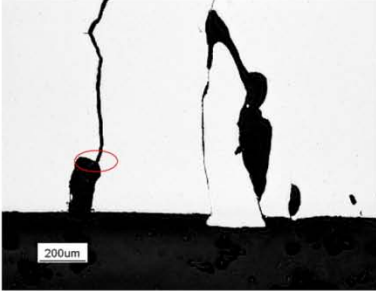
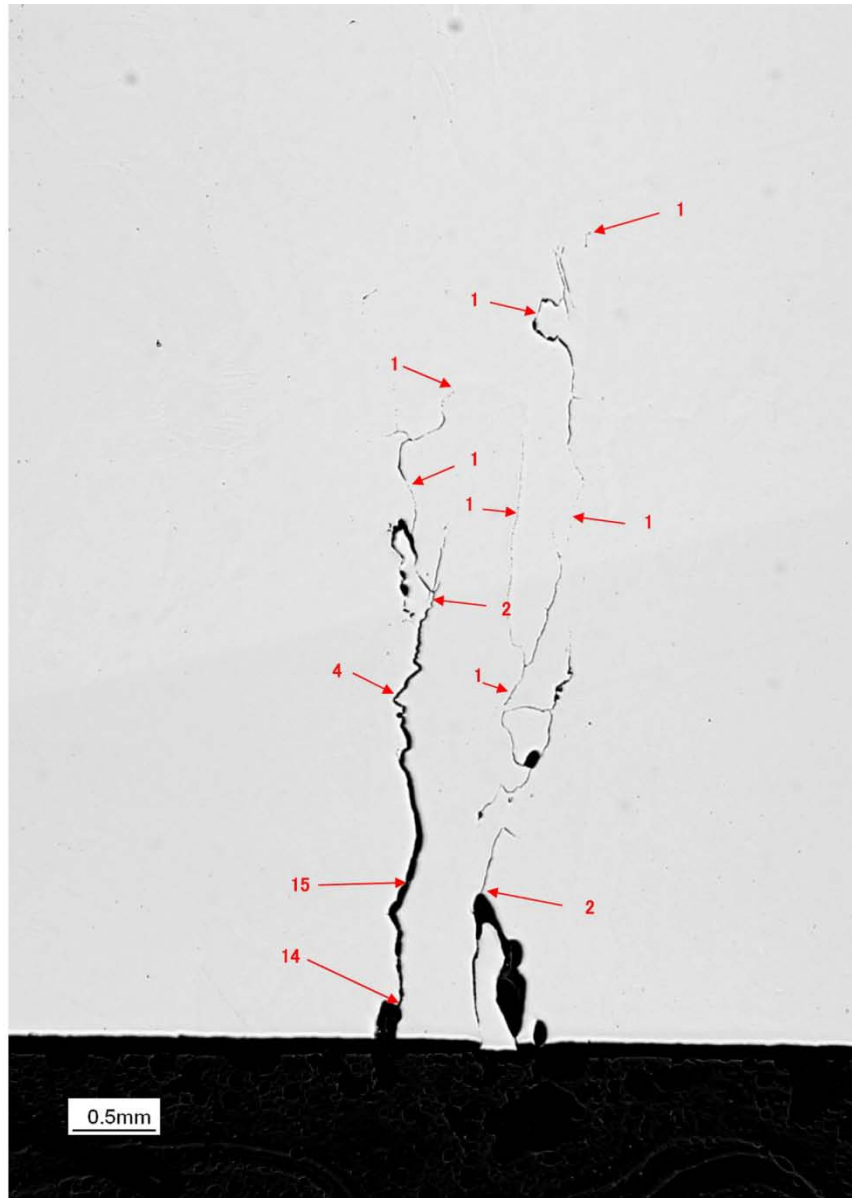
Position (Y=18)

Measured on sliced cross section	
Position (mm)	Y=18
Depth (mm)	4.9
Opening (μ m)	14 (97)
Inclination from depth direc.(Deg)	4

Typical crack opening data of PINC2.4(ST-1) test block at Y=18. (Page 1/2)

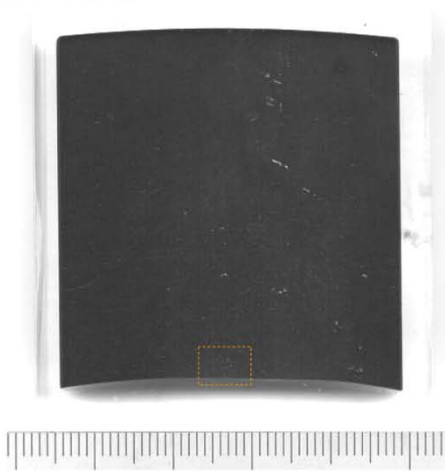
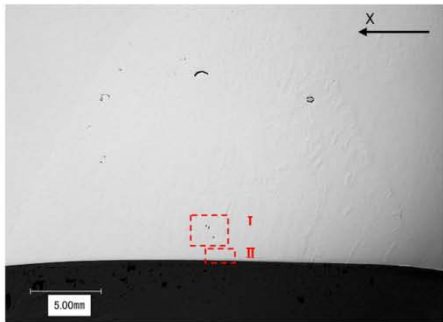
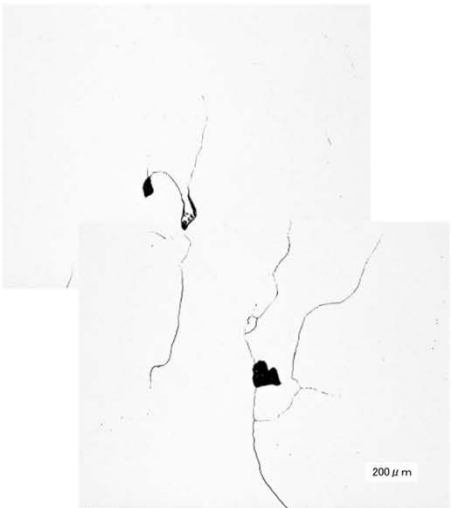
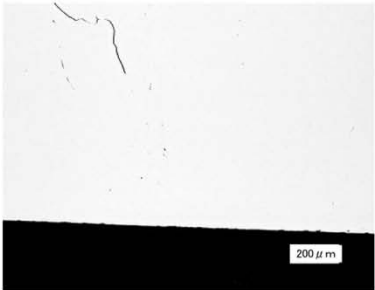
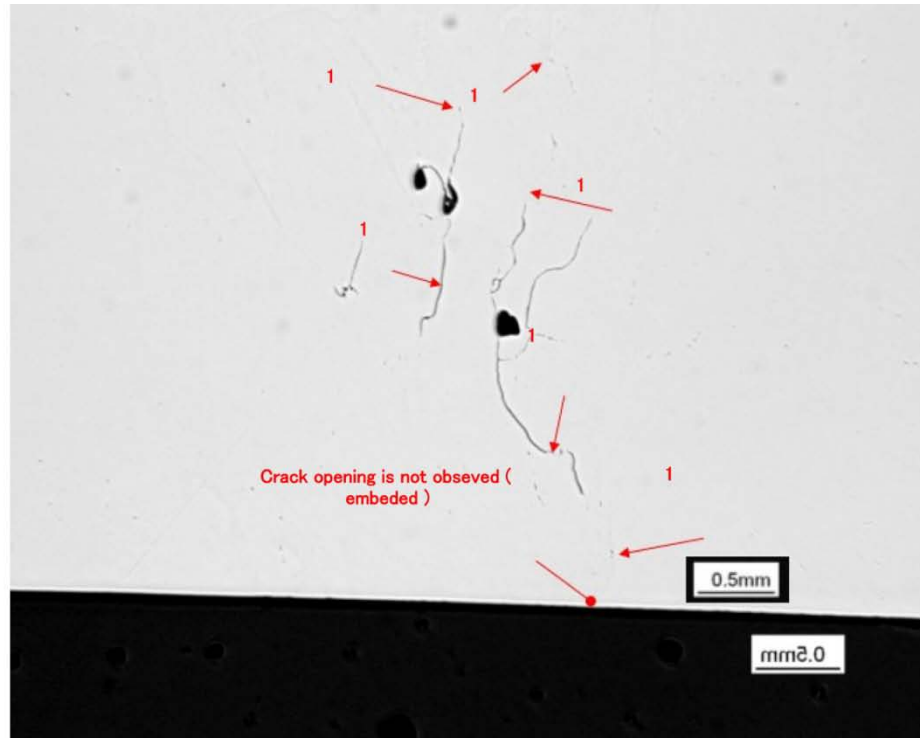
Position (Y=22)

Measured on sliced cross section	
Position (mm)	Y=22
Depth (mm)	1.3
Opening (μ m)	embedded
Inclination from depth direc.(Deg)	—

Typical crack opening data of PINC2.4(ST-1) test block at Y=22. (Page 1/2)

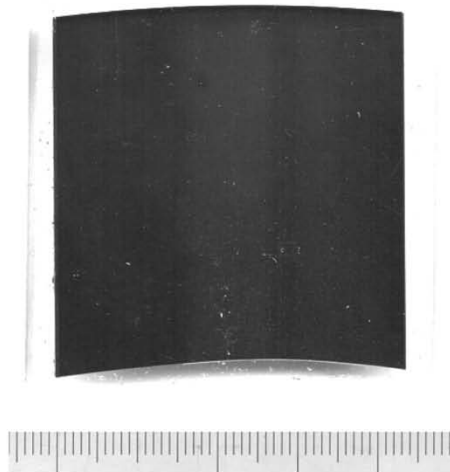
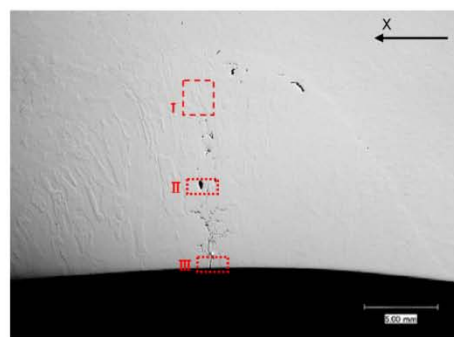
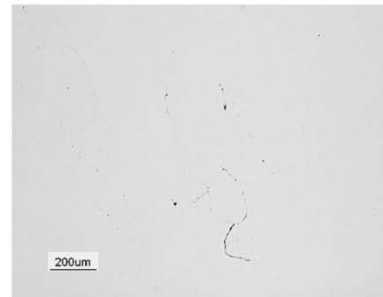
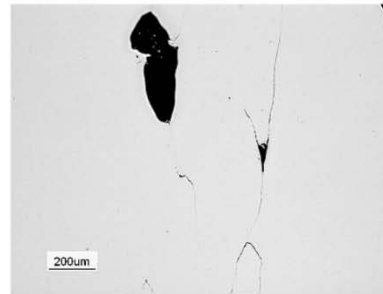
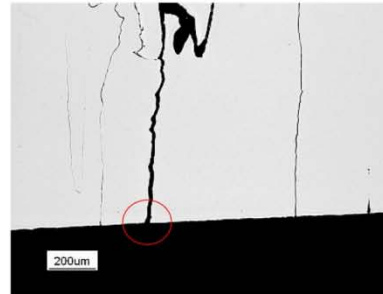
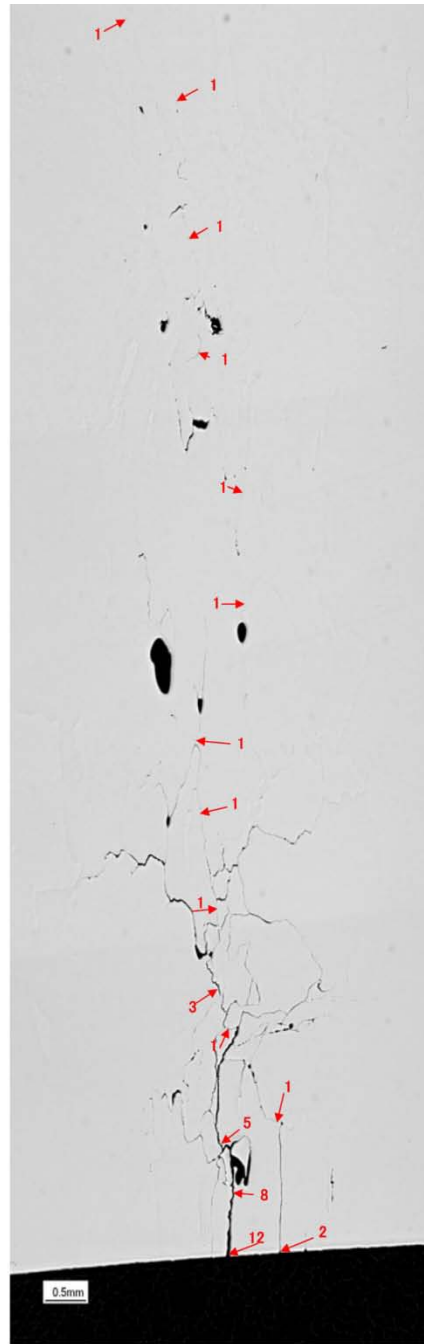
Position (Y=9)

Measured on sliced cross section	
Position (mm)	Y=9
Depth (mm)	10.6
Opening (μ m)	12
Inclination from depth direc.(Deg)	-2

Typical crack opening data of PINC2.5(ST-2) test block at Y=9. (Page 1/2)
