NUREG/CR-7019
PNNL-18713, Rev. 1

Results of the Program for the Inspection of Nickel Alloy Components

Manuscript Completed: April 2010

Pacific Northwest National Laboratory

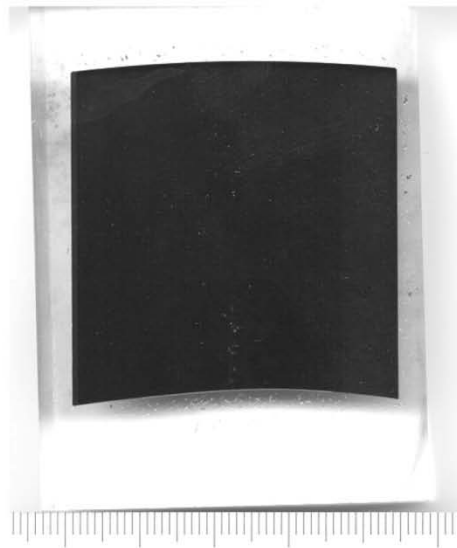
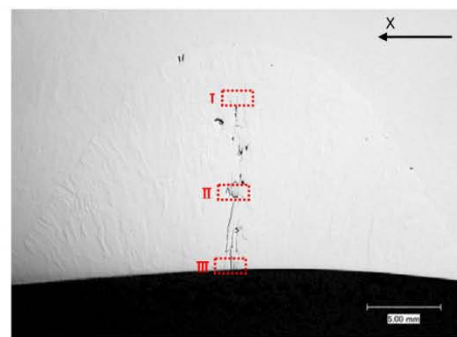
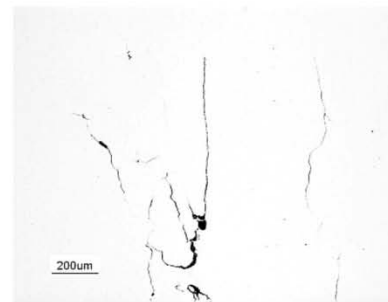
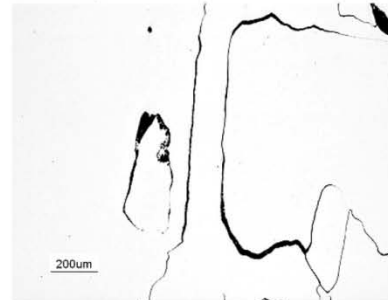
Position (Y=14)

Typical crack opening data of PINC2.5(ST-2) test block at Y=14. (Page 1/2)

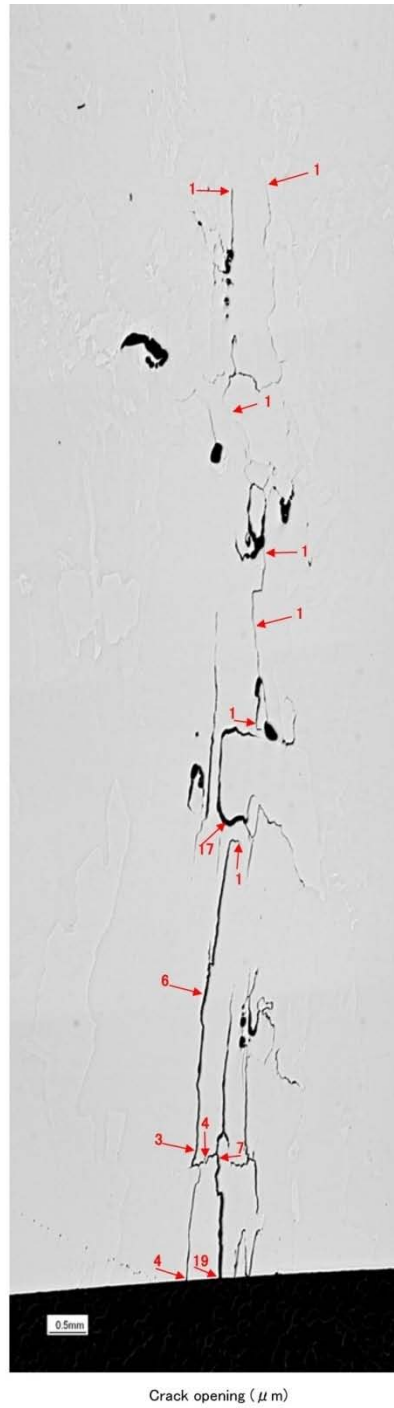
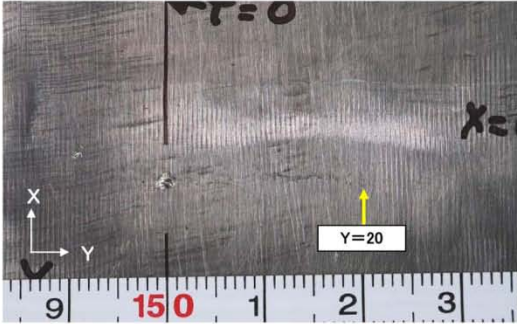
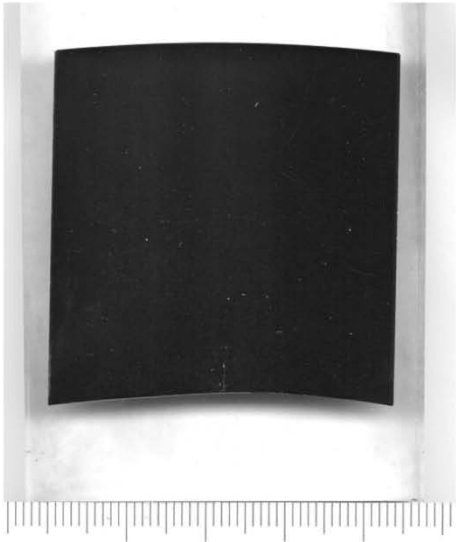
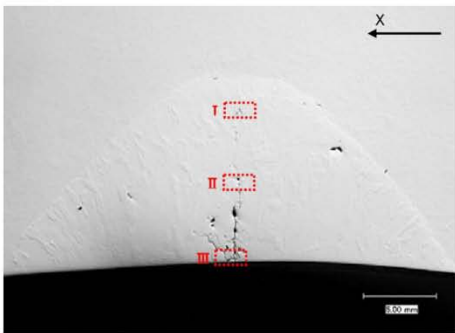
Measured on sliced cross section	
Position (mm)	Y=14
Depth (mm)	12.3
Opening (μ m)	19
Inclination from depth direc.(Deg)	1

Typical crack opening data of PINC2.5(ST-2) test block at Y=14. (Page 2/2)

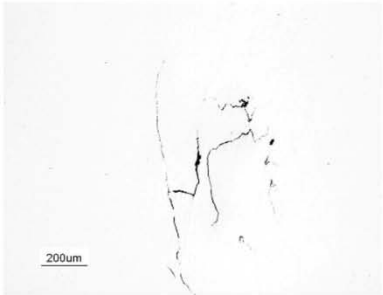
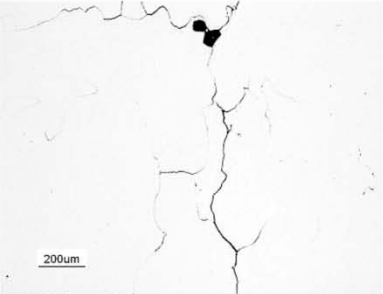
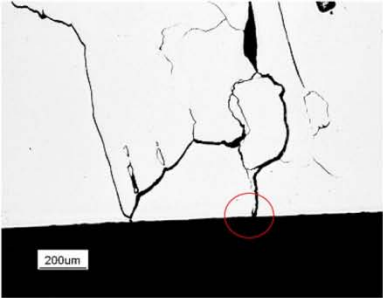
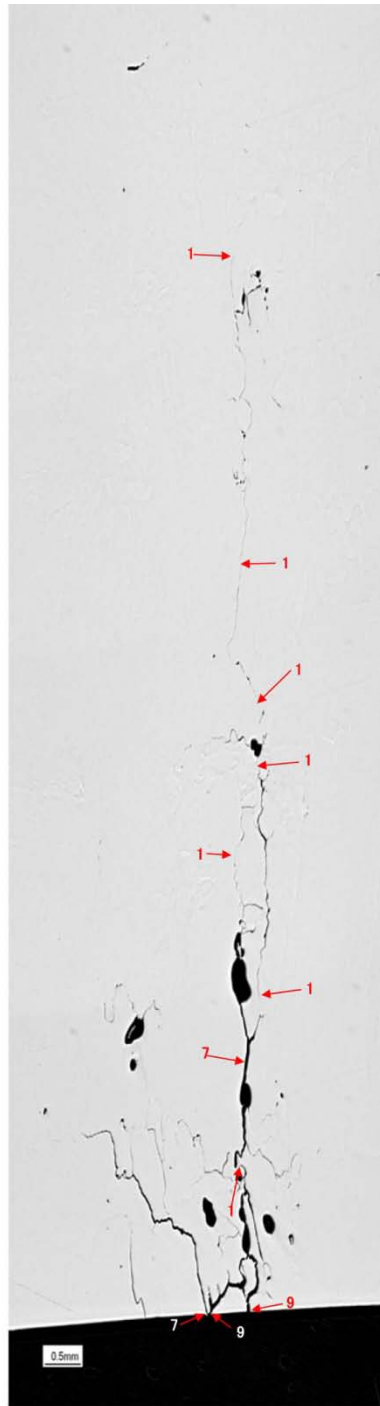
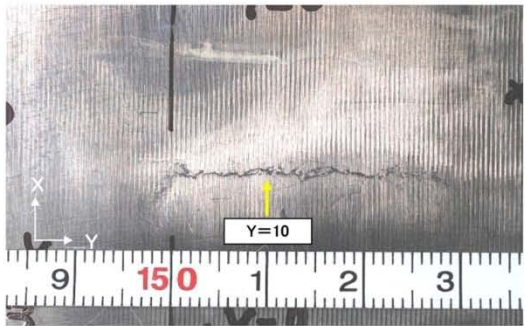
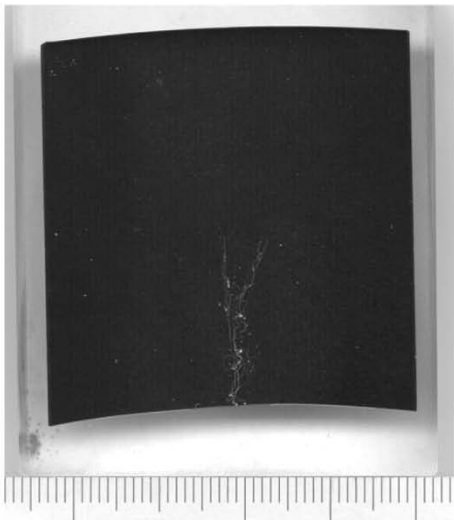
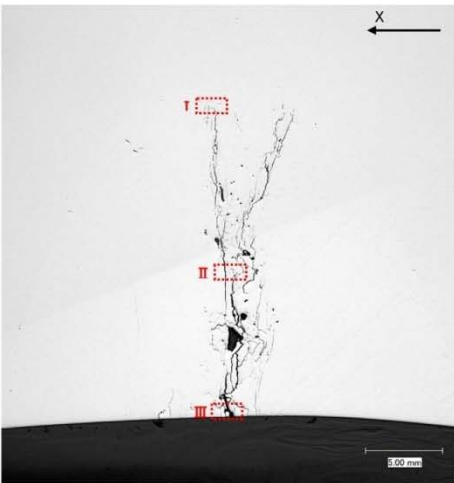
Position (Y=20)

Measured on sliced cross section	
Position (mm)	Y=20
Depth (mm)	11.0
Opening (μ m)	9
Inclination from depth direc.(Deg)	1

Typical crack opening data of PINC2.5(ST-2) test block at Y=20. (Page 1/2)

Typical crack opening data of PINC2.5(ST-2) test block at Y=20. (Page 2/2)

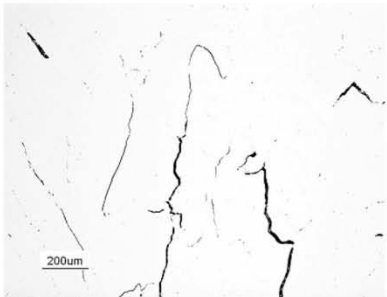
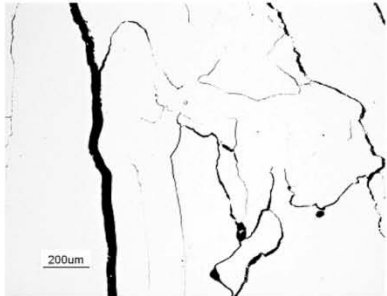
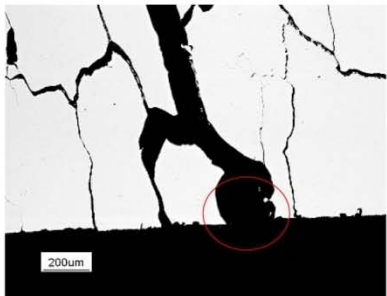
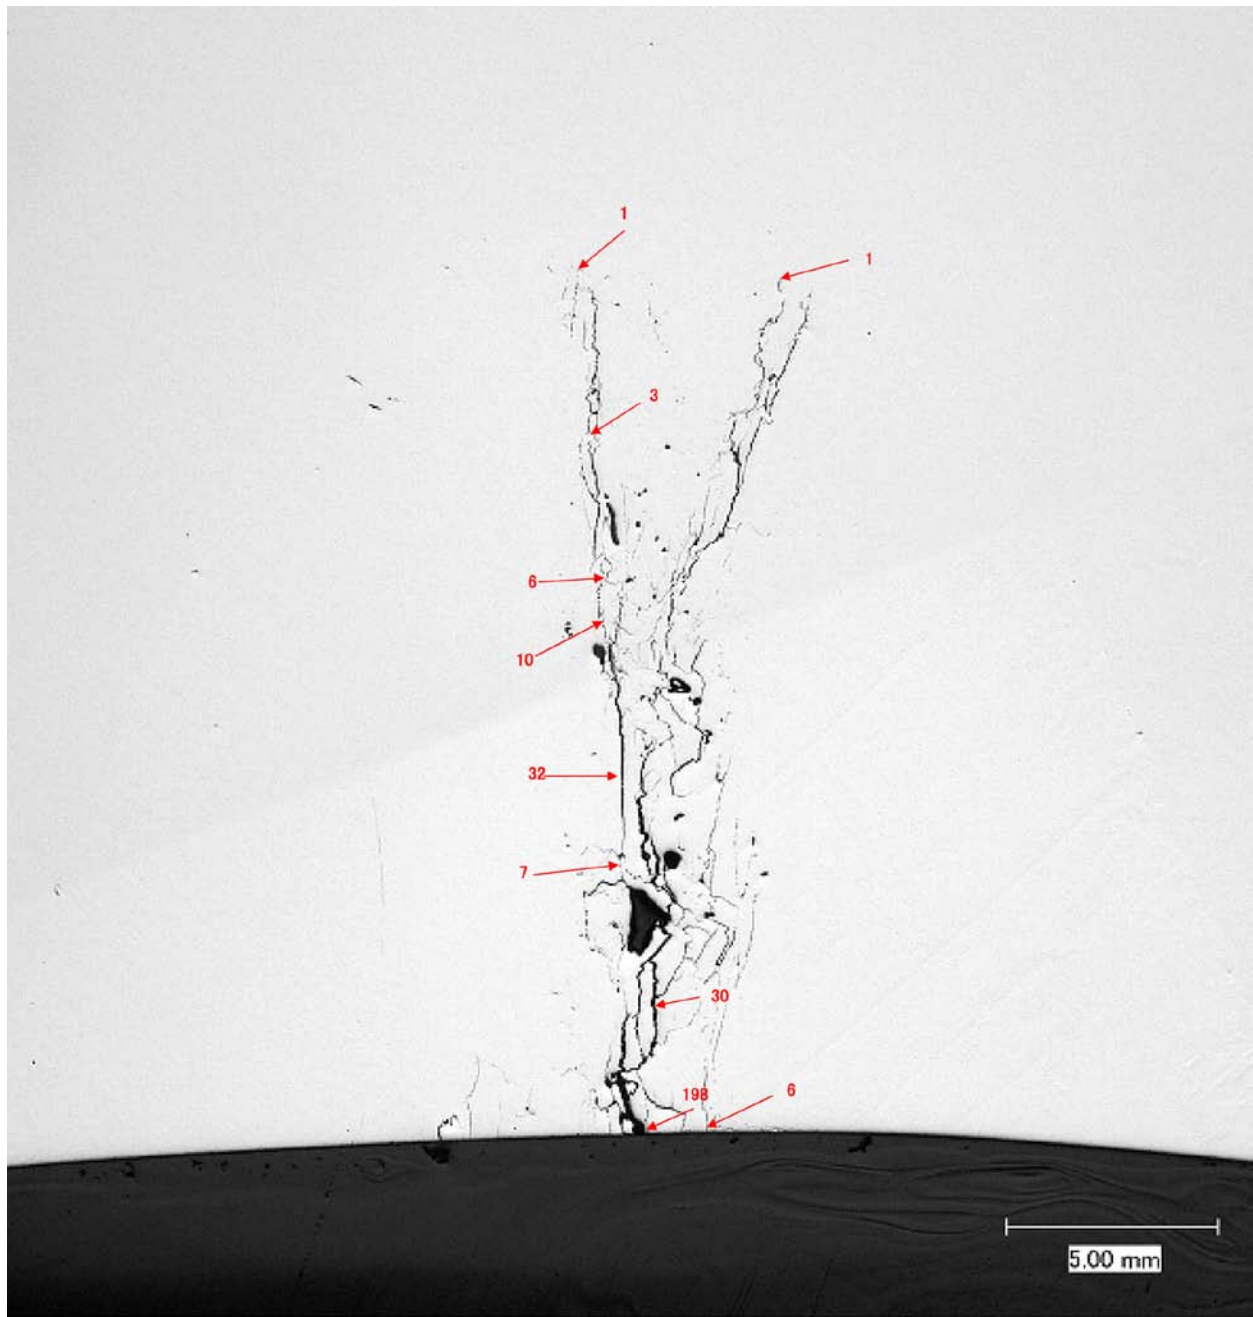
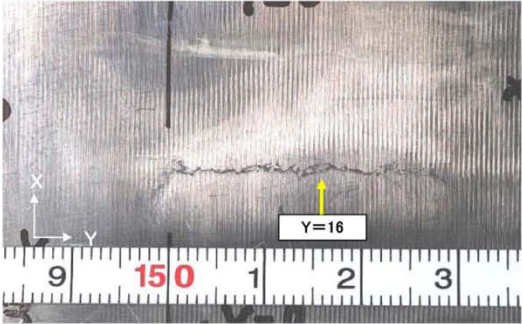
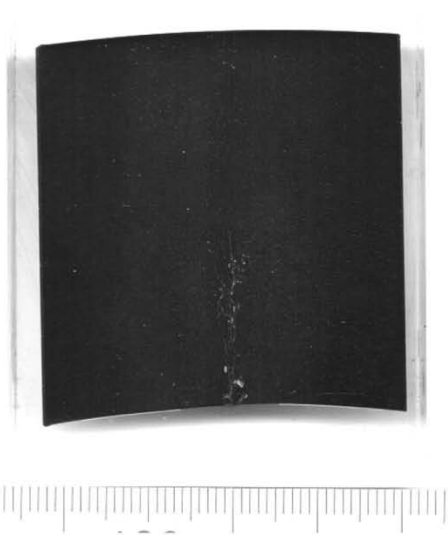
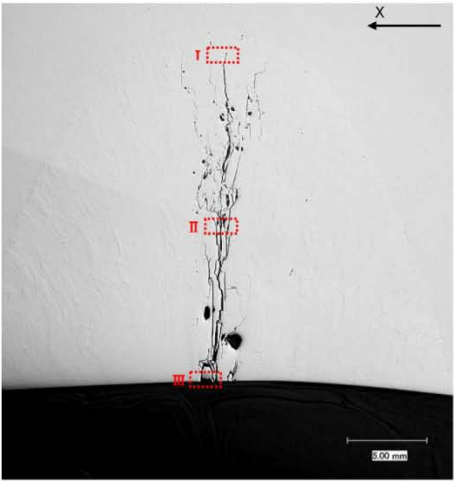
Position (Y=10)

Measured on sliced cross section	
Position (mm)	Y=10
Depth (mm)	(20.7)
Opening (μm)	198
Inclination from depth direc.(Deg)	-3

() means measured on cracked crack

Typical crack opening data of PINC2.6(ST-3) test block at Y=10. (Page 1/2)

Typical crack opening data of PINC2.6(ST-3) test block at Y=10. (Page 2/2)

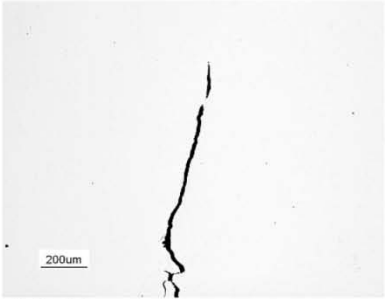
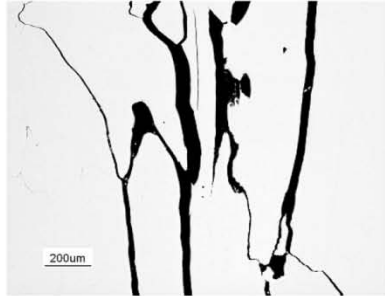
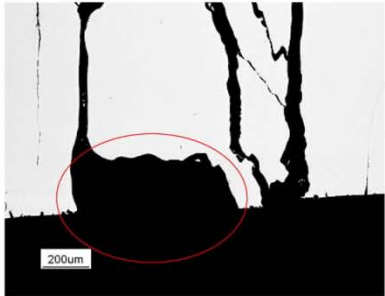
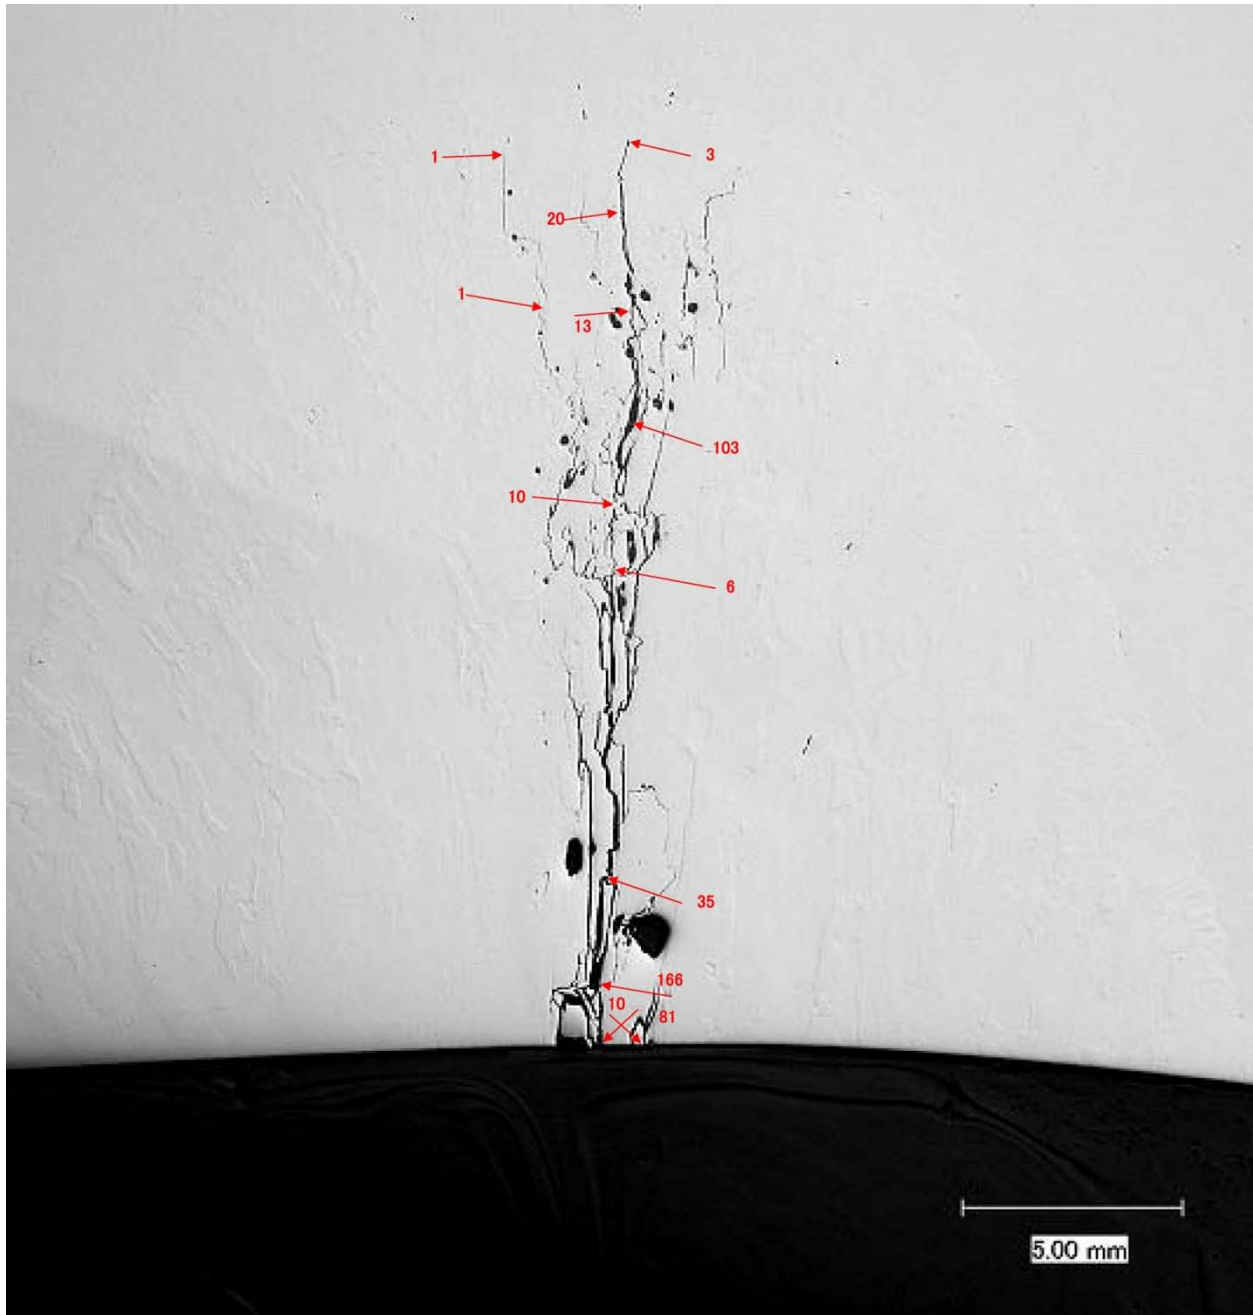
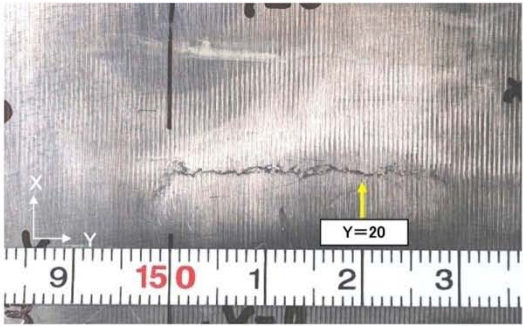
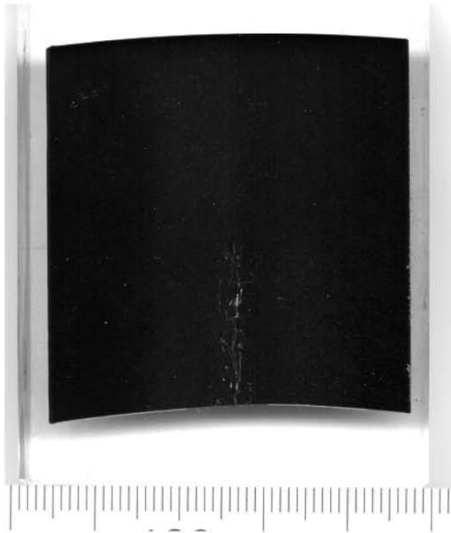
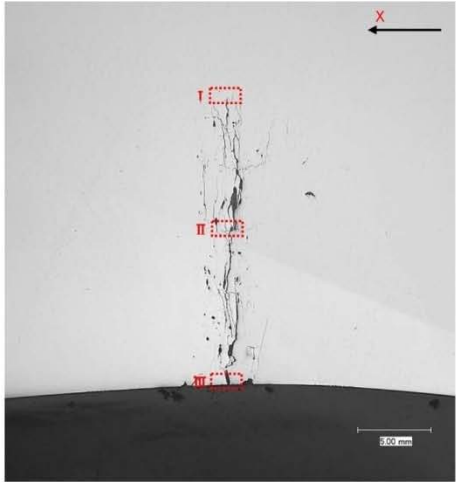
Position (Y=16)

Measured on sliced cross section	
Position (mm)	Y=16
Depth (mm)	(21.4)
Opening (μ m)	686
Inclination from depth direc.(Deg)	2

Depth measured on
broken crack is
22.3mm

Typical crack opening data of PINC2.6(ST-3) test block at Y=16. (Page 1/2)

Typical crack opening data of PINC2.6(ST-3) test block at Y=16. (Page 2/2)

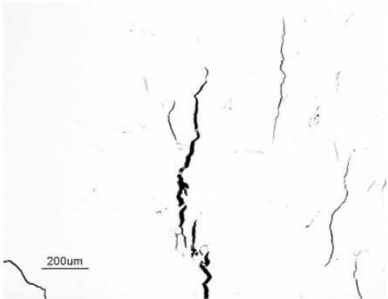
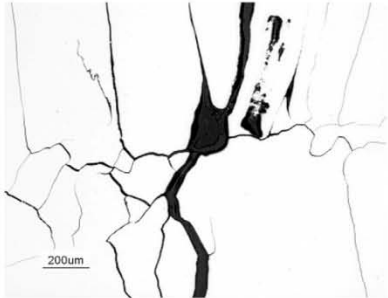
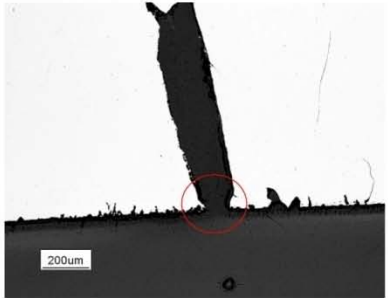
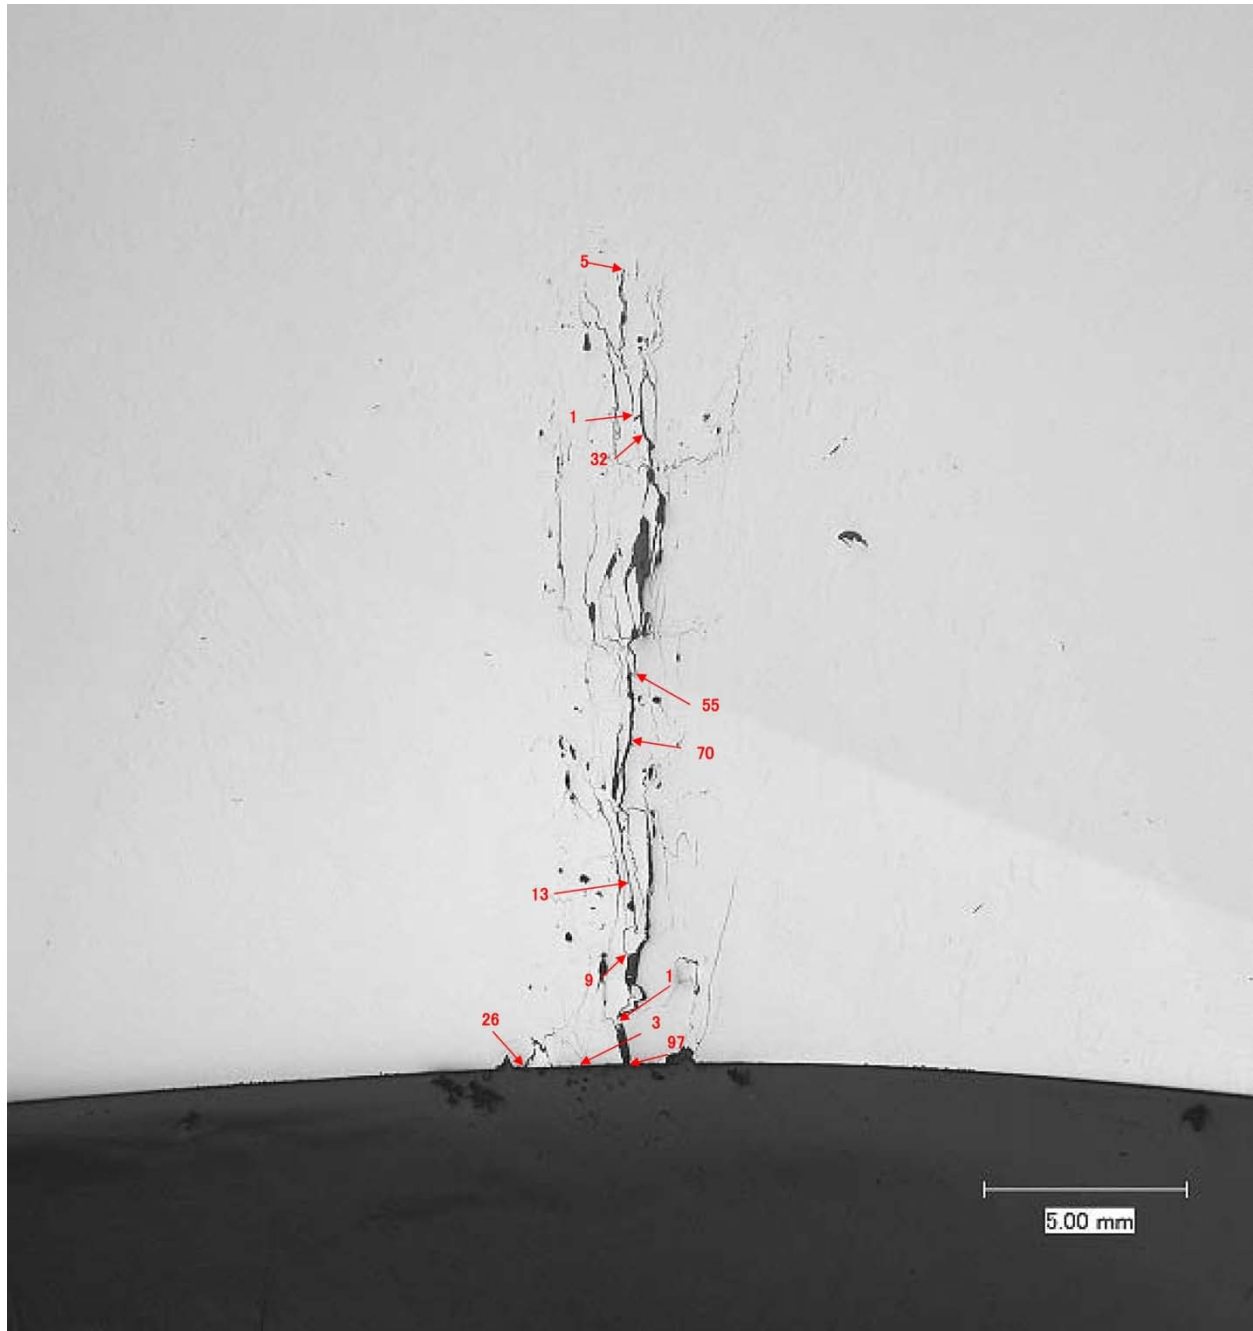
Position (Y=20)

Measured on sliced cross section	
Position (mm)	Y=20
Depth (mm)	20.2
Opening (μ m)	97
Inclination from depth direc.(Deg)	0

Typical crack opening data of PINC2.6(ST-3) test block at Y=20. (Page 1/2)

Typical crack opening data of PINC2.6(ST-3) test block at Y=20. (Page 2/2)

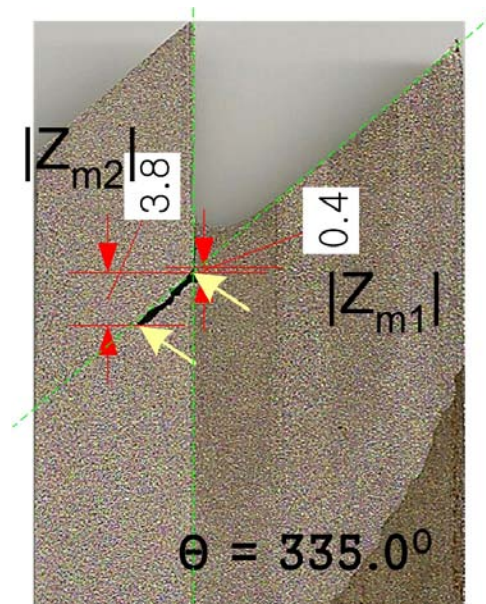
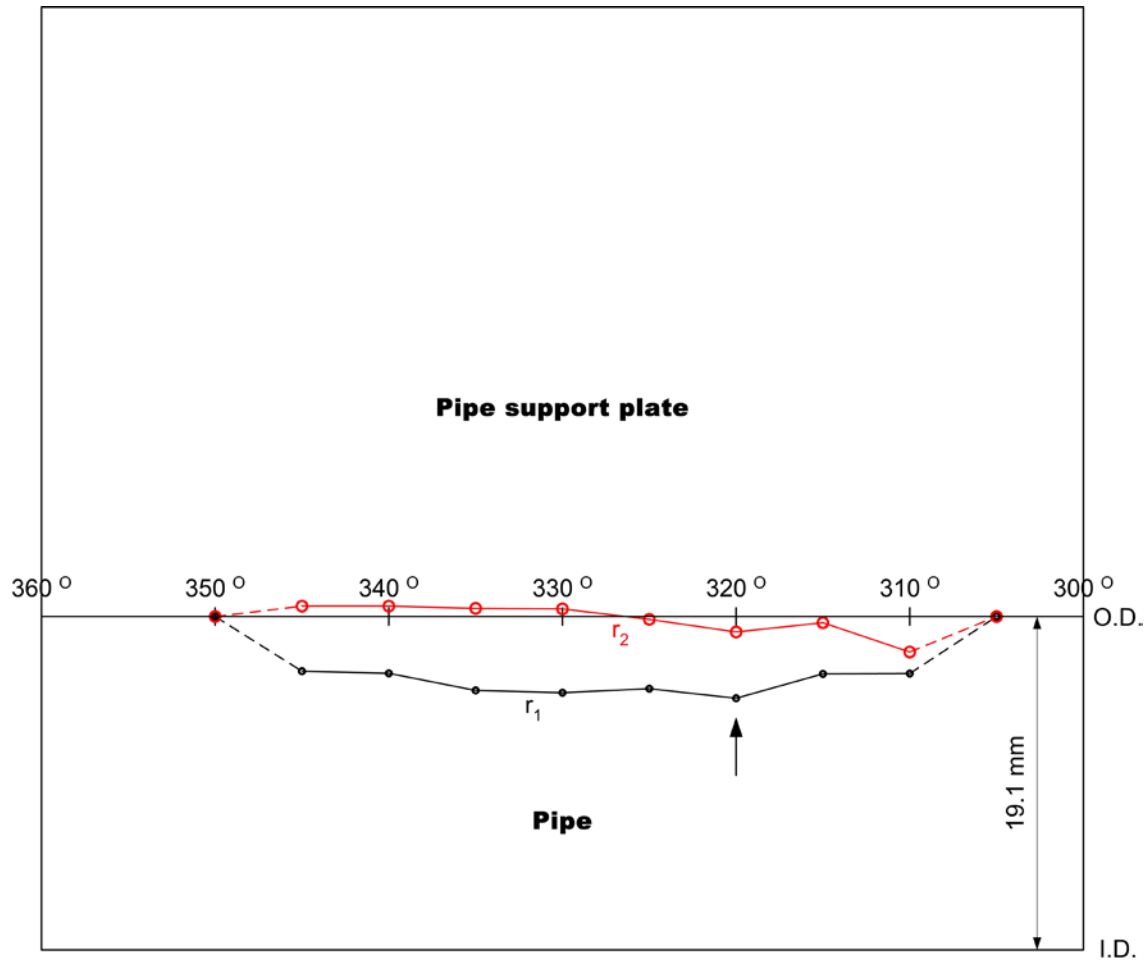
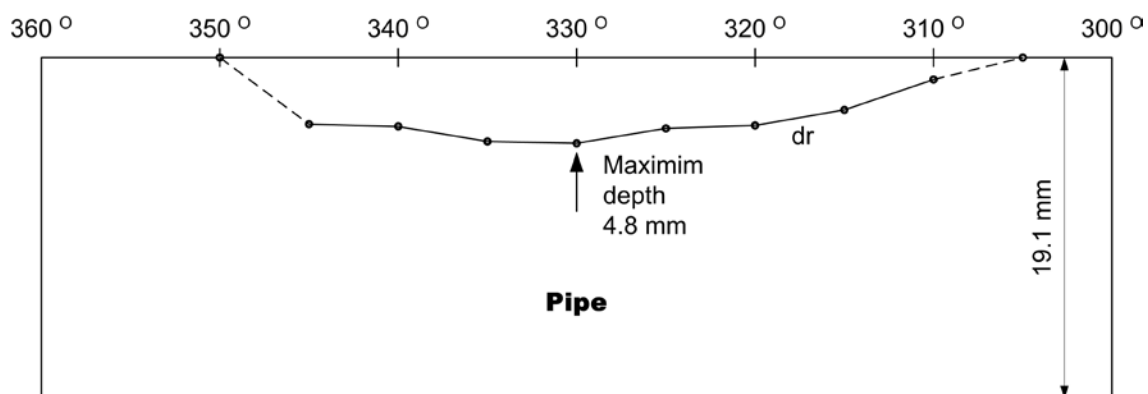
Figure 2 Flaw #1 Surface Crack of Pipe O.D.

BMI Test Block Number	Circ. Extent (deg)		Radial Extent (mm)		Vertical Position (mm)	
	θ_{min}	θ_{max}	r_{min}	r_{max}	Z_{min}	Z_{max}
Flaw No. #1	305	350	14.4	19.7	290.4	297.6

Figure 3 Depth Profile of Flaw #1 Using r_1 and r_2

Figure 4 Depth Profile of Flaw # 1 Using $dr (= r_2 - r_1)$

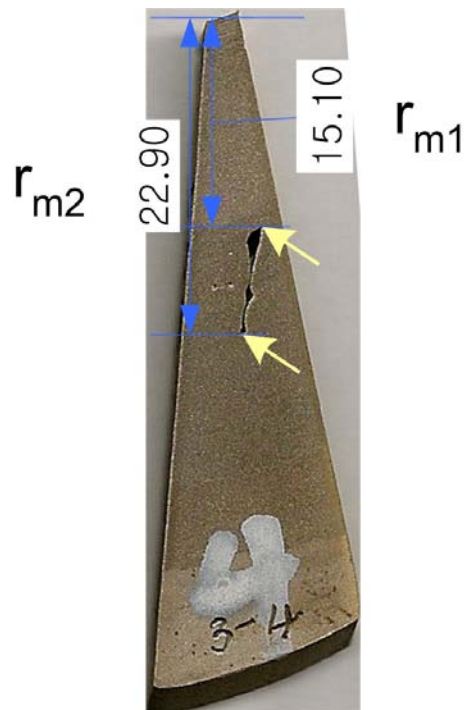
Figure 6 Flaw #3 Interface J-weld and Nozzle O.D.

BMI Test Block Number	Circ. Extent (deg)		Radial Extent (mm)		Vertical Position (mm)	
	θ_{min}	θ_{max}	r_{min}	r_{max}	Z_{min}	Z_{max}
Flaw No. #3	148	155	19.3	27.3	327.1	341.2

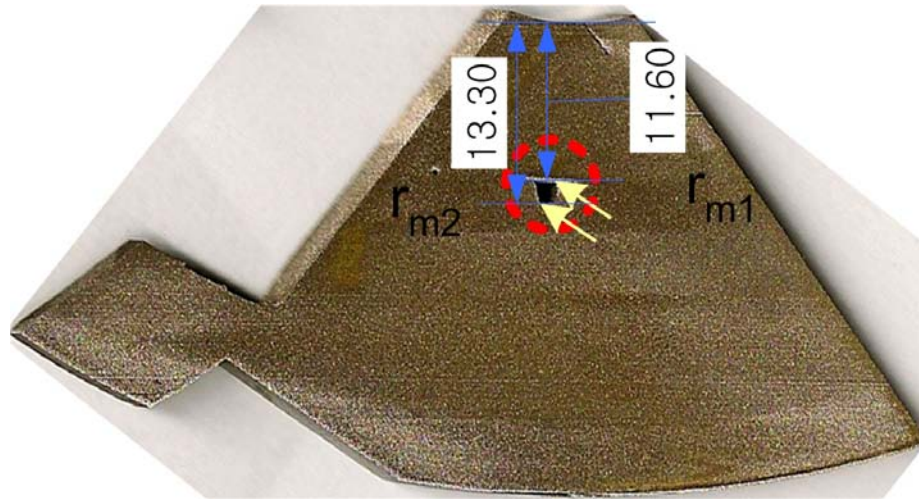
Figure 7 Flaw #3A I.D. Notch on Carbon Steel Plate

BMI Test Block Number	Circ. Extent (deg)		Radial Extent (mm)		Vertical Position (mm)	
	θ_{min}	θ_{max}	r_{min}	r_{max}	Z_{min}	Z_{max}
Flaw No. #3A	89.6	92.5	18.6	21.1	305.2	352.7

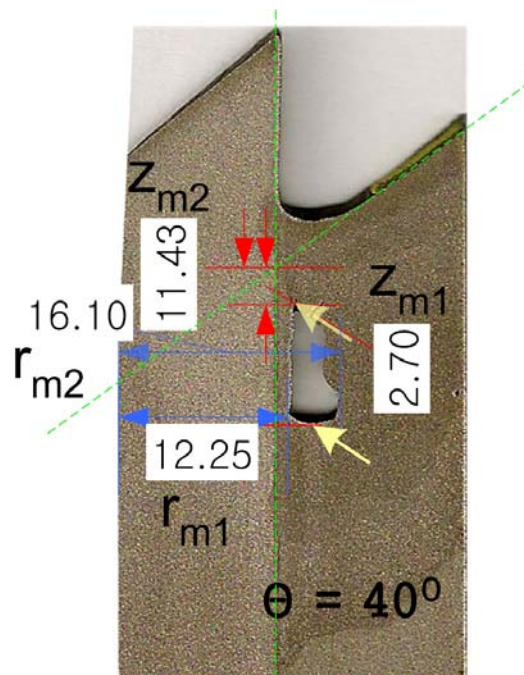
Figure 8 Flaw #4 508 from Interface J-weld and Nozzle O.D.

BMI Test Block Number	Circ. Extent (deg)		Radial Extent (mm)		Vertical Position (mm)	
	θ_{min}	θ_{max}	r_{min}	r_{max}	Z_{min}	Z_{max}
Flaw No. #4	15	70	17.4	23.7	294.1	307.9

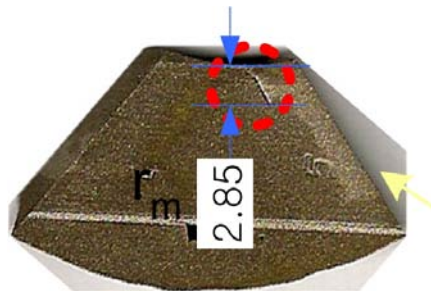
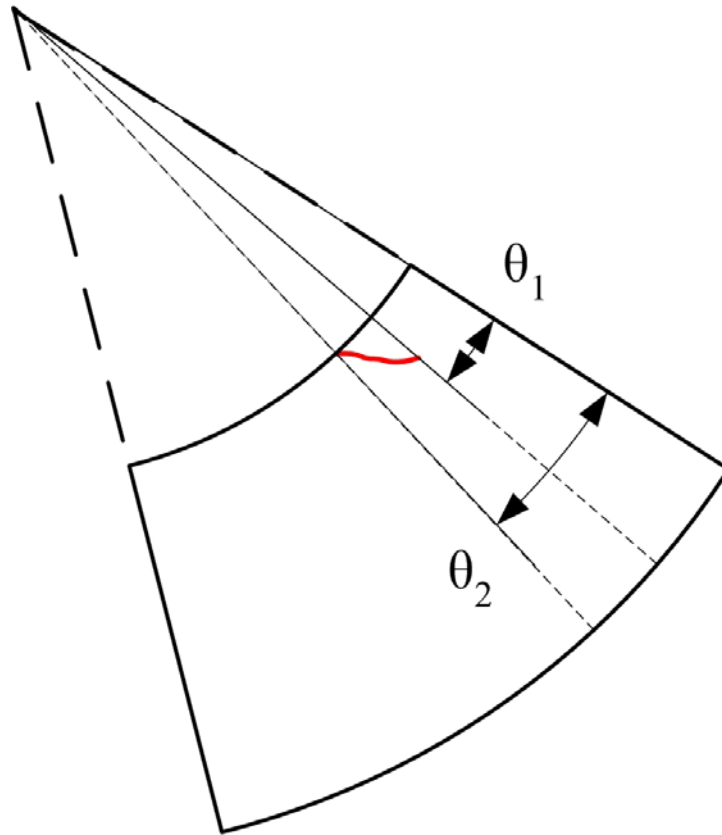
Figure 9 Flaw #5 Surface Crack of Pipe I.D.

BMI Test Block Number	Circ. Extent (deg)		Radial Extent (mm)		Vertical Position (mm)	
	θ_{\min}	θ_{\max}	r_{\min}	r_{\max}	Z_{\min}	Z_{\max}
Flaw No. #5	100	107	7.5	10.7	296.0	321.6

Figure 10 Flaw #5 Angle of crack

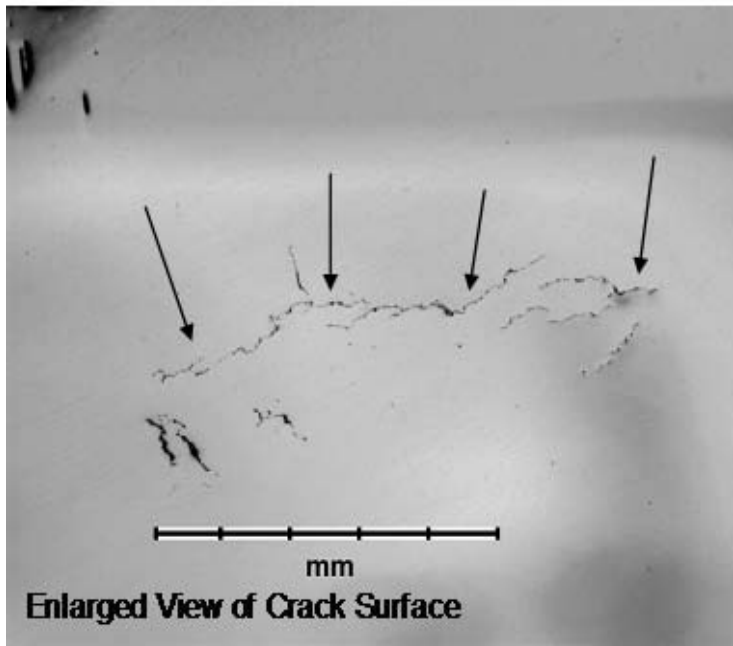
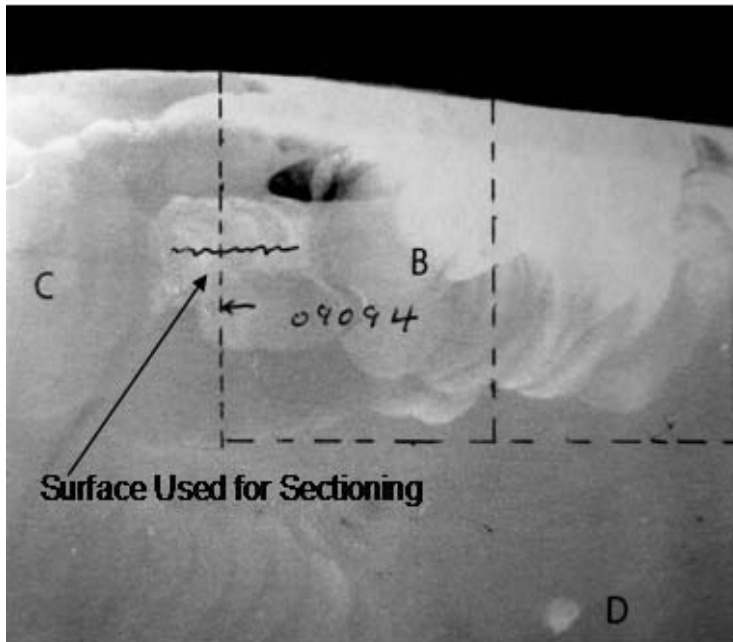
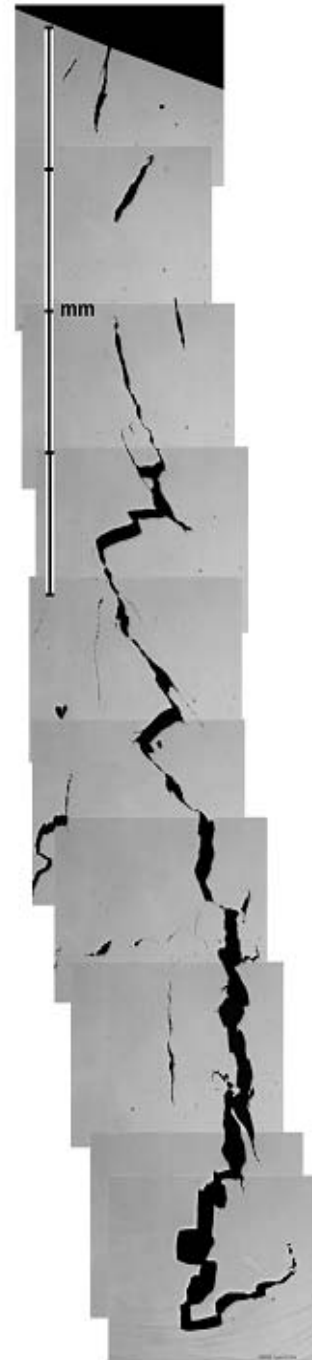
Flaw 1

Measured Length	7.5 mm
COD at Surface	28 μ m
Depth of Surface Breaking Segment	0.6 mm
Total Depth	9 mm

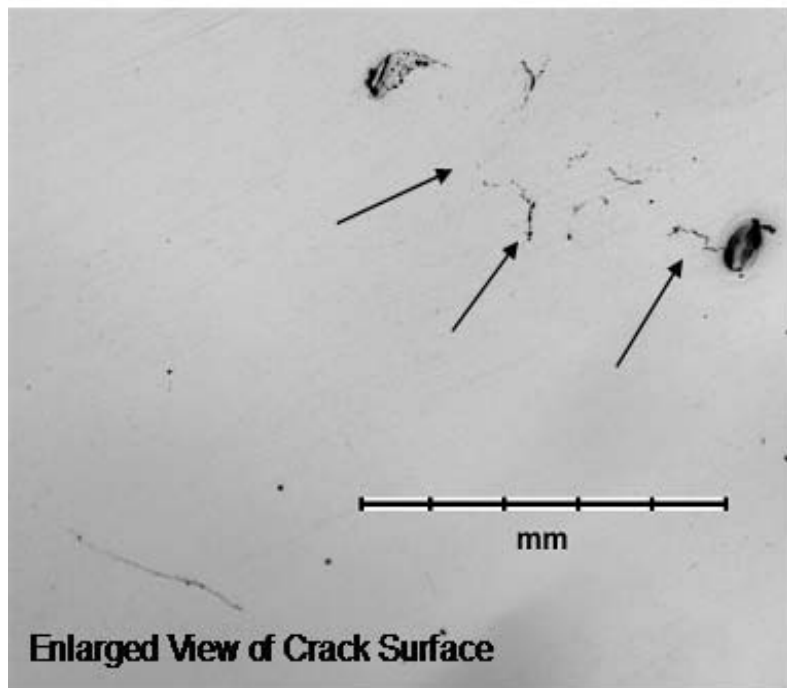
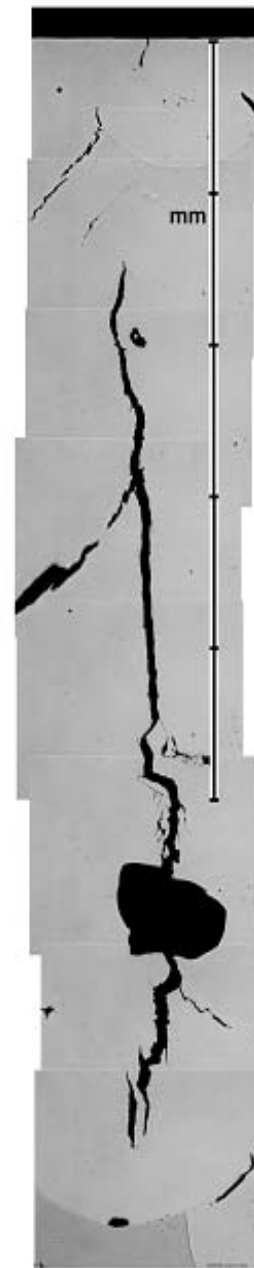
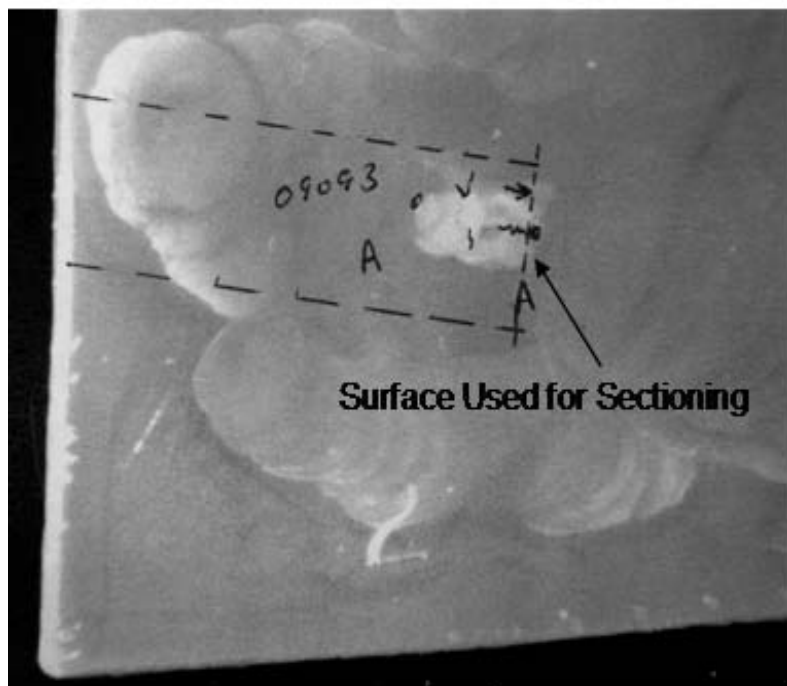
Flaw 2 is very discontinuous at the surface, and the surface-breaking component of the crack is a mere 0.2 mm into the weld. At a depth of 1.5 mm, the flaw becomes continuous and much wider. Flaw 2 can almost be considered an embedded flaw, as the surface-breaking component is so tight and shallow. No teams were able to detect Flaw 2.

Measured Length	5 mm
COD at Surface	12 μm
Depth of Surface Breaking Segment	0.2 mm
Total Depth	7 mm

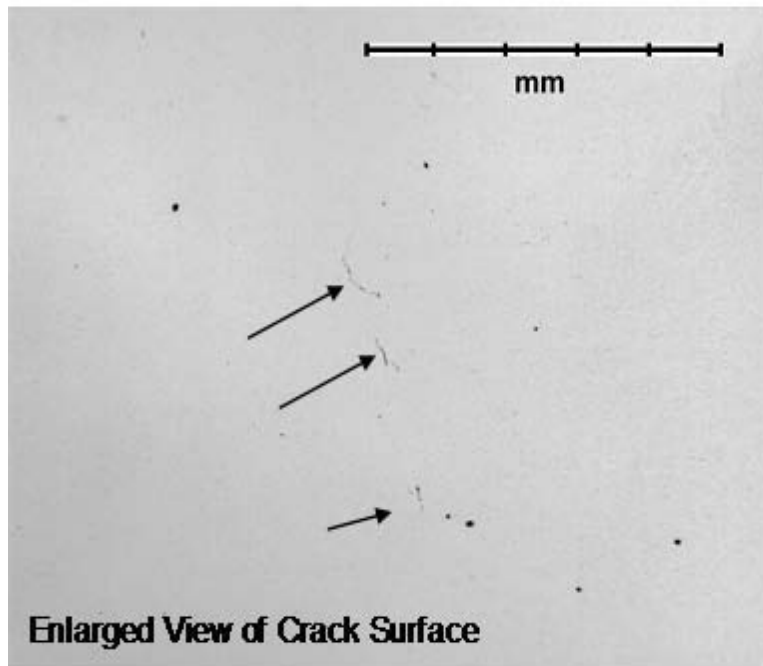
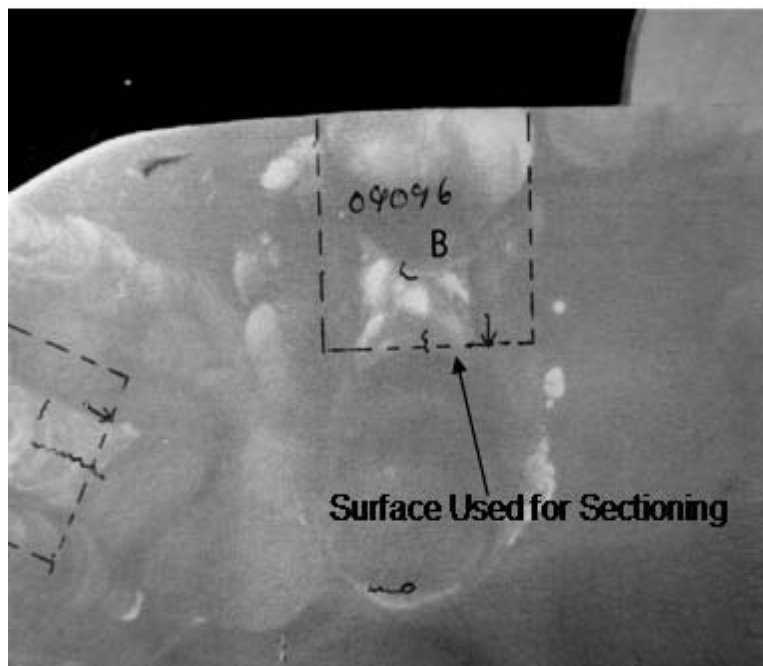
Flaw 3

Measured Length	3.5 mm
COD at Surface	15 μ m
Depth of Surface Breaking Segment	0.35 mm
Total Depth	0.35 mm

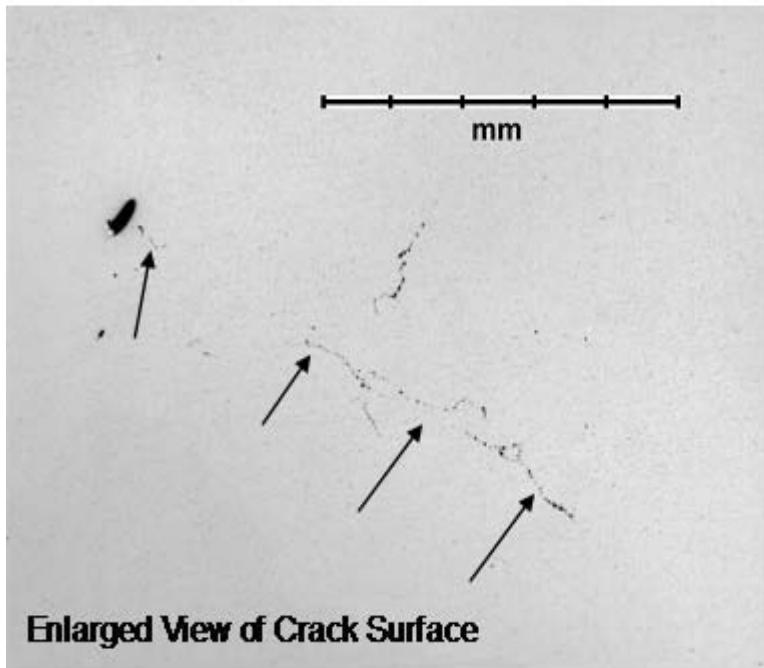
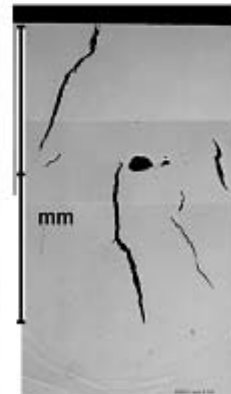
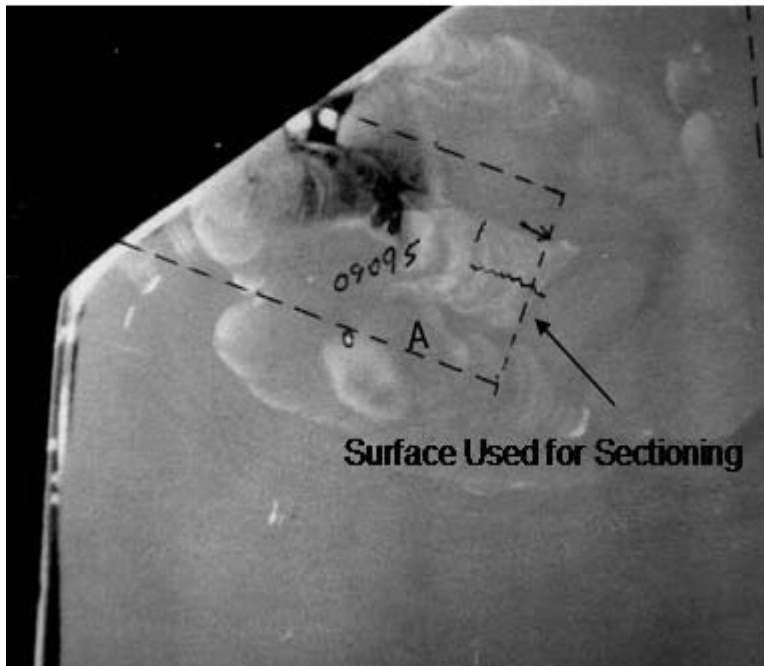
Flaw 4 had a discontinuous surface profile along the surface and along the cross section, but the surface-breaking segment of the crack was almost 1-mm deep. Also, the flaw has a “T”-shaped profile that would make it more easily detectable by eddy current systems that are sensitive to the orientation of the crack. Three teams detected Flaw 4.

Measured Length	7 mm
COD at Surface	32 μm
Depth of Surface Breaking Segment	0.9 mm
Total Depth	2 mm

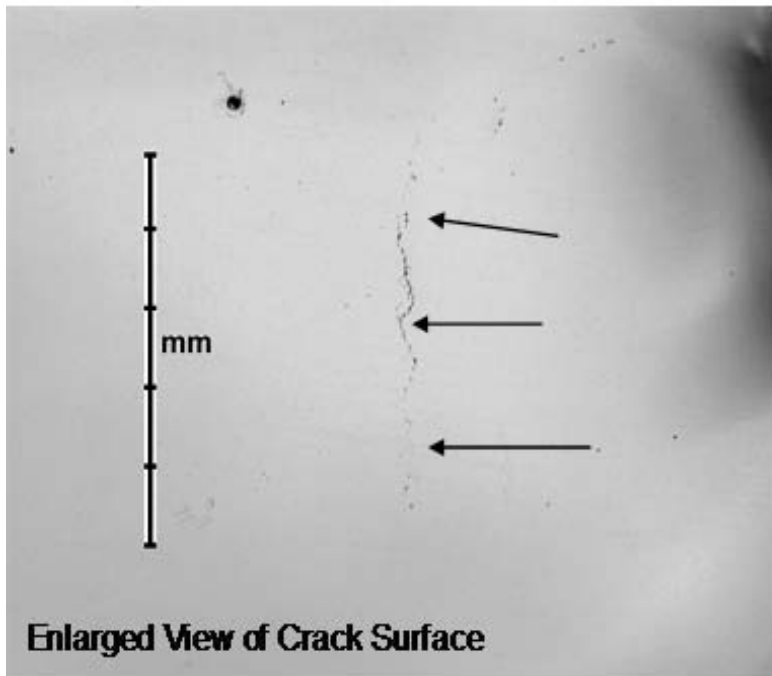
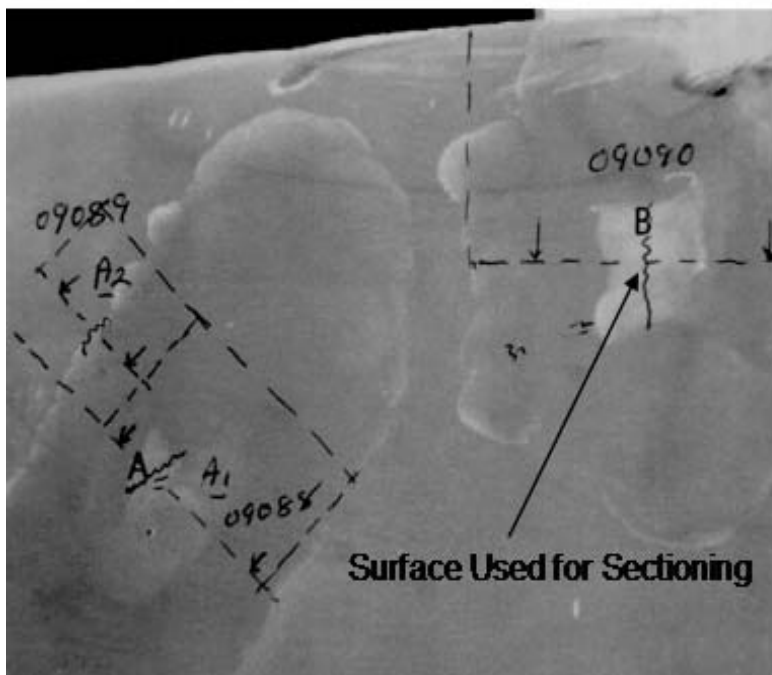
Flaw 5

Measured Length	4.5 mm
COD at Surface	12 μ m
Depth of Surface Breaking Segment	1.5 mm

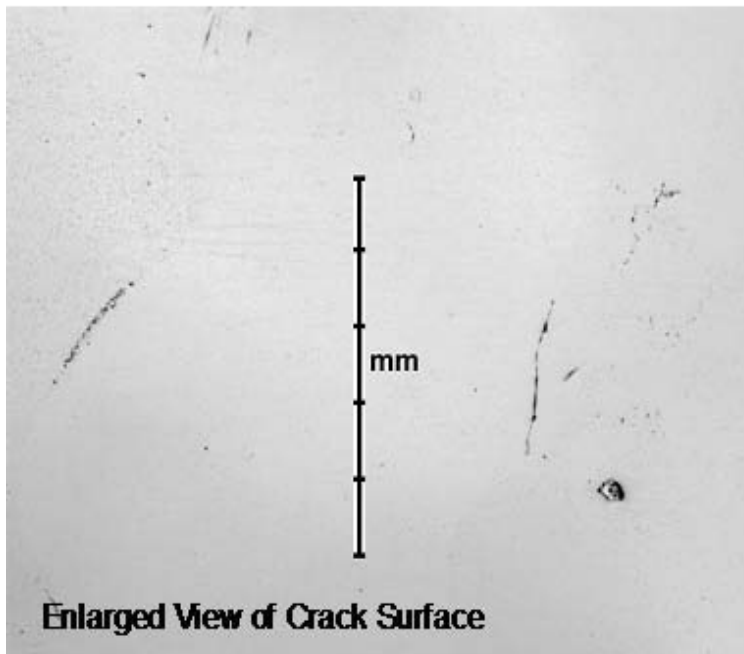
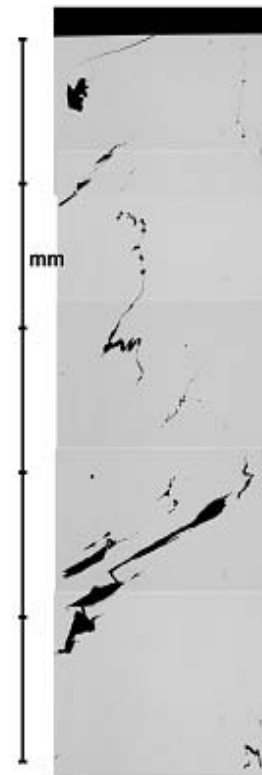
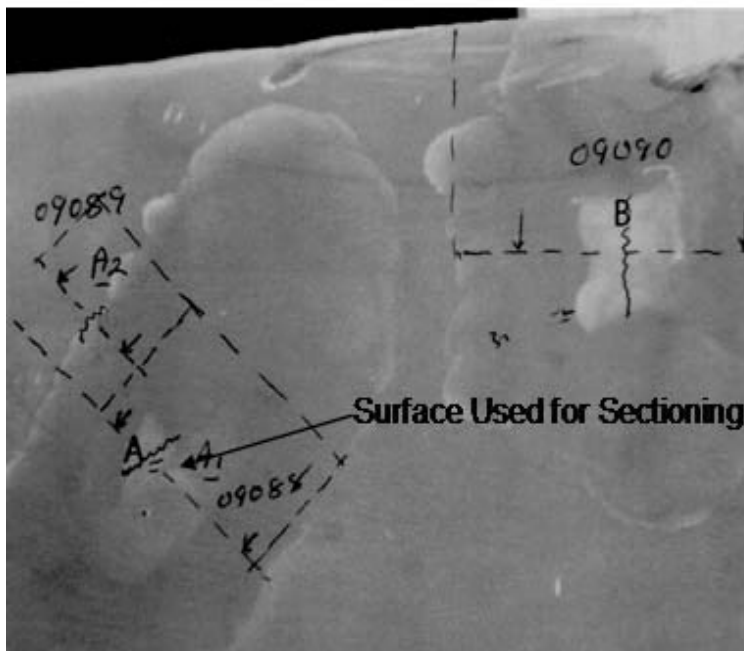
Flaw 6

For flaw 6, there was a surface blemish and an apparent crack.
