NUREG/CR-7019
PNNL-18713, Rev. 1

Results of the Program for the Inspection of Nickel Alloy Components

Manuscript Completed: April 2010

Pacific Northwest National Laboratory

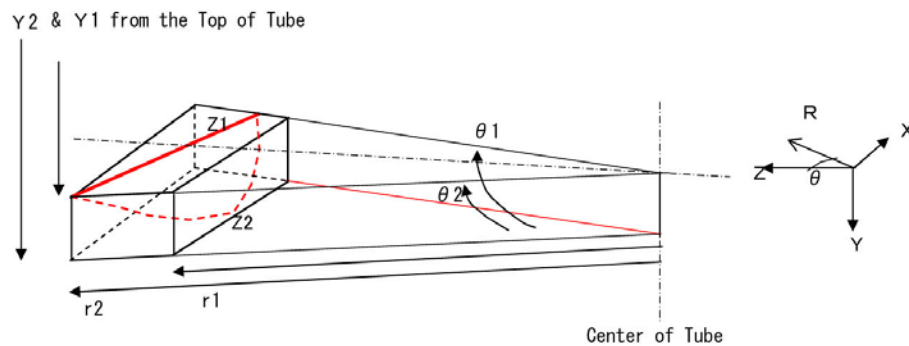
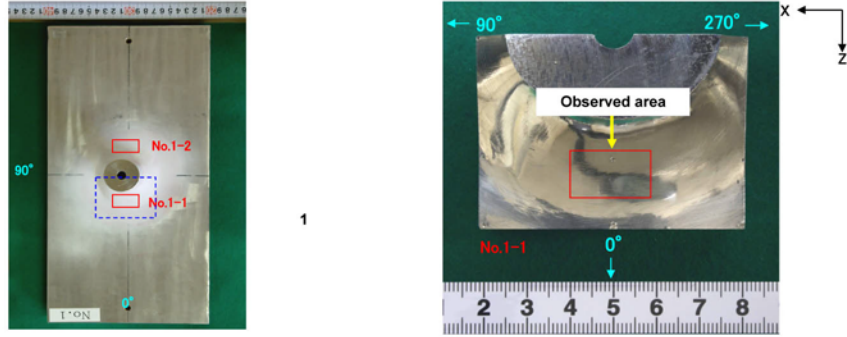
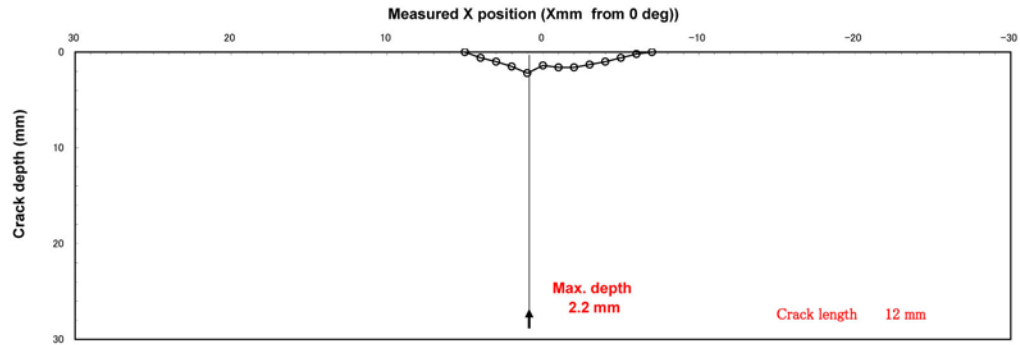
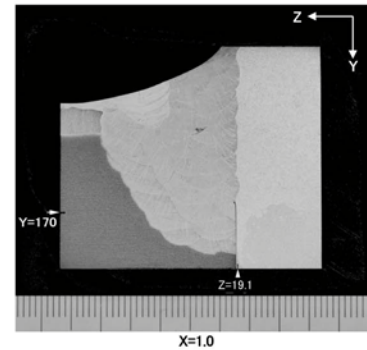
Results of destructive test on PINC 5.13-1 (parallel to weld)

Max depth	Za	Zb	Ya	Yb	L	d
	35.67	34.65	147.1	149.1	2.245	2.2

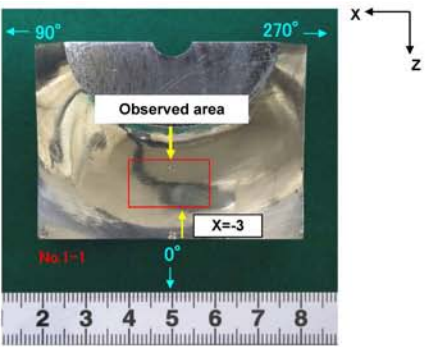
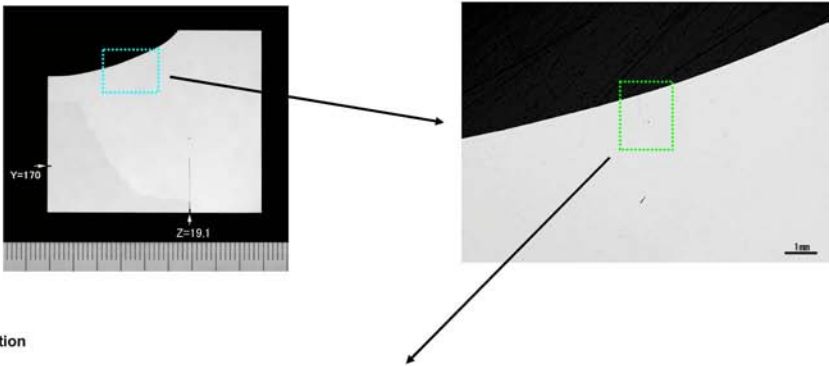
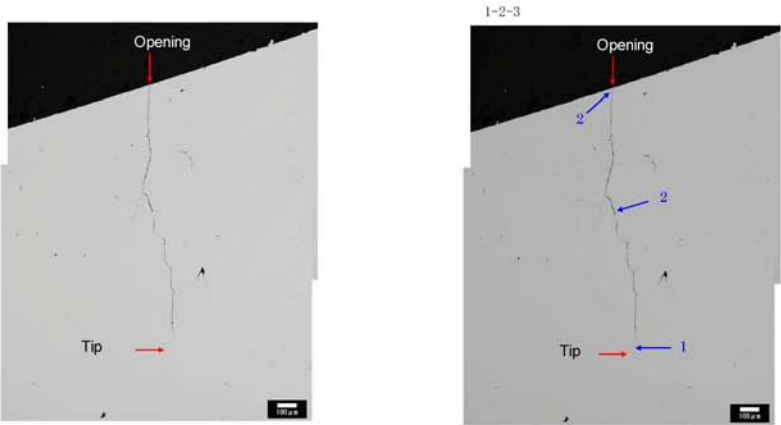
Typical crack opening data of PINC 5.13-1 (parallel to weld)
(X= - 3.0)

Position (mm)		X=-3.0
Depth (mm)	d	1.3
Opening (μm)		2
Tilt (deg) (°)		-5
Position of surf. opening (mm)	X	-3.0
	Y	147.2
	Z	36.0
Position of crack tip (mm)	X	-3.0
	Y	148.4
	Z	35.9

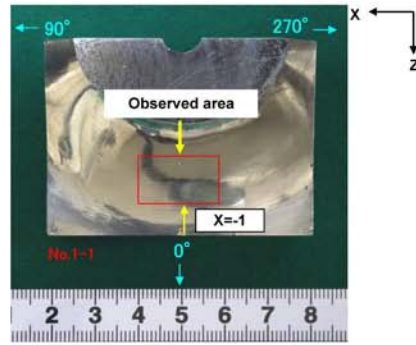
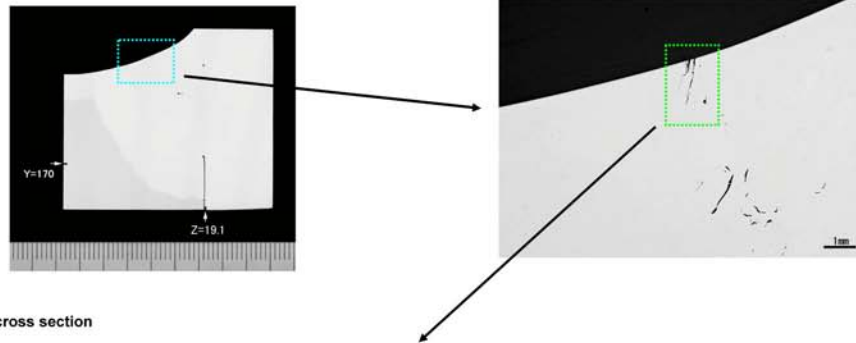
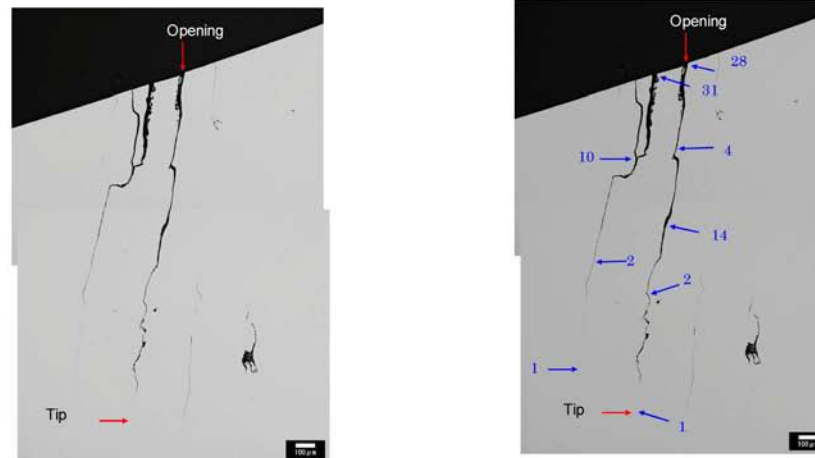
Typical crack opening data of PINC 5.13-1 (parallel to weld)
(X=-1.0)

Position (mm)		X=-1.0
Depth (mm)	d	1.6
Opening (μm)		31
Tilt (deg) (°)		8
Position of surf. opening (mm)	X	-1.0
	Y	147.0
	Z	35.7
Position of crack tip (mm)	X	-1.0
	Y	148.8
	Z	35.9

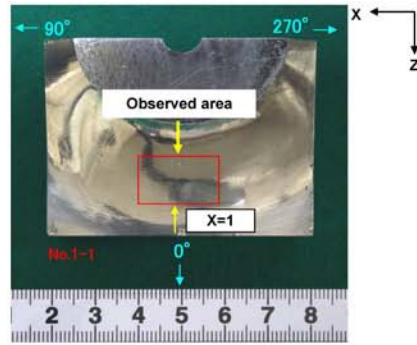
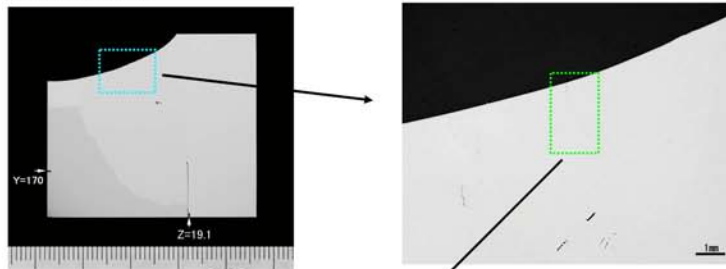
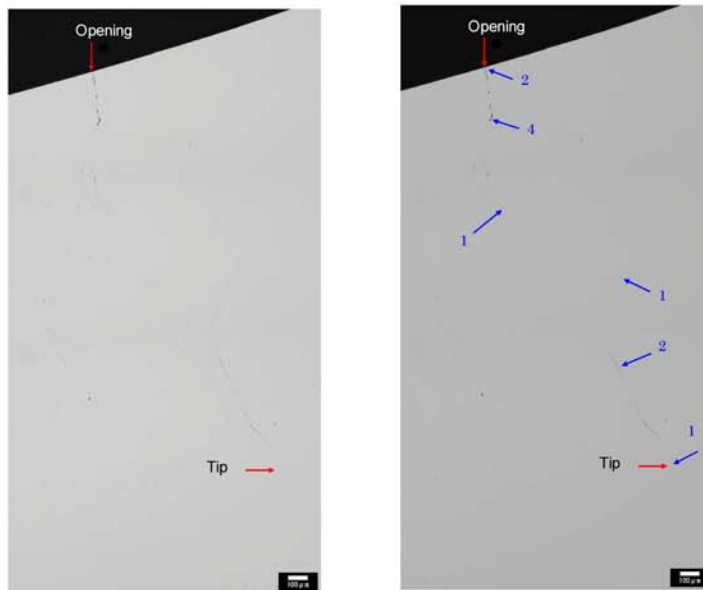
Typical crack opening data of PINC 5.13-1 (parallel to weld)
(X=1)

Position (mm)		X=1.0
Depth (mm)	d	2.2
Opening (μm)		2
Tilt (deg) (°)		-27
Position of surf. opening (mm)	X	1.0
	Y	147.1
	Z	35.7
Position of crack tip (mm)	X	1.0
	Y	149.1
	Z	34.7

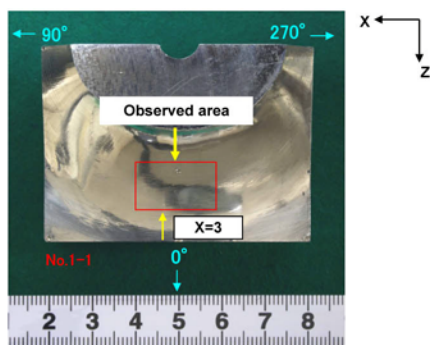
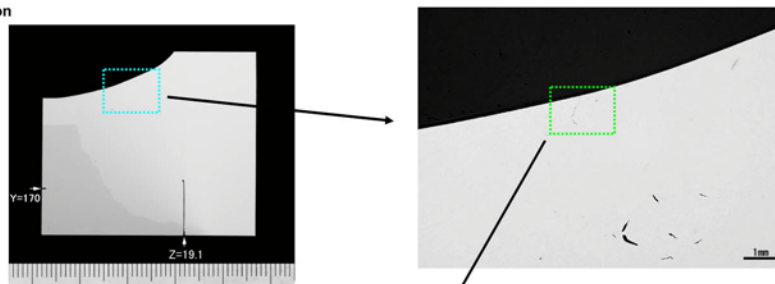
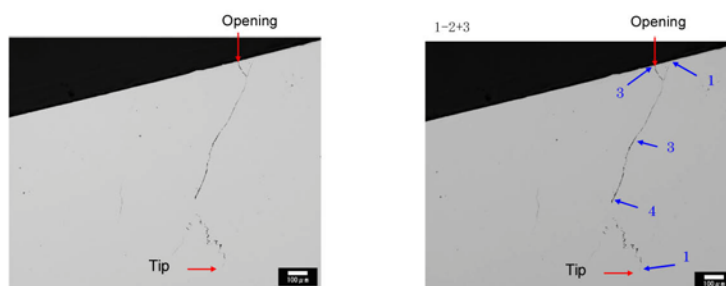
Typical crack opening data of PINC 5.13-1 (parallel to weld)
(X=3)

Position (mm)		X=3.0
Depth (mm)	d	1.0
Opening (µm)		3
Tilt (deg) (°)		2
Position of surf. opening (mm)	X	3.0
	Y	147.3
	Z	36.0
Position of crack tip (mm)	X	3.0
	Y	148.3
	Z	36.0

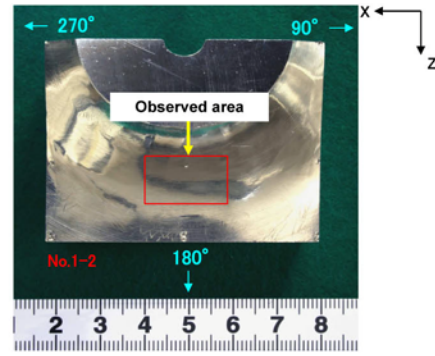
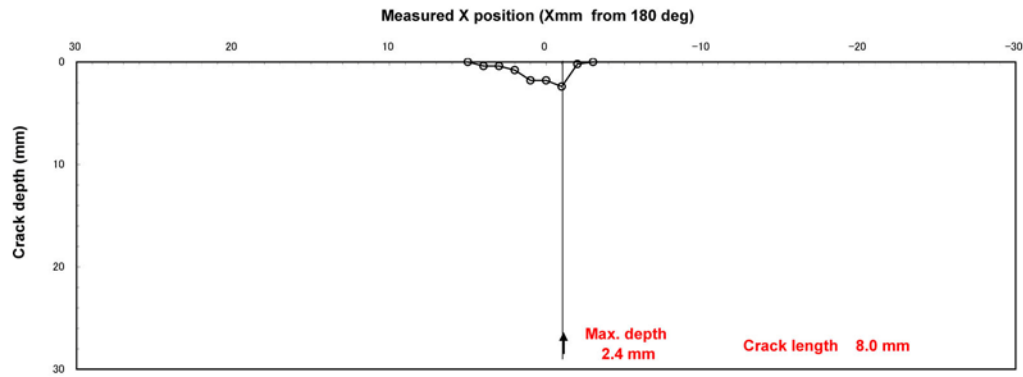
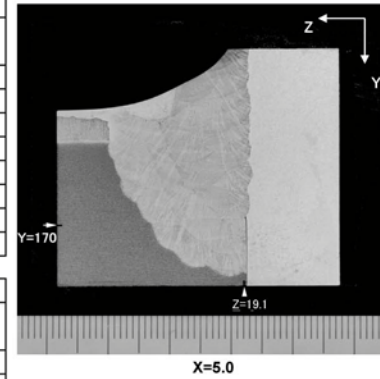
Results of destructive test on PINC 5.13-2 (parallel to weld)

Max depth	Za	Zb	Yb	Yb	L	d
	34.0	35.0	147.7	150.5	2.93	2.4

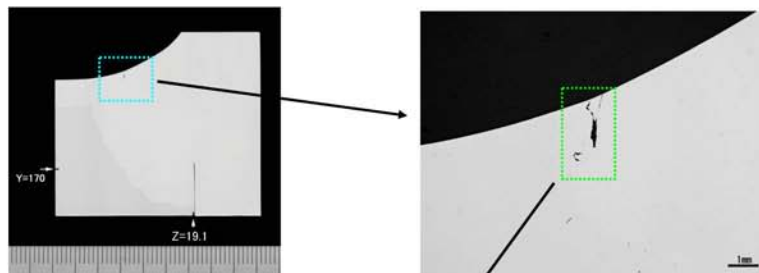
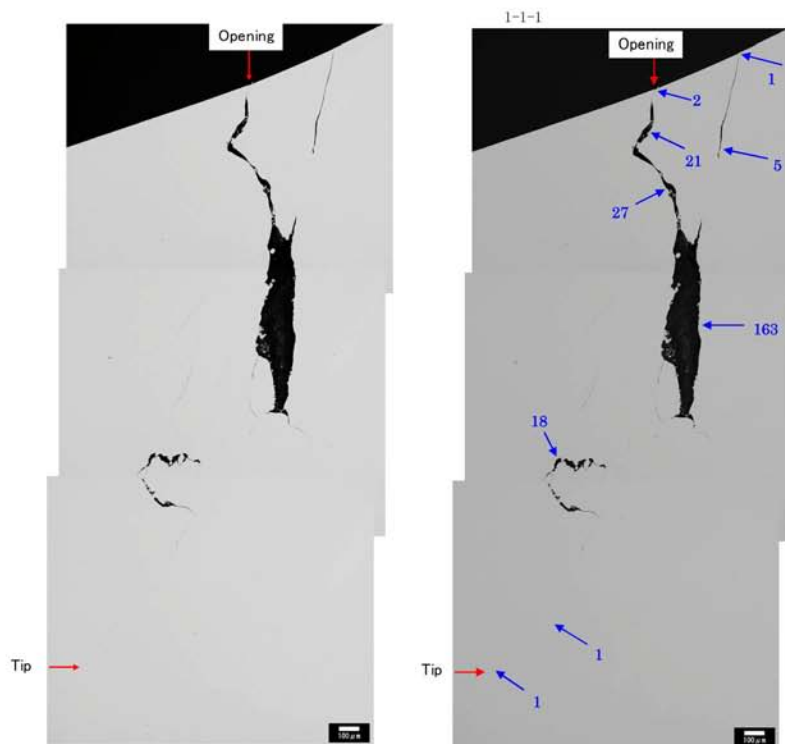
Typical crack opening data of PINC 5.13-2 (parallel to weld)
(X=-1.0)

Position (mm)		X=-1.0
Depth (mm)	d	2.4
Opening (µm)		2
Tilt (deg)	(°)	20
Position of surf. opening (mm)	X	-1.0
	Y	147.7
	Z	34.0
Position of crack tip (mm)	X	-1.0
	Y	150.5
	Z	35.0

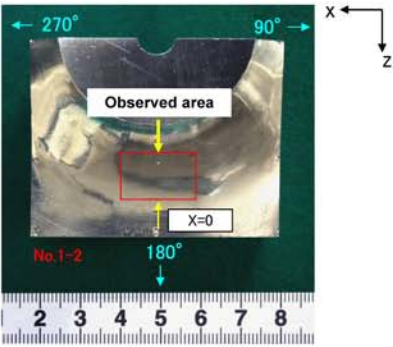
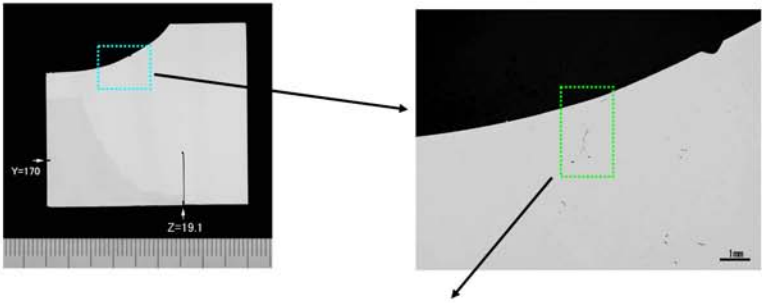
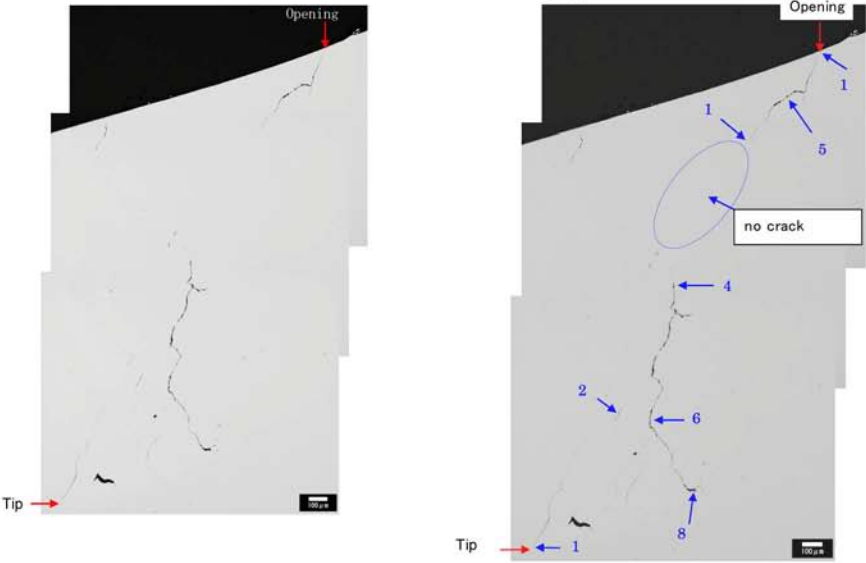
Typical crack opening data of PINC 5.13-2 (parallel to weld)
(X=0)

Position (mm)		X=0.0
Depth (mm)	d	1.8
Opening (μm)		1
Tilt (deg)	(°)	29
Position of surf. opening (mm)	X	0.0
	Y	147.8
	Z	34.1
Position of crack tip (mm)	X	0.0
	Y	150.3
	Z	35.5

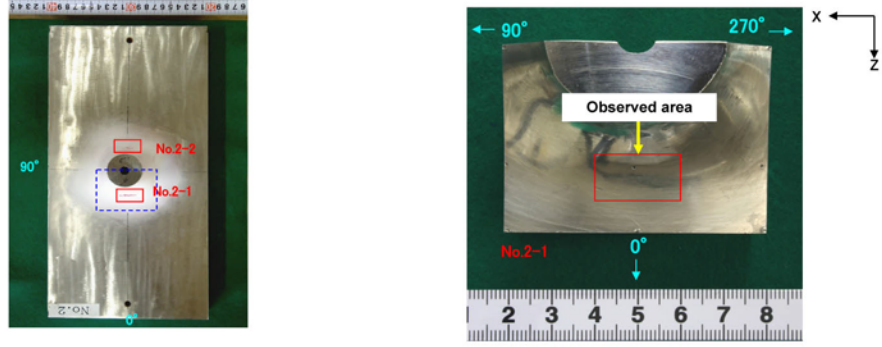
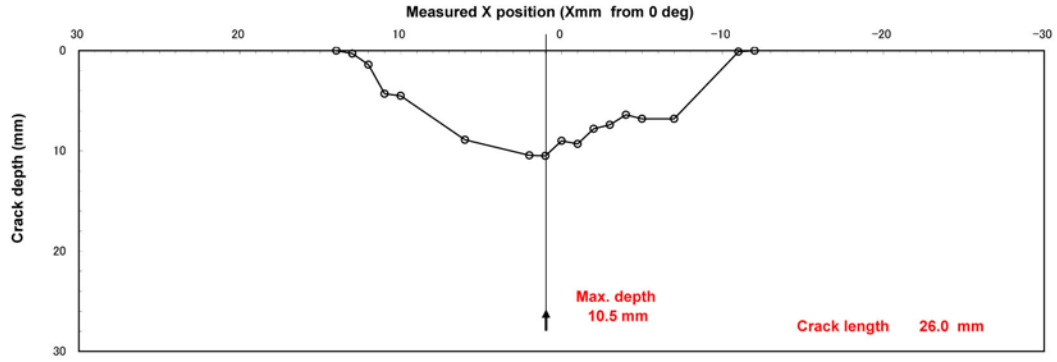
(2) Profile of SCC

Position (mm)		X=14.0	X=13.0	X=12.0	X=11.0	X=10.0
Depth (mm)	d	0.0	0.3	1.4	4.3	4.5
Opening (μm)		0	2	1	2	4
Tilt (deg) (°)		—	-43	-23	-10	-12
Position of surf. opening (mm)	X	14.0	13.0	12.0	11.0	10.0
	Y	—	147.9	147.9	147.8	147.4
	Z	—	33.8	34.1	33.9	33.1
Position of crack tip (mm)	X	14.0	13.0	12.0	11.0	10.0
	Y	—	148.1	149.2	152.2	151.9
	Z	—	33.6	33.5	33.1	32.2

Position (mm)		X=6.0	X=2.0	X=1.0	X=0.0	X=-1.0
Depth (mm)	d	8.9	10.5	10.5	9.0	9.3
Opening (μm)		8	210	7	17	10
Tilt (deg) (°)		-15	-20	-19	-20	-22
Position of surf. opening (mm)	X	6.0	2.0	1.0	0.0	-1.0
	Y	147.3	147.4	147.3	147.3	147.5
	Z	33.2	33.4	33.2	33.2	33.6
Position of crack tip (mm)	X	6.0	2.0	1.0	0.0	-1.0
	Y	155.9	157.2	157.3	155.8	156.1
	Z	30.8	29.7	29.8	30.1	30.1

Position (mm)		X=-2.0	X=-3.0	X=-4.0	X=-5.0	X=-7.0	X=-11.0	X=-12.0
Depth (mm)	d	7.8	7.4	6.4	6.8	6.8	0.1	0.0
Opening (μm)		19	38	13	13	8	2	0
Tilt (deg) (°)		-17	-24	-25	-22	-18	20	—
Position of surf. opening (mm)	X	-2.0	-3.0	-4.0	-5.0	-7.0	-11.0	-12.0
	Y	147.2	147.3	147.2	147.2	147.4	147.9	—
	Z	32.9	33.2	32.9	32.8	33.1	33.5	—
Position of crack tip (mm)	X	-2.0	-3.0	-4.0	-5.0	-7.0	-11.0	-12.0
	Y	154.7	154.0	153.0	153.6	153.9	148.0	—
	Z	30.7	30.1	30.2	30.3	30.9	33.5	—

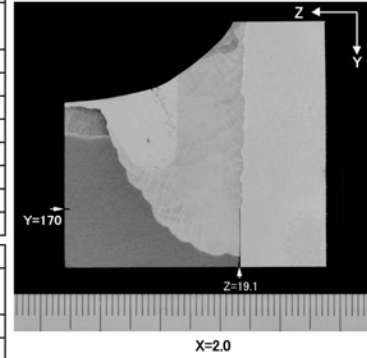
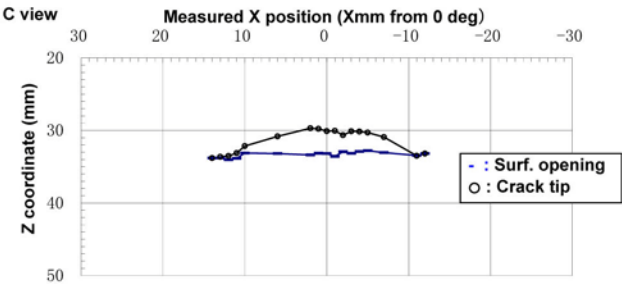
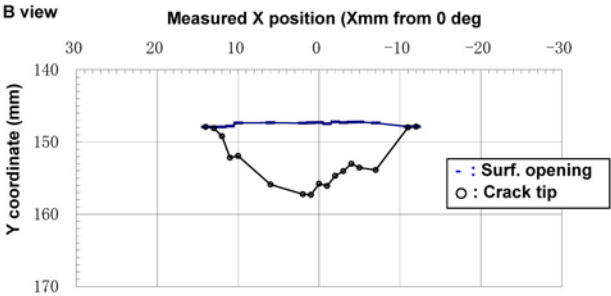
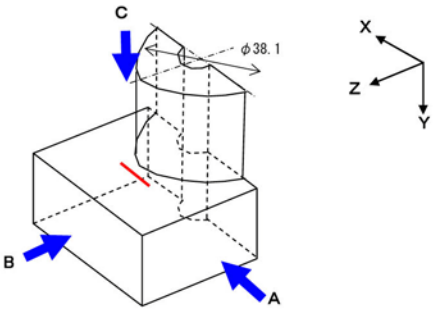
Results of destructive test on PINC 5.14-1 (parallel to weld)

Max depth	Za	Zb	Ya	Yb	L	d
	33.15	29.78	147.3	157.3	10.52	10.5

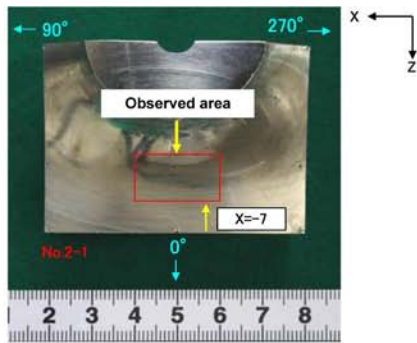
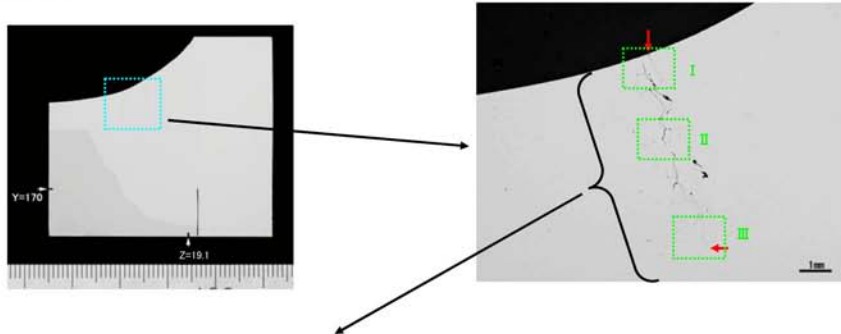
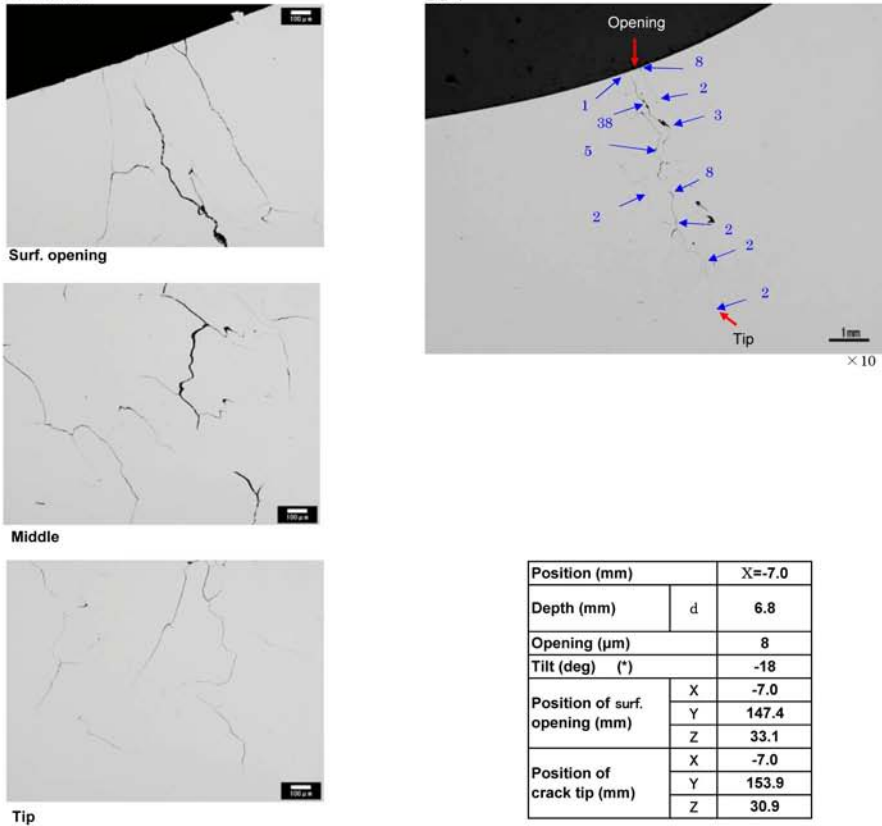
Typical crack opening data of PINC 5.14-1 (parallel to weld)
(X= -7)

Position (mm)		X=-7.0
Depth (mm)	d	6.8
Opening (μm)		8
Tilt (deg)	(°)	-18
Position of surf. opening (mm)	X	-7.0
	Y	147.4
	Z	33.1
Position of crack tip (mm)	X	-7.0
	Y	153.9
	Z	30.9

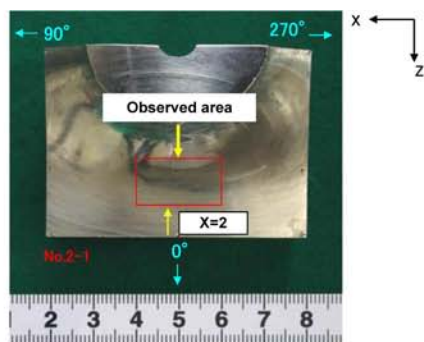
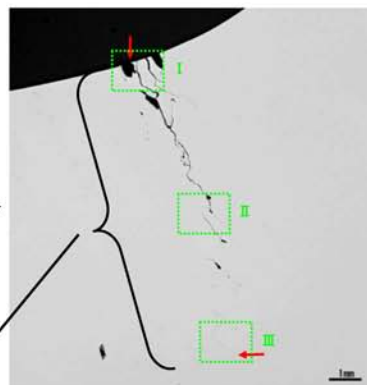
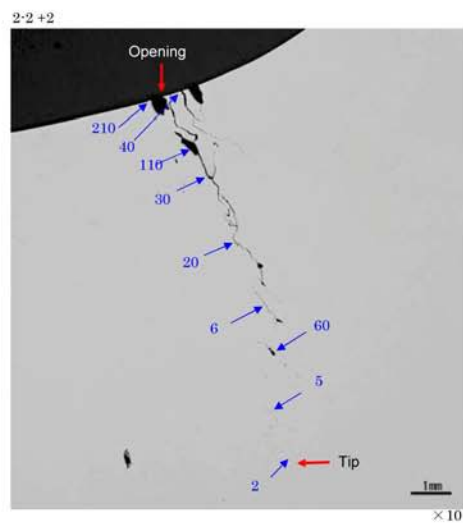
Typical crack opening data of PINC 5.14-1 (parallel to weld)
(X=2)

Position (mm)		X=2.0
Depth (mm)	d	10.5
Opening (μm)		210
Tilt (deg) (°)		-20
Position of surf. opening (mm)	X	2.0
	Y	147.4
	Z	33.4
Position of crack tip (mm)	X	2.0
	Y	157.2
	Z	29.7

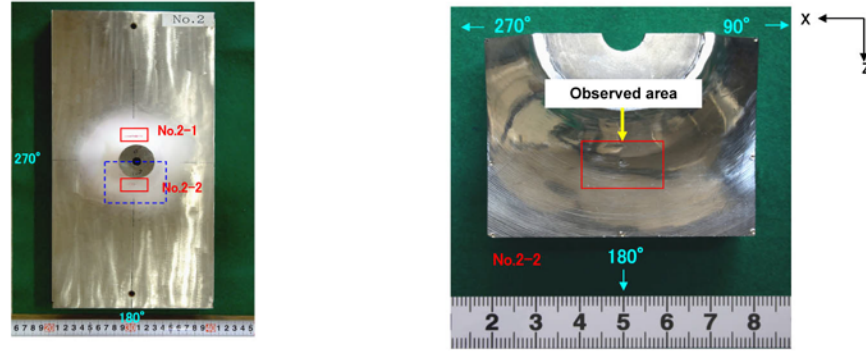
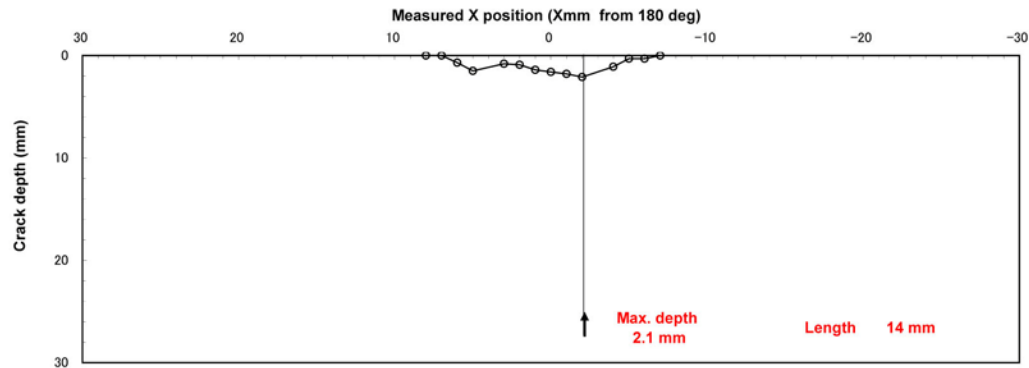
(2) Profile of SCC

Position (mm)		X=8.0	X=7.0	X=6.0	X=5.0	X=3.0
Depth (mm)	d	0.0	0.0	0.7	1.5	0.8
Opening (μm)		0	0	3	8	7
Tilt (deg) (°)		—	—	-43	-55	-79
Position of surf. opening (mm)	X	8.0	7.0	6.0	5.0	3.0
	Y	—	—	147.1	147.1	147.1
	Z	—	—	30.4	30.3	30.4
Position of crack tip (mm)	X	8.0	7.0	6.0	5.0	3.0
	Y	—	—	147.6	148.1	147.3
	Z	—	—	29.9	28.9	29.1
Position (mm)		X=2.0	X=1.0	X=0.0	X=-1.0	X=-2.0
Depth (mm)	d	0.9	1.4	1.6	1.8	2.1
Opening (μm)		9	2	5	3	17
Tilt (deg) (°)		-65	-36	-64	-54	-56
Position of surf. opening (mm)	X	2.0	1.0	0.0	-1.0	-2.0
	Y	147.0	147.3	147.4	147.3	147.2
	Z	30.3	30.9	31.4	31.1	30.9
Position of crack tip (mm)	X	2.0	1.0	0.0	-1.0	-2.0
	Y	147.5	148.4	148.3	148.5	148.5
	Z	29.4	30.1	29.4	29.5	29.0
Position (mm)		X=-4.0	X=-5.0	X=-6.0	X=-7.0	
Depth (mm)	d	1.1	0.3	0.3	0.0	
Opening (μm)		4	3	3	0	
Tilt (deg) (°)		-67	-48	-76	—	
Position of surf. opening (mm)	X	-4.0	-5.0	-6.0	-7.0	
	Y	147.0	146.8	146.9	—	
	Z	30.5	30.0	30.0	—	
Position of crack tip (mm)	X	-4.0	-5.0	-6.0	-7.0

Y	147.6	147.0	147.0	—	
	Z	29.1	29.7	29.6	—

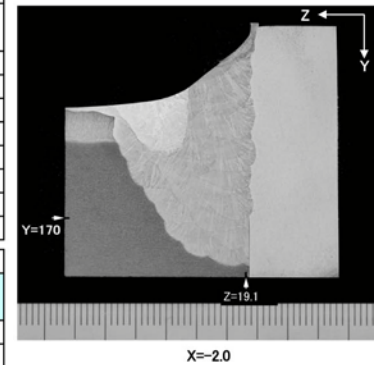
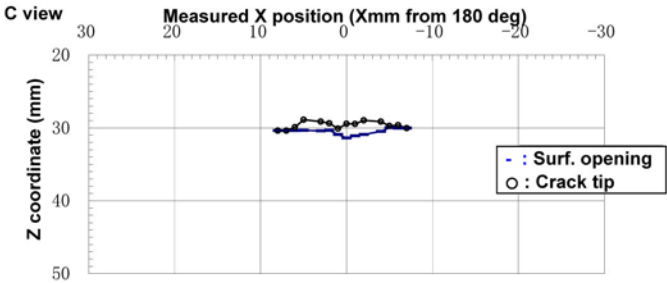
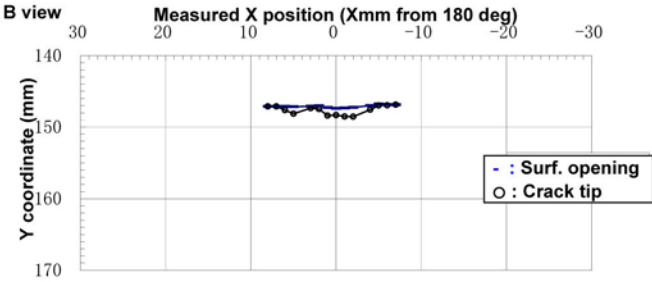
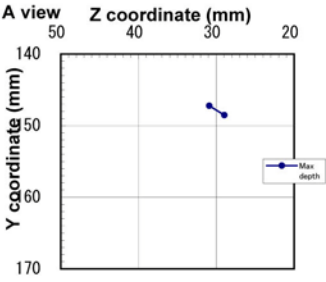
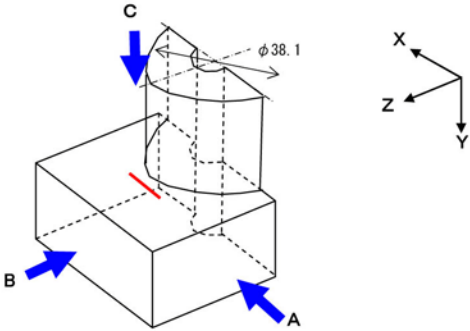
Results of destructive test on PINC 5.14-2 (parallel to weld)

Max depth	Za	Zb	Ya	Yb	L	d
	30.9	29.0	147.2	148.5	2.3	2.1

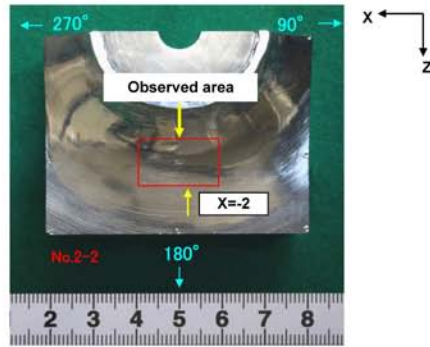
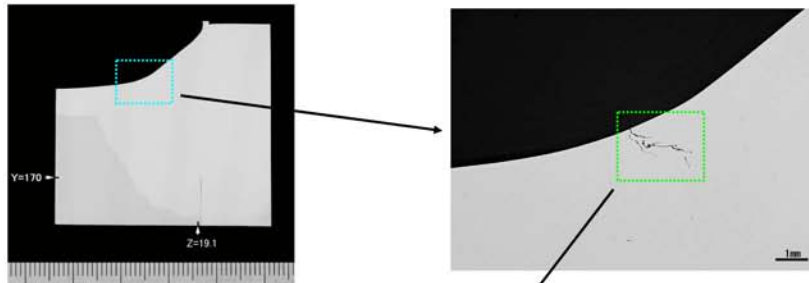
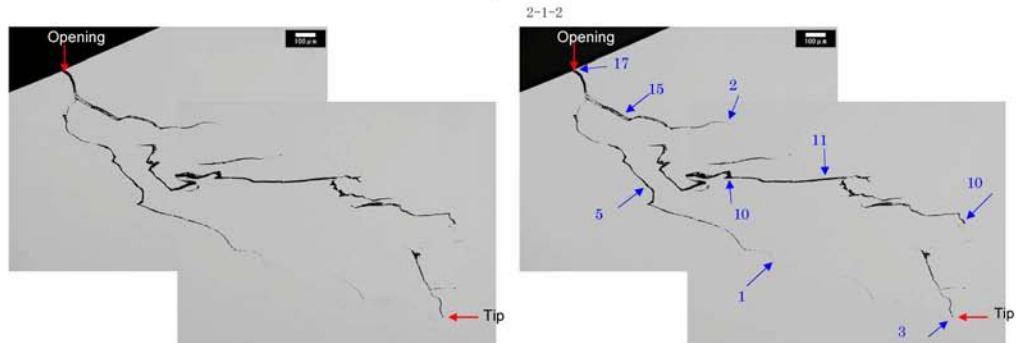
Typical crack opening data of PINC 5.14-2 (parallel to weld)
(X=-2)

Position (mm)		X=-2.0
Depth (mm)	d	2.1
Opening (µm)		17
Tilt (deg)	(°)	-56
Position of surf. opening (mm)	X	-2.0
	Y	147.2
	Z	30.9
Position of crack tip (mm)	X	-2.0
	Y	148.5
	Z	29.0

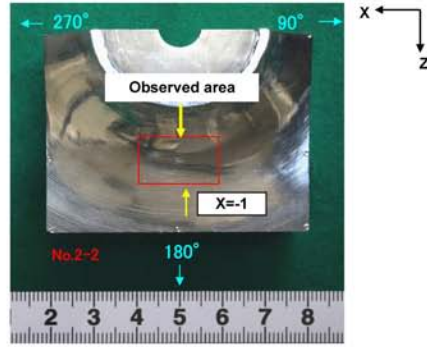
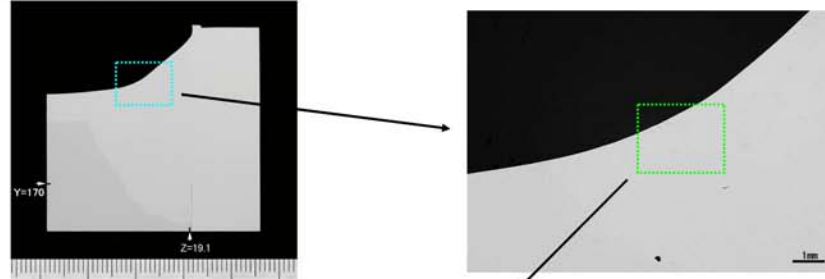
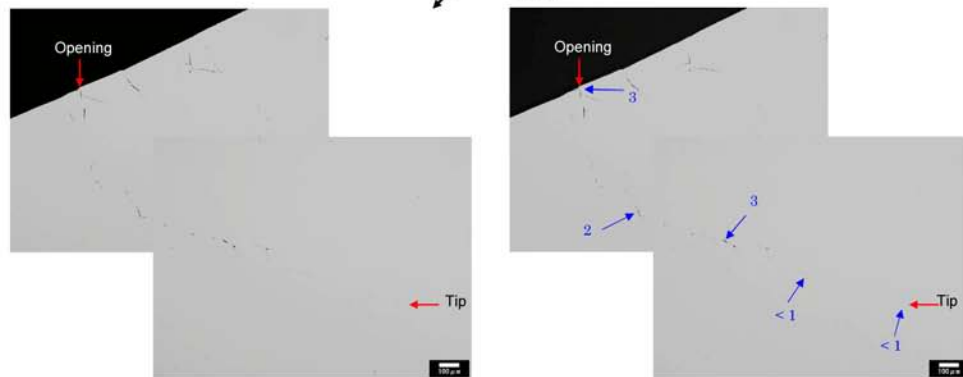
Typical crack opening data of PINC 5.14-2 (parallel to weld)
(X=-1)

Position (mm)		X=-1.0
Depth (mm)	d	1.8
Opening (μm)		3
Tilt (deg)	(°)	-54
Position of surf. opening (mm)	X	-1.0
	Y	147.3
	Z	31.1
Position of crack tip (mm)	X	-1.0
	Y	148.5
	Z	29.5

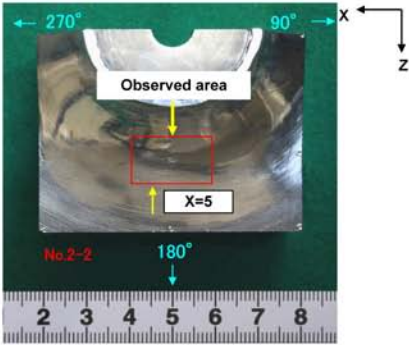
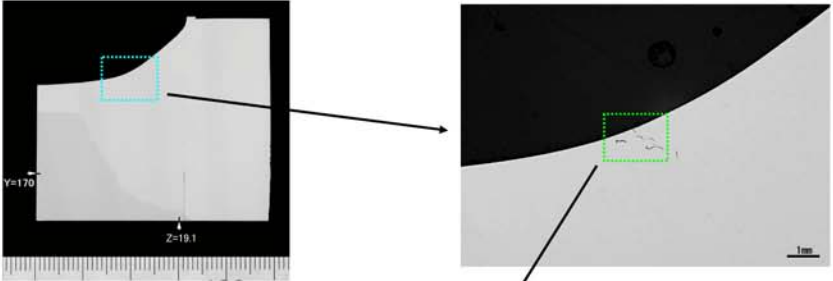
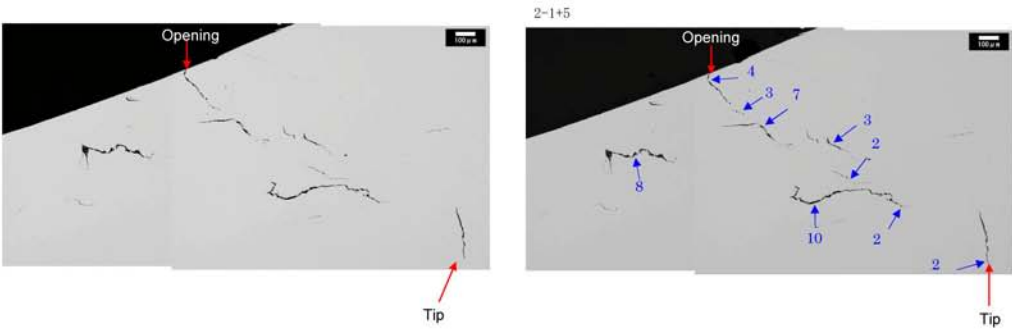
Typical crack opening data of PINC 5.14-2 (parallel to weld)
(X=5)

Position (mm)		X=5.0
Depth (mm)	d	1.5
Opening (μm)		8
Tilt (deg) (°)		-55
Position of surf. opening (mm)	X	5.0
	Y	147.1
	Z	30.3
Position of crack tip (mm)	X	5.0
	Y	148.1
	Z	28.9

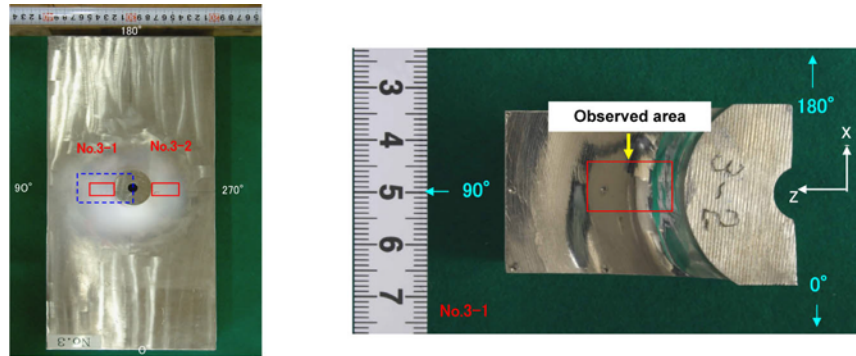
(2) Profile of SCC

Position		(1)	(2)	(3)	(4)	(5)
Depth (mm)	d	0.0	0.2	0.8	1.7	1.9
Opening (μm)		0	0	3	2	2
Tilt (deg) (°)		—	17	10	-29	-14
Position of surf. opening (mm)	y	157.1	156.2	155.3	154.3	153.6
	X	—	-1.3	-0.7	-1.0	-1.2
	Y	148.5	148.2	147.9	147.7	147.4
	Z	36.3	35.5	34.6	33.7	32.9
Position of crack tip (mm)	X	—	-1.4	-0.9	0.0	-0.7
	Y	—	148.4	148.7	149.2	149.1
	Z	—	35.4	34.2	33.0	32.0

Position		(6)	(7)	(8)	(9)	(10)	(11)	(12)
Depth (mm)	d	2.5	3.5	2.2	2.0	0.8	0.2	0.0
Opening (μm)		2	6	3	2	2	3	0
Tilt (deg) (°)		-1	10	-10	3	-10	-9	—
Position of surf. opening (mm)	y	152.6	151.6	151.0	150.3	147.3	144.9	143.8
	X	-0.3	-0.5	0.2	-0.9	-0.3	-0.4	—
	Y	146.8	146.6	146.0	145.9	144.9	143.5	143.0
	Z	32.2	31.3	30.6	29.6	28.1	25.8	25.1
Position of crack tip (mm)	X	-0.2	-1.1	0.6	-1.0	-0.2	-0.3	—
	Y	149.0	149.7	148.0	147.6	145.7	143.7	—
	Z	31.0	29.7	29.6	28.7	27.7	25.7	—

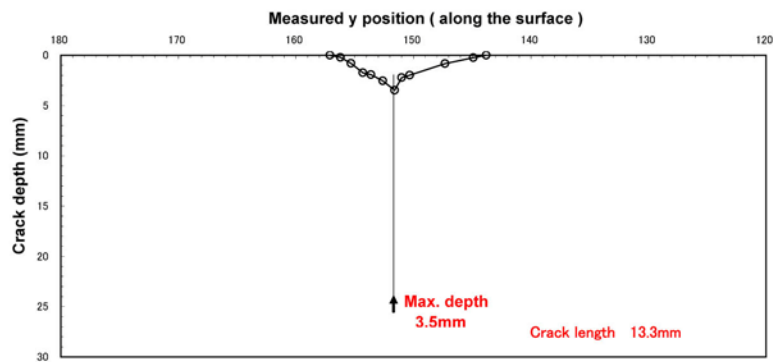
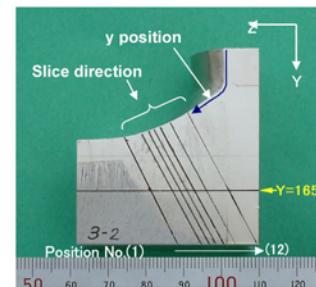
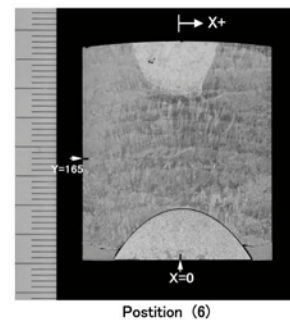
Results of destructive test on PINC 5.15-1 (perpendicular to weld)

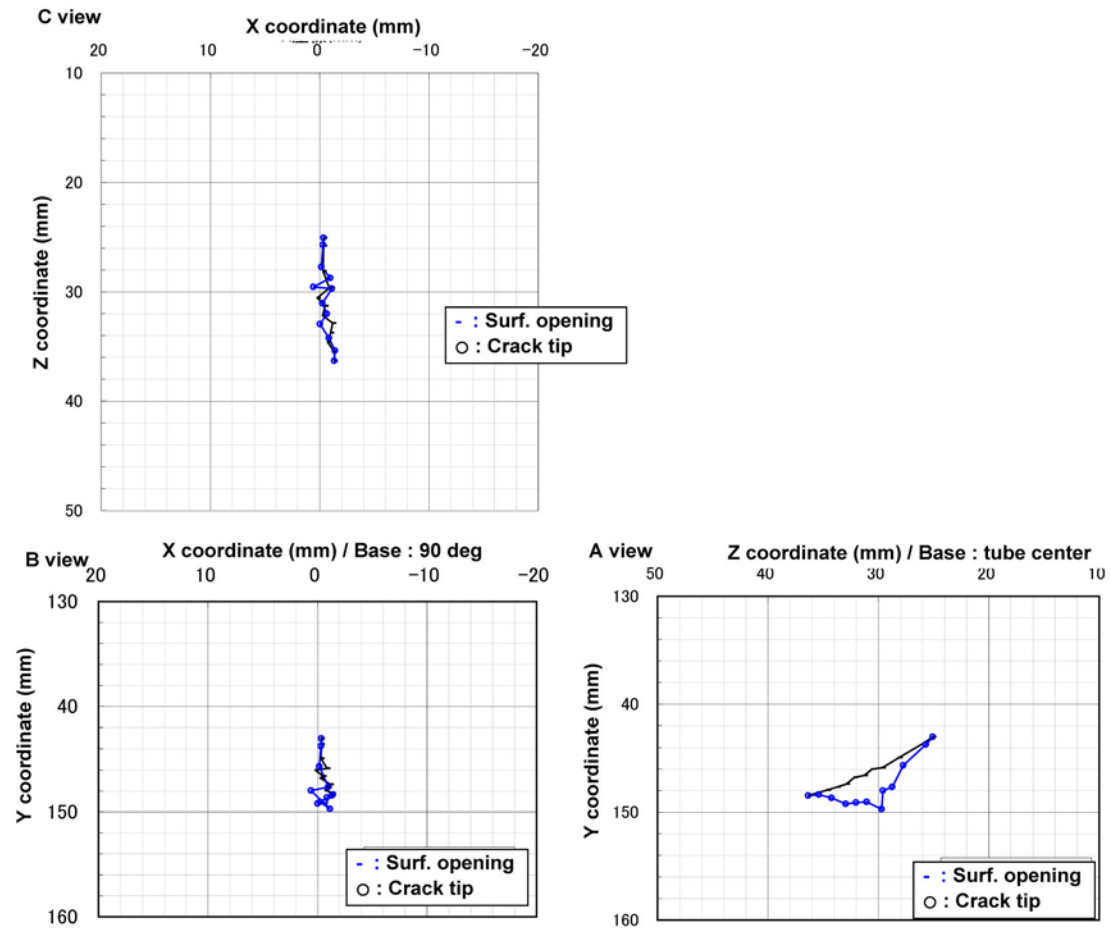
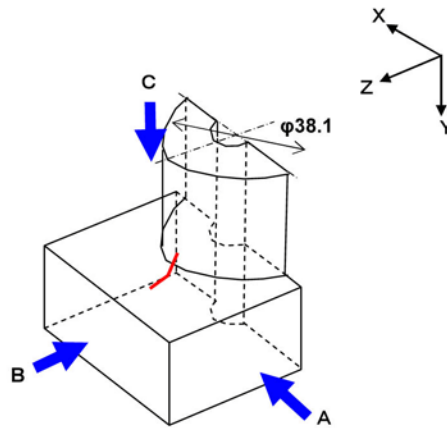
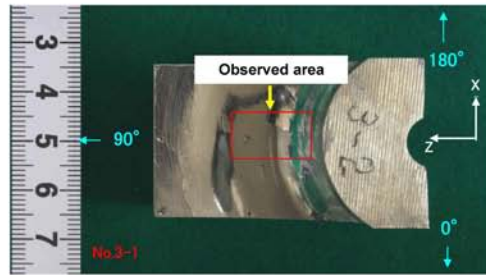
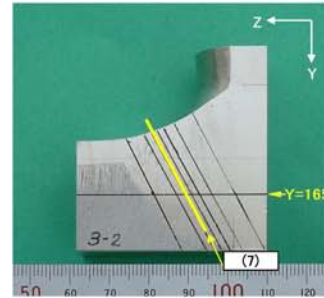
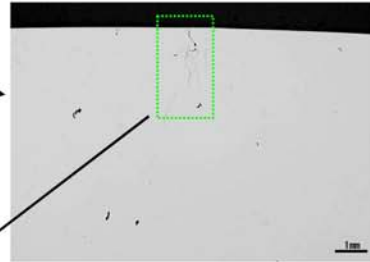
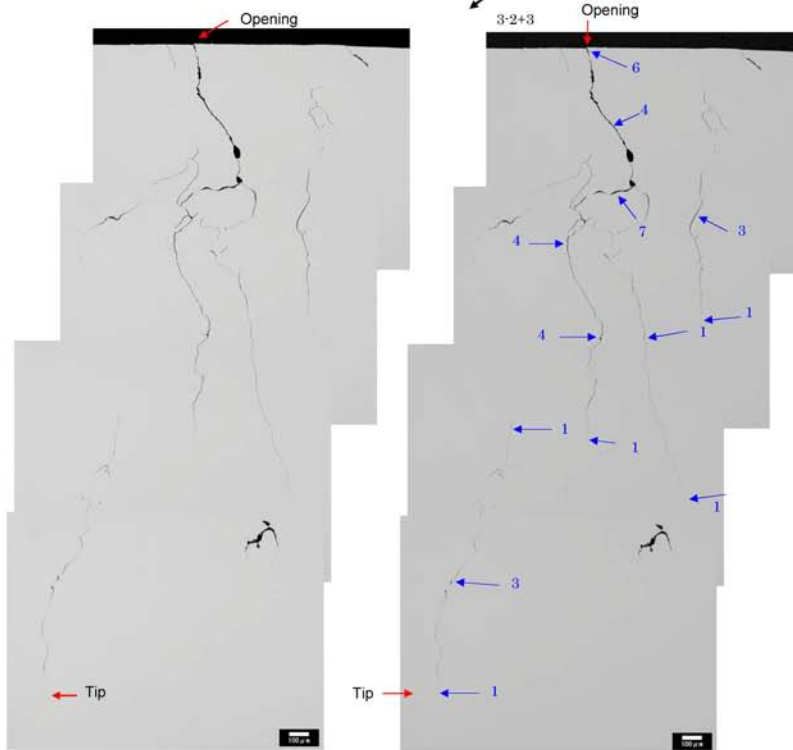
Typical crack opening data of PINC 5.15-1 (perpendicular to weld)
(Position = (7))

Position		(7)
Depth (mm)	d	3.5
Opening (μm)		6
Tilt (deg)	(°)	10
Position of surf. opening (mm)	y	151.6
	X	-0.5
	Y	146.6
	Z	31.3
Position of crack tip (mm)	X	-1.1
	Y	149.7
	Z	29.7

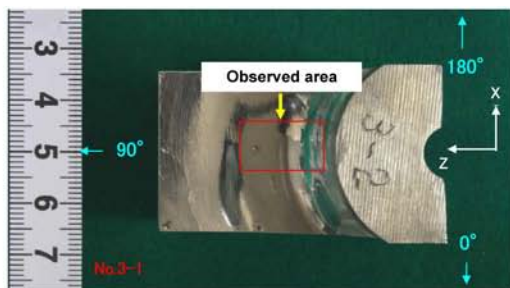
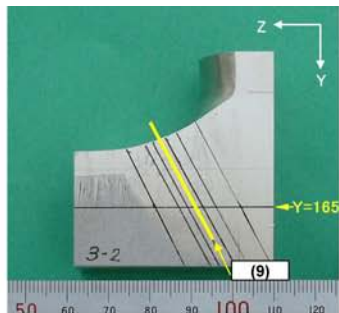
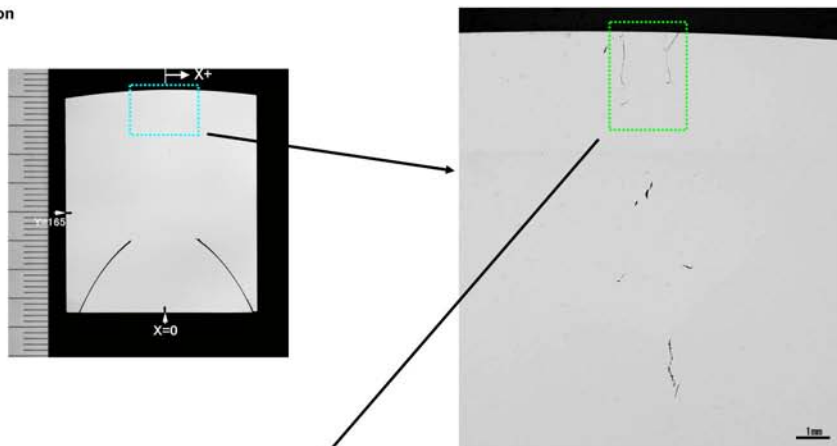
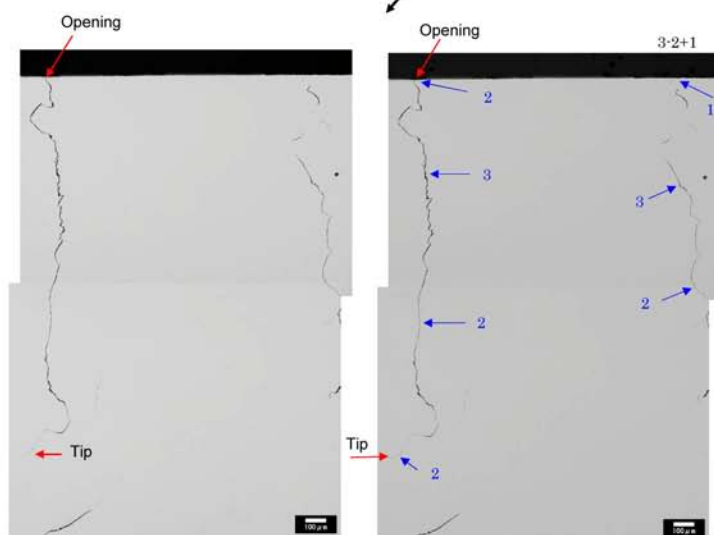
Typical crack opening data of PINC 5.15-1 (perpendicular to weld)
(Position = (9))

Position		(9)
Depth (mm)	d	2.0
Opening (µm)		2
Tilt (deg) (°)		3
Position of surf. opening (mm)	y	150.3
	X	-0.9
	Y	145.9
	Z	29.6
Position of crack tip (mm)	X	-1.0
	Y	147.6
	Z	28.7

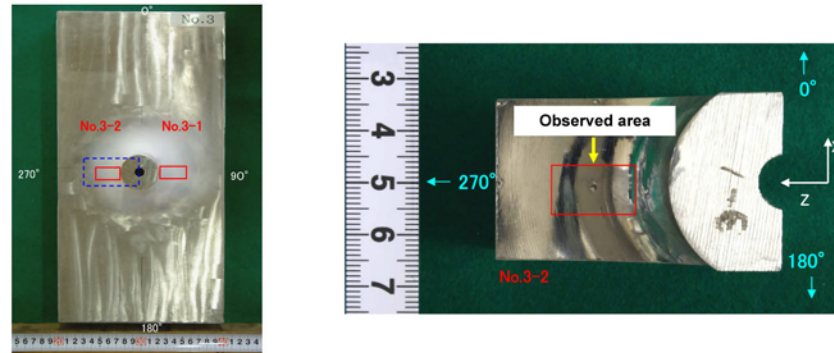
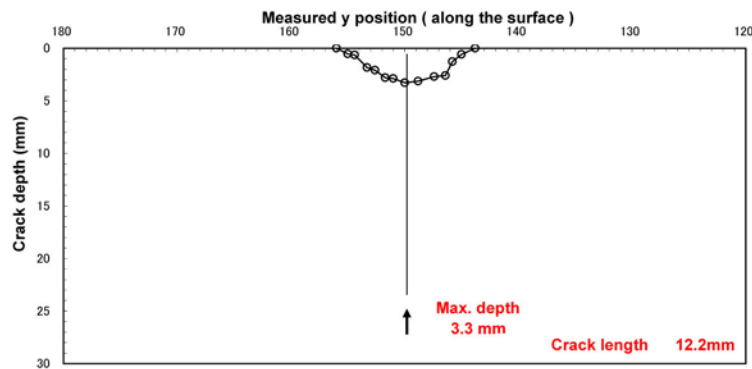
Results of destructive test on PINC 5.15-2 (perpendicular to weld)

Position		(1)	(2)	(3)	(4)	(5)
Depth (mm)	d	0.0	0.5	0.6	1.8	2.1
Opening (μm)		0	1	1	2	1
Tilt (deg) (°)		—	3	-12	-5	10
Position of surf. opening (mm)	y	156.0	155.0	154.4	153.3	152.6
	X	—	0.4	0.3	-0.2	0.1
	Y	148.7	148.5	148.2	147.7	147.7
Position of crack tip (mm)	Z	35.2	34.3	33.5	32.7	31.7
	X	—	0.3	0.5	-0.1	-0.3
	Y	—	149.0	148.8	149.3	149.6
Position of crack tip (mm)	Z	—	34.1	33.2	31.9	30.8

Position		(6)	(7)	(8)	(9)	(10)	(11)	(12)	(13)	(14)
Depth (mm)	d	2.8	2.9	3.3	3.1	2.7	2.6	1.3	0.6	0.0
Opening (μm)		3	131	2	14	3	3	12	1	0
Tilt (deg) (°)		5	18	-7	13	-1	0	22	26	—
Position of surf. opening (mm)	y	151.7	151.0	150.0	148.8	147.4	146.4	145.8	145.0	143.8
	X	-0.1	0.6	-0.4	0.4	-0.8	-0.8	-1.6	-1.7	—
	Y	146.9	146.8	146.1	145.9	145.1	145.1	144.4	143.9	143.3
Position of crack tip (mm)	Z	31.1	30.2	29.5	28.6	28.0	27.0	26.4	25.6	24.9
	X	-0.3	-0.4	0.0	-0.4	-0.8	-0.8	-2.1	-2.0	—
	Y	149.4	149.3	149.1	148.7	147.5	147.4	145.5	144.4	—
Position of crack tip (mm)	Z	29.9	28.9	28.0	27.2	26.8	25.9	25.8	25.4	—

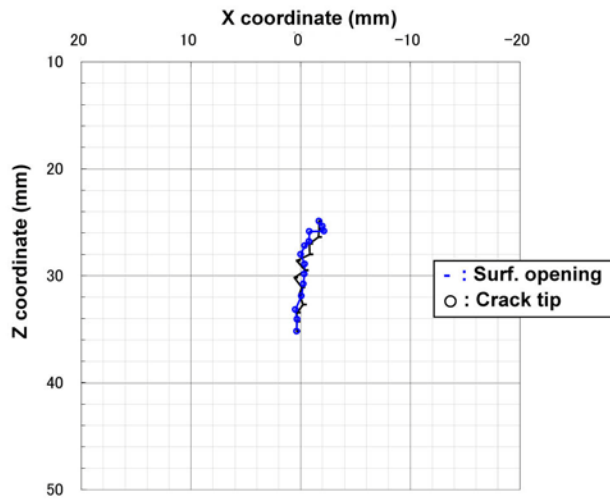
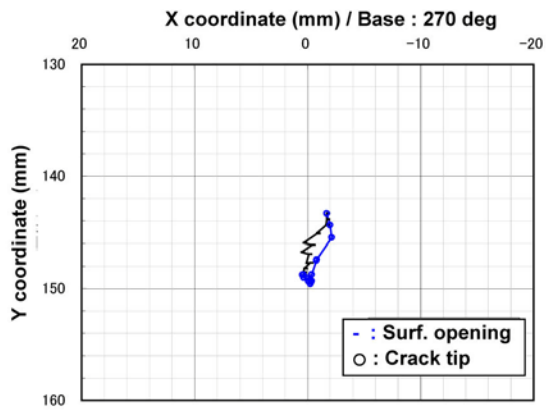
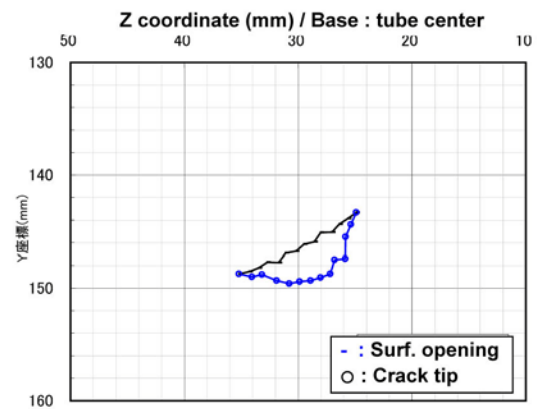
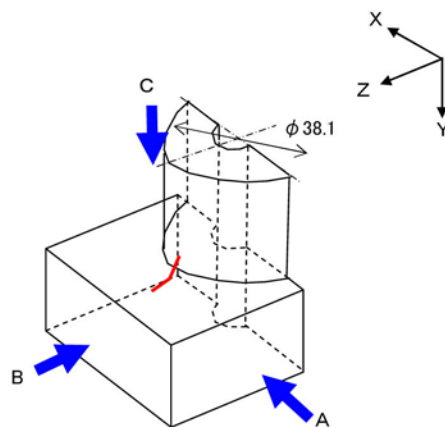
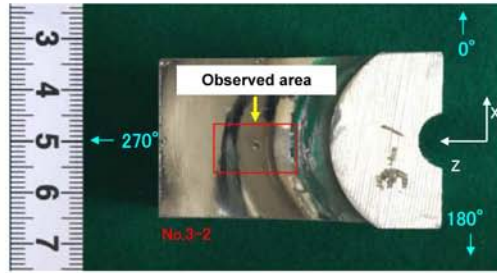
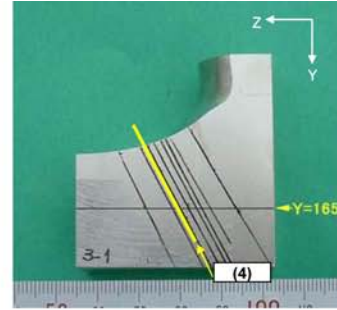
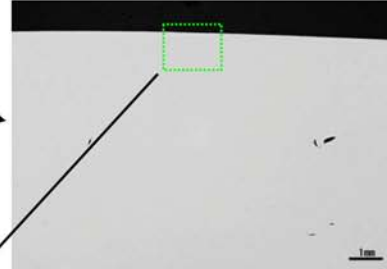
Typical crack opening data of PINC 5.15-2 (perpendicular to weld)
(Position = (4))

Position		(4)
Depth (mm)	d	1.8
Opening (μm)		2
Tilt (deg)	(°)	-5
Position of surf. opening (mm)	y	153.3
	X	-0.2
	Y	147.7
	Z	32.7
Position of crack tip (mm)	X	-0.1
	Y	149.3
	Z	31.9

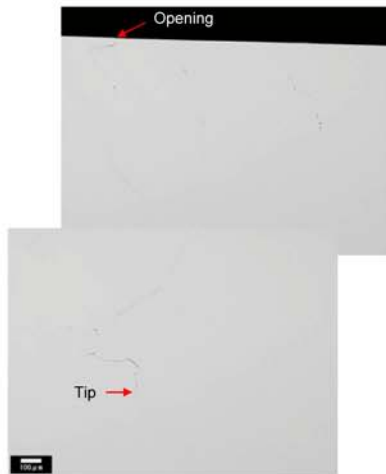
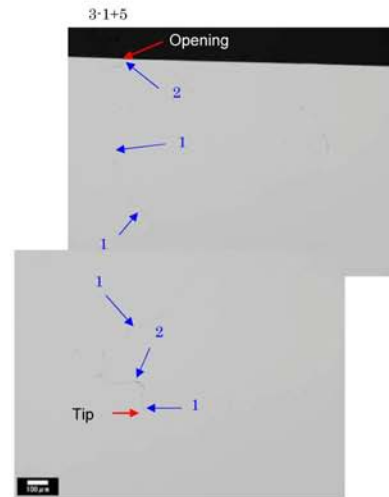
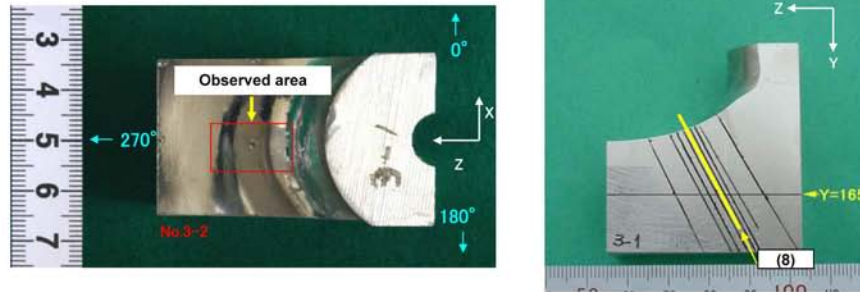
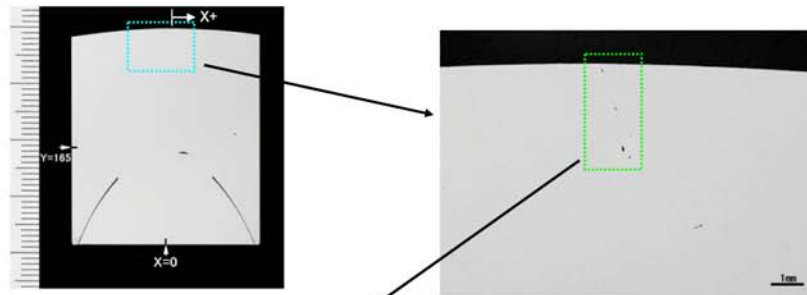
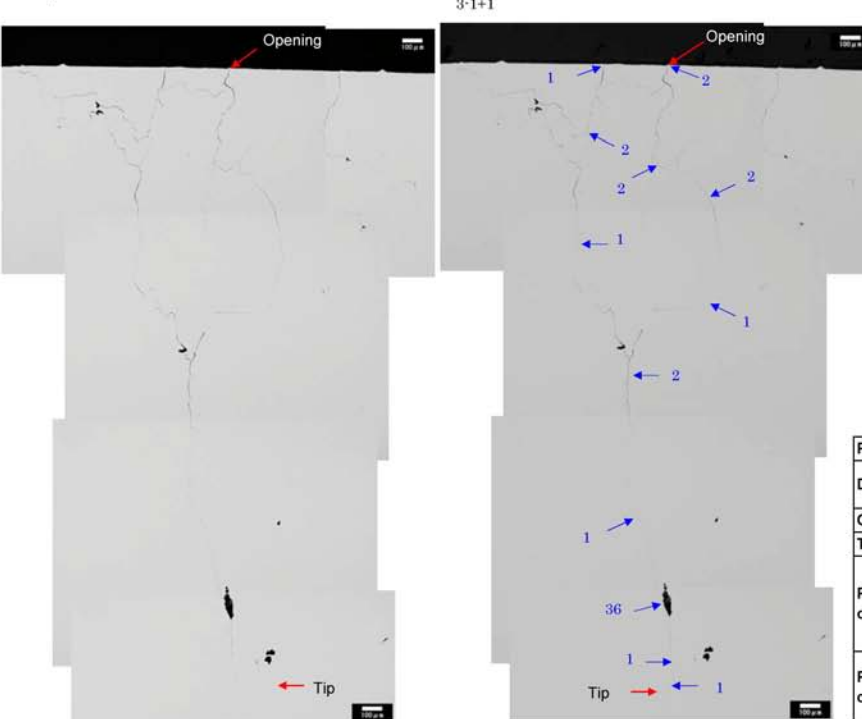
Typical crack opening data of PINC 5.15-2 (perpendicular to weld)
(Position = (8))

Position		(8)
Depth (mm)	d	3.3
Opening (μm)		2
Tilt (deg)	(°)	-7
Position of surf. opening (mm)	y	150.0
	X	-0.4
	Y	146.1
	Z	29.5
Position of crack tip (mm)	X	0.0
	Y	149.1
	Z	28.0
