NUREG/CR-7019
PNNL-18713, Rev. 1

Results of the Program for the Inspection of Nickel Alloy Components

Manuscript Completed: April 2010

Pacific Northwest National Laboratory

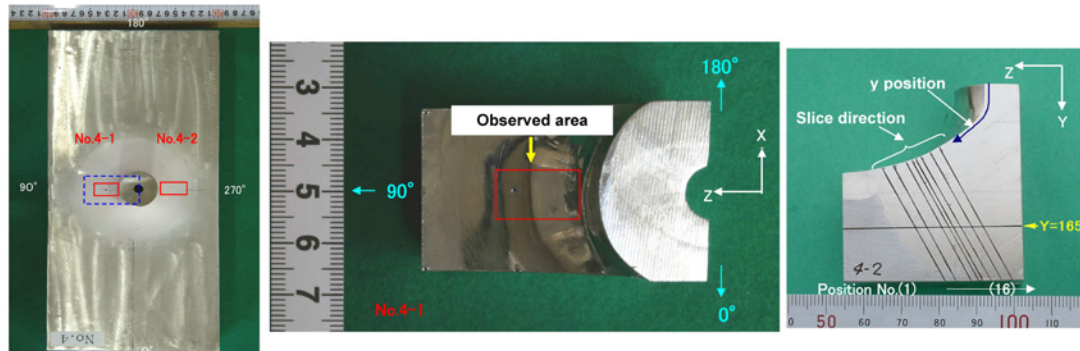
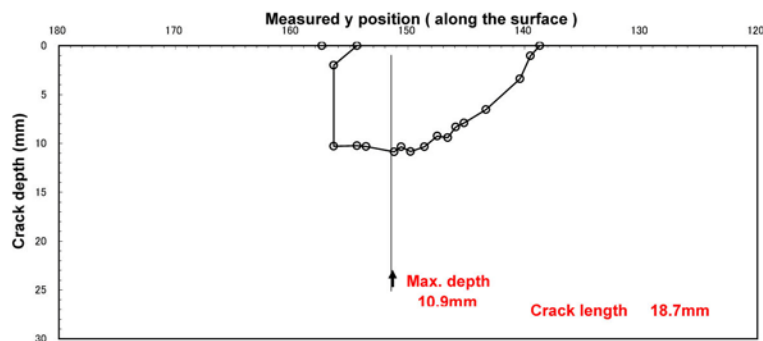
Results of destructive test on PINC 5.16-1 (perpendicular to weld)

Position		(1)	(2)	(3)	(4)	(5)	(6)	(7)	(8)
Depth (mm)	d	0.0	8.3	10.2	10.3	10.9	10.4	10.8	10.4
Opening (μm)		0	Embedded	2	4	15	5	11	17
Tilt (deg) (°)		—	-	5	3	4	0	2	3
Position of surf. opening (mm)	y	157.4	156.4	154.4	153.6	151.2	150.6	149.8	148.6
	X	—	-1.1	-1.1	1.2	0.8	0.7	0.1	1.2
	Y	147.5	147.3	149.0	146.8	146.6	145.6	145.4	144.9
	Z	38.8	37.9	37.0	36.2	35.3	32.8	31.9	30.3
Position of crack tip (mm)	X	—	1.2	0.3	0.2	0.0	0.1	0.9	0.9
	Y	—	156.5	156.0	155.9	155.3	154.7	154.6	153.9
	Z	—	33.3	31.6	30.6	27.9	27.2	26.3	25.6

Position		(9)	(10)	(11)	(12)	(13)	(14)	(15)	(16)
Depth (mm)	d	9.3	9.4	8.3	7.9	6.6	3.4	1.0	0.0
Opening (μm)		528	5	90	339	5	3	1	0
Tilt (deg) (°)		5	4	17	-1	-3	24	16	—
Position of surf. opening (mm)	y	147.5	146.6	145.9	145.2	143.3	140.4	139.5	138.7
	X	2.0	2.0	2.0	0.0	-0.3	1.3	2.2	—
	Y	144.0	143.7	143.0	142.8	141.3	139.3	138.7	138.1
	Z	29.6	28.7	28.1	27.1	25.9	23.9	23.2	22.5
Position of crack tip (mm)	X	1.3	1.3	-0.5	0.1	0.0	-0.2	1.9	—
	Y	152.3	152.2	150.5	149.9	147.2	142.3	139.6	—
	Z	25.4	24.5	24.3	23.6	23.0	22.4	22.8	—

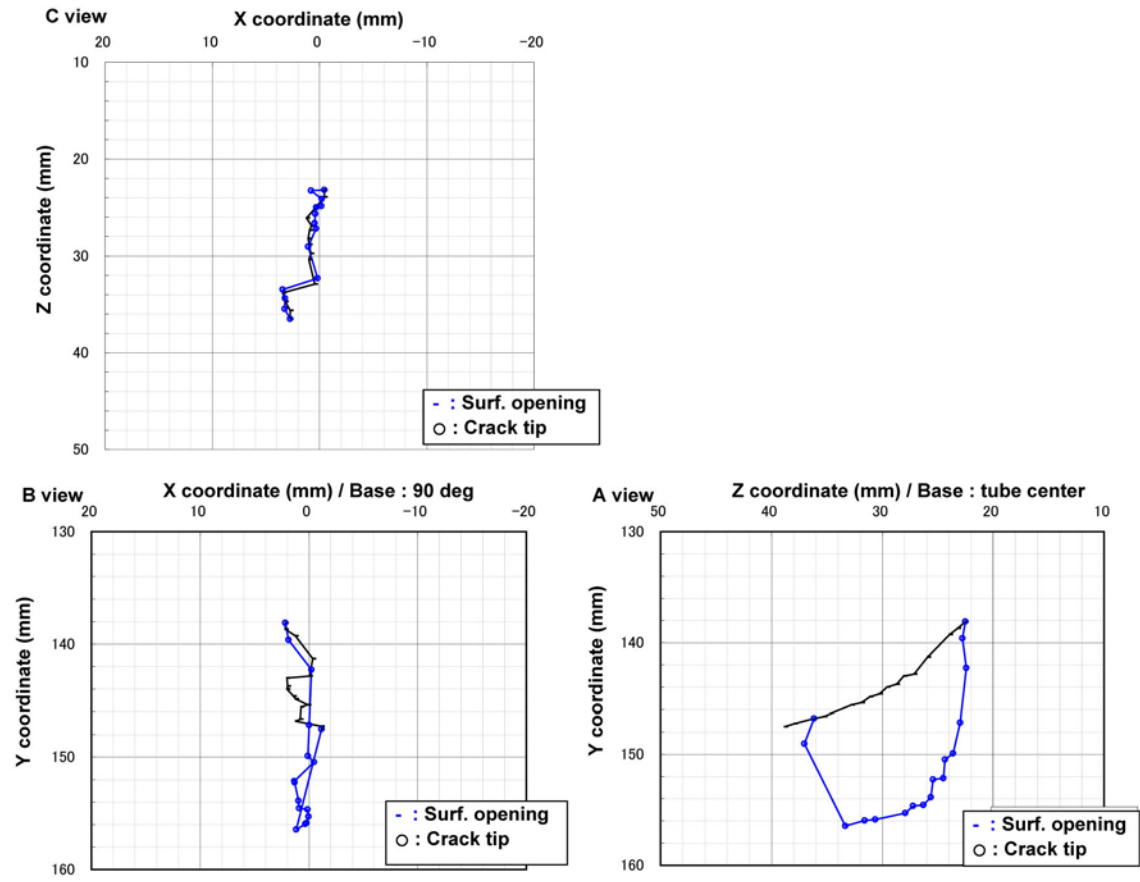
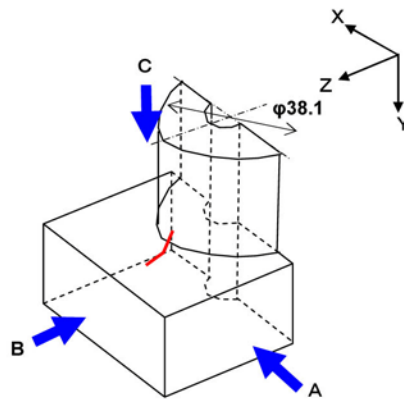
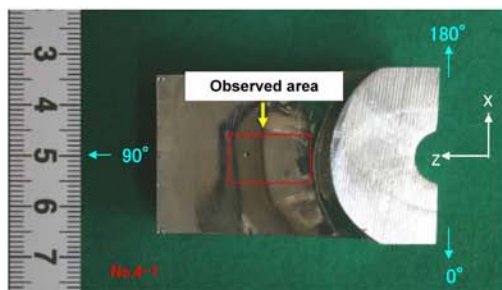
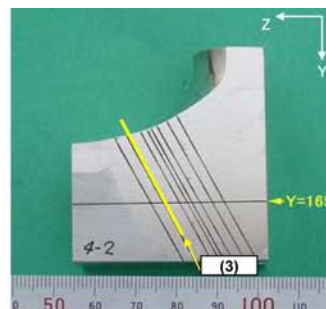
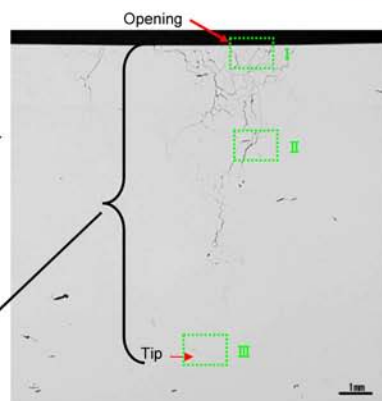
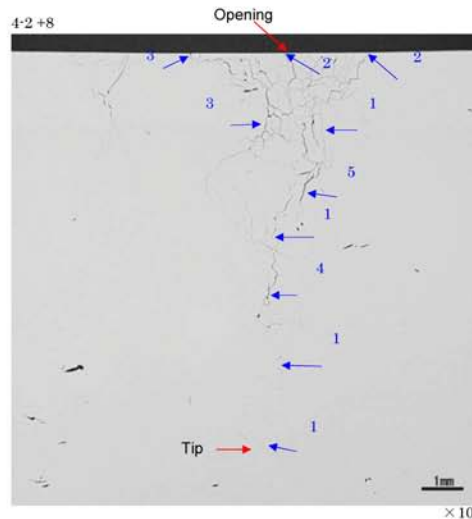
Typical crack opening data of PINC 5.16-1 (perpendicular to weld)
(Position = (3))

Position		(3)
Depth (mm)	d	10.2
Opening (µm)		2
Tilt (deg) (°)		5
Position of surf. opening (mm)	y	154.4
	X	1.2
	Y	146.8
	Z	36.2
Position of crack tip (mm)	X	0.3
	Y	156.0
	Z	31.6

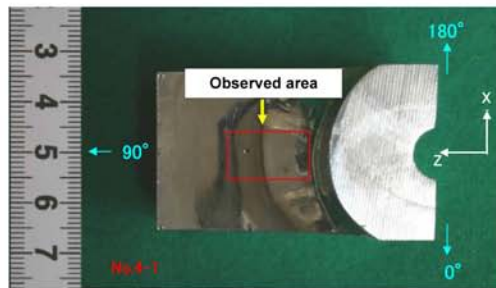
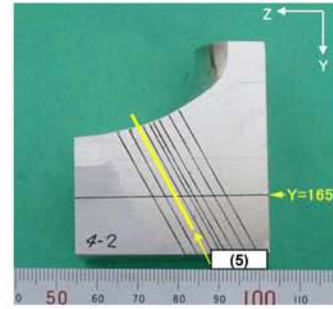
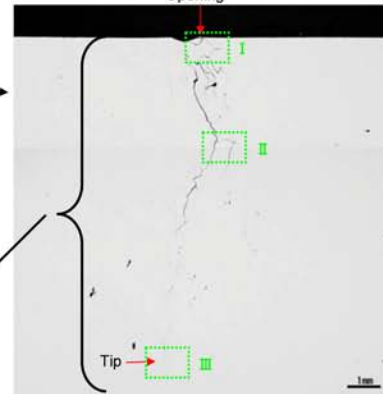
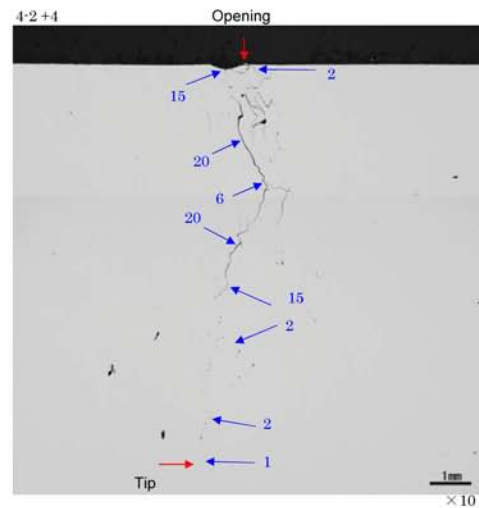
Typical crack opening data of PINC 5.16-1 (perpendicular to weld)
(Position = (5))

Position		(5)
Depth (mm)	d	10.9
Opening (μm)		15
Tilt (deg)	(°)	4
Position of surf. opening (mm)	y	151.2
	X	0.7
	Y	145.6
	Z	32.8
Position of crack tip (mm)	X	0.0
	Y	155.3
	Z	27.9

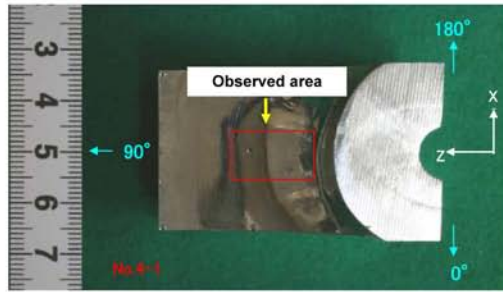
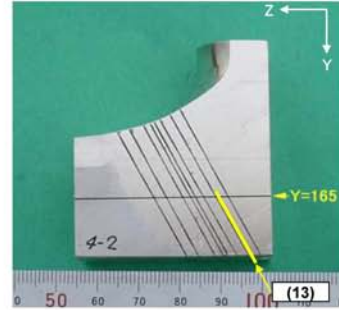
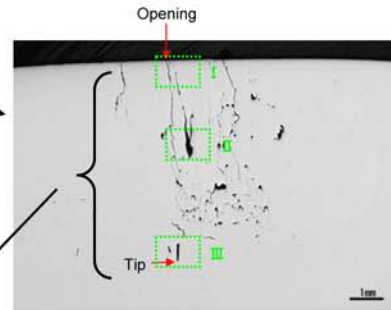
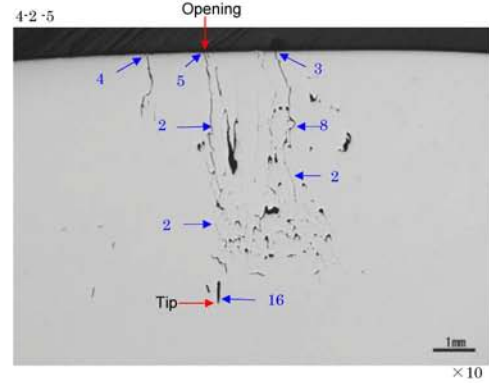
Macro. photo of cross section

Micro. photo of cross section

Position		(13)
Depth (mm)	d	6.6
Opening (μm)		5
Tilt (deg)	(°)	-3
Position of surf. opening (mm)	y	143.3
	X	-0.3
	Y	141.3
	Z	25.9
Position of crack tip (mm)	X	0.0
	Y	147.2
	Z	23.0

Typical crack opening data of PINC 5.16-1 (perpendicular to weld)
(Position = (13))

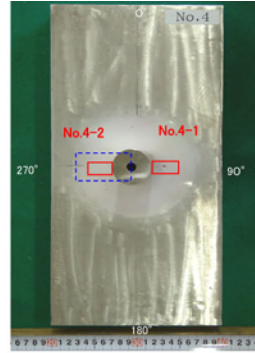
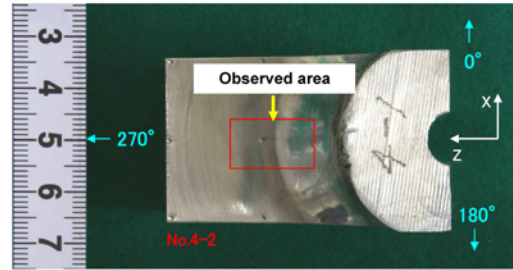
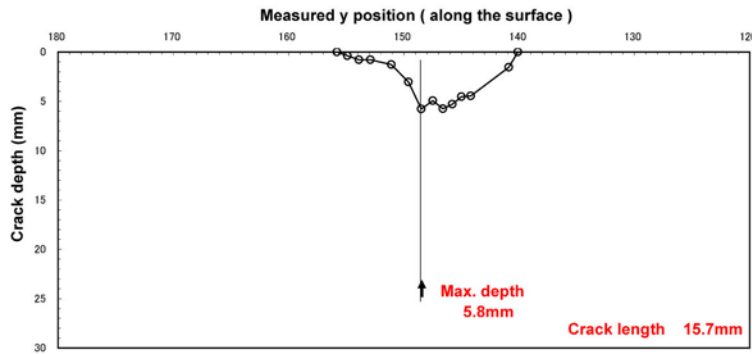
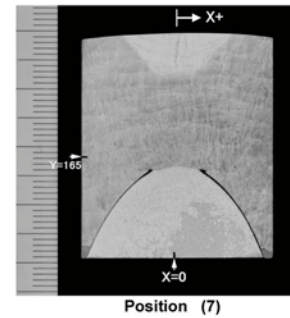
(2) Profile of SCC

(3) Measured data of SCC

Results of destructive test on PINC 5.16-2 (perpendicular to weld)

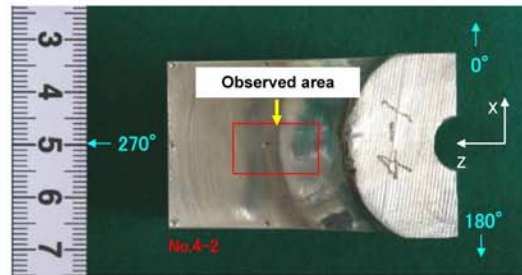
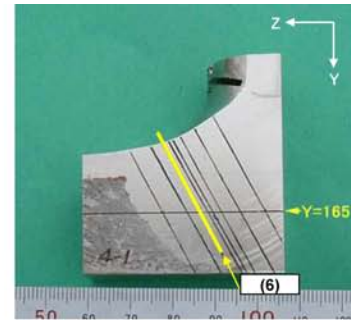
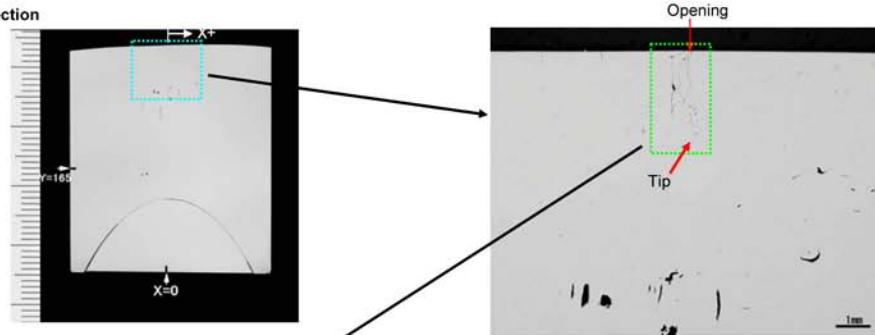
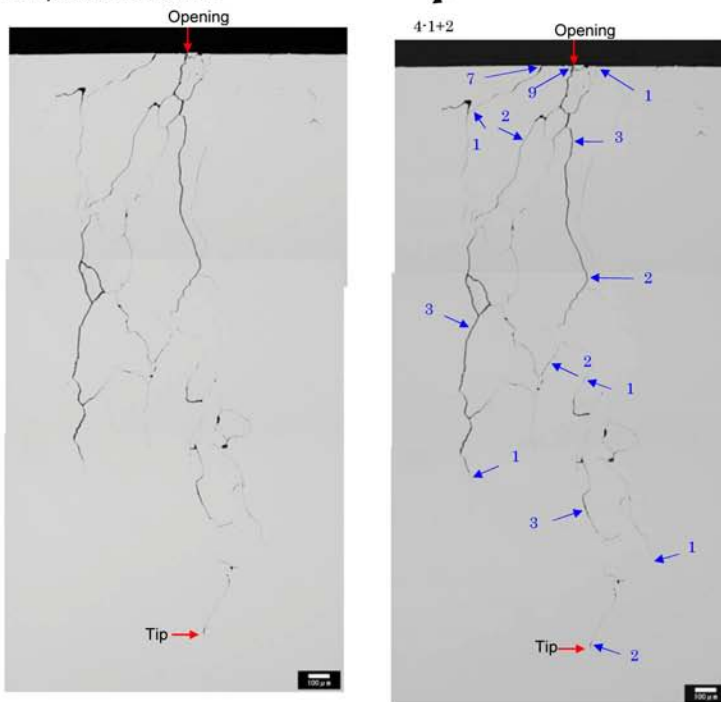
Macro. photo of cross section

Micro. photo of cross section

Position		(6)
Depth (mm)	d	3.0
Opening (μm)		9
Tilt (deg) (°)		-1
Position of surf. opening (mm)	y	149.6
	X	1.0
	Y	146.3
	Z	30.4
Position of crack tip (mm)	X	1.0
	Y	149.0
	Z	29.0

Typical crack opening data of PINC 5.16-2 (perpendicular to weld)
(Position = (6))

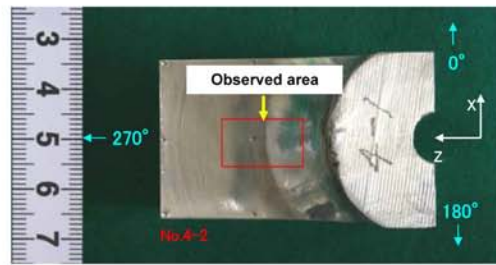
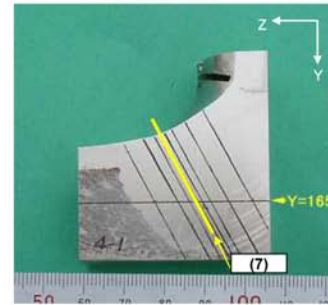
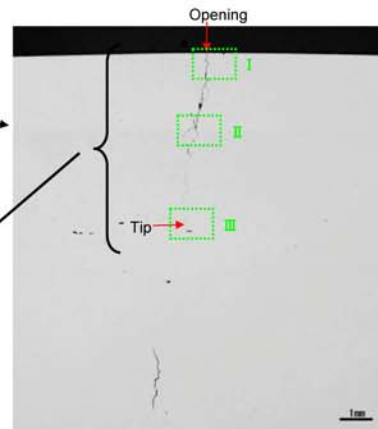
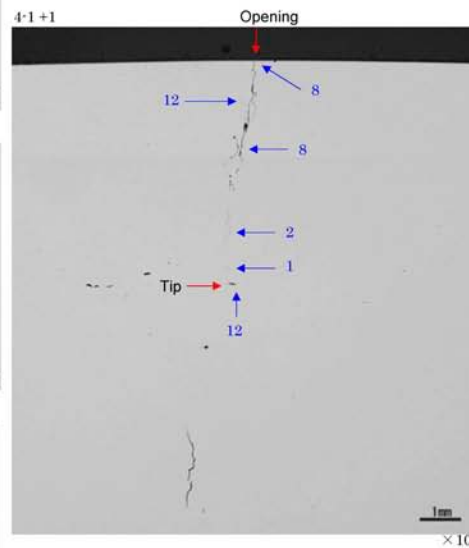
Macro. photo of cross section

Micro. photo of cross section

Position		(7)
Depth (mm)	d	5.8
Opening (μm)		8
Tilt (deg)	(°)	5
Position of surf. opening (mm)	y	148.5
	X	0.8
	Y	145.6
Position of crack tip (mm)	Z	29.8
	X	0.3
	Y	150.8
	Z	27.2

Typical crack opening data of PINC 5.16-2 (perpendicular to weld)
(Position = (7))

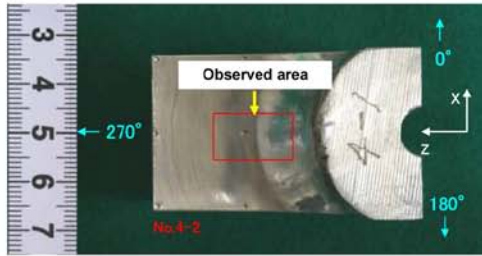
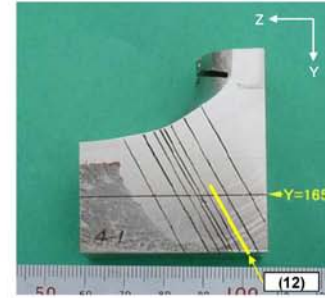
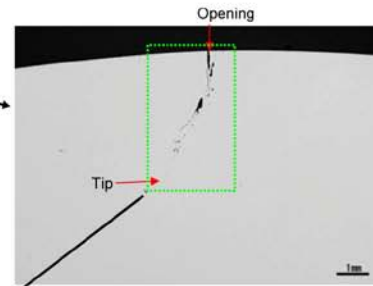
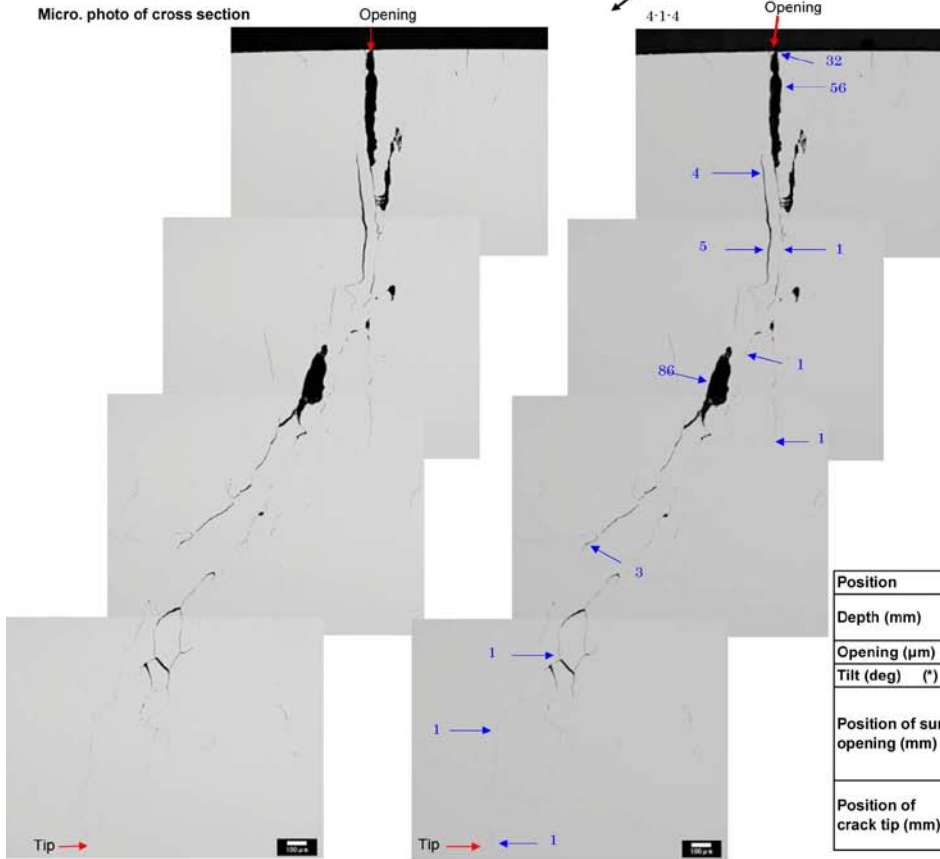
Macro. photo of cross section

Micro. photo of cross section

Position		(12)
Depth (mm)	d	4.5
Opening (μm)		32
Tilt (deg)	(°)	18
Position of surf. opening (mm)	y	144.2
	X	1.2
	Y	142.9
	Z	26.1
Position of crack tip (mm)	X	-0.2
	Y	146.9
	Z	24.1

Typical crack opening data of PINC 5.16-2 (perpendicular to weld)
(Position = (12))

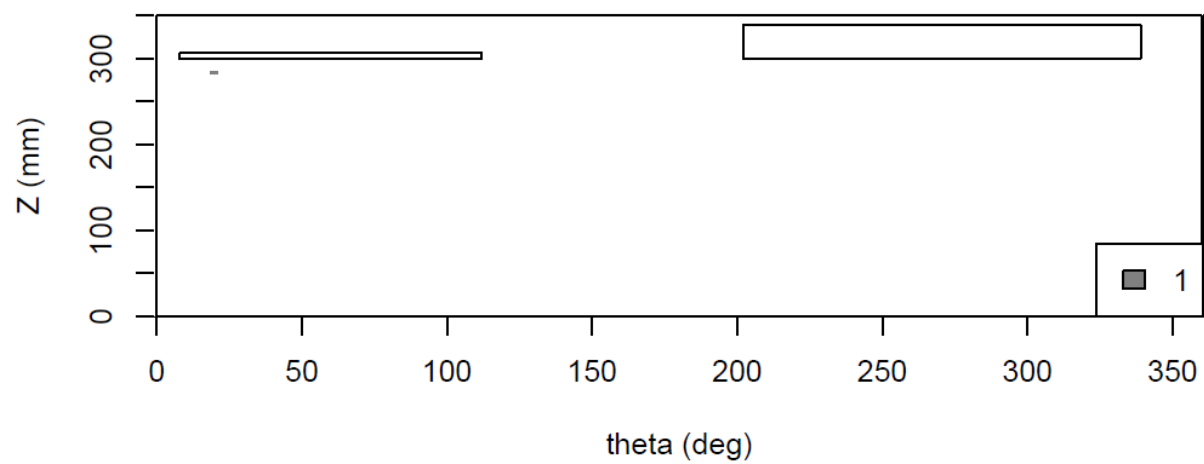
False Call Density for Tube5.1 # false calls= 1

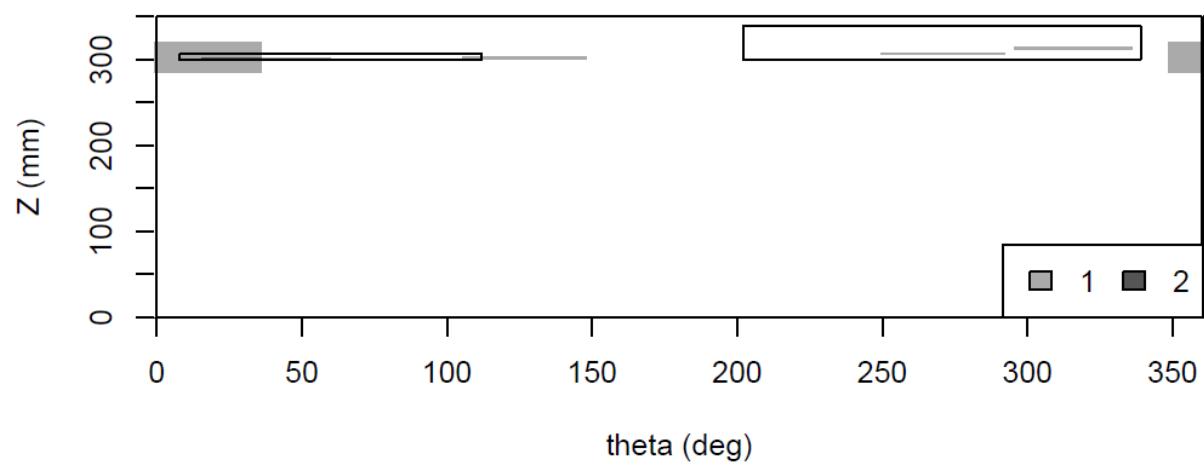
Hit Density for Tube5.1 # Hits= 5

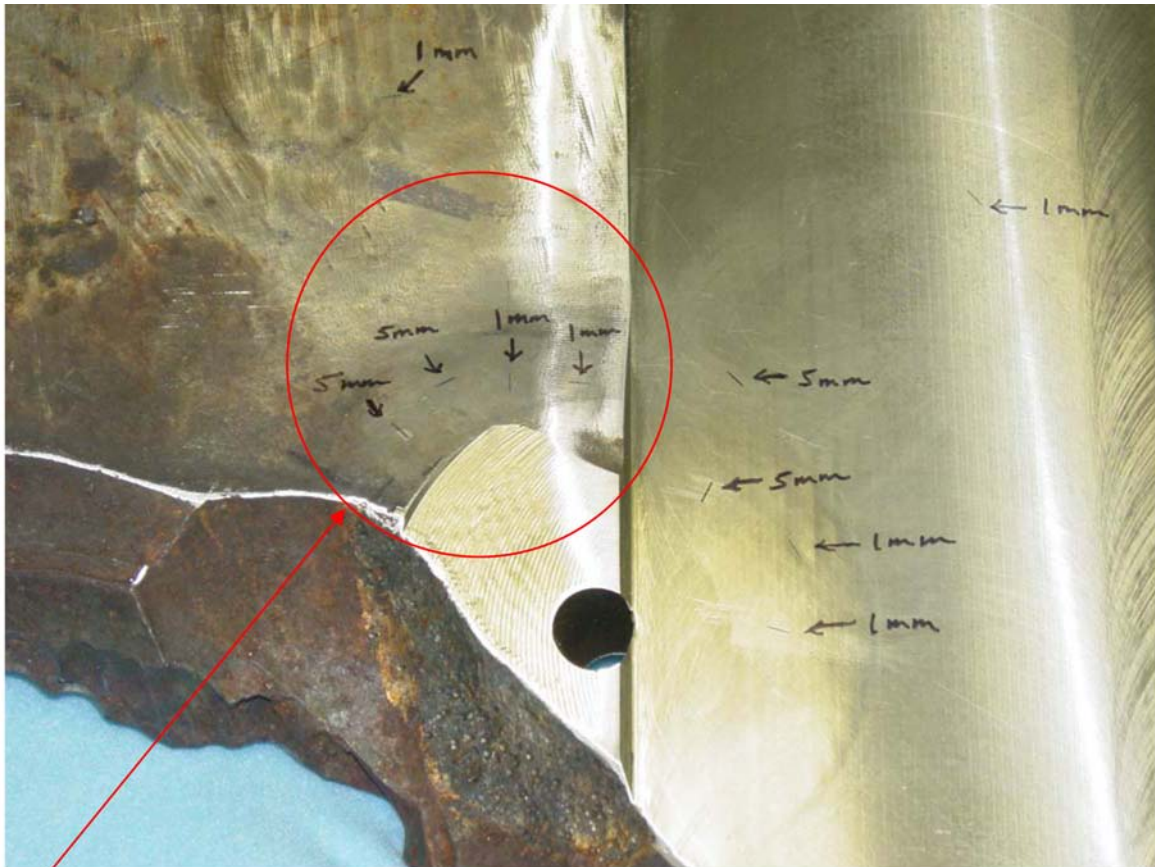
G.1 Calibration/Verification Standard

Two Larger Flaws are 4-mm Long \times 5-mm Deep \times 0.203-mm Wide

Two Smaller Flaws are 4-mm Long \times 1-mm Deep \times 0.102-mm Wide

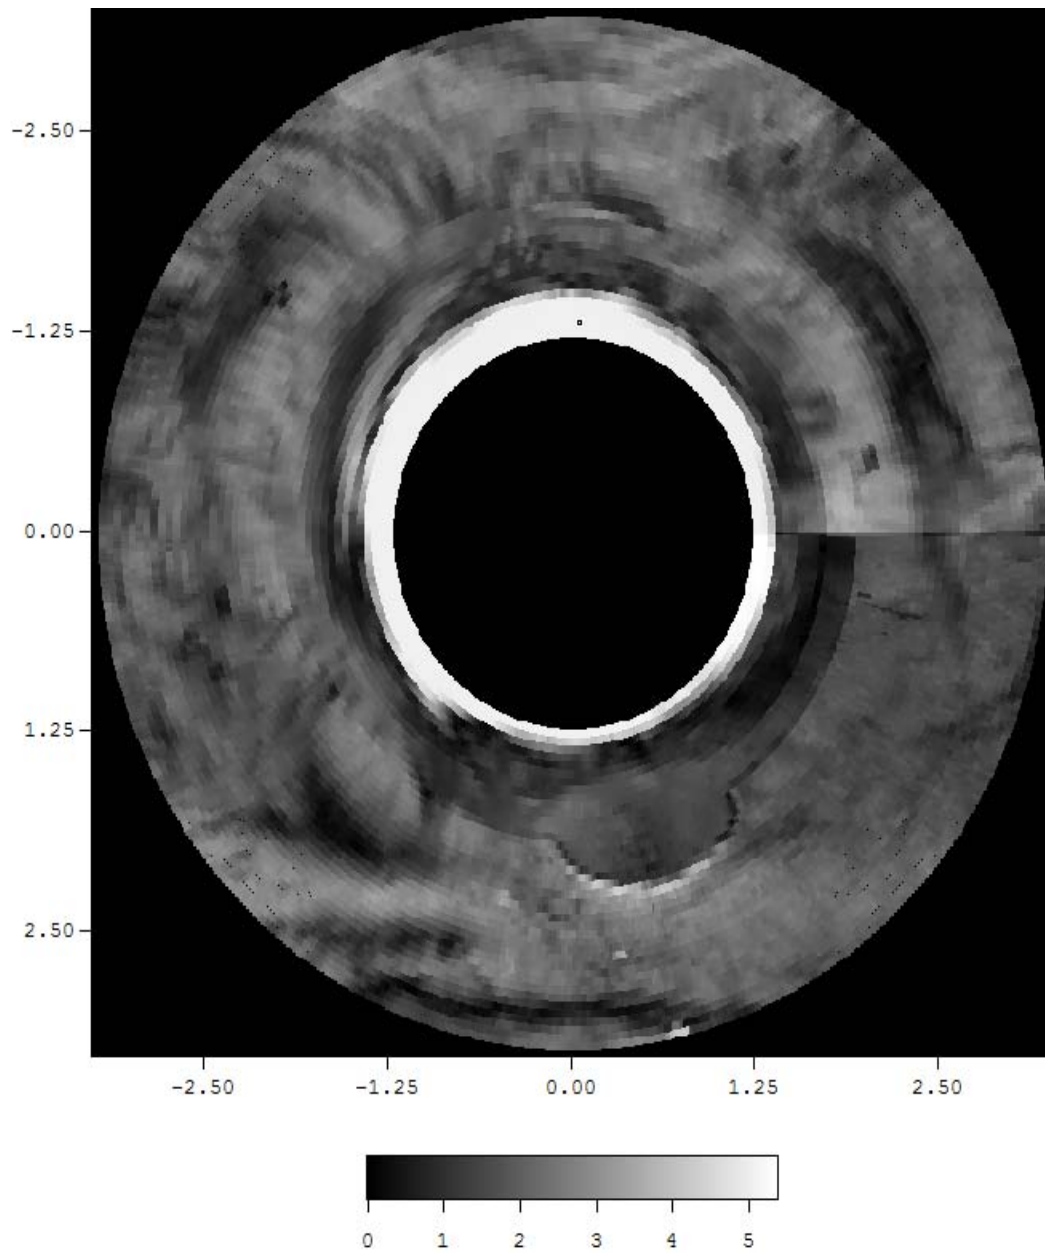
PINC_5_8_RADIAL_360_48DB_11_21_07_rect_hdf_xy_1_magInterp

No flaws were identified in PINC 5.8. A fabricated area was, however, identified and shown in the following image.

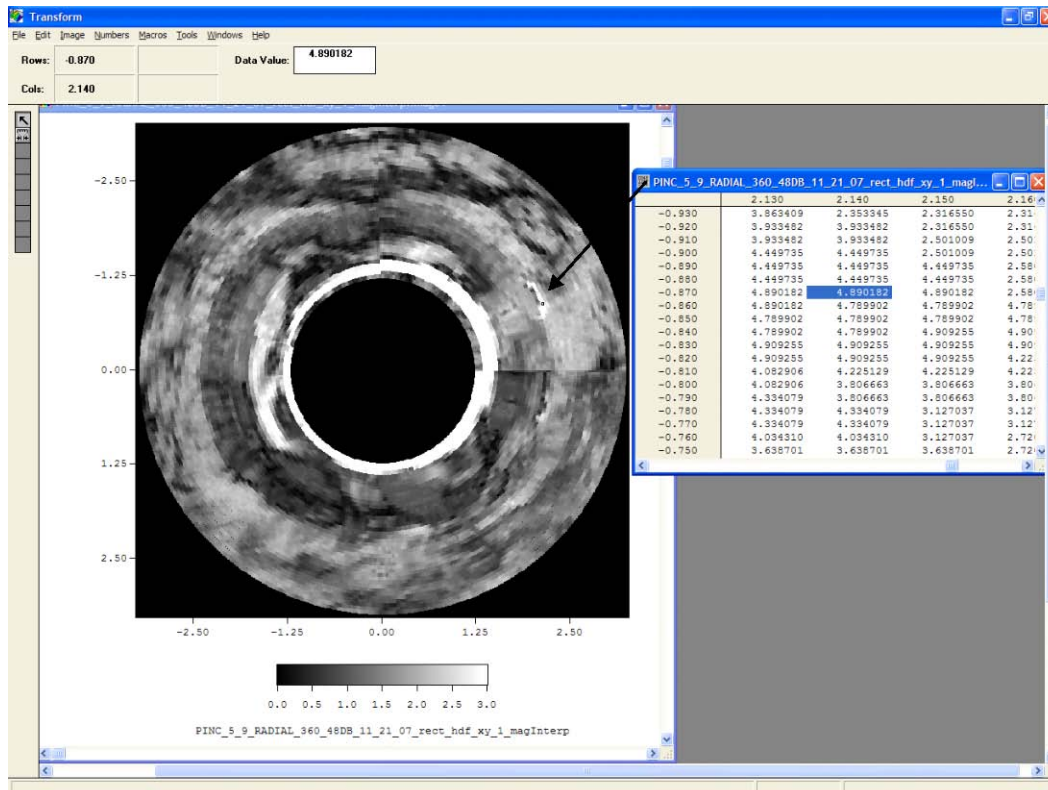
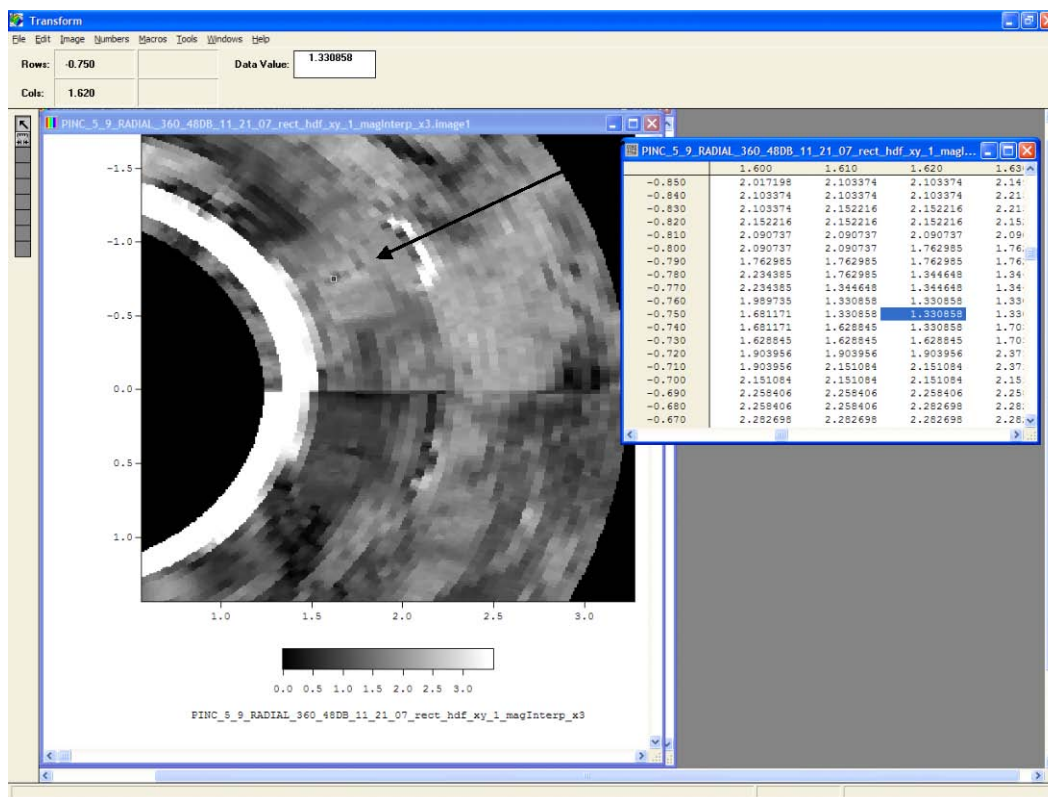
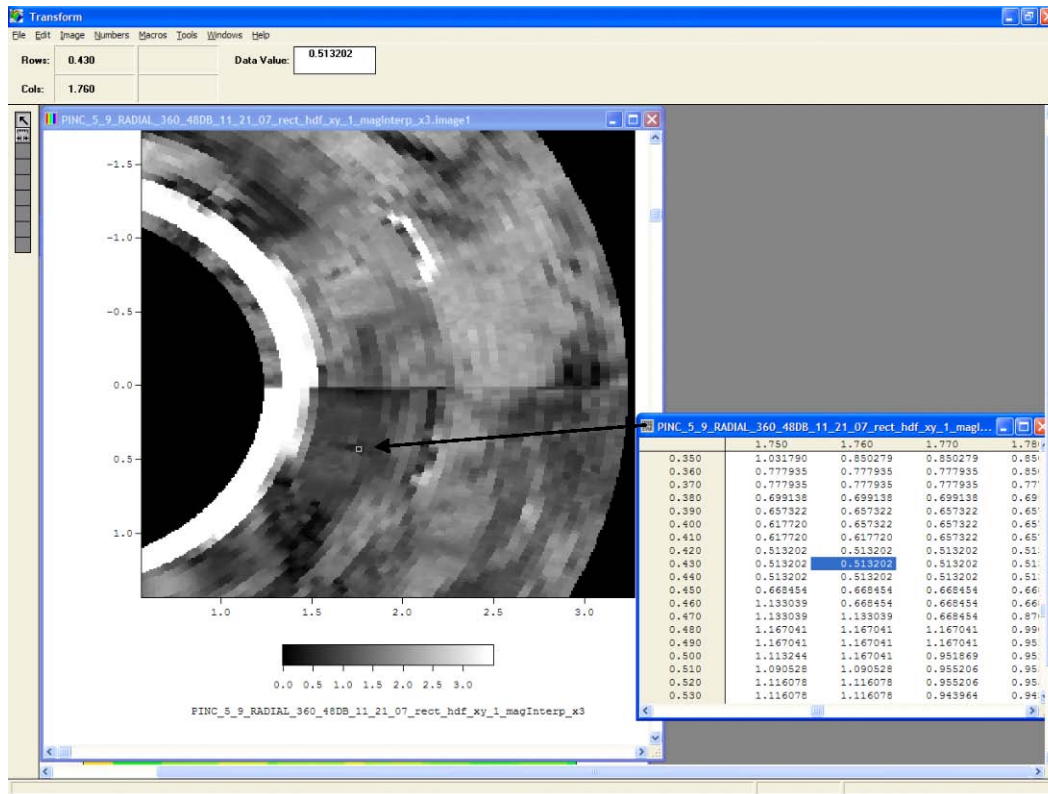
G.4 PINC 5.9

Two flaws were visible on PINC 5.9. The image below shows the magnitude of the edge of the fabrication.

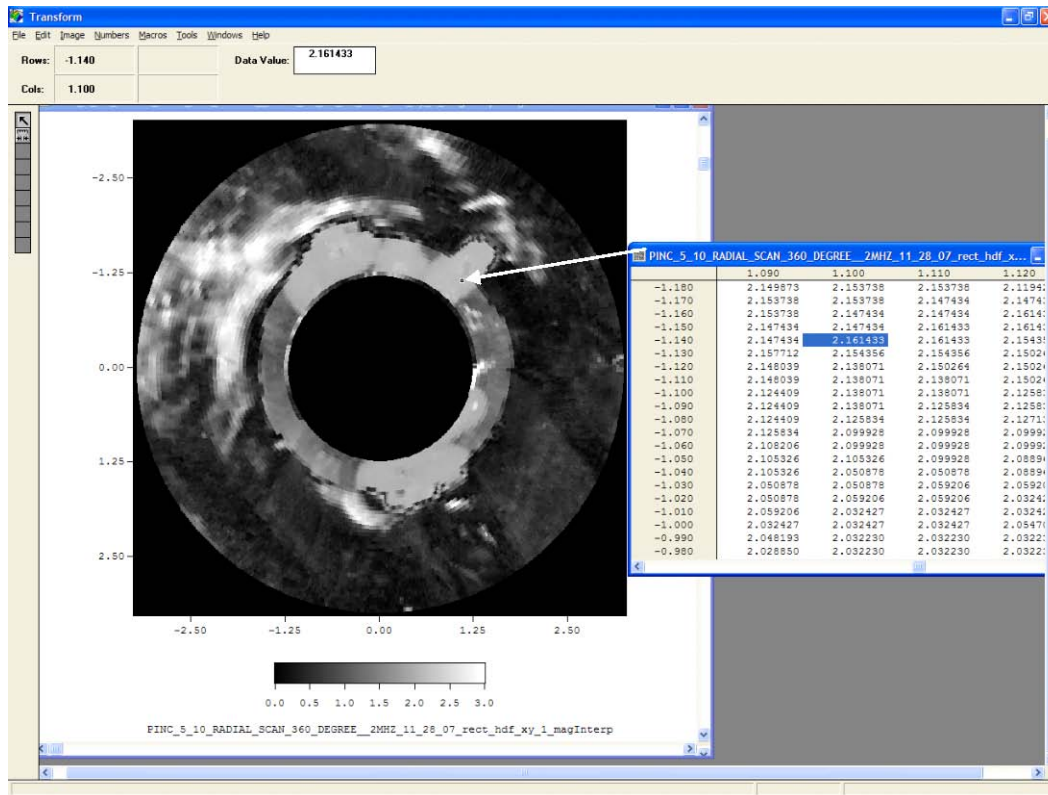
G.5 PINC 5.10

General magnitude of the fabrication area.

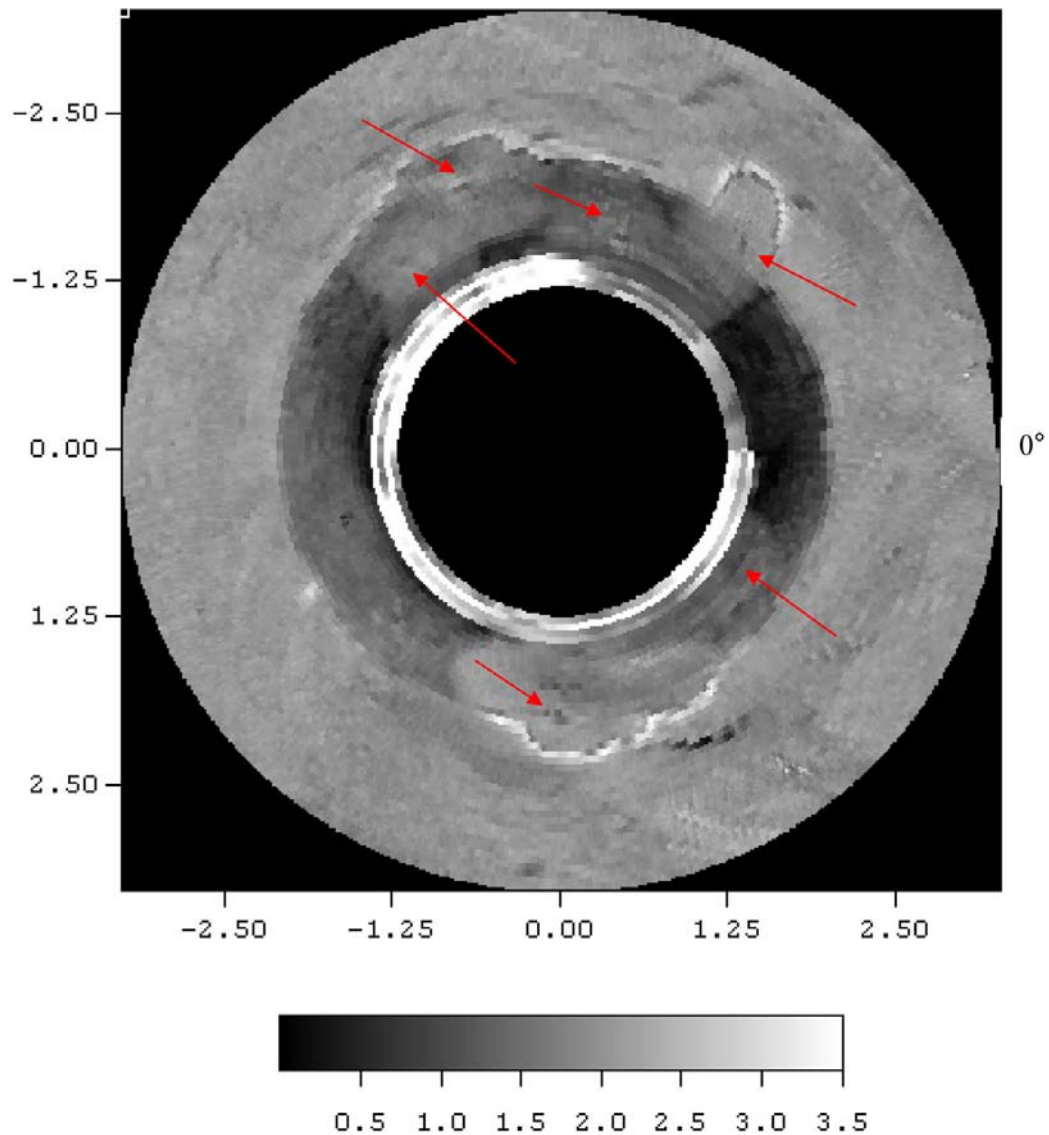
Here is another image that we used in a different report which shows six flaws. It is a stretch to say you can see them all unless you know what you are looking for. In the example shown above, we point to a different area for the flaw location. We would need to zero in on the flaw and scan at high resolution to identify.

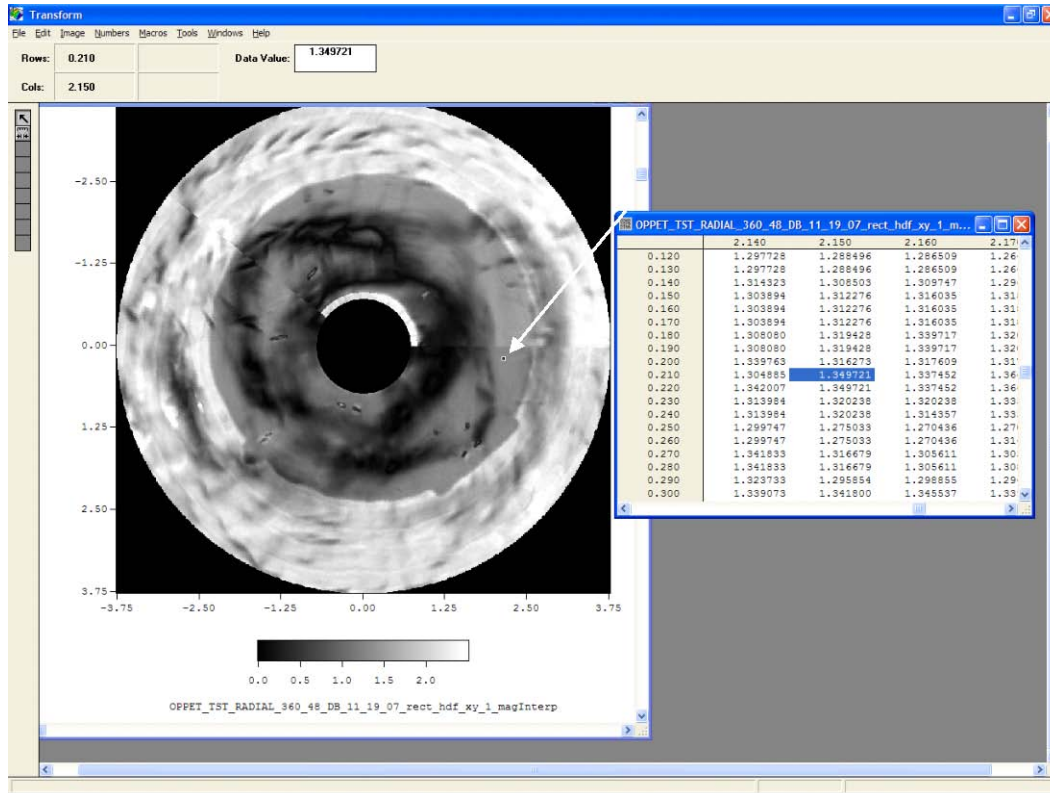
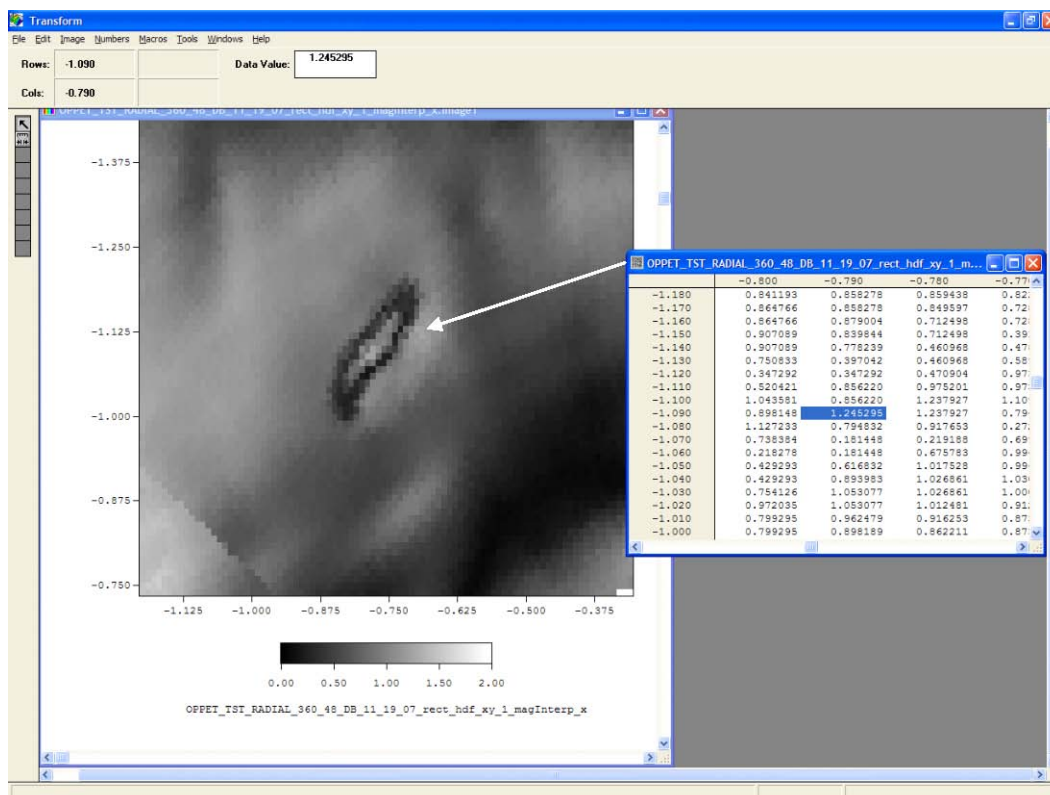
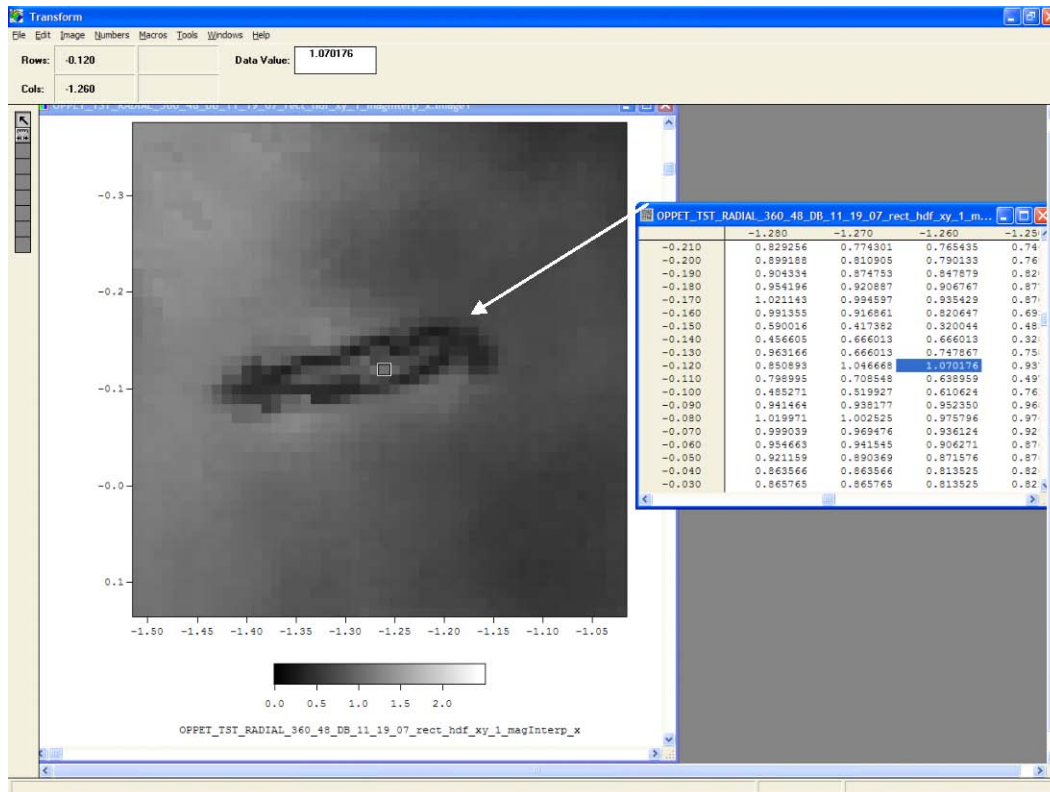
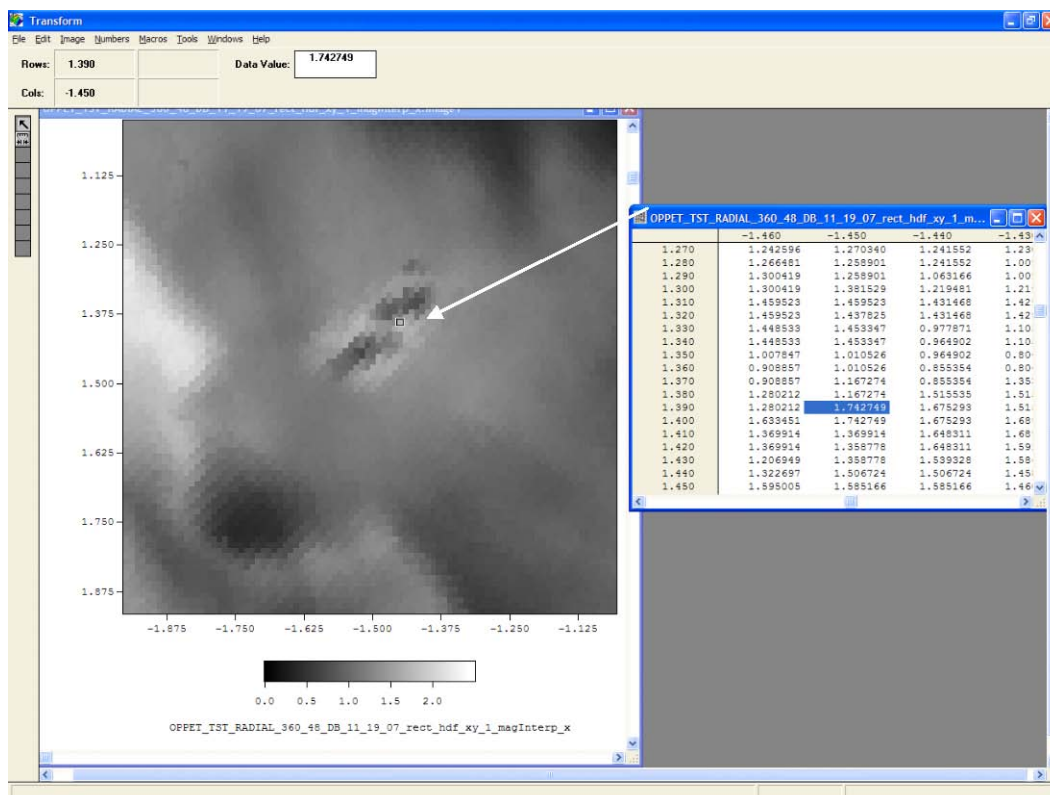
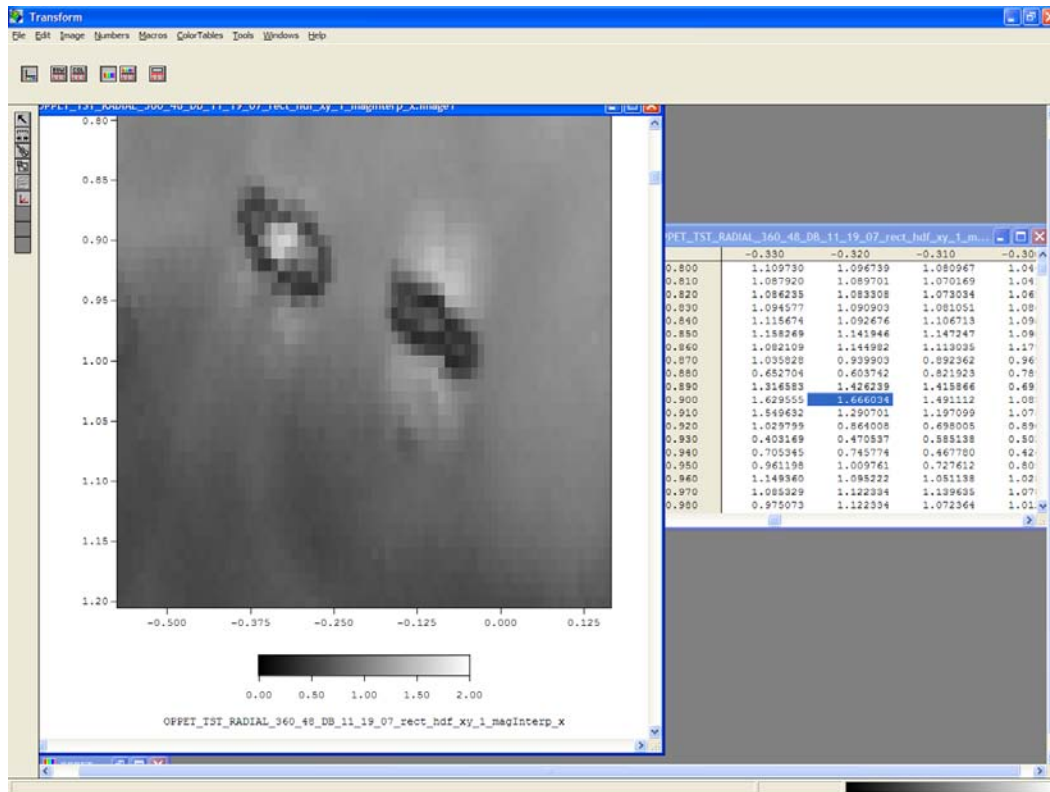
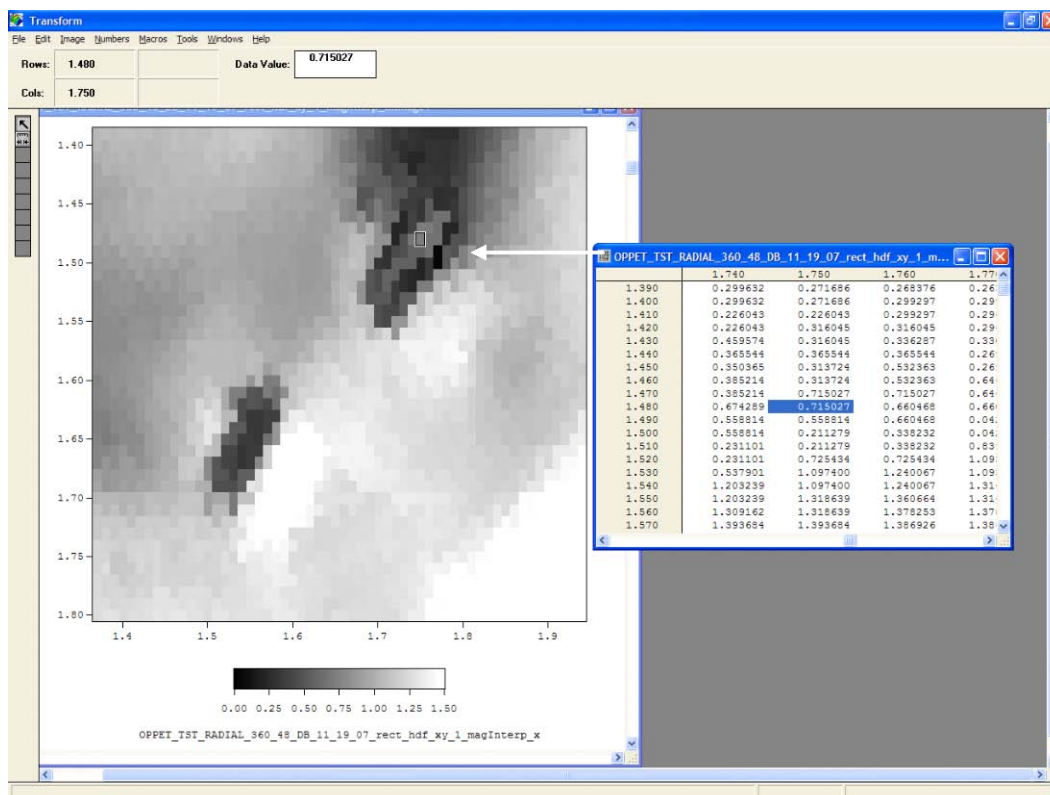
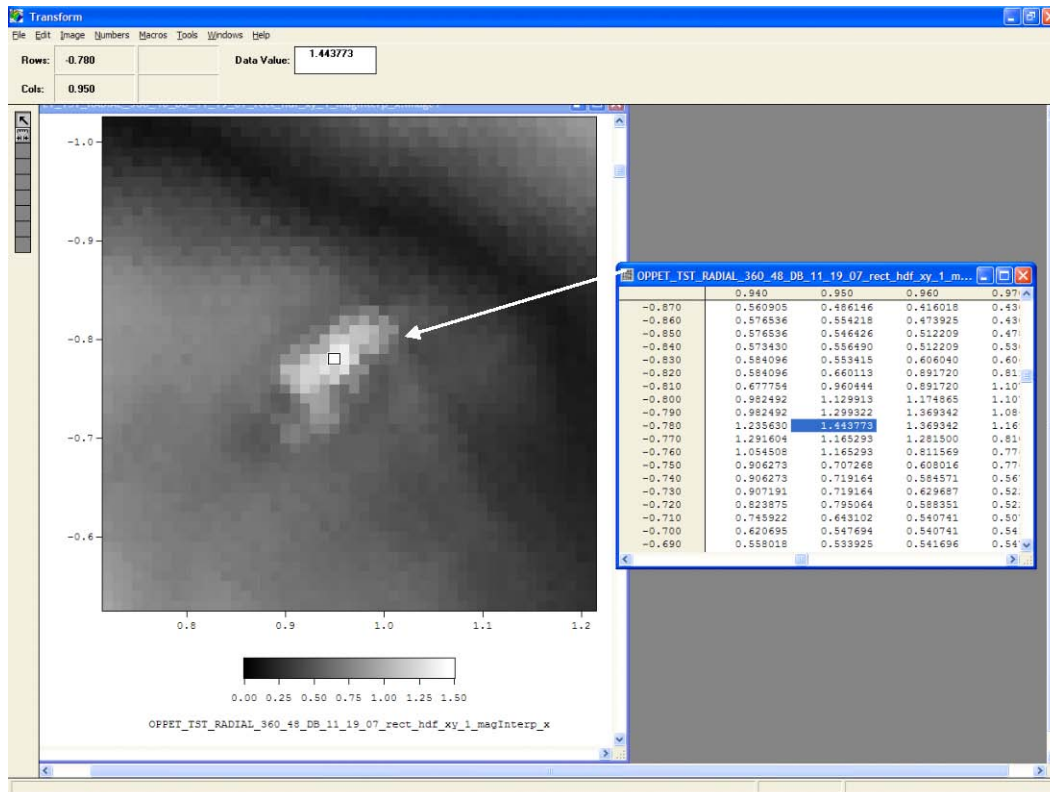
G.8 PINC 5.6

Six indications were identified.
