600-YARD BULLET CATCHER
FINAL STATUS SURVEY REPORT

LAKE CITY ARMY AMMUNITION PLANT
Lake City, Missouri

Cabrera Services, Inc.
809 Main Street
East Hartford, CT 06108

01-3030.03, Revision 3

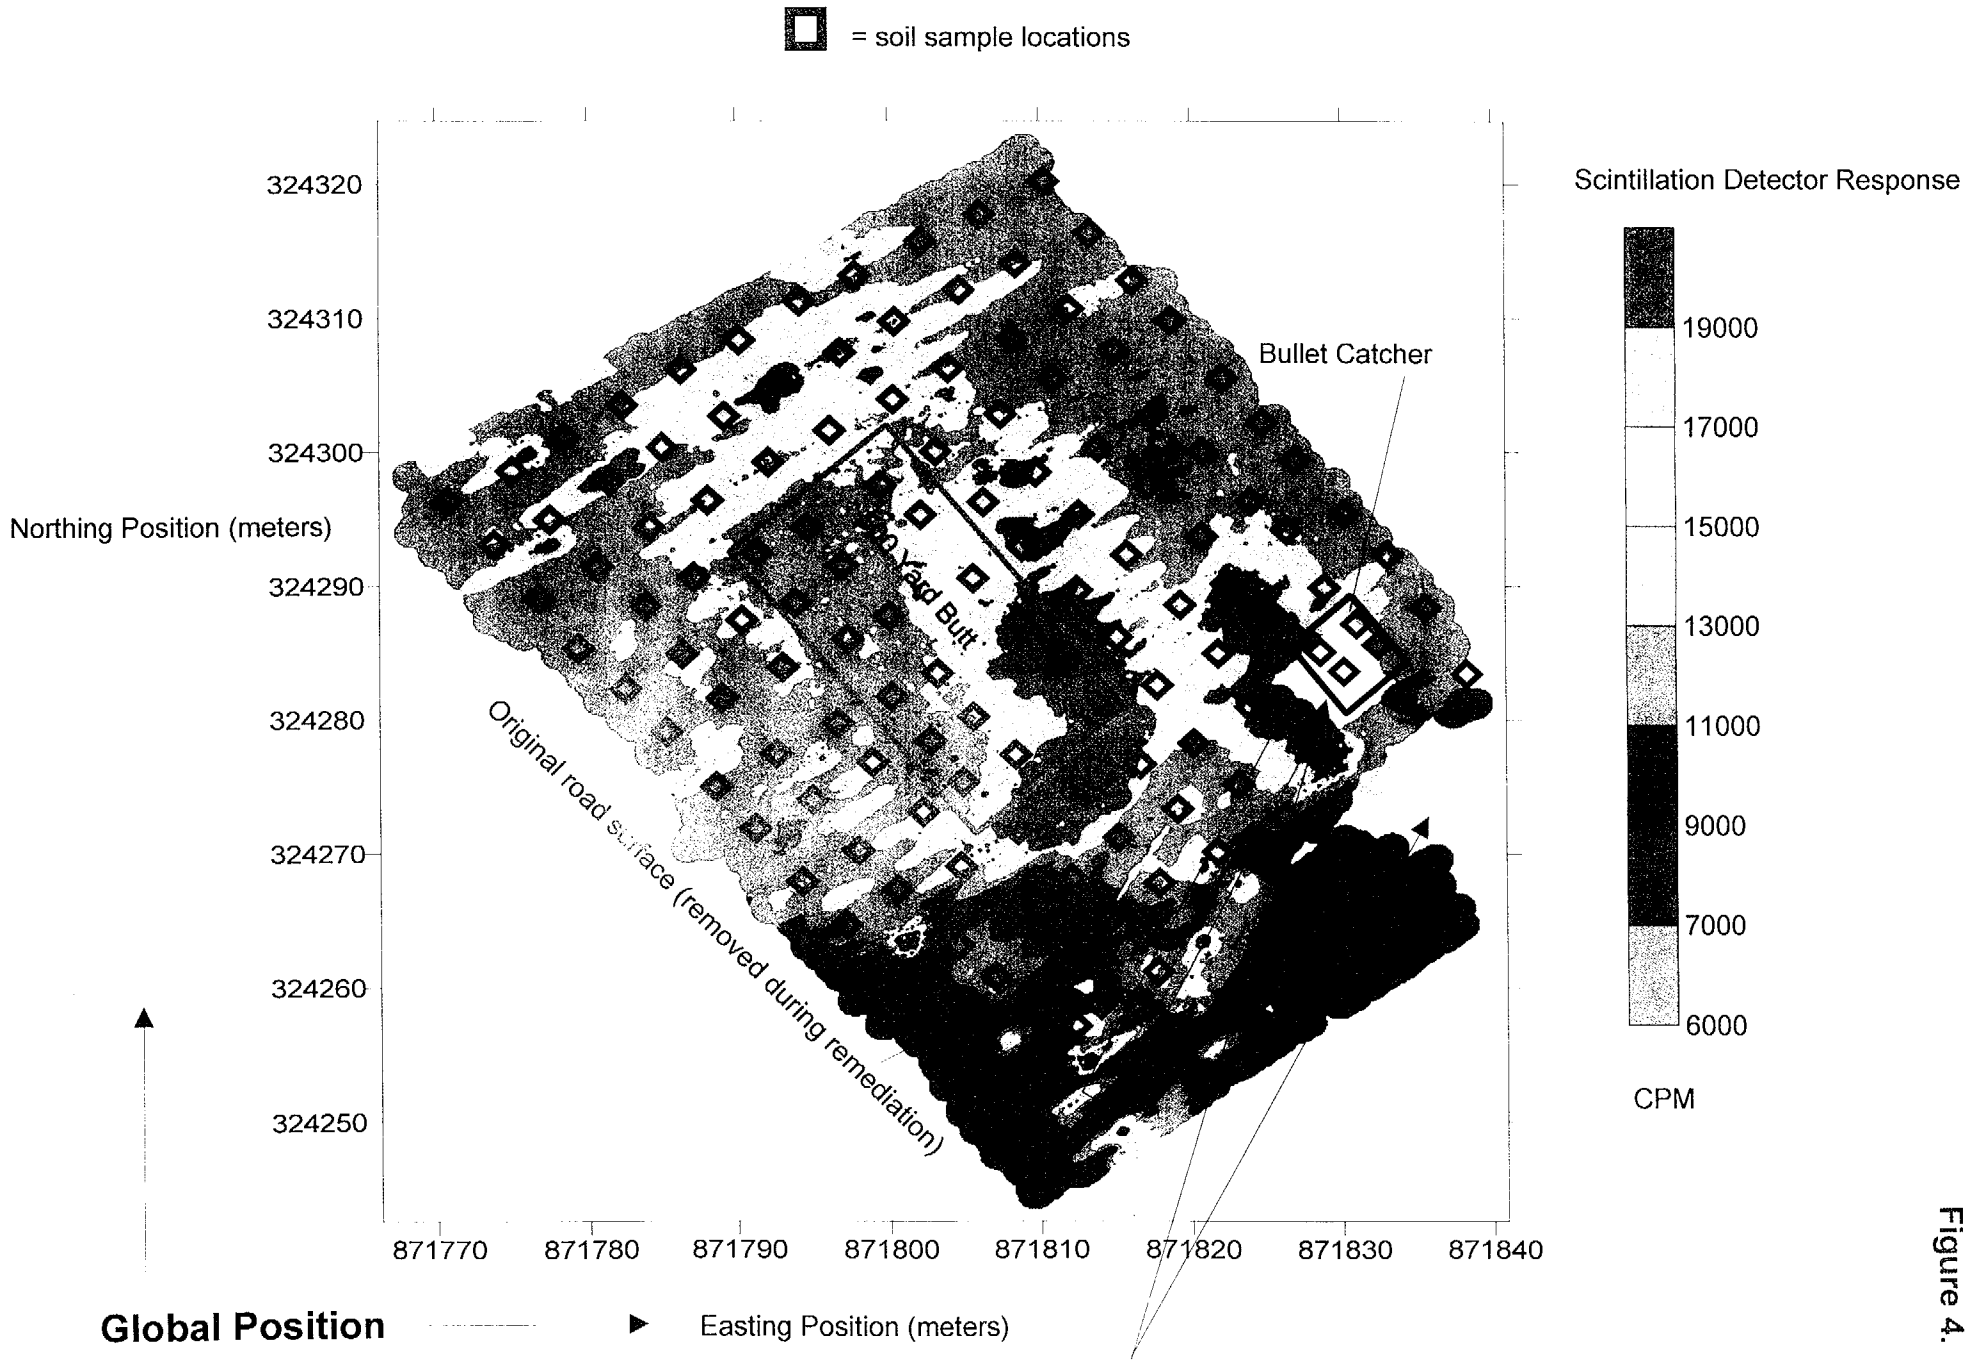
Figure 4.

Scans of the residual soil in the bullet catcher area indicate that the uranium levels are similar to background after the removal of all of the contaminated soil from the area. The range of count rate observed after remediation was 6,535 to 16,904 cpm for 28954 readings. The average count rate in the scan was 12,403, the standard deviation was 1,110, and the 95% level (μ_α) was 12,413. The count rate data collected is too voluminous to provide a hard copy. This data is in excel format on the final report compact disc. This data was used to create the plots in Figure 4, page F-7 and Figure 8, page F-11.

The blank space in and next to the bullet catcher is due to the inability to collect GPS data in that area. The Bullet catcher steel walls were a very effective satellite shield.
