Causes and Significance of Design-Basis Issues at U.S. Nuclear Power Plants

U.S. Nuclear Regulatory Commission
Office Nuclear Regulatory Research
Washington, DC 20555-0001

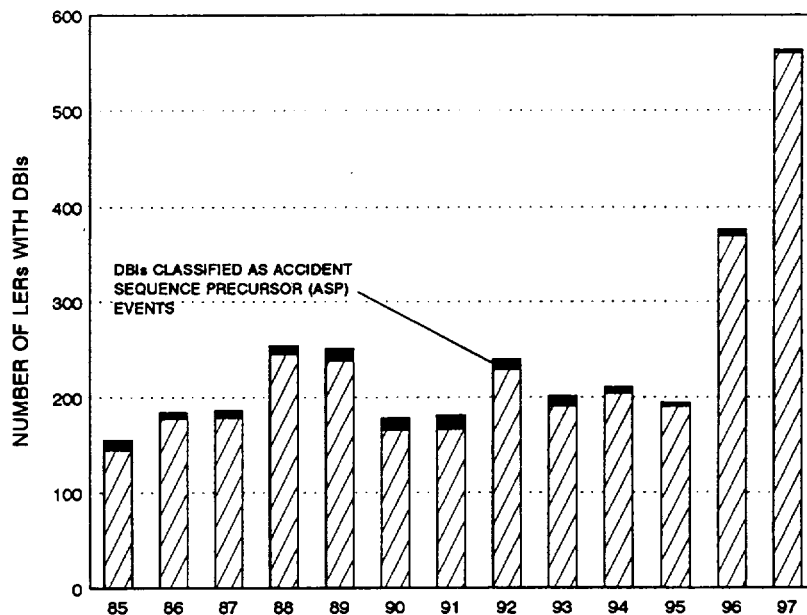
U.S. operating plants reported over 3100 LERs with DBIs during the period 1985–1997, or about 240 per year. The number of DBIs on a year-to-year basis for 1985–1997 is shown in Figure 1. The portion of DBIs that

met the ASP CCDP of at least 1×10^{-6} is shown in black for each year. From 1985–1997, LERs have identified increasing numbers of DBIs involving both trains and systems, however the majority of these DBIs have been of low safety significance from an ASP perspective.

Figure 1 Trend of design basis issues reported for 1985–1997

For 1985–1987 the number of DBIs ranged from 155–184 per year. For 1988 and 1989, the number significantly increased to 254 and 251, respectively. This increase coincided with the broad implementation, beginning in 1987, of NRC safety systems functional inspections and safety systems outage modification inspections. For 1985–1995, the number of DBIs varied between 155 and 194. There was a significant increase in DBIs in 1996 (from 194 to 377) and again in 1997 (from 377 to 563). This increase appeared to coincide with certain NRC initiatives including: NRC team

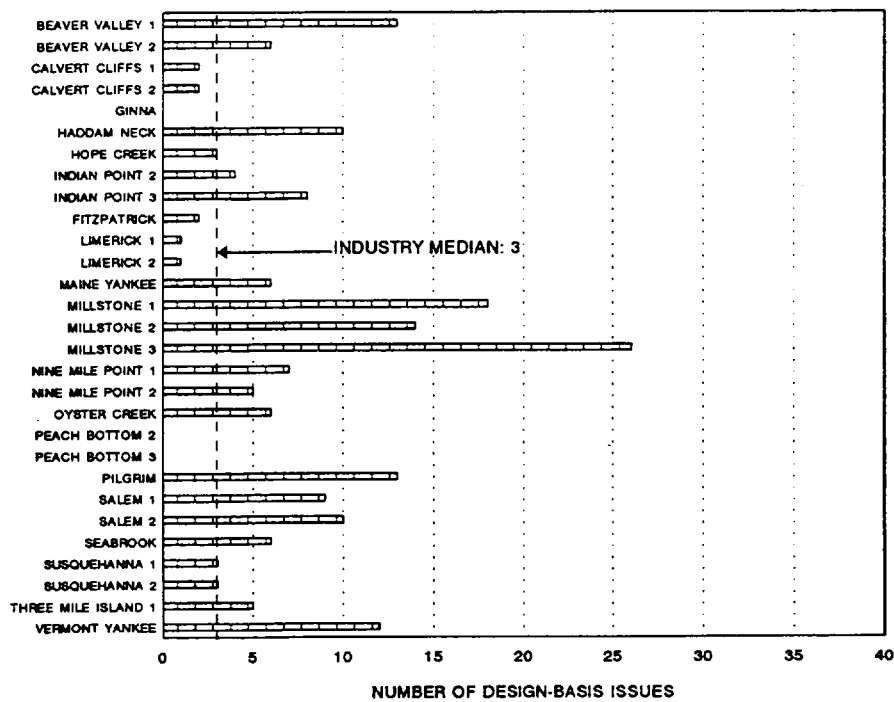
Figure 3 Region I plant distribution of design-basis issues for 1997

The number of DBIs for 1997 varied widely among plants. Figures 3 through 6 show the number of DBIs for 1997 for plants located in each of the four NRC regions. As noted earlier, in 1997 the industry average for all 110 operating plants was 5.1 DBIs per plant. In addition, the industry median was 3 DBIs per plant as shown in Figures 3 through 6. Other observations include:

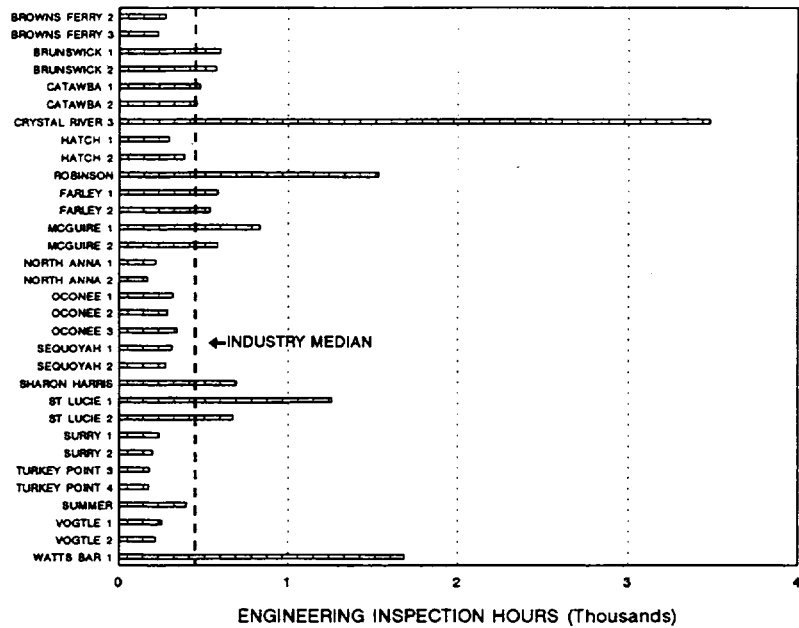
Figure 14 Region II plant engineering inspection hours for 1997

Figures 13–16 show the engineering inspection hours for each plant in Regions I–IV for 1997, respectively. The 1997 industry median and average for NRC engineering inspection hours per plant were 452 hours and 613 hours, respectively. Browns Ferry 1 (Region II) had a low of approximately 90 engineering inspection hours, while Millstone 3 (Region I) had a high of almost 3700 engineering inspection hours. As shown in

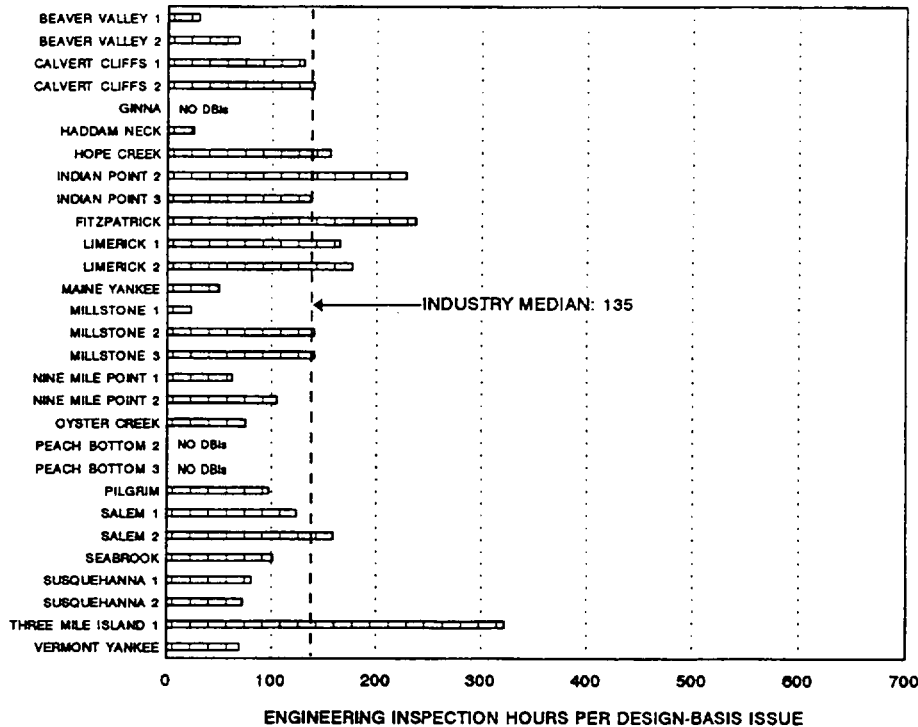
Figure 17 Region I plant engineering inspection hours per design-basis issue for 1997

Figures 17–20 show the number of engineering inspection hours per DBI for each plant during 1997 for Regions I–IV, respectively. These figures were produced using the information shown in Figures 13–16 which shows the plant-by-plant distribution of NRC engineering inspection effort (in hours) for 1997, and Figures 3–6, which shows the plant-by-plant distribution of DBIs for 1997. Dividing the inspection hours for each plant by the total number of DBIs (found from all initiators), provides the number of engineering inspection hours per DBI for each plant. The 1997 industry median for engineering inspection hours per DBI was 135.

ratio) are not plotted, but are annotated as “no DBIs.” Of the 20 that had no DBIs during 1997, 15 came from either Region II or IV. In addition, 13 of the 20 plants that reported no DBIs during 1997, received less than the median number of engineering inspection hours. In many cases, the plants that did not submit LERs with DBIs for 1997 had similar designs to plants that did submit LERs with DBIs. Additionally, DBIs documented in 1997 generic feedback correspondence was typically applicable to a broad range of nuclear power plant facilities. Similarly, the 10 CFR 50.54(f) letter issued in 1996 requesting reviews of design-basis control programs and processes contributed to the identification of DBIs during 1997. Had comprehensive NRC engineering team inspections been conducted at more facilities reporting no DBIs for 1997, it would be expected that additional DBIs may have been discovered and reported.

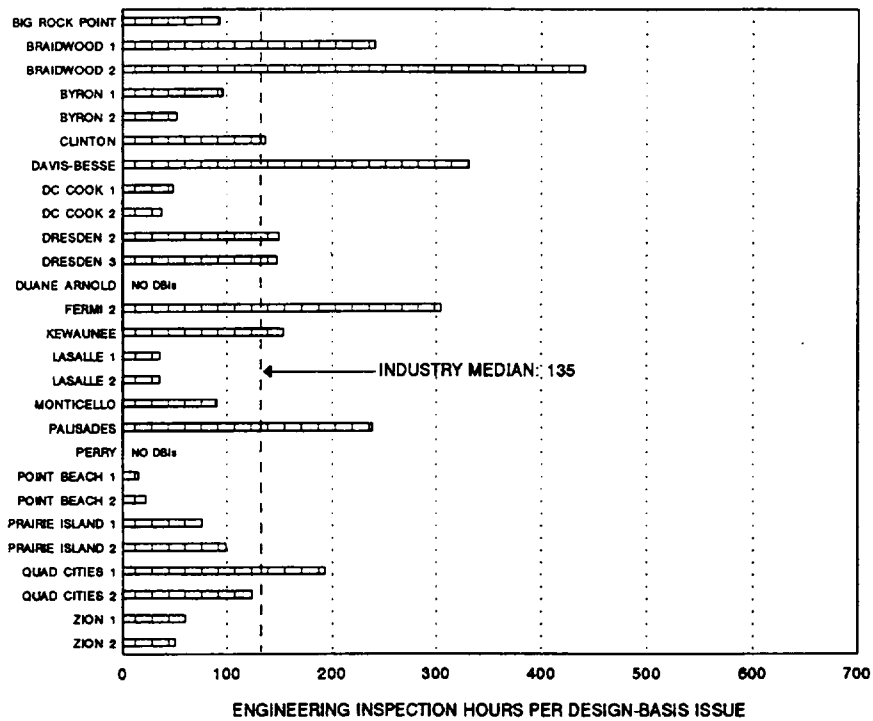
Figure 19 Region III plant engineering inspection hours per design-basis issue for 1997

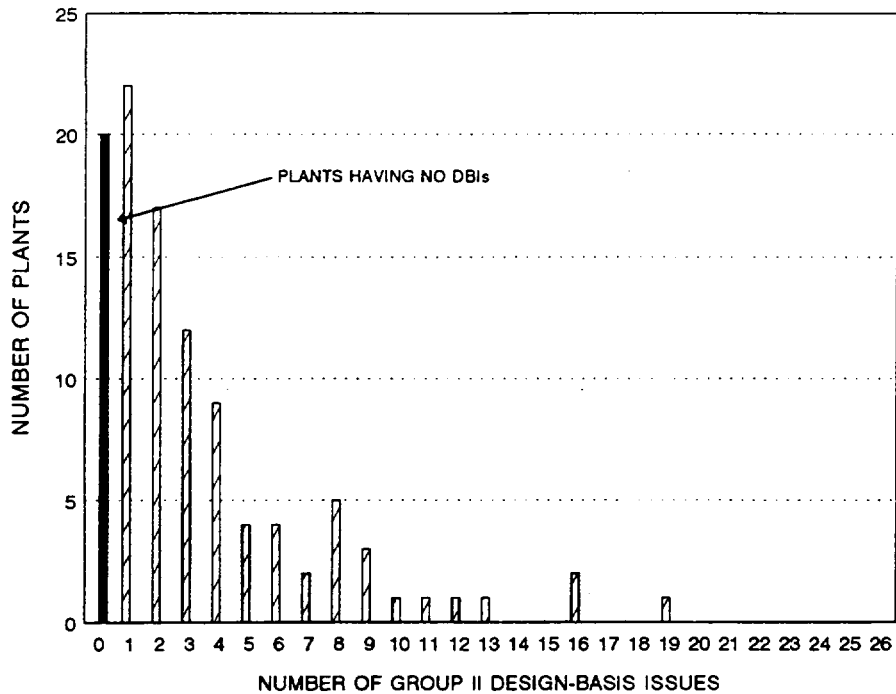
Figure 26 Plant distribution Group II design-basis issues

Figure 26 shows the distribution of the number of plants with varying numbers of Group II DBIs. For 1997, out of the 449 DBIs analyzed, 350 DBIs were of minimal risk or no risk significance (Group II). These 350 Group II DBIs involved 85 different plants. A total of 20 plants had no DBIs during 1997. The most frequent number of Group II DBIs submitted by a plant was one, which occurred at 22 plants.

However, in 1997, 17 plants submitted from 7 to 19 Group II DBIs involving minimal risk or no risk significance - an average of about 10 LERs with minimal or no risk significant DBIs per plant. As shown in Figure 26, a significant number of plants reported a relatively large number of LERs with DBIs having minimal or no risk significance, indicating that the LER rule in effect at the time was not effective in discriminating (screening out) the reporting of DBIs having minimal or no risk significance.
