NUREG/CR-5779  
ORNL-6687  
Vol. 1

# Aging of Non-Power-Cycle Heat Exchangers Used in Nuclear Power Plants

Operating Experience and Failure Identification

**Oak Ridge National Laboratory**

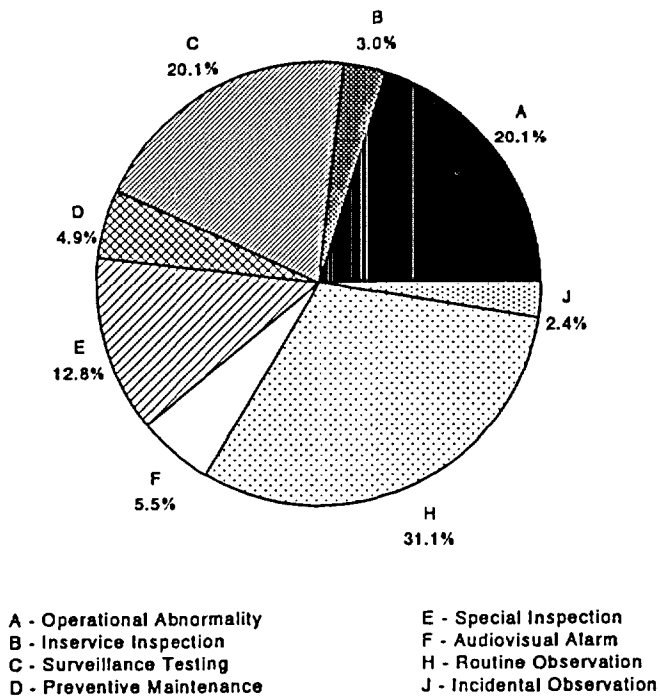
Figure 5.9 Detection methods, tube blockage

Flow blockage failures were most often recognized by excessive pressure differential (approximately 53% of events). Other blockages were found during inspections and tests (21%), by high system or component temperatures (14%), or by low flow (12%). The distribution, by method of detection, of tube blockage failures as shown in Fig. 5.9 is quite similar to that for total failures. Routine observations account for about one-third of the total, followed by operational abnormalities and surveillance testing at one-fifth each. Special inspections detected about one-eighth of the tube blockage failures, and the remainder were detected by audiovisual alarms, preventive maintenance, inservice inspection, and incidental observation.

As would be expected, the incidence of failure discoveries by the various detection categories varies significantly between the different failure types. Figs. 5.9 - 5.12 present the distributions, by detection method, for the more significant failure types.

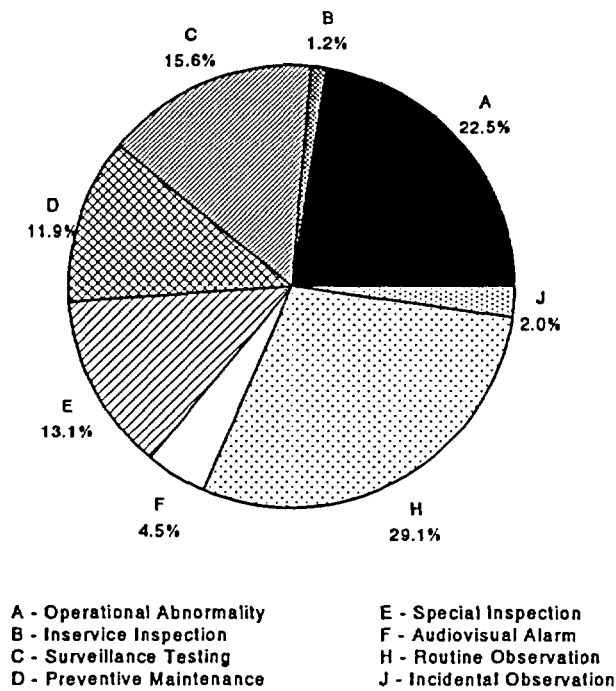
Figure 5.11 Detection methods, internal leakage

inspections and tests, or from visual observation (such as water in lubricating oil). Distribution, by detection method, of the internal leak failures is shown in Fig. 5.11. Slightly more than half the failures were detected by routine observations and operational abnormalities. Surveillance testing, special inspections, and observations during preventative maintenance each accounted for about one-eighth of the total.

Internal leaks, between the two fluid streams, are detectable from changes in closed system surge tank level, from chemical or activity measurement, from
