Subject: License Termination Request for NRC License Number 21-32115-01

Esperion Facilities
Decommissioning Final Status Report
NRC License Number: 21-32115-01

May 17, 2006

Prepared by:
Chase Environmental Group
3501 Workman Rd., Suite H
Knoxville, TN 37921

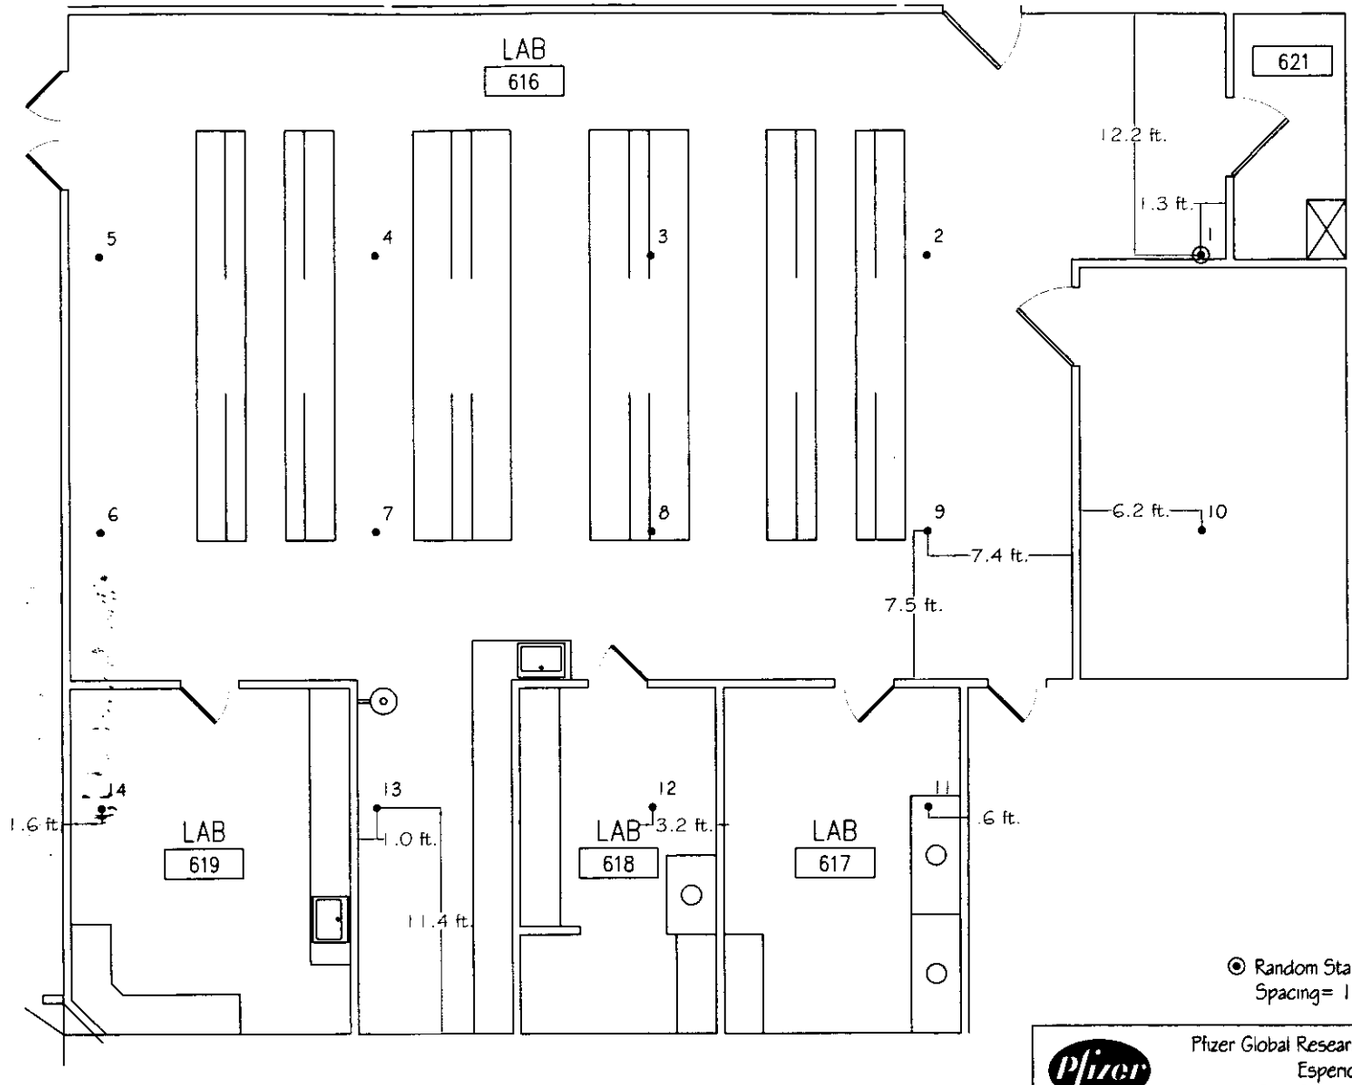
State Street Site, Survey Unit ES01 | Page: of

◉ Random Start Location
Spacing= 14 ft.
