OFFICE OF NUCLEAR REACTOR REGULATION STAFF ASSESSMENT OF  
ELECTRIC POWER RESEARCH INSTITUTE NEI 03-08, REVISION 2, "NEEDED" INTERIM  
GUIDANCE REGARDING BAFFLE-FORMER BOLT INSPECTIONS  
IN WESTINGHOUSE-DESIGN PRESSURIZED WATER REACTORS

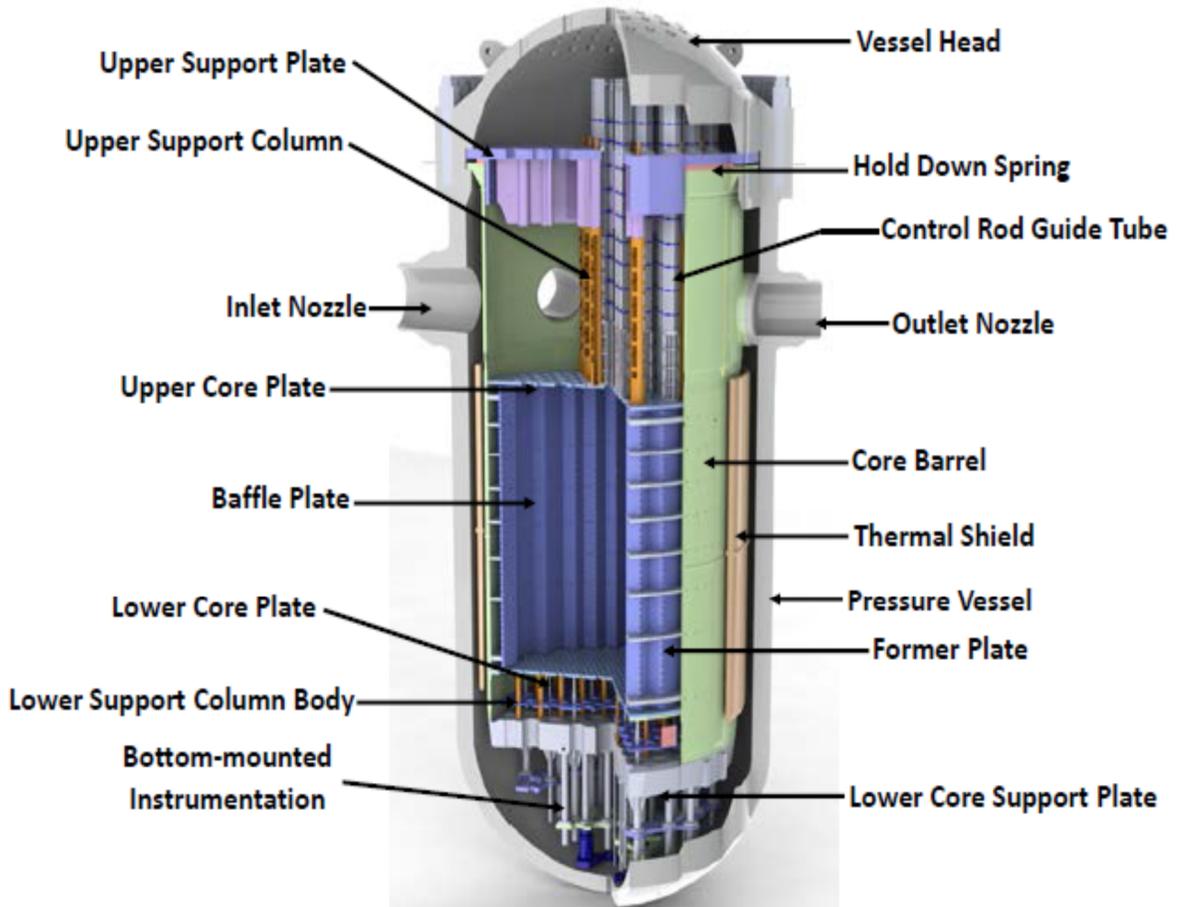
Figure 1. Typical Westinghouse reactor vessel internals general arrangement and major components

In Westinghouse-design PWRs, BFBs are part of the baffle-former assembly (Figures 1 and 2). BFBs secure the vertical baffle plates to the horizontal former plates, which in turn are bolted to the core barrel by the barrel-former bolts. The baffle plates thus form a shroud around the core that closely follows the outline of the core. The main function of the baffle plates is to direct and concentrate the flow of coolant through the core. Baffle plates span the whole height of the active core and vary in width. The baffle plates are made of 1.5-inch-thick, Type 304 stainless steel.

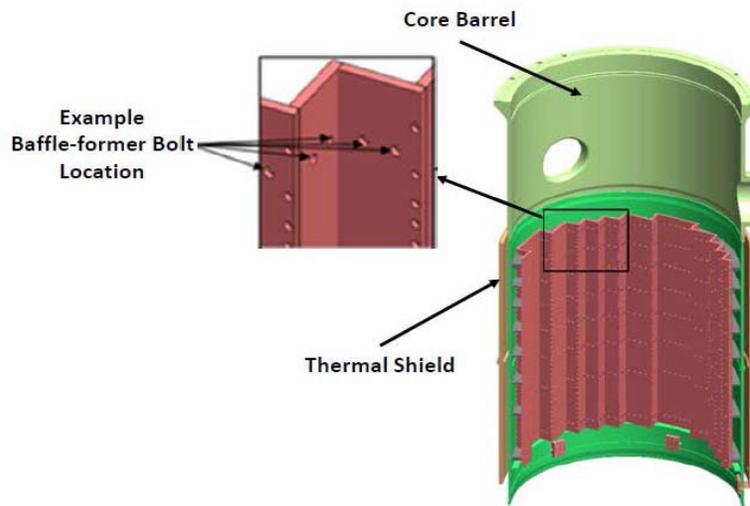
Figure 2. Typical Westinghouse baffle-former assembly

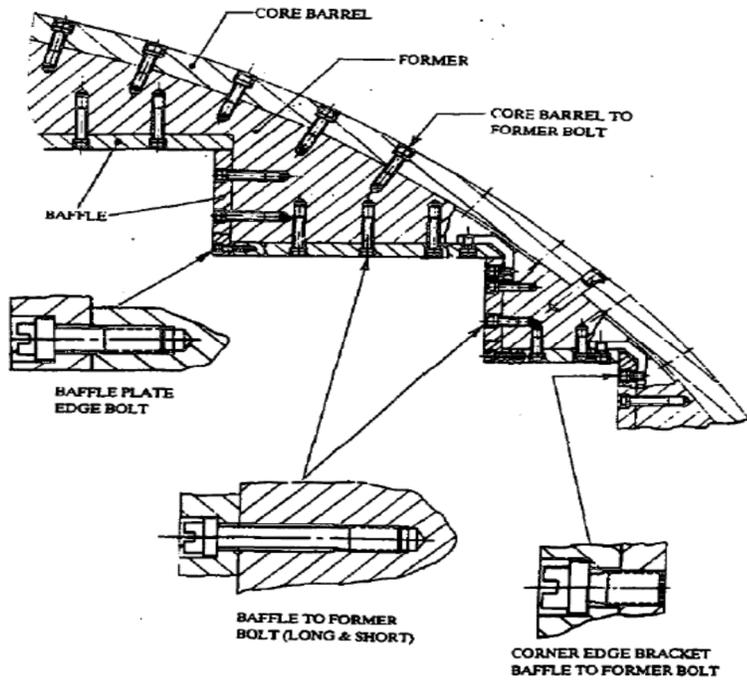
Figure 3. Cross section of one octant of a typical Westinghouse baffle-former assembly showing locations of bolt types

For a four-loop Westinghouse-design PWR, there are eight horizontal rows of BFBs, and the number of bolts across the plate vary with the plate width, from 2 bolts on the narrowest plates to 12 on the largest plates. In other designs, the number of rows and bolts across the width of the plate vary. There are also edge bolts that secure the corners of the baffle plates together to help minimize gaps at the plate corners. Figure 3 shows a cross section of the baffle-former assembly and core barrel showing the locations of these various bolts. Figure 4 shows the appearance of a BFB head similar to the configuration used in 4-loop plants, as seen from inside the core baffle. A locking bar resting in a slot on the bolt head is tack welded to the baffle plates, to prevent the bolts from backing out and to retain the bolt head if the bolt shank fractures. Other Westinghouse plant designs have slightly different bolt head designs, with some designs employing a lock washer rather than a lock bar.

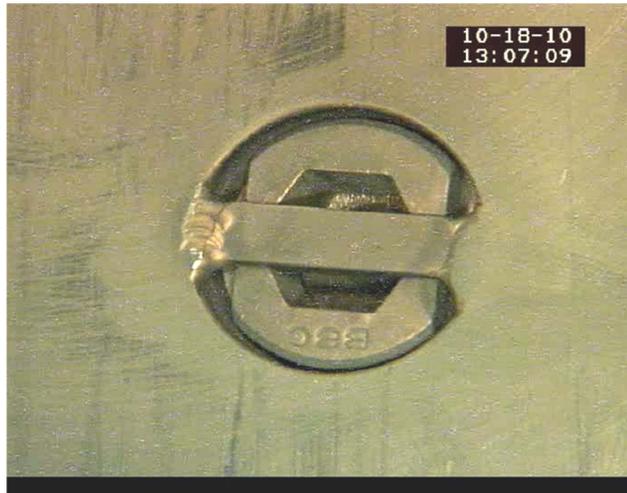
Figure 4. Appearance of BFB head as seen from the core side

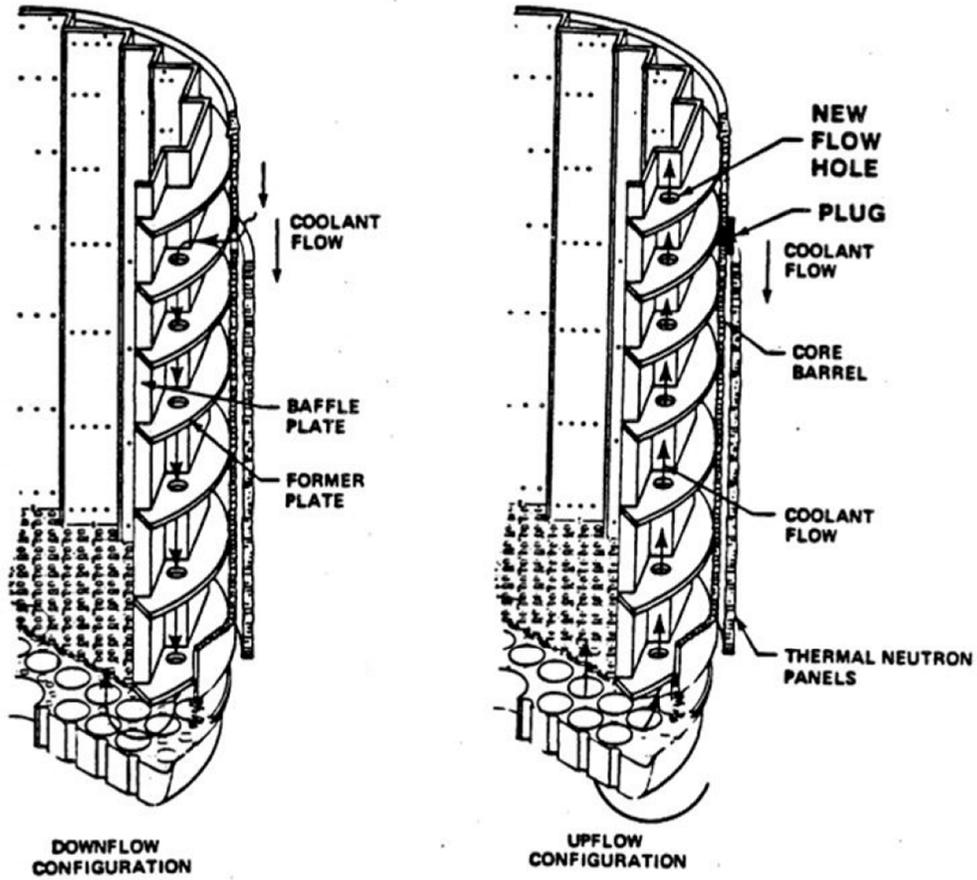
Figure 5. Schematic of flow paths in Westinghouse-designed reactor internals, comparing downflow and upflow configurations

The main flow path for coolant into the reactor vessel is down the downcomer between the reactor vessel and the core barrel, then up through the lower core plate and through the core. A small portion of the flow (bypass flow) is directed between the core barrel and the core baffle for cooling purposes. In some plants, this flow enters through holes near the top of the core barrel and flows downward, joining the main core flow when it exits through a gap between the baffle plates and the lower core plate. This is referred to as a “downflow” configuration. In other plants, mostly newer Westinghouse units, the bypass flow enters at the bottom and flows upward, parallel to the main core flow (“upflow” configuration). Figure 5 shows both flow configurations. In addition, some plants originally constructed as “downflow” plants were converted to an “upflow” configuration as indicated in Figure 5 by plugging the holes near the top of the core barrel and providing new flow holes through the top of the highest former plate.
