WOLF CREEK
NUCLEAR OPERATING CORPORATION

Subject: Docket No. 50-482: Results of the Ultrasonic Examinations of the Full Structural Weld Overlays on the Pressurizer Nozzle Welds

Results of Ultrasonic Examinations of Full Structural Weld Overlays of the Wolf Creek Generating Station Pressurizer Nozzle Welds

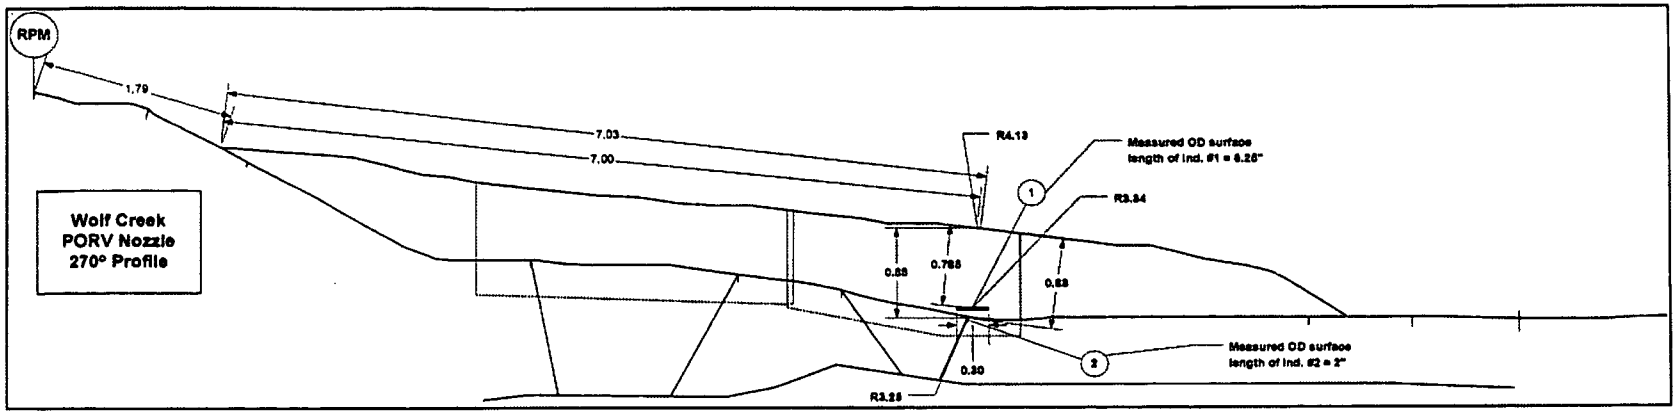
FLAW INDICATION PLOTS

Relief nozzle weld overlay. Two recordable indications (one laminar and one planar) were identified and were acceptable. See Enclosure I for the evaluation/disposition of the indications. No repairs were performed on the weld overlay.

FLAW INDICATION EVALUATION SUMMARY FOR: PORV NOZZLE		
Appendix Q Criteria	**Acceptance Standard**	**Summary of Results**
Evaluation: Laminar Flaw Indications [Ref. 9.1 of Evaluation Worksheet]	ASME Section XI, 1998 Edition 2000 Addenda, Table IWB-3514-3	ACCEPTABLE CONDITION: The single laminar flaw indication is acceptable with an area of 1.5 sq. in. compared with the 7.5 sq. in. allowable.
Evaluation: Reduction in Coverage in the PSI/ISI Base Material Examination Volume Due to Laminar Flaw Indications [Ref. 9.2 of Evaluation Worksheet]	<10% Reduction in Coverage	ACCEPTABLE CONDITION: For the SS weld examination volume, the reduction in coverage (RiC) for circumferential beams is 0.8%, and the RiC for axial beams is 1.41%. For the DM weld examination volume, there is no RiC.
Evaluation: Consideration of the Largest Radial Planar Flaw (Axial and Circumferential) That Could Exist in Any Uninspectable Volume Within the Weld Overlay Examination Volume [Ref. 9.3 of Evaluation Worksheet]	ASME Section XI, 1998 Edition 2000 Addenda, Table IWB-3514-2 Inservice Examination Standards	ACCEPTABLE CONDITION: The assumed axial planar flaw due to the laminar flaw indication has an actual a/t of 5.6% versus the allowable a/t of 12.8%. The assumed circumferential planar flaw due to the laminar flaw indication has an actual a/t of 6.2% versus the allowable a/t of 17.1%.

Evaluation: Planar Flaw Indications in PSI/ISI Base Material and Weld Overlay Examination Volumes [Ref. 9.4 of Evaluation Worksheet]	ASME Section XI, 1998 Edition 2000 Addenda, Table IWB-3514-2 Preservice Examination Standards	ACCEPTABLE CONDITION: The single planar flaw indication has no measurable through-wall dimension.
Evaluation: Flaw Indications in PSI/ISI Base Material Examination Volume and Within Outer 25% of Underlying Weld and Base Metal Must Satisfy Design Requirements of the Weld Overlay [Ref. 9.5 of Evaluation Worksheet]	Design Requirements of the Weld Overlay	ACCEPTABLE CONDITION: No planar flaw indications were detected in the outer 25% of the underlying weld and base metal.

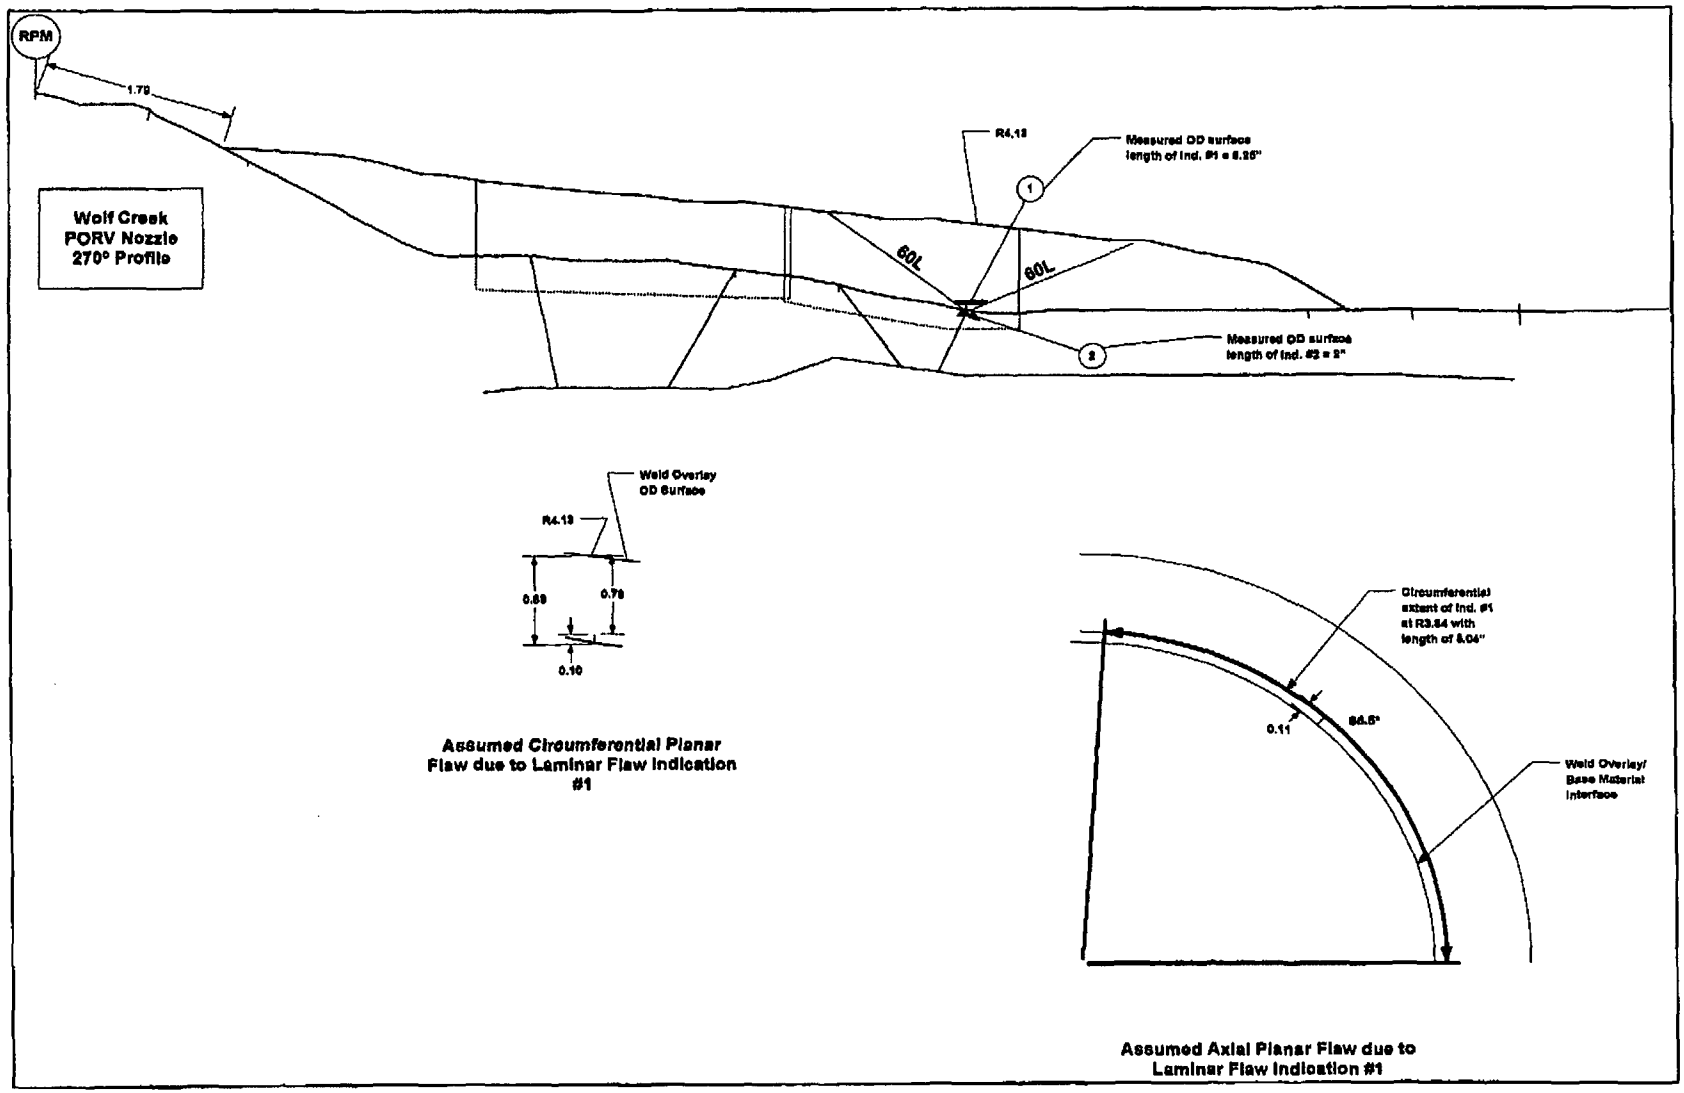
ASSUMED LARGEST PLANAR FLAW IN ANY UNINSPECTABLE VOLUME PLOTS

S=	0.79	in.	
2a=	0.10	in.	
a=	0.050	in.	
l=	5.04	in.	corrected length
Tswol=	0.89	in.	Note 1

a=	0.050	in.	
a/t=	0.01		
a/t=	12.6	Y %	
a/t=	12.6	%	allowable

a/t=	5.6	%	actual	Aspect Ratio (act)	0.01	t=	0.312	a/t=	13.9	t=	1.0	a/t=	12.7
				Y actual =	15.8								
ACCEPTABLE				Y=	1.0

S=	0.79	in.	
2a=	0.11	in.	
a=	0.055	in.	
l=	0.3	in.	
Tswol=	0.89	in.	Note 1

a=	0.055	in.	
a/l=	0.18		
a/t=	17.1	Y %	
a/t=	17.1	%	allowable
a/t=	6.2	%	actual
ACCEPTABLE

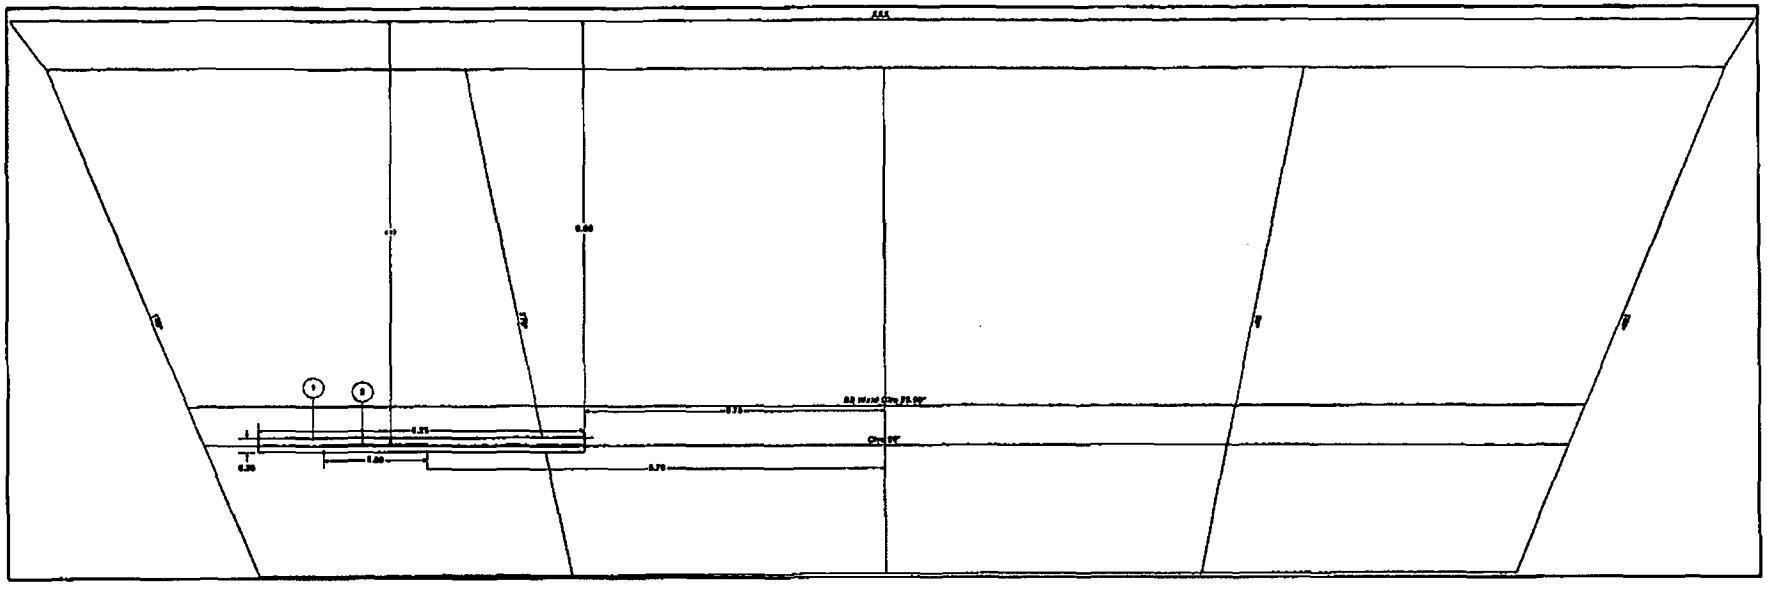
LAYOUT OF INDICATIONS

FLAW INDICATION EVALUATION SUMMARY FOR: WOLF CREEK SAFETY NOZZLE C		
Appendix Q Criteria	**Acceptance Standard**	**Summary of Results**
Evaluation: Laminar Flaw Indications [Ref. 9.1 of Evaluation Worksheet]	ASME Section XI, 1998 Edition 2000 Addenda, Table IWB-3514-3	ACCEPTABLE CONDITION: The single laminar flaw indication is acceptable with an area of 3.4 sq. in. versus the allowable of 7.5 sq. in.
Evaluation: Reduction in Coverage in the PSI/ISI Base Material Examination Volume Due to Laminar Flaw Indications [Ref. 9.2 of Evaluation Worksheet]	<10% Reduction in Coverage	ACCEPTABLE CONDITION: For the DM Weld, the reduction in coverage (RiC) due to the laminar flaw indication for axial beams is 1.18%; the RiC for circumferential beams is 0.94%. For the SS Weld, there is no RiC due to laminar flaw indications..
Evaluation: Consideration of the Largest Radial Planar Flaw (Axial and Circumferential) That Could Exist in Any Uninspectable Volume Within the Weld Overlay Examination Volume [Ref. 9.3 of Evaluation Worksheet]	ASME Section XI, 1998 Edition 2000 Addenda, Table IWB-3514-2 Inservice Examination Standards	ACCEPTABLE CONDITION: The laminar flaw indication lies primarily at the weld overlay/base metal interface. A planar flaw indication has been detected at same location as laminar flaw indication.

Evaluation: Planar Flaw Indications in PSI/ISI Base Material and Weld Overlay Examination Volumes [Ref. 9.4 of Evaluation Worksheet]	ASME Section XI, 1998 Edition 2000 Addenda, Table IWB-3514-2 Preservice Examination Standards	**UNACCEPTABLE CONDITION: The single planar flaw indication results in an actual a/t of 29.4% versus an allowable a/t of 9.5%.**
Evaluation: Flaw indications in PSI/ISI Base Material Examination Volume and Within Outer 25% of Underlying Weld and Base Metal Must Satisfy Design Requirements of the Weld Overlay [Ref. 9.5 of Evaluation Worksheet]	Design Requirements of the Weld Overlay	ACCEPTABLE CONDITION: No planar flaw indications were detected in the outer 25% of the underlying weld and base metal.

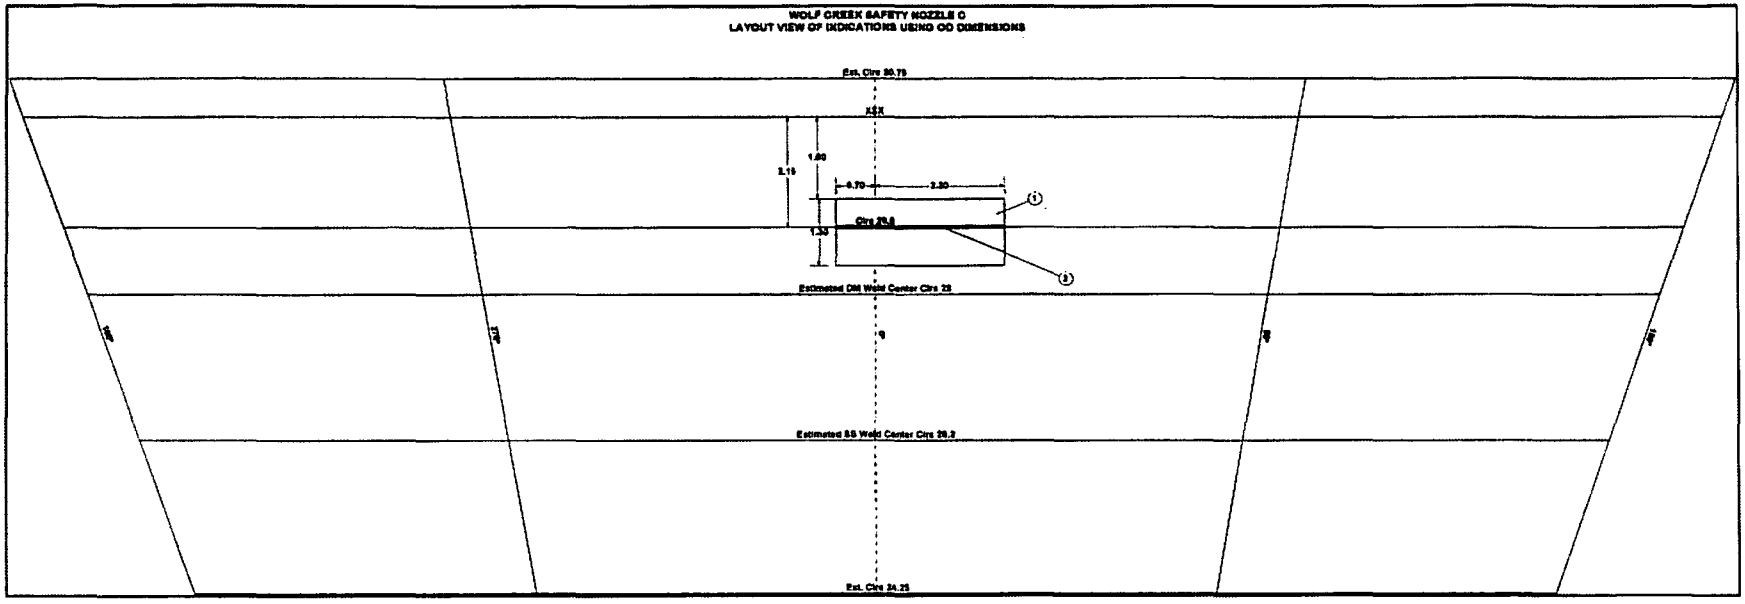
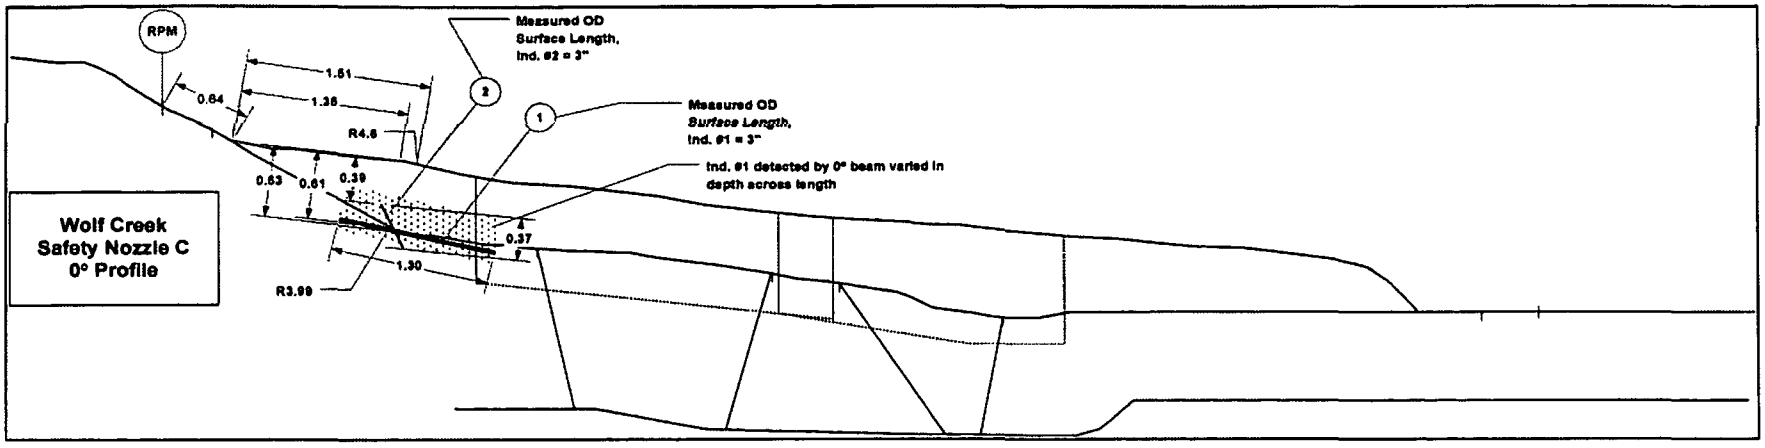
"C" Safety nozzle weld overlay. Two recordable indications (one laminar and one planar) were identified. See Enclosure II for the evaluation/disposition of the indications. As documented in Enclosure II, indication #2 (planar indication) was unacceptable per Table IWB-3514-2, requiring repair. This repair was performed by excavating the unacceptable indication. In the process of removing the unacceptable planar indication, the laminar indication was also removed. The excavated area was repaired by welding. The repair area was reexamined and one recordable (but acceptable) indication (laminar) was found in this area. See Enclosure III for the evaluation/disposition of this acceptable indication

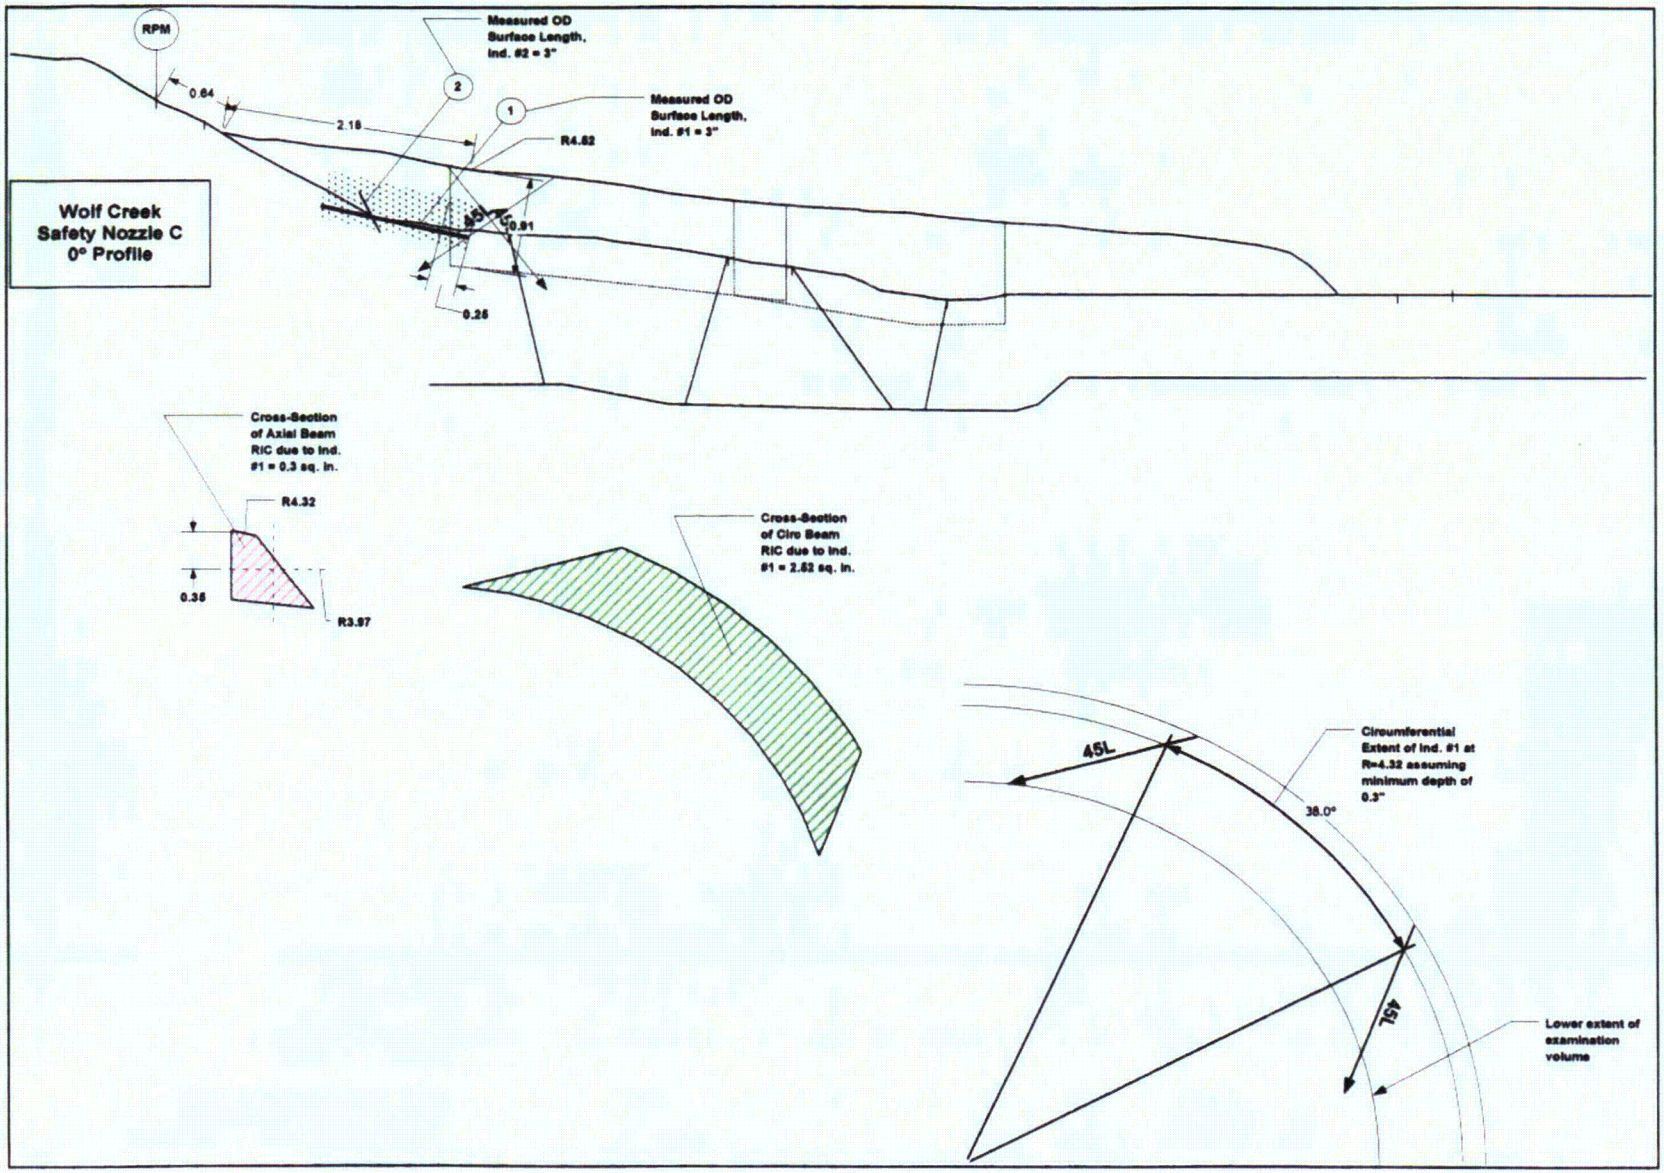
LAMINAR FLAW INDICATION #1 LIES AT WELD OVERLAY/BASE METAL INTERFACE.
A PLANAR FLAW INDICATION HAS BEEN DETECTED FROM SAME REFLECTOR.
NO ASSUMED PLANAR FLAWS ARE CONSIDERED.

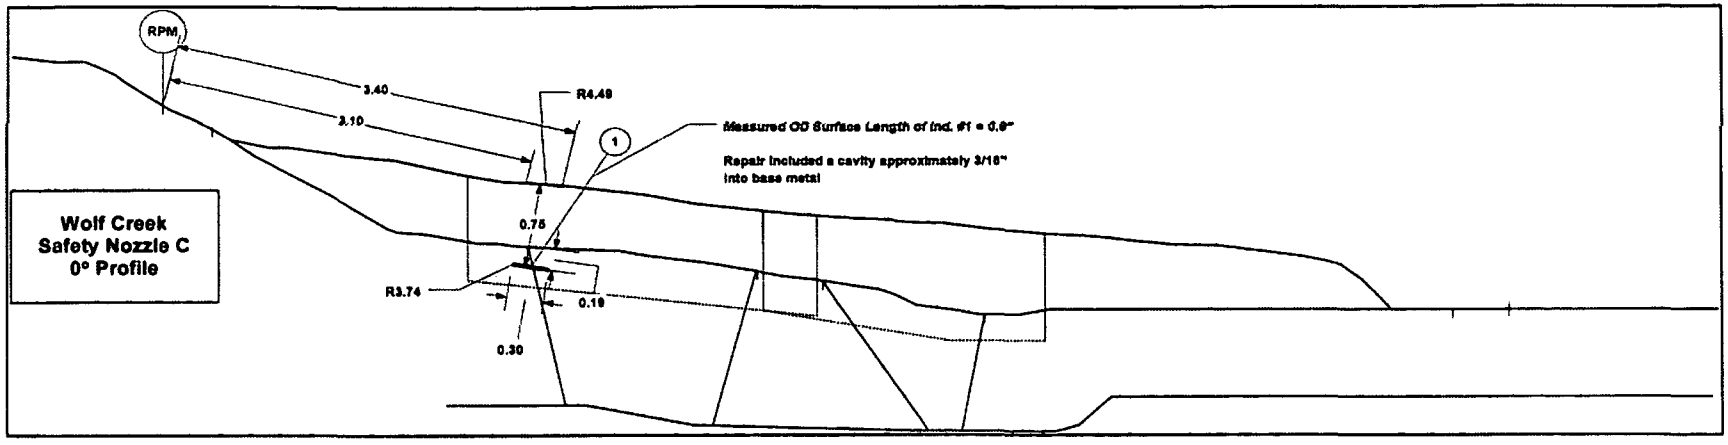
FLAW INDICATION PLOTS

Note: The plot of this indication shows a location below the the interface. This is due to a removal depth of previous indication. The previous indication was removed after a final grind of 3/16" into base material.

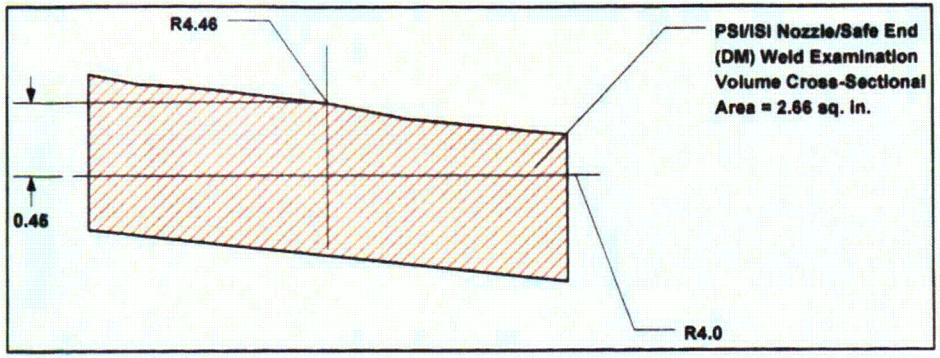
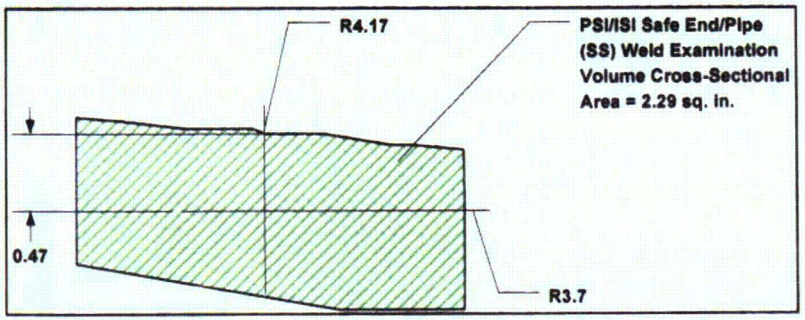
REDUCTION IN COVERAGE PLOTS

LAMINAR FLAW INDICATION #1 LIES AT WELD OVERLAY REPAIR/BASE METAL INTERFACE. THERE IS NO UNINSPECTABLE VOLUME.

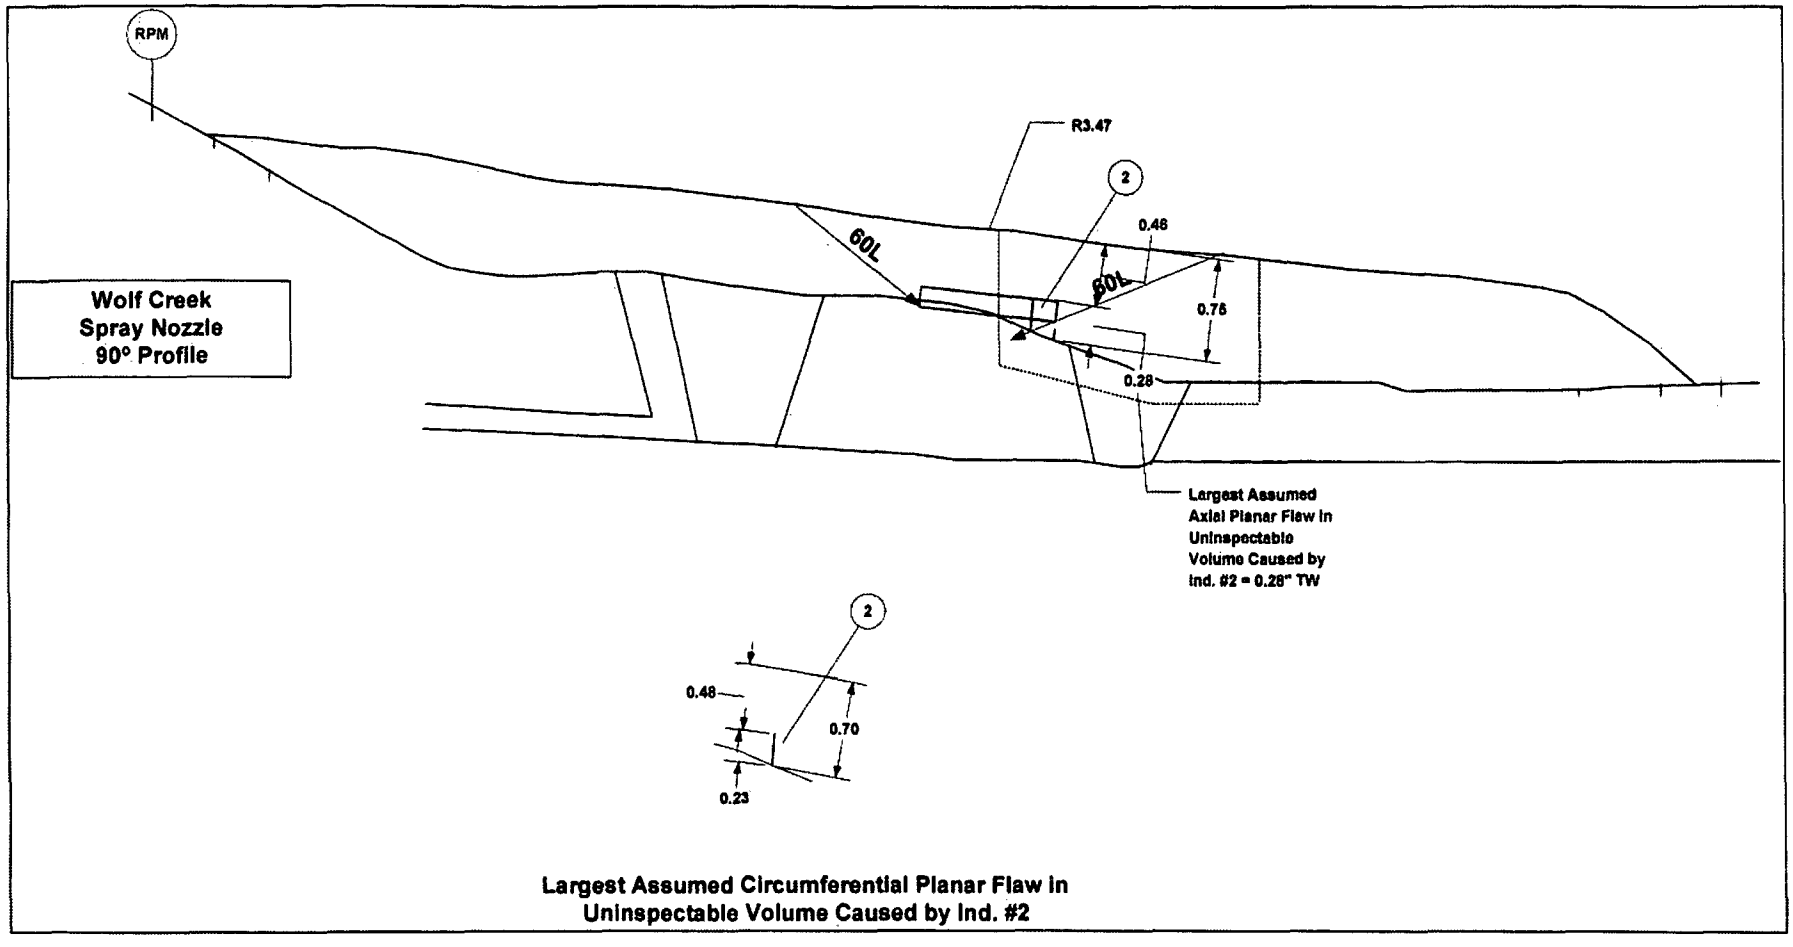
Largest Assumed Circumferential Planar Flaw in Uninspectable Volume Caused by Ind. #2

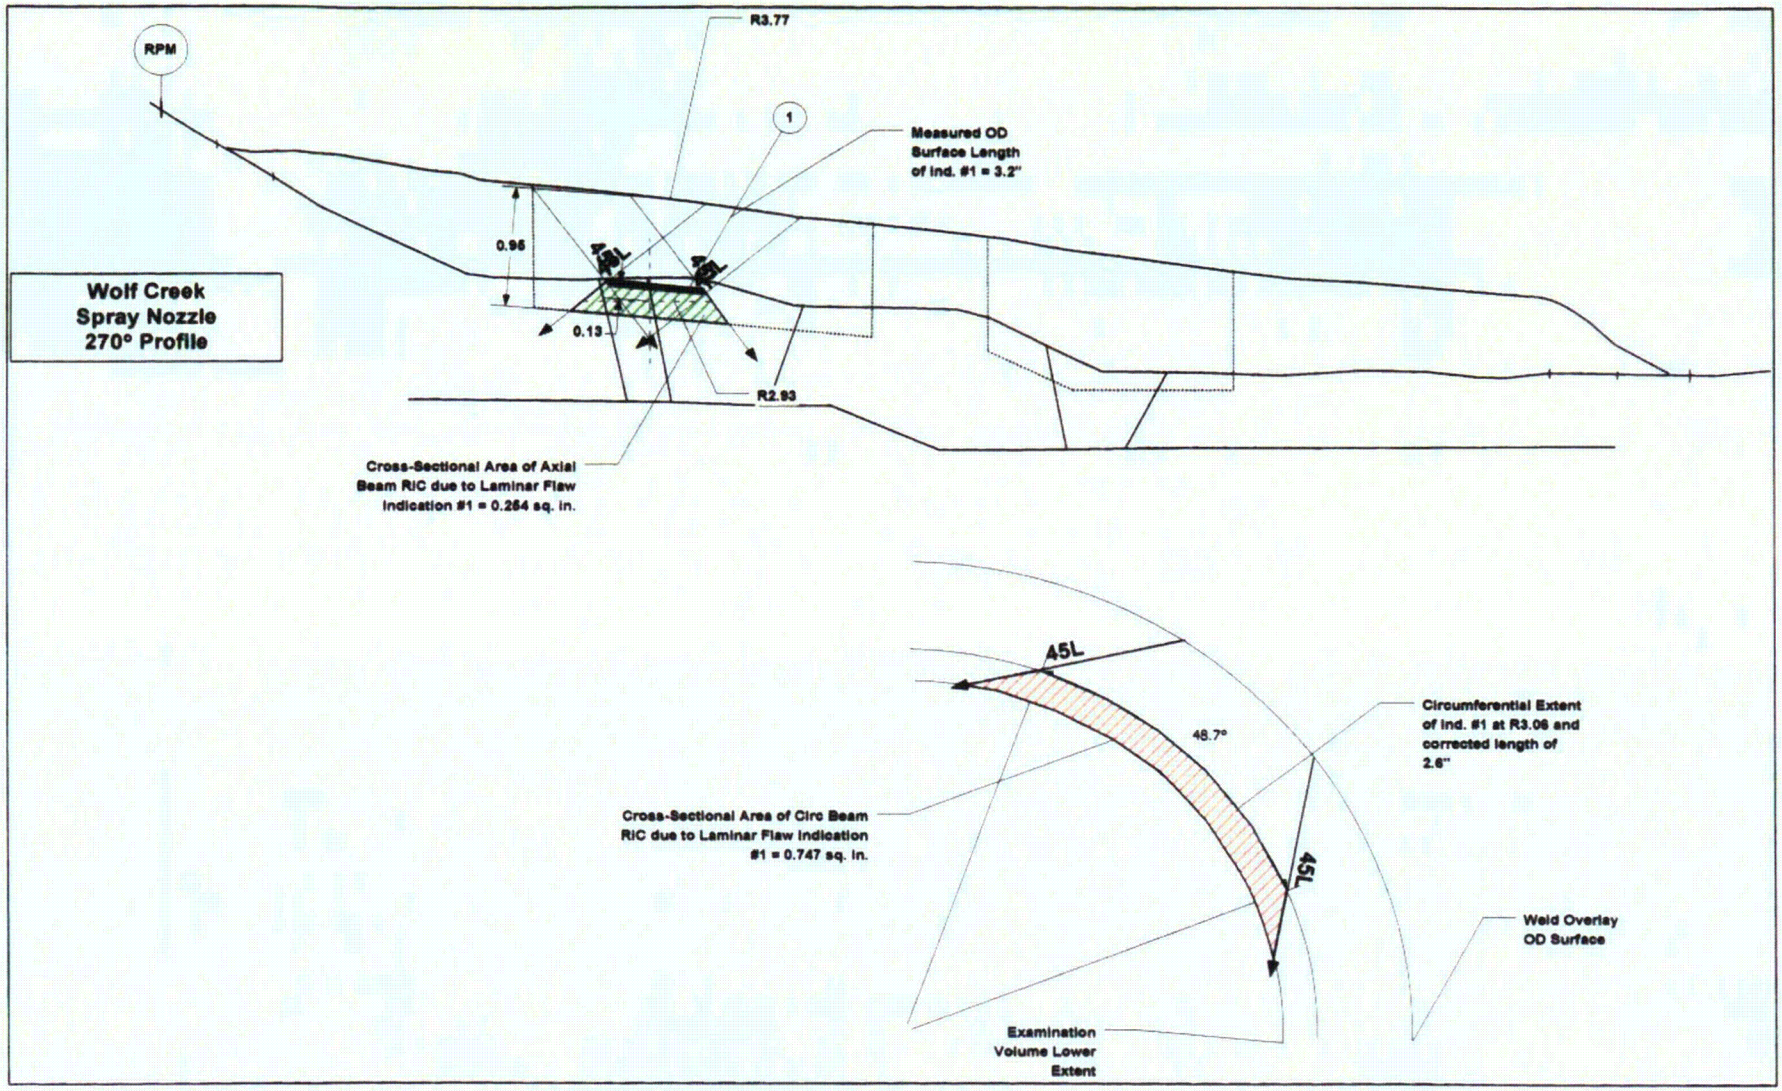
INDICATION #1 IS ASSUMED TO BE AT THE WELD OVERLAY/BASE METAL INTERFACE, I.E. NO UNINSPECTABLE VOLUME IN WELD OVERLAY
