Key Conclusions of Exponent's December 15, 2006 Report:

"Review & Analysis of the Davis-Besse March 2002 Reactor Pressure Vessel Head Wastage Event"

Exponent *Failure Analysis Associates*

March 22, 2007

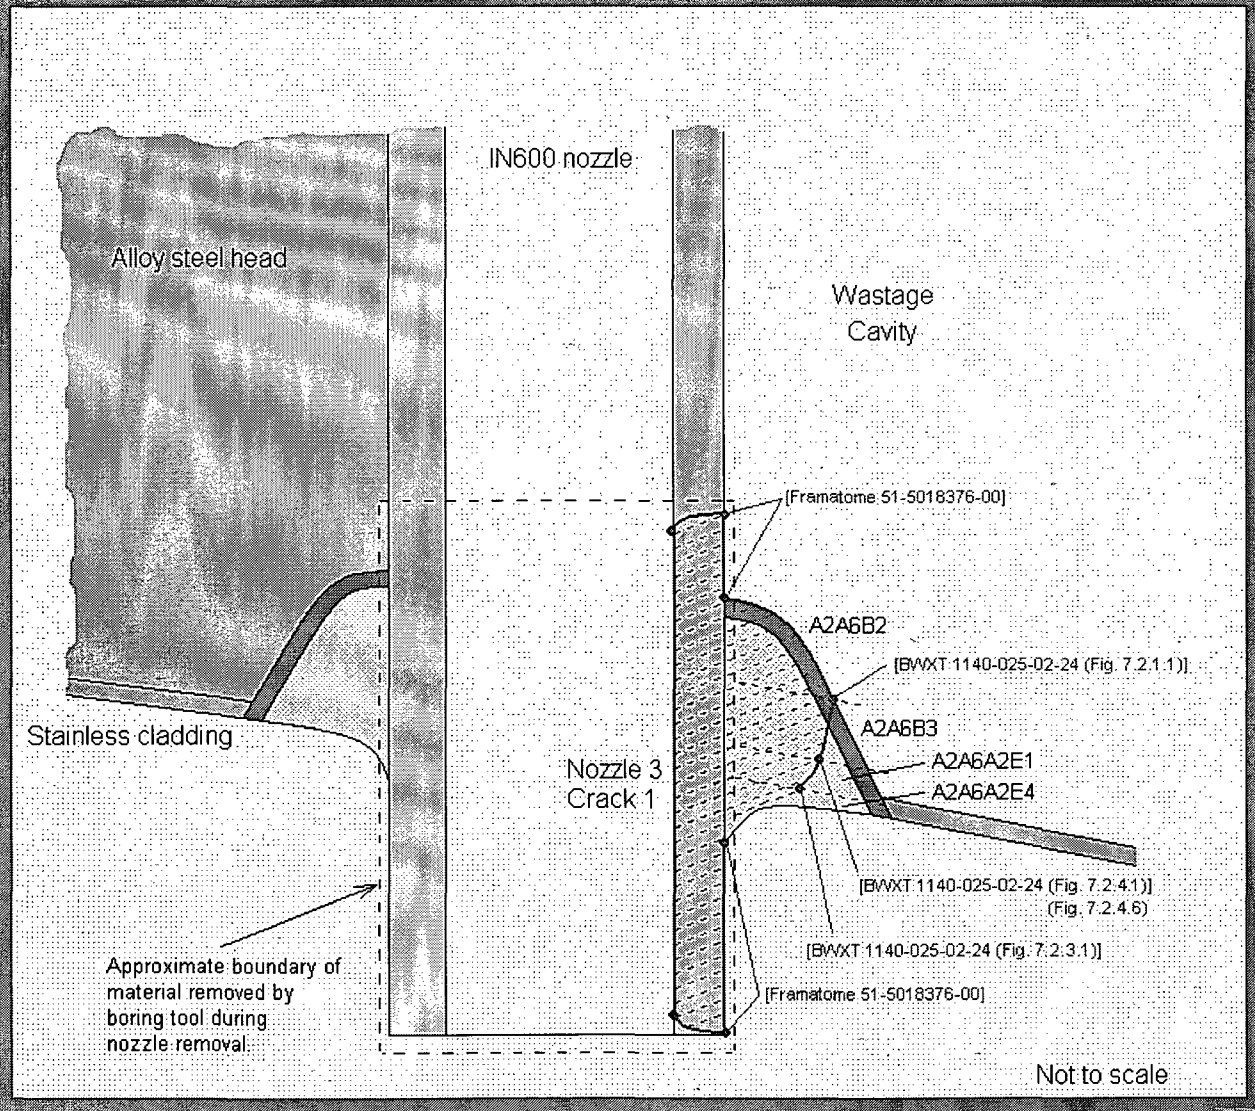
CRDM Nozzle 3 and Weld Cracking

- **May/October 2001:**
  - Nozzle 3 axial crack has grown to about 1.1 inches above the weld by October 2001
  - The leak rate from this crack is estimated at 0.02 gpm
  - The upward growing axial nozzle crack and downward growing wastage cavity have intersected
  - Mechanical erosion at the bottom of the wastage cavity increases due to the change in crack jet direction and high velocity jet impingement
  - Moisture penetrates further into the bottom of the wastage cavity due to the higher leak rate
  - Metal temperatures still remain high enough to result in phase transformation of boric acid to metaboric acid and melting
  - Combined action of wetted molten metaboric acid corrosion and mechanical action rapidly removes the 1 inch of remaining low alloy steel covering the weld
  - Undercutting of the wastage cavity likely begins

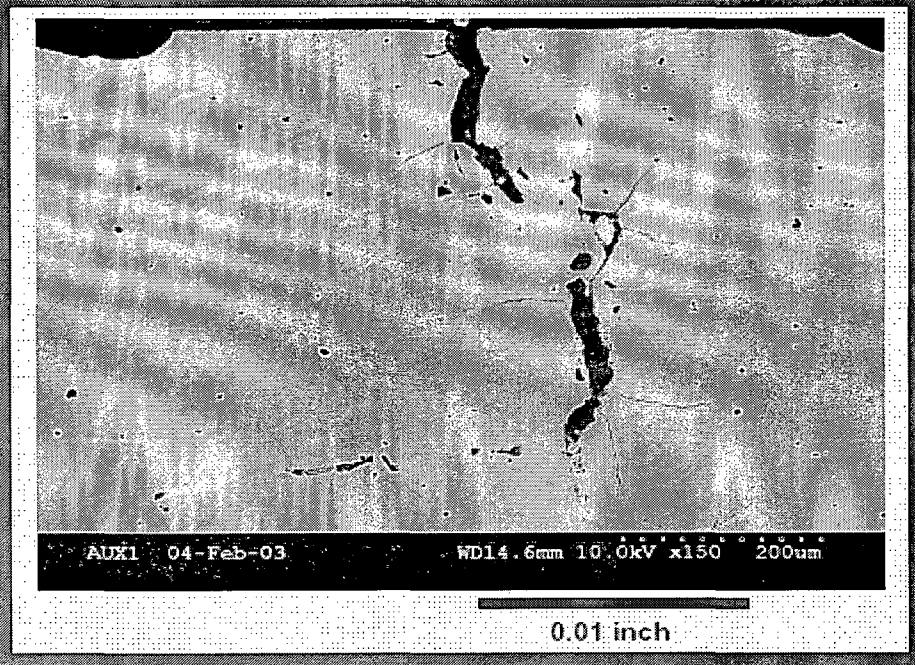
- Scanning electron micrograph of CRDM Nozzle 3 crack at 180° location showing typical width of PWSCC nozzle cracks. Maximum crack width is about 20 microns (0.0008 inches)

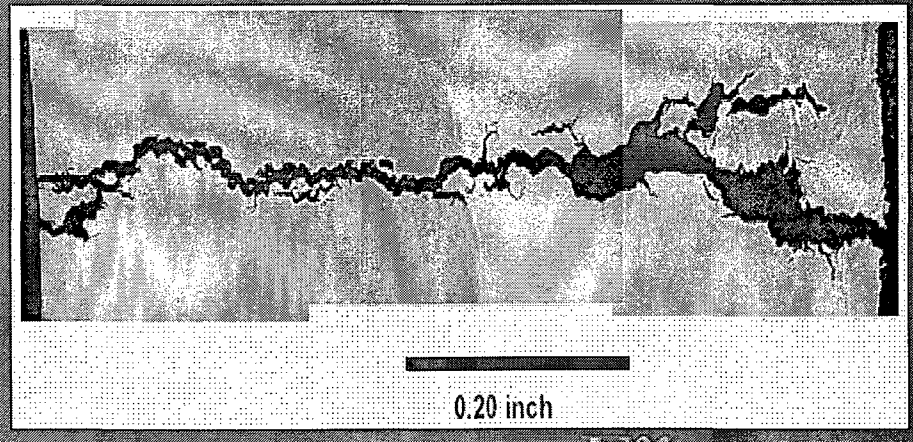
- Metallurgical examination of the Nozzle 3 weld revealed a through weld crack
  - Crack extended radially across the weld from the nozzle OD to the RPV head alloy steel
  - Crack was through weld from bottom to top
  - Crack was much wider than the axial crack in Nozzle 3 above the weld

- Optical micrograph of J-groove weld crack in CRDM Nozzle 3 at 10° location. Nominal crack width is about 400 microns (0.016 inches), about 20 times larger than the PWSCC crack in the same nozzle

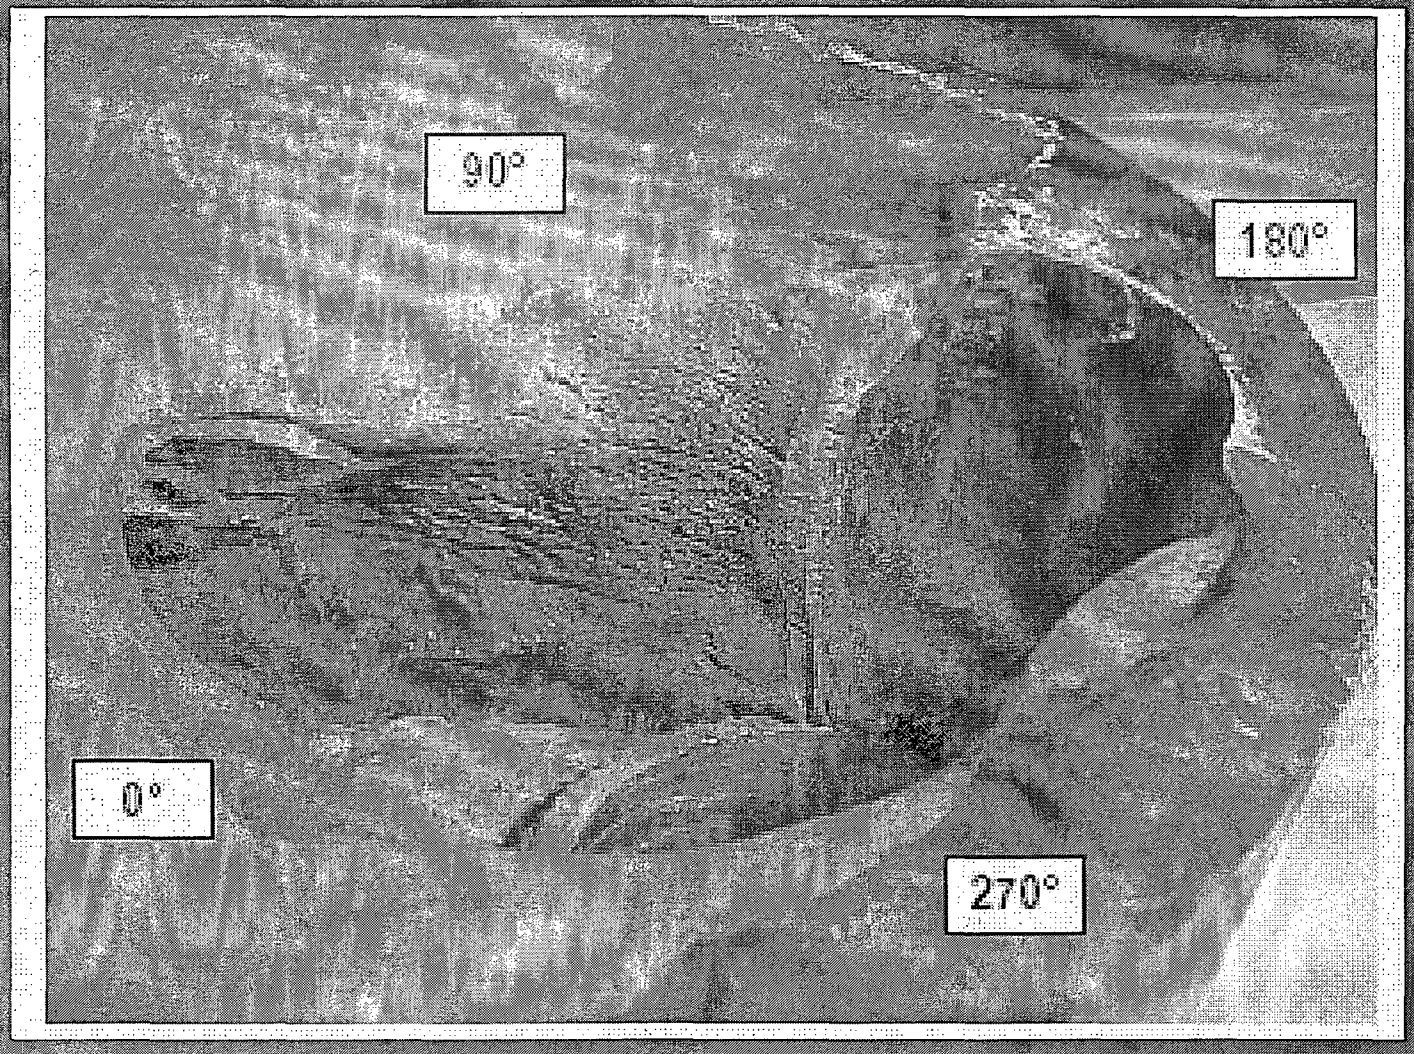
Final Wastage Cavity at CRDM Nozzle 3

- **October/November 2001:**
  - Large pre-existing weld crack is uncovered by the rapidly downward growing wastage cavity
  - Leak rate increases to around 0.16 gpm
  - Cavity metal wall temperatures remain higher than phase transformation to and melting temperature of metaboric acid
  - High velocity high flow jet impingement and wetted molten metaboric acid corrosion cause rapid wastage cavity growth, undercutting, and large cavity by February 2002
  - Significant moisture penetrates to the RPV head underneath the existing boric acid deposit from CRDM leakage
  - Head surface metal temperature remains high enough to form molten metaboric acid and presence of moisture from higher leak rate results in top-down wastage of RPV alloy steel evident in final wastage cavity morphology

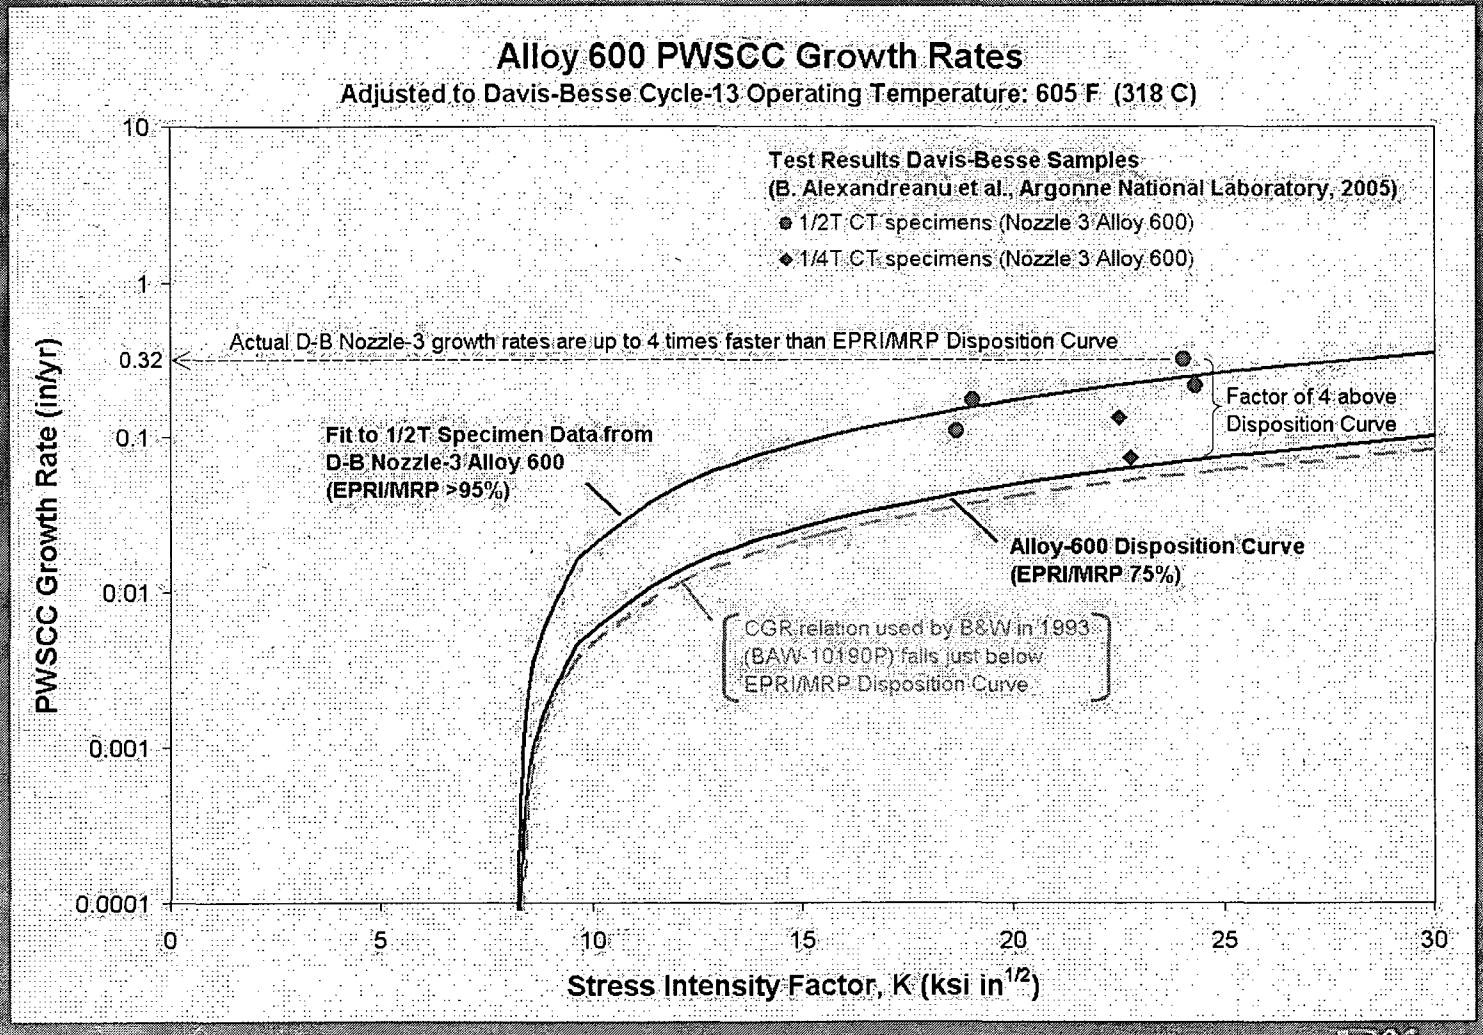
CRDM Nozzle 3 Cracking Behavior (cont'd)

- Actual Nozzle 3 Alloy 600 material exhibited very high crack growth rates in NRC/ANL work reported in 2006
- Crack growth rates for Nozzle 3 Alloy 600 material were 3 to 4 times industry expected rates, at 95th percentile of data
- Explains why the Nozzle 3 axial crack grew to 1.23 inches above the weld and 4.08 inches in total length
- Led to conclusion that cracking timeline for CRDM Nozzle 3 was much shorter than previously thought
