INSPECTION OF THE LICENSEES' IMPLEMENTATION OF INDUSTRY INITIATIVE
ASSOCIATED WITH THE OPEN PHASE CONDITION DESIGN VULNERABILITIES IN
ELECTRIC POWER SYSTEMS (NRC BULLETIN 2012-01)

Effective Date: 08/18/2020

2515/194-01 OBJECTIVE

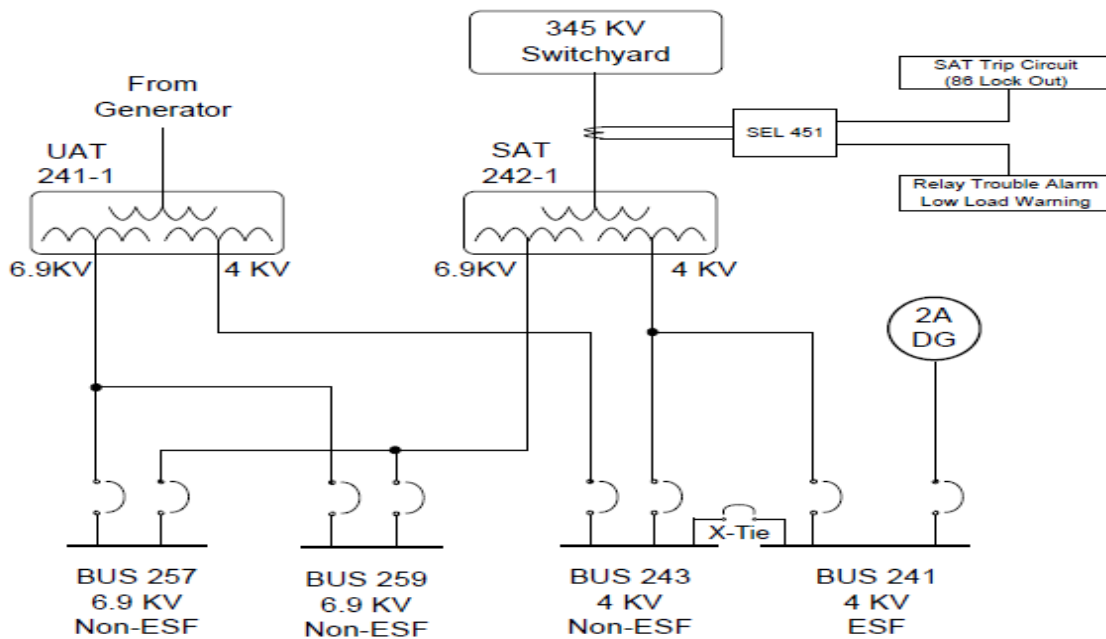
Byron Station is a two-unit pressurized water reactor plant. The electrical distribution system for each unit consists of four non-safety 6.9-kV buses, two non-safety 4 kV buses, and two engineered safety features (ESF) 4-kV station buses. During normal plant operation, the safety (or ESF buses) and non-safety buses (or non-ESF) are powered from the Unit Auxiliary Transformers (UATs). On the day of the event, two non-ESF 6.9-kV station buses that power two of the RCPs and the two 4-kV (ESF and non-ESF) buses were supplied by station auxiliary transformers (SATs) connected to the 345-kV offsite power switchyard (Figure 1 below). The other two 6.9-kV and 4-kV buses were powered from the UATs. The undervoltage condition on the SAT powered buses was caused by a broken inverted porcelain insulator stack of the phase C conductor for the 345-kV power circuit that supplies both SATs. The insulator failure caused the associated phase C conductor to break off from the power line disconnect switch resulting in a high impedance ground fault through the fallen phase C conductor and a sustained open phase condition (OPC) on the high voltage side of the SAT. The open circuit created an

unbalanced voltage condition on the two 6.9-kV non-ESF RCP buses and the two 4.16-kV (ESF and non-ESF) buses. After the reactor trip and subsequent generator trip, the two 6.9 kV buses, which were aligned to the UATs, automatically transferred to the SATs, as designed. As a result of the open circuit on C phase, the load current in phases A and B increased and caused the remaining two operating RCPs to trip on phase overcurrent. In the absence of any operating RCPs, control room operators performed a natural-circulation cooldown of the plant.

The SATs continued to power the 4.16 kV ESF buses A and B because of a design vulnerability that did not isolate the safety related buses from the degraded offsite power system. Some ESF loads that were energized relied on equipment protective devices to prevent damage from an unbalanced overcurrent condition. The phase overcurrent condition caused by the OPC actuated relays to trip several ESF loads.

Figure 1. Simplified Schematic of Electrical buses associated with one train (Unit 2)

Approximately 8 minutes after the reactor trip, the control room operators diagnosed the loss of the phase C condition and manually tripped circuit breakers to separate the unit buses from the offsite power source. When the operators opened the SAT feeder breakers to the redundant 4.16-kV ESF buses, the loss of voltage relays started the emergency diesel generators (EDGs) and restored power to the ESF buses. If the condition had been allowed to persist for an additional few minutes, damage to the RCP seals could have occurred through a loss of RCP seal cooling water. This in turn, could have resulted in a loss of coolant from the RCP seals in the containment building.
