SUBJECT: STAFF OBSERVATIONS OF TESTING FOR GENERIC SAFETY ISSUE 191 DURING FEBRUARY 12 AND FEBRUARY 13 TRIP TO THE ALDEN TEST FACILITY FOR PCI STRAINER TESTS

Observations of Testing at Alden Research Laboratory
February 12 and 13, 2008

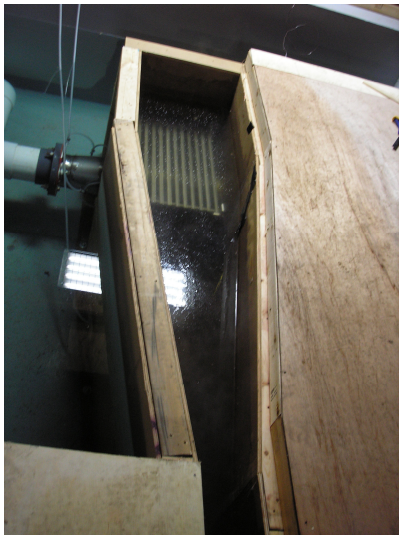
Photo 1

The flume was then drained. There was about 12 inches of debris in the bottom of the flume which reduced toward the debris addition point. The debris bed on the strainer was a transitioning bed. Some of the gaps appeared to be filled with debris and some were partially filled. On the edges of the strainer the debris appeared to be a thin bed. Some of the gaps were packed with debris. The debris bed appeared to be relatively dense. (See Photos 3 and 4.) Test personnel felt that the strainer was probably not completely covered with debris. However, the staff observed essentially complete coverage of the portions of the bed that were viewable.

The head loss associated with the full debris load with fibers added first (debris added in the following order: fibrous fines, small fibers, large fibers, particulates, chemicals) was less than 2 ft. This test resulted in a transitioning bed with some gaps mostly filled with debris, some gaps partially filled, and a thin-bed on the edges of the strainer.

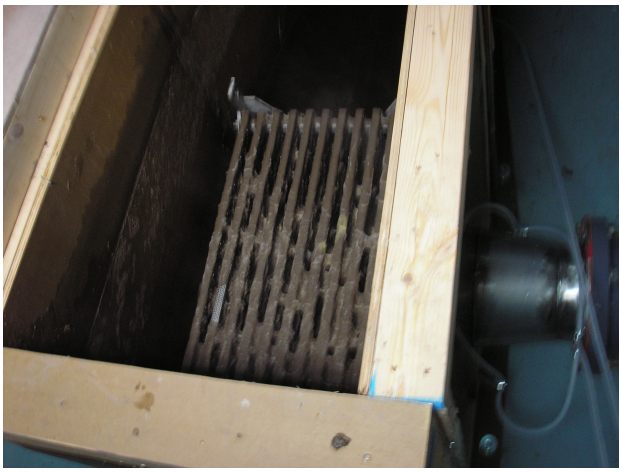
Photo 5

The flume was slowly drained until the pump started sucking air (the strainer submergence at this point was about one inch or less). The pump was secured and the flume was drained completely to allow observation of the debris bed on the strainer. The debris bed appeared to be a chocolate coating over the strainer. It appeared to be a thin bed. In addition, some debris had settled onto the strainer during drain down. It is likely that the entire bed was a homogeneous brown coating before debris fell onto it during drain down. The bed felt like a very dense sponge that was relatively strong under compression, but easily broke apart in tension. Fibers were evident in the brown particulate. (See Photos 5 to 9.)

The head loss with a small amount of latent particulate and fiber added first, particulate debris added second, and fine fibrous debris added next resulted in a very large head loss of 28 ft. The debris bed appeared to be a thin bed.
