U.S. Nuclear Regulatory Commission Accident Sequence Precursor Program 2020 Annual Report

March 2021

**Performance and Reliability Branch
Division of Risk Analysis
Office of Nuclear Regulatory Research
U.S. Nuclear Regulatory Commission
Washington, DC 20555-0001**

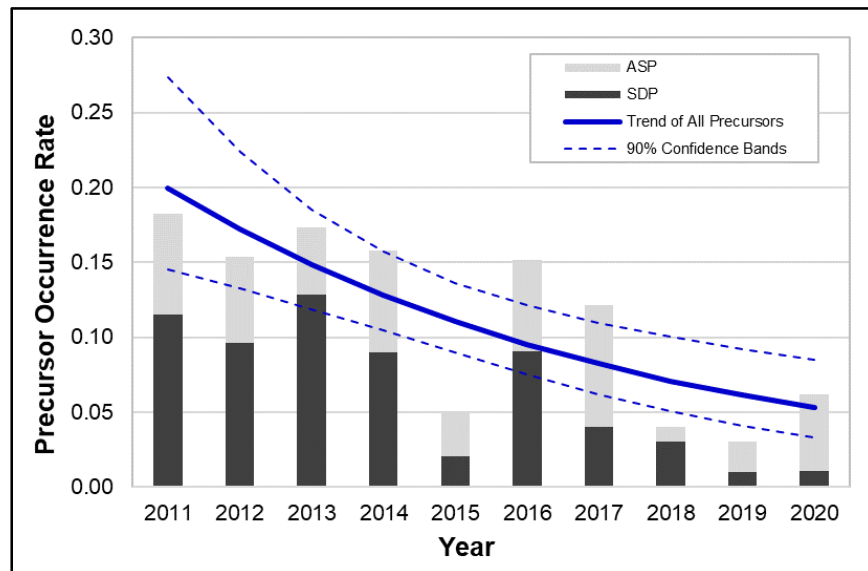
Figure 1. Occurrence Rate of All Precursors

- *Trend.* Over the past decade (2011–2020), the mean occurrence rate of all precursors exhibits a statistically significant decreasing trend (*p-value* = 0.00001).⁶ See [Figure 1](#) for additional information. A figure containing the historical precursor occurrence rates is provided in Appendix B of the [ASP Program Summary Description](#) (ADAMS Accession No. ML20049G020).

⁵ For figures with statistically significant trends, the solid line is the fitted occurrence rate of precursor using a Poisson process model. The dashed lines represent the 90-percent confidence band for the fitted occurrence rate.

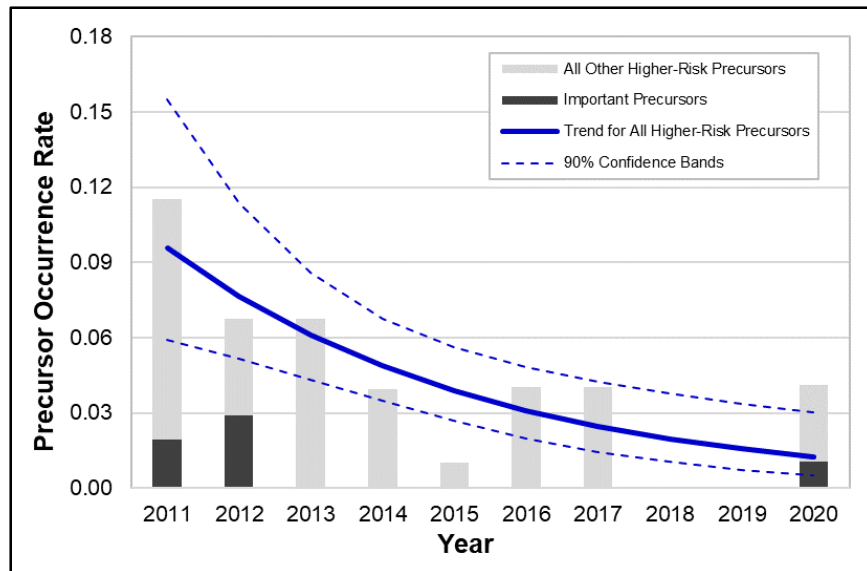
Figure 2. Occurrence Rate of Higher-Risk Precursors

- *Trends.* Over the past decade (2011–2020), the mean occurrence rate of precursors with a CCDP or Δ CDP greater than or equal to 10^{-5} exhibits a statistically significant decreasing trend (p -value = 0.00007). See [Figure 2](#) for additional information. In addition, the mean occurrence rate of precursors CCDP or Δ CDP greater than or equal to 10^{-4} exhibits a statistically significant decreasing trend (p -value = 0.03).

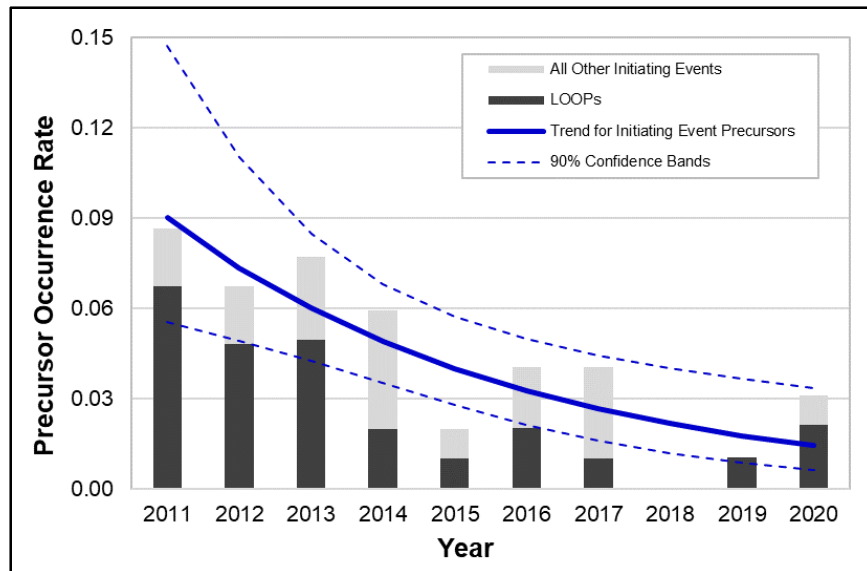
Figure 3. Occurrence Rate of Initiating Event Precursors

- *Trend.* Over the past decade (2011–2020), the mean occurrence rates of precursors involving initiating events exhibits a statistically significant decreasing trend (p -value = 0.0003). See [Figure 3](#) for additional information.

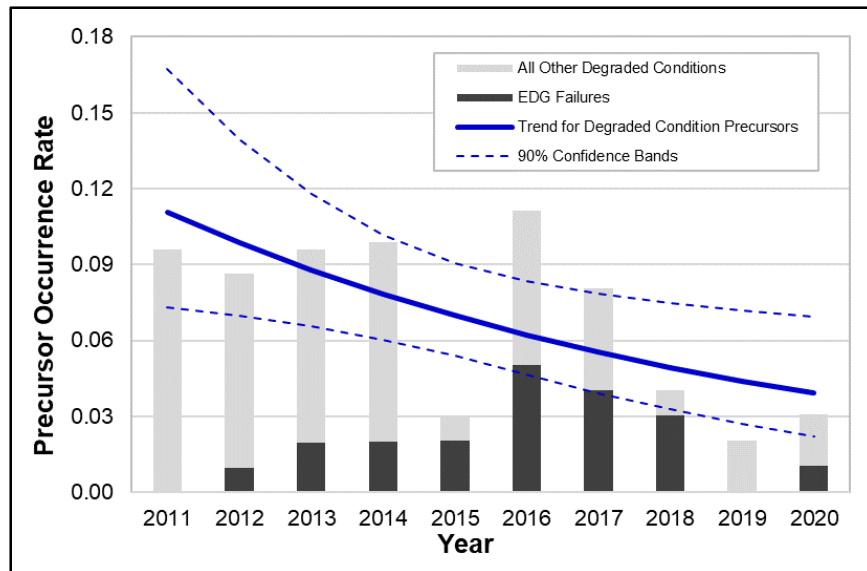
Figure 4. Occurrence Rate of Degraded Condition Precursors

- *Trend.* The mean occurrence rates of precursors involving degraded condition(s) exhibits a statistically significant decreasing trend (p -value = 0.007). See [Figure 4](#) for additional information.

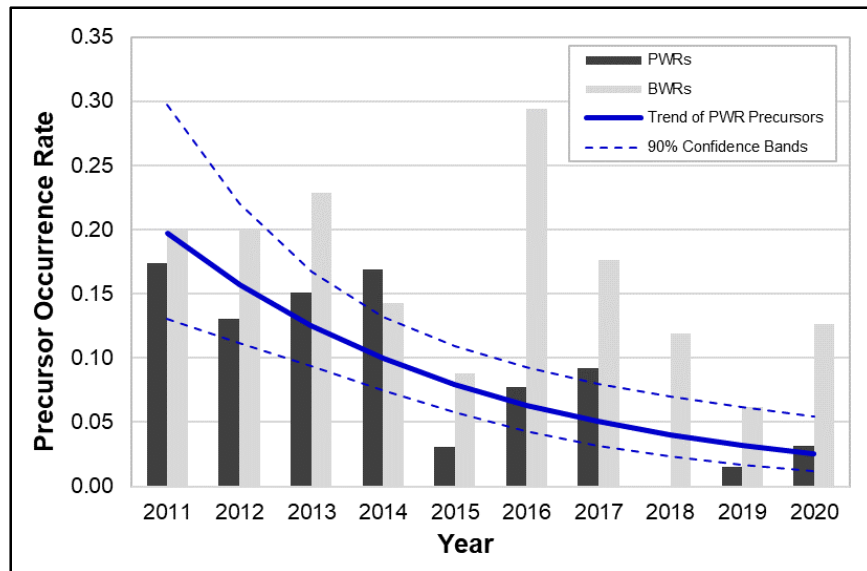
Figure 5. Occurrence Rates of Precursors at BWRs and PWRs

- *Trends.* The mean occurrence rates of precursors that occurred at BWRs does not exhibit a statistically significant trend ($p\text{-value} = 0.1$). However, there is a statistically significant decreasing trend ($p\text{-value} = 0.000003$) for the mean occurrence rate of precursors that occurred at PWRs. See [Figure 5](#) for additional information.

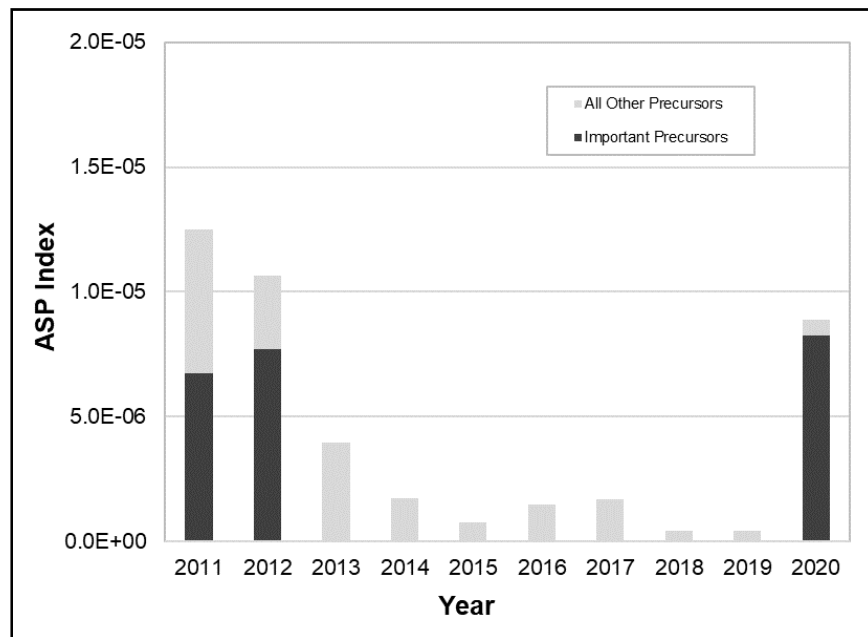
Figure 6. Integrated ASP Index

The integrated ASP index shows the cumulative plant average risk from precursors on an annual basis. The integrated ASP index is calculated using the sum of CCDPs/ Δ CDPs from precursors identified in a given year and is then normalized by dividing that sum by the total reactor-operating years for all NPPs in that year. In addition, the integrated ASP index includes the risk contribution of a precursor for the entire duration of the degraded condition (i.e., the risk contribution is included in each fiscal year that the condition existed). For example, a precursor involving a degraded condition is identified in June 2015 and has a Δ CDP of 5×10^{-6} . A review of the LER or inspection report (IR) reveals that the degraded condition has existed since a design modification that was completed in February 2011. In the integrated ASP index, the Δ CDP of 5×10^{-6} is included in the years 2011–2015 (i.e., the year it was identified and any year that the deficiency existed). The risk contributions from precursors involving initiating events are included in the year that the event occurred.

- *Trends.* The integrated ASP index does not exhibit a statistically significant trend (p -value = 0.1).¹³ See [Figure 6](#) for additional information.
