Contamination Event Report No. 92-001

Storm Drain Pond
1984 - 1992
Columbia Generating Station

November 14, 2007

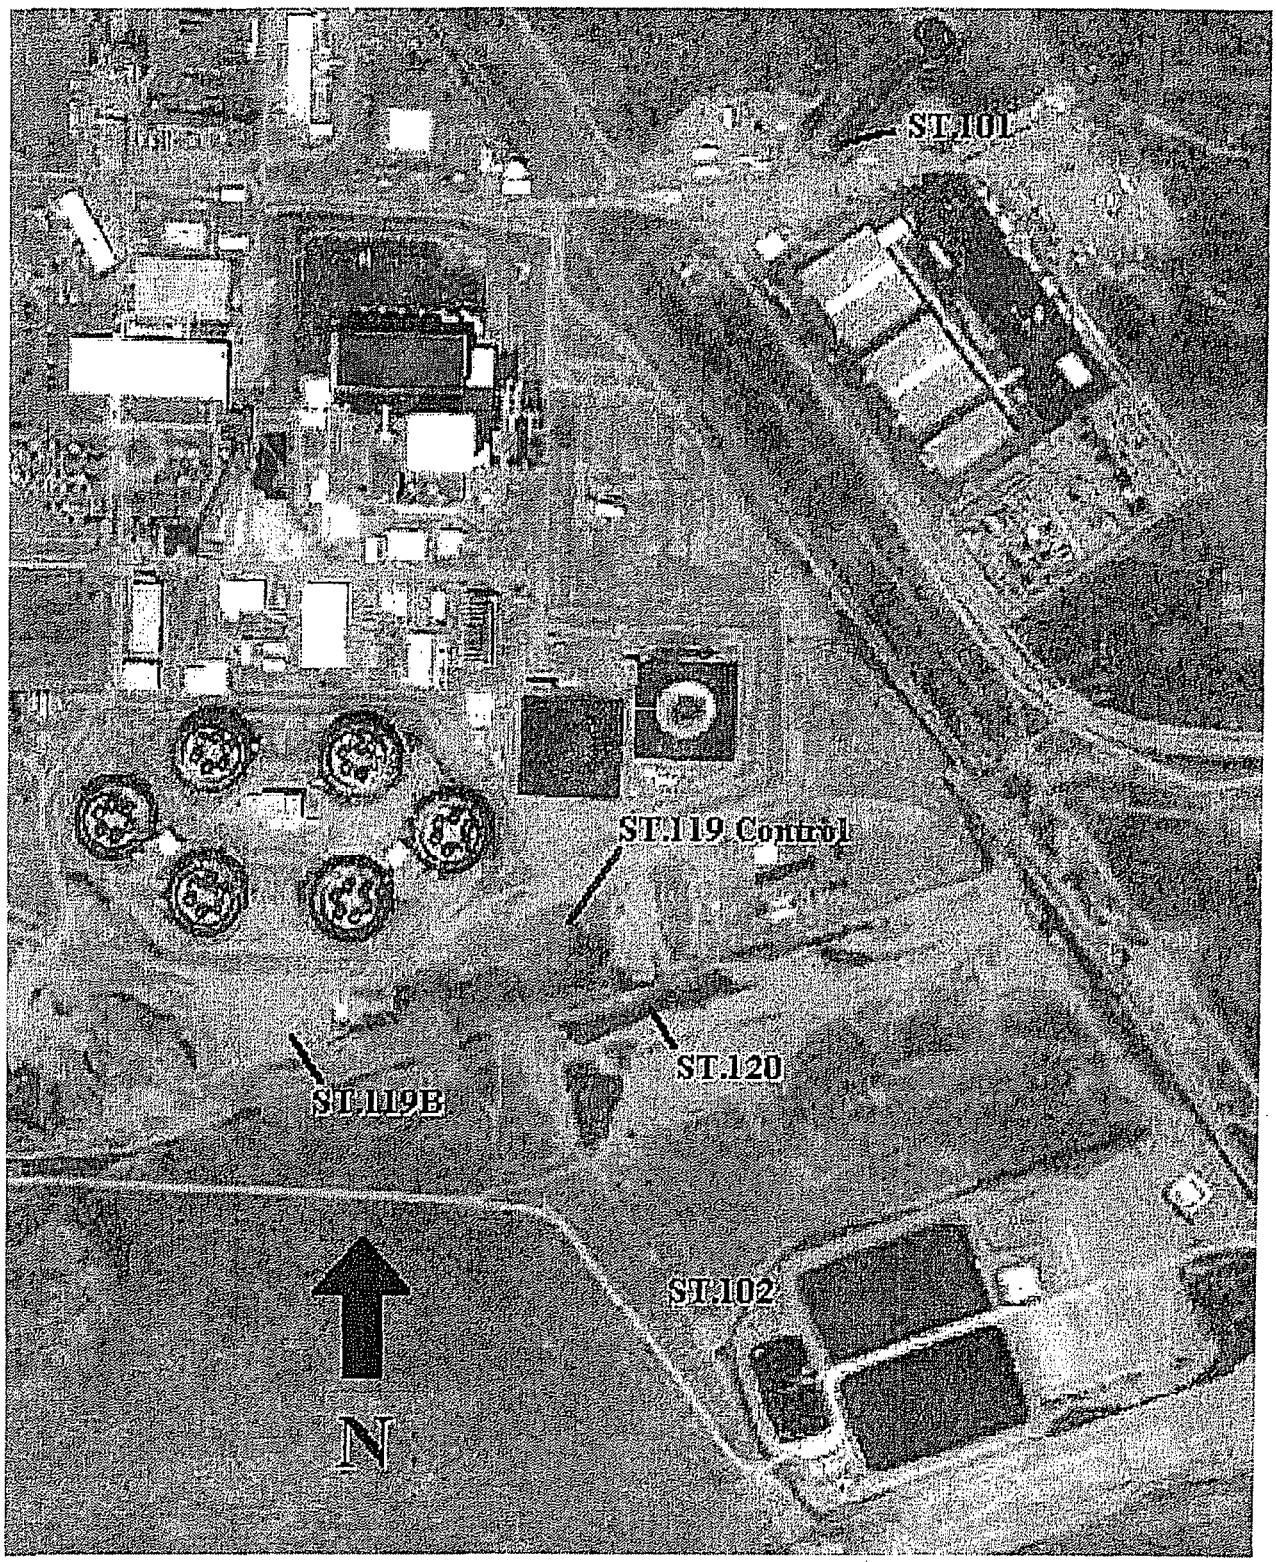
FIGURE 4-3 REMP NEAR PLANT SAMPLING LOCATIONS

STATION 102A (APPROXIMATELY 0.25 MI SOUTH). STATION 102 IN PICTURE IS BOTH 102B, 102D AND 102G.
