RIL 2021-08

USBR HL-2019-01

EROSION TESTING OF ZONED ROCKFILL EMBANKMENTS

Prepared by:
T. Wahl

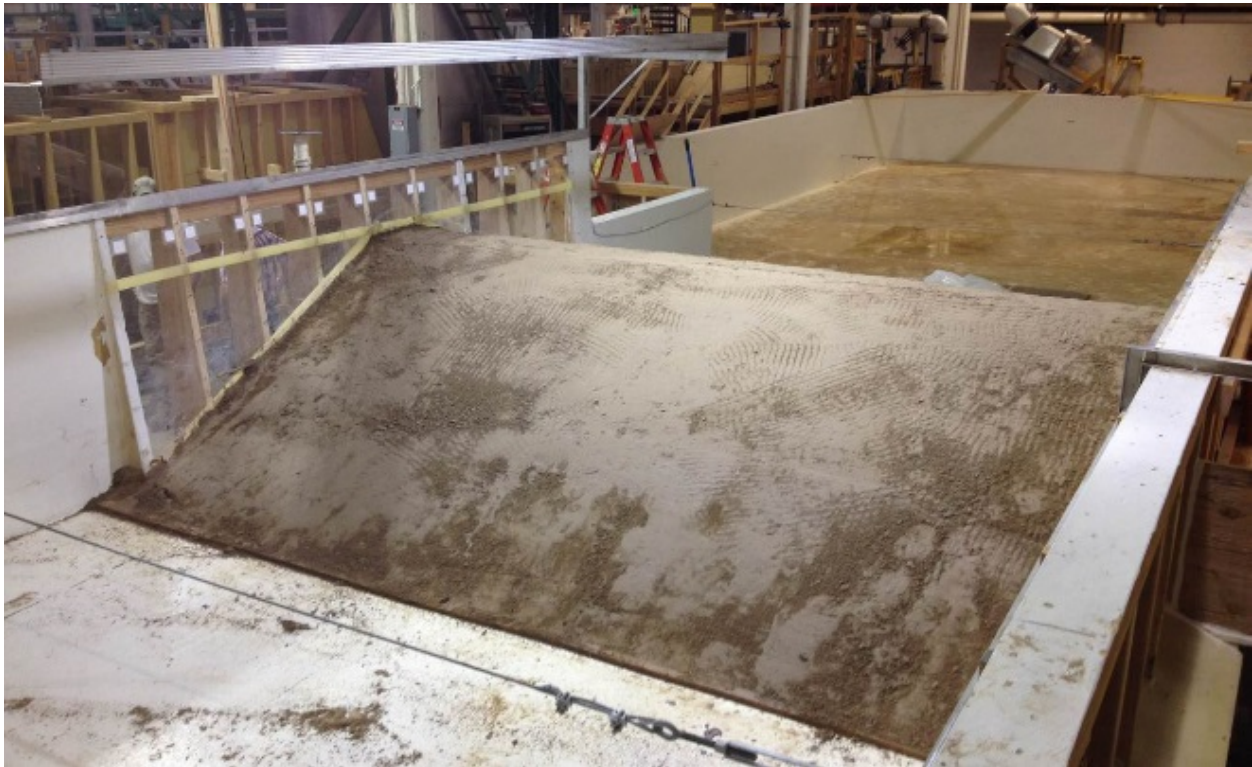
Figure 2-1 Embankment breach test facility viewed from the upstream end of the headbox, overlooking the homogeneous CL-ML embankment (Dam Safety-funded first test).

The dam breach test facility consisted of a 12.44-ft-base-width (3.79-m), 3-ft-high (0.91-m) embankment test section in a 27-ft-long (8.23 m) headbox that was elevated 2 ft (0.61 m) above a large tailbox (approx. 42 ft long by 22 ft wide, 12.8 m by 6.7 m) intended to capture the flow released during a breach test (Figure 2-1). Capturing the full flow volume allowed sediment to be retained and settled out in the tailbox before water was returned to the lab sump, minimizing the effect on other laboratory operations. However, the finite volume of the tailbox limited the total testing time once a breach had enlarged significantly; for the initial test of the homogeneous silty clay dam the test time was only about 48 minutes. For the tests of the zoned rockfill dams, the decision was made to extend the testing time and allow turbid water to return to the lab sump through a spillway section provided in the tailbox.

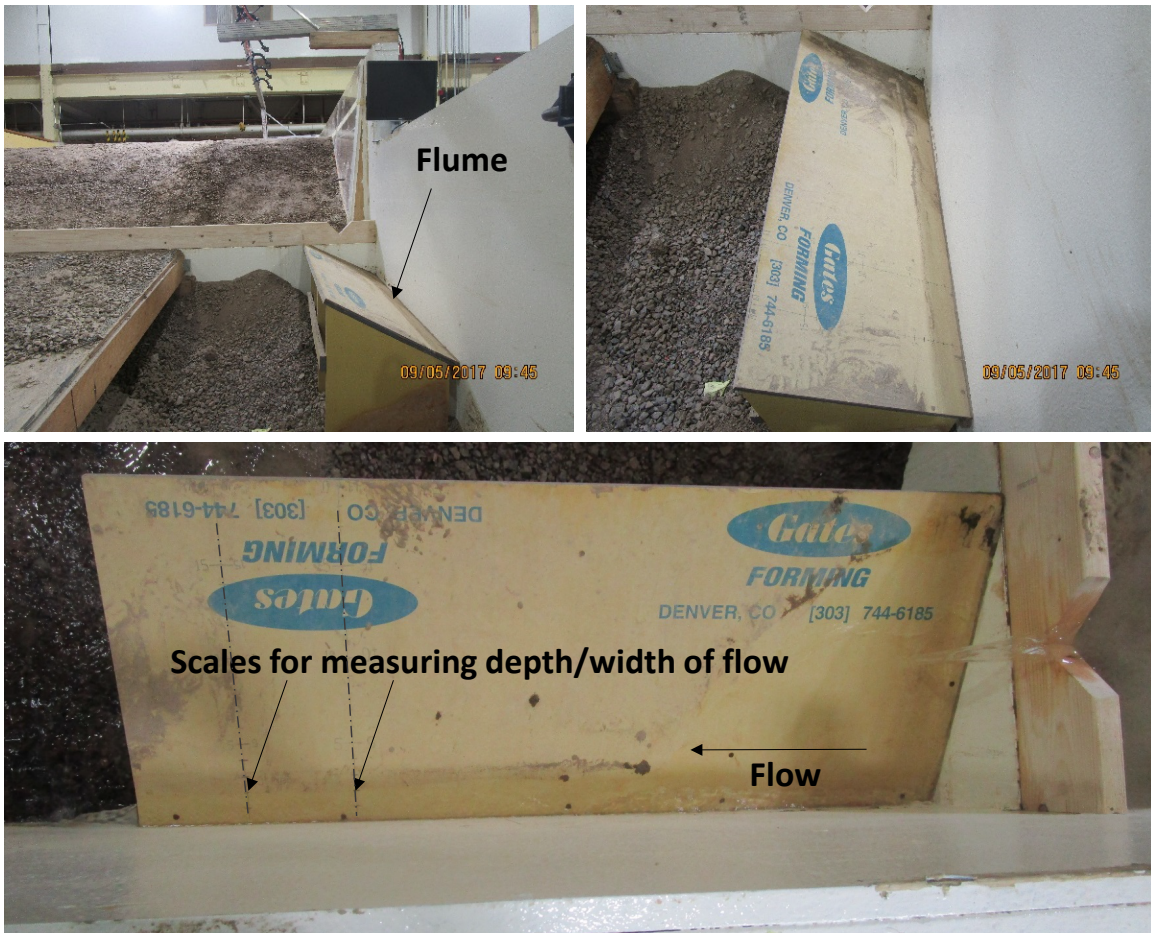
Figure 2-2 Supercritical flume downstream from left edge of embankment. The bottom photo is taken from directly overhead and shows the scales used to indicate the depth and width of flow, which were correlated to flow rate through in-place calibration.

It was anticipated that the accuracy of flows calculated through the embankment breach during the early stages of the two internal erosion tests would be poor, because the net flow would be a very small fraction of the total flow provided into the model and the flow spilled over the adjustable weir, and thus the difference (i.e., flow through the breach) would be lost in the uncertainty of the flow measurements. To overcome this, the test facility was fitted with a small supercritical flume (Figure 2-2) adapted from the concept described by Smith et al. (1981) for measuring sediment laden runoff from natural watersheds. The flume consisted of a triangular trough with a 2h:1v side slope and a 3% slope in the flow direction, attached to the sidewall of the model box just downstream from the toe of the embankment at the left abutment. In addition, prior to the internal erosion test of the zoned embankment, a small triangular notch was cut in a 2x6-inch wood stoplog added just downstream from the toe of the dam to provide a small amount of tailwater and ensure that initial flows were directed to the flume. This flume was calibrated in place with clear water prior to construction of any of the embankments, so that the flow depth and visually observed width of the water surface could be related to the flow rate. It was anticipated that this flume might be useful up to flow rates approaching 100 gallons per minute (gpm), or 6.3 L/s.

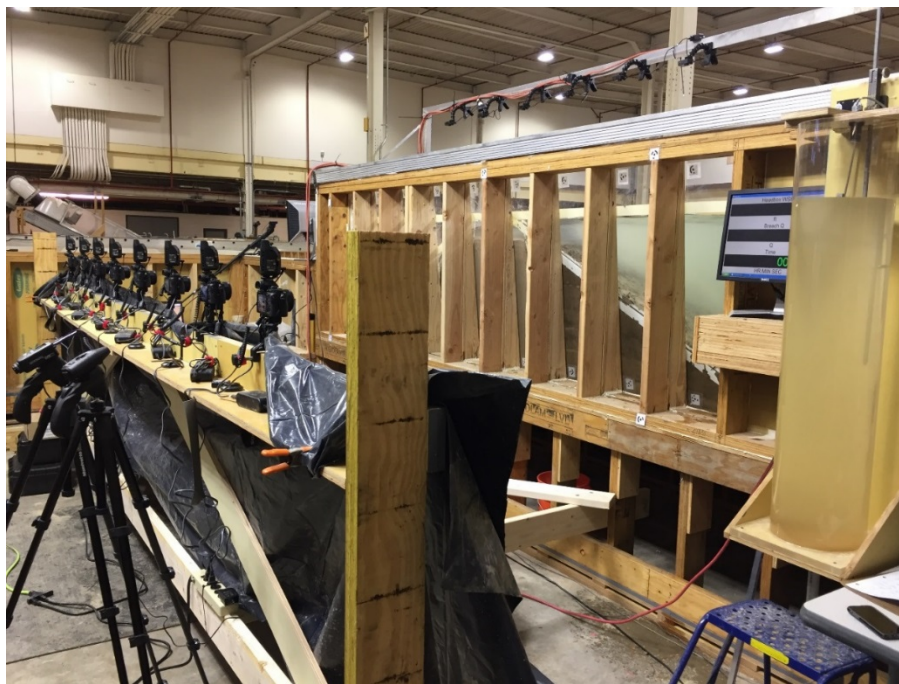
Figure 2-3 Camera equipment used during the test included six GoPro cameras deployed above the embankment and eight DSLR cameras viewing the left abutment through the acrylic wall.

Two arrays of still photo cameras were used to record images of the erosion taking place at the left abutment of the embankment test section and on the upstream and downstream surfaces of the embankments (Figure 2-3). Eight digital single lens reflex (DSLR) cameras were set up to take overlapping photos through the acrylic abutment wall, and 6 GoPro video/still cameras were positioned overhead to obtain overlapping photos of the surface of the left end of the embankment. Each camera’s field of view included photogrammetry targets to enable subsequent image analysis. Picture rates were adjusted as needed during the various tests, with intervals varying from 10 seconds up to 5 minutes. Following the completion of the tests, images were processed to create time-lapse imagery and models of the erosion progress.

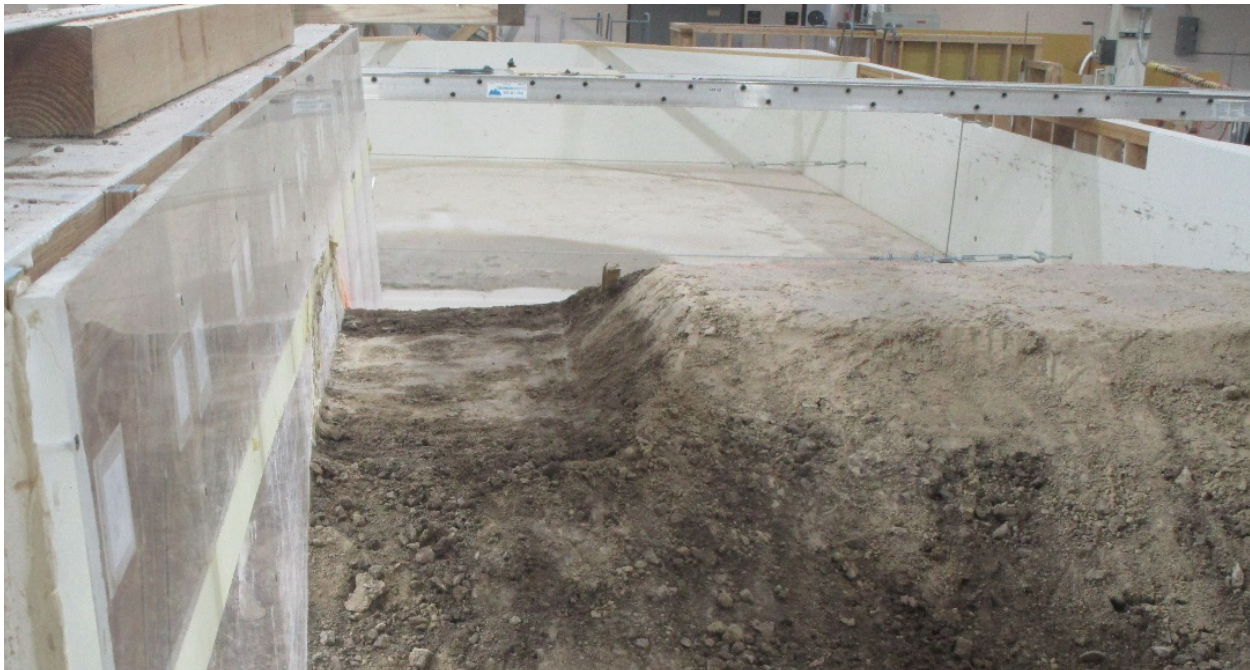
Figure 2-7 Pilot channel in zoned embankment prior to overtopping test.

For the overtopping test, a pilot channel was cut at the left abutment after the embankment was finished (Figure 2-7). The pilot channel was excavated to a depth of 5 inches (13 cm) and a base width of 15 inches (38 cm) with a 1:1 side slope on the embankment side. The invert of the pilot channel had segments of the core zone and the gravel zones exposed within it.

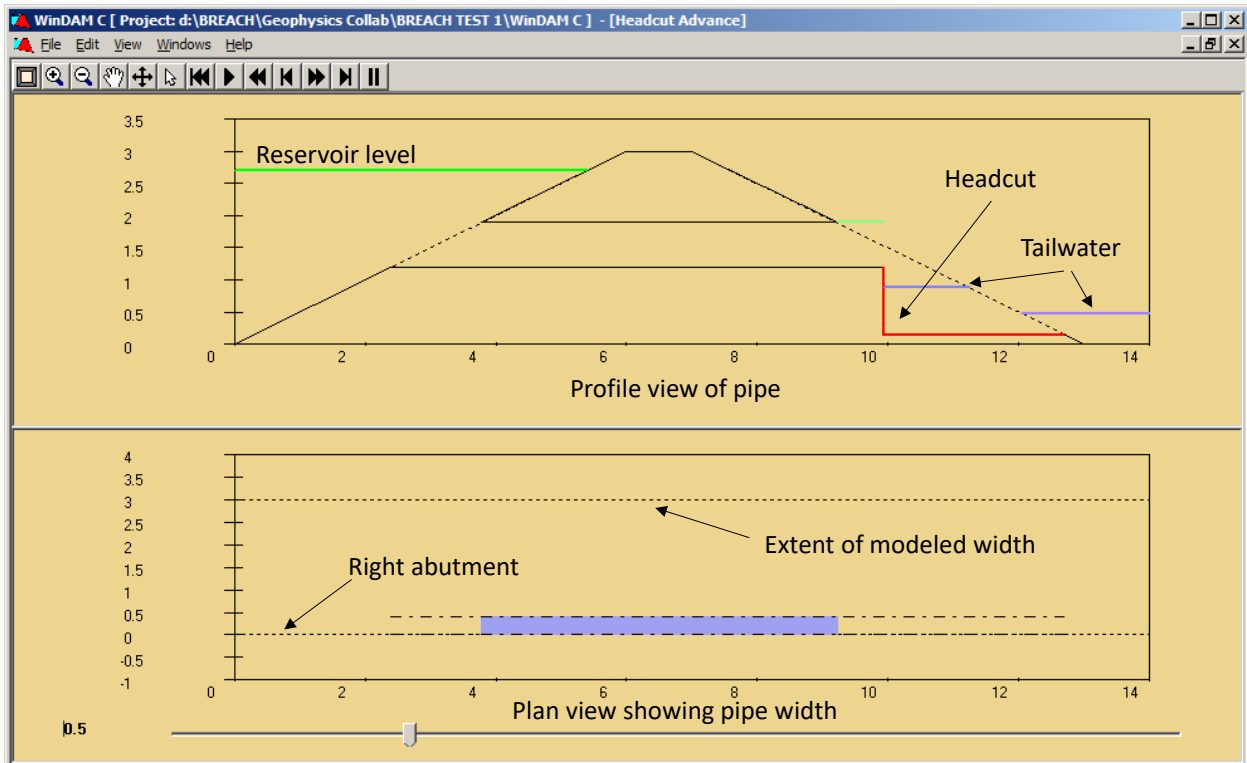
Figure 3-4 Cross-sectional elevation view (top) and plan view of internal erosion breach conduit development during WinDAM C simulation of the homogeneous embankment test at $t=0.5$ hr. Headcut erosion is depicted at the outlet of the conduit, but this did not occur in the physical model test.

With the input parameters listed above, the model predicted growth of the breach conduit and discharge that were more rapid than actually observed. The model also predicted headcut development and advancement at the exit of the conduit, but this had little effect on the outflow rate during the period of comparison (Figure 3-4). (The model simulated conduit growth well past the time at which the experiment was stopped, continuing into the phase in which the top of the conduit collapses and the breach becomes an open channel flow.) Testing different values of the input parameters led to the conclusion that the k_d value and initial conduit dimensions had the most influence on the outputs. A final run with k_d reduced to 2 ft/hr/(lb/ft²) [3.54 cm³/(N-s)] and an initial conduit size of 1 inch by 1 inch (2.5 cm square) produced output that compared well with the observed data (Figure 3-5). This value of k_d seems reasonable, since k_d varied from about 2.5 to 5.5 ft/hr/(lb/ft²) [4.4 to 9.7 cm³/(N-s)] in the JET tests of this embankment and the other embankments constructed from the same soil, and it is possible that the lower portions of the embankment received additional compaction as upper lifts were added. The initial size of the conduit also seems reasonable. WinDAM C defines the erosion pipe as a rectangular conduit and tracks the height and width independently. Since the pipe was located adjacent to the abutment, the growth of the height is greater than the growth of the width, and the height corresponds to what was observed visually through the acrylic abutment, even though the actual conduit was not truly rectangular in section. Although the rebar embedded in the embankment was a #4 bar (nominally 0.5-inch = 13 mm diameter), the area disturbed when it was withdrawn was probably greater, so a starting dimension of 1 inch (25 mm) is reasonable.

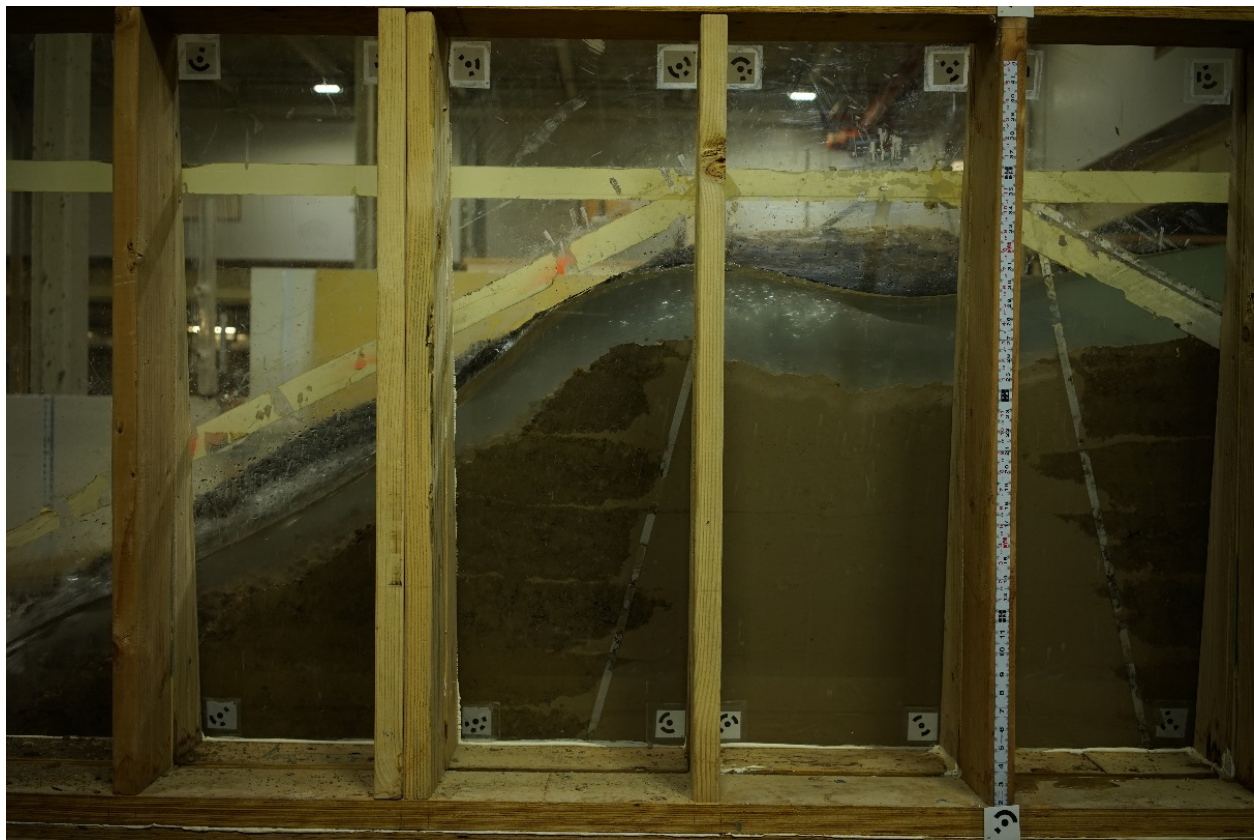
Figure 4-1 Erosion of top surface of core zone after about 6 minutes of flow on the second day of testing.

The erosion mechanism observed throughout the test was a combination of surface erosion of both the downstream slope and the crest of the core zone. At times the crest of the core actually eroded to levels significantly below the upstream edge of the gravel zone, especially at the start of the second day when there was rapid downward erosion of the top of the core, which had become saturated overnight by water standing in small depressions on the surface (see Figure 4-1). Although the core seemed less erosion resistant than the gravel zones, it was protected from more rapid erosion by the presence of the downstream gravel zone that prevented direct hydraulic attack against the downstream edge of the core.

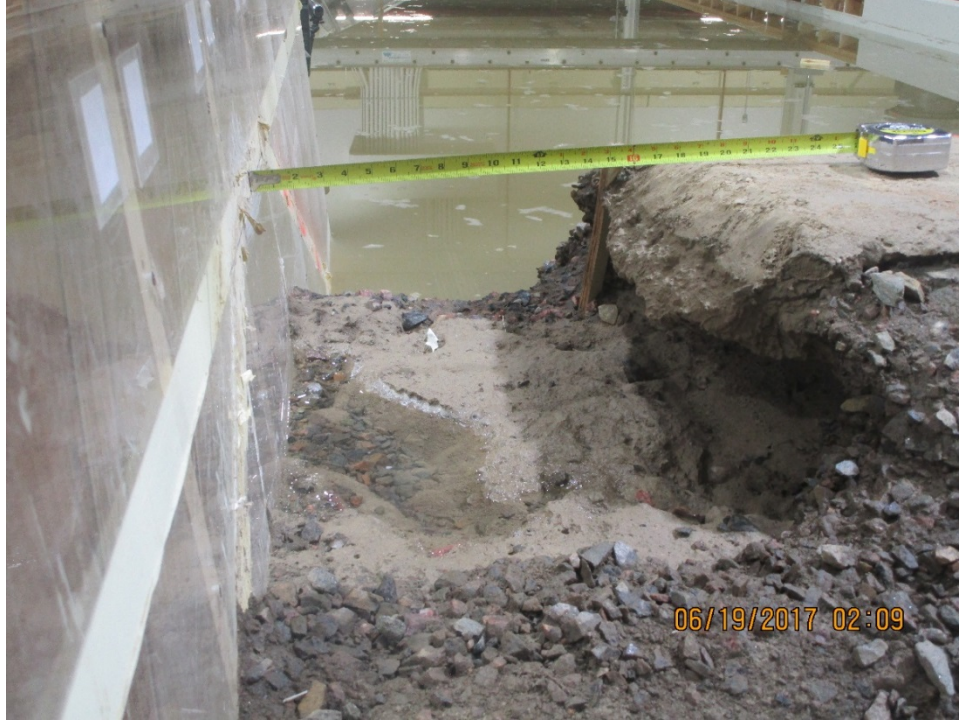
Figure 4-2 Breach pilot channel at the end of the first day of testing. Note the embedded wood stake that appeared to restrict lateral erosion.

The widening of the pilot channel appeared to some degree to be driven by flow contraction taking place at the entrance of the pilot channel and then the creation of horizontal recirculation zones immediately downstream from the pilot channel entrance. These horizontal eddies worked on the soil at the edges of the pilot channel, causing the pilot channel to widen, often at a rate that exceeded the deepening of the pilot channel. As the test progressed, an overhang began to form, with soil above the water surface hanging over areas that had eroded and widened. Eventually this overhanging soil broke off like a cantilevered beam and fell into the channel. Widening of the channel downstream from the crest was significant in the first 33 minutes of flow on the first day of testing, with the channel growing from about 15 to 24 inches wide (38 to 61 cm). Widening of the pilot channel during the first day was restricted somewhat by a wood stake that was embedded in the downstream edge of the embankment crest during construction (to hold a board separating zones as soil was initially placed) and accidentally left in place (Figure 4-2). This stake was removed before flow was resumed on the second day. As a result, the pilot channel width grew more rapidly for a short time during the second day of testing, but overall the width of the downstream channel grew slowly during the second day. Figure 4-3 shows the flow conditions just before the test was ended.

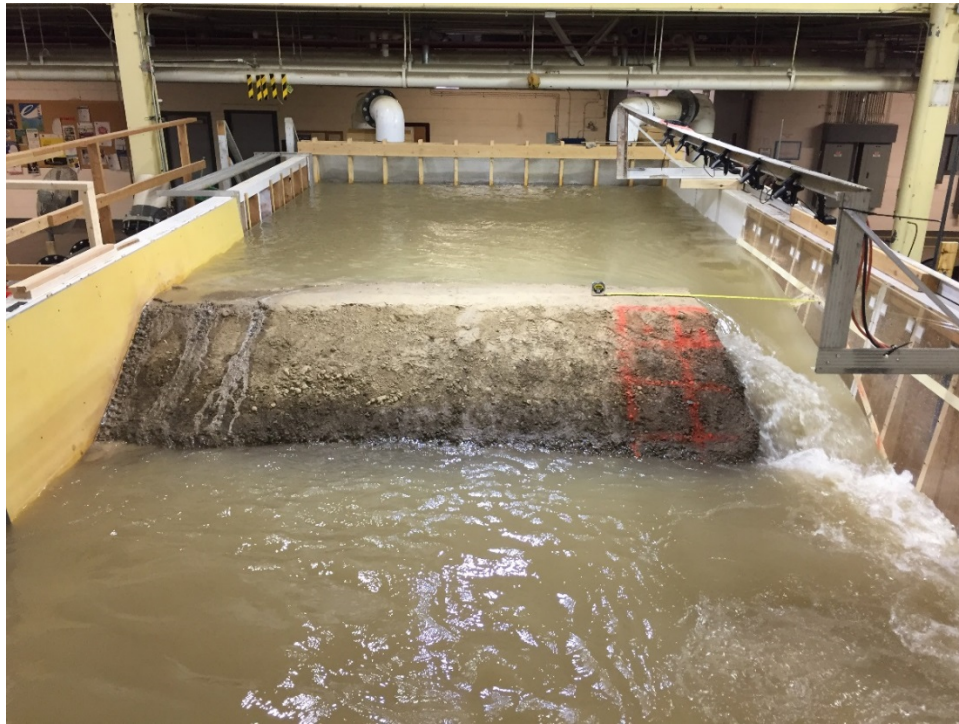
Figure 4-3 Flow conditions through the breach channel near the end of the zoned embankment overtopping test (t=2 hr 56 min).

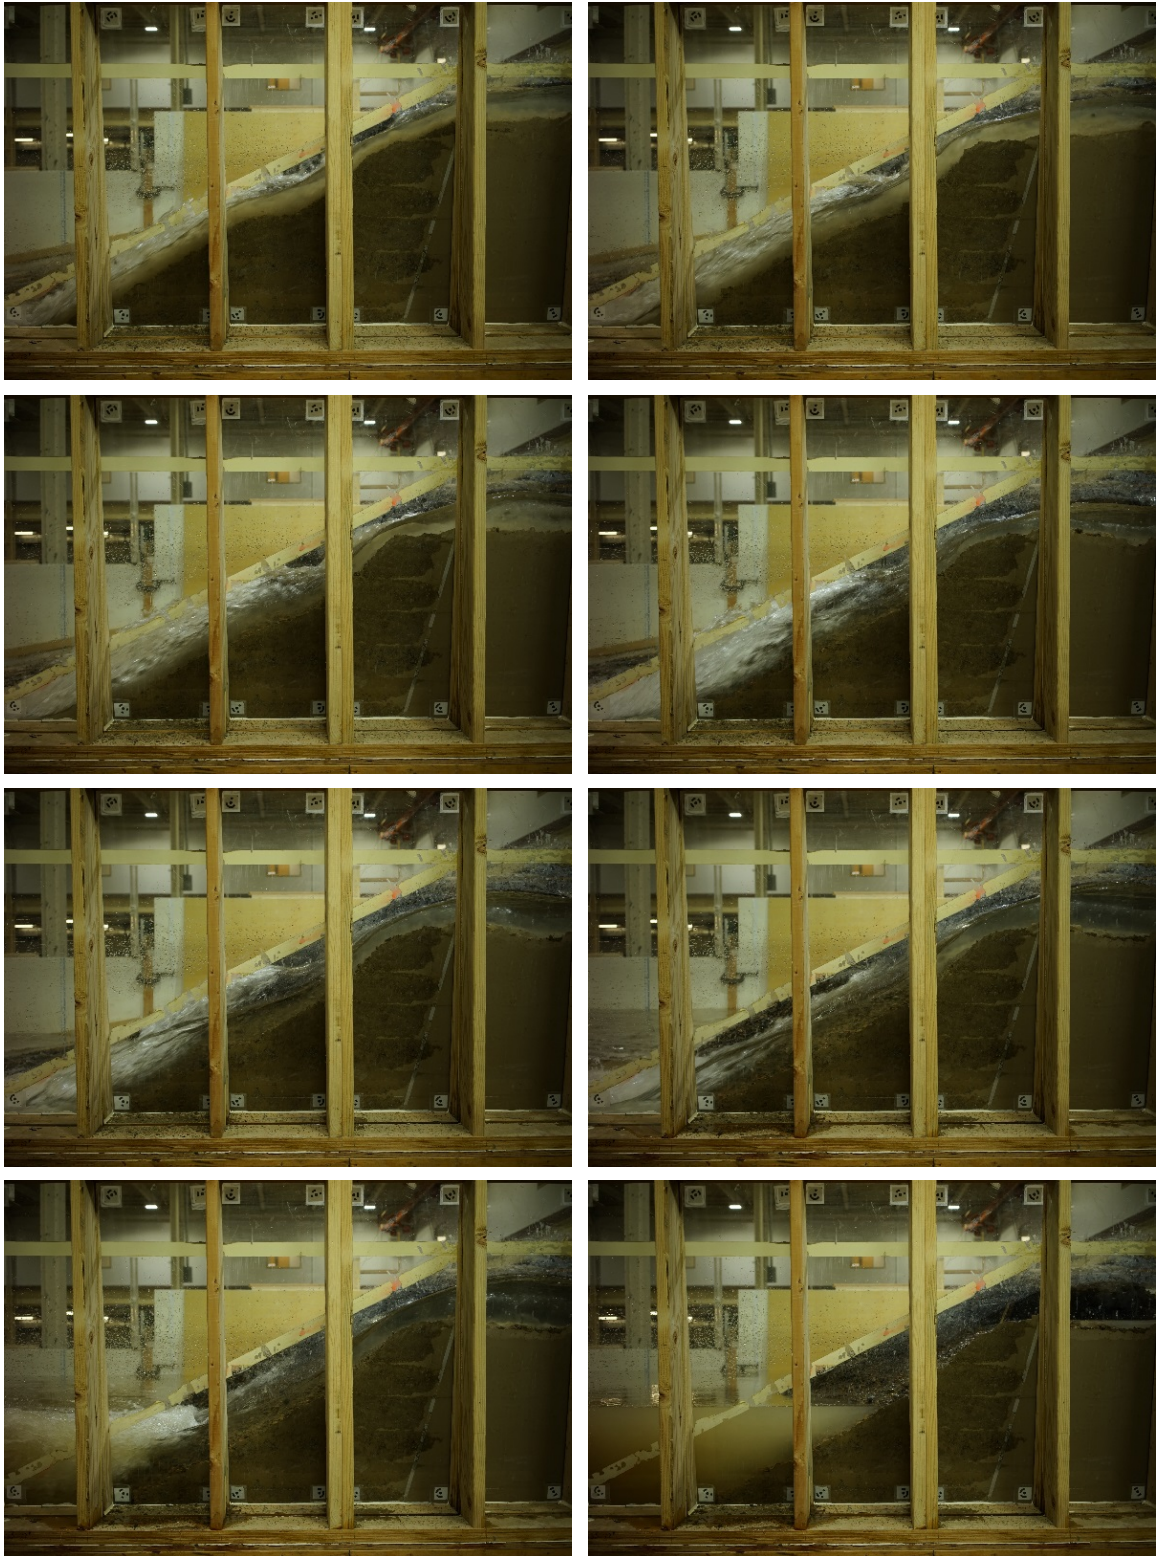
Figure 4-5 Photos of breach channel downward erosion progress on the first day of the zoned embankment overtopping test. Elapsed times (mm:ss) in the photos from left-to-right, top-to-bottom are: 3:20, 5:20, 7:20, 14:20, 19:20, 26:20, 33:20, and 33:20 (after flow was stopped).

Table 4-1 provides a summary of the data obtained from the photos shown in Figure 4-5 and Figure 4-6 from the first 3 hours of testing and the resulting k_d values. The k_d value at the end of each incremental time period was computed using the observed erosion during the preceding time interval and the average shear stress during that interval. Figure 4-7 shows the results graphically. The rate of erosion was rapid during the first 5 minutes of the test, but slowed dramatically thereafter. This was likely due to difficulty obtaining good compaction at the edge of the placement where there was no way to confine the soil. The highly erodible layer was about 6 inches (15 cm) thick. After the first few minutes, the flow depth was more difficult to determine from the photos due to turbulence, splashing, and aeration of the surface of the flow.

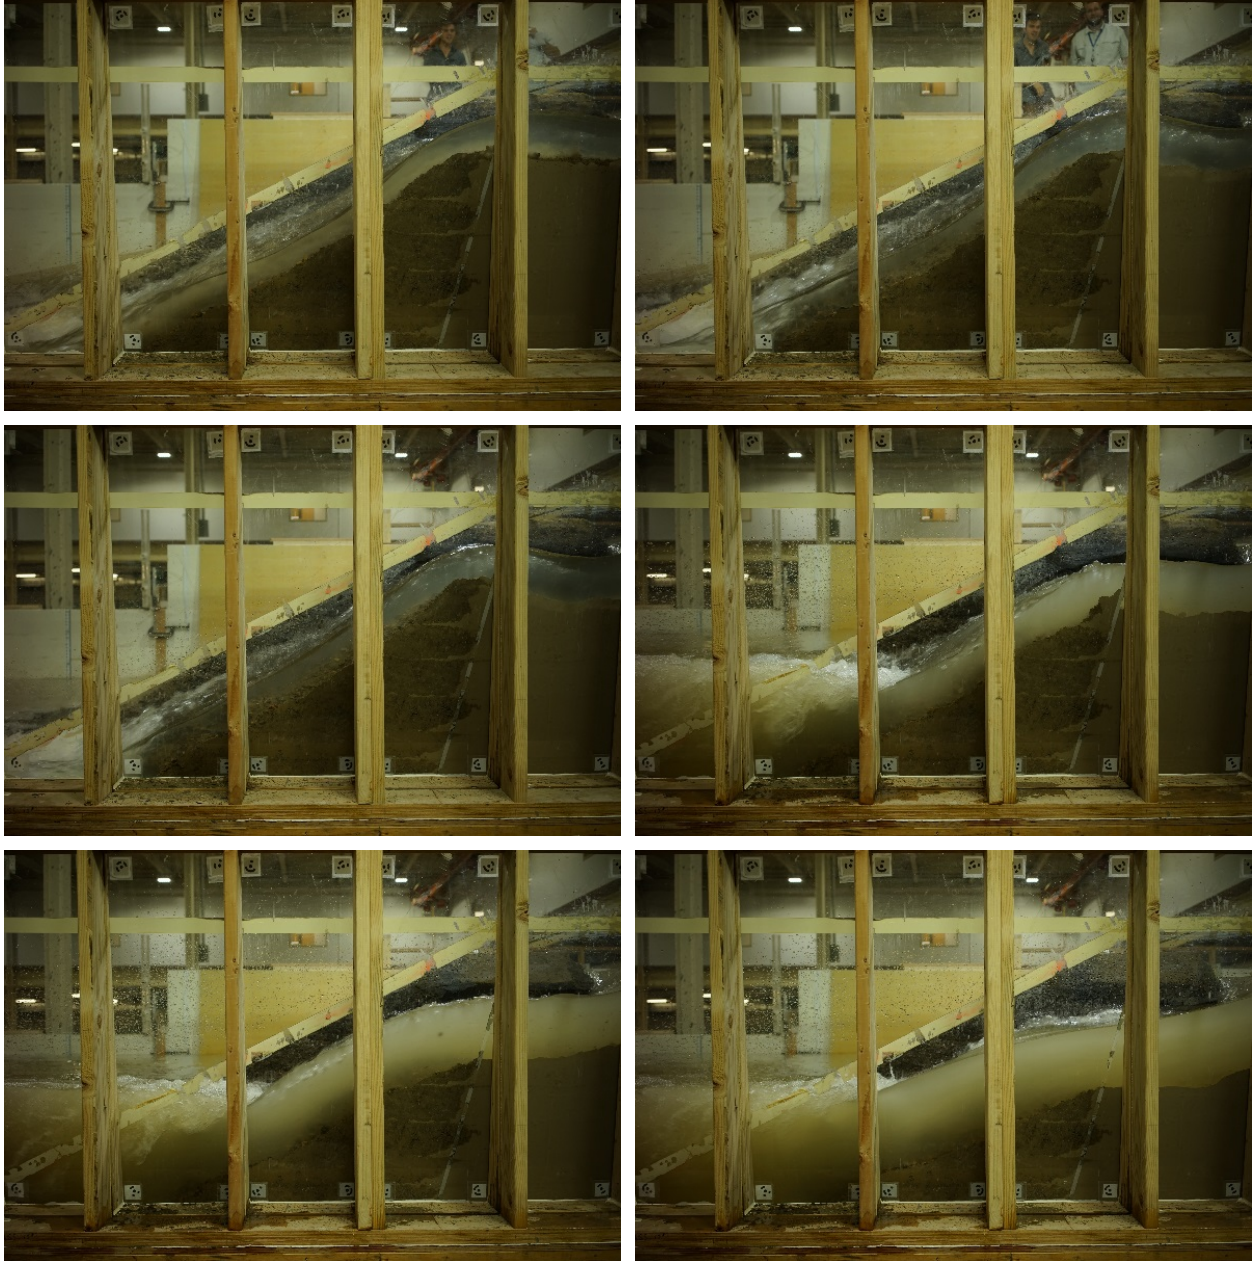
Figure 4-6 Photos of breach channel downward erosion progress on the second day of the zoned embankment overtopping test. Total elapsed times in minutes in the photos from left-to-right, top-to-bottom are: 34.5, 37, 47, 77, 120, 180.

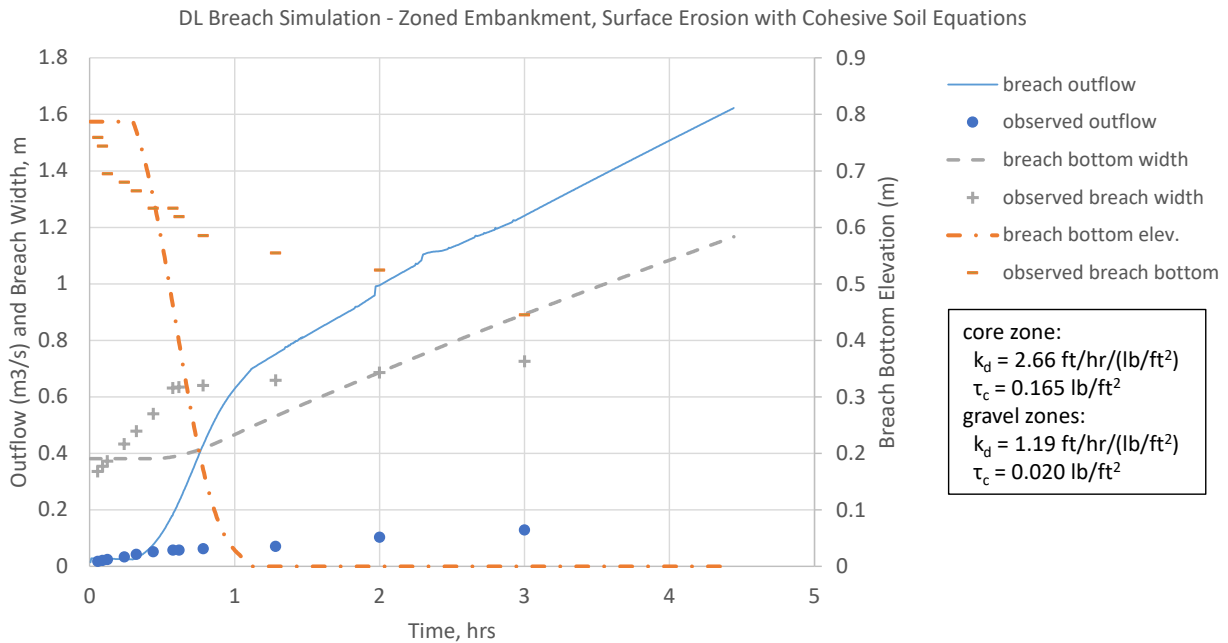
Figure 4-16 DL Breach simulation results for an initial program run with zoned embankment and cohesive soil erosion equations. Flow out of the breach becomes too large when the downstream slope is lowered enough that it begins to accelerate the lowering of the crest.

Initial model runs were made using values of k_d and τ_c obtained from the submerged jet tests and from the analysis of the photos described earlier. For the core zone, $k_d = 2.66$ ft/hr/(lb/ft²) and $\tau_c = 0.165$ lb/ft² were used (Figure 2-6, data point for “zoned overtopping test”). For the gravel zones the averages of the values calculated in Table 4-1 for times after $t = 6$ minutes were used [$k_d = 1.2$ ft/hr/(lb/ft²) and $\tau_c = 0.020$ lb/ft²]. The first runs produced an outflow hydrograph that increased very slowly at first then very rapidly (too rapidly compared to the observed outflow hydrograph) as a period of rapid crest-lowering occurred (Figure 4-16). It was difficult to infer the exact geometry of the erosion pattern because the principal output from the program was a simple text-file listing of breach bottom elevation, upstream and downstream slopes, and breach outflows. While spreadsheet templates could be used to display these data visually, no true animation or real-time view of the embankment geometry was available. A one-sided breach growth option was used for all DL Breach simulations, since the pilot channel in the model was located at the abutment.

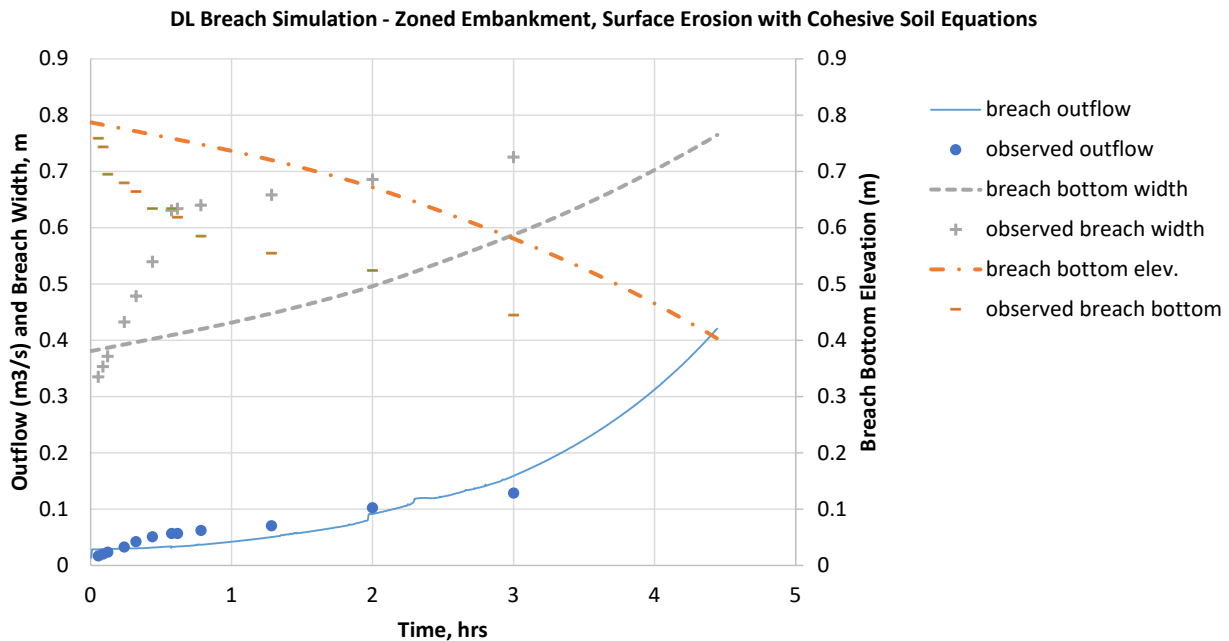
Figure 4-17 DL Breach simulation results for an improved run using zoned geometry with cohesive soil erosion equations.

downstream gravel zones) and the core. A reasonable similarity of model-predicted outflows and experimental results was obtained using the following soil parameters (Figure 4-17):

- core zone: $k_d = 2.0$ (ft/hr)/(lb/ft²) and $\tau_c = 0.020$ lb/ft²;
- gravel zones $k_d = 0.057$ (ft/hr)/(lb/ft²) and $\tau_c = 0.020$ lb/ft².

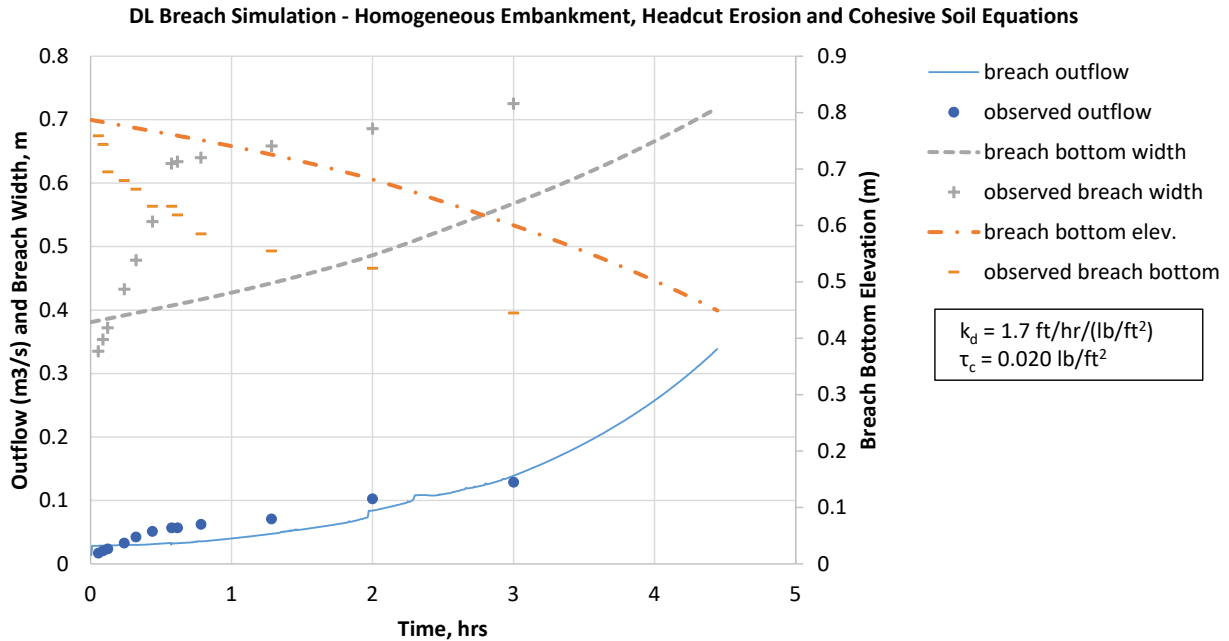
Figure 4-18 DL Breach simulation results for a homogeneous embankment with headcutting enabled. The headcut rate coefficient is so low that headcutting has no practical effect.

Following this simulation, two additional runs were made for comparison and to gain a better understanding of the internal workings of the model. One run was made with the same parameters just used for the successful headcut run shown in Figure 4-18, except that headcutting was disabled, which instead enables surface erosion of the downstream slope. This run produced the result in Figure 4-19, which appears to indicate that rapid surface erosion of the downstream slope is occurring, leading to a quick deepening of the breach that did not take place in the headcut-enabled model. This run together with the previous run confirms that in the headcut-enabled model there is no surface erosion of the downstream slope, and all erosion of the downstream portion of the embankment must occur through headcutting. This confirmation is valuable, because the DL Breach documentation states that surface erosion of the crest can occur when headcutting is enabled, but is silent about whether surface erosion of the downstream slope can still occur.

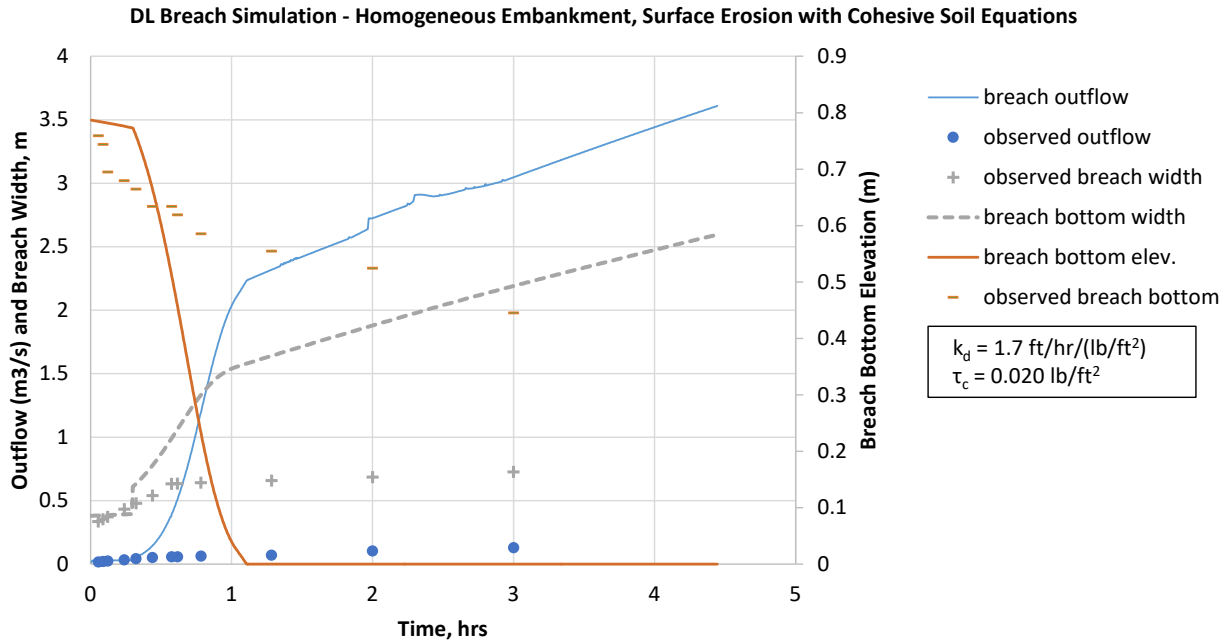
Figure 4-19 DL Breach simulation results for homogeneous embankment with surface erosion of cohesive soil. A rapid breach lowering takes place, apparently due to lowering of the downstream slope.

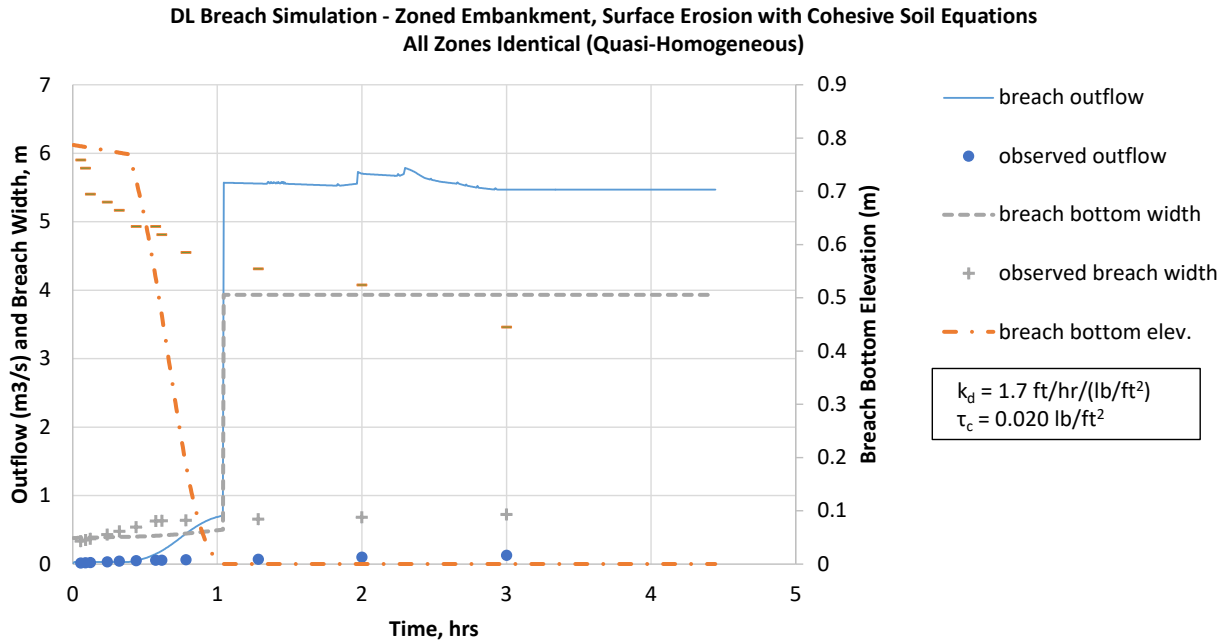
Figure 4-20 DL Breach simulation results for quasi-homogeneous zoned embankment with surface erosion. Headcutting is disabled.

A final run was made with a zoned configuration, but with all soil parameters of the two zones set equal to one another, including $k_d = 1.7 \text{ ft/hr}/(\text{lb}/\text{ft}^2) = 3.0 \text{ cm}^3/(\text{N}\cdot\text{s})$, so the embankment was defined in a zoned manner, but was quasi-homogeneous using equations for surface erosion of cohesive soils. The results, shown in Figure 4-20, were somewhat similar to the previous run, exhibiting rapid lowering of the breach bottom. However, unlike the previous run, when the breach reached the bottom of the embankment there apparently was an instantaneous sliding failure of the remainder of the embankment that caused the breach width to immediately increase to the full width of the embankment.

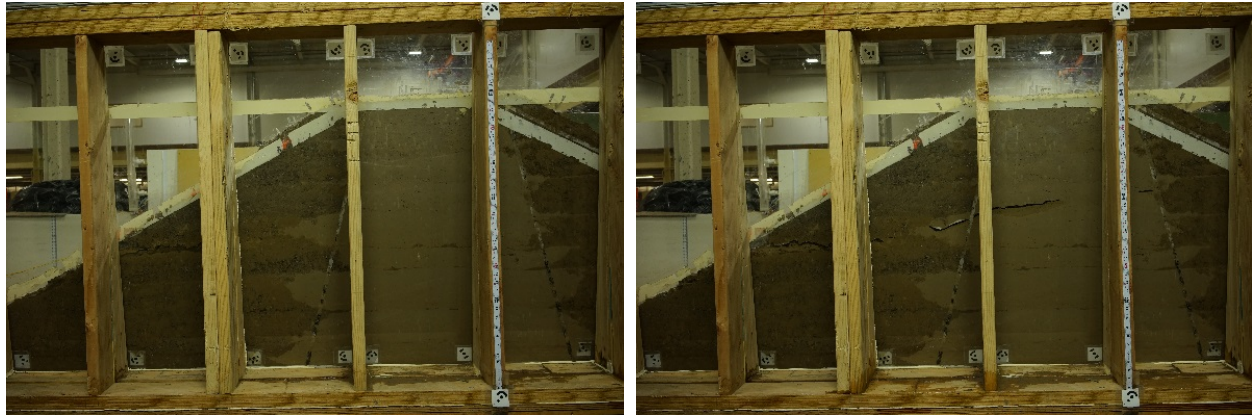
Figure 5-2 Pipe beginning to develop through embankment after removal of rebar on second day of testing. Elapsed times since the restart on the second day are 1 min (left) and 103 minutes (right). In the first photo the pipe is only visible in the downstream gravel zone. In the right hand photo, the color variation in the portion of the pipe within the core zone indicates redeposition of soil in the bottom of the pipe as erosion occurs from the roof.

removed. The initial process was consistent with what is typically described as concentrated leak erosion (USBR and USACE 2015). Figure 5-2 shows the upstream progress of erosion. The photos also show that there was not a perfect delineation of the zone boundaries as each lift was placed, but the straying of materials across the zone boundaries did not seem to affect the tests.

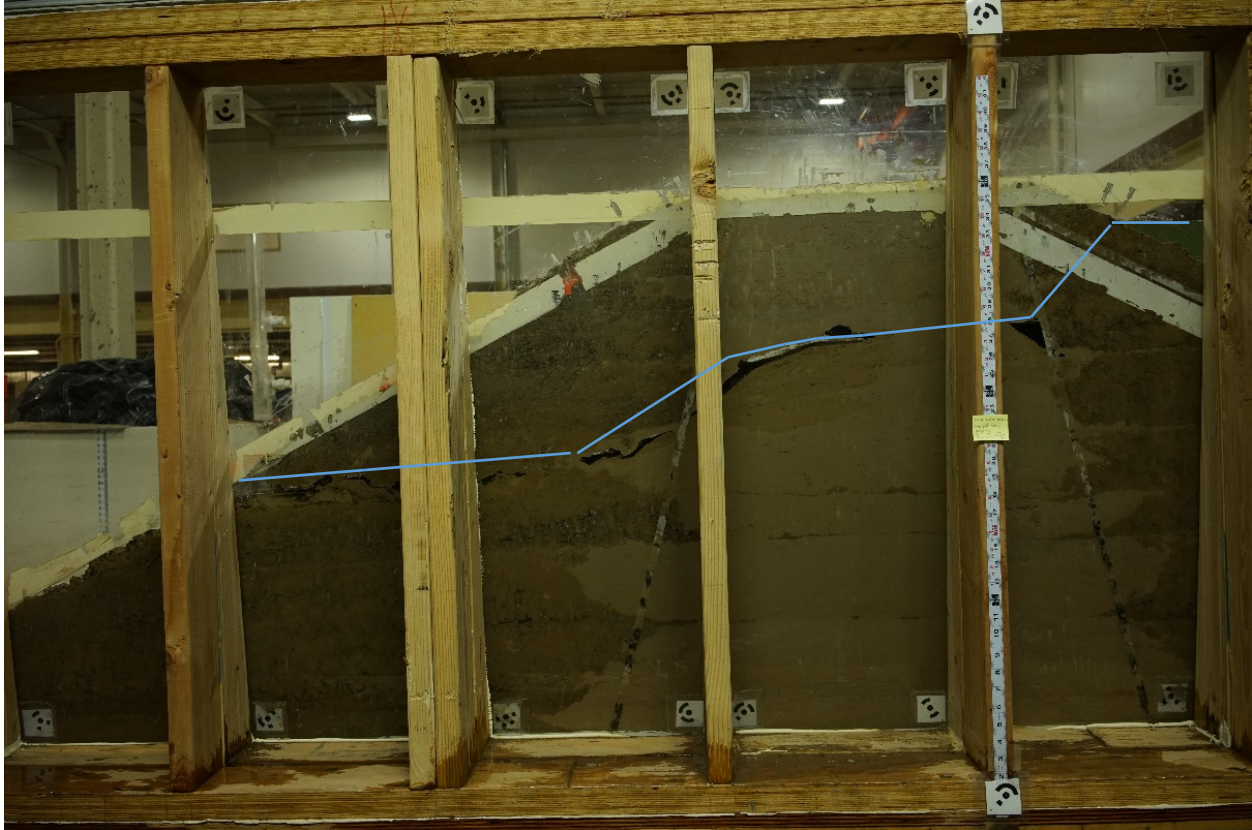
Figure 5-3 Development of stepped profile of erosion channel. An approximate hydraulic grade line for the flow is sketched over the photo in blue. As the roof of the channel collapsed and the bed migrated upward, most of the core zone began to experience open-channel, rather than pressurized flow.

Figure 5-3 shows that as the pipe continued to migrate upward, the erosion channel developed into a sequence of stepped pipes, with large losses of head occurring through the gravel zones and a low hydraulic gradient through most of the core of the embankment. In fact, flow through most of the void being created in the core appears to have a free surface, as evidenced by foam on the water surface. Near the downstream end of the core, there appears to be pressurized flow again in a steep portion of the pipe approximately paralleling the interface between the core and downstream gravel zones.

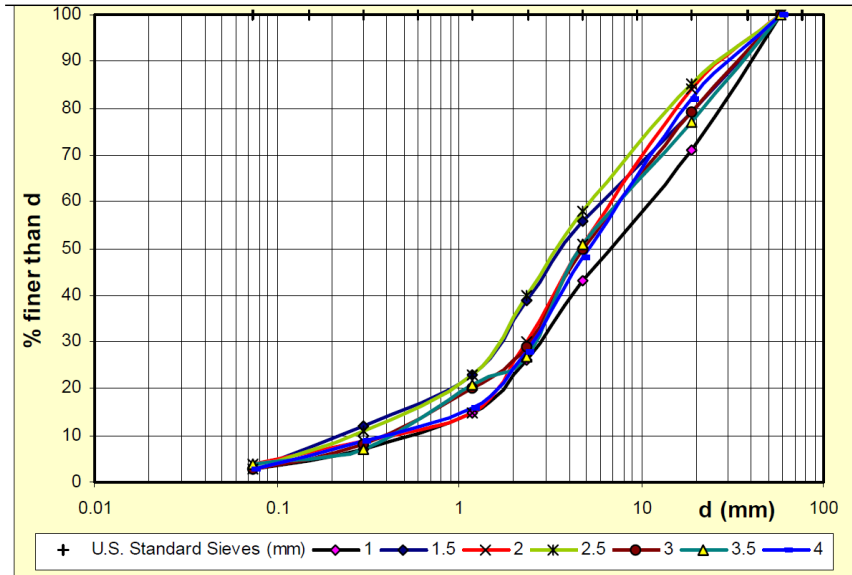
Figure 6-1 Gradation curve for IMPACT Test 2-2002, homogeneous gravel dam (from IMPACT WP2 Technical Report: Section 4). This soil qualifies as well-graded ($C_u=17.5$, $C_c=2.2$) and has less than 5 percent fines. Legend labels indicate embankment layer height in meters.

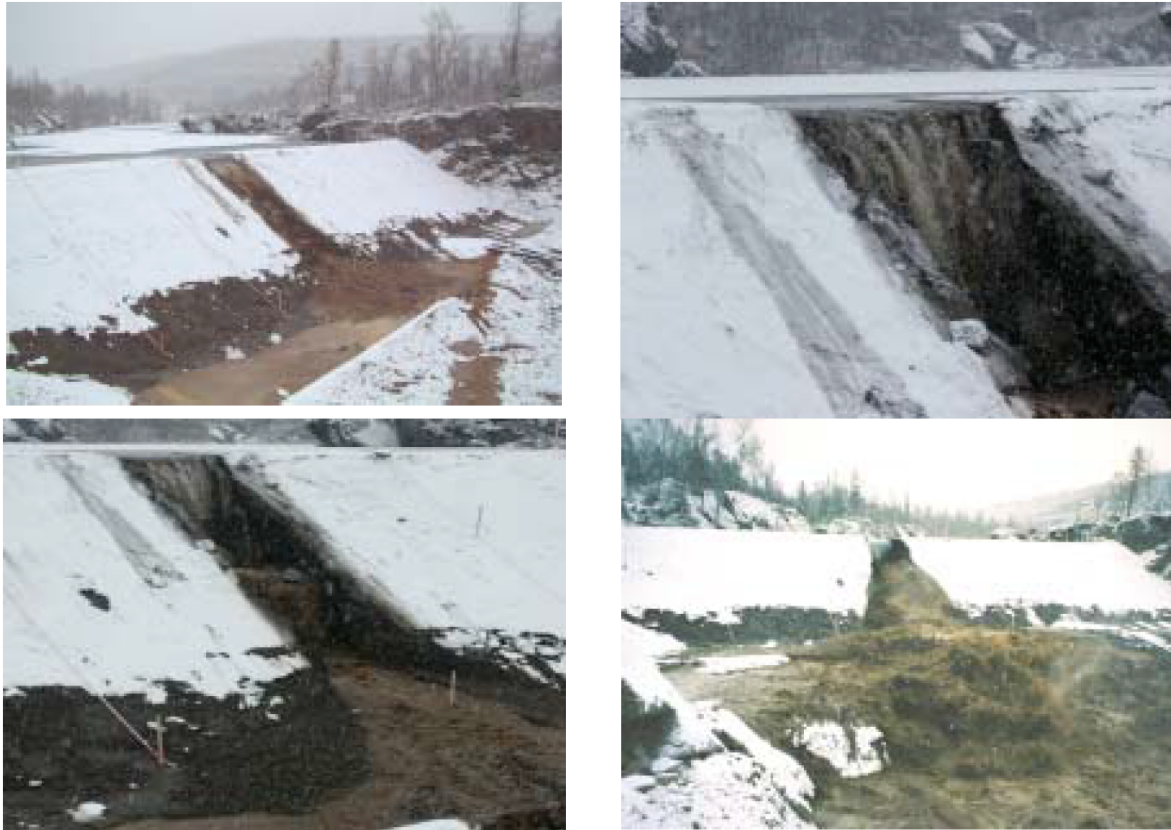
Figure 6-2 Headcut development during IMPACT test of homogeneous gravel dam, 2-2002 (from IMPACT WP2 Technical Report: Section 4).

The test of the homogeneous gravel dam took place in mid-October, with freezing temperatures the night before the test. Photos from the test in Figure 6-2 clearly show a headcut mode of erosion. It has been suggested that the embankment itself may have been partially frozen and that this may have been responsible for the headcutting behavior, but it seems doubtful that interior portions of the embankment would have been frozen. Instead, it seems more likely that the well-graded nature of the gravel, combined with the non-zero cohesion and some capillary tension created enough apparent cohesion to allow the soil to stand at a steep slope. Once established, this geometry prevented direct attack of the flow on the downstream slope, so a headcut mode of erosion occurred, with the crucial erosion taking place at the toe of the slope.
