WSRC-TR-97-0066
REVISION: Revision 1

KEYWORDS:
Waste Characterization, Tank
Farms, Closure, Tank 17

Characterization of Tank 17 Residual Waste

22 September 1997

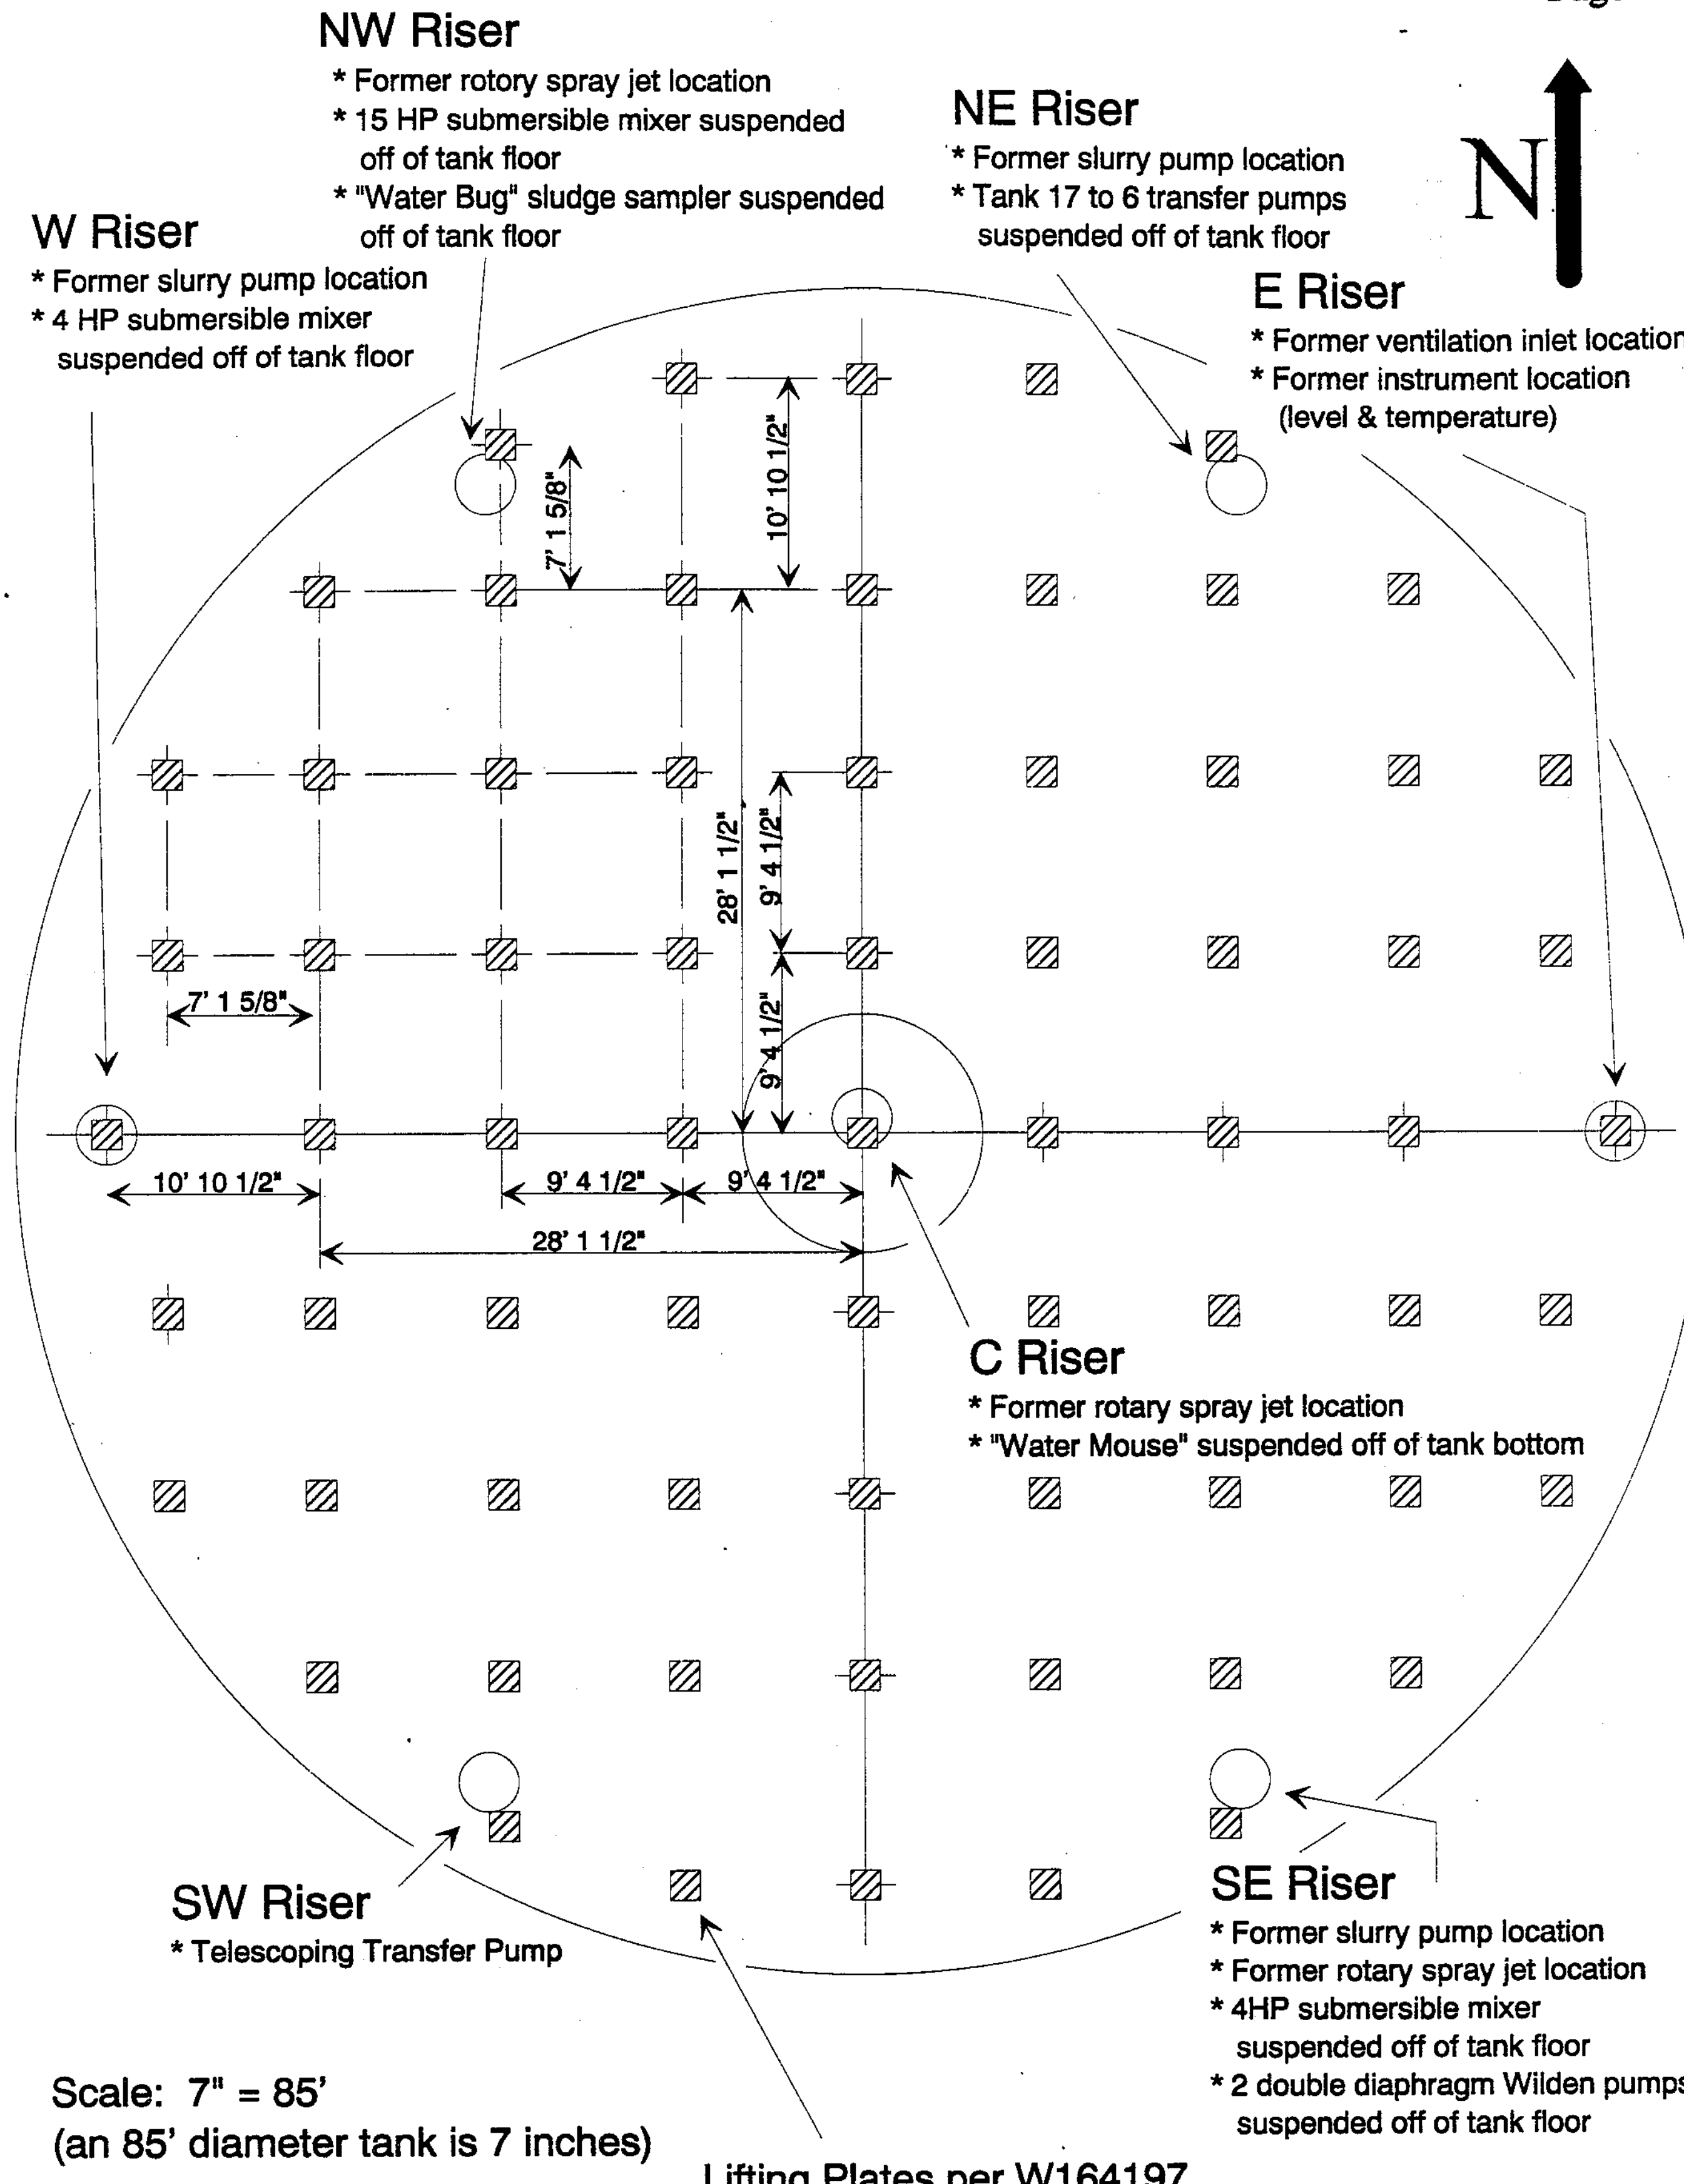
Figure 1. Tank 17 Top and Floor
Note: Lifting Plates are not all oriented with the edges aligned north-south east-west

Although the lifting lugs were removed, the lifting plates were left in place to avoid the possibility of damage to the tank floor, which could have occurred if the lifting plates had been ground off. Thus, the lifting plates now provide convenient "depth gauges" for estimating the depth of solids on parts of the floor where the sludge depth is shallow. Figure 1 shows the arrangement of lifting plates in Tank 17.

Print W164197 indicates that there are 69 lifting plates on the floor of Tank 17. The print indicates that each lifting plate is square, 12 by 12 inches, 3/8 inches high, and has a 1/4-inch weld bead around its perimeter. The print also instructs the fabricators to make the lifting plates from 1/2-inch plate, which does not agree with the height of 3/8 inch shown for the finished plate. This appears to be an error, but it is possible that the instruction to use a 1/2-inch plate was followed during fabrication, so the plates might actually be 1/2 inch high rather than 3/8 inch high. For the purposes of sludge estimation in Tank 17, it was assumed that the plates are 1/2 inch high because this produces a conservatively high estimate.

The plates that are visible in Tank 17 all appear to be at the locations shown in the print, but the plates are not all oriented with their edges north-south and east-west. Instead, the plates appear to be oriented at somewhat random orientations, indicating no particular care in their orientation when they were welded to the tank floor. The print specifies only the location of the plates, not the orientation, so the placement of the plates appears to satisfy the print. The random orientation of the plates in Tank 17 was surprising because the plates in Tank 20 had been found to be oriented north-south and east-west.[3] In this report we have made no attempt to record the specific orientation of each plate because it is not important in assessing the volume of sludge.

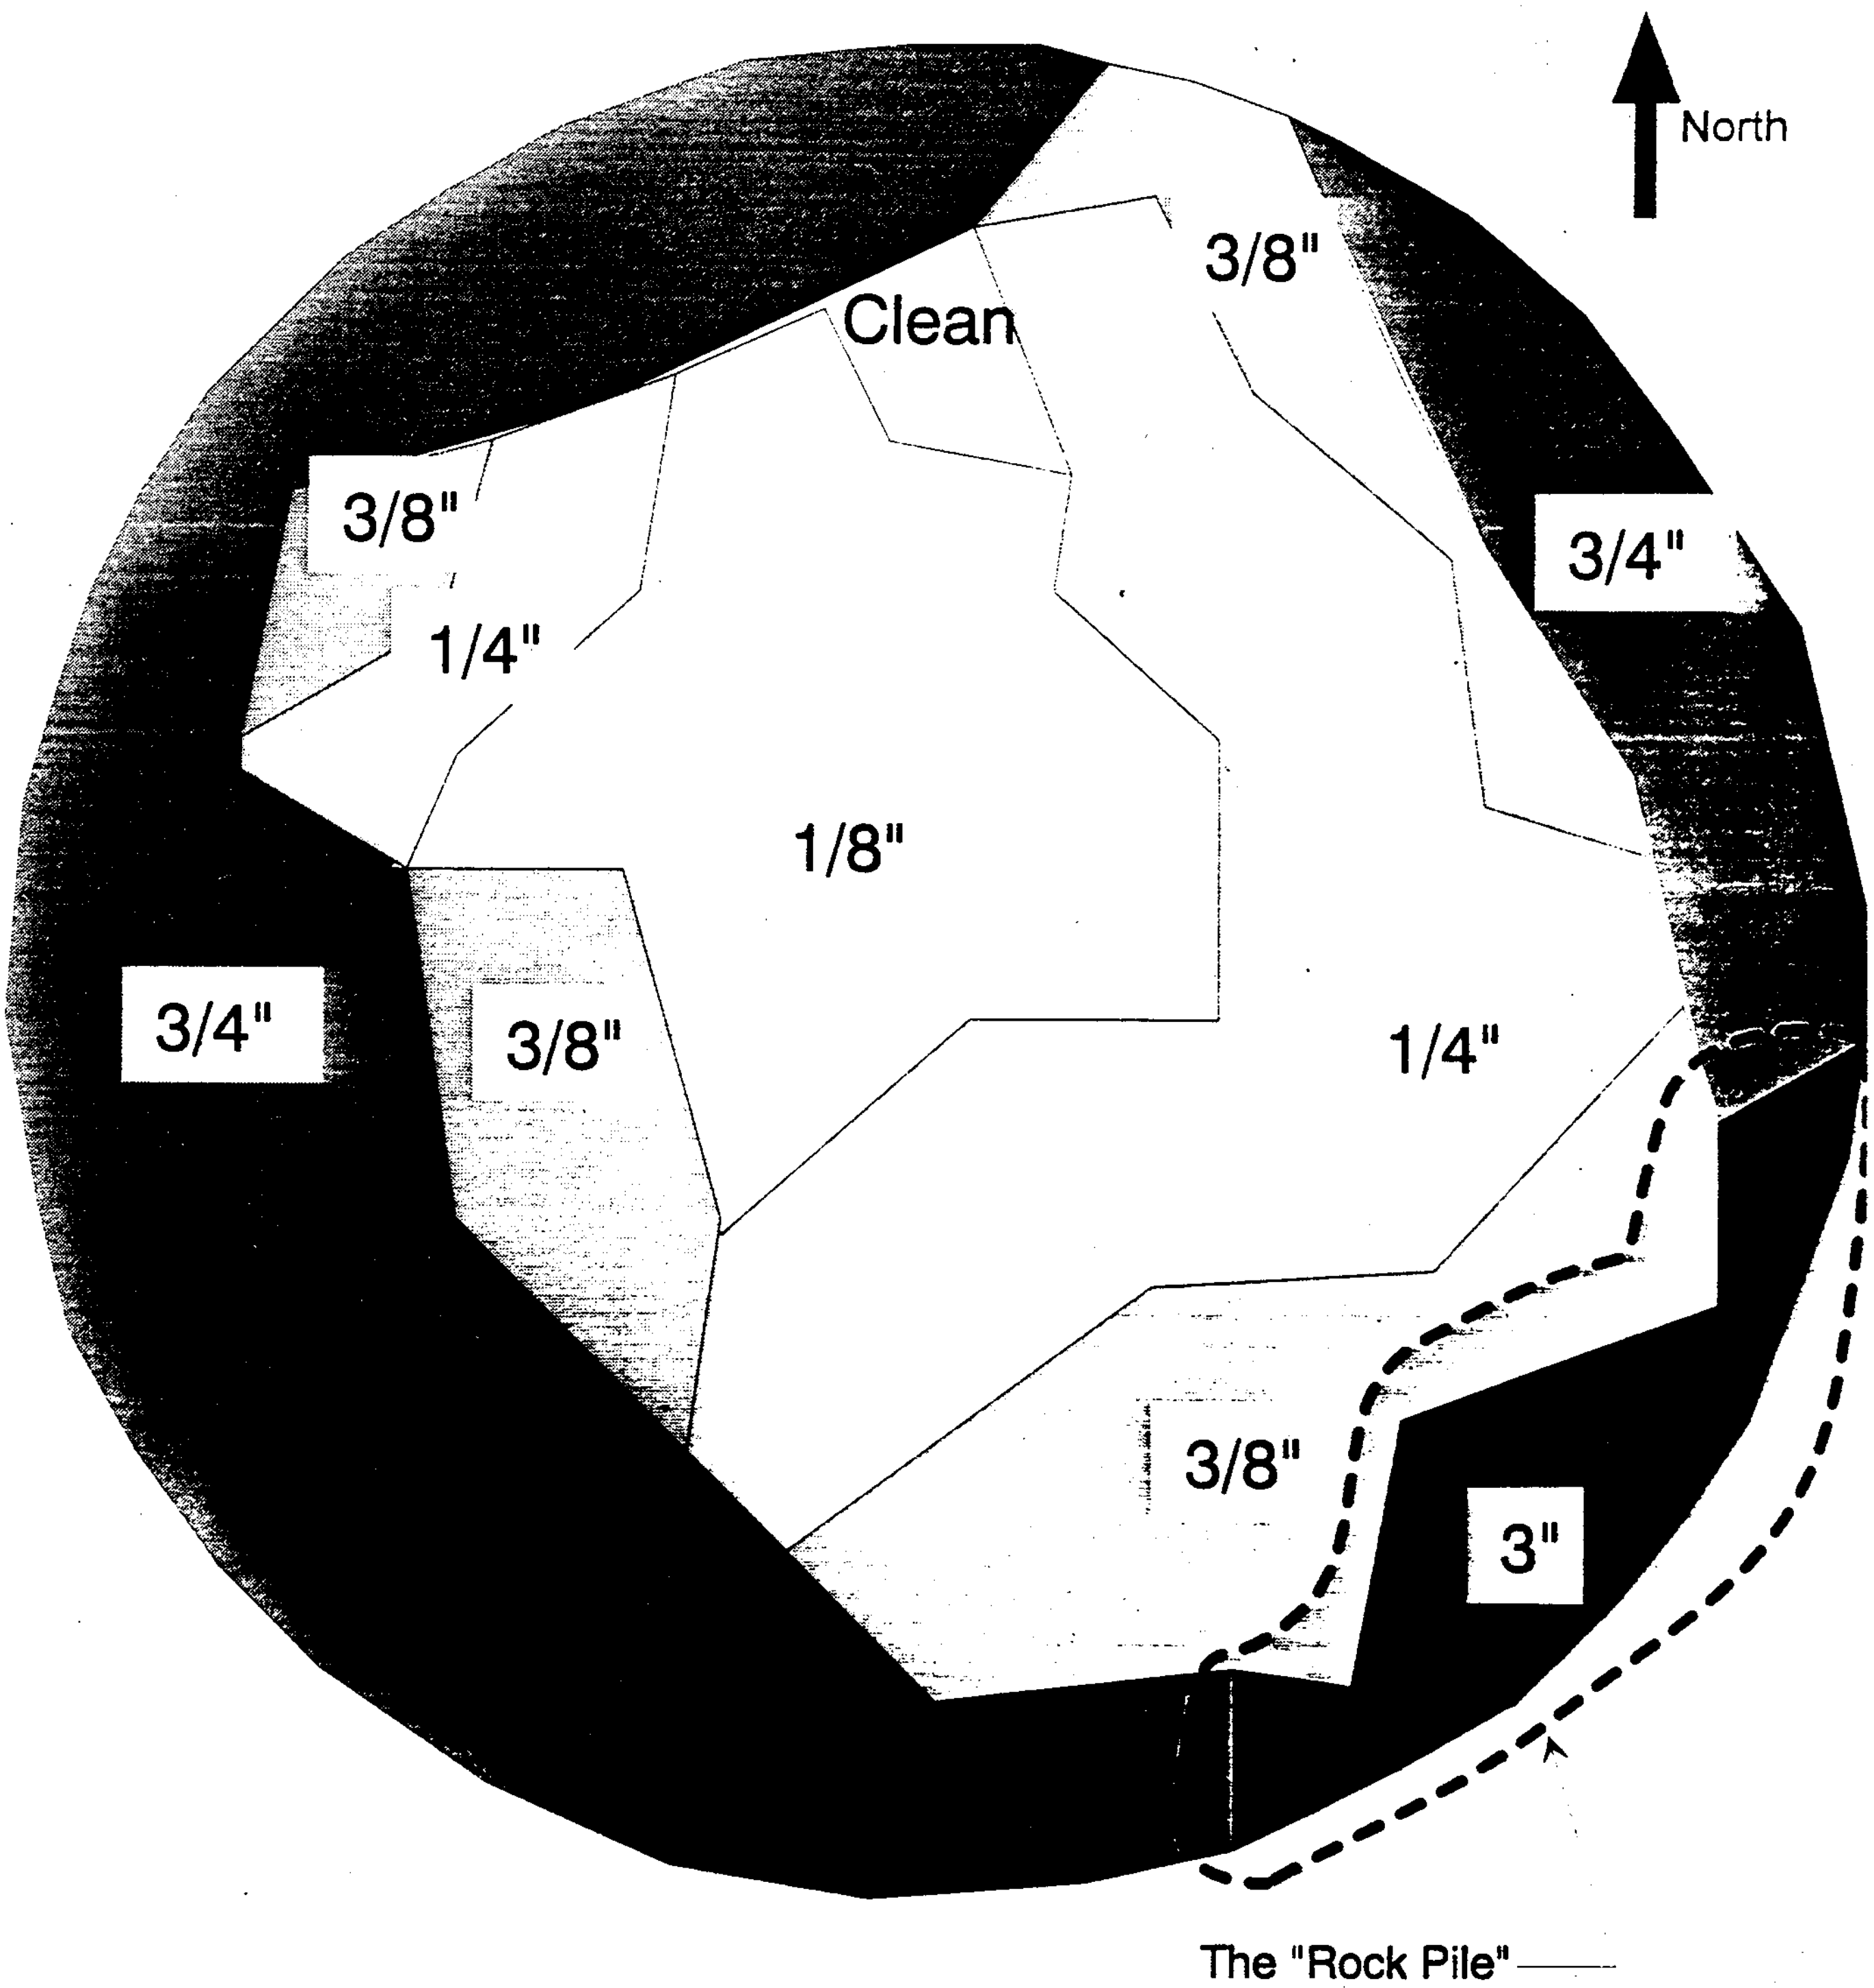
Figure 3. Tank 17 Sludge Depth as of 1500, 21 April 1997

The purpose of the sample was to determine the fraction of potentially non-radioactive material in the "rock pile," a large pile of sludge near the southeast riser (See Figure 3). Many people working on the sludge removal from Tank 17 colloquially called this pile the "rock pile" because it contained a high concentration of chips, and video images of it suggested rocks up to an inch in diameter. The chips were also seen in other parts of the tank, although they appeared in highest concentration in the "rock pile." One theory to explain the location of the "rock pile" was that the chips were actually rocks that had been originally distributed throughout the tank and were pushed by the water monitor to the vicinity of the pump, but the pump was unable to suck them up because of their high settling velocity. If these chips had indeed been large rocks, they would have accounted for a large percentage of residual solids in Tank 17, which would have dramatically reduced the estimate of the amount of contaminants in the tank.

However, the mudsnapper sample showed that the "rock pile" consisted only of 31% of inert chips, less than suggested by the video images. The chips were quite thin, so they appear large when viewed from the side, although their mass is small. Also, significantly, the large pieces that would be visible in video images, which were from 1/2 inch to 1 inch in diameter, comprised only 5% of the weight of the sample. The balance of the chips (26% of the sample) could be observed only by drying the sample and passing it through a sieve.

- It is reasonable to estimate that the "rock pile" contains about 200 gallons of inert solids. Figure 3 shows the extent of the "rock pile" at the time of a video inspection on 21 April 1997. At that time the pile was estimated to have an area of 320 square feet and an average height of 3 inches, for a volume of about 600 gallons. Thirty-one percent of 600 gallons is the basis for saying that there are approximately 200 gallons of inert solids.

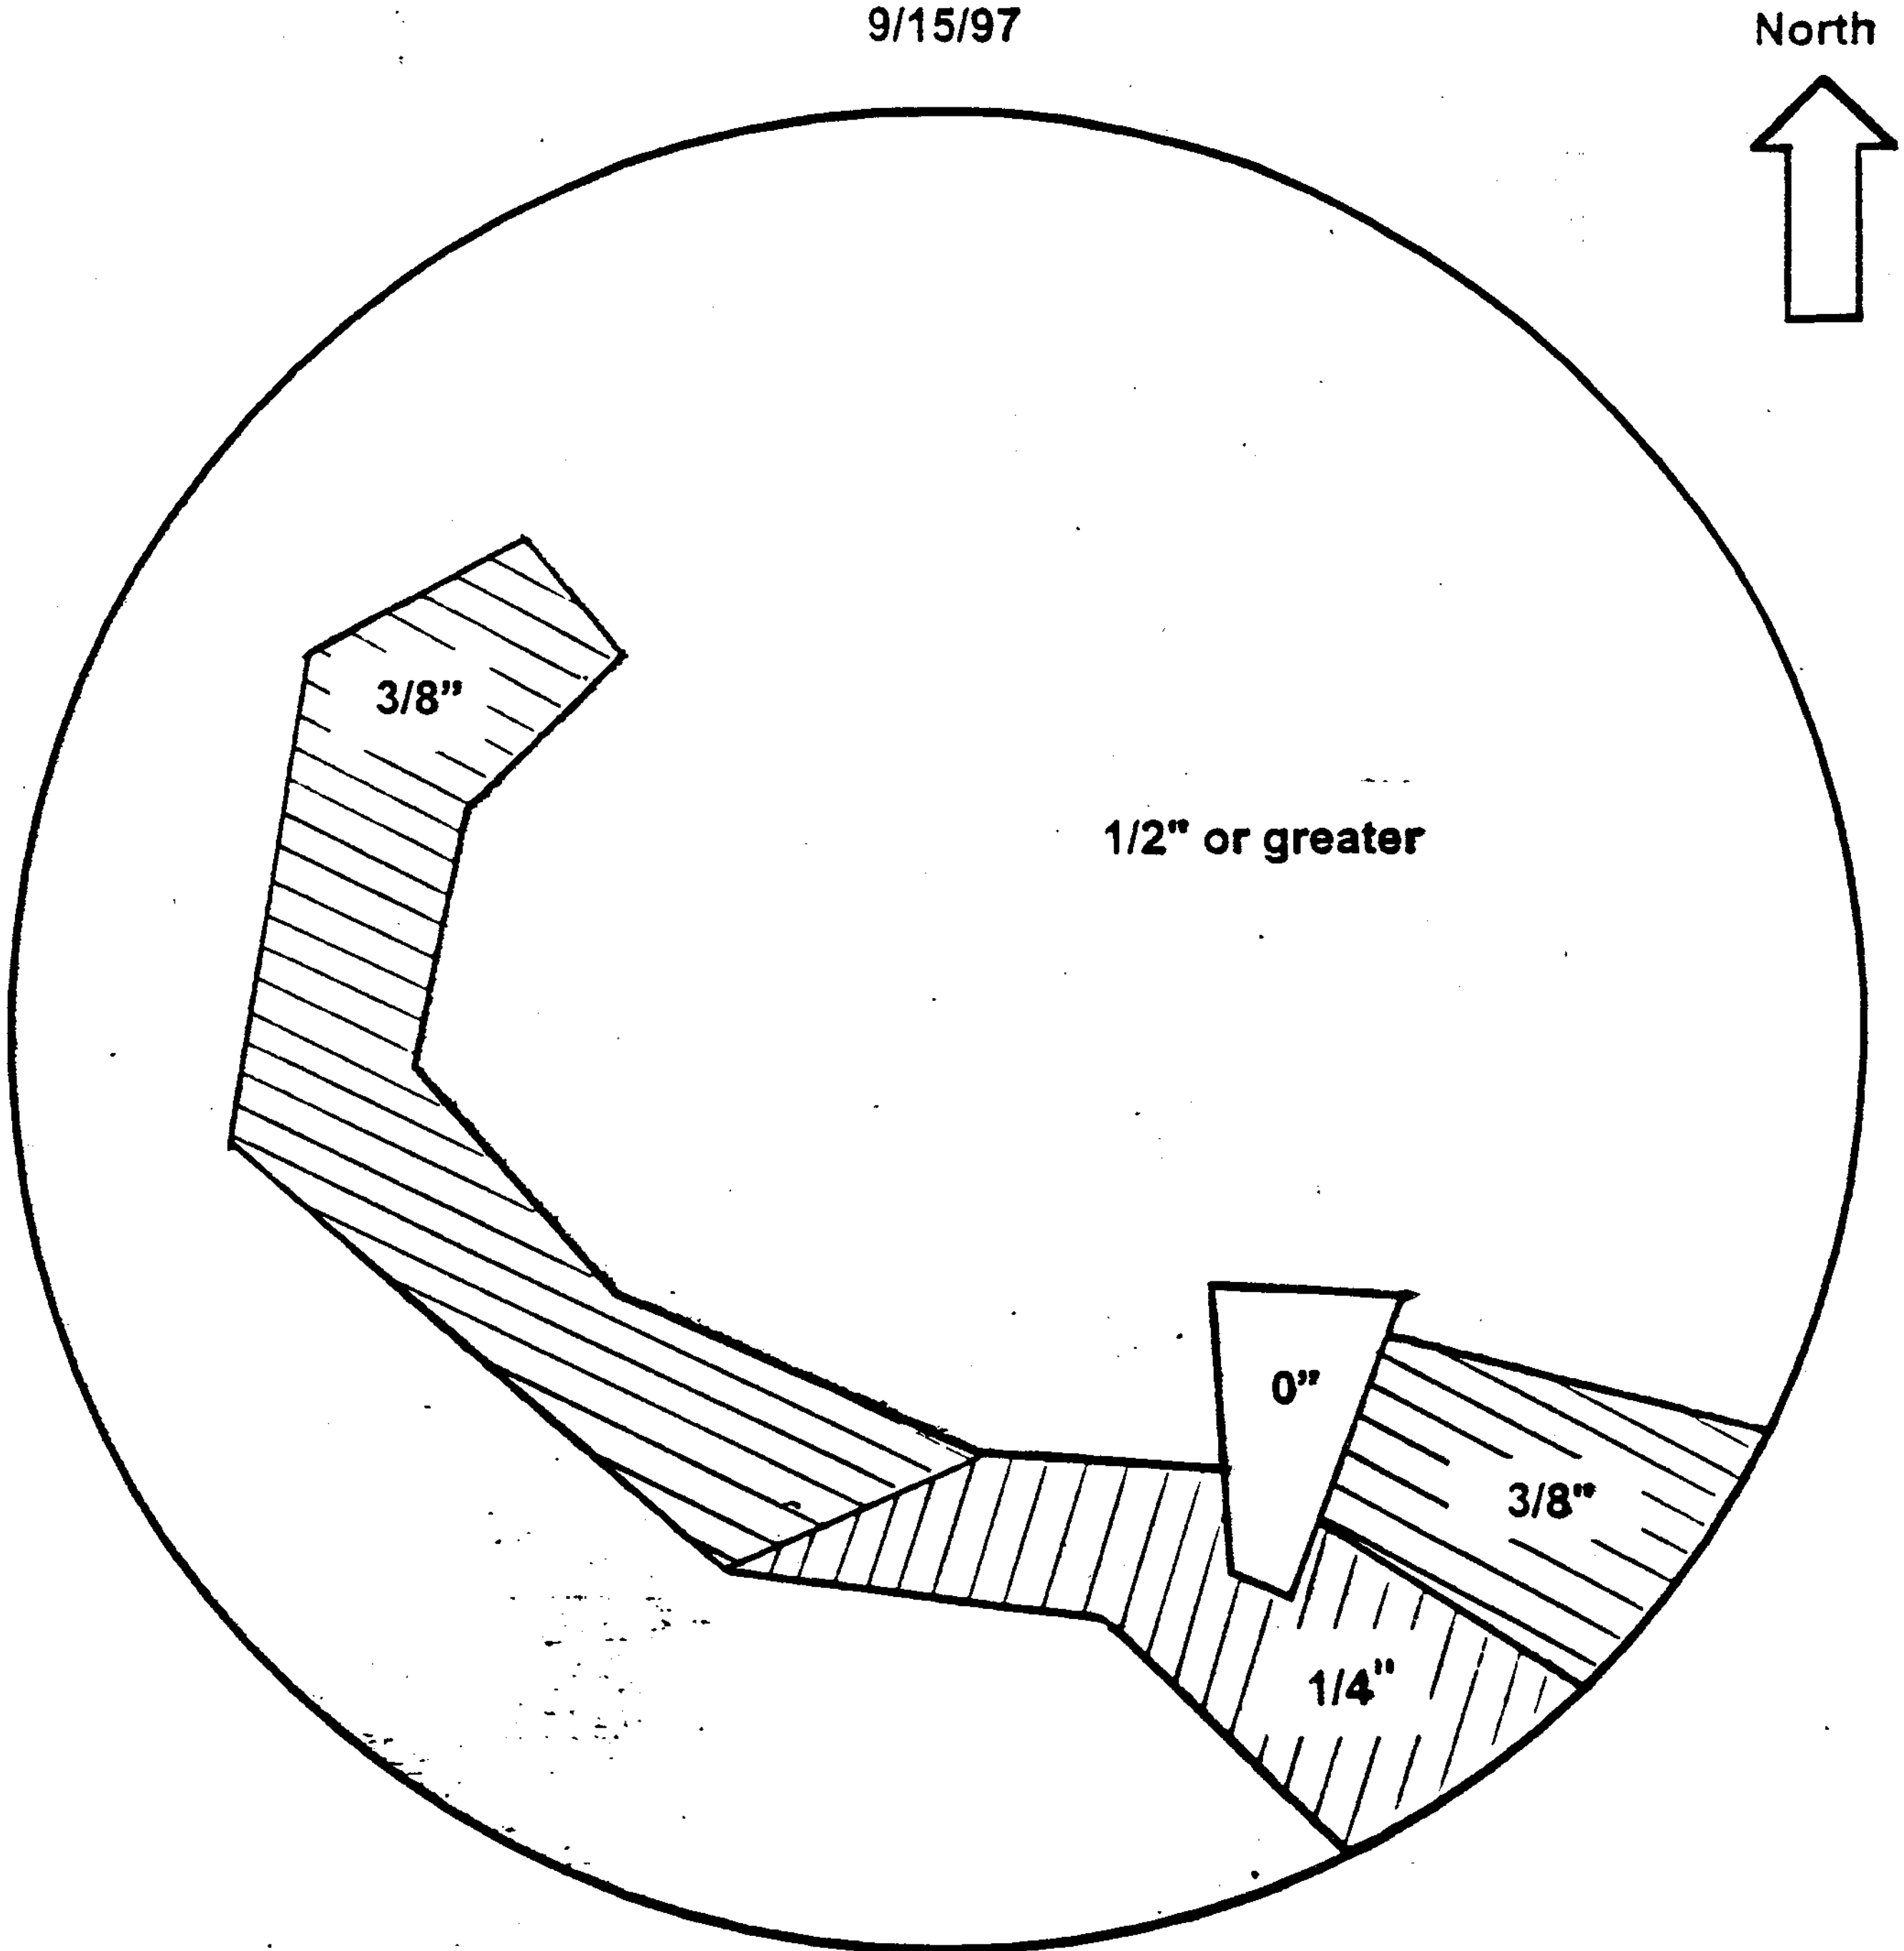
Figure 4 TANK 17 SLUDGE DISTRIBUTION MAP AFTER "WATER MOUSE" OPERATION WATER REMOVAL - LIQUID DEPTH <3/8" 9/15/97

* 1/2" or greater = 80%
* 3/8" = 13%
* 1/4" = 5%
* 0" = 2%

The Water Mouse was successful at redistributing the sludge in Tank 17. After the Water Mouse operation, a video inspection on 15 September 1997 (See Figure 4) showed that 80% of the tank was covered with sludge greater than 1/2 inch. The exact depth of the sludge at various spots in this region was difficult to estimate because the lifting plates were covered, the sludge was relatively featureless, and there were few objects in this region of the tank that could be used for judging depth.

In the portions of the tank where the lifting plates could be observed, about 13% of the tank had sludge about 3/8 inch, 5% about 1/4 inch, and only 2% of the tank floor appeared to be bare, rusty metal. The piles of course sludge that had been near the tank wall, some of which had been higher than 4 inches, were moved toward the interior of the tank. Also, much of the floor of the tank appeared to be covered with fine solids that had settled in a rippled pattern, like miniature sand dunes.

The configuration of the sludge after Water Mouse operation (Figure 4) was much more desirable than the configuration found in the inspection on 11 July 1997 (Figure 2) at the completion of spray washing. Based on the video inspection of 15 September 1997, the decision was made to close the tank.

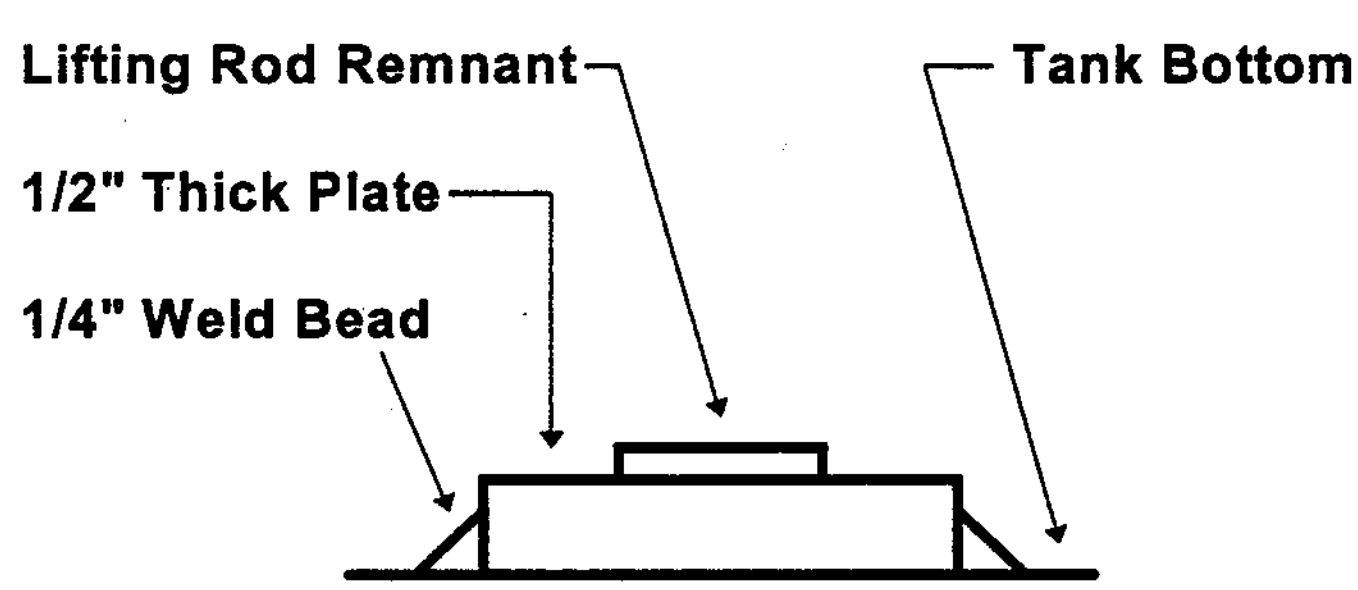
Figure A1. Lifting Plate Elevation View (Not to Scale)

A study of plant drawing W164197 Rev 0, shows that plates to be ½ inch thick attached with a ¼ inch filet weld bead. The following is a schematic of the plate.
