RIL 2021-08

USBR HL-2019-01

EROSION TESTING OF ZONED ROCKFILL EMBANKMENTS

Prepared by:
T. Wahl

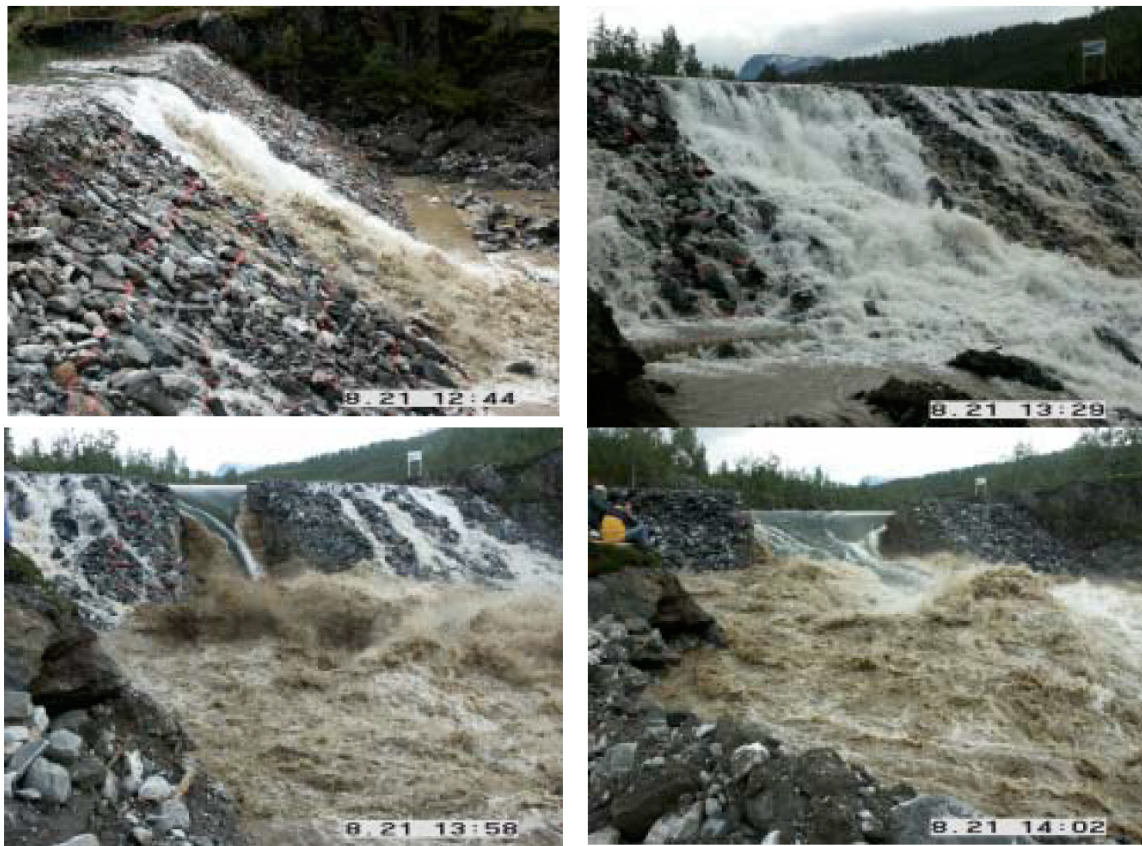
Figure 6-5 Headcut development during IMPACT test of zoned gravel dam, 1-2003 (from IMPACT WP2 Technical Report: Section 4).

Both of these tests demonstrated that broadly-graded rockfill materials can experience headcut erosion. The gravel zones of both embankments exhibited enough strength to stand at steep slopes and enough erosion resistance to avoid unraveling immediately under the initial surface flow. Although photos of the tests do not show a deep tailwater pool downstream of these embankments, it is likely that local tailwater developed quickly as materials eroded from the embankments were dropped a short distance downstream, creating a tailwater pool that could have enabled scour of the toe and creation of a vertical drop. In the test performed for the present study, the free overfall immediately downstream from the embankment did not support this kind of flow in the tailwater zone, which may partially explain why headcutting was not observed.

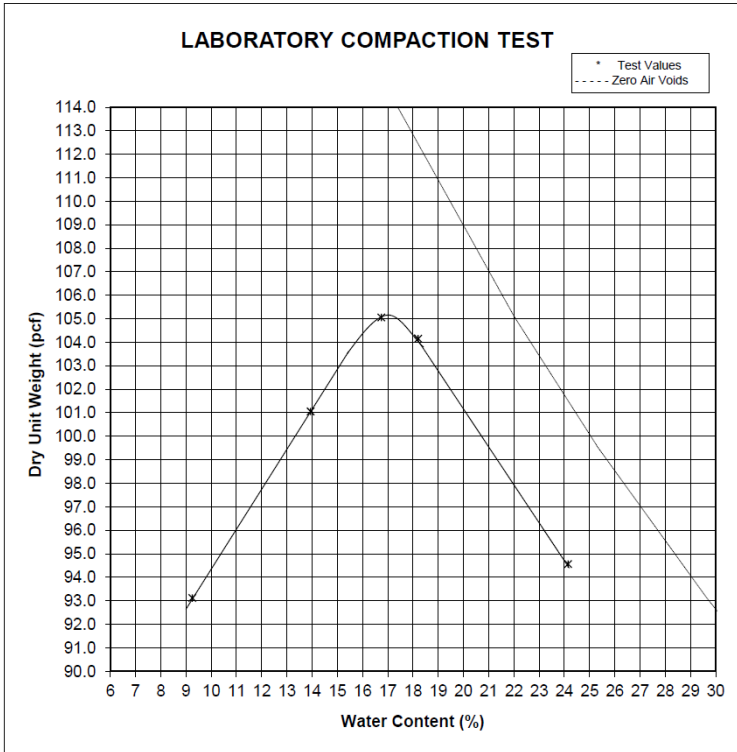
Test Information	
Project No.:	15121002
Test Date:	03/04/15
Proctor No.:	
Test Method:	ASTM D 698 Method A
Rammer Type:	Manual
Prep. Method:	Moist

Sample Description
Light brown, silt to silty clay with organics

Sample Properties	
Moisture Content	9.6
Liquid Limit	27
Plastic Limit	21
Plasticity Index	6
Specific Gravity:	2.675 Actual
Classification	CL-ML
