This report provides the results the Accident Sequence Precursor (ASP) Program for 2021. In addition, trends and key insights are provided for the past 10 years (2012 through 2021).

U.S. Nuclear Regulatory Commission Accident Sequence Precursor (ASP) Program 2021 Annual Report

June 2022

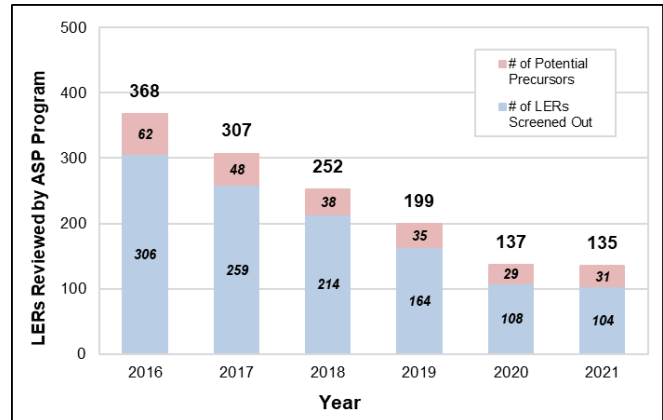
Figure 1. ASP Program LER Review Breakdown

There were 135 licensee event reports (LERs) issued in calendar year 2021. From these LERs, 104 (approximately 77 percent) were screened out in the initial screening process and 31 events were selected and analyzed as potential precursors. The overall number of LERs and potential precursors continues to decrease to historical lows. Figure 1 provides a breakdown of the number of LERs reviewed by the ASP Program since the switch was made to review LERs issued on a calendar-year basis in 2016. The ASP Program is looking at the potential of other data sources for potential precursors due to the decreasing LERs for failures that have been reported historically.

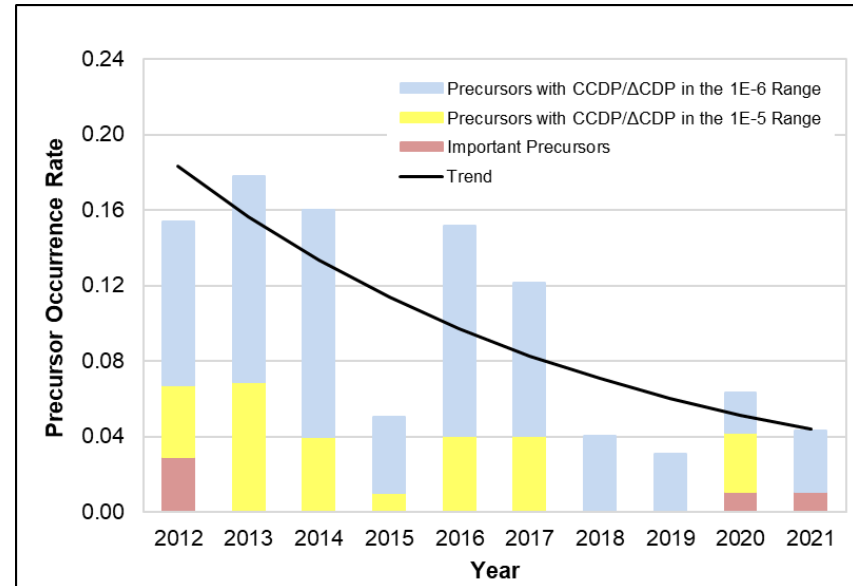
Figure 2. Occurrence Rate of All Precursors

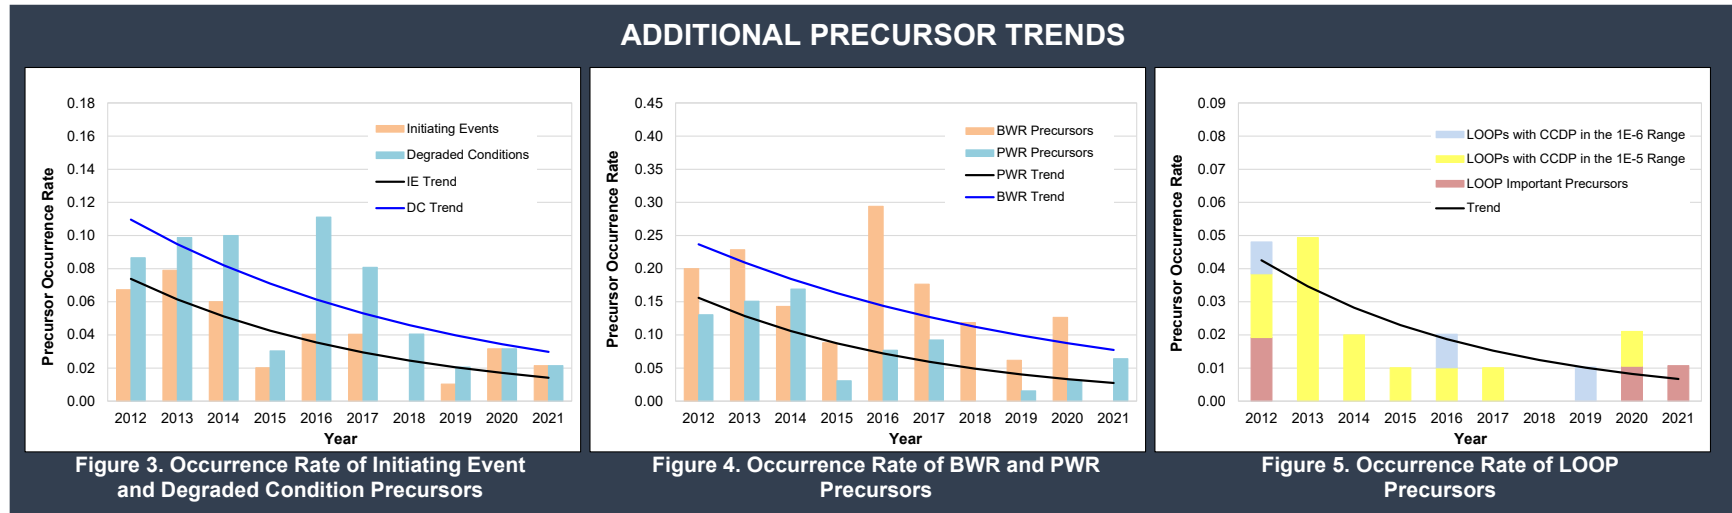
Figure 3. Occurrence Rate of Initiating Event and Degraded Condition Precursors

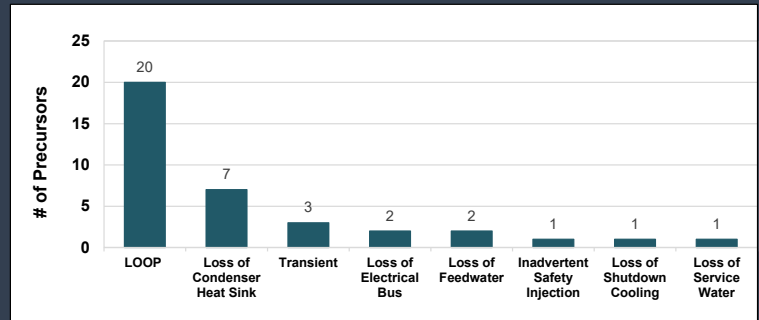
Figure 7. Most Frequent Initiating Event Precursor Types

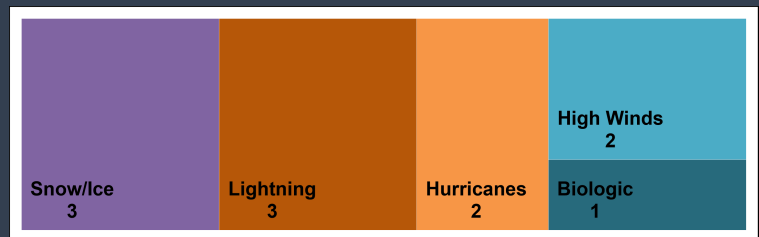
Figure 8. Natural Phenomena Precursors Causes

Natural phenomena caused 11 precursors, with snow/ice and lightning the most frequent causes.

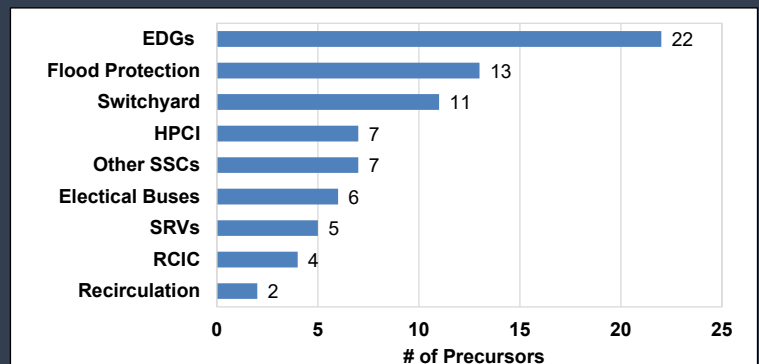
Figure 9. Most Frequent Precursor SSC Failures

The most frequent structure, system, and component (SSC) failures observed in precursors were associated with EDGs, flood protection, and switchyard.

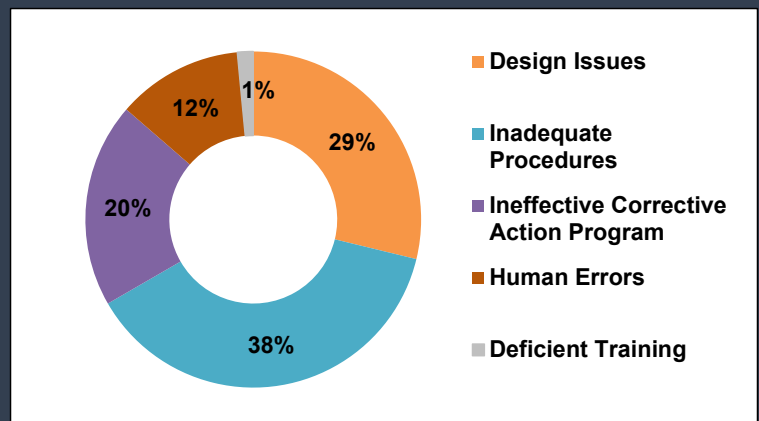
Figure 10. Dominant Precursor SSC Failures

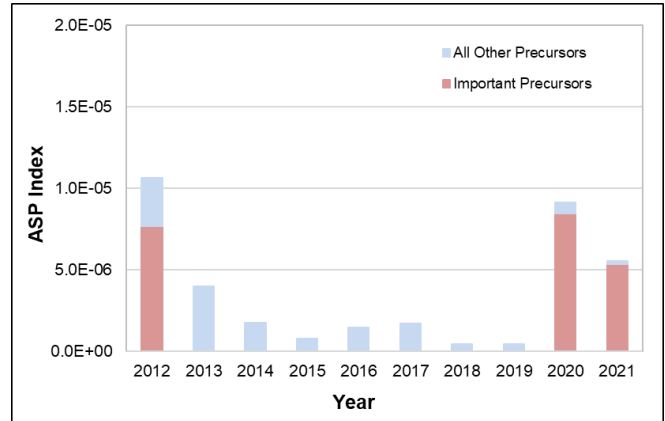
Figure 3. ASP Index

The ASP index shows the cumulative plant average risk from precursors on an annual basis. Unlike the trend analyses performed on various precursor groups that are focused on the occurrence rate of precursors, the ASP index is focused on the total risk due to all precursors. Therefore, the ASP index provides a unique way to evaluate the risk of longer-term degraded conditions over the entire duration of the condition.

The ASP index does not exhibit a statistically significant trend ($p\text{-value} = 0.7$) for the past decade (2012–2021). The total risk associated with precursors (99 total precursors) is dominated by the 5 important precursors, which account for approximately 60 percent of the total risk due to all precursors. The other 94 precursors account for approximately 47 percent to the total risk due to all precursors.
