Containment Liner Corrosion

Darrell Dunn, April Pulvirenti, and Paul Klein
U.S. Nuclear Regulatory Commission

15th International Conference on Environmental Degradation of Materials in Nuclear Power Systems – Water Reactors

August 7-11, 2011

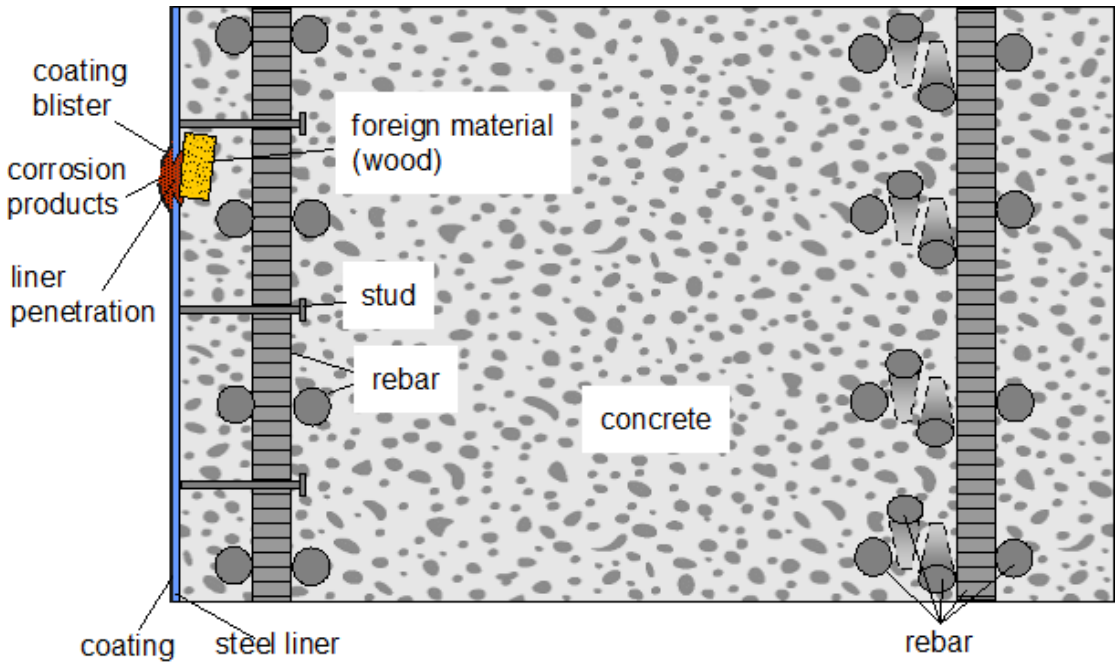
Liner Corrosion Mechanism

- Macrocell-Accelerated Localized Corrosion
- Foreign body could promote early corrosion initiation with even moderate pH decrease and minor chloride presence

- Concrete can provide moisture needed for macrocell
- Liner and rebar provides ample passive surface for cathodic reaction
- Even limited oxygen presence may provide enough cathodic action for corrosion to propagate

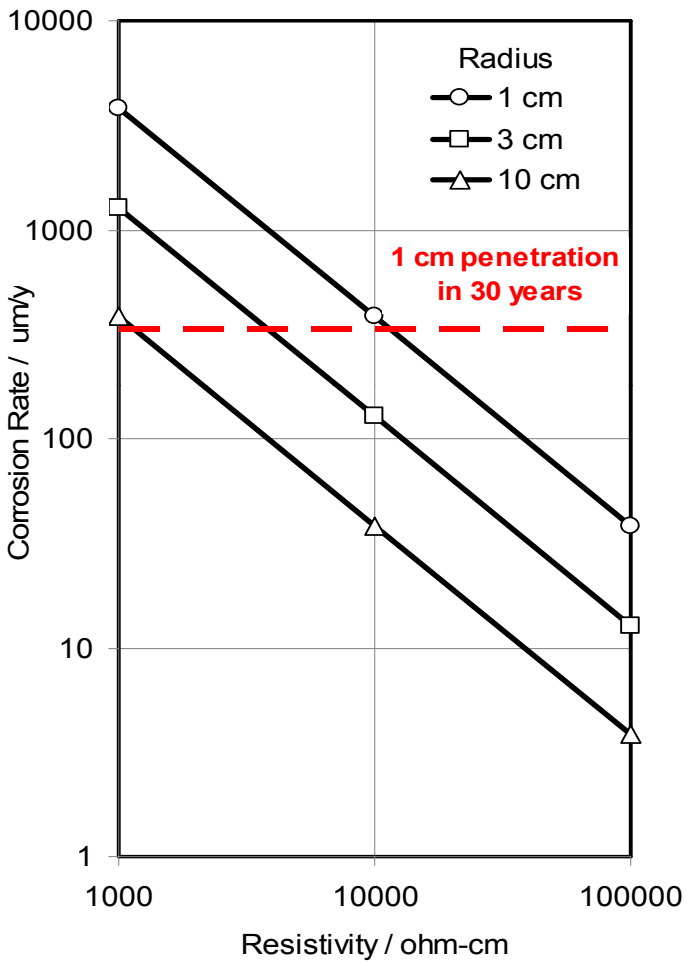
Liner Corrosion Calculation

- Calculations performed by Professor A. Sagues
- Concrete resistivity and radius of anodic area varied
- Calculated corrosion rates consistent with observed penetration of containment liners from corrosion initiated at the concrete/liner interface
