Subject: Westinghouse Hematite Decommissioning Project - Request for NRC Review of Final Status Survey Final Report Volume 3, Chapter 5, Survey Area Release Record for Land Survey Area 10, Survey Units 13 and 14 (LSA 10-13 and LSA 10-14); and Volume 6, Chapter 4, Post-remediation Groundwater Monitoring 2nd Quarter Results (License No. SNM-00033, Docket No. 070-00036)

Hematite Decommissioning Project

Final Status Survey Final Report Volume 3, Chapter 5

TITLE: **Survey Area Release Record for Land Survey Area 10, Survey Units 13 and 14 (LSA 10-13 and LSA 10-14)**

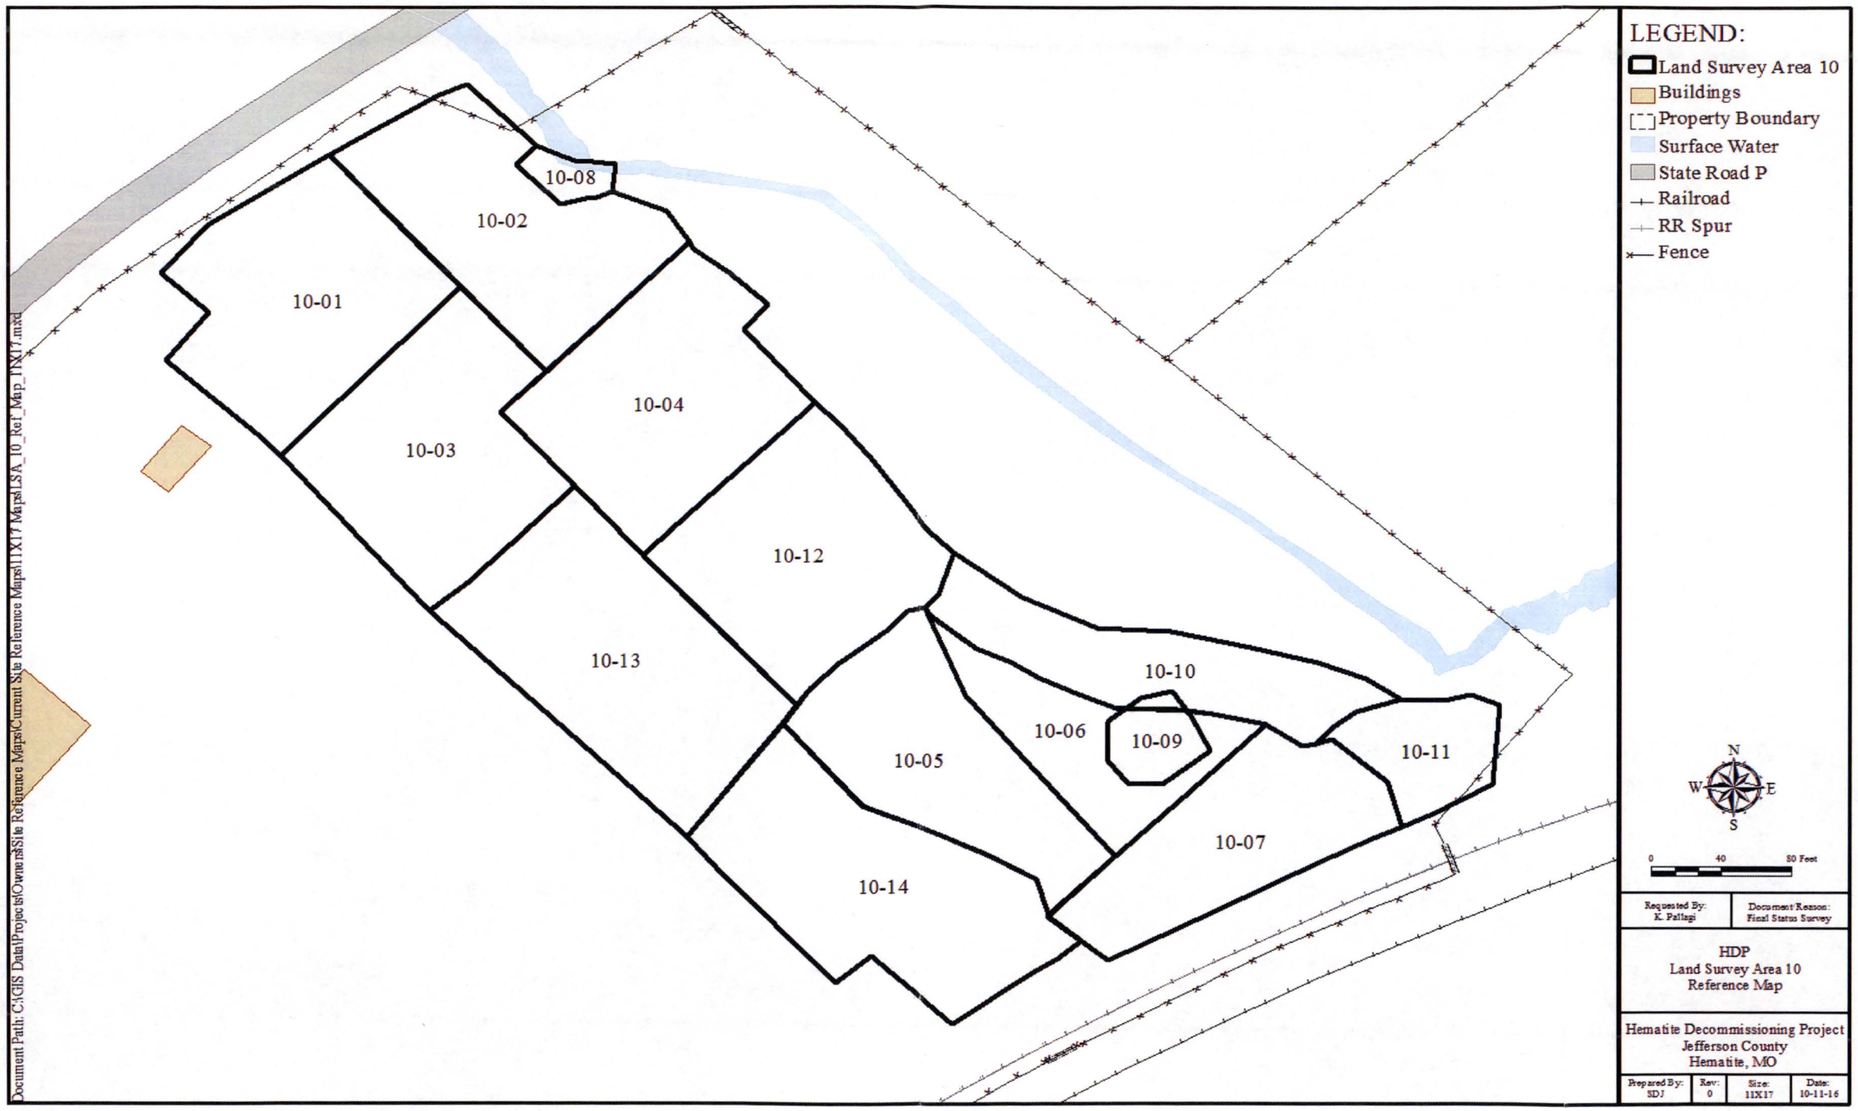
Figure 2-2
Final Configuration of Land Survey Area 10 and Survey Units

LSA 10-13 and LSA 10-14 are located within the southern half of LSA 10, the Burial Pit Area. Figure 2-2 indicates the location of LSA 10-13 and LSA 10-14 within LSA 10. Figure 2-3 presents the Final Configuration of the HDP Land Survey Areas and SUs which indicate the location of the boundaries of LSA 10-13 and LSA 10-14.

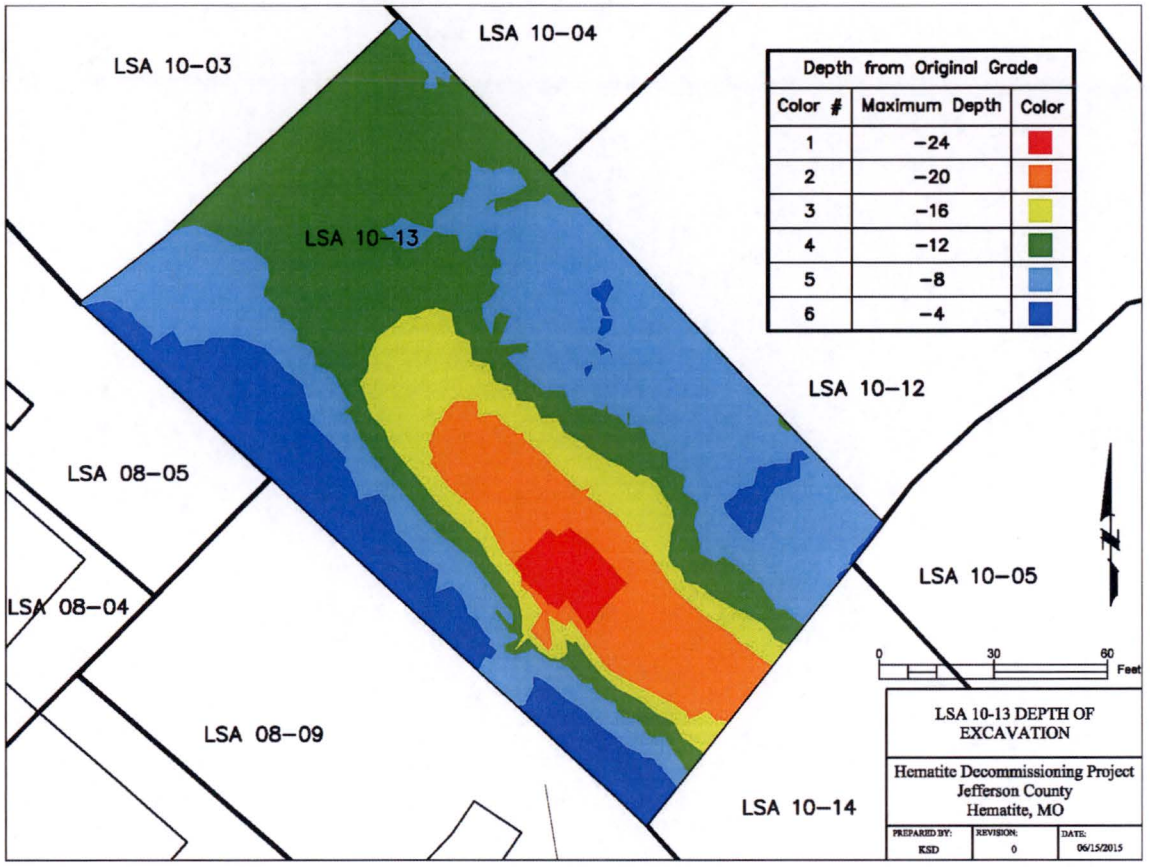
Figure 3-5
LSA 10-13 Depth of Excavation Map (Depths in Feet)*

The maximum depth of remedial excavation necessary in portions of LSA 10-13 to ensure all areas identified during site characterization and remedial action survey efforts were adequately remediated relative to the original grade was 24 feet. The estimated volume of excavated waste materials from LSA 10-13 was 6,817 cubic yards. Figure 3-5 provides the depth of excavations for LSA 10-13.

*Depth of Excavation Map presented in colored bands of feet. Maximum depth is 24 feet.

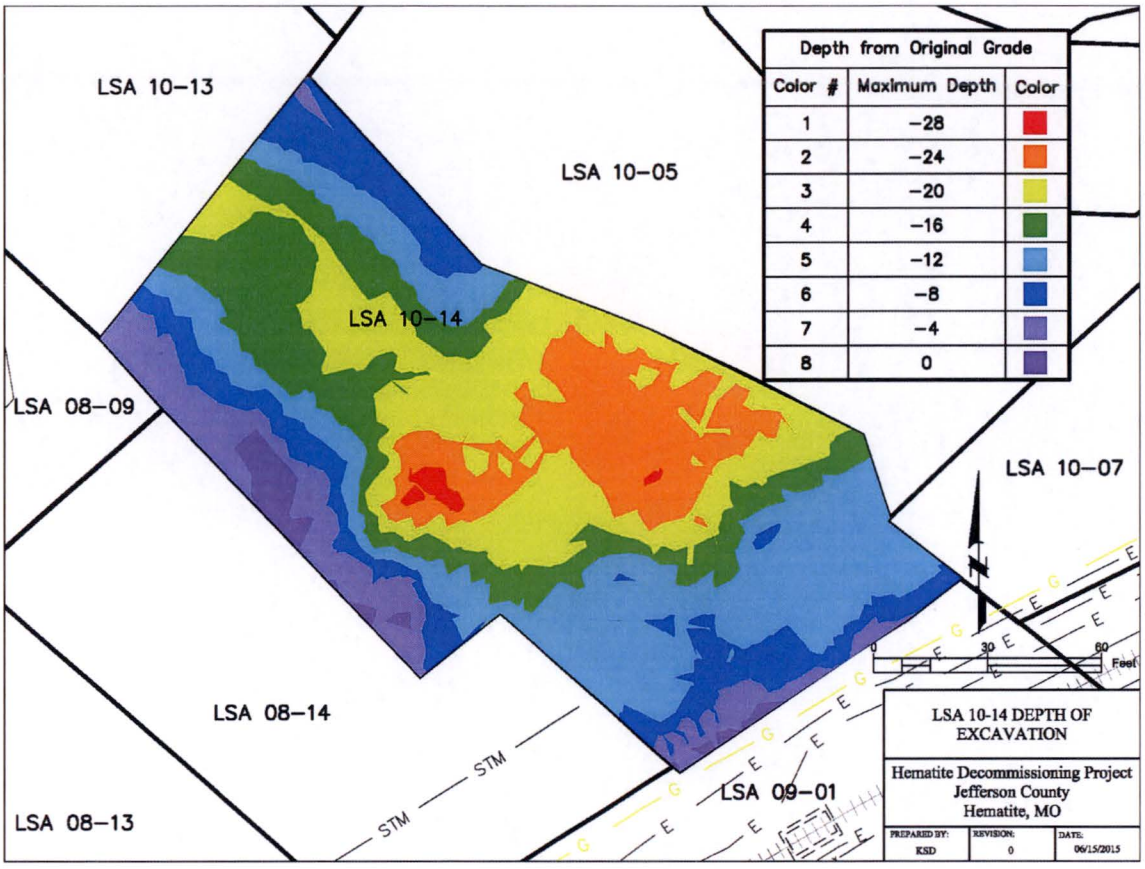
Figure 3-6
LSA 10-14 Depth of Excavation Map (Depths in Feet)*

The maximum depth of remedial excavation necessary in portions of LSA 10-14 to ensure all areas identified during site characterization and remedial action survey efforts were adequately remediated relative to the original grade was 28 feet. The estimated volume of excavated waste materials from LSA 10-14 was 8,754 cubic yards. Figure 3-6 provides the depth of excavations for LSA 10-14.

*Depth of Excavation Map presented in colored bands of feet. Maximum depth is 28 feet.

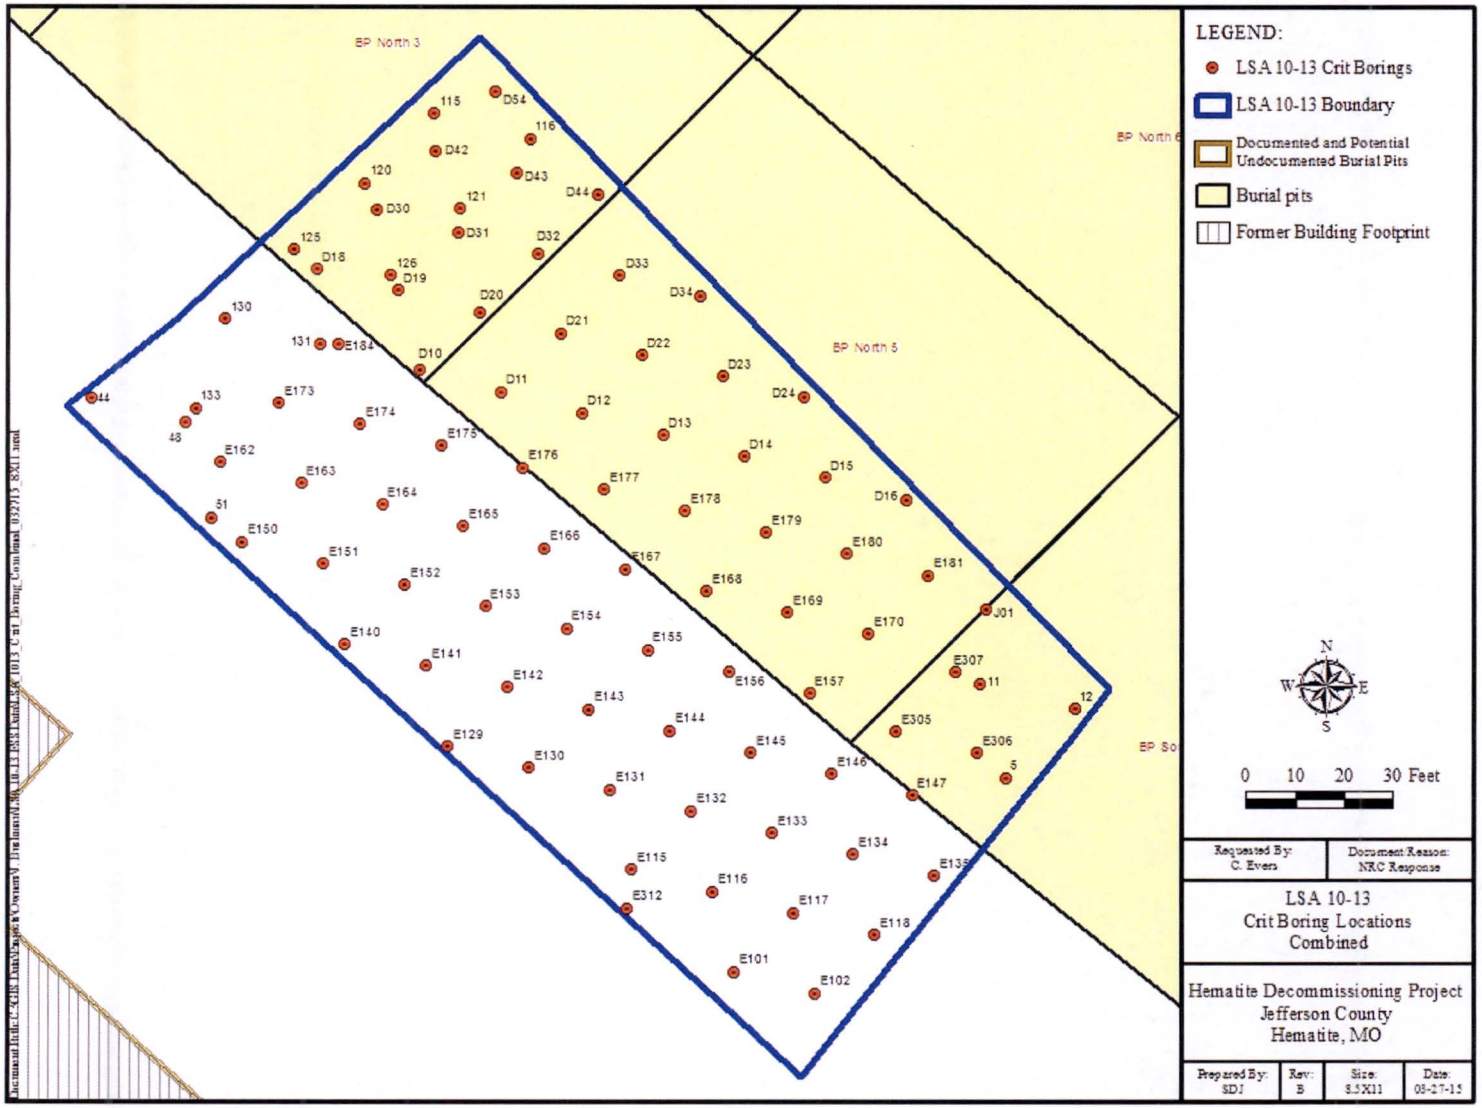
Figure 3-7
NCS Core Bore Locations in LSA 10-13

No materials indicative of burial pit waste were encountered below the excavation surface within LSA 10-13 and LSA 10-14.

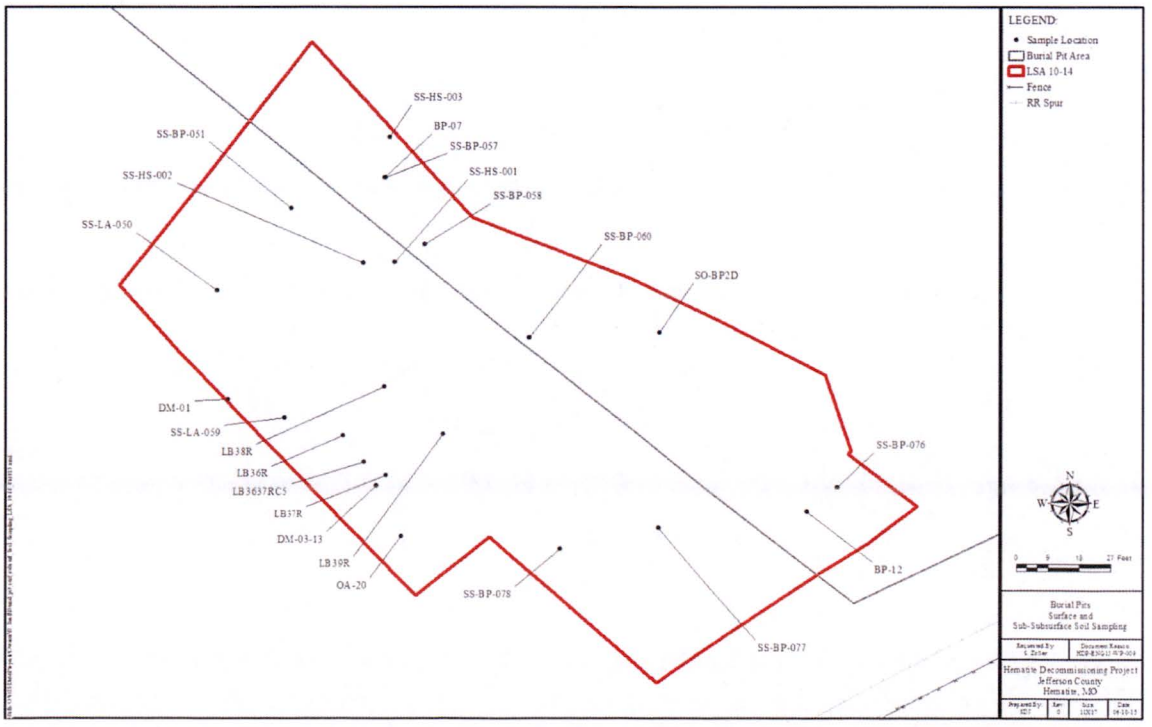
Figure 3-10
Site Characterization Borings within LSA 10-14

Within LSA 10-14, of the twenty three (23) characterization boring locations within the SU ten (10) samples (five in the Surface Stratum and five in the Root Stratum) exceeded a SOF of 1 as compared to the Uniform Stratum criteria from the surface to depths of up to 5 ft bgs (Root Stratum). Within LSA 10-14 the Surface Stratum was entirely removed. The five (5) Root Stratum samples (SS-HS-001, LB36R, LB3637RC5, LB37R, and LB39R) exceeded a SOF of 1 at depths up to 5 ft bgs, with all 5 of these locations being excavated to depths greater than 8 ft bgs. Figure 3-10 indicates the radiological characterization boring locations within LSA 10-14.

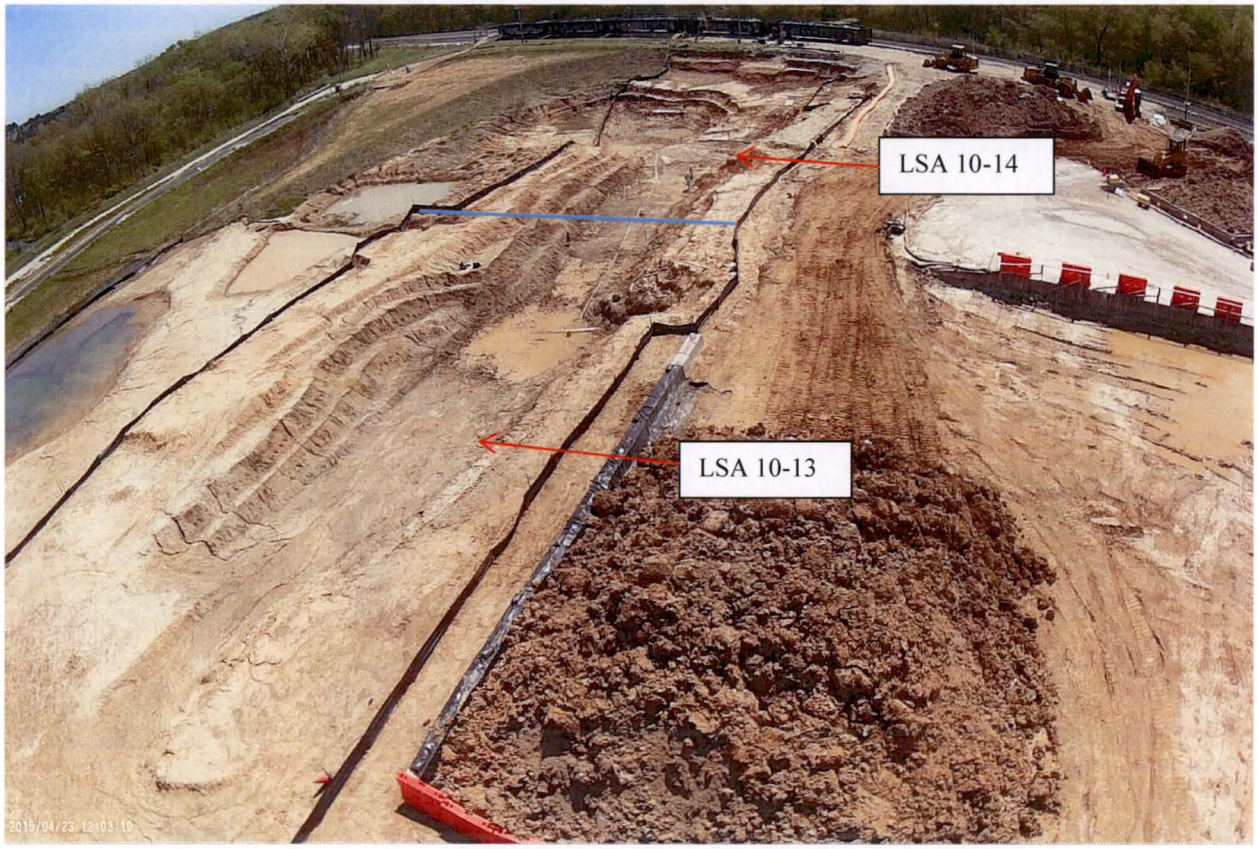
Figure 3-11
LSA 10-13 and LSA 10-14 Prepared for RASS FSS Design

The RASS was conducted 1) to guide remediation activities, 2) to determine when an area or survey unit had been adequately prepared for FSS, and 3) to provide updated estimates of the parameters to be used for planning the FSS. Upon completion of remediation within the survey unit and prior to implementation of FSS activities, a final RASS was performed to validate the status of the SU prior to implementing Isolation and Control (I & C) postings. The I & C posting for both LSA 10-13 and LSA 10-14 was completed on March 11, 2015. Figure 3-11 is a photograph which shows LSA 10-13 and LSA 10-14 ready for the final RASS.

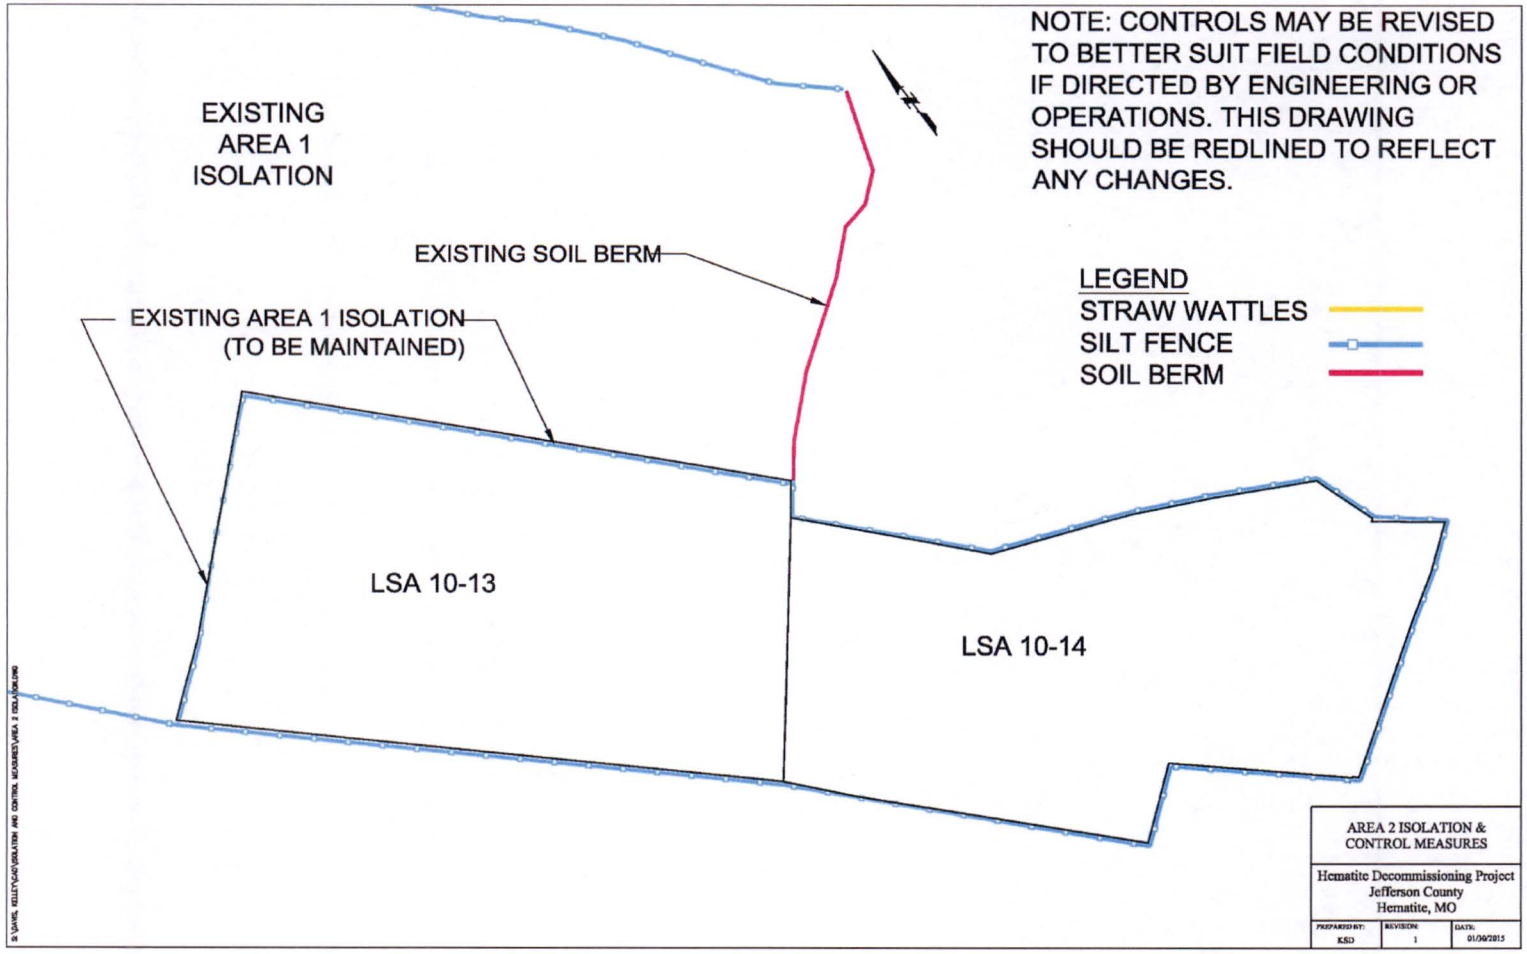
Figure 3-12
Isolation and Control of Area Containing LSA 10-13 and LSA 10-14

The administrative control of distinctive green and white rope with multiple postings labeled "Contact Health Physics Prior to Entry" was installed around the entire perimeter of the SUs prior to FSS field activities to prevent inadvertent entry by site personnel. LSA 10-13 and LSA 10-14 are located within the fenced security perimeter of the HDP which therefore prevents access by the general public.

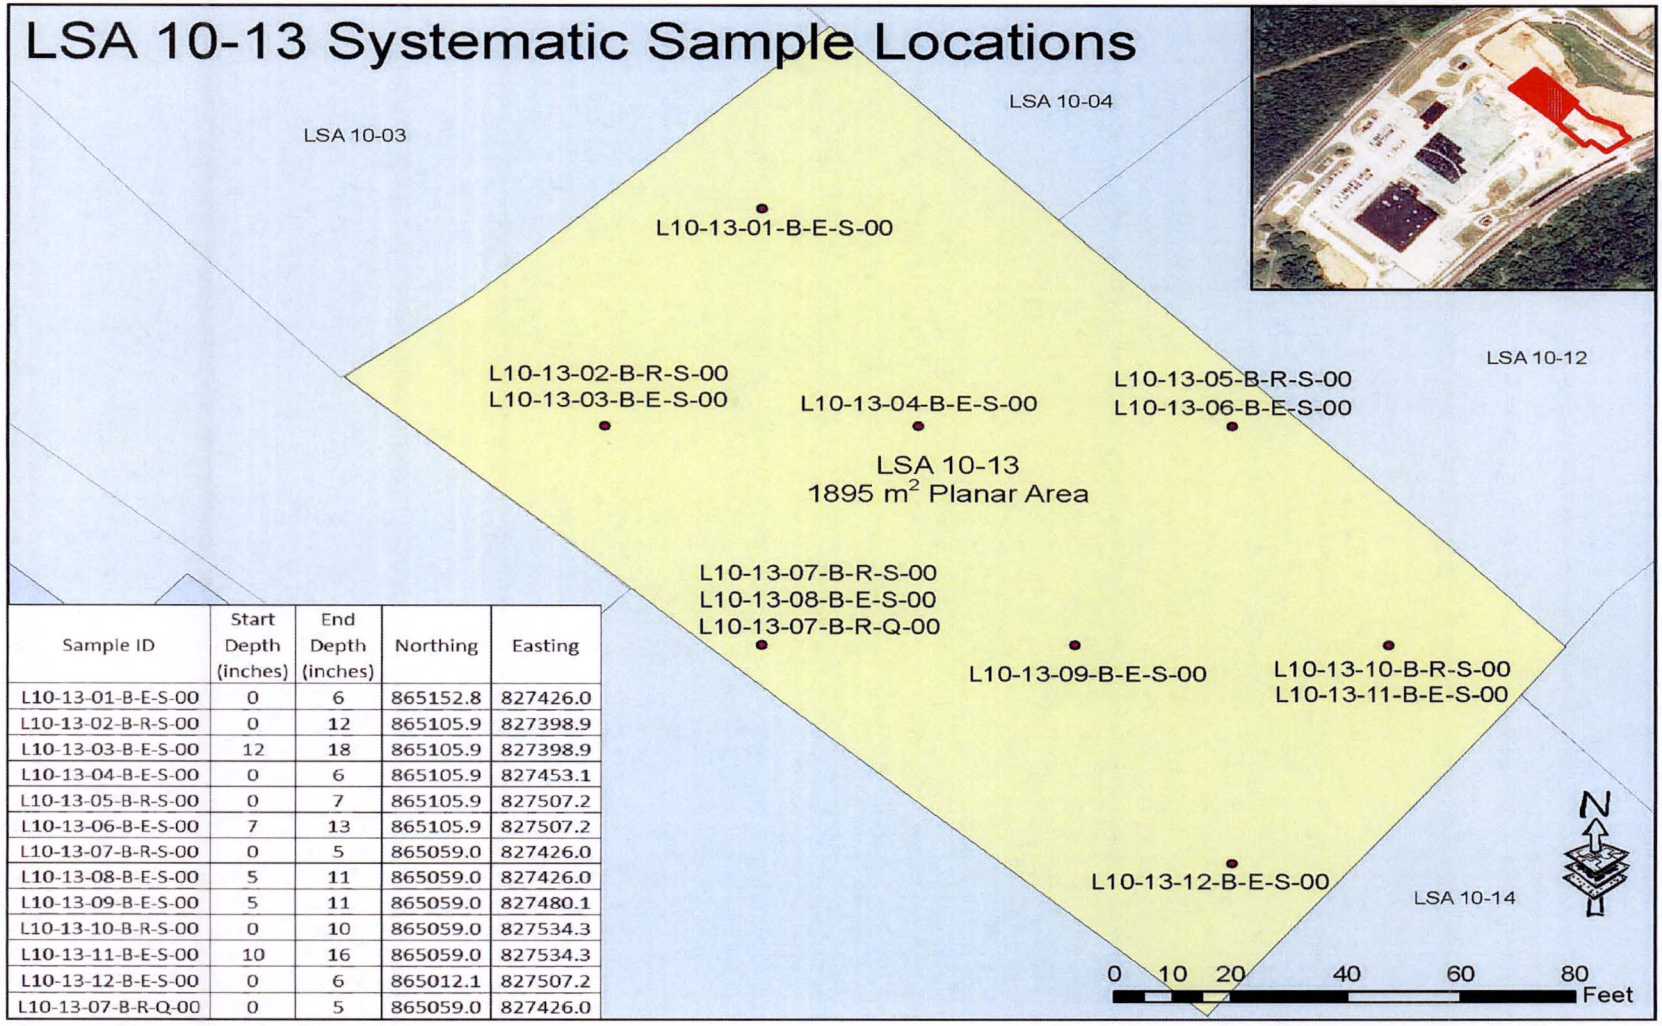
Figure 6-1
LSA 10-13 Systematic Soil Sample Locations

Figure 6-1 presents the map of the eight systematic sample locations which were sampled within LSA 10-13. The inset table notes the location coordinates (Missouri East, North American Datum (NAD) 1983) and collection intervals for each systematic location.

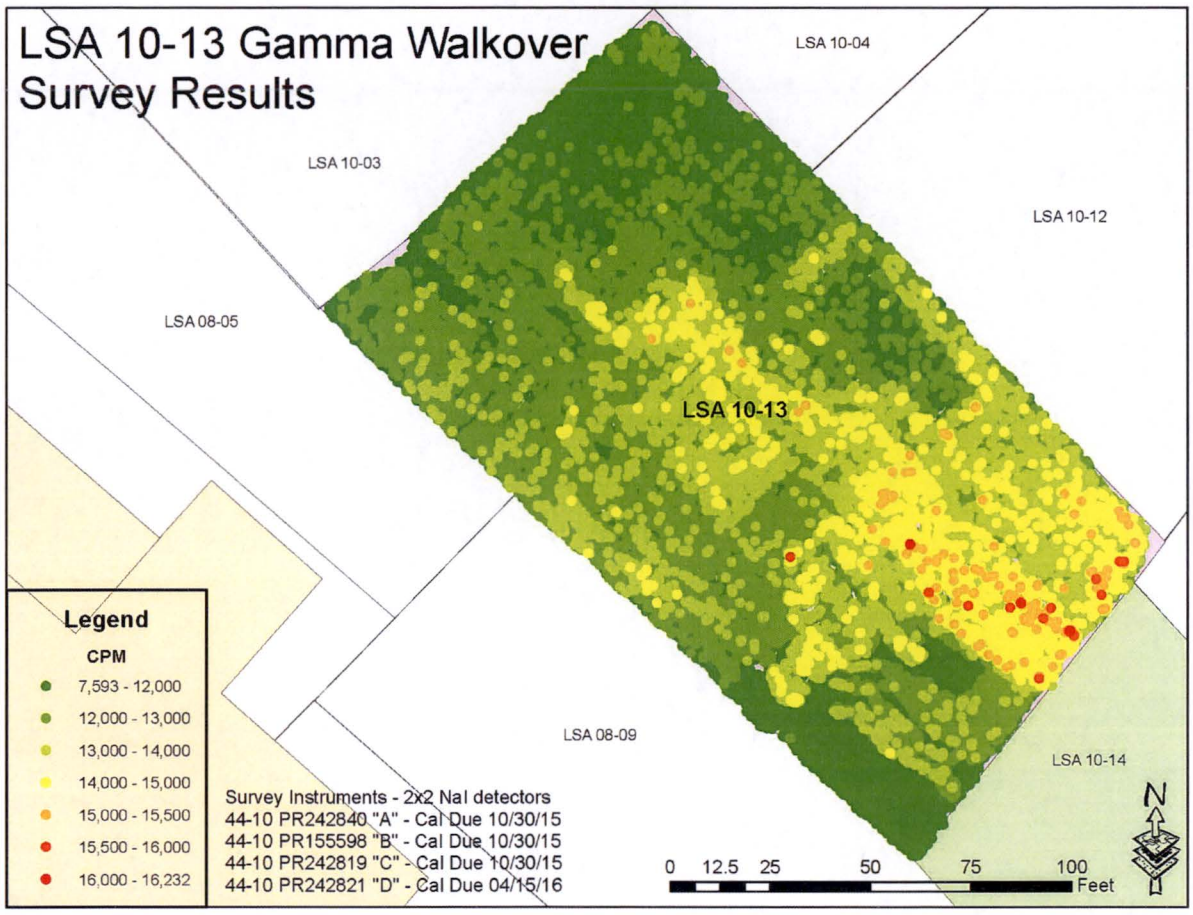
Figure 7-1
Colorimetric GWS Plot for LSA 10-13

For LSA 10-13, GWS count rates ranged between 7,593 gcpm and 16,323 gcpm, with a mean count rate of 11,985 gcpm. The median count rate was 12,035 gcpm and the standard deviation was 1,149 cpm. Figure 7-1 below presents a map of the complete GWS data set.

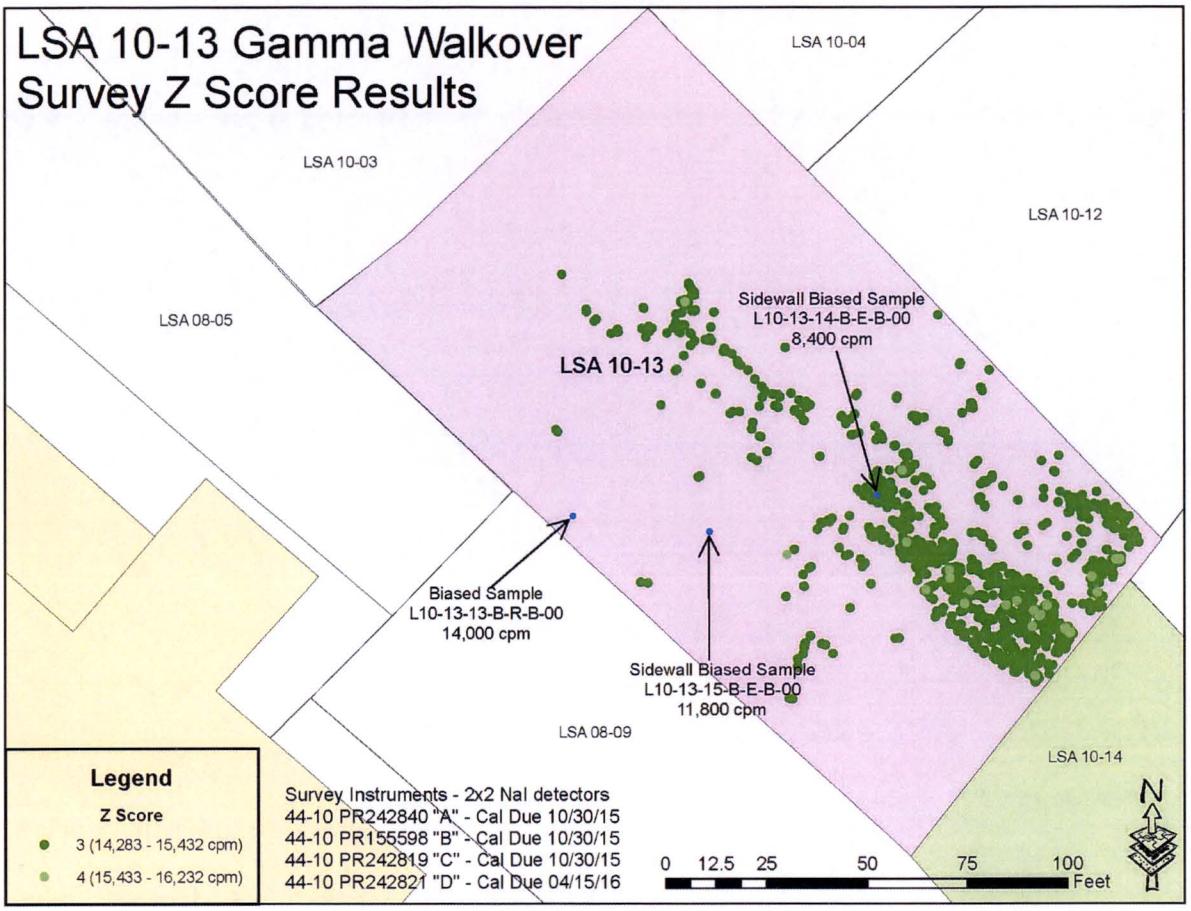
Figure 7-2
Colorimetric GWS Plot for LSA 10-13 (Measurements > Z-score of 3)

An evaluation of the entire GWS data set was performed to evaluate those small areas of elevated activity which exceeded three (3) standard deviations above the GWS mean measurement, (i.e., "+3 Z-score"). One location, L10-13-13, was selected for biased sample collection. This biased location represented the maximum GWS measurement encountered within the SU. Also, this single biased location was the only point which exceeded both the IAL based on the local background readings and a Z-score of 3. Therefore, no additional biased locations were selected for sampling. Westinghouse conservatively decided to perform additional remediation at this location after the sample was collected; the initial GWS reading at L10-13-13 was the SU maximum of approximately 21,800 gcpm. After the manual remediation, the GWS reading at this location was reduced to approximately 14,000 gcpm. This issue is discussed further in Section 9.1 – FSS Plan Deviations.

Figure 7-2 below presents a map of the +3 Z-score GWS measurements within LSA 10-13, including the selected biased sampling location (ID: L10-13-13-B-R-B-00). For completeness, the locations of the two supplemental sidewall samples (collected from locations selected by the HP Technician at random) are also shown in Figure 7-2.

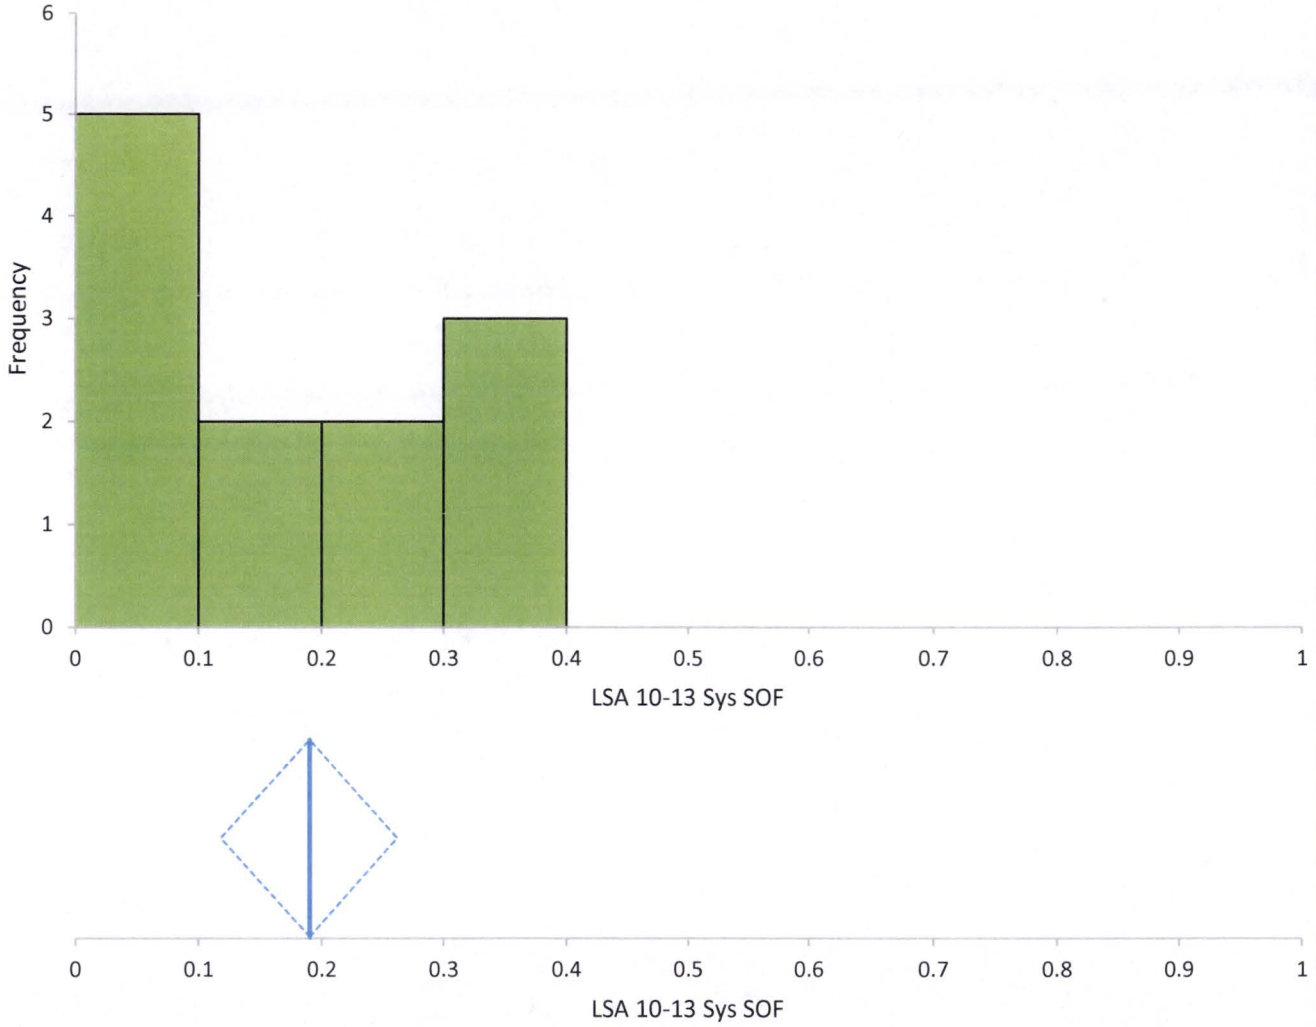
Figure 7-3
Graphic Statistical Summary for LSA 10-13 (SOF parameter)

Figure 7-3 exhibits no unusual symmetry or bimodality concerns for the LSA 10-13 data associated with the systematically collected measurement locations.

Mean	95% CI		Mean SE	SD	Variance	Skewness	Kurtosis
LSA 10-13 Sys SOF	0.19	0.12	to 0.26	0.033	0.11	0.01	0.6	-1.15

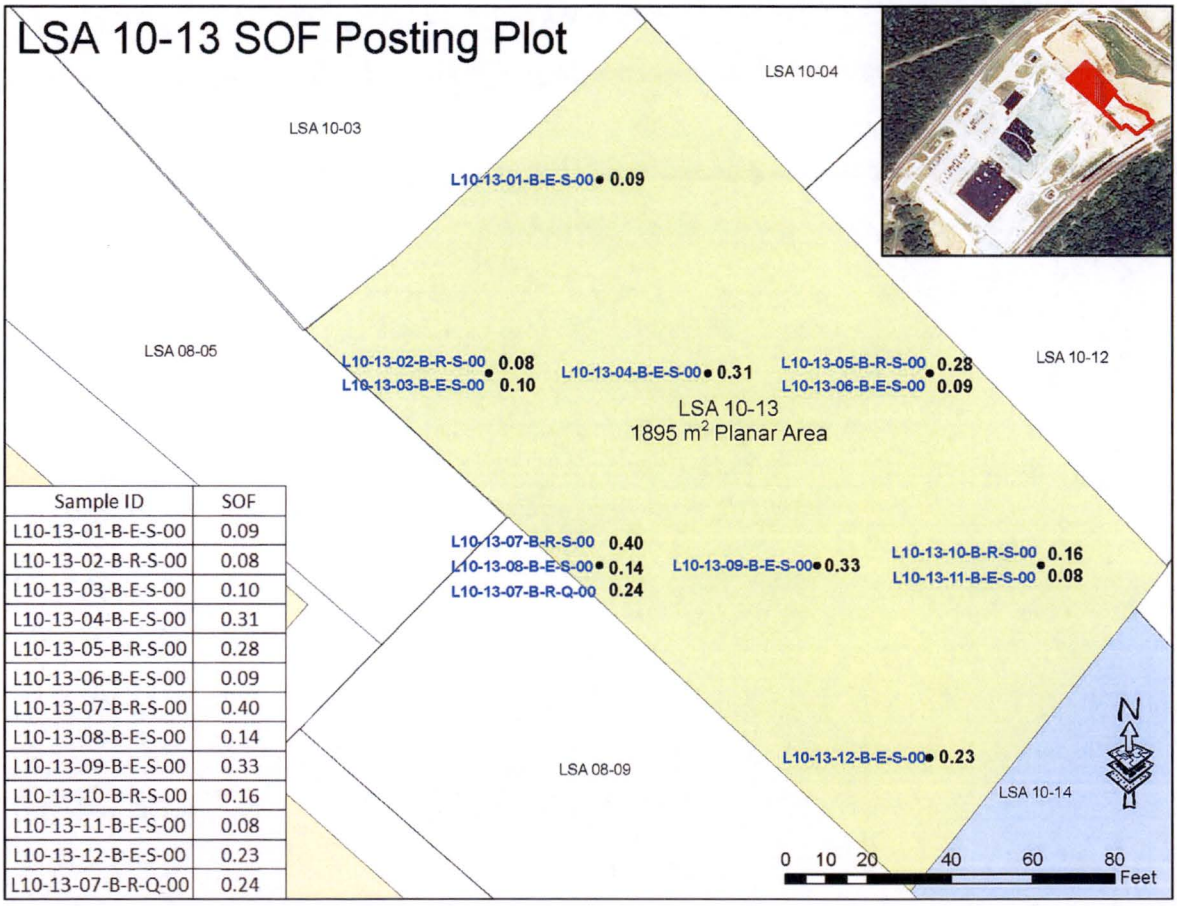
Figure 7-4
Posting Plot for LSA 10-13 Systematic Measurement Locations

A posting plot is simply a map of the survey unit with the data values (in this case the SOF values for each systematically collected sample) entered at the measurement locations. This potentially reveals heterogeneities in the data – especially possible patches of elevated residual radioactivity. The posting plot for LSA 10-13 is presented below in Figure 7-4. Figure 7-4 shows no unusual patterns in the data.

Sample ID	SOF
L10-13-01-B-E-S-00	0.09
L10-13-02-B-R-S-00	0.08
L10-13-03-B-E-S-00	0.10
L10-13-04-B-E-S-00	0.31
L10-13-05-B-R-S-00	0.28
L10-13-06-B-E-S-00	0.09
L10-13-07-B-R-S-00	0.40
L10-13-08-B-E-S-00	0.14
L10-13-09-B-E-S-00	0.33
L10-13-10-B-R-S-00	0.16
L10-13-11-B-E-S-00	0.08
L10-13-12-B-E-S-00	0.23
L10-13-07-B-R-Q-00	0.24

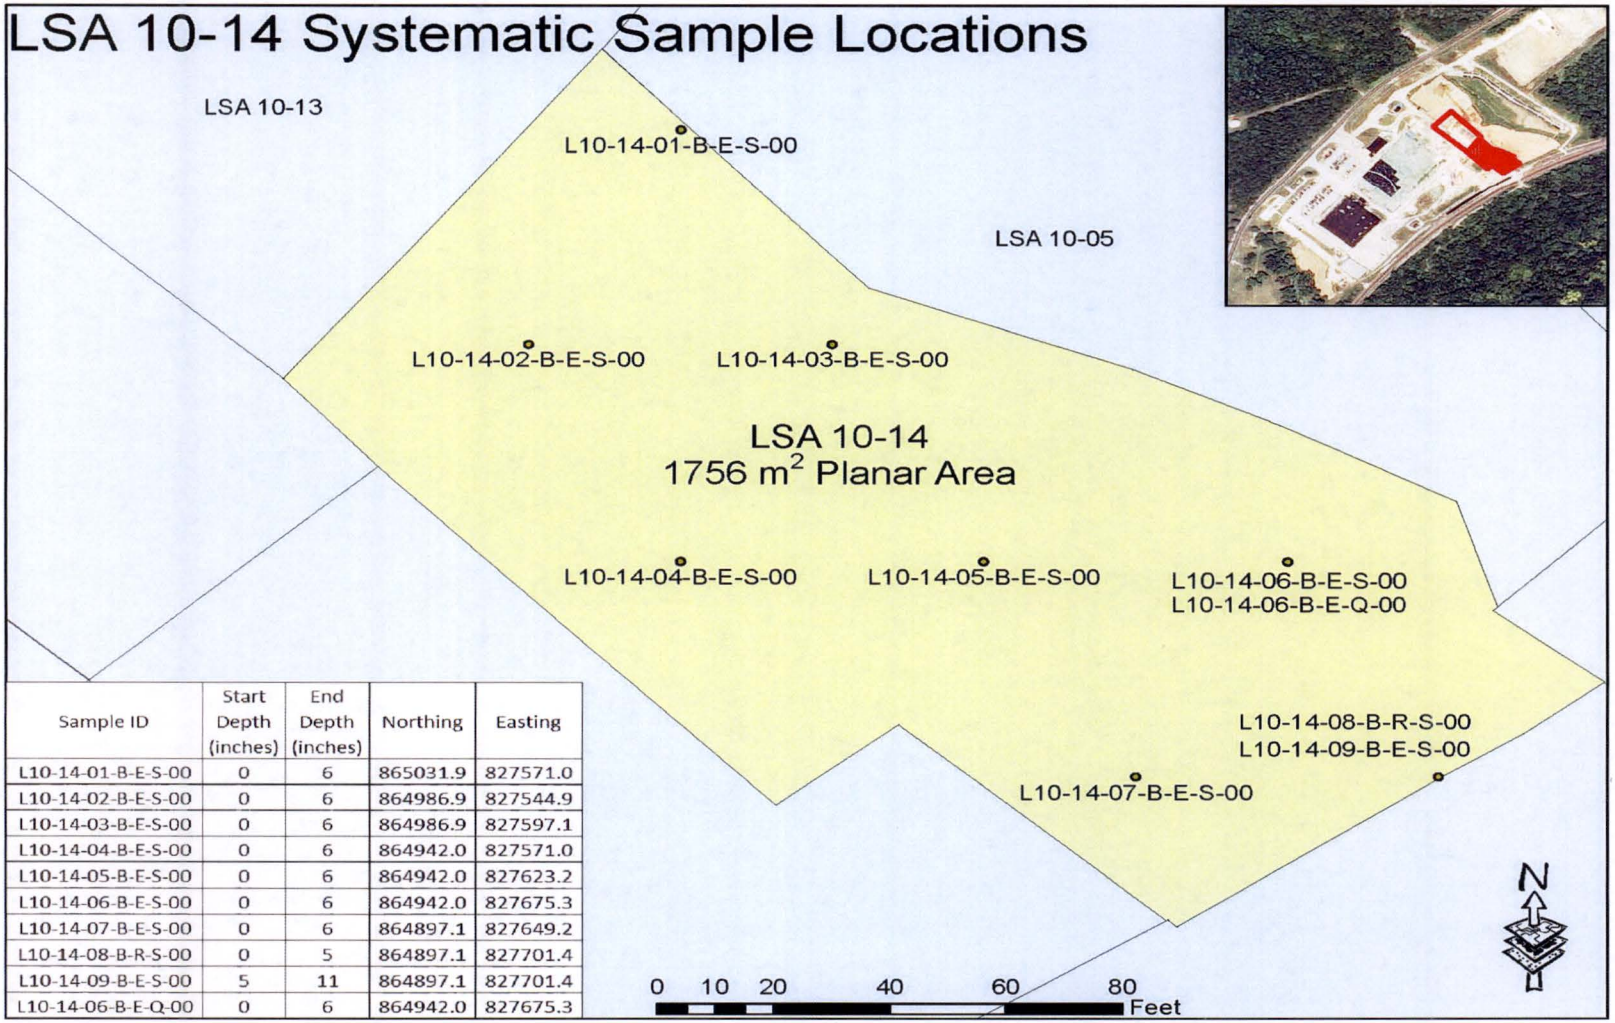
Figure 13-1
LSA 10-14 Systematic Soil Sample Locations

Figure 13-1 presents the map of the nine systematic sample locations which were sampled within LSA 10-14. The inset table notes the location coordinates (Missouri East, North American Datum (NAD) 1983) and collection intervals for each systematic location.

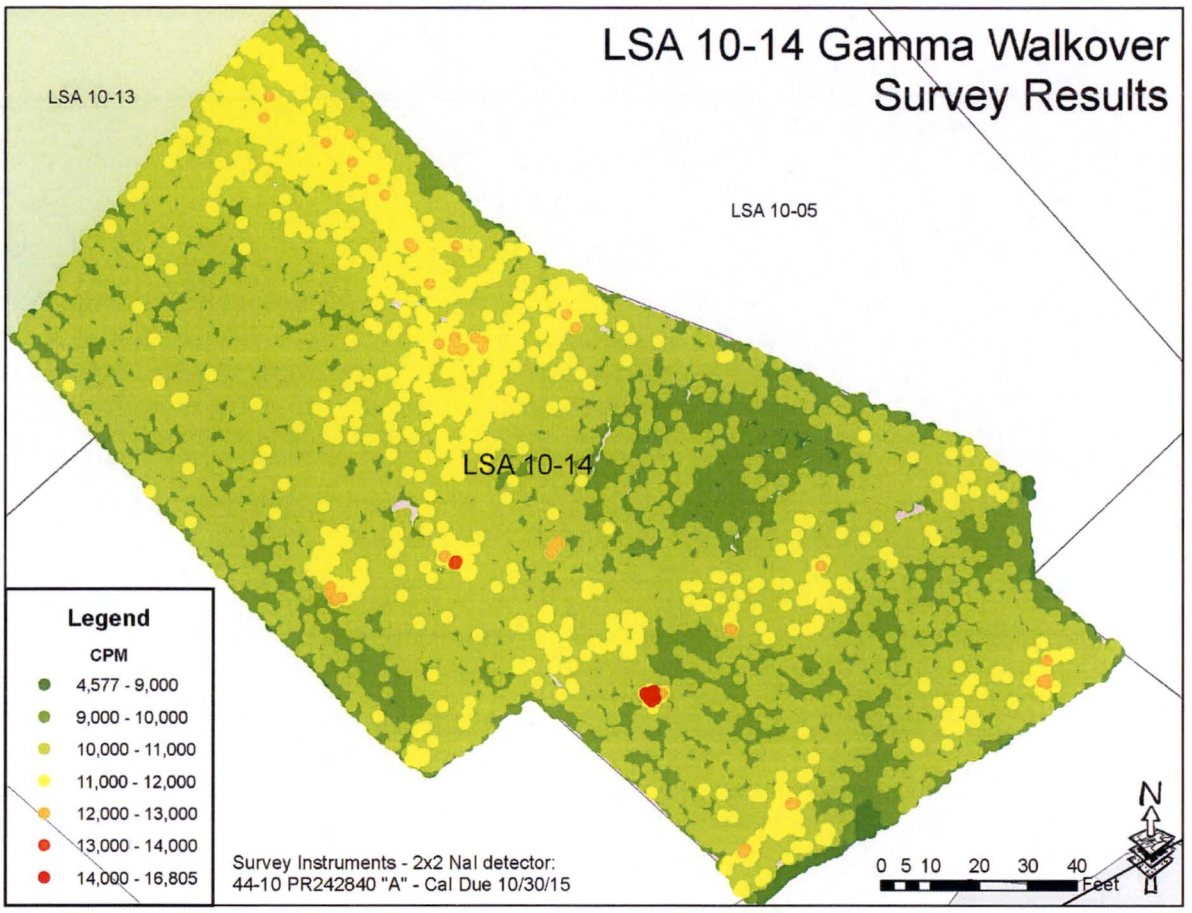
Figure 14-1
Colorimetric GWS Plot for LSA 10-14

For LSA 10-14, GWS count rates ranged between 4,577 gcpm and 16,805 gcpm, with a mean count rate of 9,711 gcpm. The median count rate was 9,703 gcpm with a standard deviation of 667 cpm. Figure 14-1 below presents a map of the complete GWS data set.

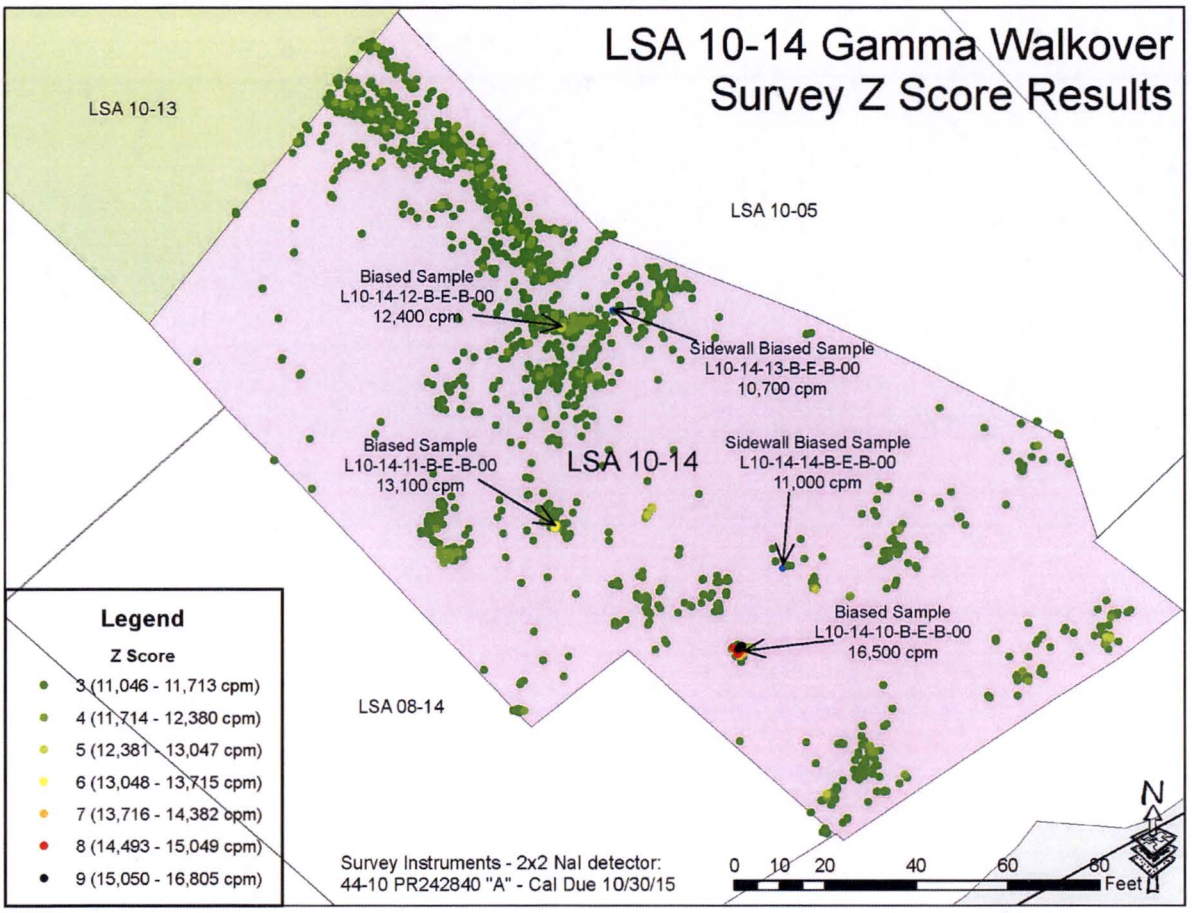
Figure 14-2
Colorimetric GWS Plot for LSA 10-14 (Measurements > Z-score of 3)

An evaluation of the entire GWS data set was performed to evaluate those small areas of elevated activity which exceeded both the IAL (> 4000 ncpm) and three (3) standard deviations above the GWS mean measurement, (i.e., "+3 Z-score"). Three locations (L10-14-10, L10-14-11, and L10-14-12) were selected for biased sample collection. The sample collected at location L10-14-10 represented the maximum GWS measurement (16,500 gcpm) within the SU.

Figure 14-2 presents a map of the +3 Z-score GWS measurements within LSA 10-14, including the three selected biased sampling locations. For completeness, the locations of the two supplemental sidewall samples (collected from locations selected by the HP Technician at random) are also shown in Figure 14-2 below.

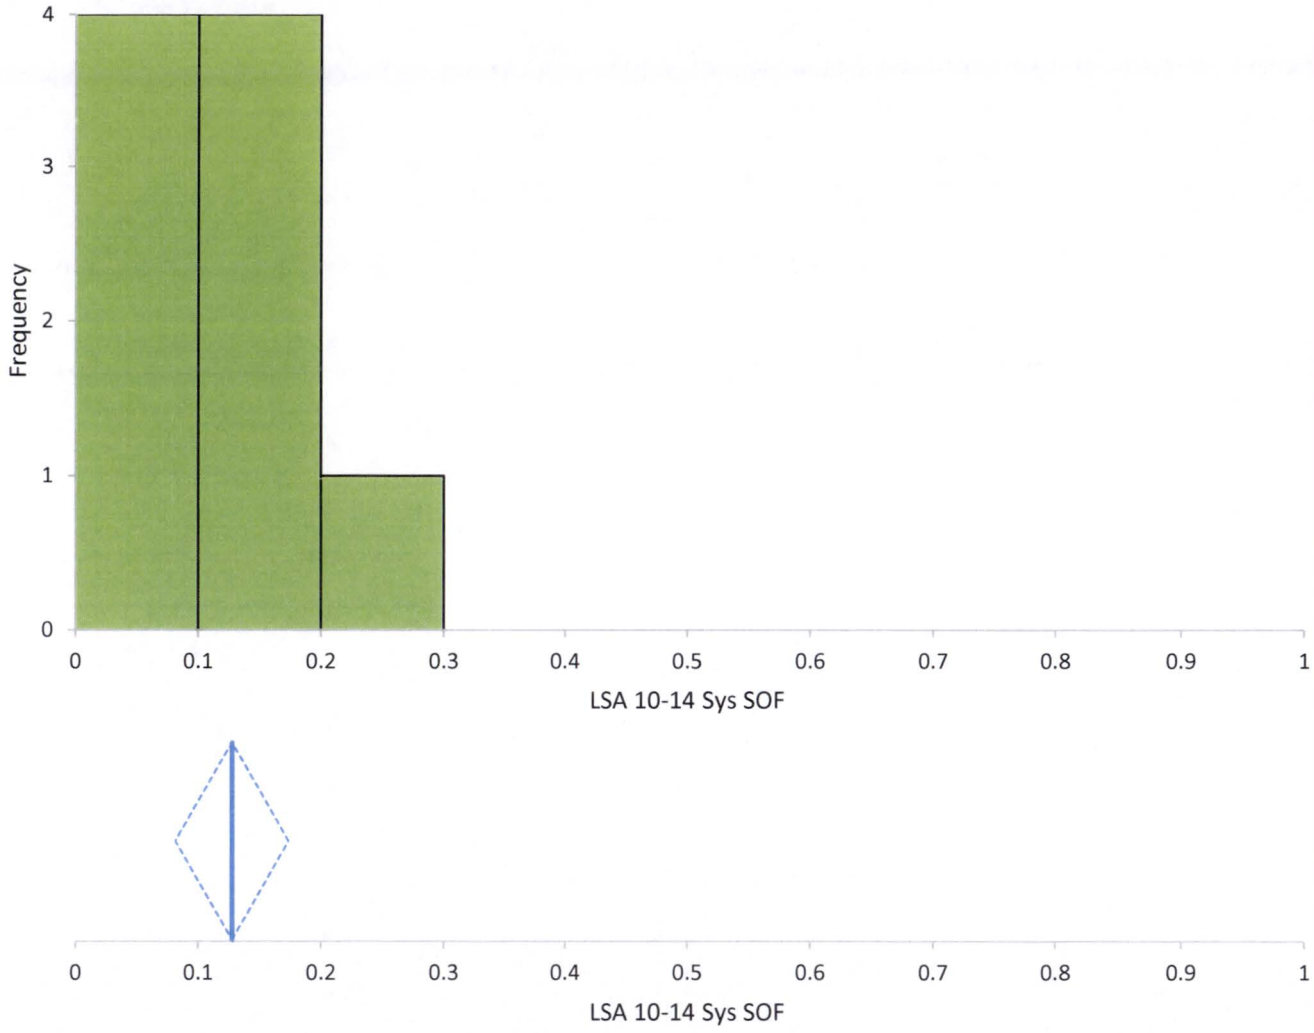
Figure 14-3
Graphic Statistical Summary for LSA 10-14 (SOF parameter)

Figure 14-3 exhibits no unusual symmetry or bimodality concerns for the LSA 10-14 data associated with the systematically collected measurement locations.

Mean	95% CI		Mean SE	SD	Variance	Skewness	Kurtosis
LSA 10-14 Sys SOF	0.13	0.08	to 0.17	0.020	0.06	0.00	0.3	-1.70
