*This report provides the results the Accident Sequence Precursor Program for 2022. In addition, trends and key insights are provided for the past 10 years (2013 through 2022).*

# **U.S. Nuclear Regulatory Commission Accident Sequence Precursor Program 2022 Annual Report**

**Performance and Reliability Branch**  
**Division of Risk Analysis**  
**Office of Nuclear Regulatory Research**  
**U.S. Nuclear Regulatory Commission**  
**Washington, DC 20555-0001**

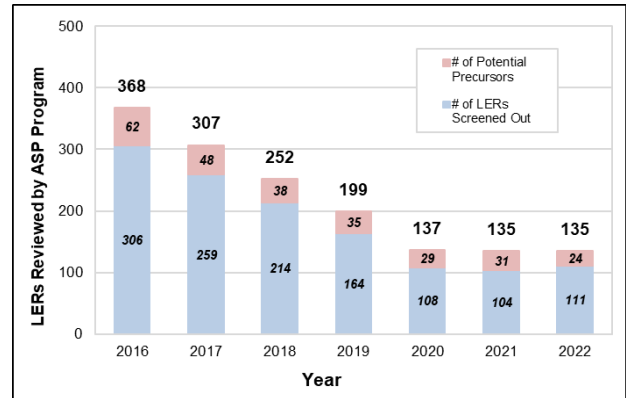
Figure 1. Breakdown of LERs Reviewed by ASP Program Since 2016

There were 135 licensee event reports (LERs) issued in calendar year 2022. From these LERs, 111 (82%) were screened out in the initial screening process and 24 events were selected and analyzed as potential precursors. The overall number of LERs and potential precursors continues to decrease to historical lows. Figure 1 provides a breakdown of the number of LERs reviewed by the Accident Sequence Precursor (ASP) Program since the switch was made to review LERs issued on a calendar-year basis in 2016.

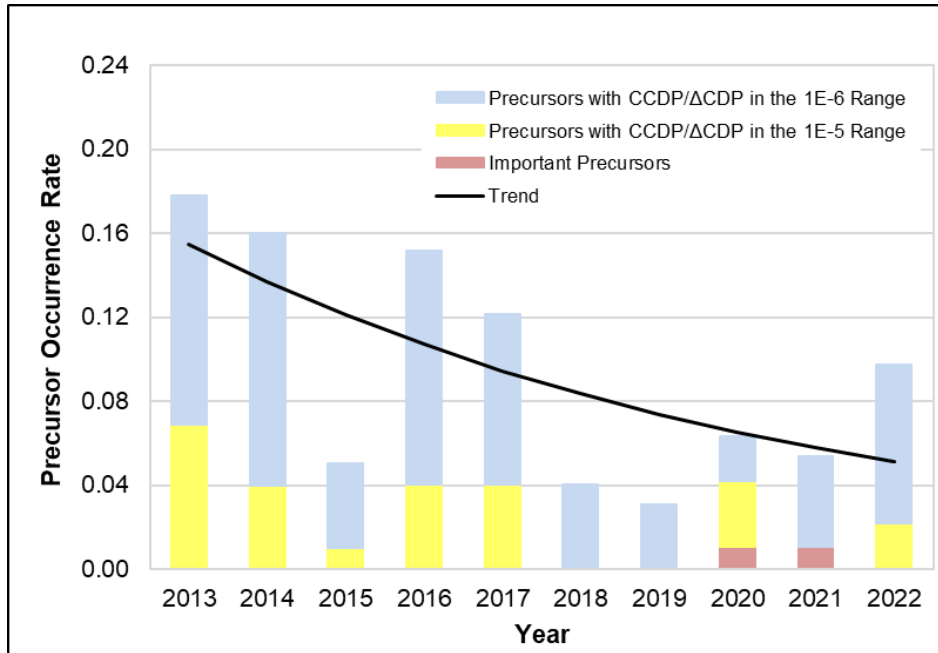
Figure 2. Occurrence Rate of All Precursors

Figure 2 provides the occurrence rate and trend of all precursors for the past decade. Additional precursor trends are provided in the Figures 3–5.

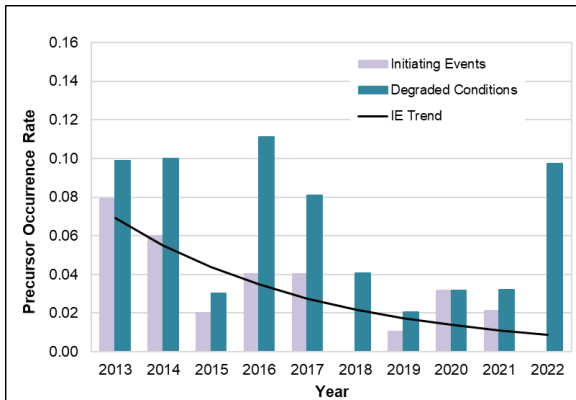
Figure 3. Occurrence Rates of IE / DC Precursors

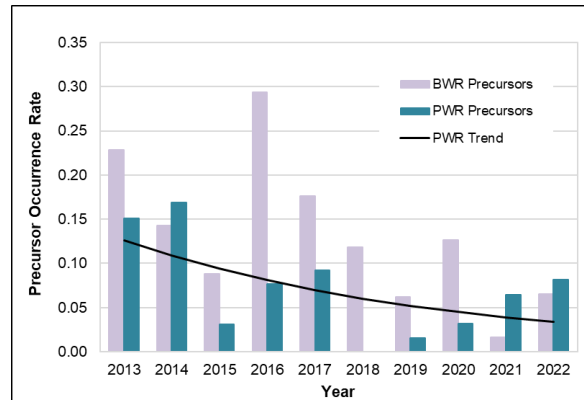
Figure 5. Occurrence Rates of BWR / PWR Precursors

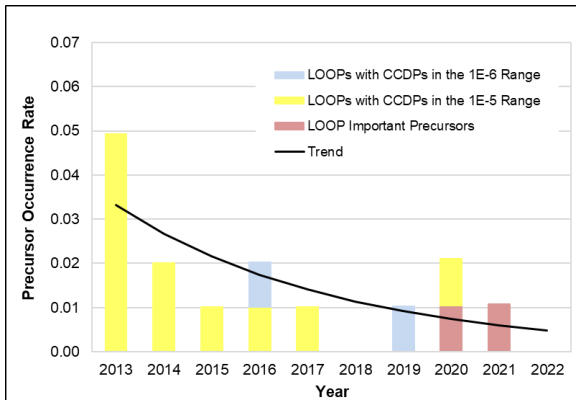
Figure 4. Occurrence Rate of LOOP Precursors

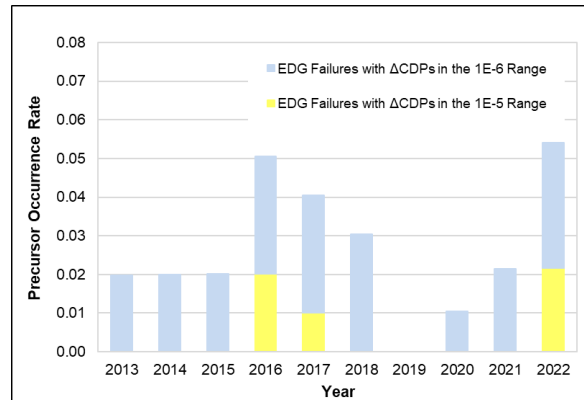
Figure 6. Occurrence Rates of EDG Precursors

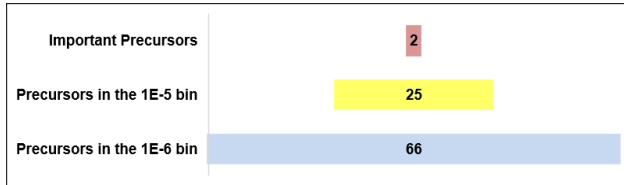
This section provides a few key insights based on the review of the 93 precursors that were identified in the past decade (2013–2022). Note that additional insights can be gathered by using the publicly available [ASP Program Dashboard](#). There were two important precursors identified during this period, both of which were due to LOOPS.

Figure 7. Precursor Breakdown by Risk Bin

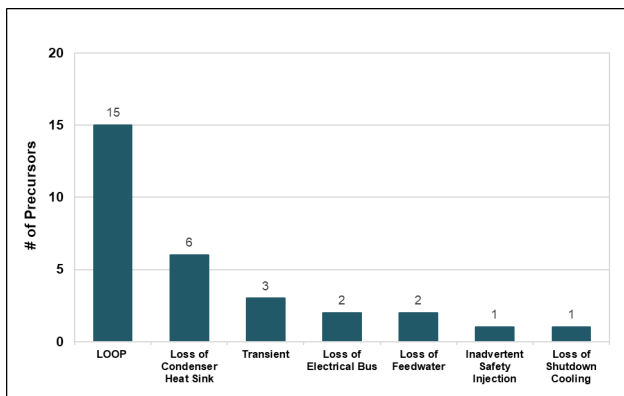
The most frequent IEs that resulted in precursors were LOOPS and losses of a condenser heat sink.

Figure 8. Most Frequent IE Precursor Types

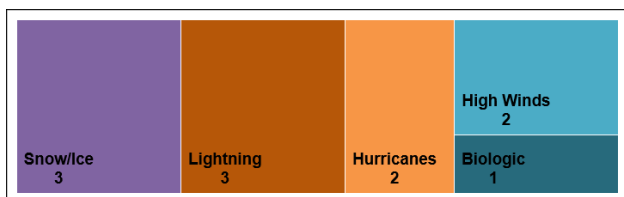
Natural phenomena caused 11 precursors, with snow/ice and lightning the most frequent causes.

Figure 9. Most Frequent Precursor SSC Failures

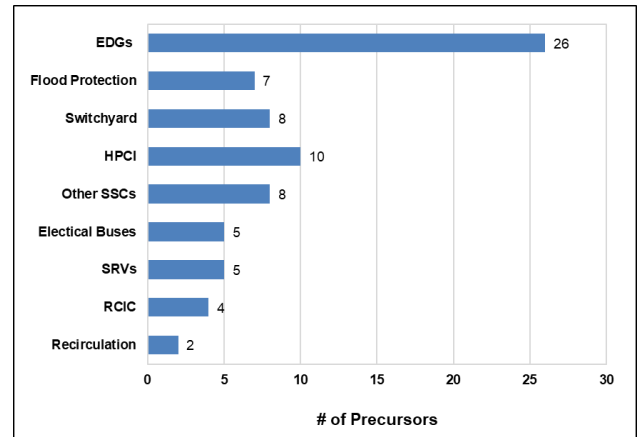
The most frequent structure, system, and component (SSC) failures observed in precursors were associated with EDGs, flood protection, and switchyard.

Figure 10. Most Frequent Precursor SSC Failures

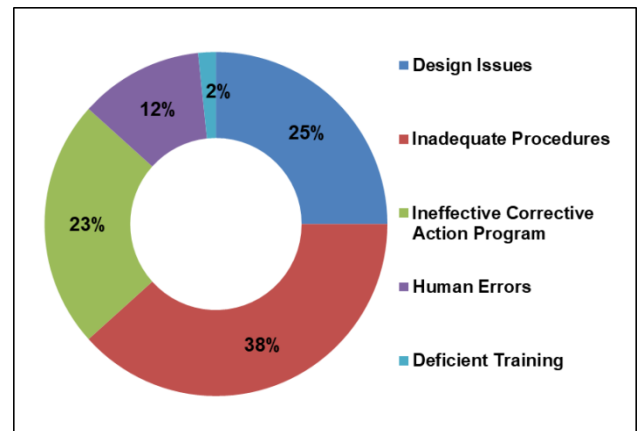
A review of the precursors associated with inspection findings that had a significant impact on the risk of the event were most likely due to inadequate procedures or design issues.

Figure 11. Dominant Precursor SSC Failures

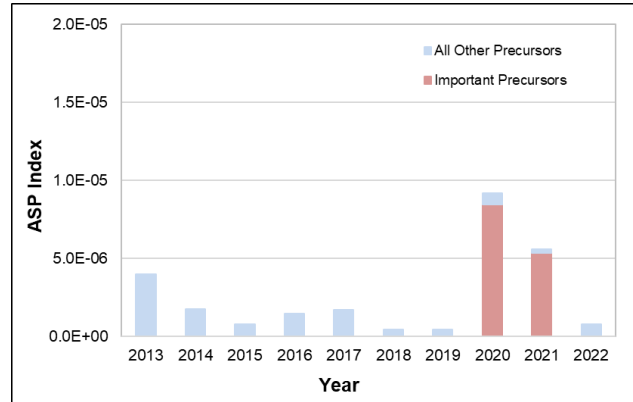
The ASP index shows the cumulative plant average risk from precursors on an annual basis. Unlike the trend analyses performed on various precursor groups that are focused on the occurrence rate of precursors, the ASP index is focused on the total risk due to all precursors. Therefore, the ASP index provides a unique way to evaluate the risk of longer-term DCs over the entire duration of the condition.

The ASP index (shown in Figure 11) does not exhibit a statistically significant trend ( $p$ -value = 0.97) for the past decade (2013–2022). The total risk associated with precursors (93 total precursors) is dominated by the 2 important precursors, which account for approximately 53% of the total risk due to all precursors. The other 91 precursors account for approximately 47% to the total risk due to all precursors.

Figure 12. ASP Index
