Common-Cause Failure Event Insights

Pumps

Idaho National Engineering and Environmental Laboratory

**U.S. Nuclear Regulatory Commission
Office of Nuclear Regulatory Research
Washington, DC 20555-0001**

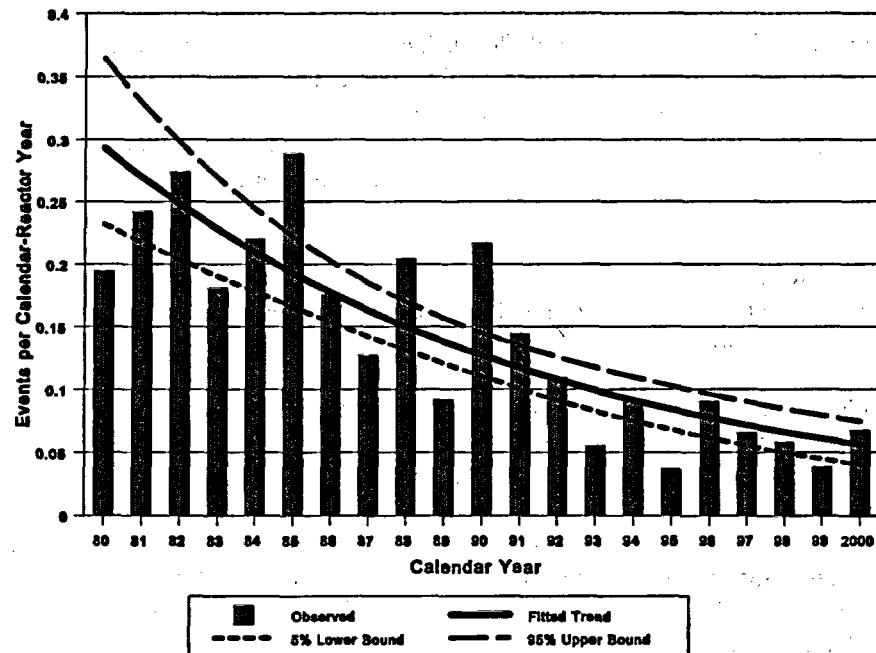
Figure ES-1. Trend for all pump CCF events. The decreasing trend is statistically significant with a p-value = 0.0001.

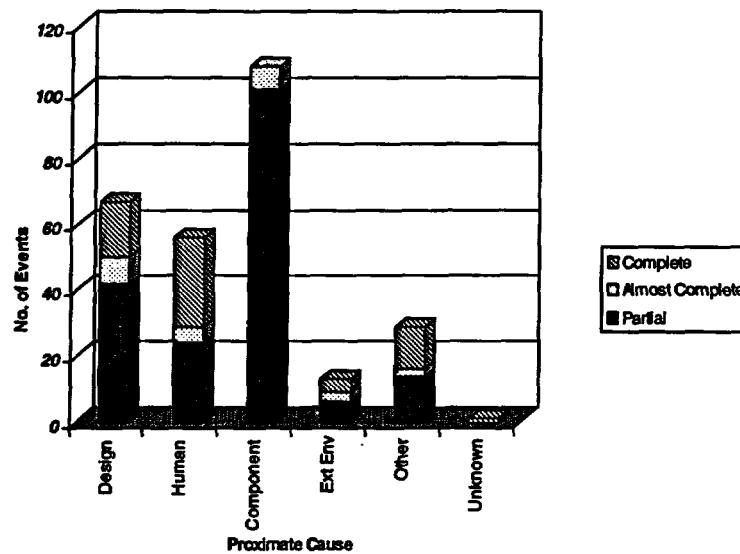
Proximate Cause. As shown in Figure ES-2, the leading proximate cause was Internal to Component, which accounted for about 39 percent of the total events; however, none of these events were Complete. Design/Construction/Installation/Manufacture Inadequacy and Human Error accounted for 24 and 20 percent of the total events, respectively. The Other and External Environment proximate causes were attributed to a small fraction of the pump CCF events.

Figure ES-2. Proximate cause distribution for all pump CCF events.

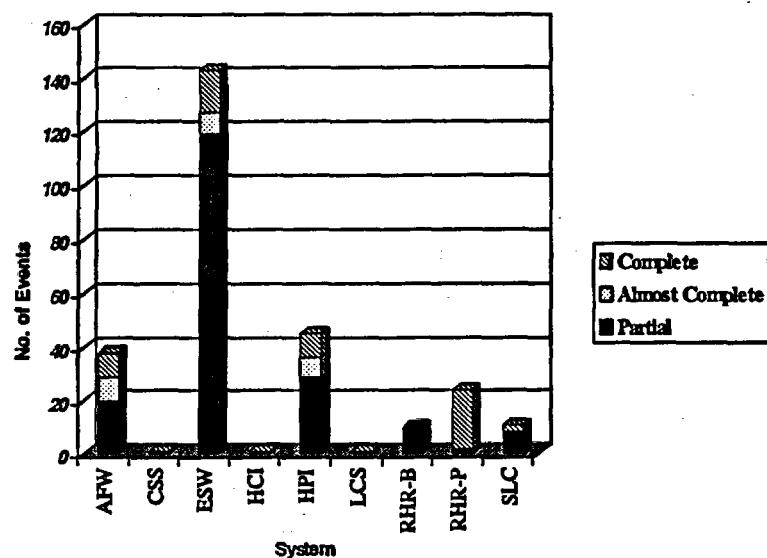
System. Figure ES-3 shows the distribution of pump CCF events by affected system. The ESW system had the most events. Most pump CCF events in the ESW system involved problems with the pump impellers and wear rings. The RHR-P system had the largest fraction of Complete CCF events (92

percent). Most of the RHR-P system events involved loss of suction, usually during refueling outages with reduced water level in the reactor coolant system.

Figure ES-3. System distribution for all pump CCF events.

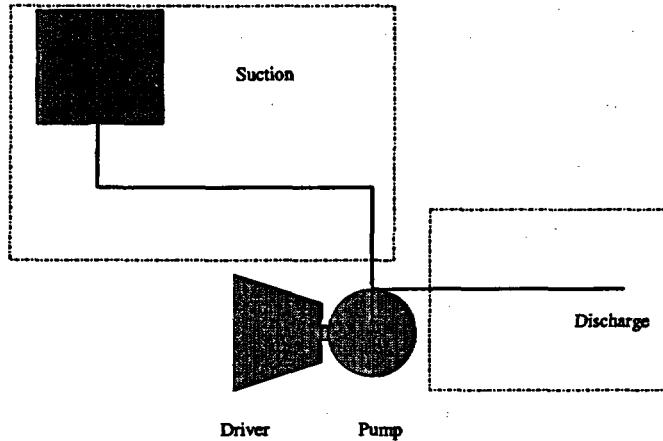
The pumps in the systems listed above have varying characteristics such as discharge pressure, flow rate, number of stages, suction type, discharge point, and control systems. However, all pumps have a set of similar characteristics that are of interest when examining failures. Therefore, we define the pump component as the combination of the suction source, the driver, the pump, and the discharge. In

this study, we will look at the segments as well as the overall pump component. Figure 2-1 shows the component boundary as defined for this study.

Figure 2-1. Pump component boundary drawing.

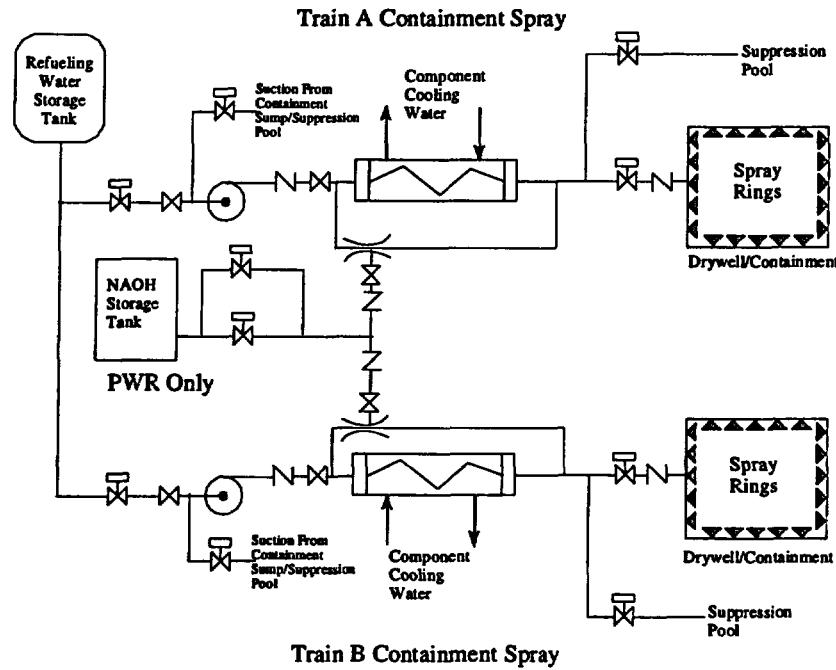
Figure 2-2. PWR Containment Spray system diagram.

Figure 2-2 to Figure 2-9 are shown to provide the reader with generic representations of the system configurations discussed within this document.

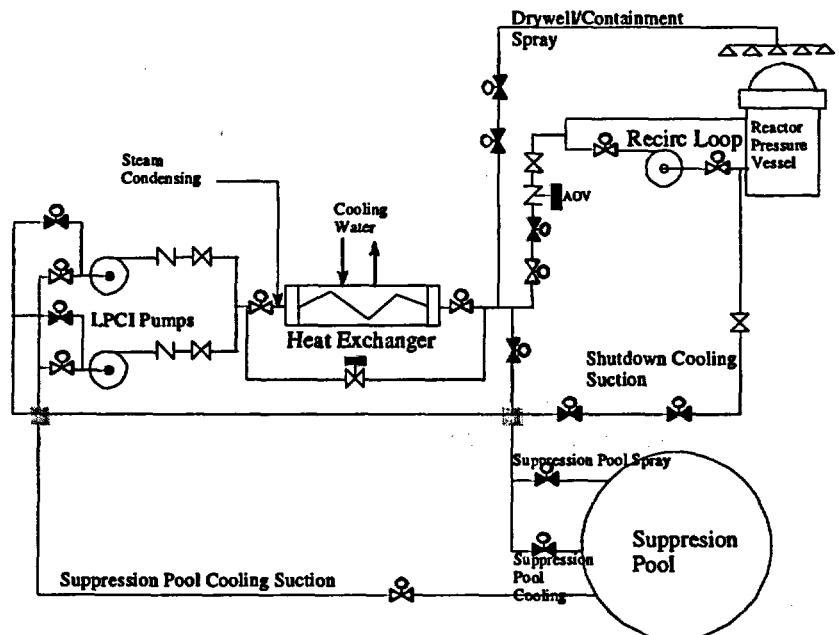
Figure 2-3. BWR RHR system diagram.

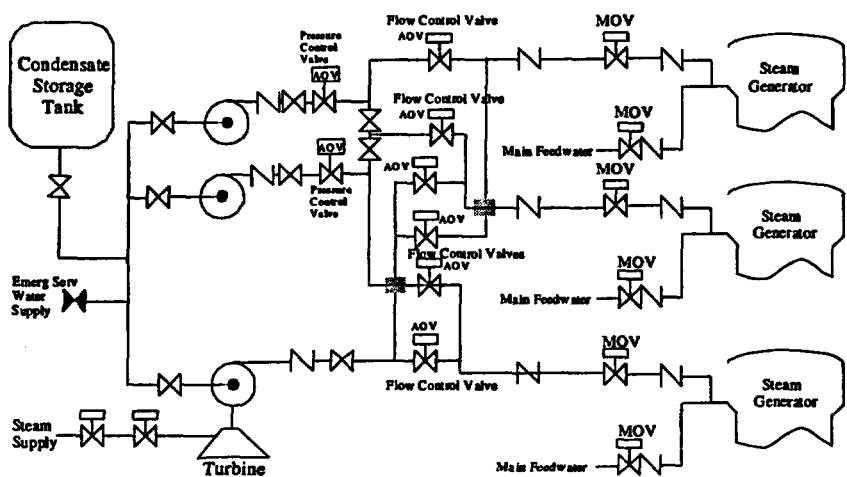
Figure 2-4. PWR Auxiliary Feedwater system diagram.

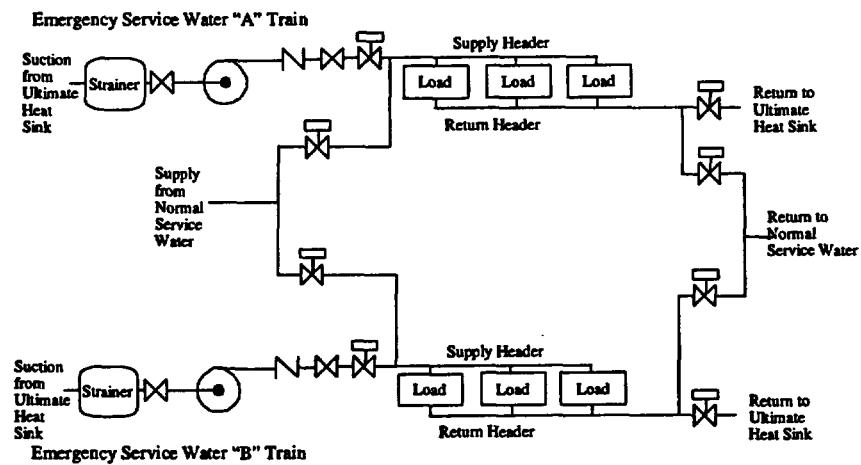
Figure 2-5. Generic Emergency Service Water system diagram.

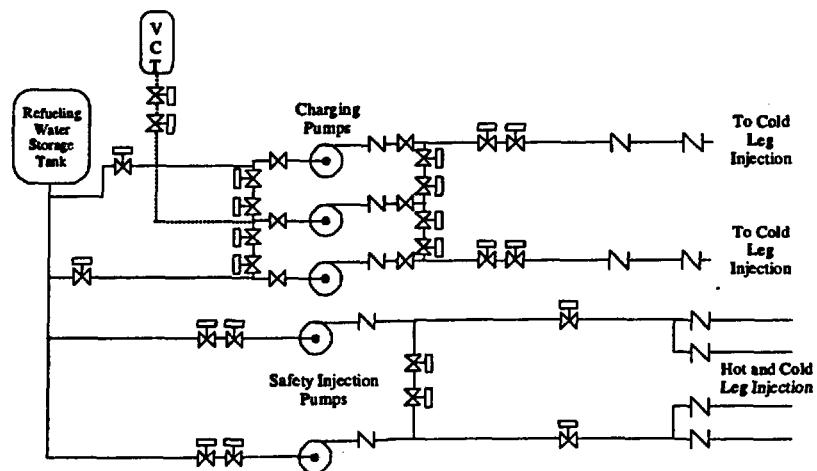
Figure 2-6. PWR High Pressure Safety Injection and Coolant Charging system diagram.

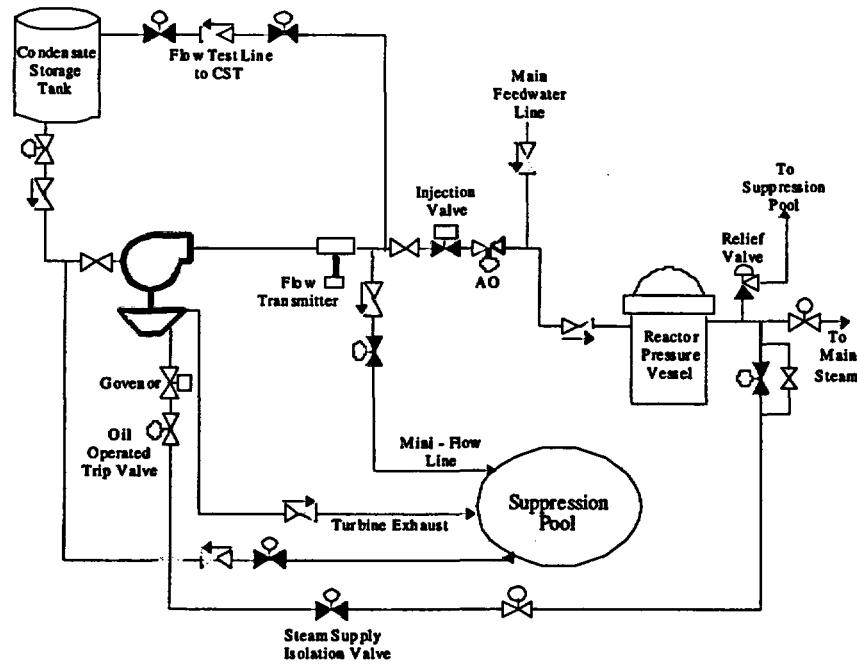
Figure 2-7. BWR High Pressure Coolant Injection and Reactor Core Isolation Cooling systems diagram.

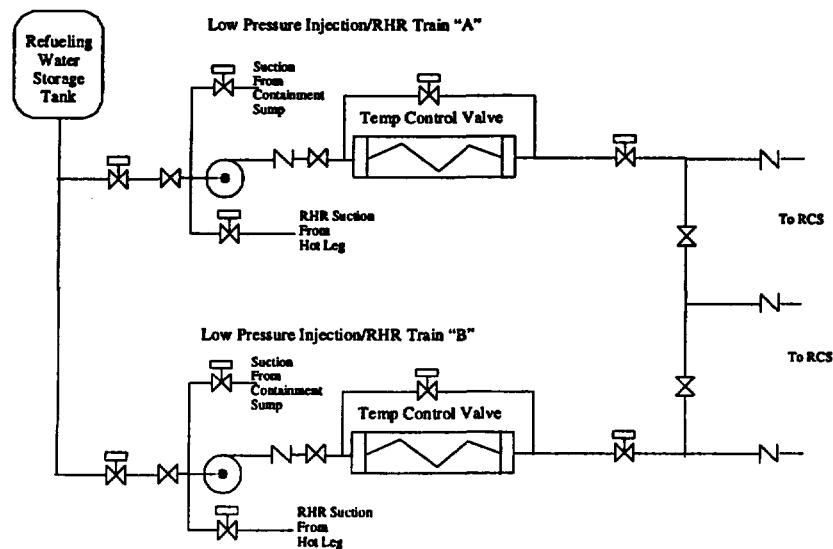
Figure 2-8. PWR RHR system diagram.

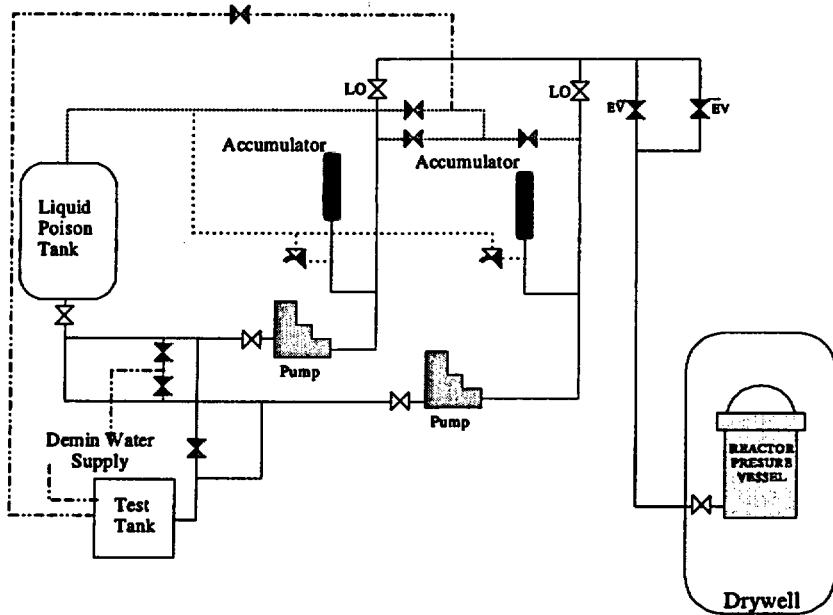
Figure 2-9. BWR Standby Liquid Control system diagram.

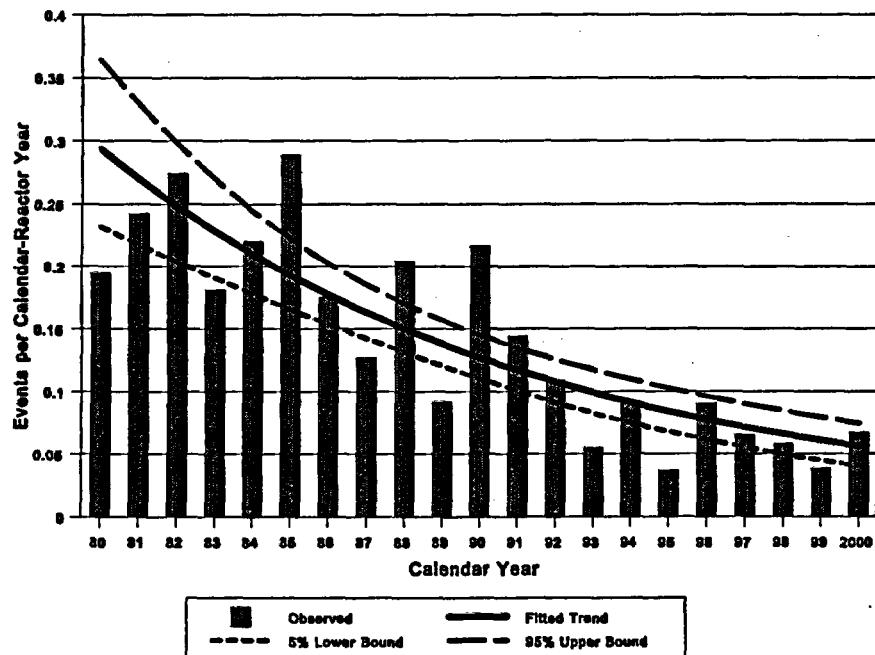
Figure 3-1 shows the yearly occurrence rate, the fitted trend, and its 90 percent uncertainty bounds for all pump CCF events over the time span of this study. The decreasing trend is statistically significant^a with a p-value^b of 0.0001. There was insufficient information to determine what caused the decreasing trend in CCF events, but there were several regulatory initiatives by the NRC and industry initiatives by utilities, INPO, and EPRI involving improved operation, maintenance, testing, and inspection during the 21 years of improving performance. Examples of these initiatives include improvements in testing, inspection, and maintenance associated with Generic Letter 89-13, *Problems with Service Water Systems Affecting Safety-Related Components*¹⁰, and Generic Letter 89-04, *Guidance on Developing Acceptable Inservice Testing Programs*¹¹. Additionally, the testing and examination code for pumps has been improved significantly since 1980.

Figure 3-1. Trend for all pump CCF events. The decreasing trend is statistically significant with a p-value = 0.0001.

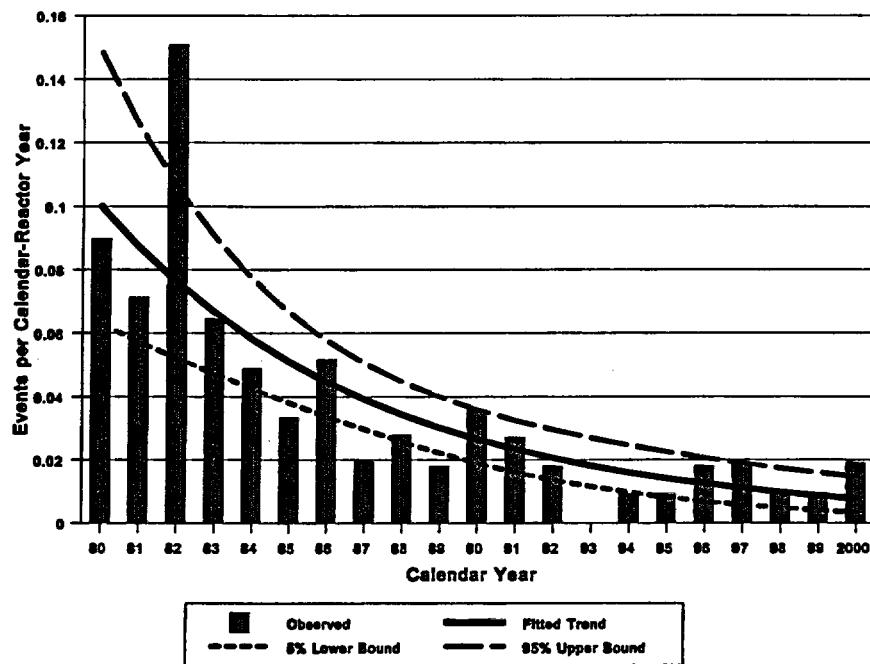
Figure 3-2 through Figure 3-4 show trends for subsets of the pump CCF events contained in Figure 3-1. Figure 3-2 shows the trend for Complete pump CCF events. The overall trend for Complete pump CCF events from 1980 to 2000 is also statistically significant with a p-value of 0.0001. This indicates a dramatic decrease of Complete pump CCF events, especially since the mid-1980's. Figure 3-3

Figure 3-2. Trend for Complete pump CCF events. The decreasing trend is statistically significant with a p-value = 0.0001.

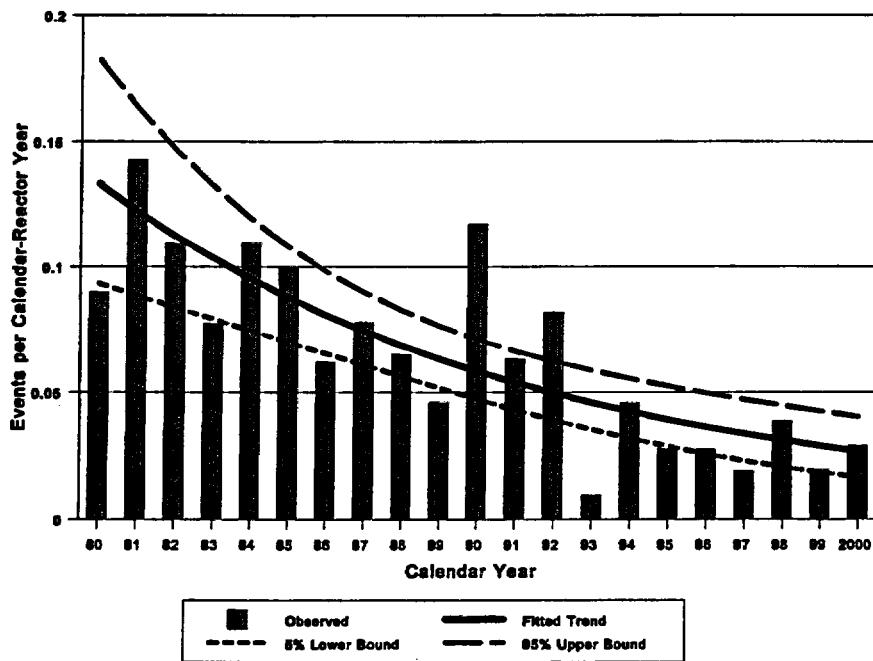
Figure 3-3. Trend for all pump CCF events for the fail-to-start failure mode. The decreasing trend is statistically significant with a p-value = 0.0001

and Figure 3-4 show similar statistically significant decreasing trends for both the fail-to-start and the fail-to-run failure modes for all pump CCF events, both with p-values of 0.0001.

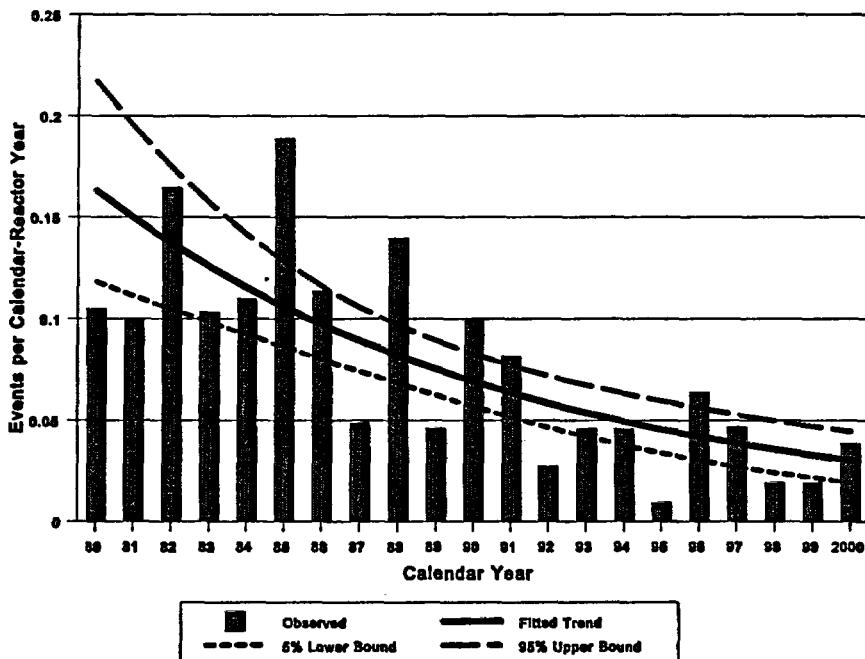
Figure 3-4. Trend for all pump CCF events for the fail-to-run failure mode. The decreasing trend is statistically significant with a p-value = 0.0001.

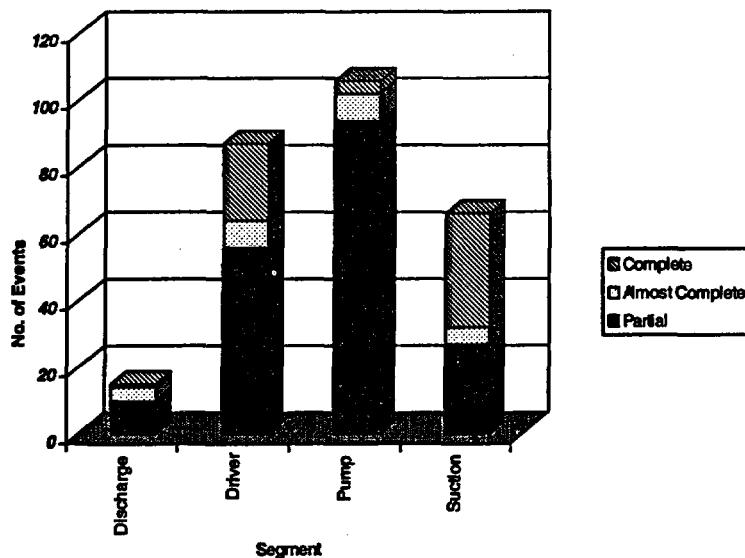
Figure 3-5 shows the distribution of the CCF events by pump segment. Overall, for all pumps, the highest number of events occurred in the pump segment (106 events or 39 percent). The driver and suction segments were also significant contributors (32 and 24 percent, respectively), while relatively few events involved the discharge segment. These statistics vary by system. For the ESW and SLC systems, most of the failures occurred in the pump segment. However, for the AFW, HPI, and RHR-B systems, most of the failures occurred in the driver segment, and for the RHR-P system, most of the failures occurred in the suction segment. Events involving the driver and suction segments were more likely to be Complete. Ninety-two percent of all Complete events occurred in these two segments. Section 4 of this report provides an in-depth analysis of the CCF events assigned to these segments.

Figure 3-5. Segment distribution for all pump CCF events.

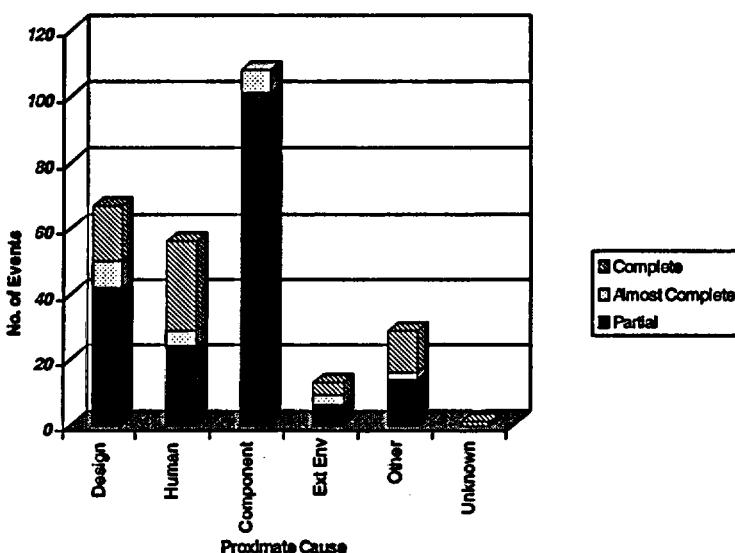
Figure 3-6 shows the distribution of CCF events by proximate cause. The leading proximate cause was Internal to Component, which accounted for about 39 percent of the total events; however, none of these events were Complete. Design/Construction/Installation/Manufacture Inadequacy and Human error accounted for 24 and 20 percent of the total events, respectively. The Other and External Environment proximate causes were attributed to a small fraction of the pump CCF events.

Figure 3-6. Proximate cause distribution for all pump CCF events.

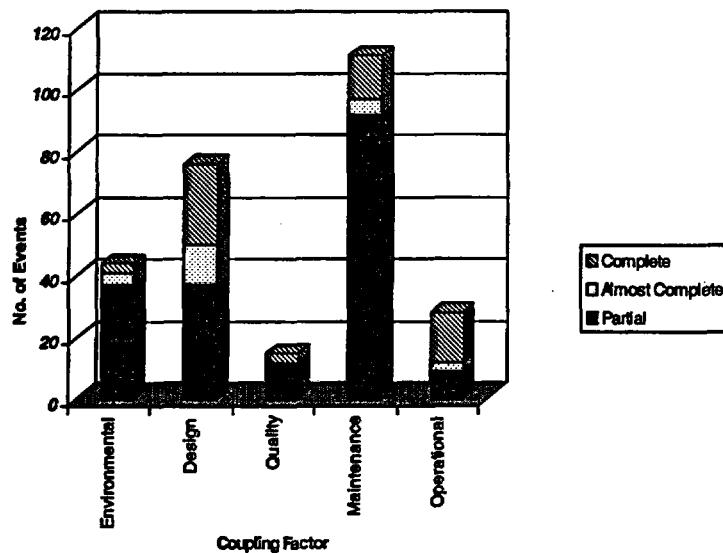
Figure 3-7 shows the coupling factor distribution for the pump CCF events. Maintenance was the leading coupling factor with 111 events (40 percent). The next leading coupling factor was Design with 76 events (28 percent). While not the leading coupling factor, over half (51 percent) of the Design, coupled events were either Complete or Almost Complete. The Environmental and Operational coupling factors account for the majority of the remaining events (44 and 28 events, respectively). Only a small fraction of the events coupled by Environmental were Complete; however, over half (57 percent) of the events coupled by Operational were Complete. These Complete events were almost all coupled by inadequate operations procedures. Only 15 events were coupled by Quality, and three of these were Complete and affected the Driver segment.

Figure 3-7. Coupling factor distribution for all pump CCF events.

The Maintenance coupling factor indicates that the maintenance frequency, procedures, or personnel provided the linkage among the events. Most of the pump CCF events with this coupling factor were coupled by maintenance/test schedules (74 out of 111) and maintenance/test procedures (23 out of 111). Internal to Component was the most prevalent proximate cause to be linked by maintenance (75 events). The maintenance linkage to the component failure proximate cause usually indicated that maintenance that is more frequent could have prevented the CCF mechanism. Very few of these events actually resulted in Complete CCF events, and most were detected as incipient failures. Examples of these are:

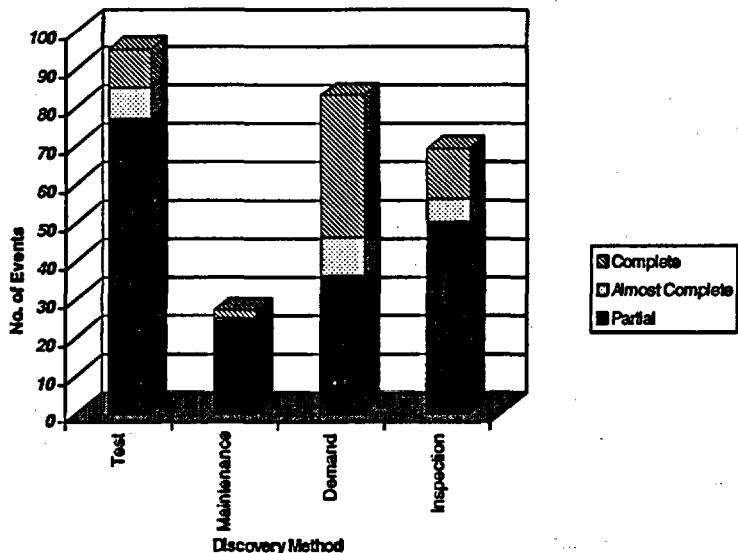
Figure 3-8 shows the distribution of how the events were discovered or detected. Testing accounted for 95 events, (35 percent), 83 events (30 percent) were discovered during Demand, Inspection accounted for 69 events (25 percent), and 27 events (10 percent) were detected during Maintenance activities. Considering the extensive and frequent surveillance test requirements for pumps contained in Technical Specifications, it is expected that a majority of the pump CCF events would be detected by Testing. The intent of testing programs is to detect degradation and initiate corrective actions before total failure. The failures detected by testing tended to be Internal to Component causes attributed to wear and aging and only a small percentage of these failures resulted in Complete CCF events. It was expected that fewer failures would be detected by Demand. Analysis of events showed that over half of the events discovered by Demand were Complete or Almost Complete. The majority of events detected by Demand were attributed to design errors, human errors, and the Others. These causes were also dominant for all Complete CCF events. This implies that testing may be effective at detecting normal wear and aging problems, but less effective at detecting failures related to design and human errors.

Figure 3-8. Discovery method distribution for all pump CCF events.

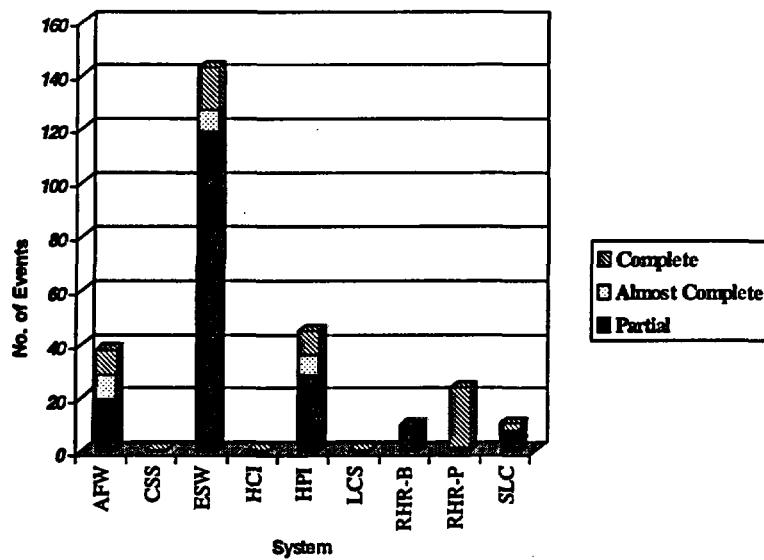
Figure 3-9 shows the distribution of pump CCF events by system and the degree of failure. The ESW system had the most events. Most pump CCF events in the ESW system involved problems with the pump impellers and wear rings. The RHR-P system had the largest fraction of Complete CCF events (92 percent). Most of the RHR-P system events involved loss of suction, usually during refueling outages with reduced water level in the RCS. Section 5 of this report provides an in-depth analysis of the pump CCF events in these systems.

Figure 3-9. Distribution of pump CCF events by system.

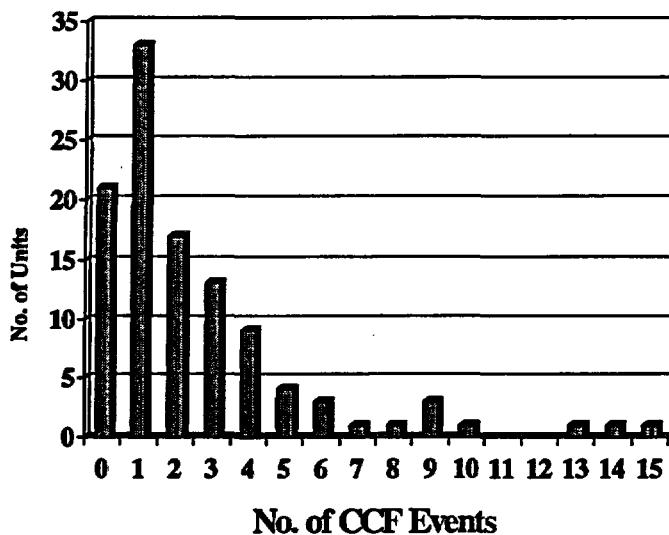
Figure 3-10 shows the distribution of pump CCF events among the NPP units. The data are based on 109 NPP units represented in the insights CCF studies. Eighty-eight of the NPP units included in this study (81 percent) experienced at least one pump CCF event, and 55 NPP units had more than one pump CCF event. While only 38 NPP units experienced more than two pump CCF events, these 38 NPP units account for 76 percent of the total number of pump CCF events.

Figure 3-10. Distribution of NPP units experiencing a multiplicity of CCFs for all pump CCF events.

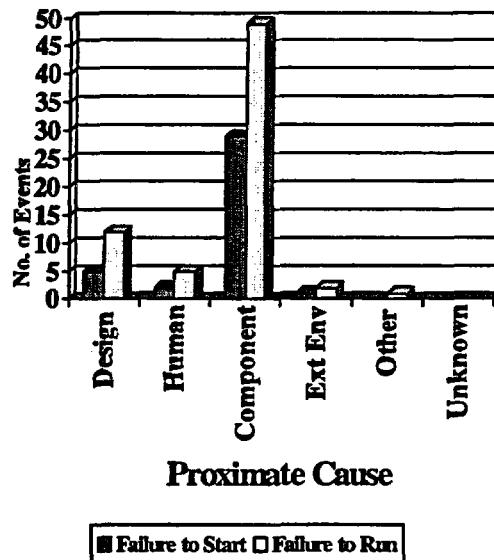
There were 106 pump CCF events affecting the pump segment (see Table B-1 in Appendix B, items 103 – 208). Of these 106 events, 37 were fail-to-start and 69 were fail-to-run. Only four of the pump segment events were Complete CCF events. Table 4-3 contains a summary of these events by proximate cause group and degree of failure. Figure 4-1 displays the events by proximate cause and failure mode.

Figure 4-1. Distribution of proximate causes for the pump segment.

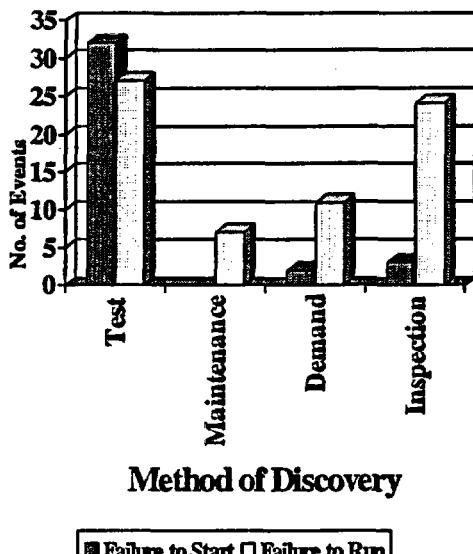
Testing was the most likely method of discovery for CCF events involving the pump segment (59 out of 106 events) as shown in Figure 4-2. The pumps are frequently tested and typically in standby during power operations. Inspection and Demand are the next most likely discovery methods (27 and 13 events, respectively). The most common piece parts involved in pump segment CCF events were the impellers and wear rings, as shown in Figure 4-3.

Figure 4-2. Distribution of the method of discovery for the pump segment.

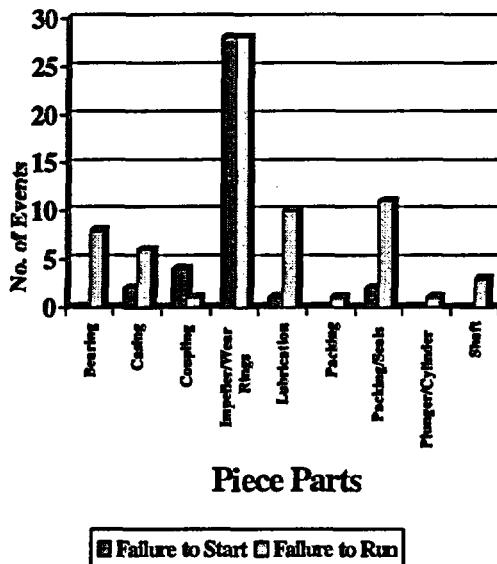
Figure 4-3. Distribution of the affected piece parts for the pump segment.

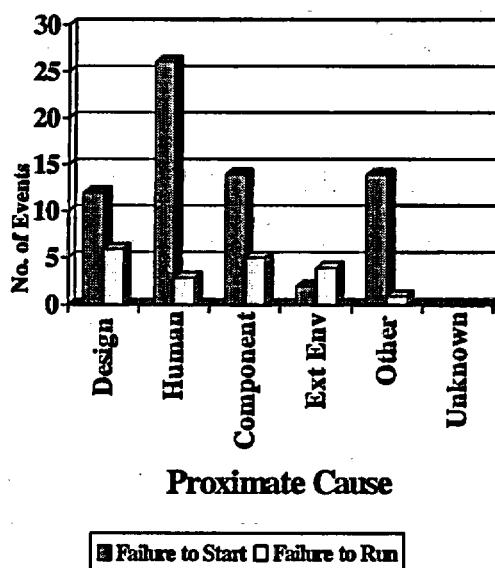
There were 87 pump CCF events affecting the driver segment, of which 24 were Complete events and 6 were Almost Complete (see Table B-1 in Appendix B, items 16 – 102). The failure mode for the majority of the pump CCF events involving the driver was fail-to-start (68 events). Only 19 events involved fail-to-run. The most likely proximate cause was Operational/Human, followed by Internal to Component and Design/Construction/ Installation/Manufacture Inadequacy. Table 4-5 contains a summary of these events by proximate cause group and degree of failure. Figure 4-4 shows the distribution of events for the driver segment by proximate cause and failure mode.

Figure 4-4. Distribution of proximate causes for the driver segment.

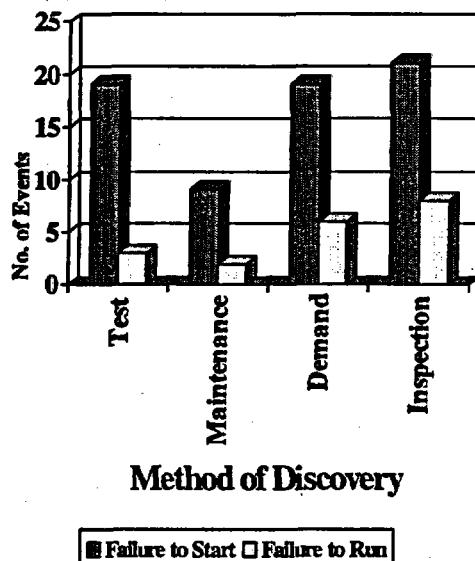
Figure 4-5. Distribution of the method of discovery for the driver segment.

Inspection was the most likely method of discovery for driver events (29 events) as shown in Figure 4-5, followed closely by Demands and testing. The most likely piece parts involving driver segment events were circuit breakers, instruments, and control circuits as shown in Figure 4-6.

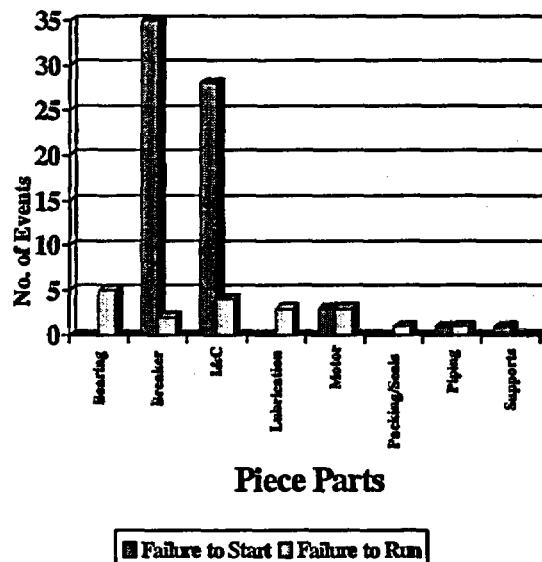
Figure 4-6. Distribution of the affected piece part for the driver segment.

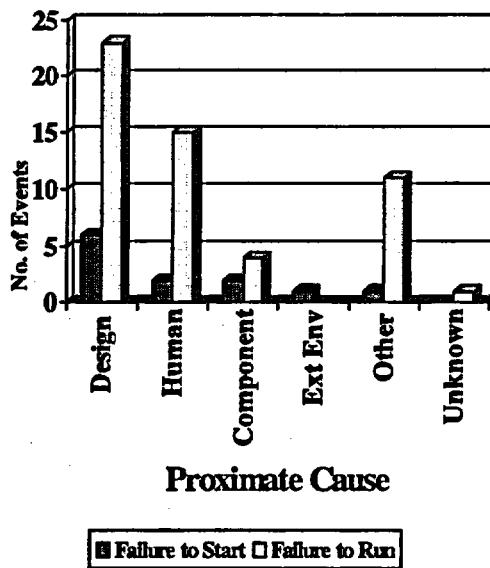
Figure 4-7. Distribution of proximate causes for the suction segment.

Sixty-six events affected the suction segment of the pumps (see Table B-1 in Appendix B, items 209 – 274). Thirty-four were Complete events. The most likely proximate cause was Design/Construction/Installation/Manufacture. The failure mode was fail-to-run for 54 events and fail-to-start for 12 events. Table 4-7 contains a summary of these events by proximate cause group and degree of failure. Figure 4-7 shows the distribution of events by proximate cause and failure mode.

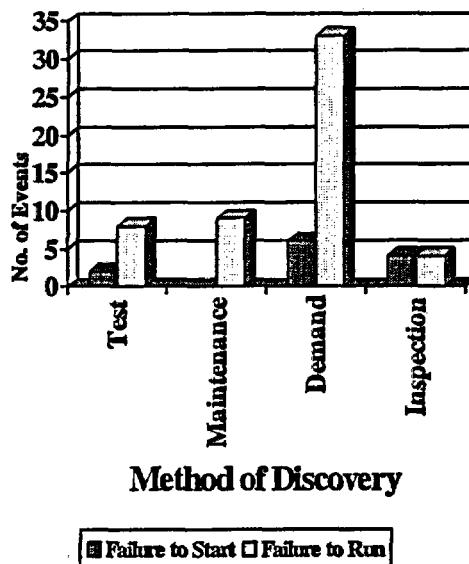
Figure 4-8. Distribution of the method of discovery for the suction segment.

Demand was the most likely method of discovery for the suction segment events (39 of 68 events) as shown in Figure 4-8. Since most events were attributed to design problems and human error, this implies that testing has not been effective in detecting failures with these causes. The most likely

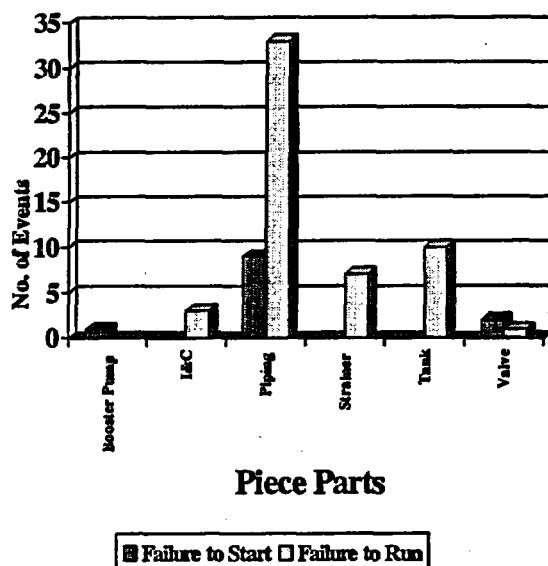
Figure 4-9. Distribution of the affected piece parts for the suction segment.

piece part involved in the suction segment CCF events was piping as shown in Figure 4-9. The piping piece part indicates that something caused a loss of NPSH to the pumps that is not a valve, strainer, etc.

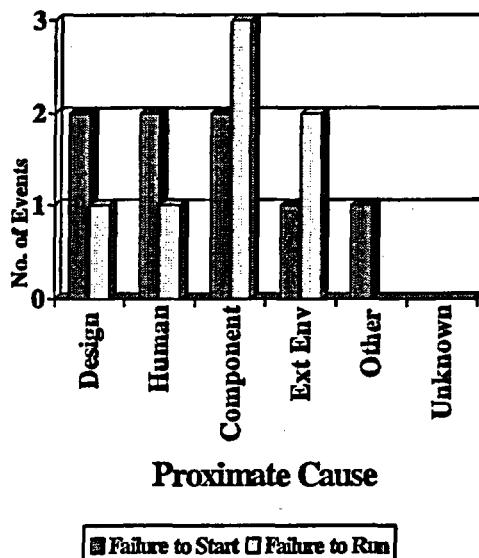
Figure 4-10. Distribution of proximate causes for the discharge segment.

Fifteen events affected the discharge segment of the pumps, of which one event was Complete and four were Almost Complete (see Table B-1 in Appendix B, items 1 – 15). No one proximate cause was dominant. The failure mode for eight events was fail-to-start and the failure mode for seven events was fail-to-run. Table 4-9 contains a summary of these events by proximate cause group and degree of failure. Figure 4-10 shows the distribution of events by proximate cause and failure mode.

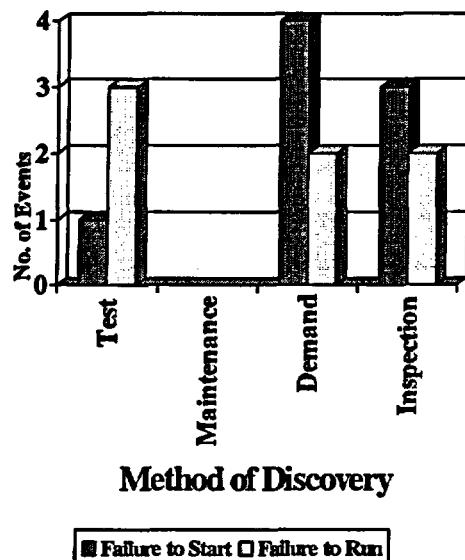
Figure 4-11. Distribution of the method of discovery for the discharge segment.

The method of detection was rather evenly split among demand, inspection, and testing for the discharge segment events as shown in Figure 4-11. Most discharge segment events involved the state of the valves in the discharge of the pumps as shown in Figure 4-12. Table 4-10 lists the short description for the Complete discharge segment event. The descriptions of all pump CCF events can be found in Appendix A.

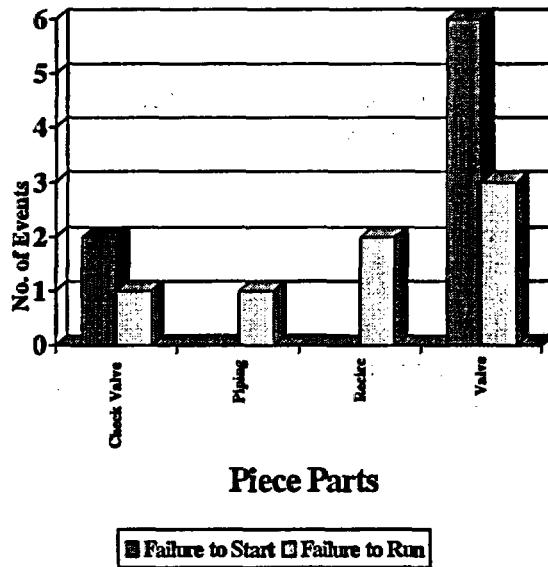
Figure 4-12. Distribution of the affected piece parts for the discharge segment.

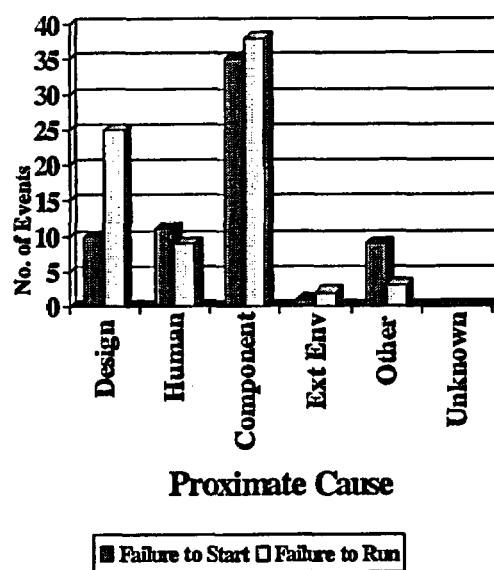
Figure 5-1. Proximate cause distribution for the ESW system.

One hundred and forty three pump CCF events affected pumps in the ESW system (see Table C-1 in Appendix C, items 40 – 182). Figure 5-1 through Figure 5-4 show selected distributions graphically. The Internal to Component was the dominant proximate cause (51 percent of the events for this system) affecting both the fail-to-start and fail-to-run. The most likely discovery method was testing. Most pump CCF events in the ESW system involved problems with the pump impellers and wear rings. Consistent with this, most of the failures involved the pump segment (50 percent).

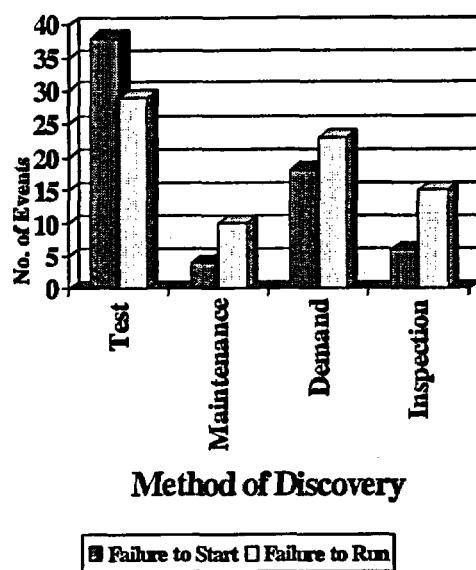
Figure 5-2. Method of discovery distribution for the ESW system.

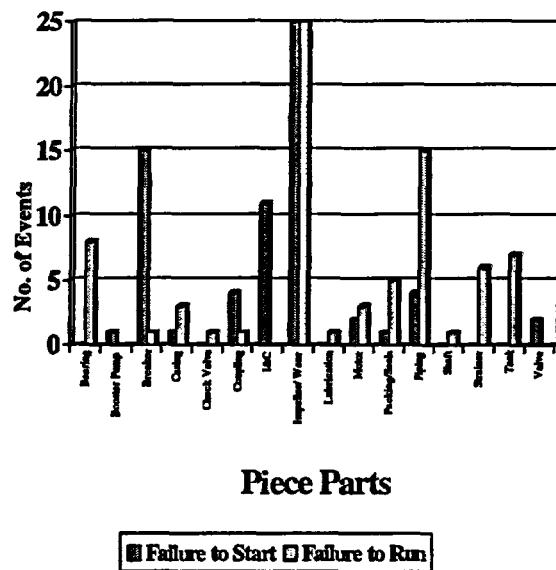
Figure 5-3. Piece part distribution for the ESW system.

Sixteen of the ESW pump CCF events were Complete. The set of Complete CCF events is dominated by two units at a single facility, accounting of 14 of the 16 events. Most these events occurred in the early 1980s and involved a design configuration issue, which caused the ESW pumps to fail when suction water was diverted for the chillers. Most of the other events involved air introduction into the ESW suction path. Very few of the Complete and Almost Complete events are attributed to the impeller or wearing rings. However, the ESW pumps CCFs are dominated by this piece part.

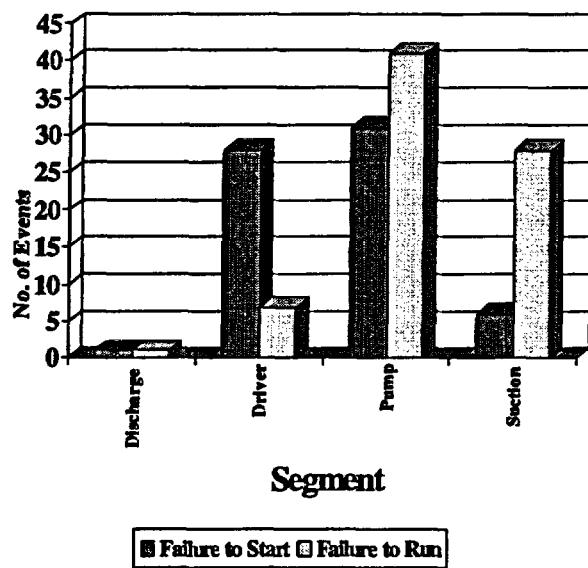
Figure 5-4. Segment distribution for the ESW system.

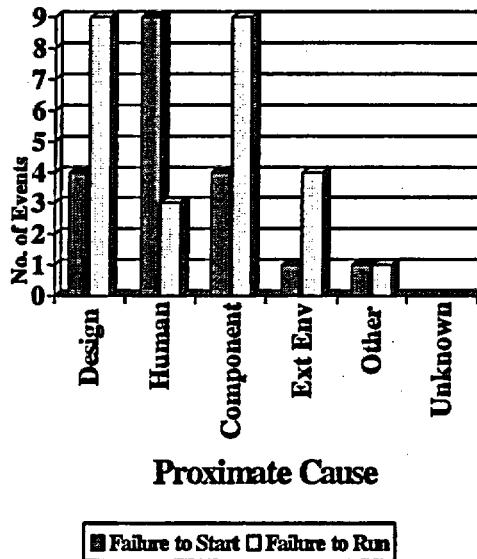
Figure 5-5. Proximate cause distribution for the HPI system.

Forty-five pump CCF events affected pumps in the HPI system (see Table C-1 in Appendix C, items 184 – 228). Figure 5-5 through Figure 5-8 show selected distributions graphically. The most likely proximate causes were the Internal to Component, Design/Construction/Installation/Manufacture Inadequacy, and Operational/Human Error. The failure mode for 26 events was fail-to-run and the failure mode for 19 events was fail-to-start. The most likely discovery method was Inspection.

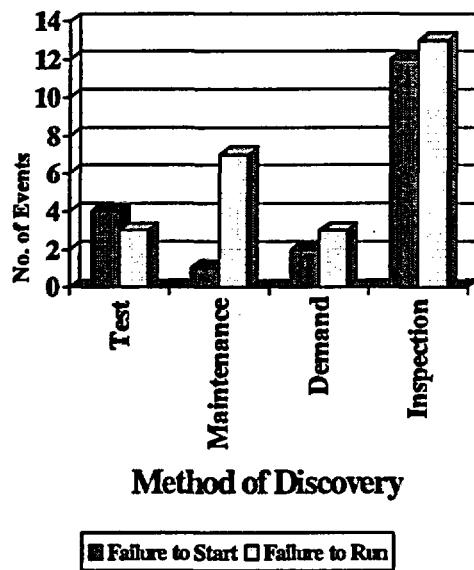
Figure 5-6. Method of discovery distribution for the HPI system.

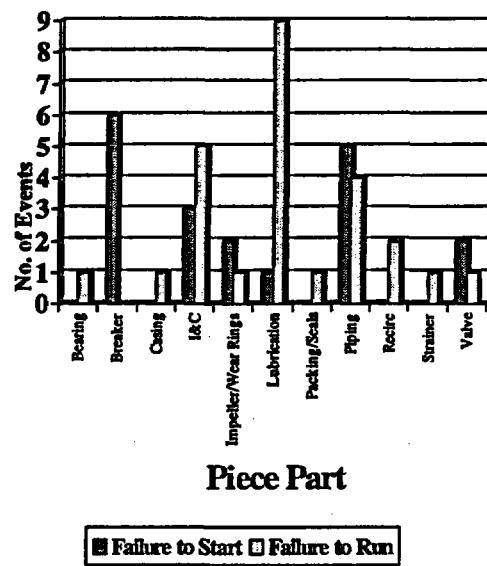
Figure 5-7. Piece part distribution for the HPI system.

Nine of the HPI pump CCF events were Complete and seven events were Almost Complete. Most of these events involve line blockage (foreign material, bio-fouling, boron solidification, frozen lines) or system misalignment. For all HPI events, the dominant failed piece parts were lubrication, piping, instruments, and control circuits and circuit breakers. Sixteen events involved failure of the driver segment while 13 events involved the pump segment.

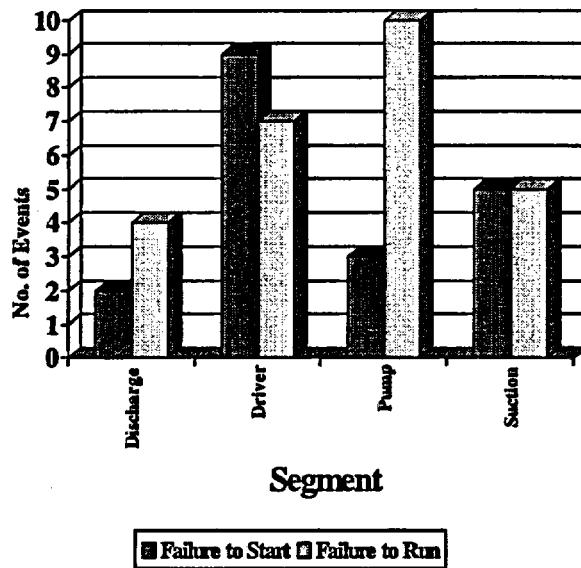
Figure 5-8. Segment distribution for the HPI system.

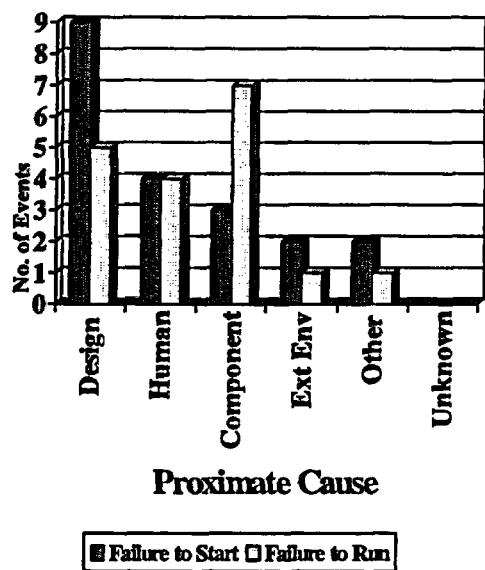
Figure 5-9. Proximate cause distribution for the AFW system.

Thirty-eight pump CCF events affected pumps in the AFW system (see Table C-1 in Appendix C, items 1 – 38). Figure 5-9 through Figure 5-12 show selected distributions graphically. The most likely proximate cause was Design/Construction/ Installation/Manufacture Inadequacy (37 percent), followed by Internal to Component (26 percent) and Operational/Human Error (21 percent). The failure mode for 18 events was fail-to-run and the failure mode for 20 events was fail-to-start. The most likely discovery method was Demands. There were nine Complete and nine Almost Complete AFW pump CCF events. Almost half the AFW pump CCF events were observed safety-significant events. The last Complete AFW pump CCF event occurred in 1994.

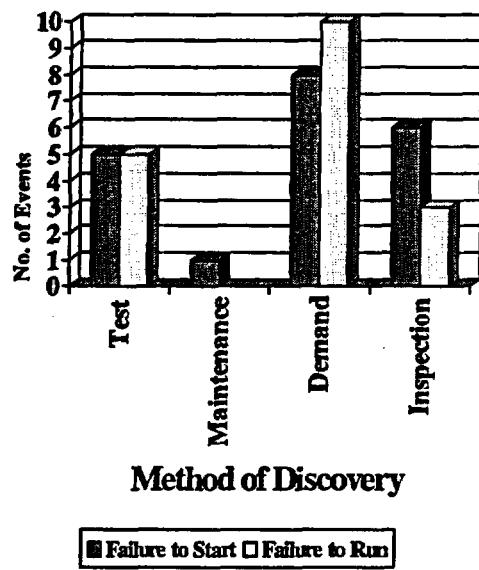
Figure 5-10. Method of discovery distribution for the AFW system.

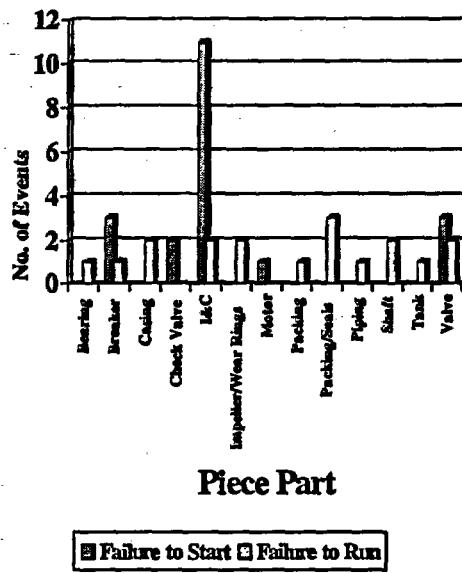
Figure 5-11. Piece part distribution for the AFW system.

The dominant piece parts involved in the AFW pump Complete and Almost Complete CCF events were instrument and control circuits. Examples follow: Degraded relays, permissive interlock, interlock improperly engaged, pumps not returned to automatic, autostart defeat switches labeled backwards, incorrect modification of pump circuitry. These events involved human error, failed equipment, improper operation, and bad design. Consistent with this, most of the events involved the driver segment with a dominant failure mode of fail-to-start. Another important contribution was the leaking of check valves that caused the AFW pumps to become steam bound.

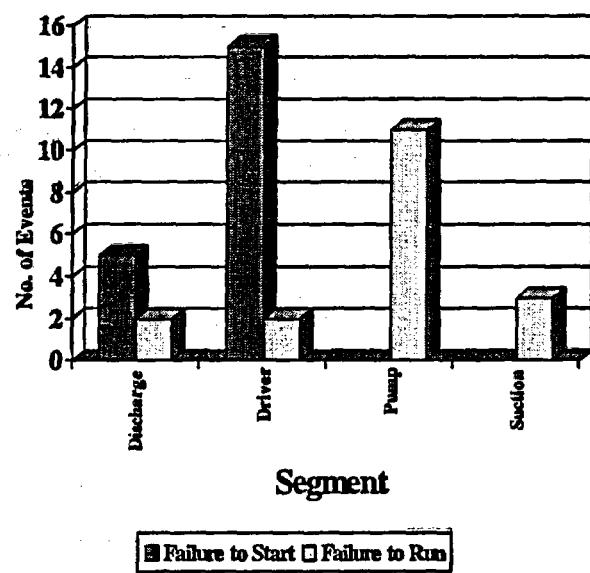
Figure 5-12. Segment distribution for the AFW system.
