Subject: Westinghouse Hematite Decommissioning Project - Request for NRC Review of Final Status Survey Final Report Volume 3, Chapter 5, Survey Area Release Record for Land Survey Area 10, Survey Units 13 and 14 (LSA 10-13 and LSA 10-14); and Volume 6, Chapter 4, Post-remediation Groundwater Monitoring 2nd Quarter Results (License No. SNM-00033, Docket No. 070-00036)

Hematite Decommissioning Project

Final Status Survey Final Report Volume 3, Chapter 5

TITLE: **Survey Area Release Record for Land Survey Area 10, Survey Units 13 and 14 (LSA 10-13 and LSA 10-14)**

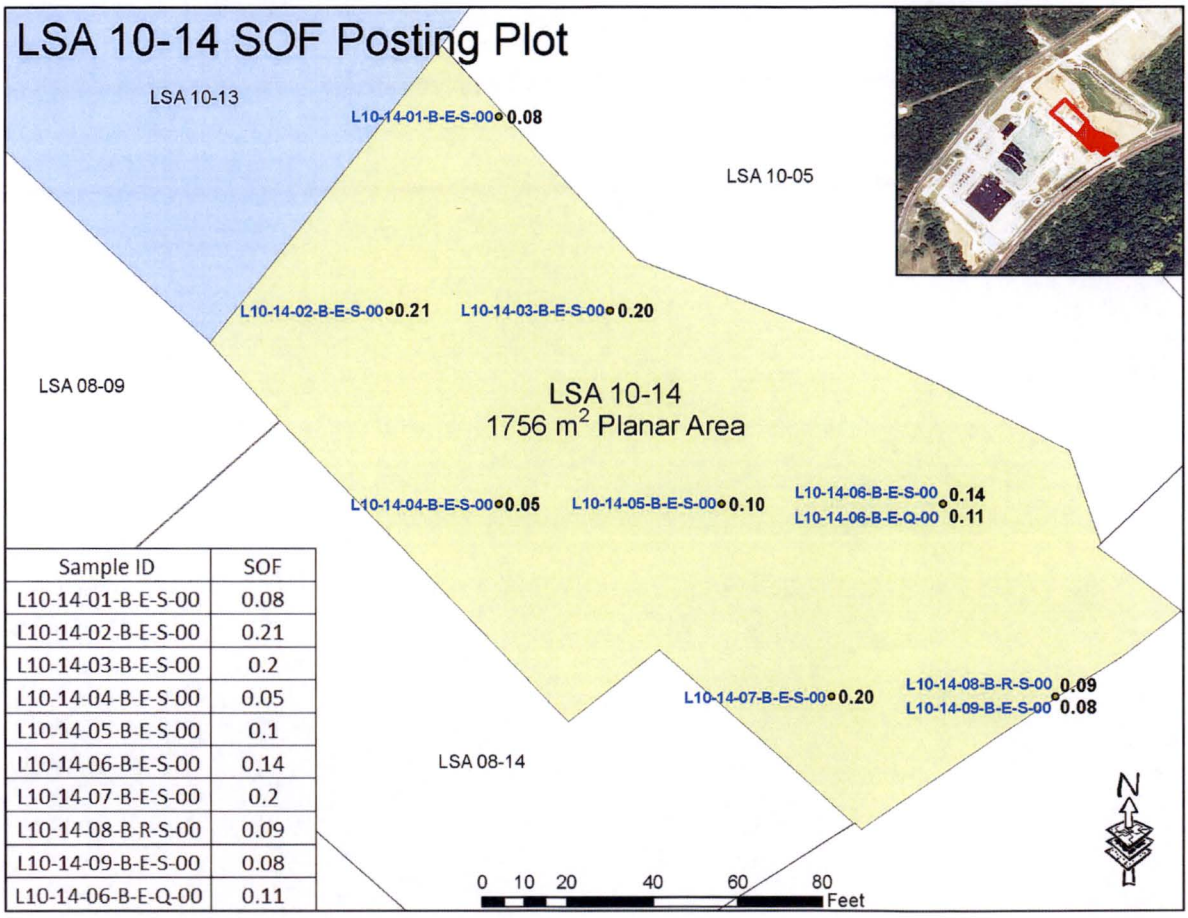
Figure 14-4
Posting Plot for LSA 10-14 Systematic Measurement Locations

A posting plot is simply a map of the survey unit with the data values (in this case the SOF values for each systematically collected sample) entered at the measurement locations. This potentially reveals heterogeneities in the data – especially possible patches of elevated residual radioactivity. The posting plot for LSA 10-14 is presented below in Figure 14-4. Figure 14-4 shows no unusual patterns in the data.

Sample ID	SOF
L10-14-01-B-E-S-00	0.08
L10-14-02-B-E-S-00	0.21
L10-14-03-B-E-S-00	0.2
L10-14-04-B-E-S-00	0.05
L10-14-05-B-E-S-00	0.1
L10-14-06-B-E-S-00	0.14
L10-14-07-B-E-S-00	0.2
L10-14-08-B-R-S-00	0.09
L10-14-09-B-E-S-00	0.08
L10-14-06-B-E-Q-00	0.11
