Common-Cause Failure Event Insights

Pumps

Idaho National Engineering and Environmental Laboratory

**U.S. Nuclear Regulatory Commission
Office of Nuclear Regulatory Research
Washington, DC 20555-0001**

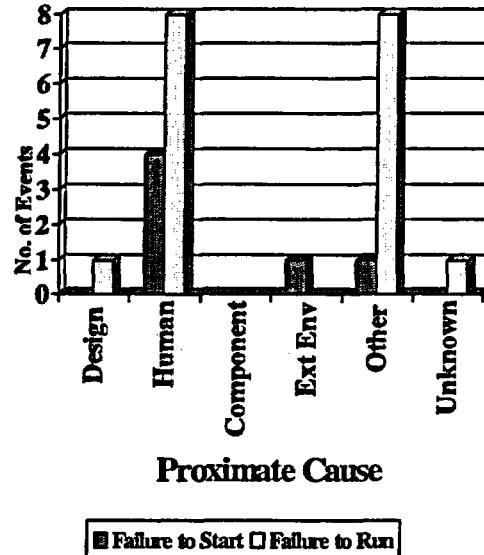
Figure 5-13. Proximate cause distribution for the RHR-P system.

Twenty-four pump CCF events affected pumps in the RHR-P system (see Table C-1 in Appendix C, items 240 – 263). Figure 5-13 through Figure 5-16 show selected distributions graphically. The RHR-P system had the largest fraction of Complete CCF events (92 percent). One event was Almost Complete. Consistent with this, the dominant proximate causes were Operational/Human Error and Other, and the dominant method of discovery was Demands. The pump CCF data indicates that events caused by human error or component failures outside the pump boundary are more likely to be Complete events and are more likely to be detected by demand than by testing, maintenance or inspection. The failure mode for most RHR-P system CCF events was fail-to-run (18 events). The last Complete RHR-P pump CCF event was in 2000, indicating that the overall problems with RHR-P pumps have not been completely addressed. However, the last loss of suction CCF event was in 1987, which indicates that this failure mode has been addressed.

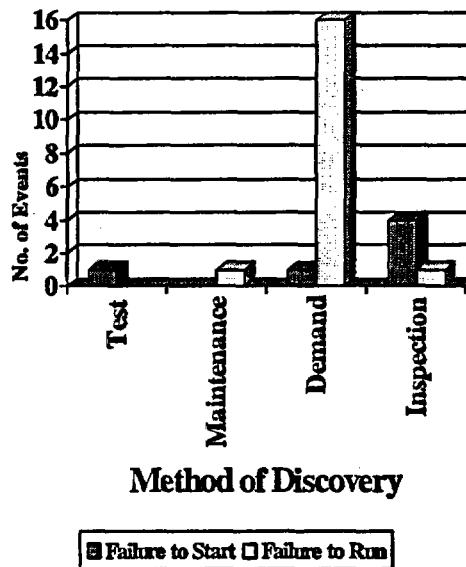
Figure 5-14. Method of discovery distribution for the RHR-P system.

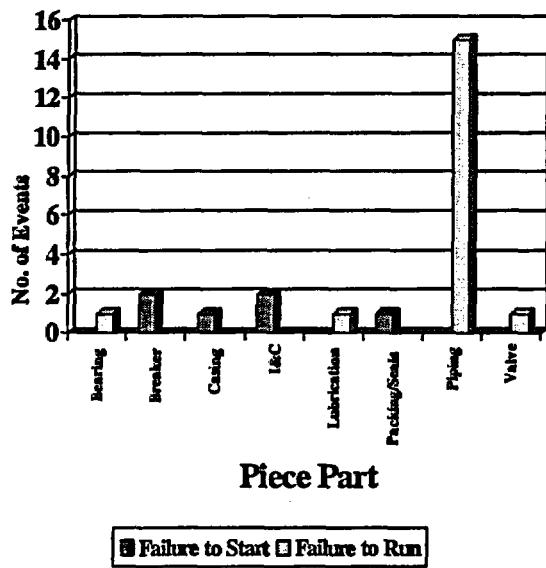
Figure 5-15. Piece part distribution for the RHR-P system.

The Suction segment and the piping piece part (piping was used as the piece part for the loss of suction events) dominate the events in this system. Most of the RHR-P system events involved loss of suction, usually during refueling outages with reduced water level in the RCS. These events occurred repeatedly, but were caused by different mechanisms including suction vortexing, air entrainment, operator error, and malfunctioning level instruments. All 16 of the suction segment events were either Complete or Almost Complete. Four of the remaining Complete events were due to improper system lineups caused by human error.

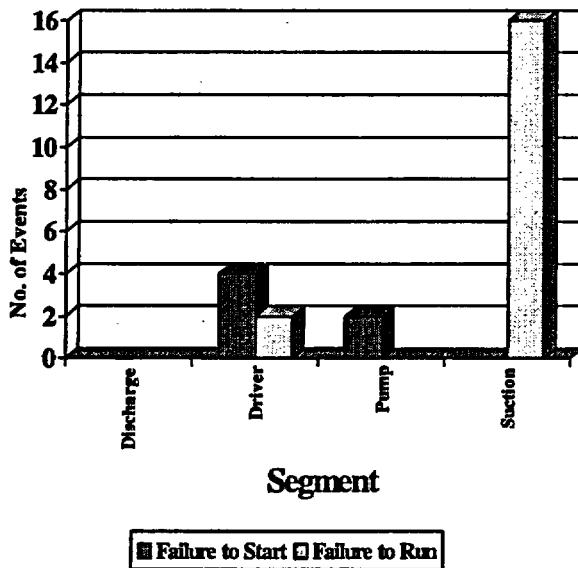
Figure 5-16. Segment distribution for the RHR-P system.

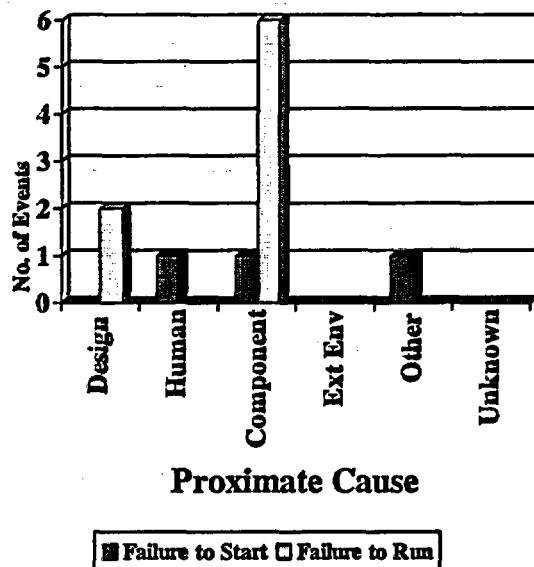
Figure 5-17. Proximate cause distribution for the SLC system.

Eleven pump CCF events affected pumps in the SLC system (see Table C-1 in Appendix C, items 264 – 274). Figure 5-17 through Figure 5-20 show selected distributions for the SLC system. The dominant proximate cause was Internal to Component (64 percent) and the dominant failure mode was fail-to-run (73 percent). The most likely discovery methods were inspection and testing. A variety of piece parts failed, affecting mostly the pump segment. Three of the SLC system CCF events were Complete and none were Almost Complete. One of the Complete events involved a short circuit in the pump control circuit and two events involved inadequate pump suction head. The Partial SLC pump CCF events were associated with worn internals and leaks.

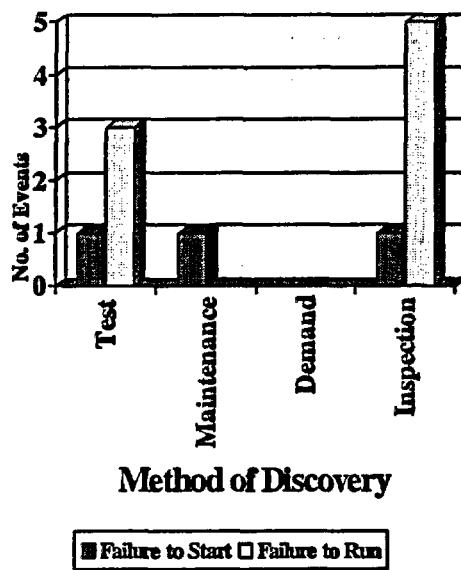
Figure 5-18. Method of discovery distribution for the SLC system.

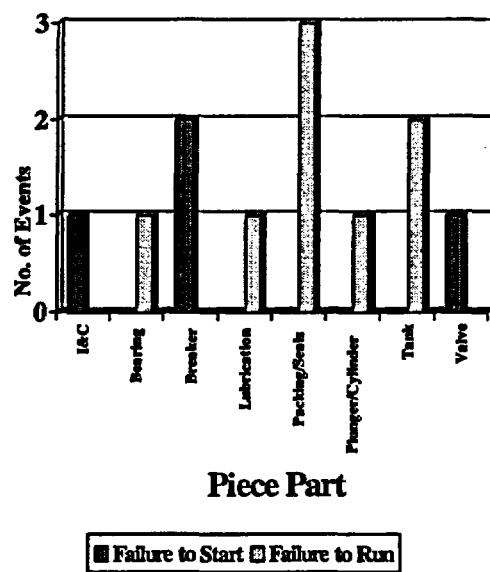
Figure 5-19. Piece part distribution for the SLC system.

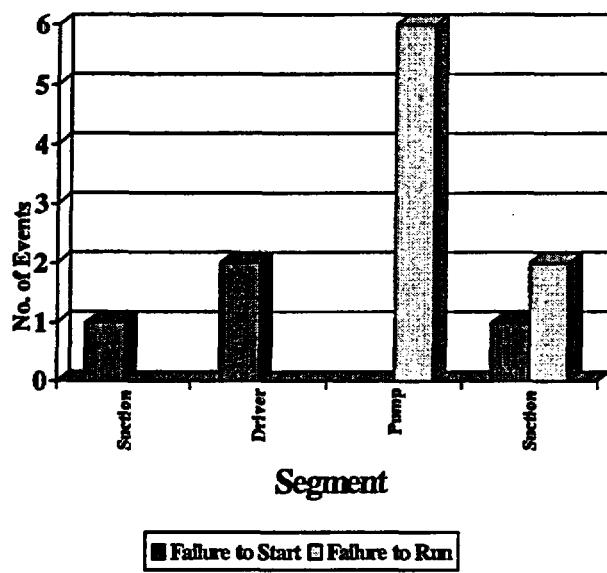
Figure 5-20. Segment distribution for the SLC system.

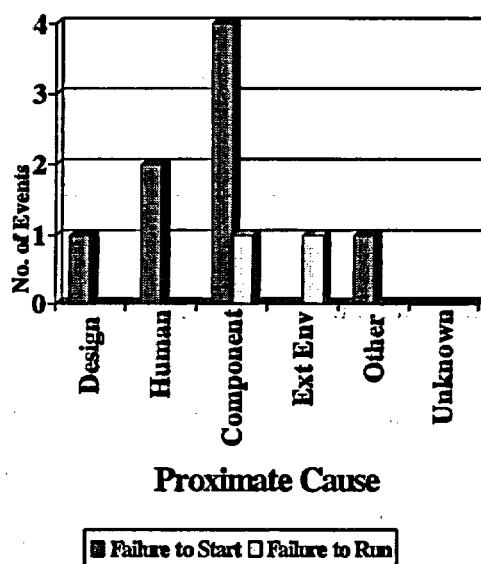
Figure 5-21. Proximate cause distribution for the RHR-B system.

Ten pump CCF events affected pumps in the RHR-B system (see Table C-1 in Appendix C, items 230 – 239). Figure 5-21 through Figure 5-24 show selected distributions for the RHR-B system. The most likely proximate cause was Internal to Component (50 percent) and the dominant failure mode was fail-to-start (80 percent). The most likely discovery method was Testing and half of the events involved circuit breaker failures. None of the RHR-B system CCF events were classified as either Complete or Almost Complete.

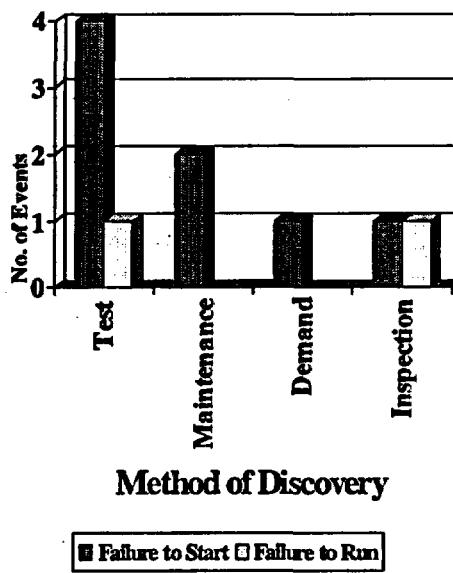
Figure 5-22. Method of discovery distribution for the RHR-B system.

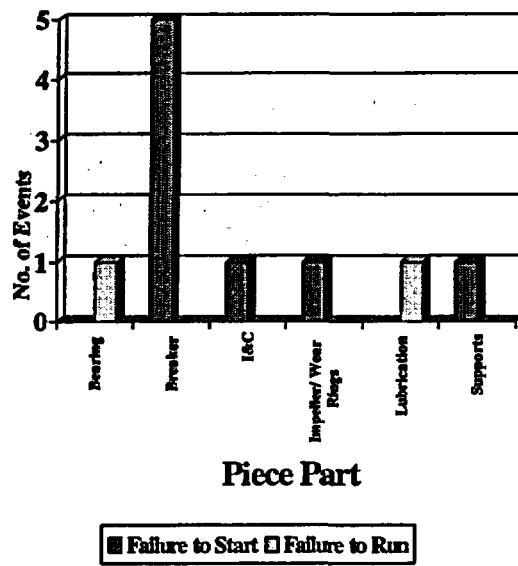
Figure 5-23. Piece part distribution for the RHR-B system.

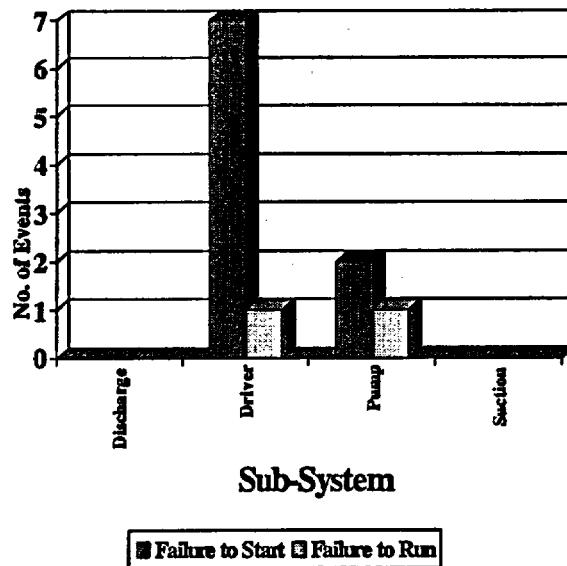
Figure 5-24. Segment distribution for the RHR-B system.
