PUBLIC SERVICE ELECTRIC & GAS
SALEM NUCLEAR POWER STATION UNIT 1

Flux Thimble Thermocouple Ultrasonic Profilometry and Eddy Current Encircling Coil Inspection of Stored Thimble Tubes

FINAL REPORT PACKAGE

July - August 1993

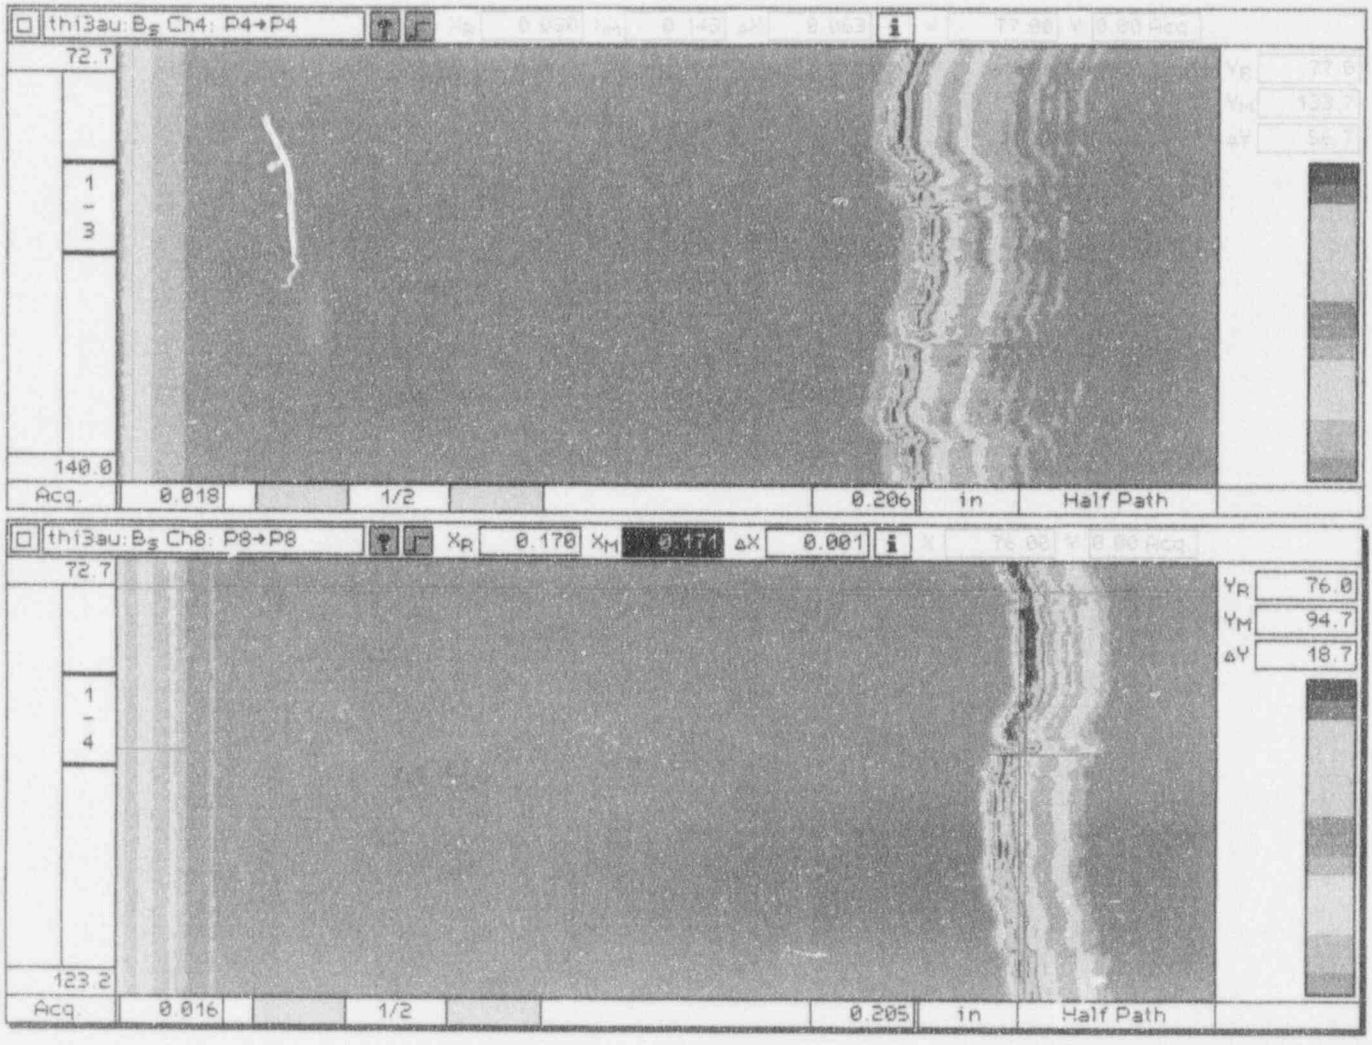
Figure 10
Thimble number 3
Wear, .001 inch (depth)

A display of the largest guide fretting wears (including the attempted cut on thimble number 8) are presented in the UT profile results Figures 10, 11. Thimbles not shown had no cross-sectional area wall loss wear found on any thimble. The displays presented in Figures 9 through 12 are composed of multiple B-scan (profile) displays. The number of B scans presented is related to the circumferential extent of each individual indication. Only the attempted thimble cuts on thimble numbers 7 and 8 displayed wear on more than one circumferential channel. The circumferential extent is based upon which transducers detect the indication. The transducers with only the deepest indications are typically displayed on B scans.

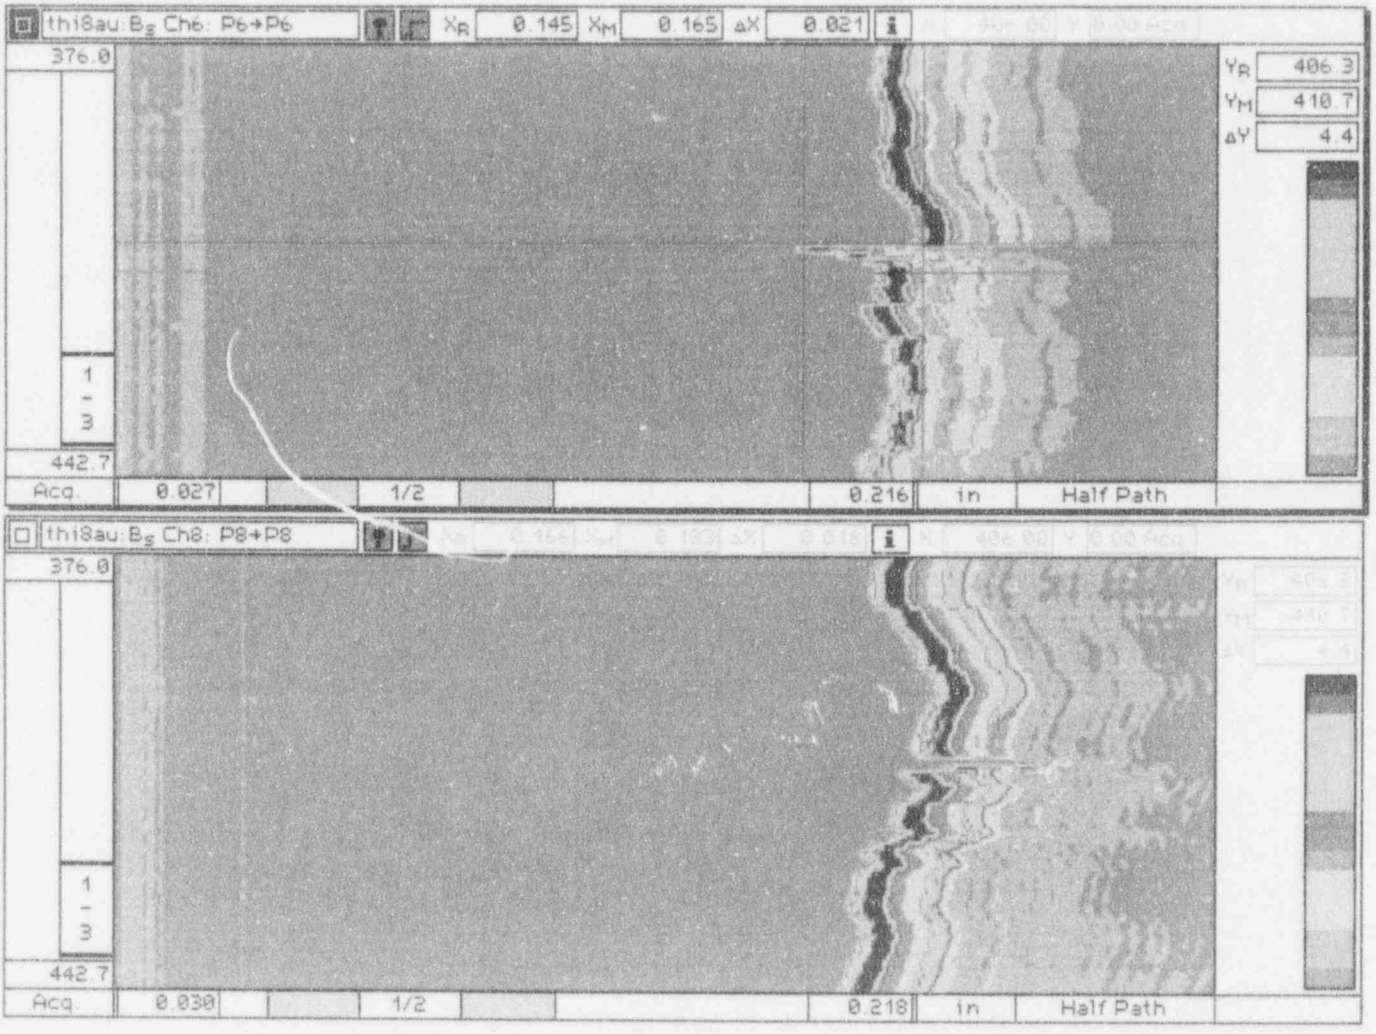
Figure 11
Thimble number 8
Partial aborted cut
Chrome section

No significant wear was detected on any of the thimble tubes. The largest indication detected was located on tube number 8 in the chrome plated portion of the thimble tube (less than 30.0"). This indication was determined and visually verified as an aborted tube cut scar, 0.021 inch deep. The attempted cut had displaced some cladding material outward and ovalized the tubing directly below the scar. This aborted thimble cut location exhibited the highest amplitude eddy current signal reported as wear on any thimble tube. Thimble tube number 7 also contained a partial tube cut, although not as deep as number 8. This was reported as the second largest wear by eddy current. Thimble tube numbers 3, 4 & 9 had indications exhibiting "dent" characteristics, (Figure 5), that were not discernable with ultrasonics because of their extremely small size. Chrome transition areas (where they existed) were easily discernable with eddy current (Figures 7 & 8) and could also be detected with ultrasonics (Figure 9). Chrome transition areas are listed in Table 2. No cladding bulging or ovality was detected in the thimble tubes tested. No thimble tubing tested had greater than 0.002 inch wear detected by ultrasonics at any elevation. Cross sectional area wall loss (CAWL) is therefore less than 3 percent at any elevation.
