SUBJECT: FINAL SIGNIFICANCE DETERMINATION FOR A WHITE FINDING AND NOTICE
OF VIOLATION - NRC SPECIAL INSPECTION REPORT 05000298/2007007 -
COOPER NUCLEAR STATION

Incremental Change in Core Damage Probability Resulting from Degraded Voltage Regulator Diode Installed in the Division 2 Diesel Generator

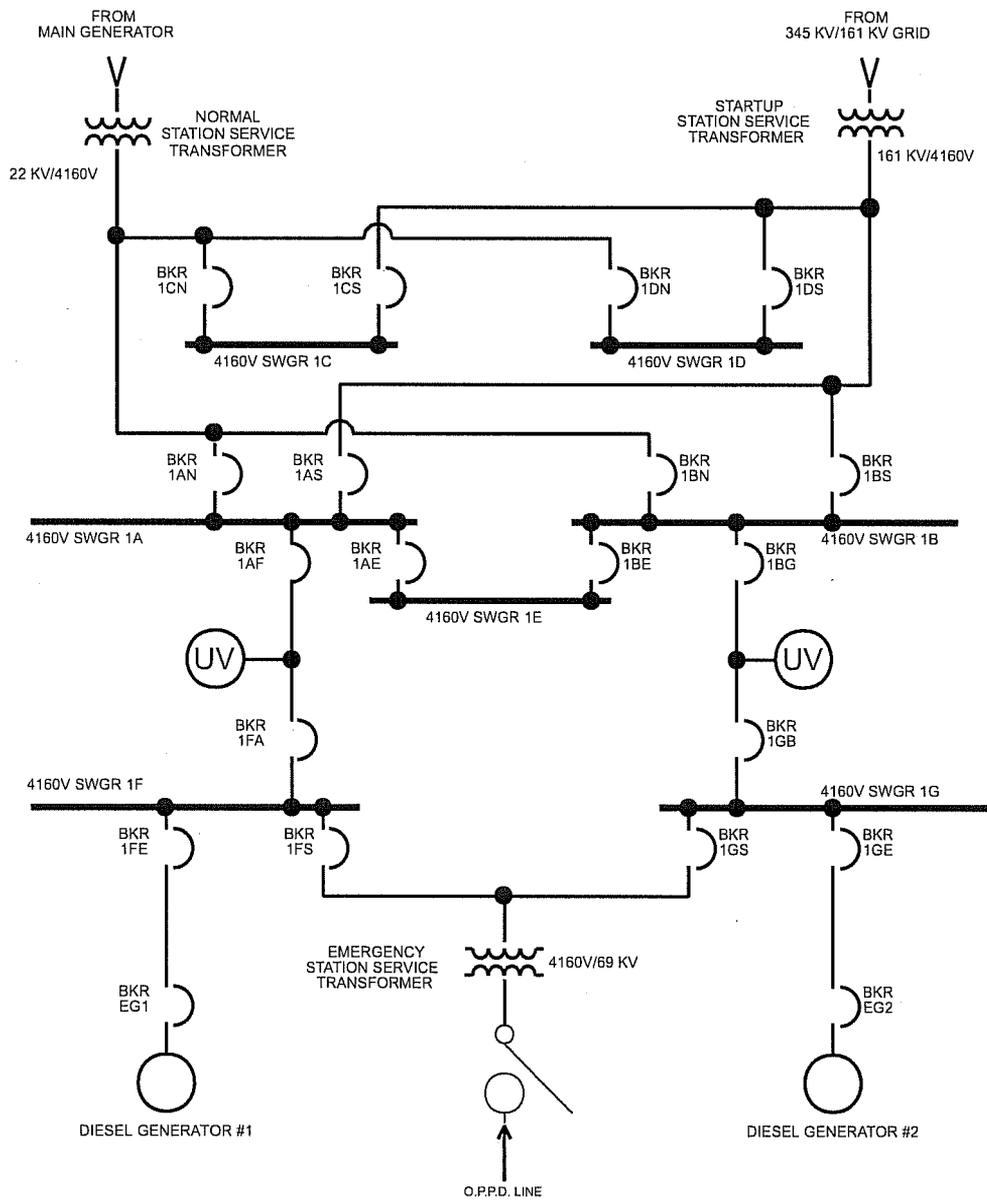
Figure 1.1 Cooper Nuclear Station Single Line, 4160 Volt Distribution

Figure 1.1 illustrates the power supplies and distribution for the station loads at the 4160 volt AC bus level.

The defective diode was installed in the voltage regulator for 56 days while CNS was at power. The voltage regulator card was part of the excitation control for DG-GEN-DG2 (illustrated as diesel generator #2 in Figure 1.1). All other power sources available to the 4160 Volt AC buses remained available and unaffected by the defective diode.

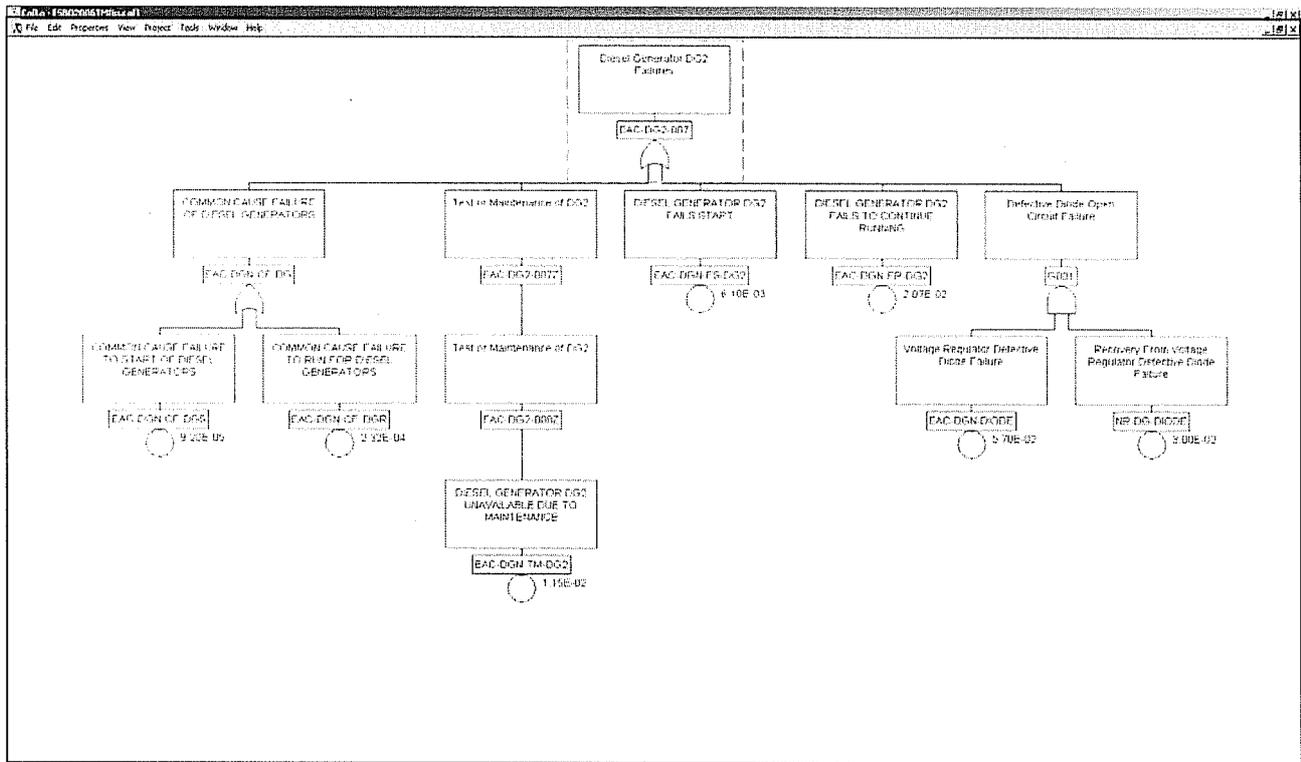
Conditional CDF was also quantified using the CNS model of record with the adjustments detailed for the base CDF. The defective diode was modeled as a new and separate event placed in the diesel generator fault tree as an input to gate EAC-DG2-007, "Diesel Generator DG2 Failures". The original DG2 fail-to-run event EAC-DGN-FR-DG2 was also retained in the tree. The defective diode probability was set at $5.70E-02$ (see Appendix C) and adjusted to reflect a non-recovery probability of 0.03 (see Appendix B). The following represents the addition of defective diode modeling.

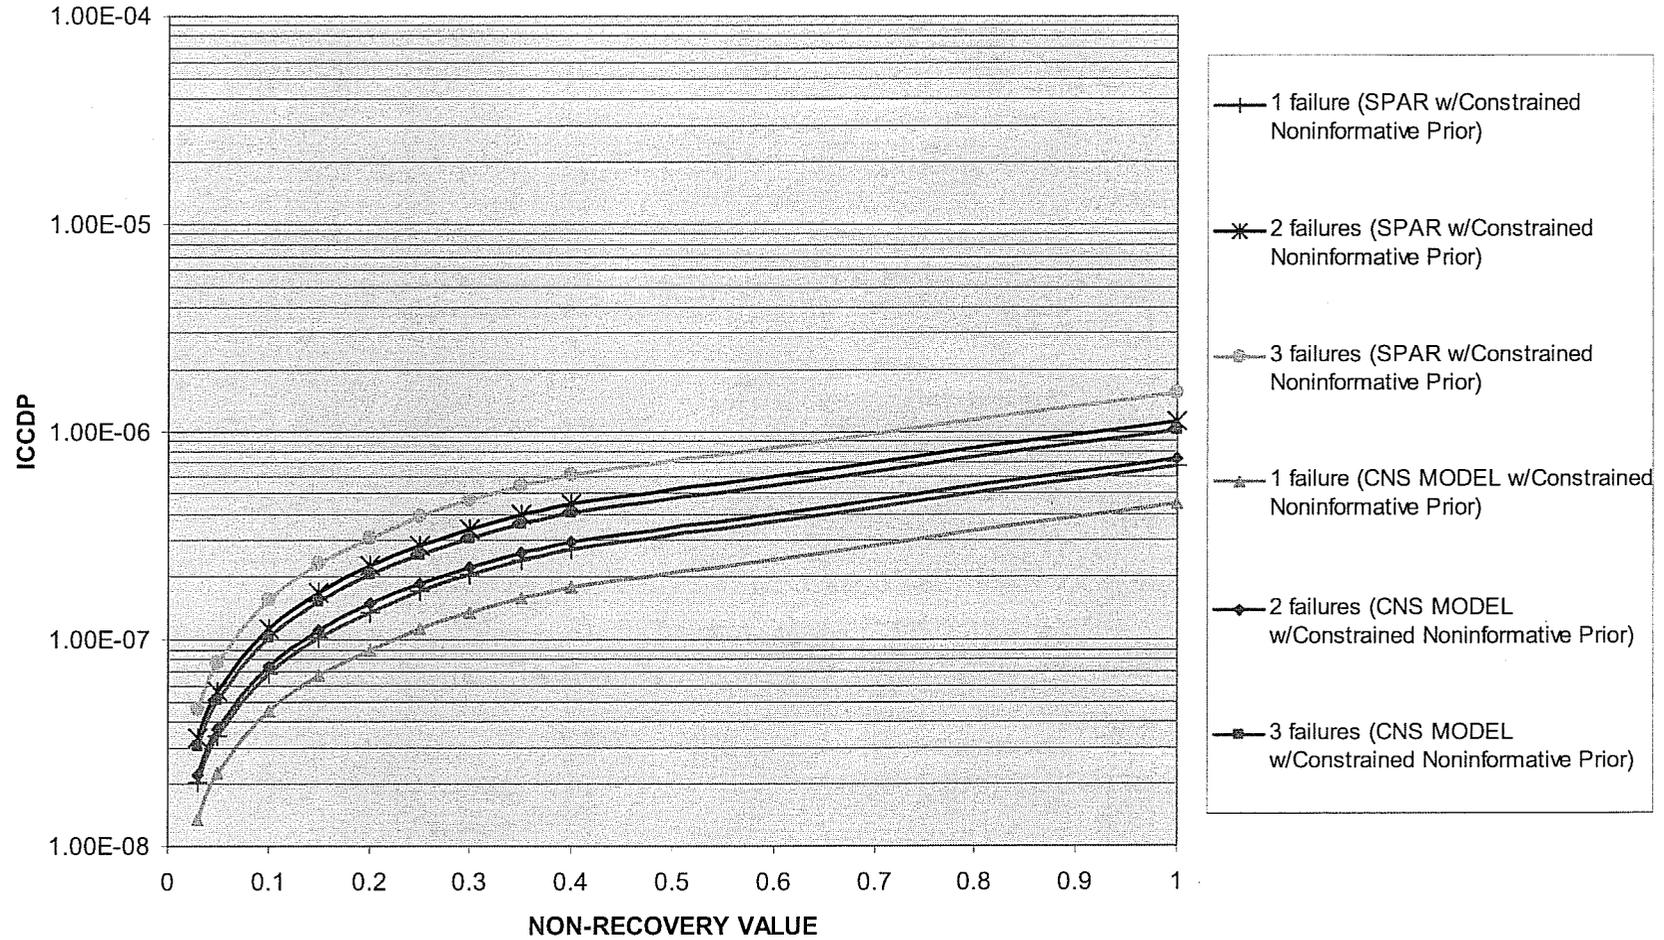
Figure 2.2.1-1 ICCDP Sensitivity with Respect to Defective Diode Failure and DG Non-recovery Probabilities

Tables 2.2.1-1 and 2.2.1-2, as well as Figure 2.2.1-1, represent the sensitivity of ICCDP in relation to both non-recovery probabilities and diode failure probabilities. Diode failure probabilities are varied to detail how the assumed number of failures experienced while the defective diode was installed affects overall ICCDP. Non-recovery probabilities are incremented in steps of 0.5 to provide relative sensitivity insights.

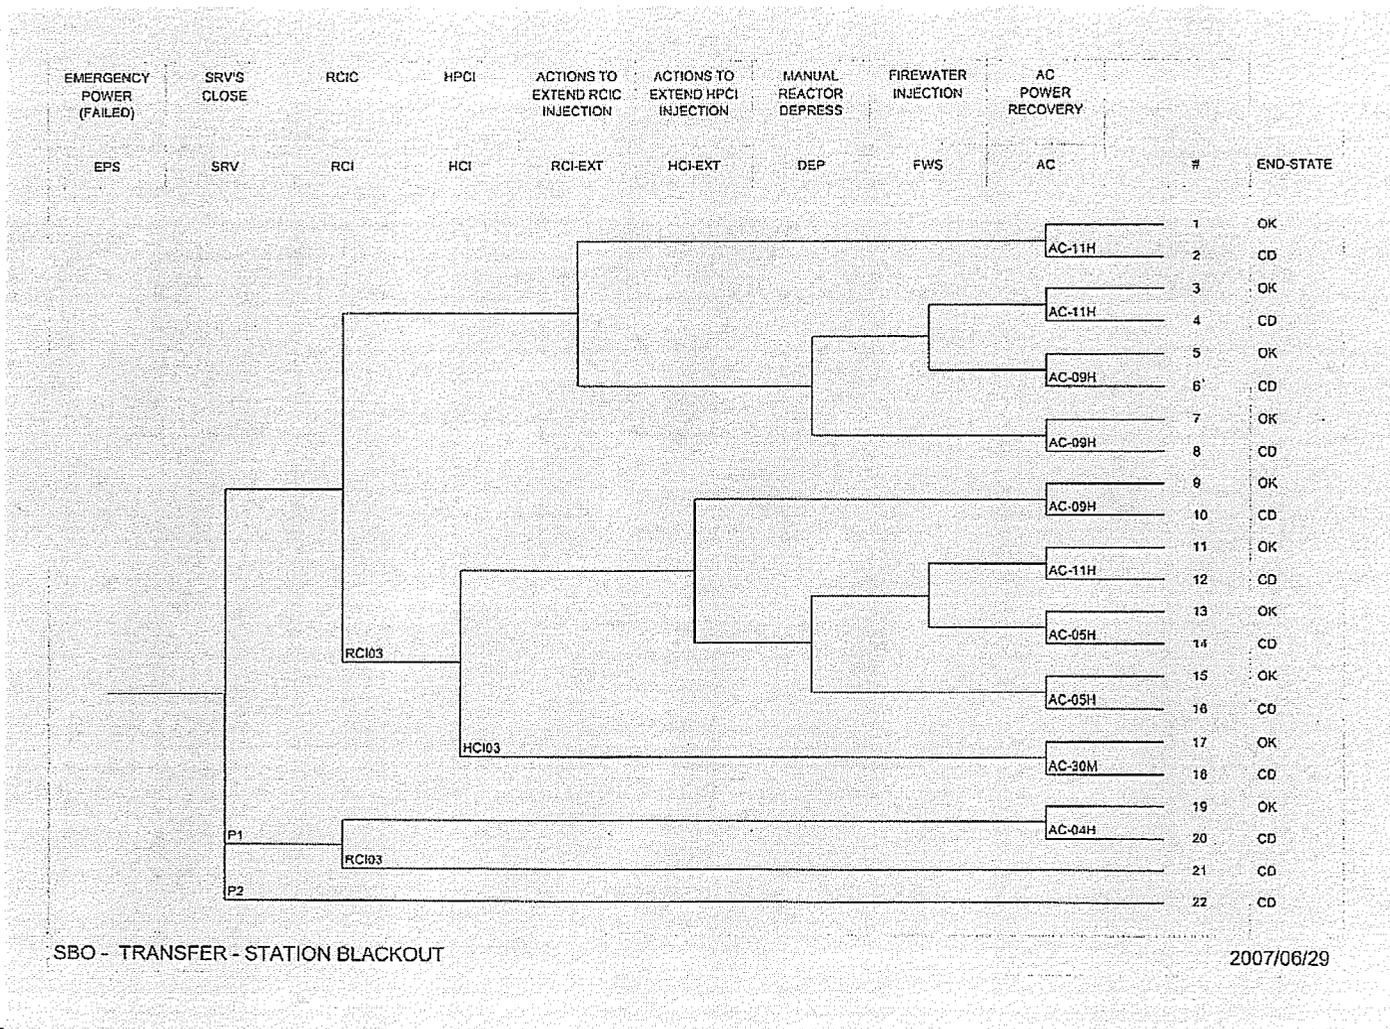
Figure A-2 SPAR Model Event Tree Modifications

The SBO event tree in SPAR was also adjusted to reflect the need to better reflect battery depletion times and both the ability to extend HPCI and RCIC mission times. Figure A-2 represents the adjusted SPAR SBO tree. Specifically, a node was added to reflect the ability of specific actions to extend HPCI mission time and the AC power recoveries were adjusted to reflect the additional recovery time available when using the extended battery depletion times. The event tree does not reflect extended boil off times available to restore AC power prior to core damage.

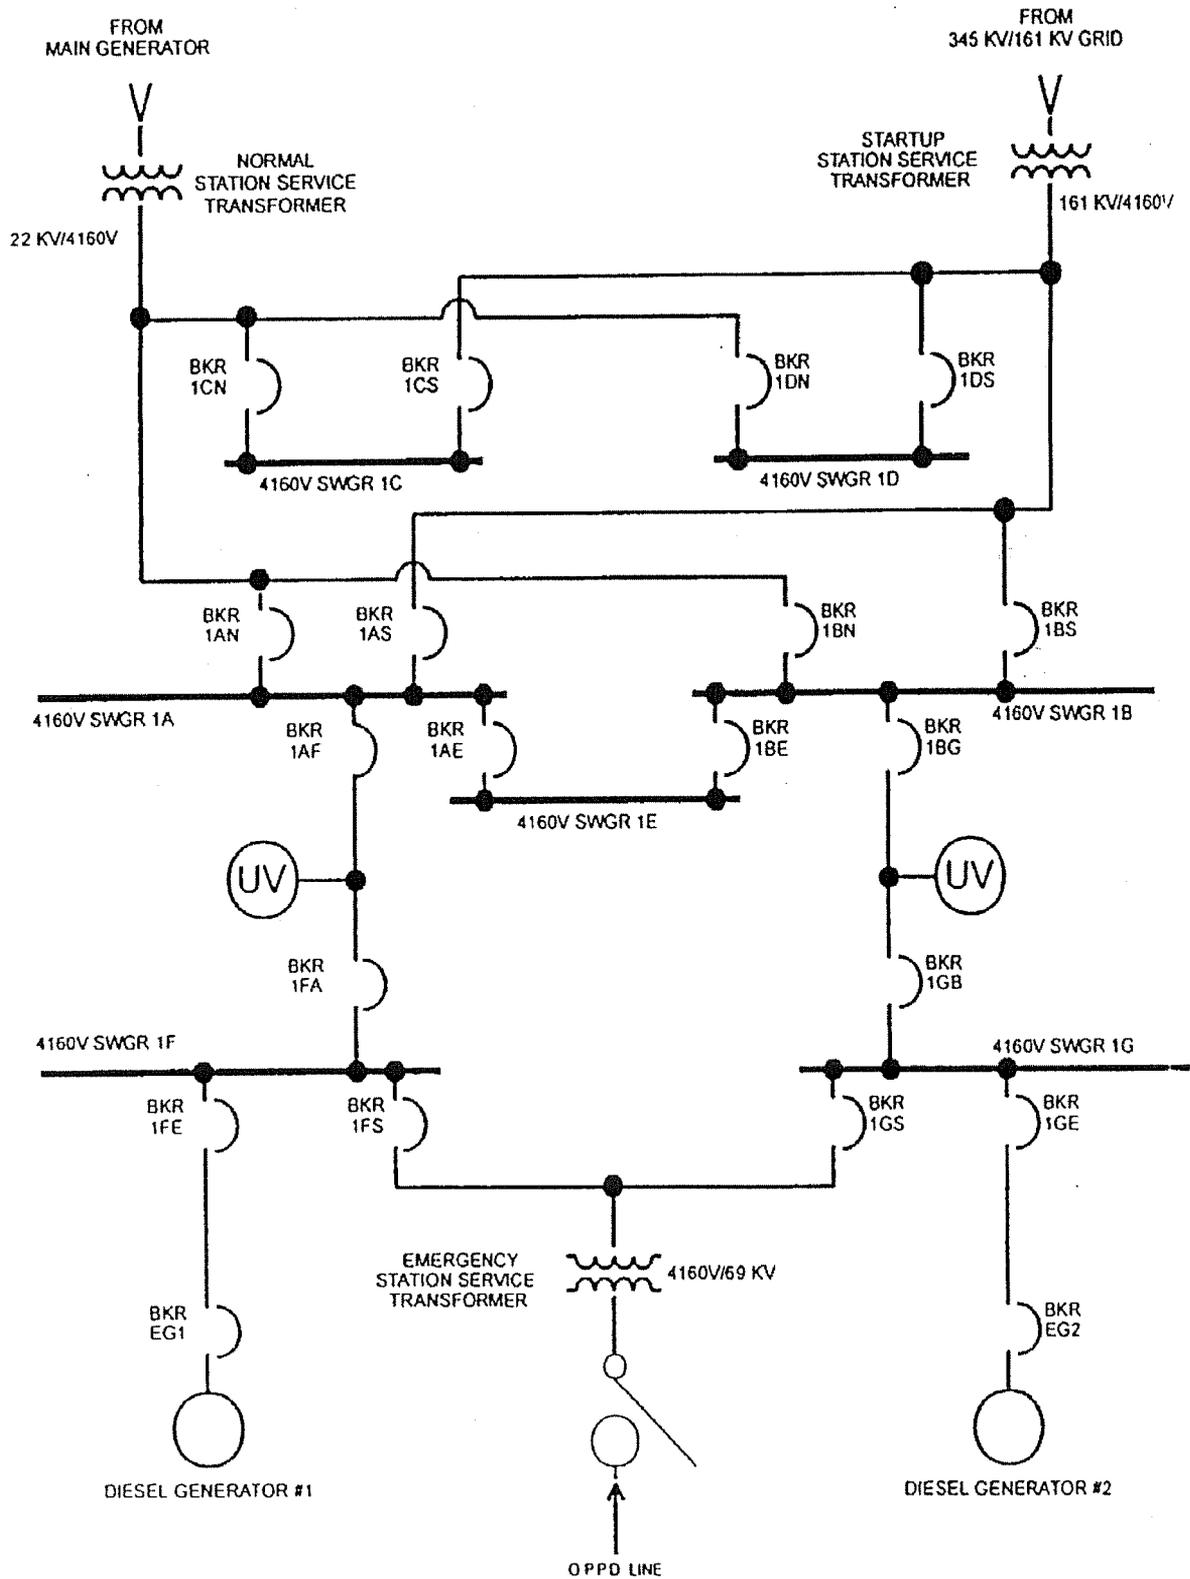
Figure 1. CNS 4160 VAC Distribution

The configuration of the CNS offsite power sources and the main generator supply is illustrated in Figure 1. CNS supplies power to the grid at 345kV. The 345kV switchyard is designed with a "breaker and a half" scheme, so if the CNS Main Generator output breakers trip, the remainder of the 345kV yard is unaffected. The primary offsite power source at CNS is the Startup Station Service Transformer (SSST) which is supplied via a step-down transformer T2 from the 345kV switchyard. The SSST can also be supplied by a 161kV transmission line that leaves the site and terminates close to the city of Auburn.

At power, CNS normally supplies the non-1E and 1E 4160 VAC switchgear from the station unit auxiliary transformer (Normal Station Service Transformer or NSST). If the CNS generator trips or the NSST de-energizes without a generator trip, the station switchgear is designed to transfer station to the SSST if available via a "fast transfer". The fast transfer occurs within 3-5 cycles such that no loads are shed during this transfer. Since the 4160 volt Essential Buses 1F and 1G are supplied by 4160 Volt Buses A and B, the Essential Buses also "fast transfer" to the SSST.

The SSST is supplied by the 161kV CNS switchyard which is connected to the CNS 345kV switchyard via an auto-transformer and a 161kV switchyard via the CNS to Auburn 161kV transmission line. If the SSST is not available or the tie breakers between 4160 Volt Bus A and F (and B and G) trip, the Essential Buses 1F and 1G transfer to the Emergency Station Service Transformer via a short duration dead bus transfer.

The ESST is supplied by a 69kV sub-transmission line from the 69kV Substation near Brock, Nebraska which has multiple sources. A trip of the CNS main generator supply would have a minimal affect on the voltage at the Brock Substation. If the ESST is available and breakers 1FA and 1GB are OPEN, the ESST supply breakers (1FS and 1GS) to the 1F and 1G switchgear will close after a short delay (in which the 4160 motors trip) and the ESST will supply both class 1E switchgear.

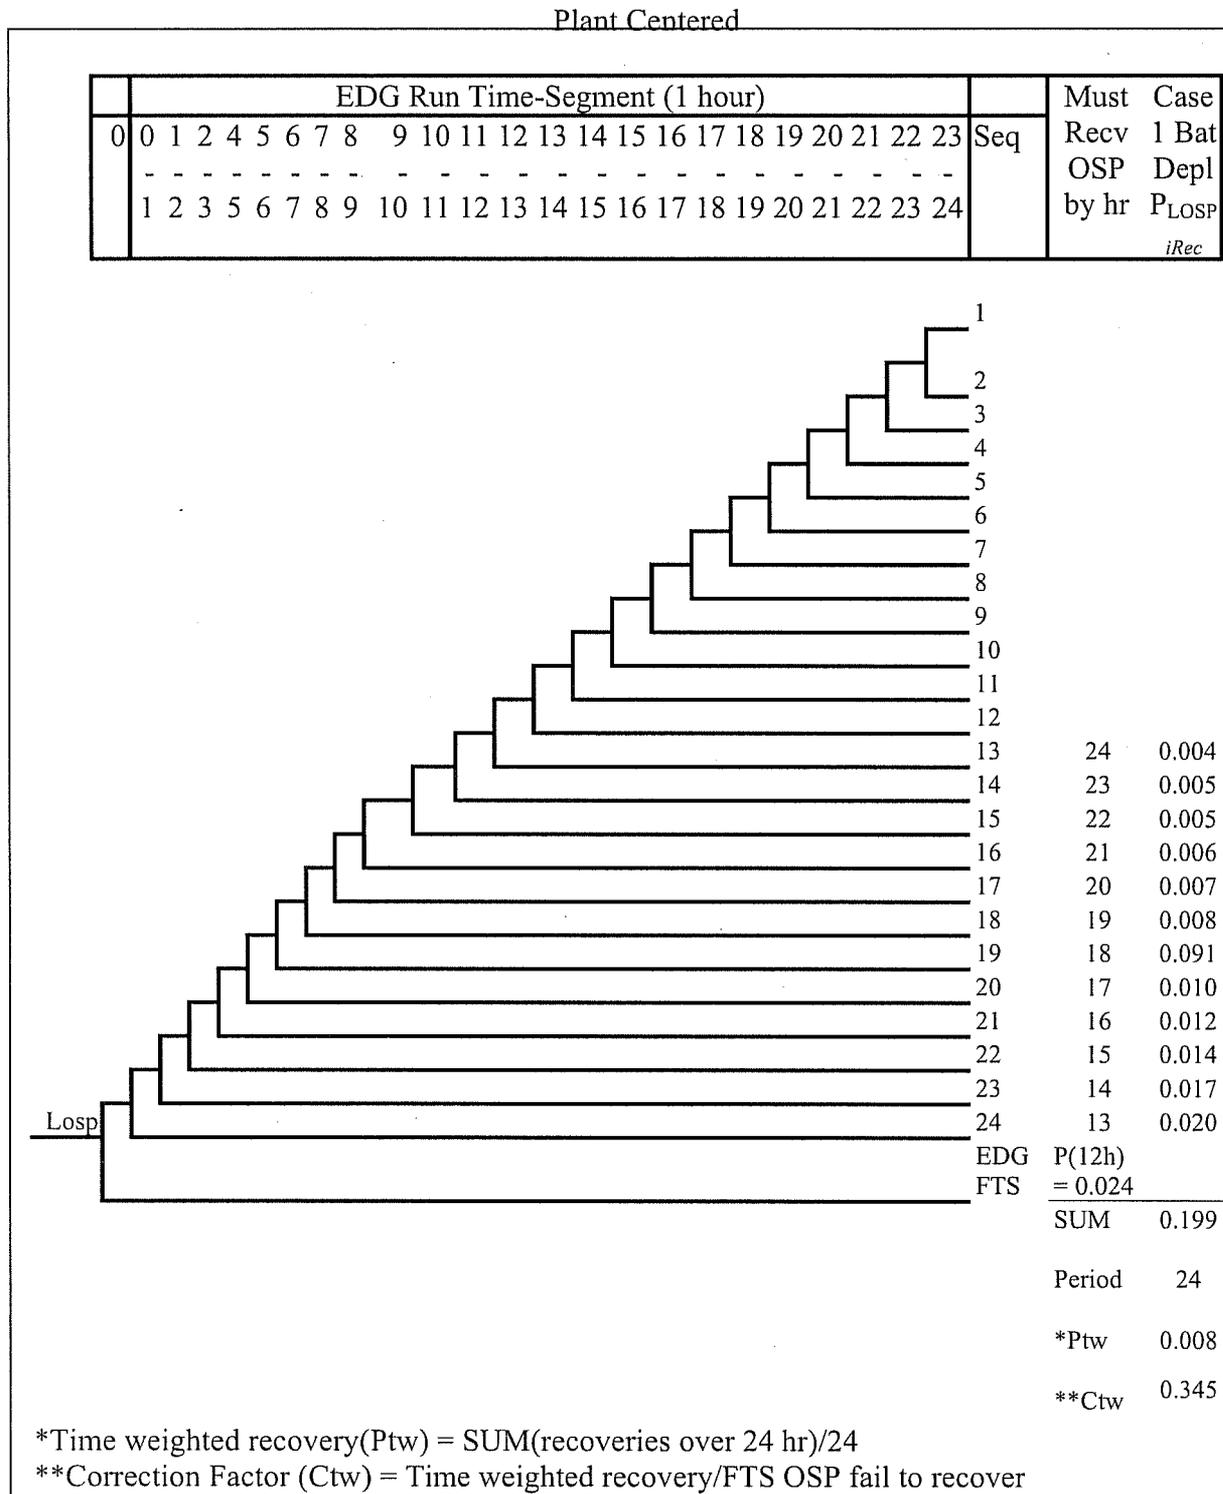
Figure 5-1: EDG Time Dependent Loss of Offsite Power Event Tree (Plant Centered)

For the above scenarios, the current SBO accident sequences are quantified as though the SBO event occurs at the time of the loss of offsite power event (time = 0). This assumption is considered conservative from an offsite power recovery standpoint given that one or both EDGs may be available for a while to provide support for operation of AC powered accident mitigating systems. Temporary operation of an EDG would allow more time for operators to recover offsite power and thus would reduce the SBO CDF. Explicitly accounting for the SBO scenarios where the EDG(s) runs temporarily requires integration of the run failure rate and the offsite power recovery probability over the mission time of the accident sequence. A discrete approximation to this integration can be performed by breaking out the original 24 hour EDG mission time into equal run time segments (1 hour segments) with corresponding EDG failure probabilities. Since offsite power is lost at time zero, the latest time to recover power increases by an hour for each succeeding EDG successful run segment. Correspondingly, with each succeeding hour that the SBO event is delayed, the offsite power recovery failure probability would decrease. The event tree shown in Figure 5-1 illustrates the EDG run scenarios to be quantified to obtain a time-weighted offsite power recovery failure probability for the extended RCIC success sequences.

The time weighted correction factor would be applied to SBO accident sequence cut sets in which a diesel fail to run basic event occurred.

Tables 5-1 through 5-3 below compile the offsite power recovery failure as a function of the available recovery times for diesel generator failure to run sequences for each of the three LOSP event categories (plant centered, grid centered, weather related). The first column represents the sequence in the event tree shown in Figure 5-1. The second column is the time at which it is assumed that the last diesel generator fails to run following the loss of offsite power initiator. The columns labeled "AC Recovery Required" represent the time at which core damage is assumed and the associated offsite power recovery failure probability (P_{losp_i}). The offsite power recovery factor as a function of time (P_{losp_i}) is calculated as illustrated in Figure 5-1 for all seven cases.
