THERMO-LAG ASSESSMENT REPORT FOR HOUSTON LIGHT AND POWER COMPANY SOUTH TEXAS PROJECT ELECTRIC GENERATING STATION

REVISION 0

SOUTH TEXAS PROJECT ELECTRIC GENERATION STATION
PO BOX 289
WADSWORTH, TEXAS 77483

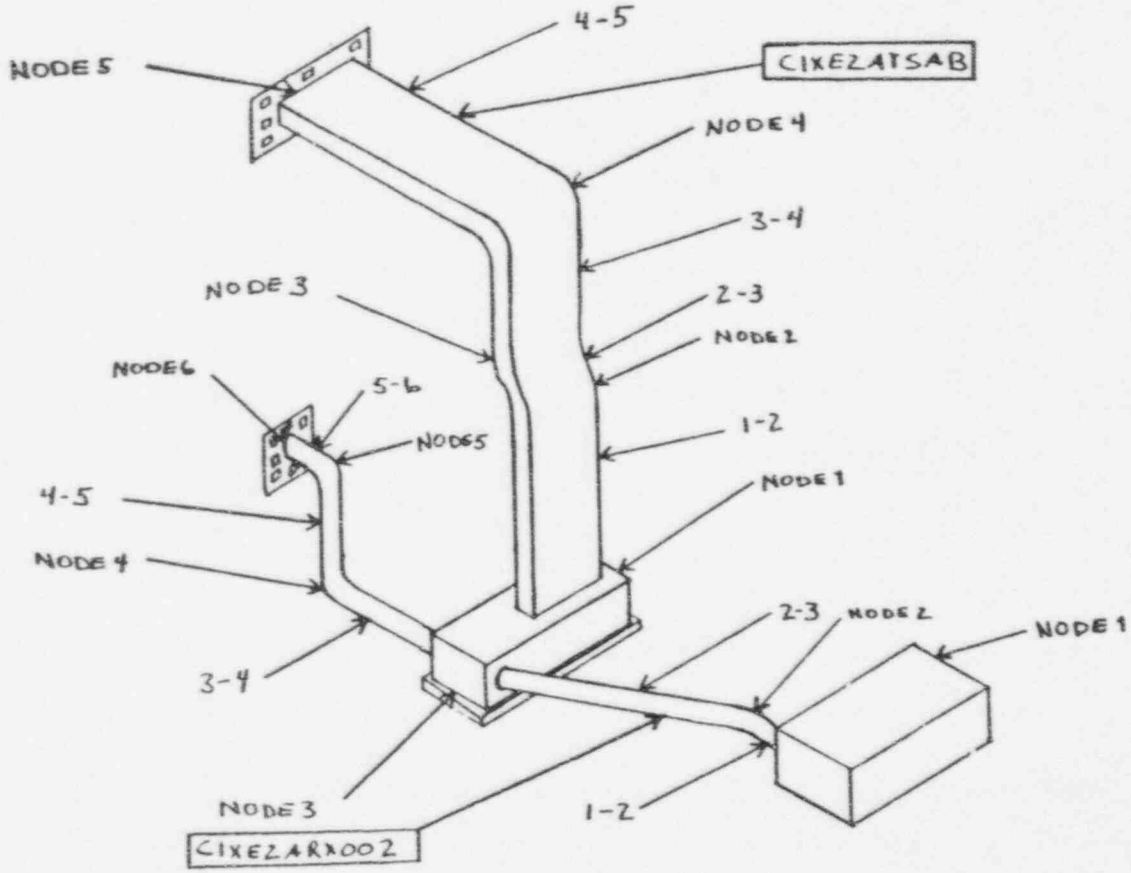
SKETCH OF INSTALLED CONFIGURATION

1. THERMO-LAG BARRIER SYSTEM/PROTECTED COMMODITY IDENTIFIER: C1XE2ATSAB

E-3 FASTENER SPACING WAS MAINTAINED AT 12" OR LESS. THERE WAS HOWEVER NO REQUIREMENT FOR BAND TO JOINT SPACING SO THAT DIMENSION VARIES. THE INSTALLED CONFIGURATION IS A BOX RESTING ON THE FLOOR, WITH BANDS INSTALLED ON THE SIDE PANELS WITHIN 4" OF THE JOINTS. THESE SIDE PANELS ARE IN COMPRESSION. THE TOP PANEL IS MISSING BANDING IN ONE DIRECTION, BUT THE TOP PANEL JOINTS ARE NOT CONSIDERED A FAILURE MODE. ALSO THE 3 HOUR PANELS DID NOT TEND TO DISTORT IN TESTS LIKE THE THINNER 1 HOUR PANELS. THE GREATER BAND TO JOINT SPACING IS CONSIDERED TO BE INSIGNIFICANT AND THE INSTALLED IS CONSIDERED BOUNDED BY THE TESTED CONFIGURATIONS.

ALTHOUGH MINOR BARRIER OPENINGS OCCURRED DURING THE HOSE STREAM TEST FOR BOTH TUEC 11-4 AND NEI 2-3, THE COMMODITIES WITHIN THE INSTALLED BOX DESIGN BARRIER CONFIGURATIONS WOULD NOT BE PRONE TO DAMAGE DUE TO FIRE FIGHTING ACTIVITIES OR FROM FALLING EXTERNAL OBJECTS DURING FIRE CONDITIONS.

AS INSTALLED, THERE IS NO BOUNDING TEST AND THEREFORE NO FIRE RATING FOR THE STRUCTURE INTERFACE. THE PRINCIPAL ATTRIBUTE MISSING FROM THE INSTALLED CONFIGURATION IS STRESS SKIN AND TROWEL GRADE SUPPORT BETWEEN THE "PICTURE FRAME" AND CABLE TRAY COVERAGE PROVIDING ADDITIONAL STRUCTURAL PROTECTION AT THE INTERFACE AREA.

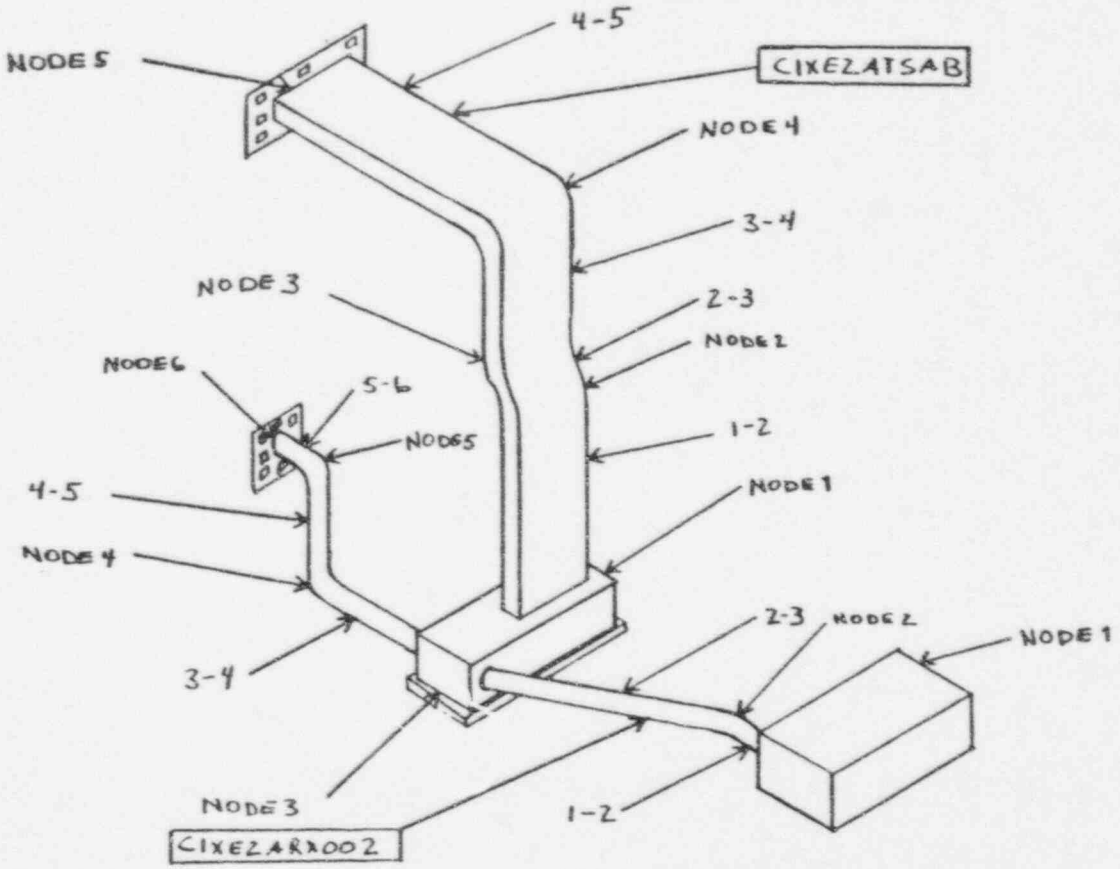
SKETCH OF INSTALLED CONFIGURATION

FIGURE F-3	INSTALLED TO TESTED FIRE BARRIER EVALUATION			PAGE 4 0F 31
PERFORMANCE PARAMETERS	1 THERMO-LAG BARRIER SYSTEM/PROTECTED COMMODITY IDENTIFIER: C1XE2ARX002			
	2 APPLICABLE FIRE BARRIER SYSTEM SEGMENT: NODE 1			
COMMODITY	3A INSTALLED CONFIGURATION	4A TESTED CONFIGURATION(S) EVALUATED	5A APPLICABLE TESTS	6A EVALUATION/ REF. NO.
TYPE	JUNCTION BOX MOUNTED TO FLOOR	LBDS CABLES AIR DROPPING FROM CABLE TRAYS TO WALL SLEEVES	NEI TEST 2-3 TUEC TEST 11-4	DIFFERENT COMMODITIES, BOUNDING WILL DEPEND ON MATERIAL, MASS AND ORIENTATION. SEE EVALUATION E-1
SIZE	36" X 24" X 12" JUNCTION BOX	3" AND 6" LBDS 24 AIR DROP CABLES FROM 2 STACKED 24" CABLE TRAYS TO EMBEDDED SLEEVES.	NEI TEST 2-3 TUEC TEST 11-4	DIFFERENT SIZES, BOUNDING WILL DEPEND ON MATERIAL, MASS AND ORIENTATION. SEE EVALUATION E-1
MATERIAL	STEEL	ALUMINUM ELECTRICAL CABLES	NEI TEST 2-3 TUEC TEST 11-4	TESTED BOUNDS INSTALLED. NO EVALUATION REQUIRED.

E-3 FASTENER SPACING WAS MAINTAINED AT 12" OR LESS. THERE WAS HOWEVER NO REQUIREMENT FOR BAND TO JOINT SPACING SO THAT DIMENSION VARIES. THE INSTALLED CONFIGURATION IS A BOX RESTING ON THE FLOOR, WITH BANDS INSTALLED ON THE SIDE PANELS WITHIN 4" OF THE JOINTS. THE SIDE PANELS ARE IN COMPRESSION. THE TOP PANEL IS MISSING BANDING IN ONE DIRECTION, BUT THE TOP PANEL JOINTS ARE NOT CONSIDERED A FAILURE MODE. ALSO THE 3 HOUR PANELS DID NOT TEND TO DISTORT IN TESTS LIKE THE THINNER 1 HOUR PANELS. THE GREATER BAND TO JOINT SPACING IS CONSIDERED TO BE INSIGNIFICANT AND THE INSTALLED IS BOUNDED BY THE TESTED CONFIGURATIONS.

WHILE A MINOR BARRIER OPENING OCCURRED IN THE ENCLOSURE FOR BOTH TUEC TEST 11-4 AND NEI TEST 2-2(BASELINE), THE INSTALLED CONFIGURATION INVOLVES CABLES IN ELECTRICAL BOXES WHICH WOULD NOT BE PRONE TO DAMAGE DUE TO FIRE FIGHTING ACTIVITIES OR FALLING EXTERNAL OBJECTS DURING FIRE CONDITIONS.

AS INSTALLED, THERE IS NO BOUNDING TEST AND THEREFORE NO FIRE RATING FOR THE STRUCTURE INTERFACE. THE PRINCIPAL ATTRIBUTE MISSING FROM THE INSTALLED CONFIGURATION IS STRESS SKIN AND TROWEL GRADE SUPPORT BETWEEN THE "PICTURE FRAME" AND CONDUIT COVERAGE PROVIDING ADDITIONAL STRUCTURAL AND THERMAL PROTECTION AT THE INTERFACE AREA.

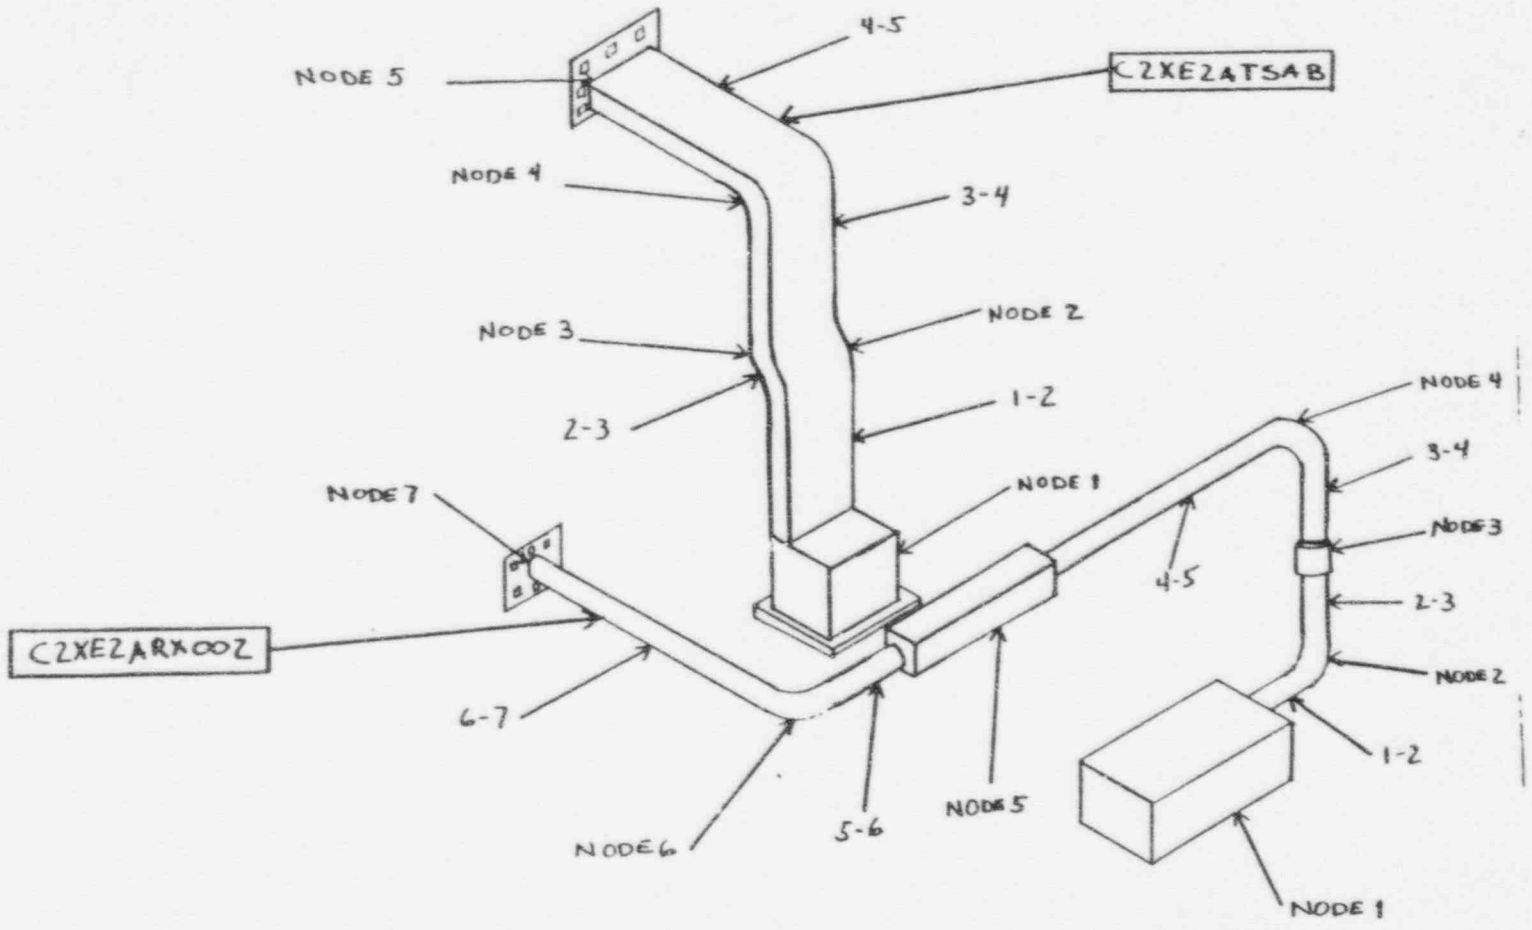
SKETCH OF INSTALLED CONFIGURATION

FIGURE F-3	INSTALLED TO TESTED FIRE BARRIER EVALUATION			PAGE 4 OF 31
PERFORMANCE PARAMETERS	1 THERMO-LAG BARRIER SYSTEM/PROTECTED COMMODITY IDENTIFIER: C2XE2ATSAB			
	2 APPLICABLE FIRE BARRIER SYSTEM SEGMENT: NODE 1			
COMMODITY	3A INSTALLED CONFIGURATION	4A TESTED CONFIGURATION(S) EVALUATED	5A APPLICABLE TESTS	6A EVALUATION/ REF. NO.
TYPE	CABLE TRAY AND CONDUIT	LBDS CABLES AIR DROPPING FROM CABLE TRAY TO SLEEVES	NEI TEST 2-3 TUEC TEST SCHEME 11-4	DIFFERENT COMMODITIES, BOUNDING WILL DEPEND ON MATERIAL, MASS AND ORIENTATION. SEE EVALUATION E-1
SIZE	24" CABLE TRAY	3" AND 6" LBDS 24 AIR DROP CABLES FROM 2-STACKED 24" WIDE CABLE TRAYS TO EMBEDDED SLEEVES	NEI TEST 2-3 TUEC TEST SCHEME 11-4	DIFFERENT SIZES, BOUNDING WILL DEPEND ON MATERIAL, MASS AND ORIENTATION. SEE EVALUATION E-1
MATERIAL	STEEL	ALUMINUM ELECTRICAL CABLES	NEI TEST 2-3 TUEC TEST SCHEME 11-4	TESTED BOUNDS INSTALLED. NO EVALUATION REQUIRED.

E-3 FASTENER SPACING WAS MAINTAINED AT 12" OR LESS. THERE WAS HOWEVER NO REQUIREMENT FOR BAND TO JOINT SPACING SO THAT DIMENSION VARIES. THE INSTALLED CONFIGURATION IS A BOX RESTING ON THE FLOOR, WITH BANDS INSTALLED ON THE SIDE PANELS ARE WITHIN 4" OF THE JOINTS. THE SIDE PANELS ARE IN COMPRESSION. THE TOP PANEL IS MISSING BANDING IN ONE DIRECTION, BUT SINCE THE TOP PANEL RESTS ON THE SIDE PANELS, ITS JOINTS ARE NOT CONSIDERED A FAILURE MODE. ALSO THE 3 HOUR PANELS DID NOT TEND TO DISTORT IN TESTS LIKE THE THINNER 1 HOUR PANELS AND THE BOX CONFIGURATION IS SITTING ON THE FLOOR. DUE TO THE ABOVE, THE GREATER BAND TO JOINT SPACING IS CONSIDERED TO BE INSIGNIFICANT AND THE INSTALLED IS BOUNDED BY THE TESTED CONFIGURATIONS.

ALTHOUGH MINOR BARRIER OPENINGS OCCURRED DURING THE HOSE STREAM TEST FOR BOTH TUEC 11-4 AND NEI 2-3, THE COMMODITIES WITHIN THE INSTALLED BOX DESIGN BARRIER CONFIGURATIONS WOULD NOT BE PRONE TO DAMAGE DUE TO FIRE FIGHTING ACTIVITIES OR FROM FALLING EXTERNAL OBJECTS DURING FIRE CONDITIONS.

AS INSTALLED, THERE IS NO BOUNDING TEST AND THEREFORE NO FIRE RATING FOR THE STRUCTURE INTERFACE. THE PRINCIPAL ATTRIBUTE MISSING FROM THE INSTALLED CONFIGURATION IS STRESS SKIN AND TROWEL GRADE SUPPORT BETWEEN THE "PICTURE FRAME" AND CABLE TRAY COVERAGE PROVIDING ADDITIONAL STRUCTURAL PROTECTION AT THE INTERFACE AREA.

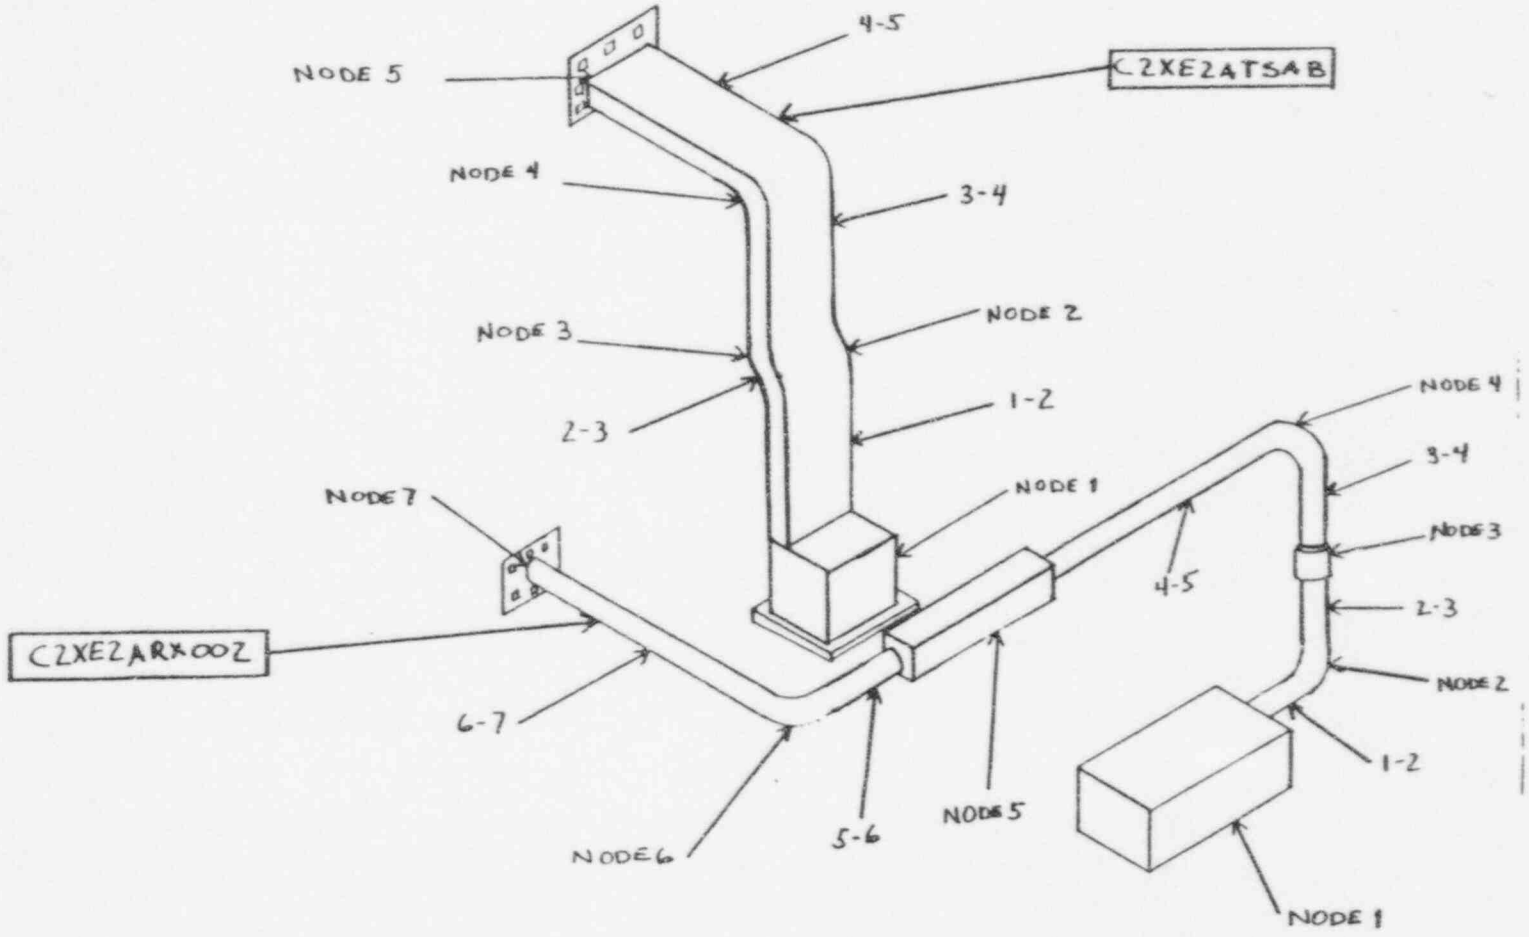
SKETCH OF INSTALLED CONFIGURATION

FIGURE F-3	INSTALLED TO TESTED FIRE BARRIER EVALUATION			PAGE 4 0F 38
PERFORMANCE PARAMETERS	1 THERMO-LAG BARRIER SYSTEM/PROTECTED COMMODITY IDENTIFIER: C2XE2ARX002			
	2 APPLICABLE FIRE BARRIER SYSTEM SEGMENT: NODE 1			
COMMODITY	3A INSTALLED CONFIGURATION	4A TESTED CONFIGURATION(S) EVALUATED	5A APPLICABLE TESTS	6A EVALUATION/ REF. NO.
TYPE	JUNCTION BOX MOUNTED TO FLOOR	LBDS CABLES AIR DROPPING FROM CABLE TRAYS TO WALL SLEEVES	NEI TEST 2-3 TUEC TEST 11-4	DIFFERENT COMMODITIES, BOUNDING WILL DEPEND ON MATERIAL, MASS AND ORIENTATION. SEE EVALUATION E-1
SIZE	48" X 30" X 12" JUNCTION BOX	3" AND 6" LBDS 24 AIR DROP CABLES FROM 2 STACKED 24" CABLE TRAYS TO EMBEDDED SLEEVES.	NEI TEST 2-3 TUEC TEST 11-4	DIFFERENT SIZES, BOUNDING WILL DEPEND ON MATERIAL, MASS AND ORIENTATION. SEE EVALUATION E-1
MATERIAL	STEEL	ALUMINUM ELECTRICAL CABLES	NEI TEST 2-3 TUEC TEST 11-4	TESTED BOUNDS INSTALLED. NO EVALUATION REQUIRED.

E-3 FASTENER SPACING WAS MAINTAINED AT 12" OR LESS. THERE WAS HOWEVER NO REQUIREMENT FOR BAND TO JOINT SPACING SO THAT DIMENSION VARIES. THE INSTALLED CONFIGURATION IS A BOX RESTING ON THE FLOOR, WITH BANDS INSTALLED ON THE SIDE PANELS WITHIN 4" OF THE JOINTS. THE SIDE PANELS ARE IN COMPRESSION. THE TOP PANEL IS MISSING BANDING IN ONE DIRECTION, BUT THE TOP PANEL JOINTS ARE NOT CONSIDERED A FAILURE MODE. ALSO THE 3 HOUR PANELS DID NOT TEND TO DISTORT IN TESTS LIKE THE THINNER 1 HOUR PANELS. THE GREATER BAND TO JOINT SPACING IS CONSIDERED TO BE INSIGNIFICANT AND THE INSTALLED IS BOUNDED BY THE TESTED CONFIGURATIONS.

ALTHOUGH A MINOR OPENING DEVELOPED IN THE ENCLOSURE FOR BOTH TUEC TEST 11-4 AND NEI TEST 2-3, THE INSTALLED CONFIGURATION INVOLVES CABLES IN A BOX WHICH WOULD NOT BE PRONE TO DAMAGE DUE TO FIRE FIGHTING ACTIVITIES OR FALLING EXTERNAL OBJECTS DURING FIRE CONDITIONS.

AS INSTALLED, THERE IS NO BOUNDING TEST AND THEREFORE NO FIRE RATING FOR THE STRUCTURE INTERFACE. THE PRINCIPAL ATTRIBUTE MISSING FROM THE INSTALLED CONFIGURATION IS STRESS SKIN AND TROWEL GRADE SUPPORT BETWEEN THE "PICTURE FRAME" AND CONDUIT COVERAGE PROVIDING ADDITIONAL STRUCTURAL PROTECTION AT THE INTERFACE AREA.
