Progress Energy Carolinas  
**Shearon Harris Nuclear Power Plant  
 Units 2 and 3**  
**Part 2, Final Safety Analysis Report**  
 New Hill, North Carolina

Schematic Block Diagram and  
 Map Showing Structural Relations  
 for Faults in the Site Area  
 FIGURE 2.5.1-236

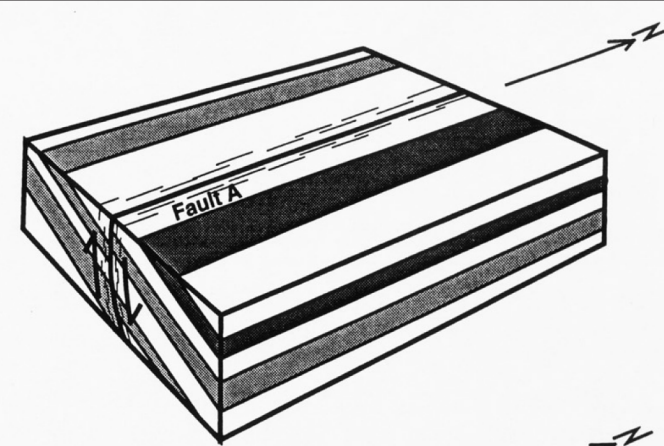
**Stage 1:**

- Longitudinal basin faulting (Fault A)
- Tilting of beds
- Formation of north-striking, opening-mode fractures.

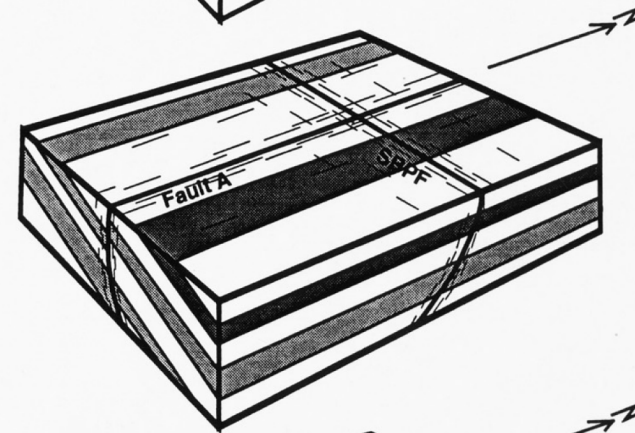
**Stage 2:**

- Transverse basin faulting
- Initial formation of south borrow pit fault (SBPF).
- East-striking, opening mode fractures

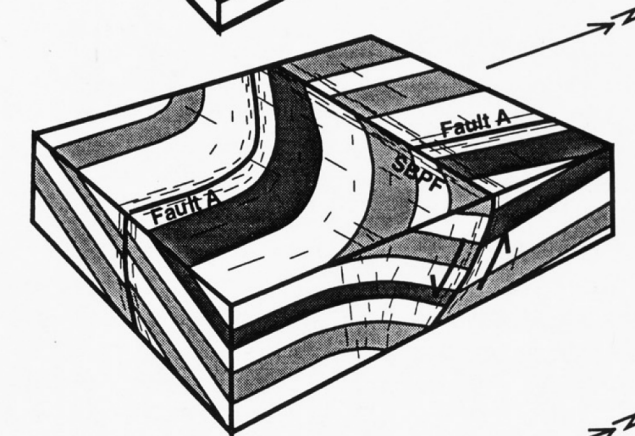
**Stage 2A:**

- Normal faulting
- Formation of map-scale, hanging wall anticline.
- East-striking, opening mode fractures.

Stages 2A and 2B may be coeval.

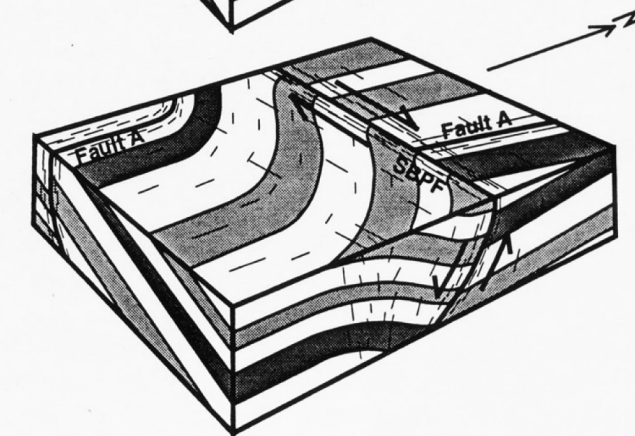
**Stage 2B:**

- Continued movement along SBPF.
- Dextral, strike-slip faulting;
- Formation of outcrop-scale, hanging wall syncline.
- East- and north-striking shearing mode fractures.

Stages 2A and 2B may be coeval.

Schematic diagram showing a possible kinematic model for the south borrow pit fault and associate structures.
