Moab UMTRA Project
Crescent Junction Disposal Cell Interim Completion Report Addendum - N

Revision 0

December 2024

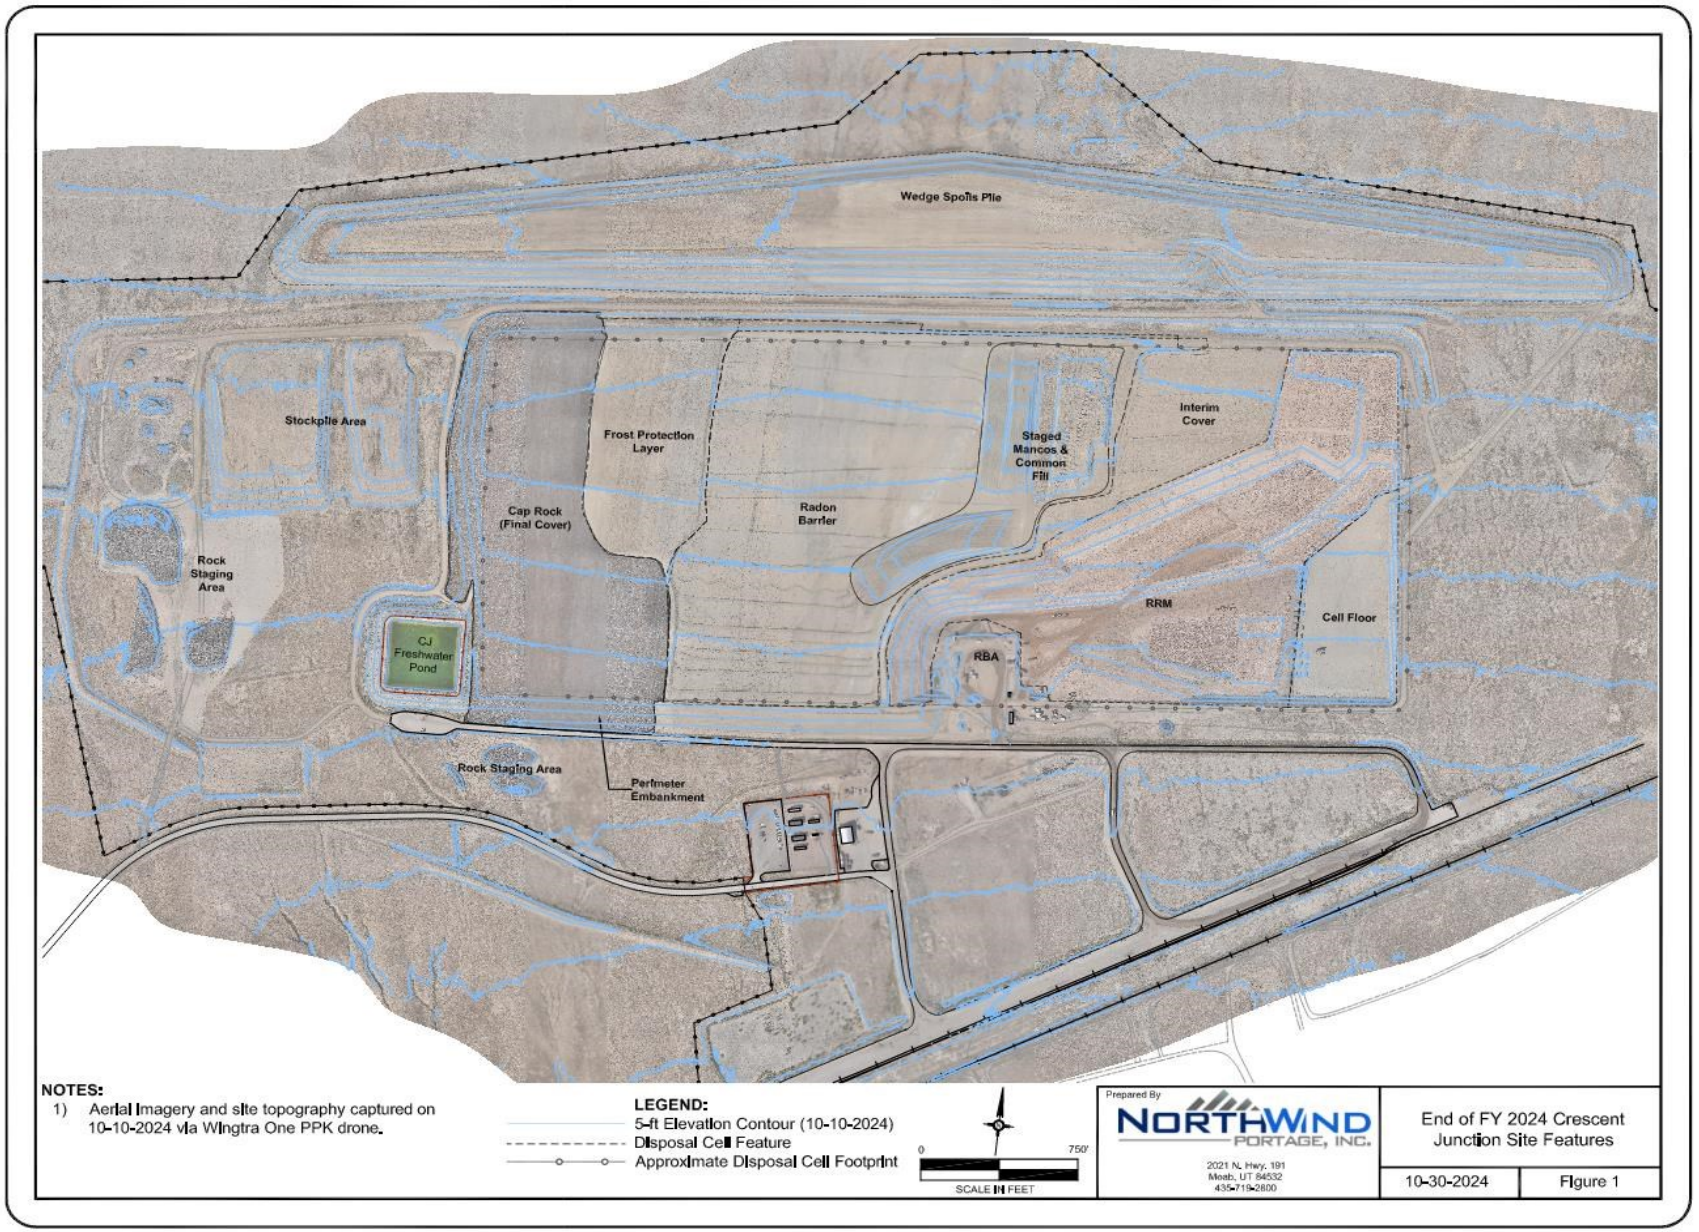
Figure 3. General Extent of Cover Layers and Cell Floor Excavation

excavation and placement of each type of material, performed in accordance with design specifications or drawings and with Addendum E of the *Remedial Action Plan* (RAP), the *Remedial Action Inspection Plan* (RAIP). The distribution survey associated with each material type is also included in this section, as appropriate. Figure 3 shows the general extent of cell cover layers as of the end of this Addendum period.

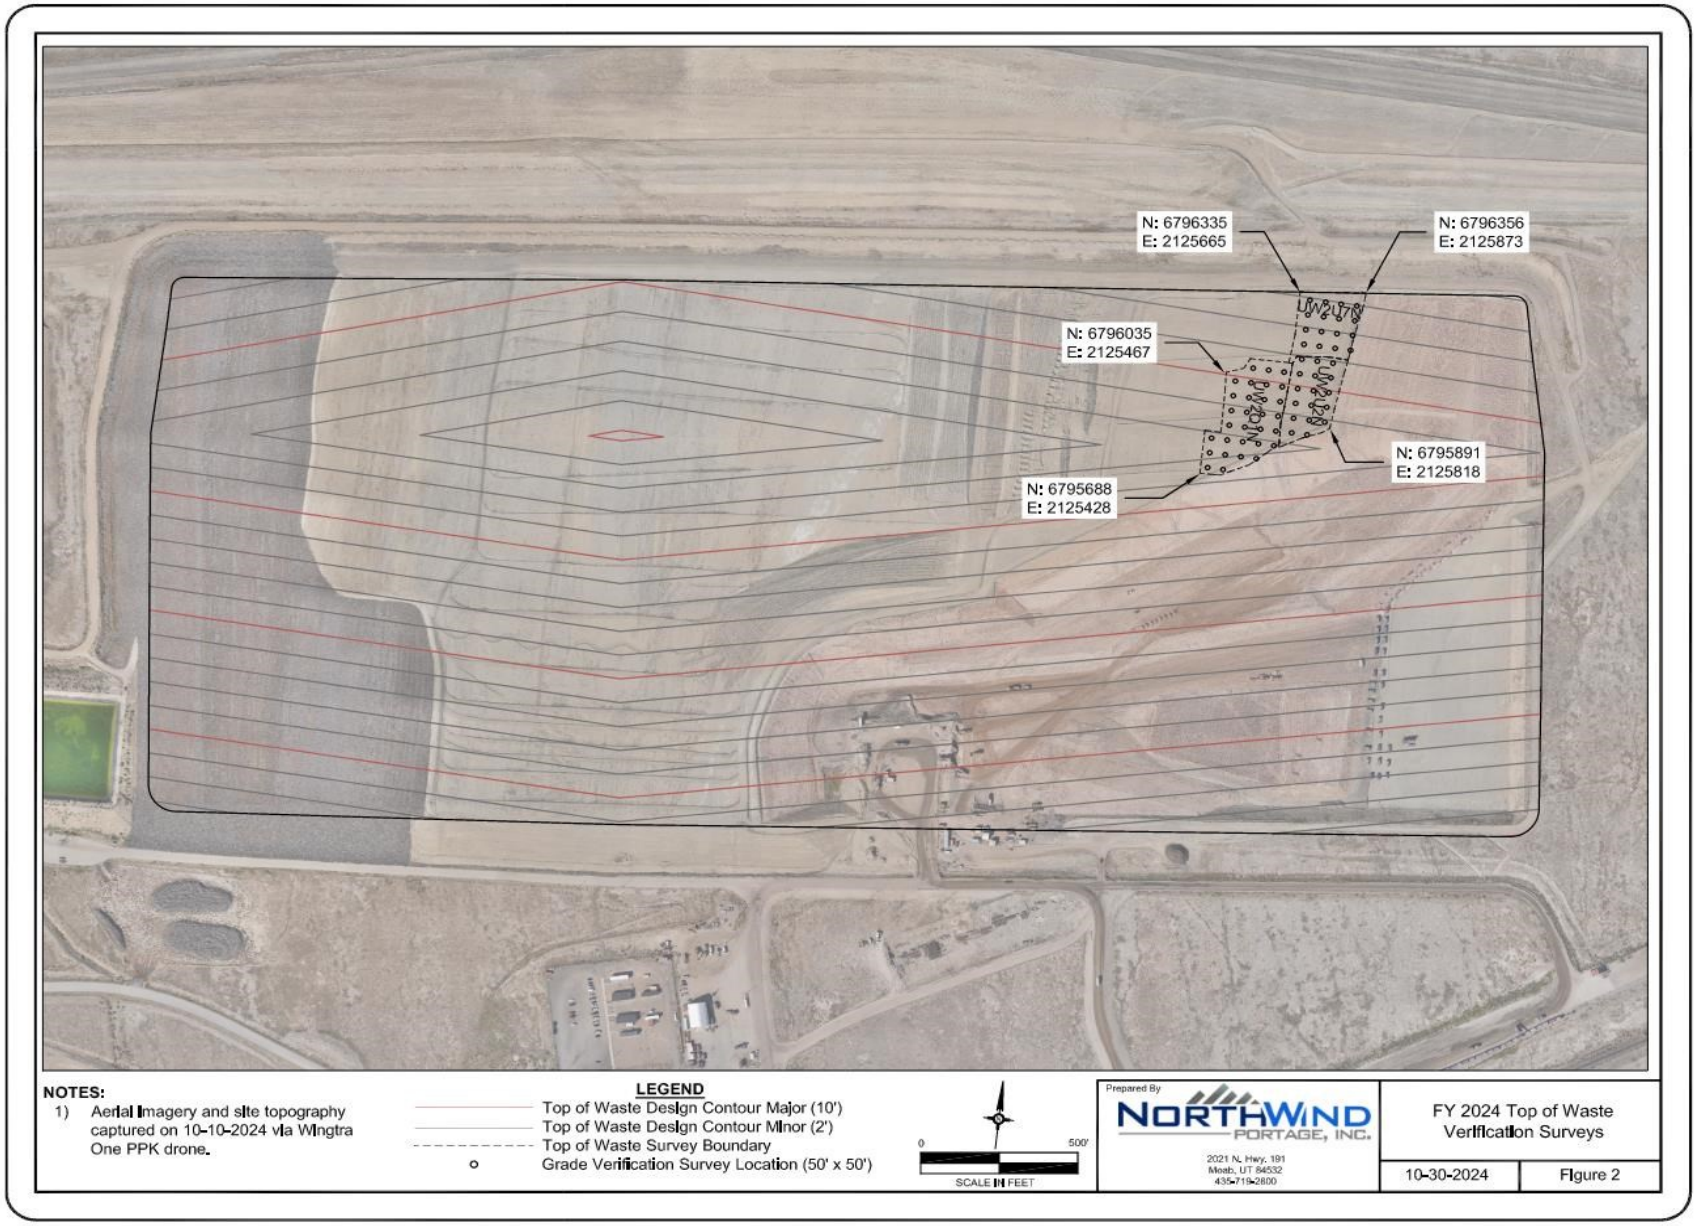
Figure 4. Distribution of Survey Points to Verify Compliance with RRM Specifications

RRM inspections and tests are shown in Table 3. The distribution of survey points is shown in Figure 4. The standard proctor test results summary, lift approval summaries, one lift approval package for RRM, and top-of-waste buyoff survey are provided in Appendix A2.

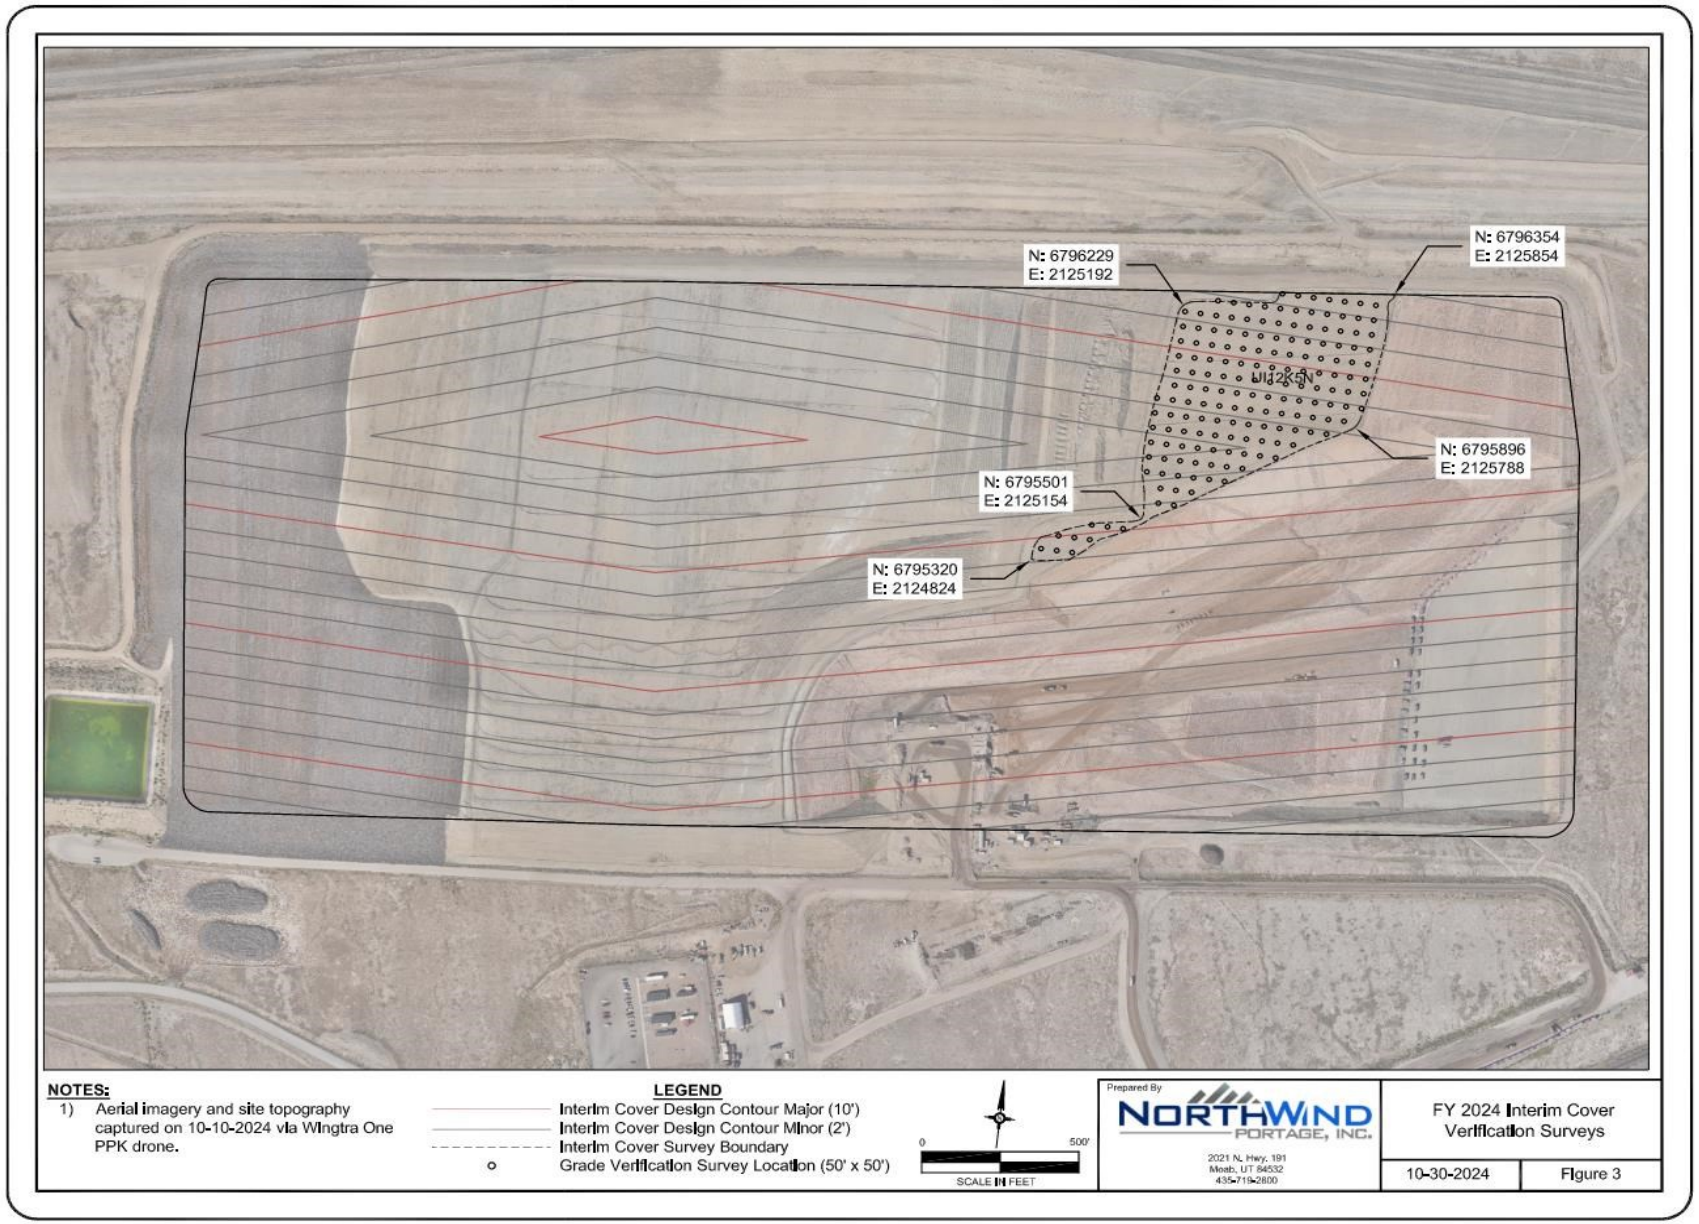
Figure 5. Distribution of Survey Points to Verify Compliance with Interim Cover Specifications

The inspection and testing for the interim cover can be found in Table 4. The distribution of survey points is shown in Figure 5. The standard proctor test results summary, lift approval summaries, one lift approval package, and buyoff surveys for the interim cover are provided in Appendix A3.

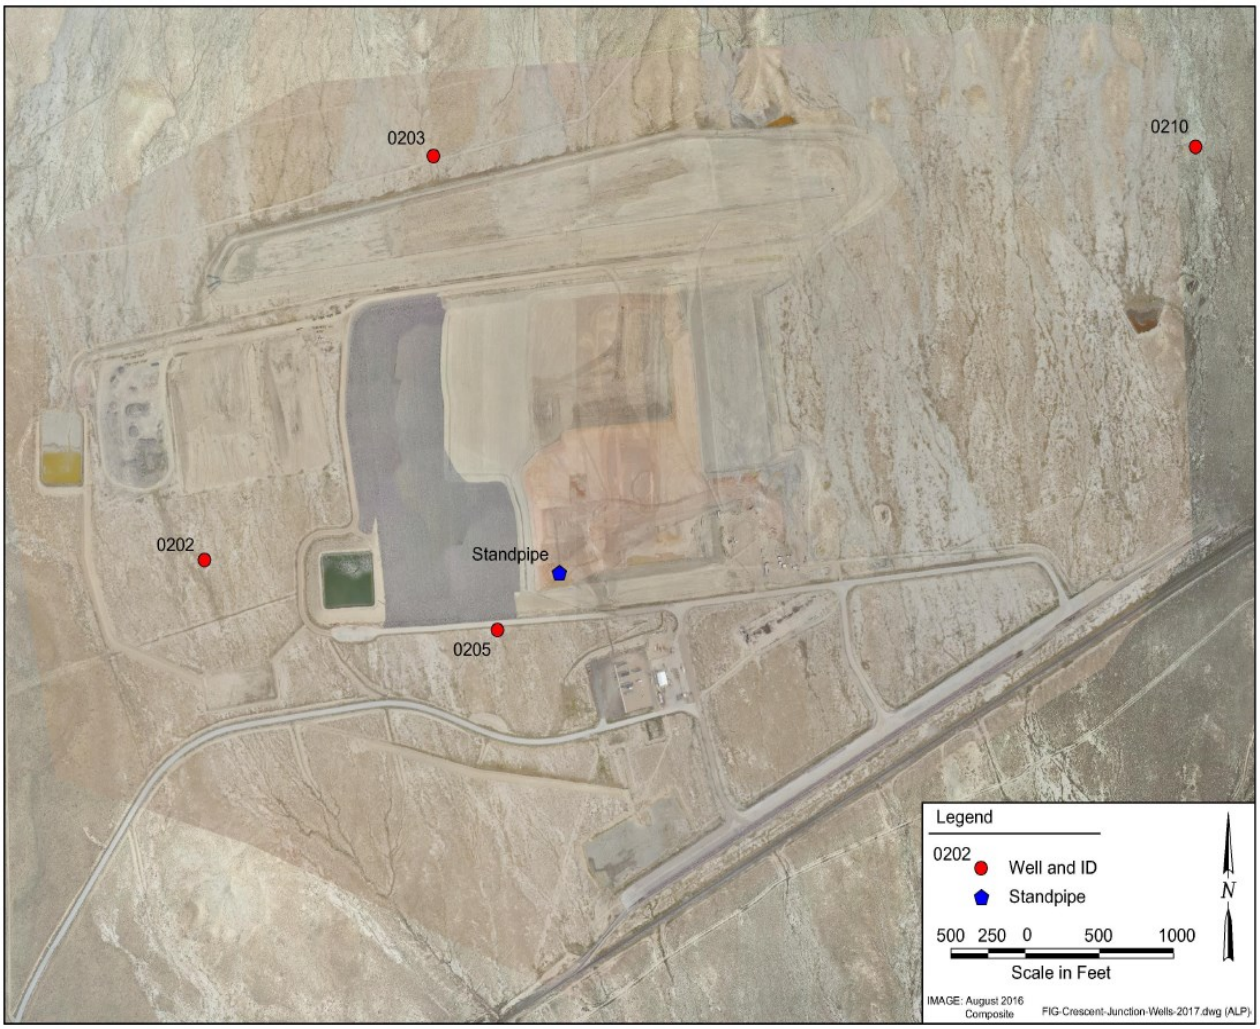
Figure 6. Locations of Monitoring Wells and Standpipe

A second standpipe was installed on May 11, 2023. Table 9 provides the results of the standpipe (locations shown on Figure 6) monitoring for the presence of free liquids in the disposal cell. During this reporting period, no water was present in the standpipe.

In addition to monitoring the standpipe, monitoring wells 0202, 0203, 0205, and 0210 (Figure 6) were also checked for the presence of groundwater. These results are presented in Table 10. Groundwater has consistently been detected in wells 0202 and 0205 since June 2019 and June 2015, respectively. Wells 0203 and 0210 were dry throughout this reporting period.

Water level, precipitation, and recovery test data along with the analytical results continue to suggest that the groundwater source is surface runoff flowing off the cover.
