4.4. Coupons

4.4.1. Pre- and Post-Test Coupon Photographs

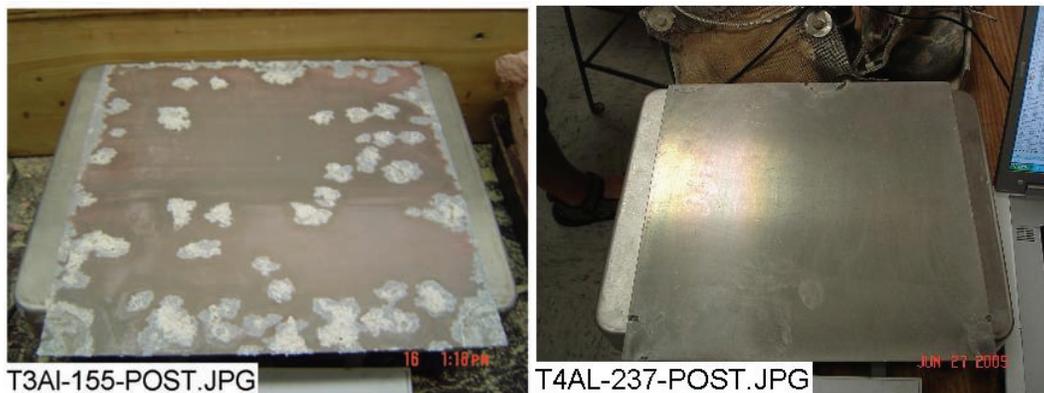
Figures 4-99 through 4-101 are pictures of submerged aluminum coupons from each test. Figure 4-102 shows an unused aluminum coupon. With the exception of Test #4, the test solution had a large effect on the aluminum coupons. Coupons in Tests #1 and #5 developed a brown coating on the surface, whereas coupons in Tests #2 and #3 accumulated white particle deposits across their surface. In addition, a copper layer was evident on the Tests #2 and #3 coupons. The layer can be attributed to electrochemical ion transfer. Tests #1 and #5 coupons had a more uniform distribution of deposit across their surface, whereas coupons in Tests #2 and #3 had more of a “blotchy” arrangement on their surfaces. The Test #4 coupon was relatively unchanged.

Figure 4-100. ICET Test#3 Al-155 submerged, post-test (left); ICET Test#4 Al-237 submerged, post-test, (right).

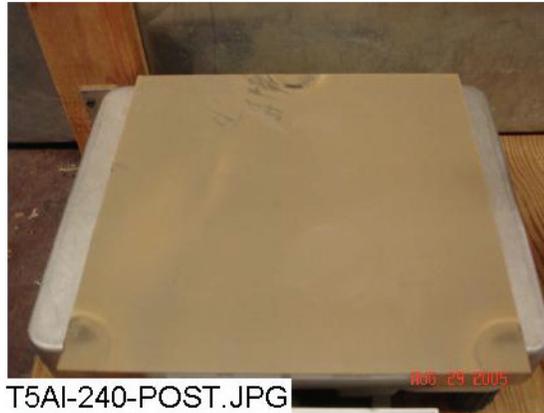
T5AI-240-POST.JPG

Figure 4-101. ICET Test #5 Al-93 submerged, post-test.

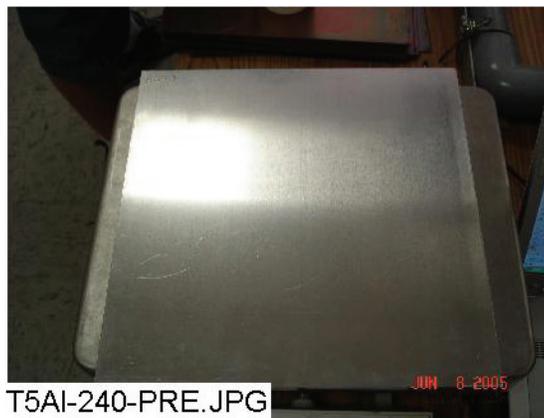
T5AI-240-PRE.JPG

Figure 4-102. Unused Al coupon.

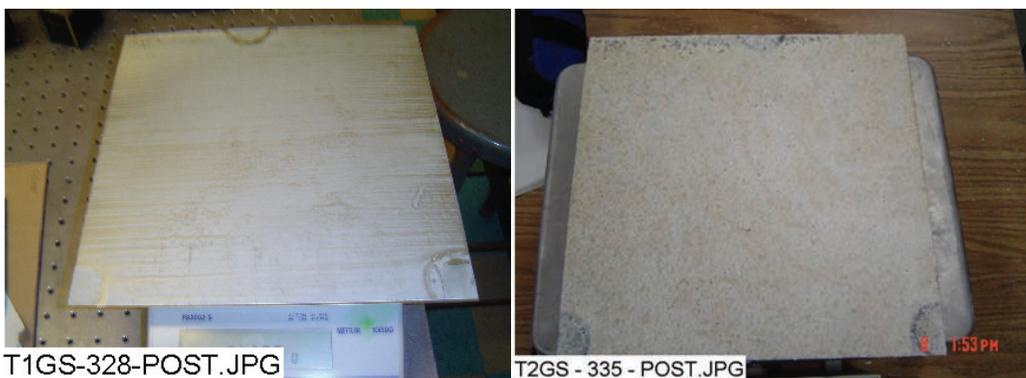
Figures 4-103 to 4-105 are pictures of submerged galvanized steel coupons from each test. Figure 4-106 shows an unused galvanized steel coupon. The galvanized steel coupons from Tests #1 and #5 appeared to have the same type of white deposit, although the deposition patterns are different. The deposits on these coupons were attached securely to the surface, although there was not a great amount of deposit. The Tests #2 and #3 coupons both accumulated a large amount of white particles on their surfaces. These particles could be rubbed off the coupon with relative ease. The Test #4 coupon appeared relatively unchanged from its pretest appearance.

Figure 4-103. ICET Test #1 GS-328 submerged, post-test (left); ICET Test #2 GS-335 submerged, post-test (right).

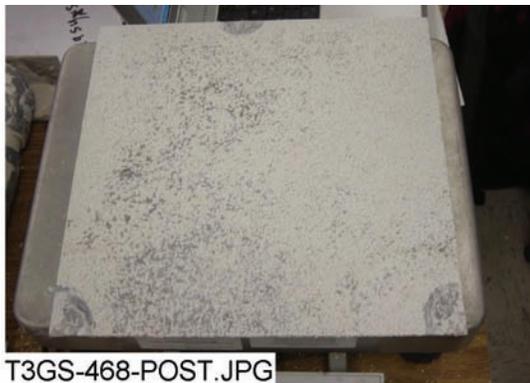
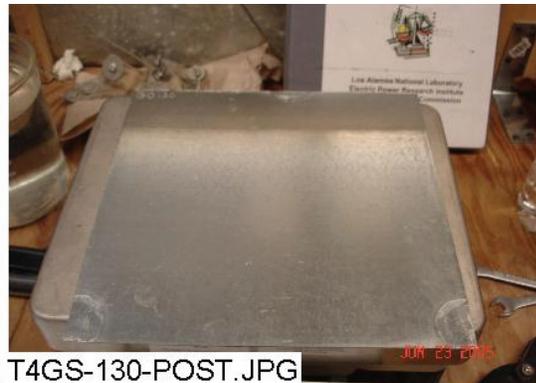
Figure 4-104. ICET Test #3 GS-468 submerged, post-test (left); ICET Test #4 GS-130 submerged, post-test (right).

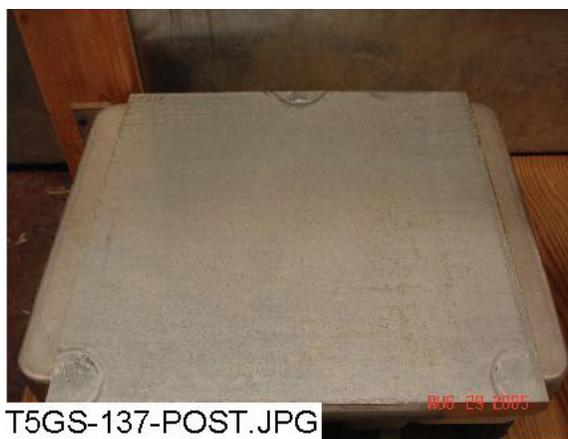
Figure 4-105. ICET Test #5 GS-332 submerged, post-test.

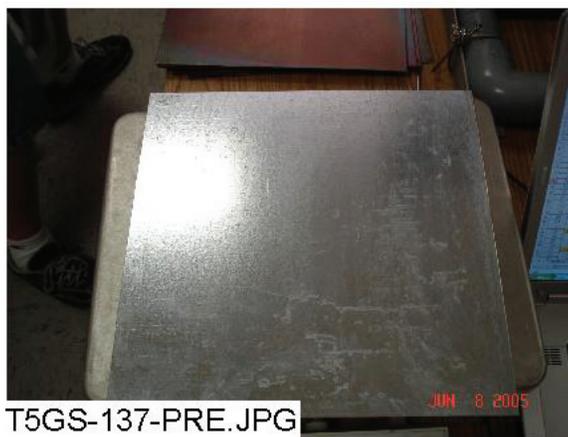
Figure 4-106. Unused GS coupon.

Figures 4-126 through 4-128 are post-test pictures of unsubmerged galvanized steel coupons from each test. Each post-test photograph depicts coupons that were loaded in Rack 3, which was in the center position of the middle tier of the tank (Figure 2-2). The concentration and pattern of deposition on the Tests #1 and #2 coupons are similar. The deposition patterns exhibited by these coupons are a combination of faint white streaks and small white clusters located in random locations. There are much fewer deposits on the Tests #3, #4, and #5 coupons. Each coupon is predominantly gray to silver, which is consistent with its original color (Figure 4-106).

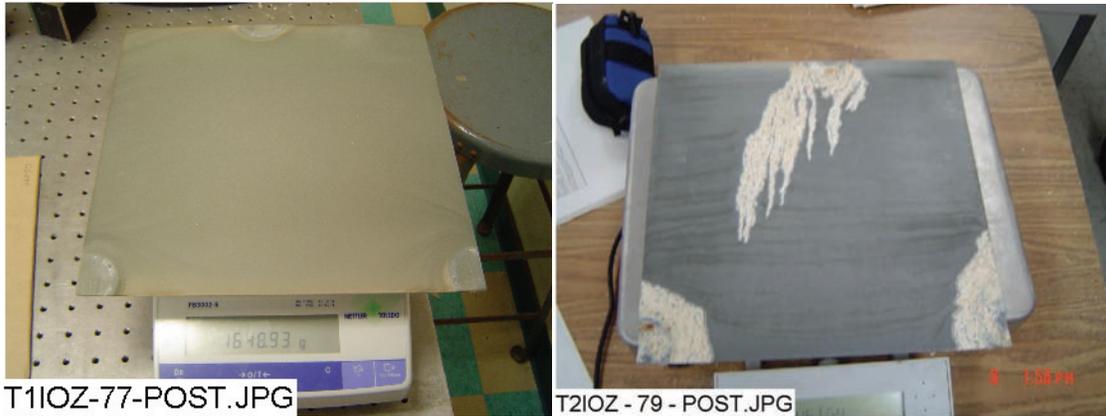
Figures 4-107 through 4-109 are pictures of submerged IOZ-coated steel coupons from each test. Figure 4-110 shows an unused IOZ-coated steel coupon. The Tests #1 and #5 coupons developed a brownish hue, with the color of Test #1 being more pronounced. The Test #2 coupon shows a relatively large amount of white deposit originating in the areas where the coupon came in contact with the rack. The Test #3 coupon had a small amount of white deposit in the areas where the coupon was in contact with the rack, as well as a small amount of white precipitate distributed across the surface of the coupon. The Test #4 coupon developed a small amount of white precipitate on the top edge of the coupon; however, it was not significantly changed from its pretest appearance.

Figure 4-107. ICET Test #1 IOZ-77 submerged, post-test (left); ICET Test #2 IOZ-79 submerged, post-test (right).

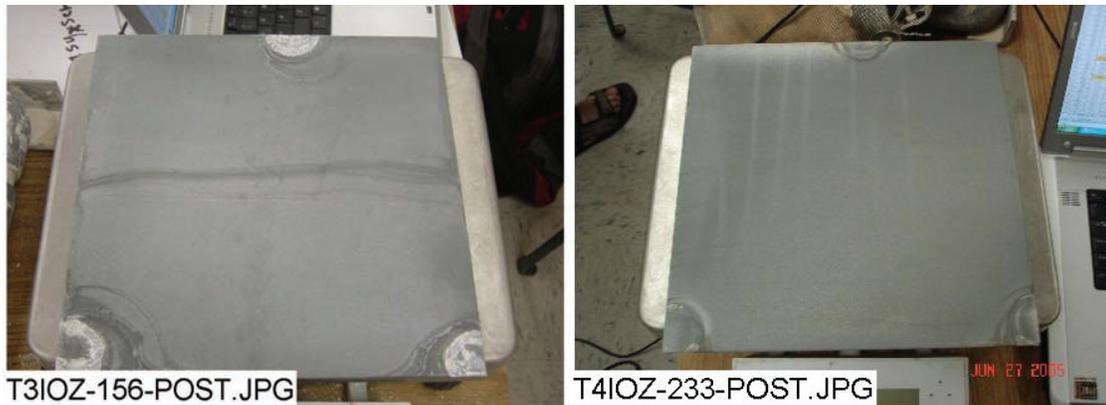
Figure 4-108. ICET Test #3 IOZ-156 submerged, post-test (left); ICET Test #4 IOZ-233 submerged, post-test (right).

gains for Tests #1, #2, #4, and #5 were similar, while the Test #3 weight gain was 45–60 g less. It is possible that water retention was impeded by the Test #3 surface coating (Figure 4-120). The mean weight gain/loss of the submerged carbon steel (uncoated steel, US) coupons did not exceed 1.5 g, with the exception of the Test #1 coupon, which lost approximately 23 g. The aluminum coupons in Tests #1 and #5 lost significant weight, about 25% and 3% of their pretest weights, respectively. There were no significant weight changes in the aluminum coupons in the other tests. The submerged galvanized steel coupons in Tests #2 and #3 experienced mean weight gains of approximately 3% and 1.5% of their pre-test values, respectively. Tests #1, #4, and #5 coupons exhibited insignificant weight changes. The mean weight gain of the submerged inorganic-zinc-coated steel coupons ranged from 1.6 to 3.8 g. The submerged copper coupons experienced mean weight differentials that did not exceed 0.5 g.

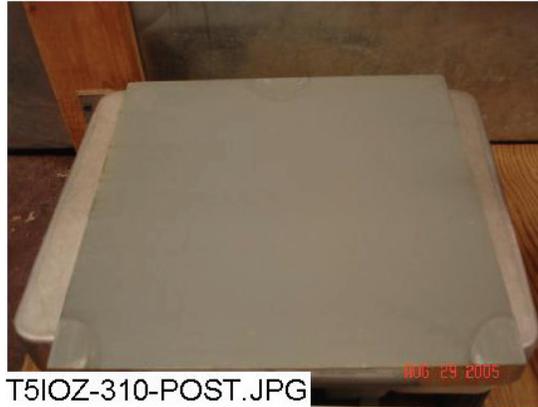
Figure 4-109. ICET Test #5 IOZ-310 submerged, post-test.

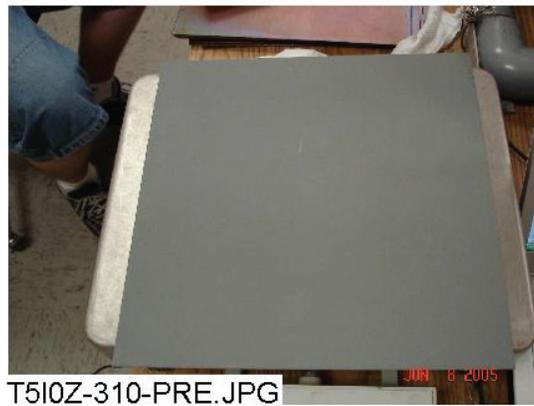
Figure 4-110. Unused IOZ-coated coupon.

Figures 4-132 through 4-134 are post-test pictures of unsubmerged inorganic zinc-coated steel coupons from each test. Each post-test photograph depicts coupons that were loaded in Rack 5, which was in the southern position of the top tier of the tank. The pattern of deposition for Tests #1, #2, #4, and #5 coupons consists of lightly-concentrated, white clusters. The Test #3 coupon depositions consist of vertical streaks that are mainly congregated near the right-hand-side coupon edge. Each coupon is predominantly dull gray, which is consistent with its original appearance (Figure 4-110).

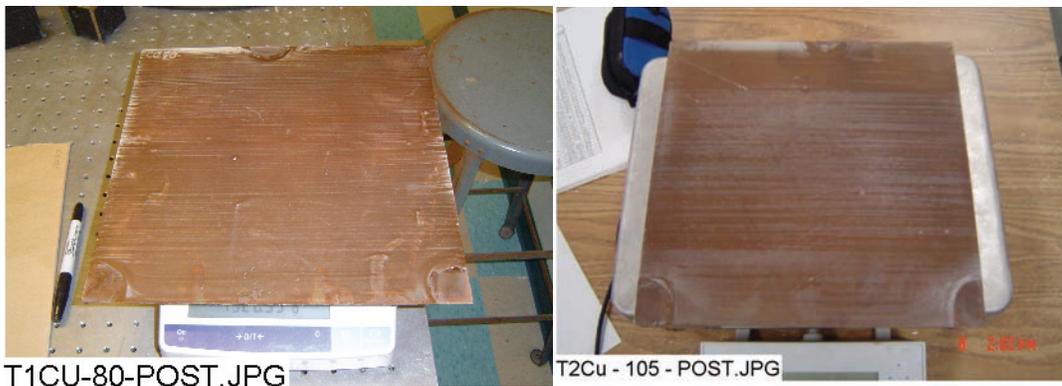
Figures 4-111 through 4-113 are pictures of submerged copper coupons from each test. Figure 4-114 shows an unused copper coupon. The coupons from Tests #1, #2, #4, and #5 have similar types of particle deposition. They all accumulated small amounts of white particles that were arranged in horizontal streaks across the coupon surface. The Test #3 copper coupon accumulated a large amount of white particles distributed across the coupon's entire surface. This deposition could be rubbed off relatively easily.

Figure 4-111. ICET Test #1 CU-80 submerged, post-test (left); ICET Test #2 CU-105 submerged, post-test (right).

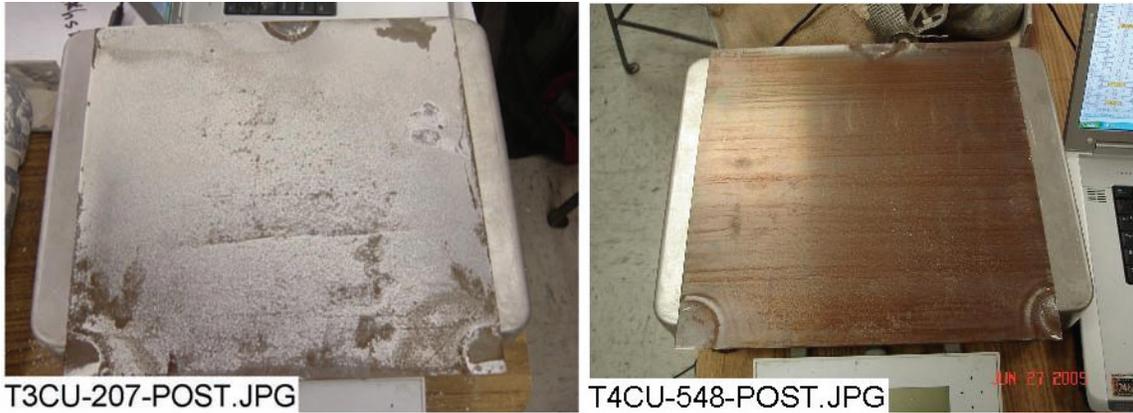
Figure 4-112. ICET Test #3 CU-207 submerged, post-test (left); ICET Test #4 CU-100 submerged, post-test (right).

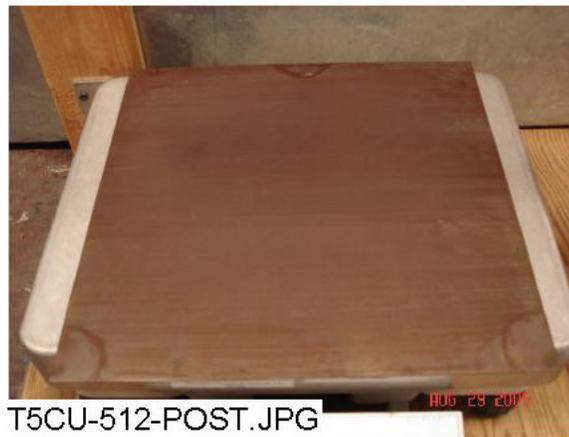
Figure 4-113. ICET Test #5 CU-100 submerged, post-test.

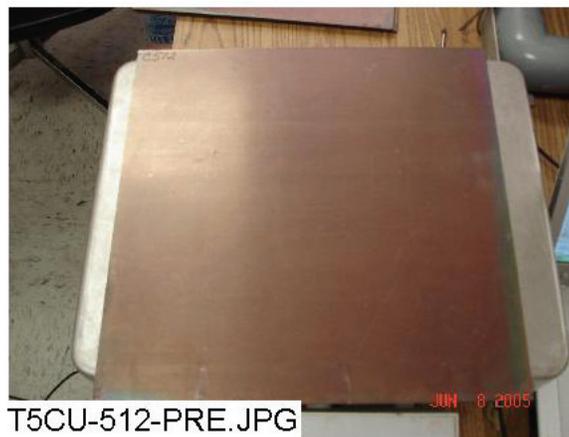
Figure 4-114. Unused CU coupon.

Figures 4-129 through 4-131 are post-test pictures of unsubmerged copper coupons from each test. Each post-test photograph depicts coupons that were loaded in rack #7, which was in the northern position of the top tier of the tank (Figure 2-2). The pattern of deposition for each coupon is similar and consists of faint white, vertical streaks. The depositions on the Tests #1 and #5 coupons are the least concentrated. The deposition concentration on the remaining coupons is similar. Each coupon is predominantly reddish-brown, which is consistent with their original color (Figure 4-114).

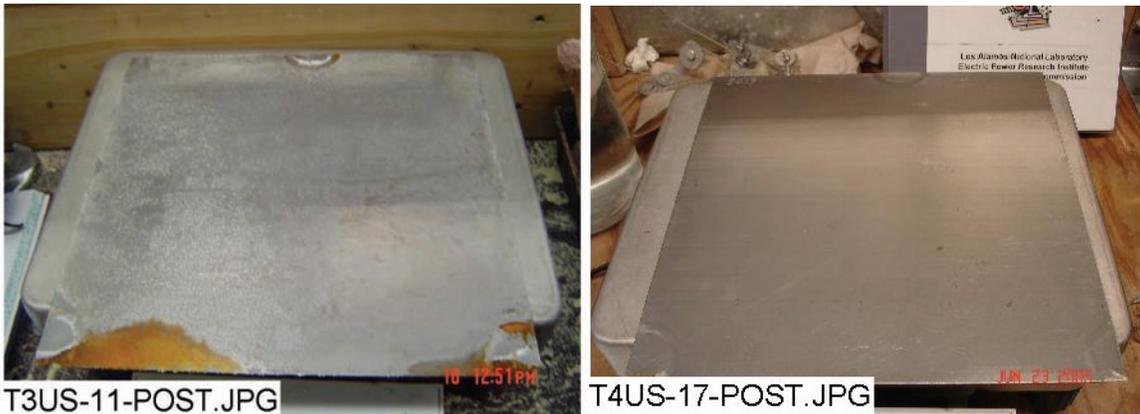
Figures 4-115 through 4-117 are pictures of submerged carbon steel (uncoated steel, US) coupons from each test. Figure 4-118 shows an unused carbon steel coupon. Tests #1 and #5 carbon steel coupons both accumulated a small amount of white particles on their surfaces. This

accumulation caused the surfaces to develop a dull, sandy finish. The Test #2 coupon developed a large amount of yellowish corrosion product on its surface, and its surface was roughened. The Test #3 coupon accumulated some white particles, distributed evenly over the surface of the coupon. Some yellowish corrosion also developed on the bottom edge of the coupon. The Test #4 coupon was largely unchanged from its pre-test condition.

Figure 4-116. ICET Test #3 US-11 submerged, post-test (left); ICET Test #4 US-17 submerged, post-test (right).

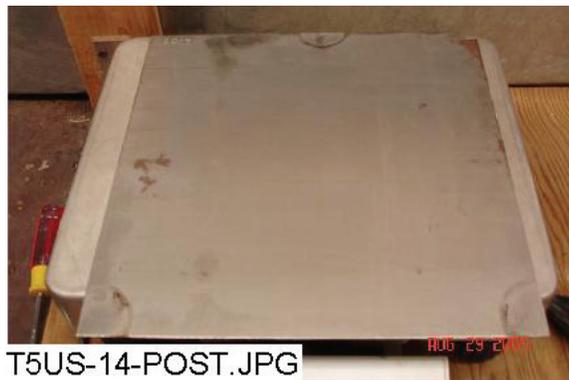
Figure 4-117. ICET Test #5 US-14 submerged, post-test.

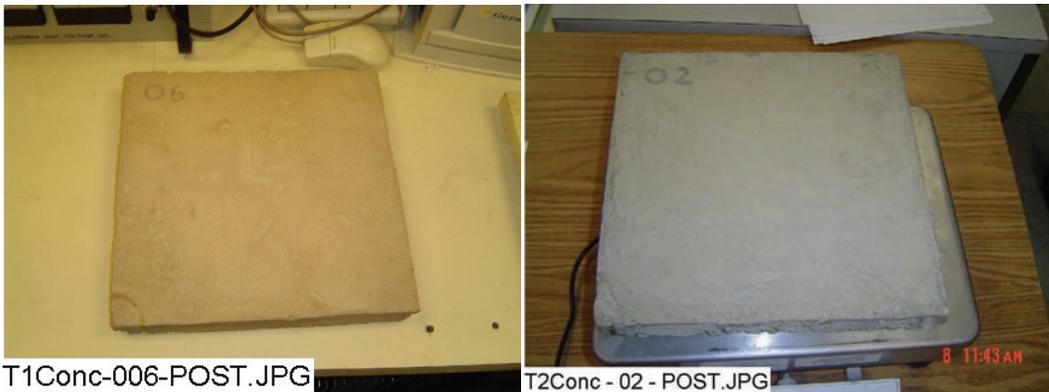
Figures 4-119 through 4-121 are pictures of submerged concrete coupons from each test. Figure 4-122 shows an unused concrete coupon. Concrete coupons from Tests #1, #4, and #5 all developed a brownish color, with the coupons from Tests #1 and #5 having a deeper color change. The Test #2 coupon was relatively unchanged. The Test #3 coupon accumulated a large amount of white particles that were distributed evenly over the surface of the coupon.

Figure 4-119. ICET Test #1 Conc-6 submerged, post-test (left); ICET Test #2 Conc-2 submerged, post-test (right).

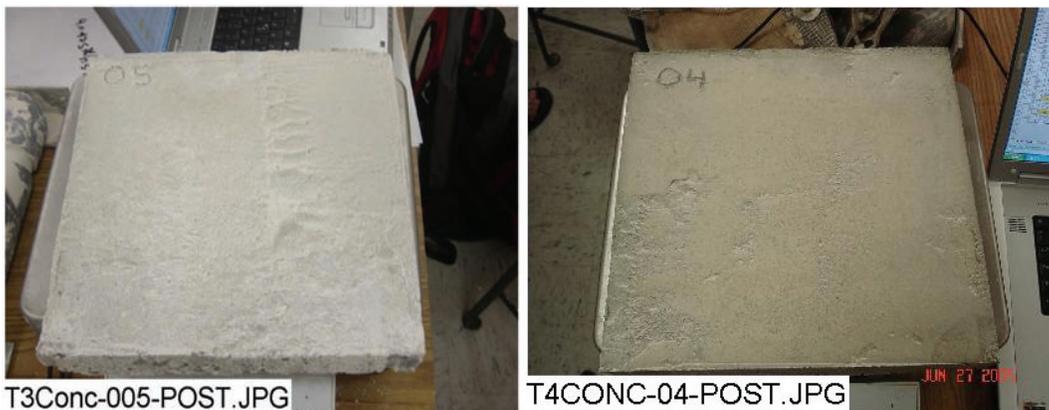
Figure 4-120. ICET Test #3 Conc-5 submerged, post-test (left); ICET Test #4 Conc-4 submerged, post-test (right).

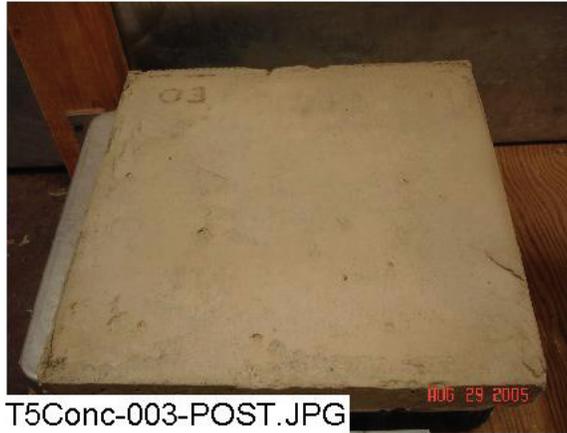
Figure 4-121. ICET Test #5 Conc-003 submerged, post-test.

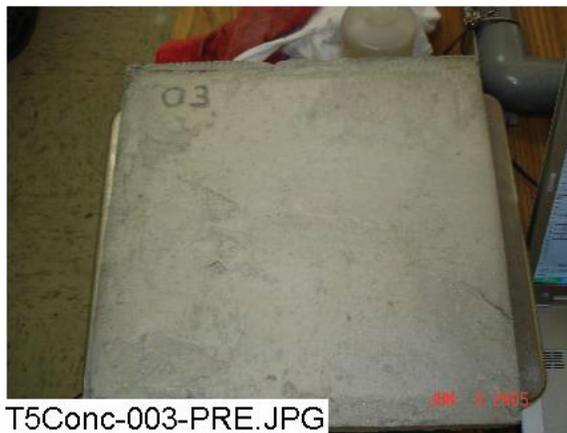
Figure 4-122. Unused concrete coupon.

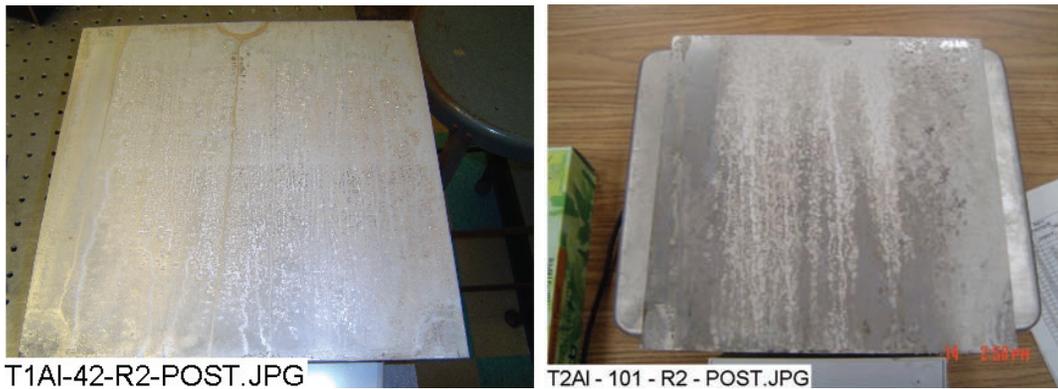
Figures 4-123 through 4-125 are post-test pictures of unsubmerged aluminum coupons from each test. Each post-test photograph depicts coupons that were loaded in Rack 2 (see Figure 2-2), which was in the southern position of the middle tier of the tank. Using the same rack location facilitates direct comparison of aluminum coupons from each test. Each post-test aluminum coupon exhibits a similar vertical, streak pattern of white deposits. The deposit concentration was also similar for all of the displayed coupons. Each coupon is predominantly dull gray, with a tint of reddish-brown visible on the coupons from Tests #1, #4, and #5.

Figure 4-123. Test #1 Al-42 unsubmerged (left); Test #2 Al-101 unsubmerged (right).

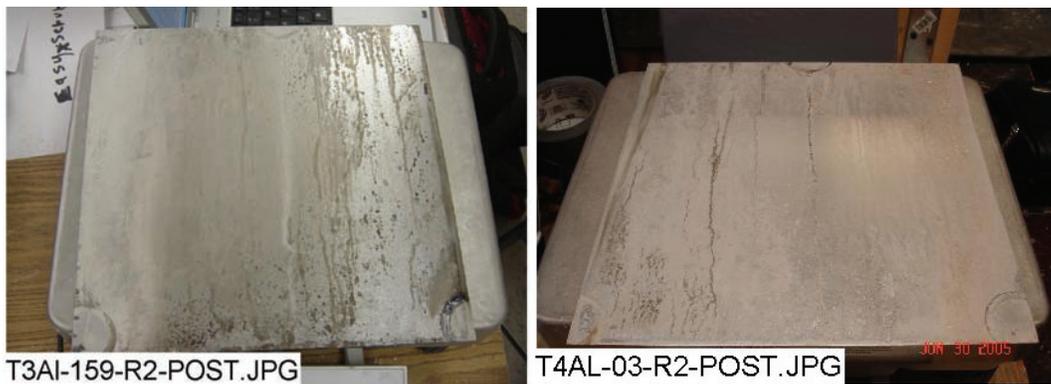
Figure 4-124. Test #3 Al-159 unsubmerged (left); Test #4 Al-3 unsubmerged (right).

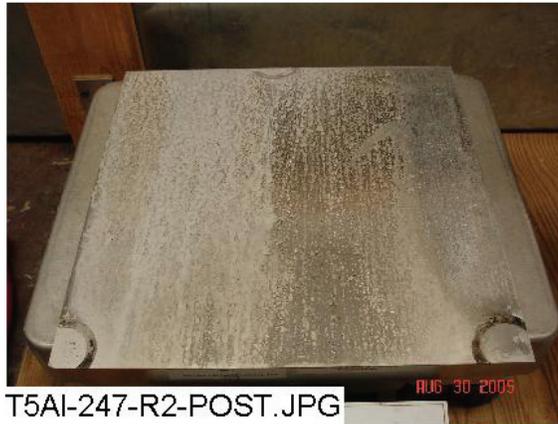
Figure 4-125. Test #5 Al-247 unsubmerged.

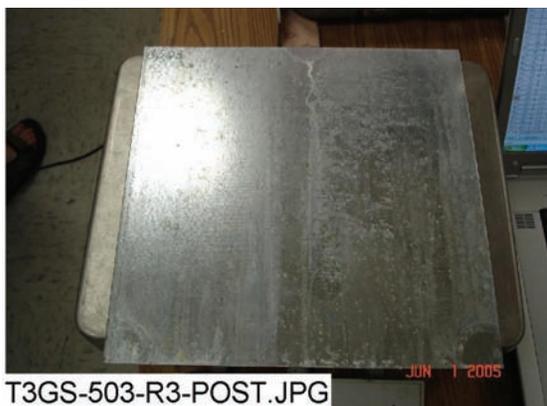
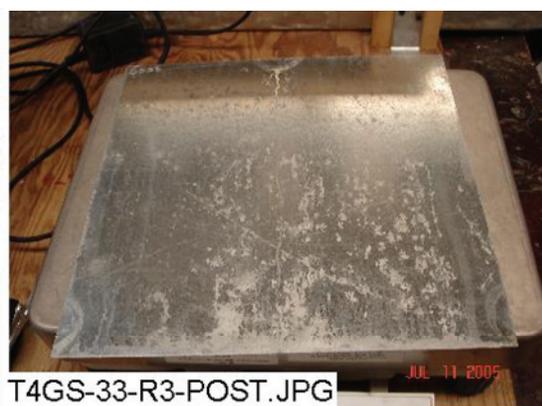
Figure 4-127. Test #3 GS-503 unsubmerged (left); Test #4 GS-33 unsubmerged (right).

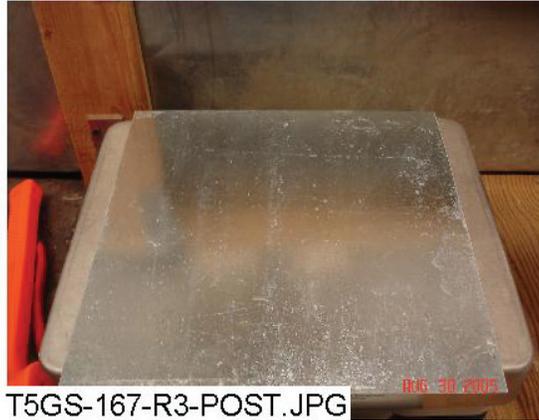
T5GS-167-R3-POST.JPG

Figure 4-128. Test #5 GS-167 unsubmerged.

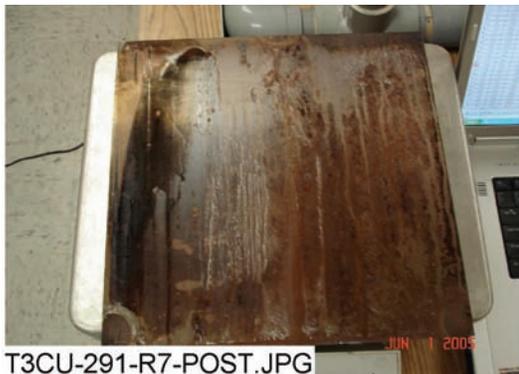
Figure 4-130. Test #3 CU-291 unsubmerged (left); Test #4 CU-584 unsubmerged (right).

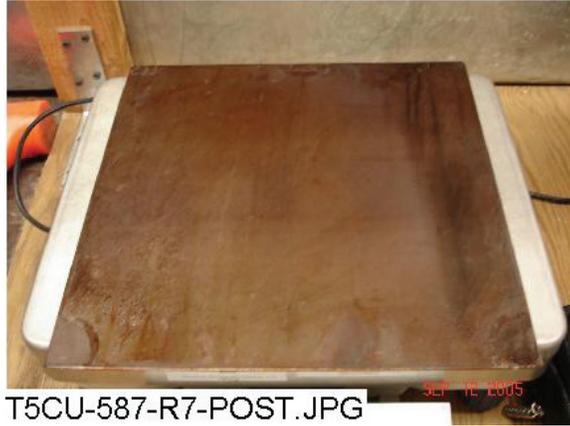
Figure 4-131. Test #5 CU-587 unsubmerged.

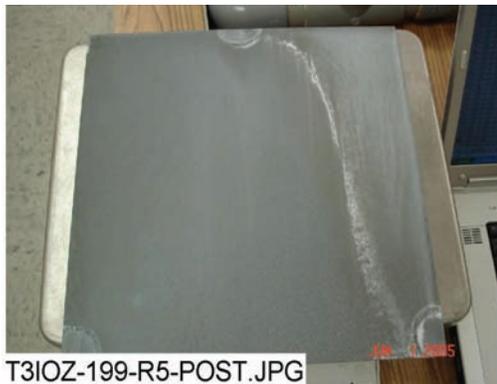
Figure 4-133. Test #3 IOZ-199 unsubmerged (left); Test #4 IOZ-275 unsubmerged (right).

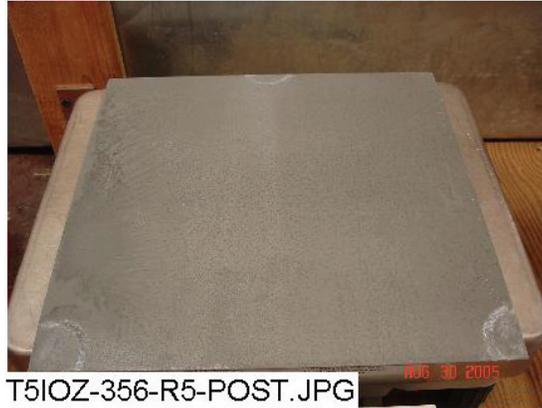
Figure 4-134. Test #5 IOZ-356 unsubmerged.

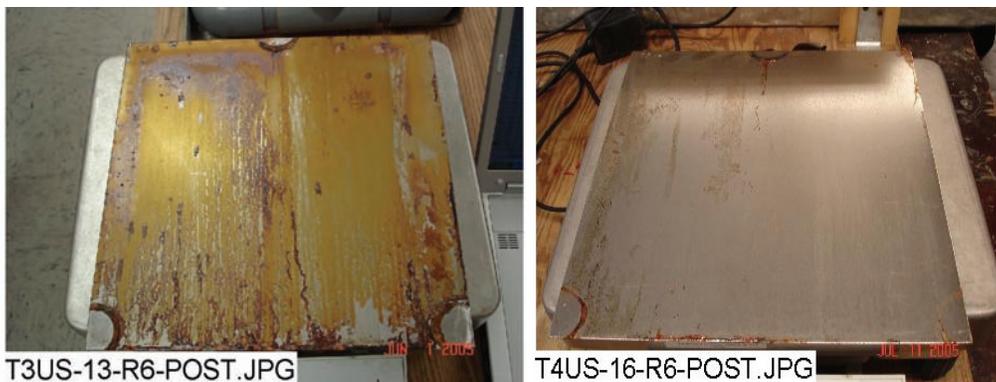
Figures 4-135 through 4-137 are post-test pictures of unsubmerged uncoated carbon steel coupons from each test. Each post-test photograph depicts coupons that were loaded in Rack 6, which was in the center of the top tier of the tank (Figure 2-2). The deposits for each coupon consist of reddish-brown rust. However, the concentration of rust varies between tests. The concentration of the Tests #2 and #3 coupons is significant and covers nearly the entire surface of each coupon. The coupons from Tests #1, #4, and #5 exhibit sparsely concentrated, rust-like splotches. Each coupon is predominantly dull silver, close to its original color (Figure 4-118).

Figure 4-136. Test #3 US-13 unsubmerged (left); Test #4 US-16 unsubmerged (right).

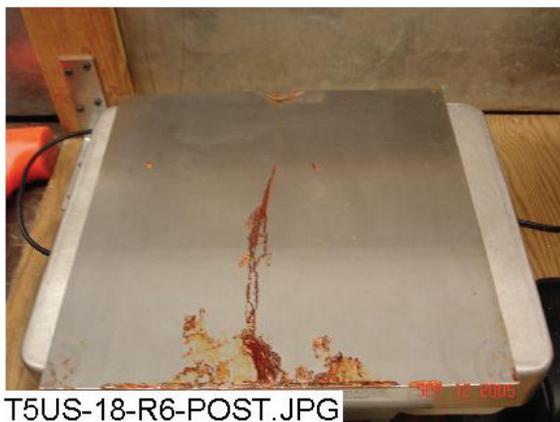
Figure 4-137. ICET Test #5 US-18 unsubmerged.

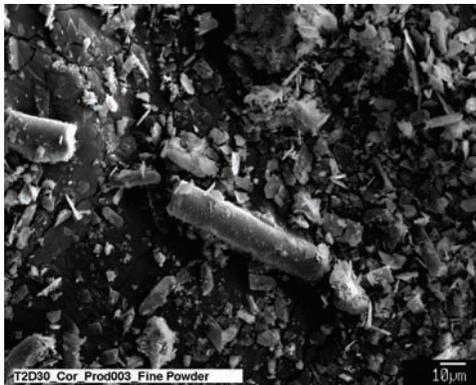
Figure 4-172. SEM image at 650× magnification of a Test #2, Day 30, sample of fine powder on a vertical piece of the submerged PVC rack. (T2D30_Cor_Prod003_Fine Powder)

Figures 4-172 and 4-173 show the SEM images of the deposition products collected from a vertical section of the submerged CPVC rack. In Figure 4-172, the cylindrical debris appears to be fiberglass, which mixed with other corrosion/precipitation products and debris. EDS results from Figure 4-174 indicate that the deposition products shown in Figure 4-173 were composed mainly of oxygen, phosphorus, magnesium, and carbon, with small amounts of aluminum, silicon, calcium, and sodium. Because TSP was used in Test #2, a precipitate of phosphate salts such as magnesium phosphate may have deposited on the submerged CPVC rack, in addition to other carbonate and metallic salts precipitates.

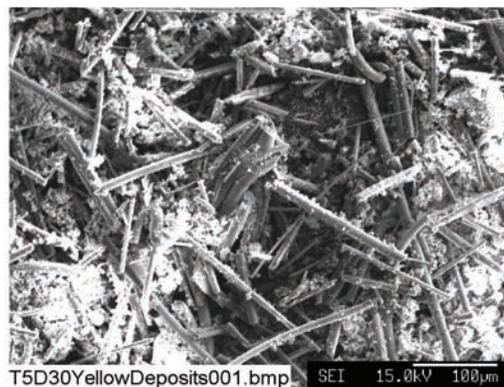
Figure 4-181. SEM image, magnified 100 times, of the Test #5 Day 30, fine yellow powder on the submerged rack. (T5D30YellowDeposits001.bmp)

The deposition products collected upon completion of Test #5 were fine yellow powders that had deposited on a horizontal piece of the submerged CPVC rack. The SEM images of the deposition products are shown in Figures 4-181 and 4-182. From the figures, the deposition products were composed mainly of fiberglass debris and other substances. (Note that cal-sil was used only in Tests #3 and #4). The yellow color of the deposition products is consistent with the color of the fiberglass used in the test. Figure 4-183 shows the EDS spectrum of a particle as labeled in Figure 4-182, which was composed of carbon and oxygen, with smaller amounts of aluminum, silicon, sodium, calcium, and magnesium, as summarized in Table 4-14. As a result, the substance was likely a carbonate precipitate.

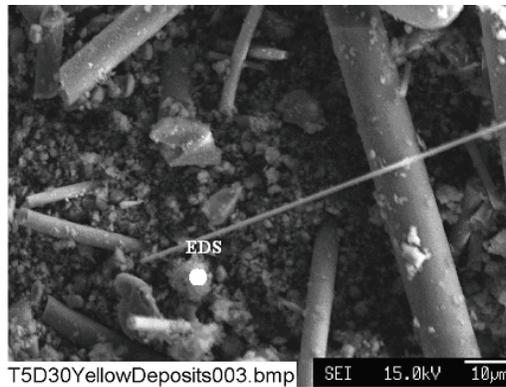
Figure 4-182. Annotated SEM image, magnified 1000 times, for the Test #5, Day 30, fine yellow powder on the submerged rack. (T5D30YellowDeposits003.bmp)

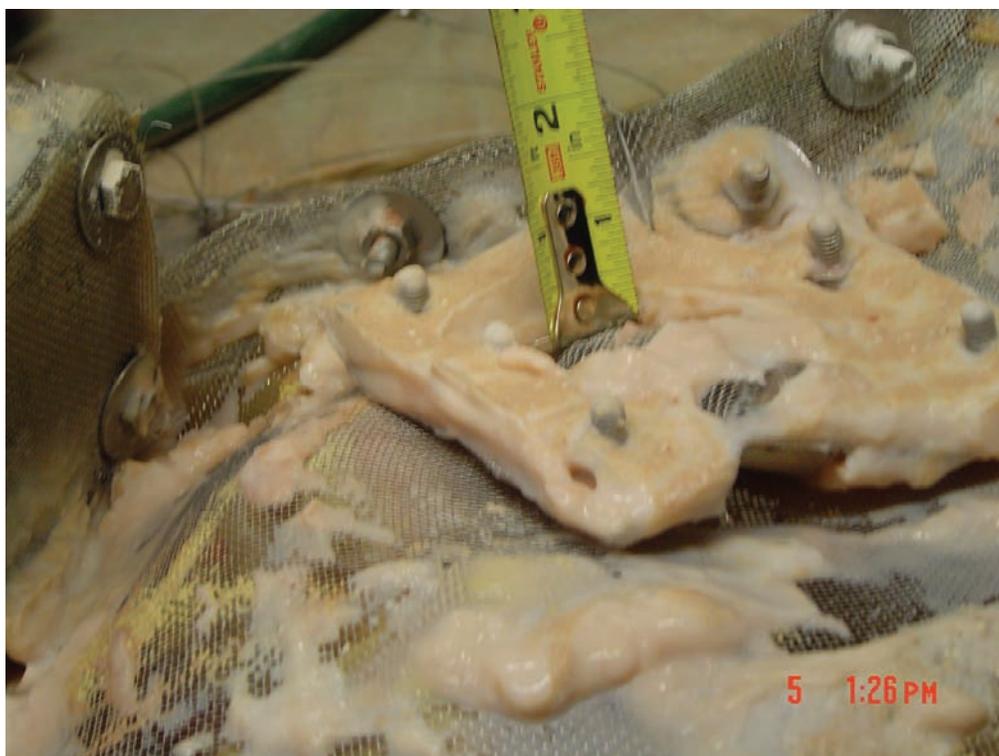
Figure 4-184. Stainless steel mesh covered with gel-like material.

There were two unique observations from ICET Test #3. First, a significant amount of white gel-like precipitates were observed in the test solution for several hours on the first day of the test during and after the injection of TSP. Looking through the tank's submerged view window, the test solution appeared to be nearly saturated with these precipitates that were moving robustly in a circular pattern. Second, when the test was completed, deposits of pinkish-white gel-like material were found on the top of the sediment and on other objects on the tank bottom. This material covered the majority of objects on the tank bottom including the birdcage, but it was not a continuous covering. Figures 4-184 and 4-185 are photographs of the gel-like material.

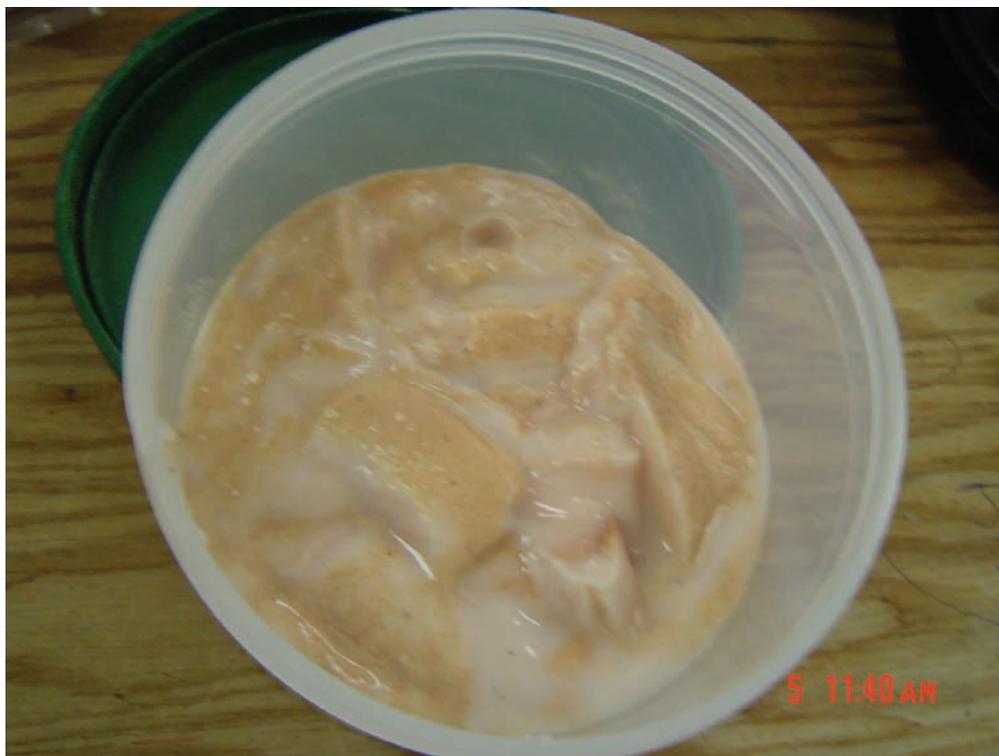
Figure 4-185. Gel-like material recovered from the bottom of the tank.
