### **1.5-MHZ PHASED-ARRAY DATA ON FLAWS IN THE PRESSURIZER SURGE LINE SPECIMEN**

An Evaluation of Ultrasonic Phased Array Testing for Cast Austenitic Stainless Steel Pressurizer Surge Line Piping Welds

Confirmatory research is being conducted for the U.S. NRC at PNNL to assess effectiveness and reliability of advanced NDE methods for the inspection of primary system pressure boundary components/materials in LWRs. The work reported here provides a technical evaluation to assess the capabilities of phased-array ultrasonic testing methods as applied to the inspection of welds in CASS pressurizer (PZR) surge line piping. A set of thermal fatigue cracks (TFCs) were implanted into CASS PZR surge-line specimens salvaged from cancelled NPPs that were fabricated of vintage materials formed in the 1970s. Flaw responses from these cracks were used to evaluate detection and sizing performance of the PA-UT methods applied. The results reported here show that longitudinal mode, transmit-receive matrix phased-array probes, over the applied frequency range, provides effective sound fields for detection and characterization of TFCs in CASS PZR surge line components. PA-UT results were compared a

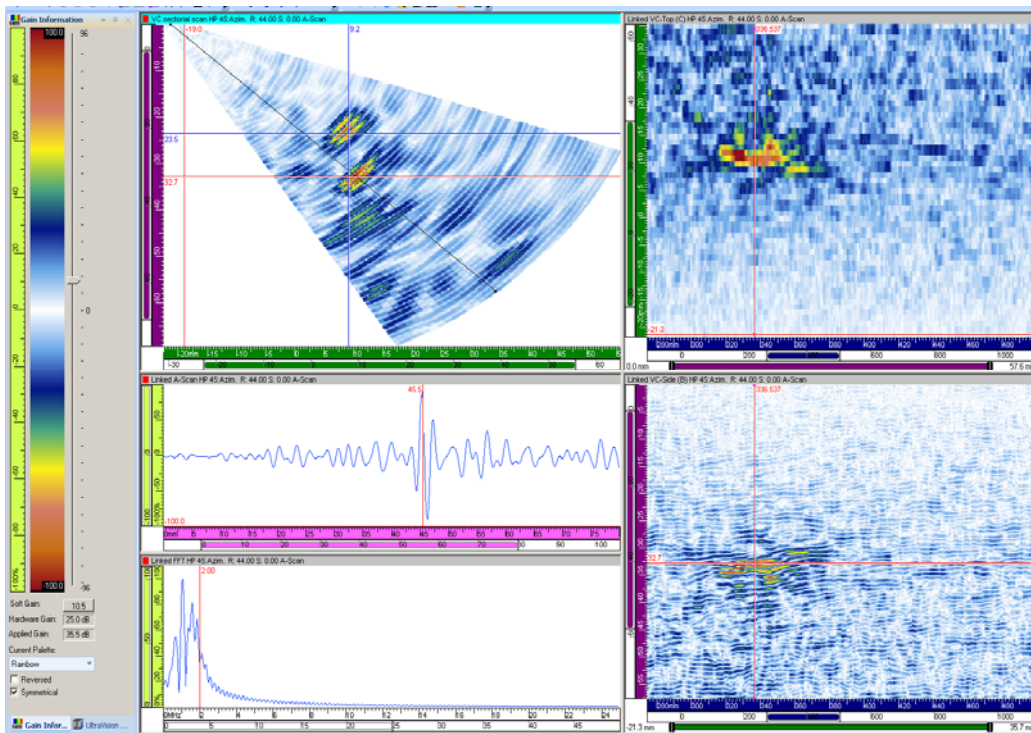
Figure C.7 1.5 MHz Data on Pipe Side of 7C-059, Flaw 2, for Depth Sizing

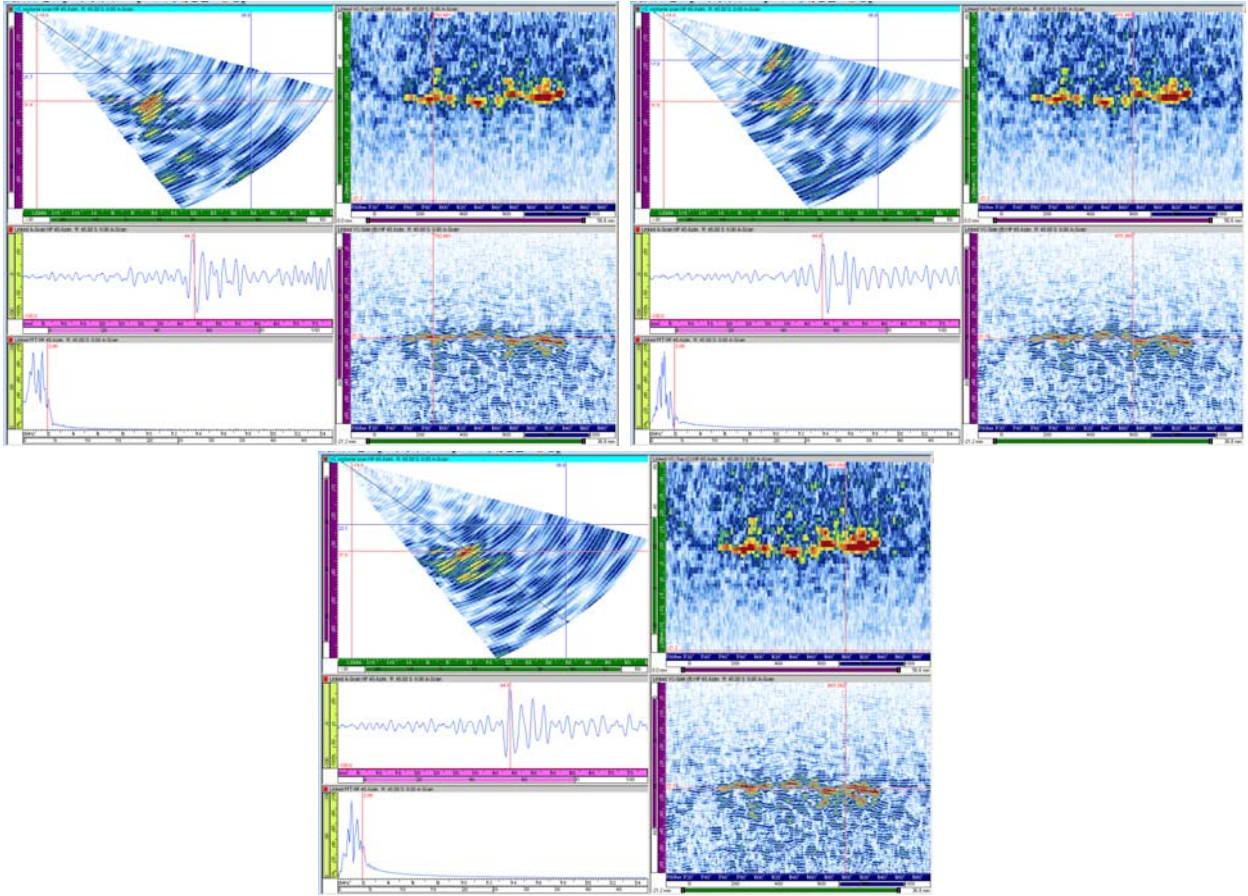
**Figure C.15 1.5 MHz Data on Pipe Side of 7C-059, Flaw 4a, 4b, and 4c, for Depth Sizing**

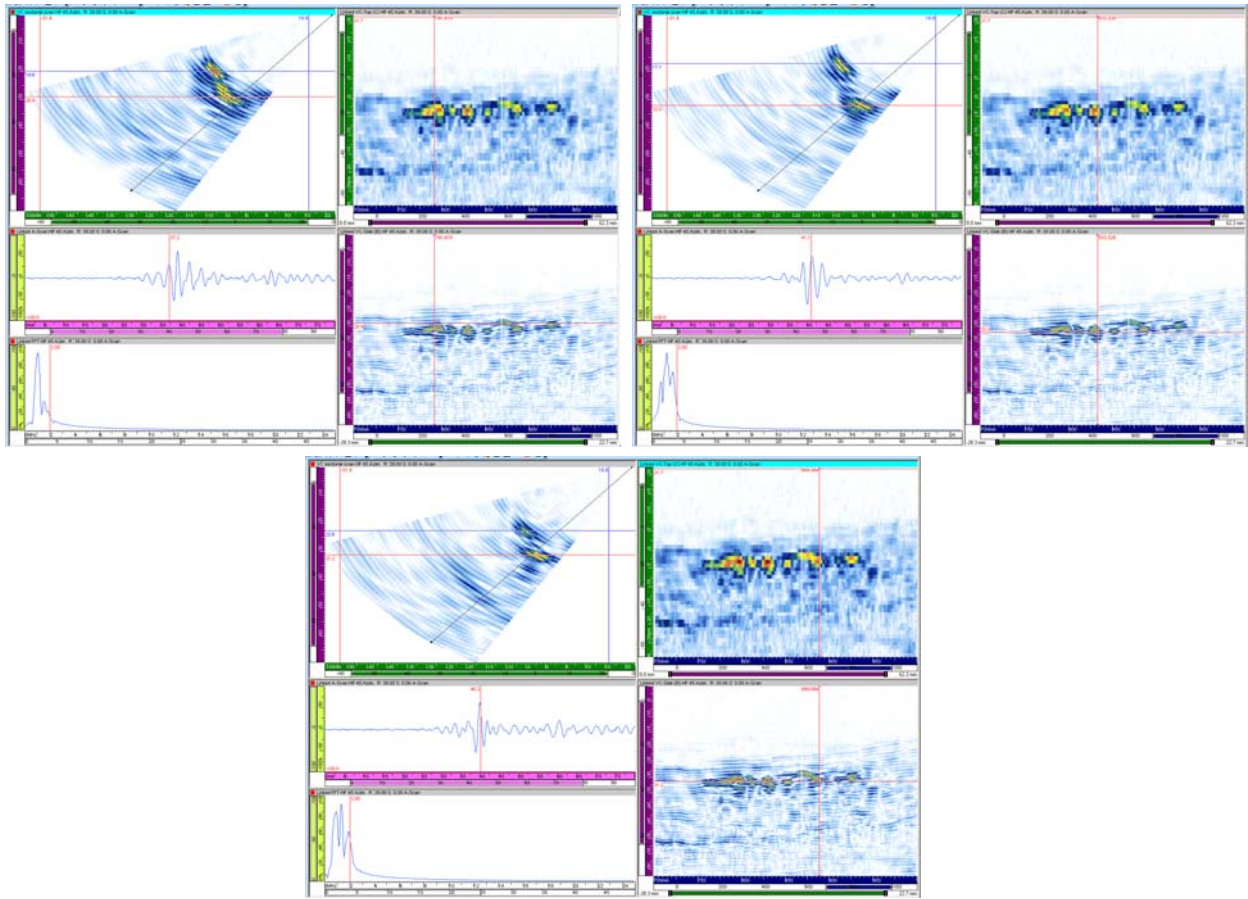
**Figure C.16 1.5 MHz Data on Elbow Side of 7C-059, Flaw 4a, 4b, and 4c, for Depth Sizing**

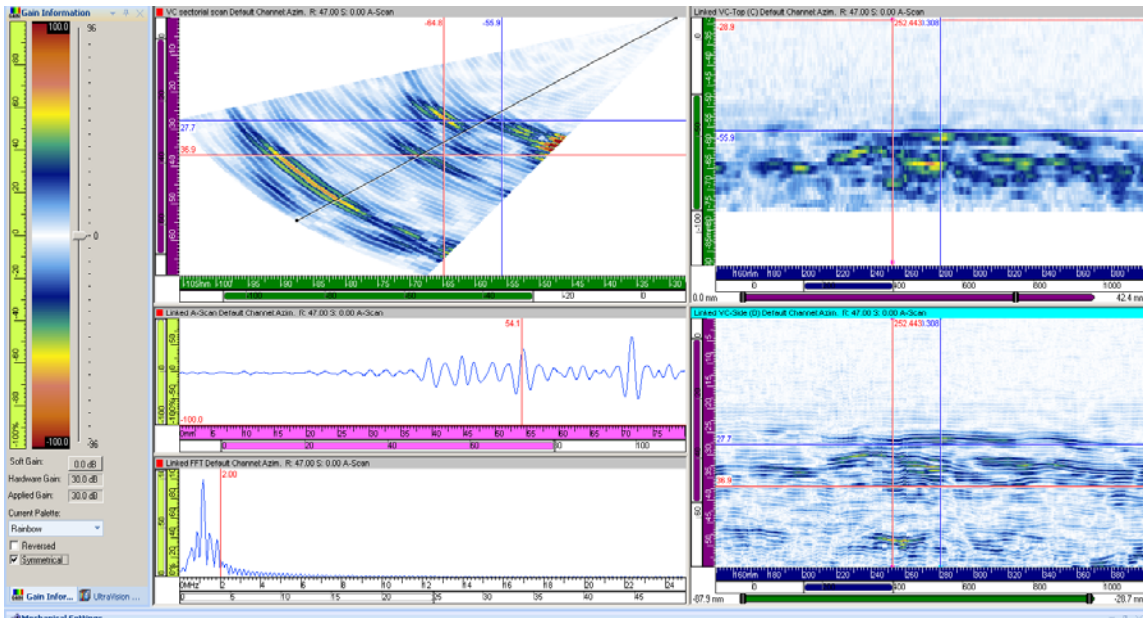
Figure C.24 1.5 MHz Data on Elbow Side of 9C-001, Flaw 2, for Depth Sizing

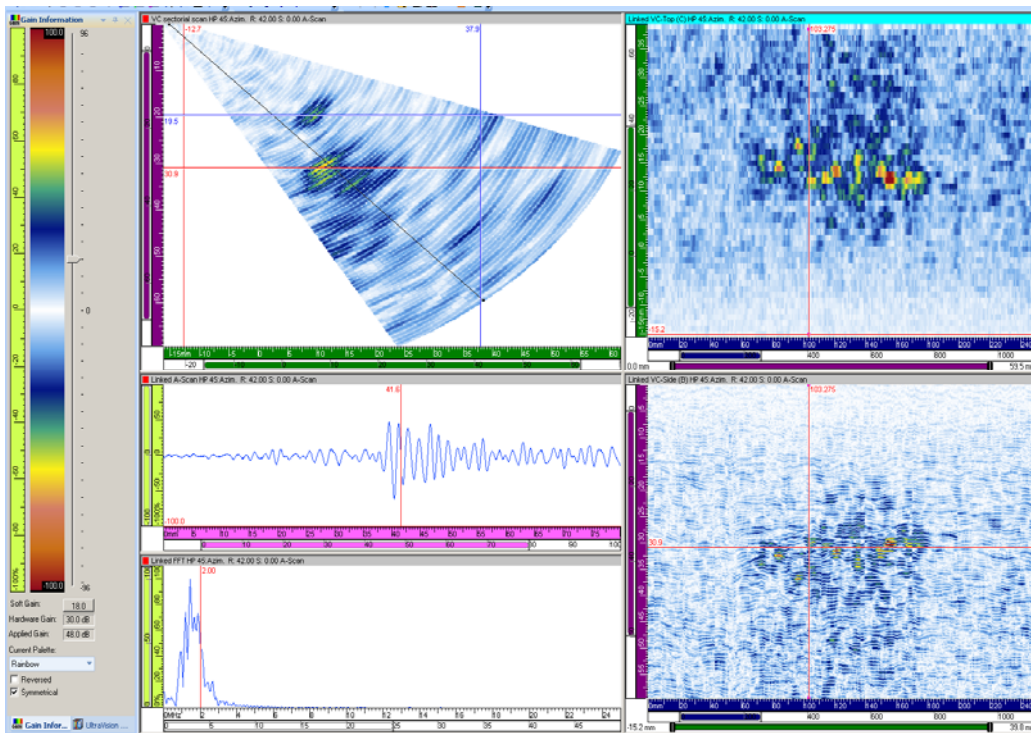
Figure D.3 2.0 MHz Data on Pipe Side of 7C-059, Flaw 1, for Depth Sizing

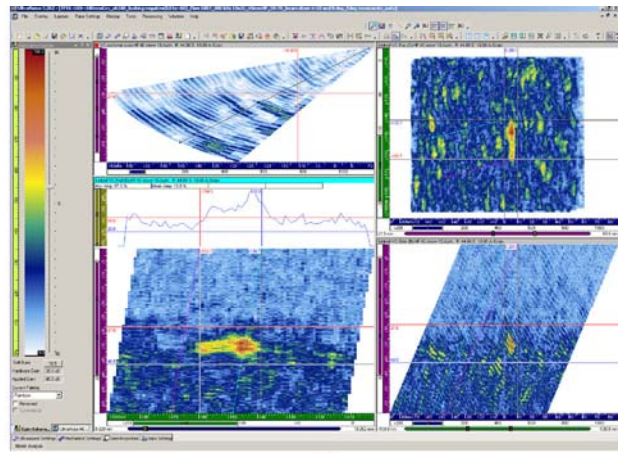
**Figure E.31 Raster Data at 0.8 MHz on Validation Specimen, Flaw 1087, Looking Positive (a) Beam Skew +10, (b) Skew 0, (c) Skew -10, and Looking Negative (d) Skew +10, (e) Skew 0, (f) Skew -10**
