A Survey of Crane Operating Experience at U.S. Nuclear Power Plants from 1968 through 2002

**U.S. Nuclear Regulatory Commission
Office of Nuclear Regulatory Research
Washington, DC 20555-0001**

Manuscript Completed: June 2003
Date Published: July 2003

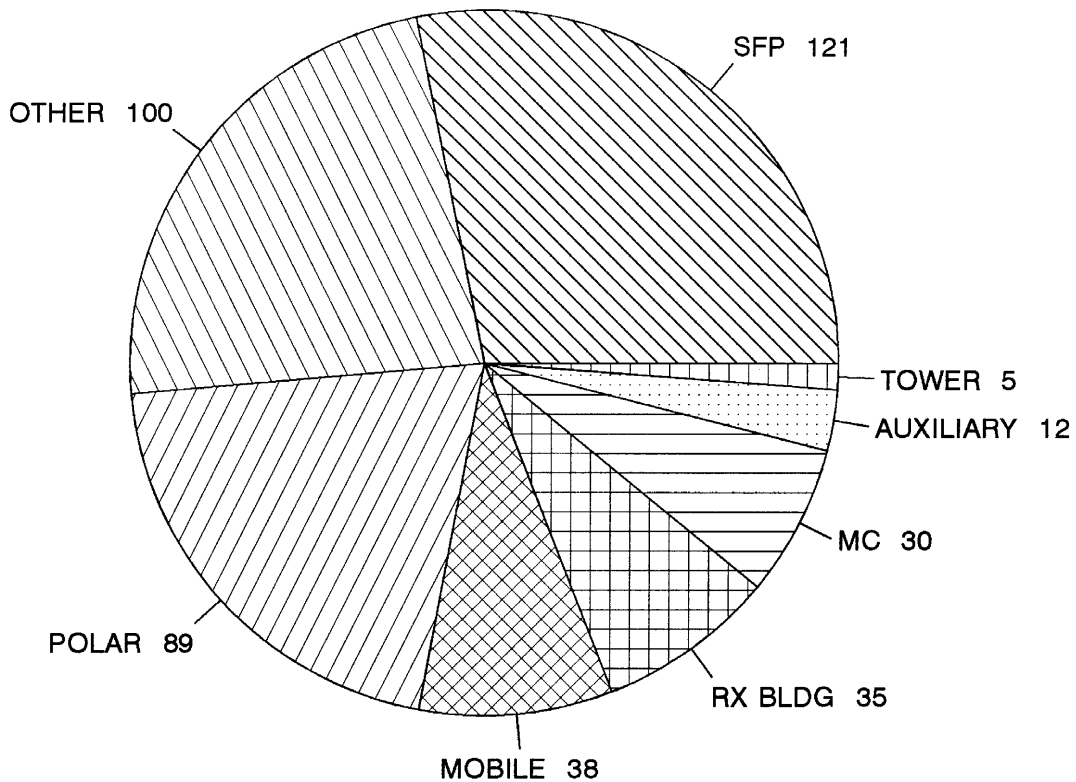
Figure 3: Crane issue distribution by crane type

For the 430 reported crane issues during the period 1968 through 2002, Figure 3, “Crane issue distribution by crane type,” shows the total number of crane issues documented for each crane type. The number of crane issues for each crane type was not broken down by reactor type, operational phase, or weight of load at the time of the event. Crane types include polar, spent fuel pool (SFP), tower, auxiliary building, refueling/manipulator (MC), reactor building (RB), mobile, and other. The category “other” refers to cranes which do not specifically fit into one of the remaining categories, and could include turbine building cranes, special cask handling cranes, unspecified cranes, or miscellaneous cranes used inside or outside of areas containing safety-related components. If the event report did not specify the crane type, it was categorized as other. The crane reporting the most number of issues (approximately 28 percent of the total) was the SFP crane (121). The reason for the high number of issues is due in part to the number of times that the crane is used in moving fuel assemblies. The SFP cranes were responsible for many procedural violations involving building ventilation requirements, and fuel assembly drop events. The “other” category is high (100) because it represents several miscellaneous crane types. Small cranes and hoists were not included as part of this survey.

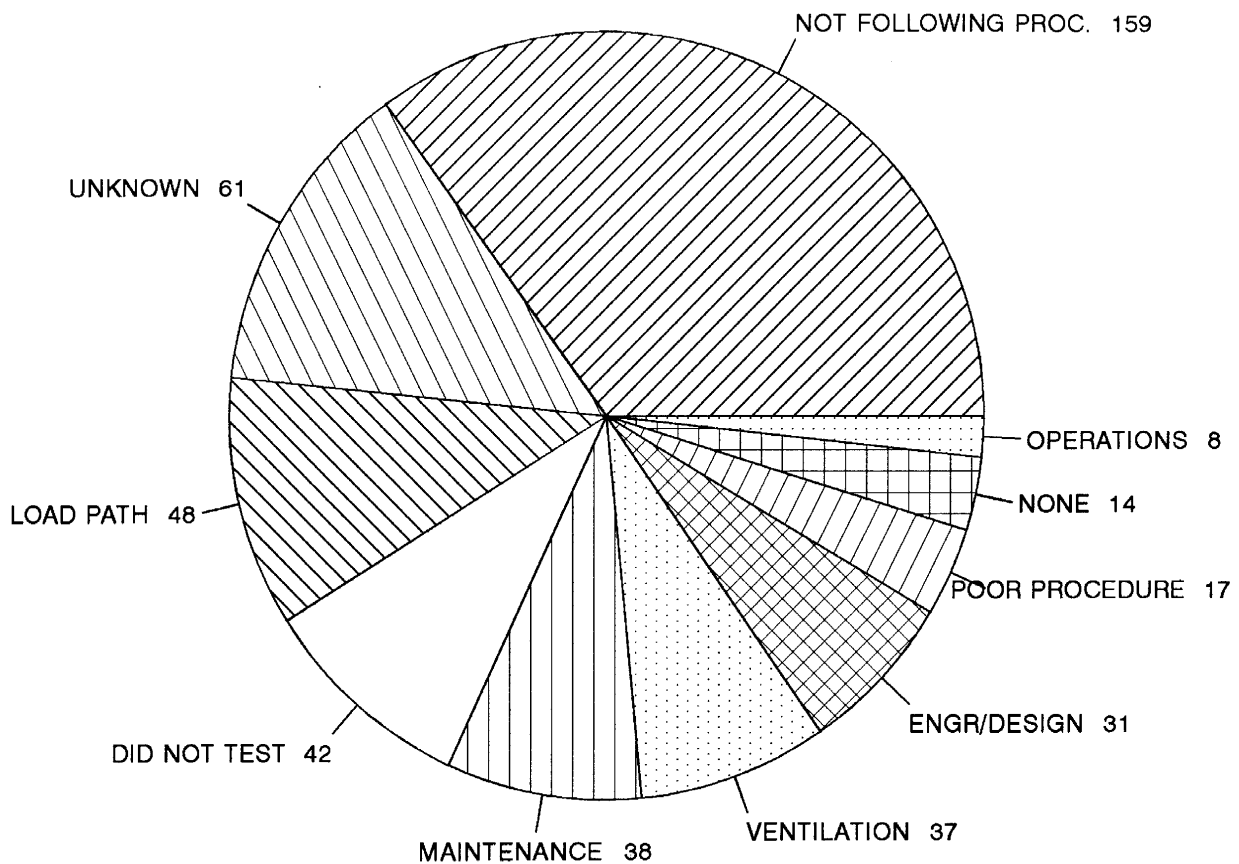
Figure 6: Principal reasons for crane events

Upon review of the 430 crane issues, a cause of the issue was either listed in the crane issue report, was determined by the available facts presented in the document, was indeterminate (category "Unknown"), or there was insufficient information given in the report to conclude that any deficiency existed (category "None"). Figure 6, "Principal reasons for crane events," shows the distribution of causes for the crane issue being reported. "Not Following Procedures" was the largest category with 159. Other categories that are similar to "Not Following Procedures" would be "Ventilation" (i.e., failure to establish the required ventilation prior to load movements in certain areas), "Did Not Test" (i.e., failure to perform crane surveillance tests prior to use) and "Load Path" (i.e., failure to move loads over established safe load path areas). There were 61 crane events where the cause of the event was categorized as "Unknown." In most of these instances, the event report lacked sufficient detail to determine the cause with certainty.

The probability of a drop over SSE would be related to the probability of the failure to follow procedures. As shown in Figures 2 and 6, a large percentage of crane issues are either related to not following procedures, or to not properly implementing procedures. For the purposes of this assessment, it was conservatively assumed that all failures to follow procedures (159) event could have caused a drop over SSE. This would result in a probability of $159/54000$ or approximately $3E-03$ failures per lift. A lower estimate of $1.5E-03$ was used which assumes that 50 percent of the crane events caused by not following procedures, resulted in a load drop over SSE.

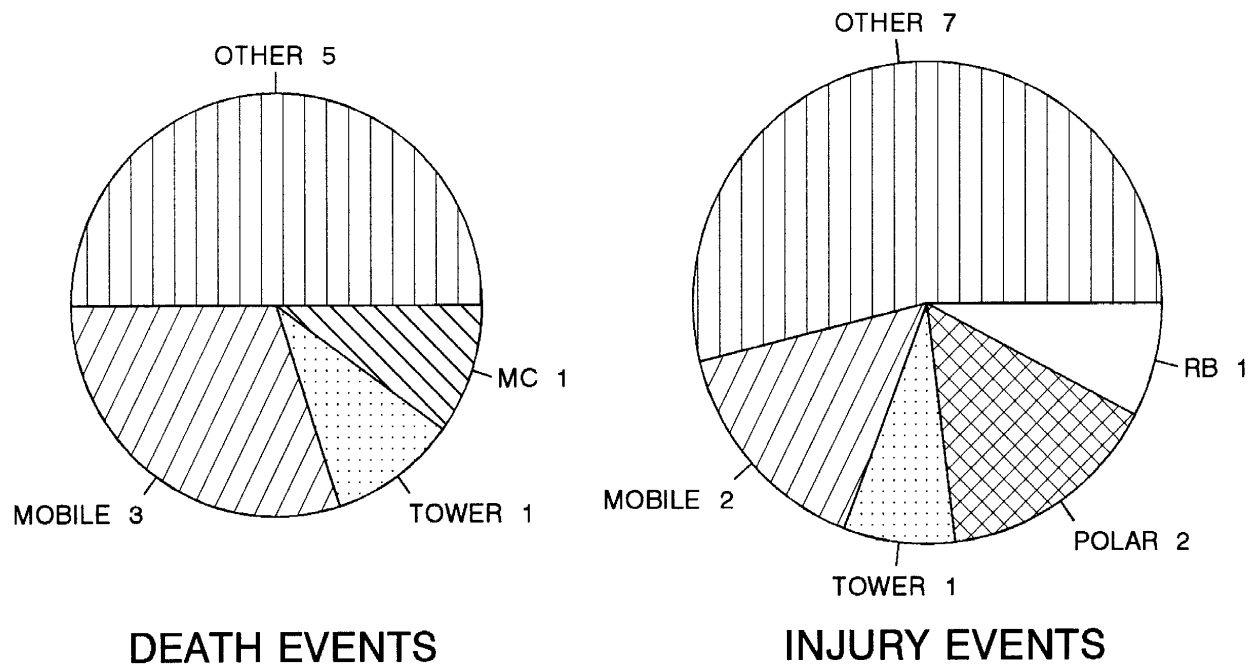
Figure 11: Crane types resulting in deaths or injuries

From an occupational safety standpoint, crane events leading to death or injury were reviewed. For the period 1968 through 2002 there were 10 events that resulted in a death, and 16 events that resulted in an injury. Figure 11, "Crane types resulting in deaths or injuries," shows the number of events that led to either a death, an injury, or both a death and an injury. In reviewing deaths and injuries caused by crane operation, each event was sorted by crane type. Crane types were put into eight different categories.

As shown by Figure 11, there were three crane events that involved an RB or Polar crane out of the total of 27 events that resulted in either a death or injury. Most deaths and injuries occurred while using cranes that typically do not move loads that impact safety-related equipment (i.e., tower, mobile, or other categories). These types of cranes have typically not been as well controlled and maintained in the past as are polar, reactor building, or spent fuel pool cranes. Mobile cranes and Other cranes represent the highest percentage of both deaths and injuries. See Section 2.3.12 for a discussion of events that led to a death.

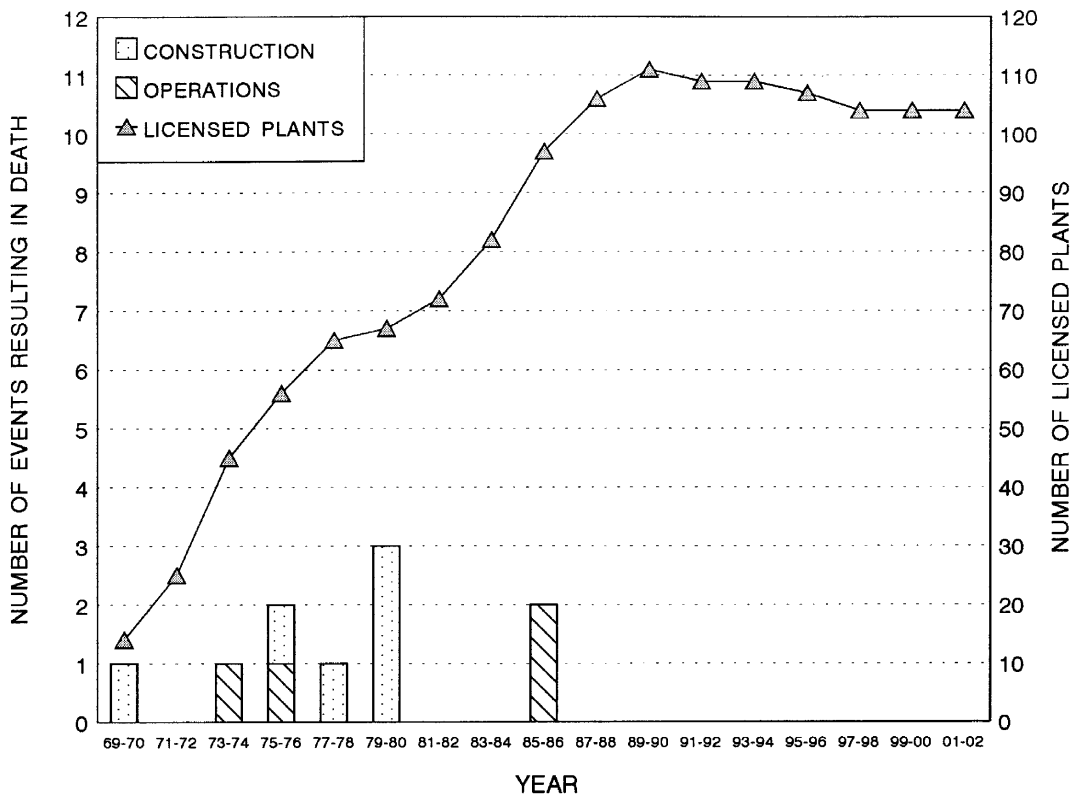
Figure 12: Distribution of crane related deaths

Figure 12, "Distribution of crane related deaths," shows the number of crane related events leading to at least one death. In some instances, one crane event resulted in multiple deaths. There have been 10 reported crane events that have led to deaths in the nuclear industry for the period 1968 through 2002. The highest concentration of crane related deaths at nuclear power plants occurred during the first decade (1969 to 1980). For Decade 1, six of eight events that led to a death occurred at facilities still under construction. The last death in a crane related accident in the U.S. nuclear industry was Decade 2 (1985). Table 3, "Reported crane events resulting in deaths" provides information for each of the reported crane events that involved a death. Figure 12 also shows the cumulative number of nuclear power plants that had an operating license during the period from 1968 through 2002.

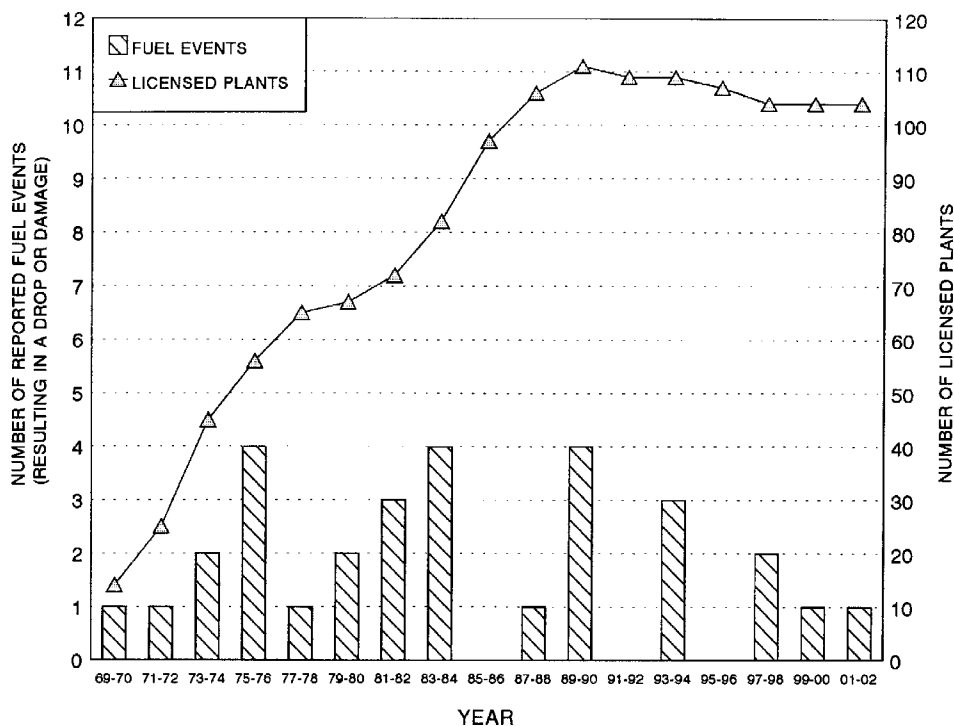
Figure 14: Distribution of fuel assembly load drops or fuel handling damage events

There have been 30 crane events involving either a fuel assembly drop or damage to a fuel assembly caused by handling. There was a steady increase in the number of operating units to over 100 during the period of the survey that was also accompanied by a steady overall improvement in fuel handling performance. Figure 14, "Distribution of fuel assembly load drops or fuel handling damage events," shows the event distribution in two-year increments. Fuel assembly events resulting in a drop or fuel damage are listed in Table 4: "Fuel assembly load drop or fuel handling damage events." Many of the fuel assembly issues have been captured in NRC generic communications listed in Appendix G. From a risk perspective, none of the 30 fuel assembly drop or fuel handling events resulted in radiation exposure or risk to personnel. A comparison of the three decades presents the following observations:

Decade 2. There were 12 events, one involved fuel handling damage. During Decade 2, there was a positive trend. The number of events increased by 9 percent, however the average number of operating units increased by 113 percent when compared to Decade 1.

Decade 3. There were 7 events, one involved fuel handling damage. During Decade 3, another positive trend occurred; the number of events decreased by 33 percent, concurrent with an increase in the number of operating units by 9 percent when compared to Decade 2.

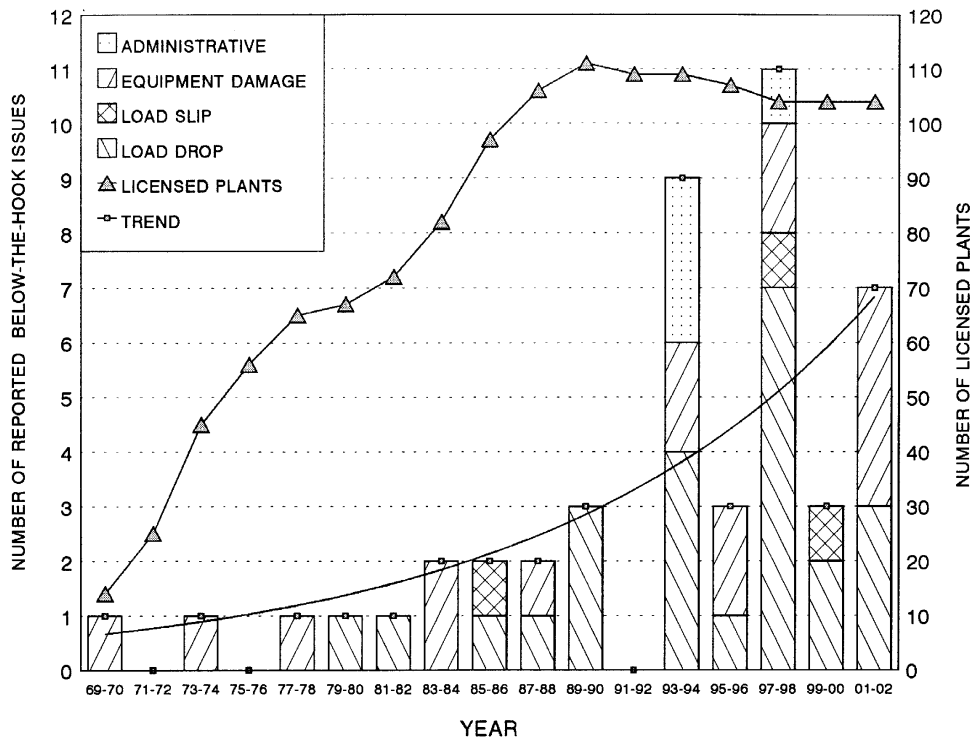
Figure 17: Below-the-hook crane events

For the period 1968 through 2002, there have been 47 below-the-hook events that have been reported. A below-the-hook event is classified as an event where rigging or handling errors resulted in an event. Figure 17, "Below-the-hook crane events," shows a significant overall increase in the number of events. Figure 17 also categorizes below-the-hook events into "administrative," "equipment damage," "load slip," and "load drop." Many of these events have resulted in load drops and damaged equipment. A comparison of the three decades presents the following observations:

Decade 2. There were 10 below-the-hook events. Six involved a load drop, three involved equipment damage, and one involved a load slip. During Decade 2, the number of events increased by 150 percent, concurrent with an increase in the number of operating units by 113 percent when compared to Decade 1.

Decade 3. There were 33 below-the-hook events, of which 17 involved load drops, 10 involved equipment damage, four involved administrative issues, and two involved load slips. During Decade 3, the number of events increased by 230 percent, concurrent with an increase in the number of operating units by 9 percent when compared to Decade 2.

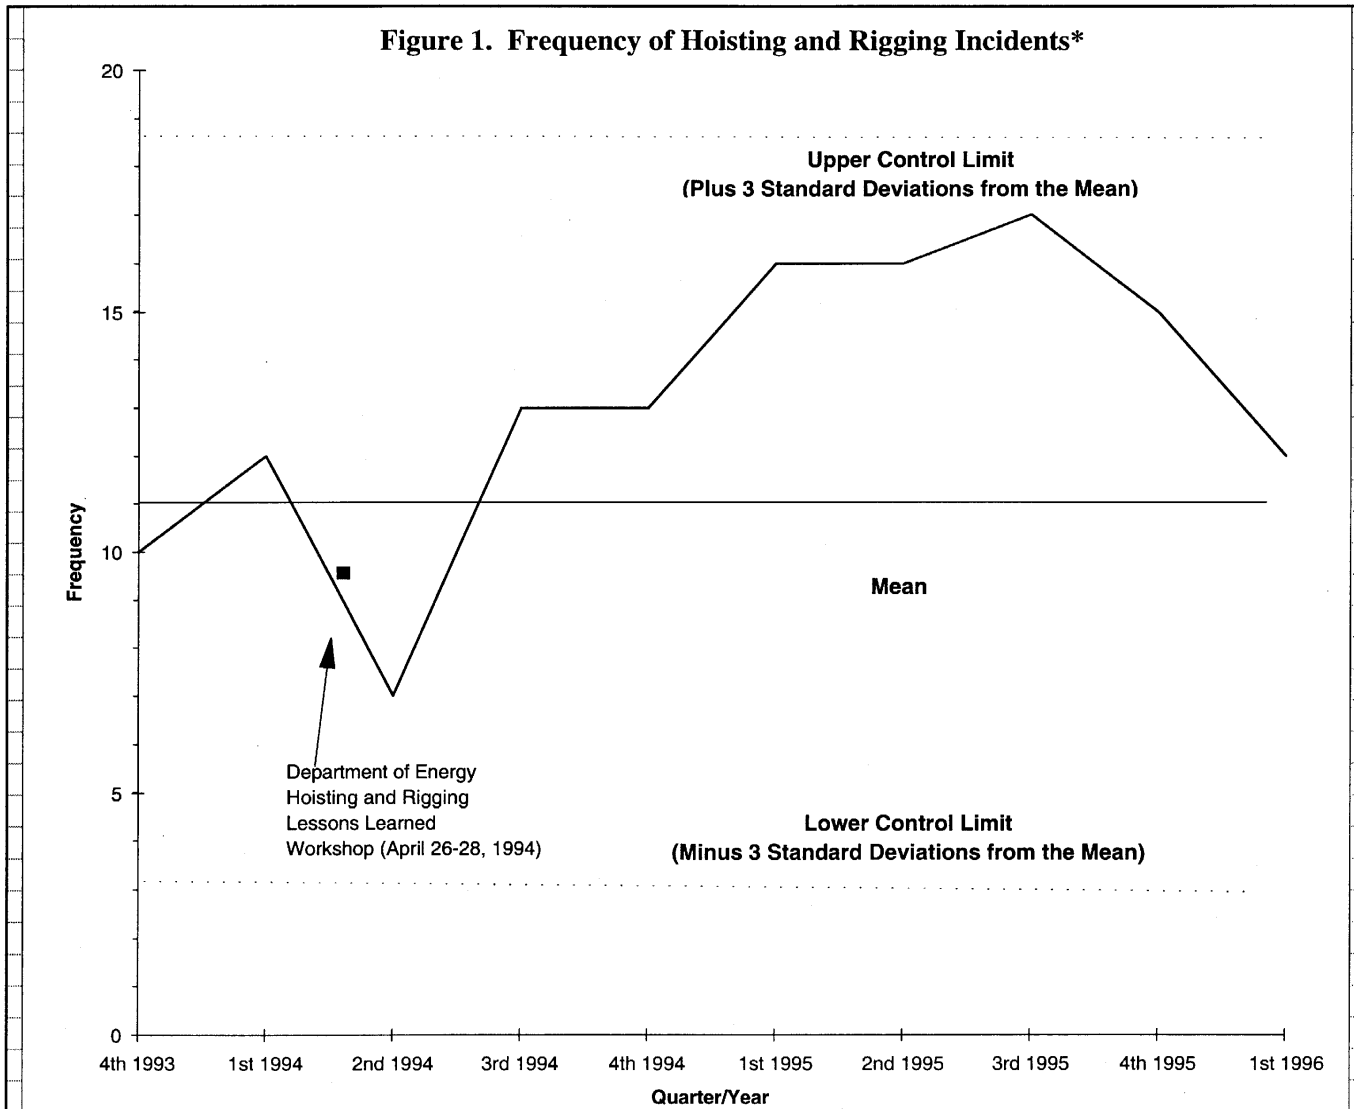
The trend since 1993 is depicted in Figure 1. While random variations in safety performance are expected, there may be other factors that influence the time interval between incidents, including work stoppages and additional caution for a period following an event; these are discussed in Appendix A. Despite fatalities, suspended operations, and the workshop, there has been no statistically significant change in the frequency of reported H&R occurrences or in the H&R process within the Department.

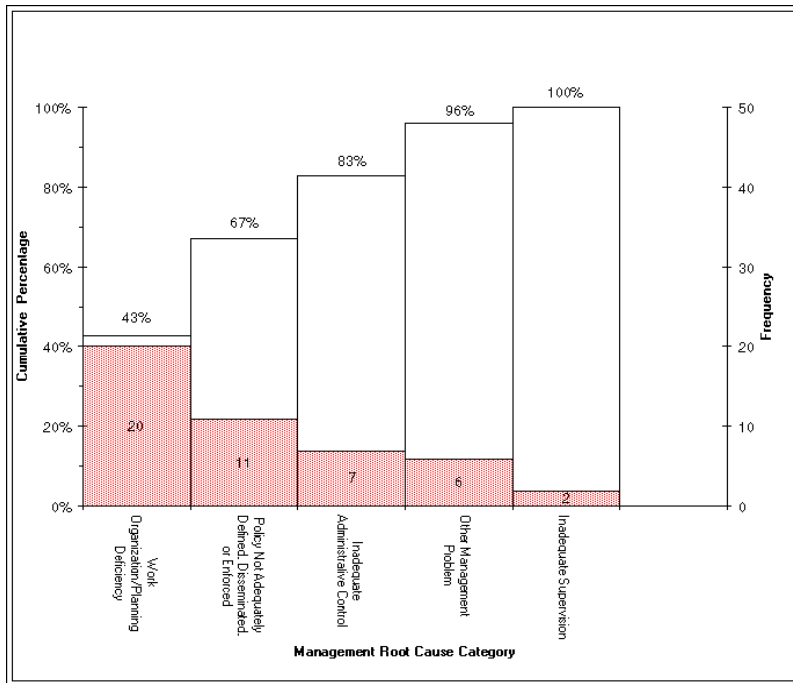
Figure 3. Management Root Cause Categories

Further analysis shows that deficient work planning (43 percent) and inadequate definition, dissemination, and enforcement of policy (24 percent) are responsible for two thirds of the incidents attributable to management deficiencies. Inattention to detail (56 percent) and not following procedures (28 percent) account for 84 percent of H&R incidents caused by personnel error. (See Figures 3 and 4, respectively.) Furthermore, inattention to detail is the most prevalent cause of all 131 H&R incidents, accounting for about one in every five incidents. Additionally, there are no indications that certain root causes are becoming less frequent over time, are being remedied, or are being replaced with other causal factors.
