# LONG-TERM SURVEILLANCE PLAN FOR THE BODO CANYON DISPOSAL SITE, DURANGO, COLORADO

Uranium Mill Tailings Remedial Action Project

**DOE/AL/62350-77**  
**REV. 2**

**Prepared by  
Jacobs Engineering Group Inc.  
Albuquerque, New Mexico**

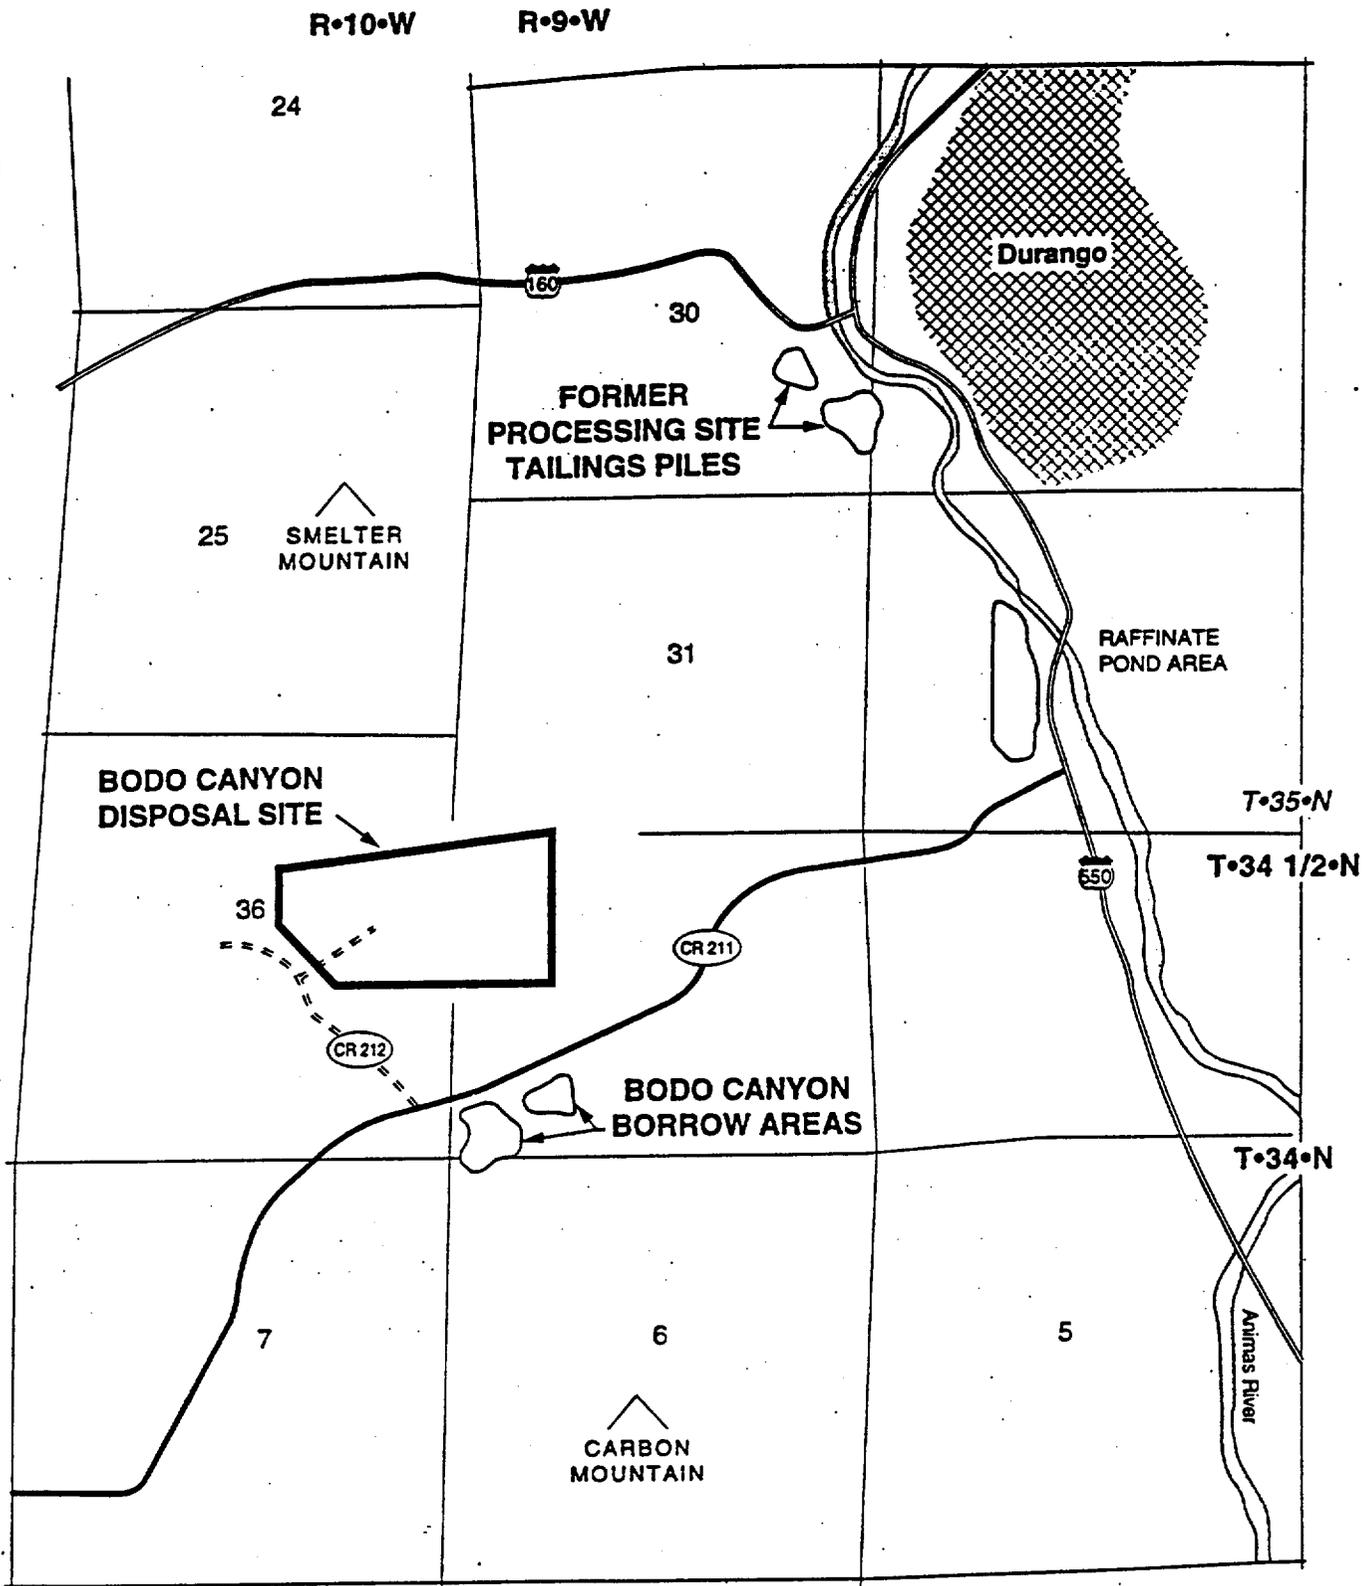
**FIGURE 2.2**  
**BODO CANYON, COLORADO,**  
**DISPOSAL SITE AREA MAP**

Figure 2.2 is a map of the Durango, Colorado, area. The disposal site can be located using the following directions:

The disposal site comprises approximately 120.6 acres (ac) (48.8 hectares [ha]) in La Plata County, Colorado, approximately 3.5 road miles (mi) (5.6 kilometers [km]) southwest of Durango, Colorado (Figure 2.1), in the eastern half of Section 36, Township 35 North, Range 10 West, and the western half of Section 31, Township 34 1/2 North, Range 9 West, New Mexico Principal Meridian (Figure 2.2) (DOE, 1993b).

The disposal site is in the upper west end of Bodo Canyon, an ephemeral drainage basin of about 4.5 square miles (mi<sup>2</sup>) (11.6 square kilometers [km<sup>2</sup>]) bordered by Smelter Mountain on the north, Carbon Mountain on the south, and the Animas River on the east (Figure 2.2).

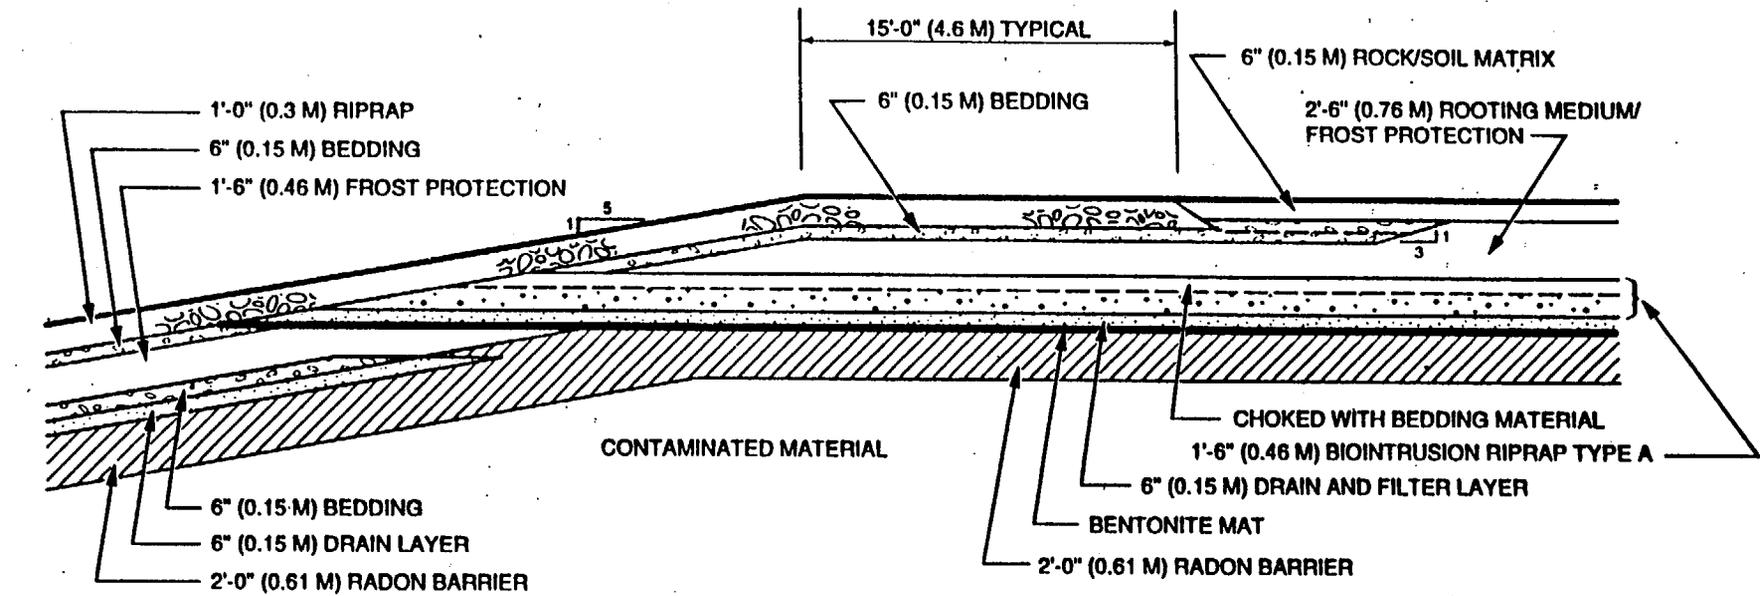
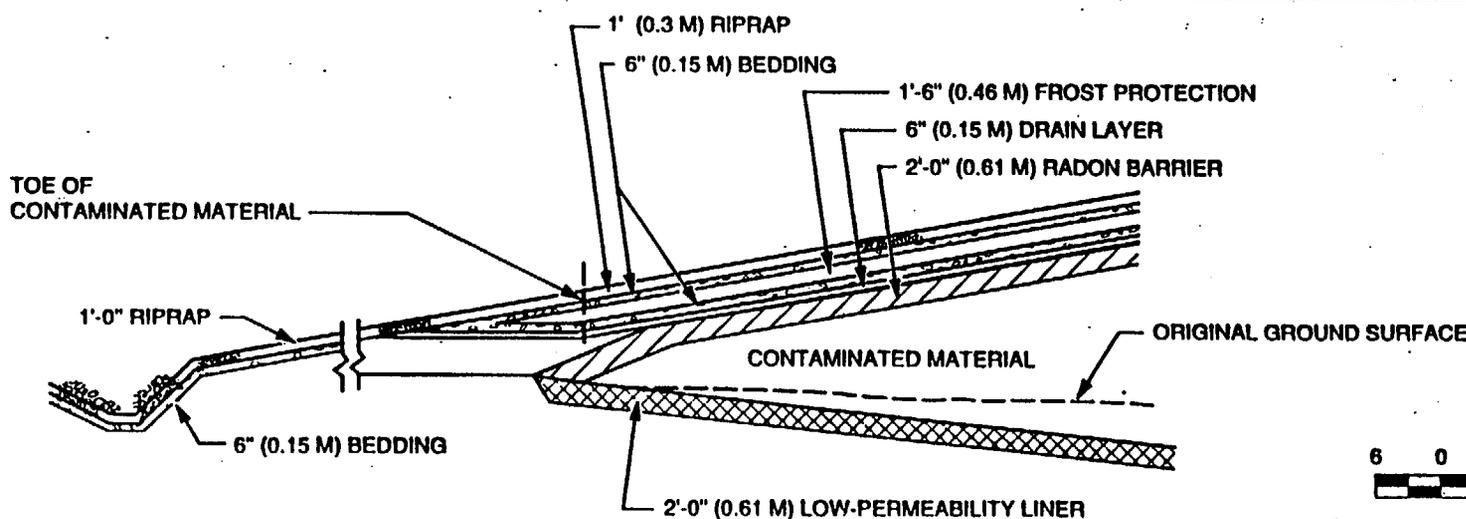
**FIGURE 2.4**  
**AS-BUILT CROSS SECTION OF COVER SYSTEM**  
**BODO CANYON, COLORADO, DISPOSAL CELL**

The topslope was completed with a 1.5-ft (0.5-m) biointrusion layer, a 2.5-ft (0.8-m) frost-protection layer, and a 6-inch (150-mm) rock/soil matrix. The matrix has a 1.5 to 2.0 percent grade away from a drainage divide at the center of the cell. In addition to the rock/soil layer, the cell topslope is covered with native grasses. The cover system for the embankment topslope is illustrated in Figures 2.4 and 2.5.

- A low-permeability liner on the sides and below the contaminated tailings (Figure 2.4).
- A compacted radon/infiltration clay barrier above the tailings material (Figure 2.5).
- A high-conductivity sand drain/filter layer placed on the top of the radon barrier (Figure 2.5).

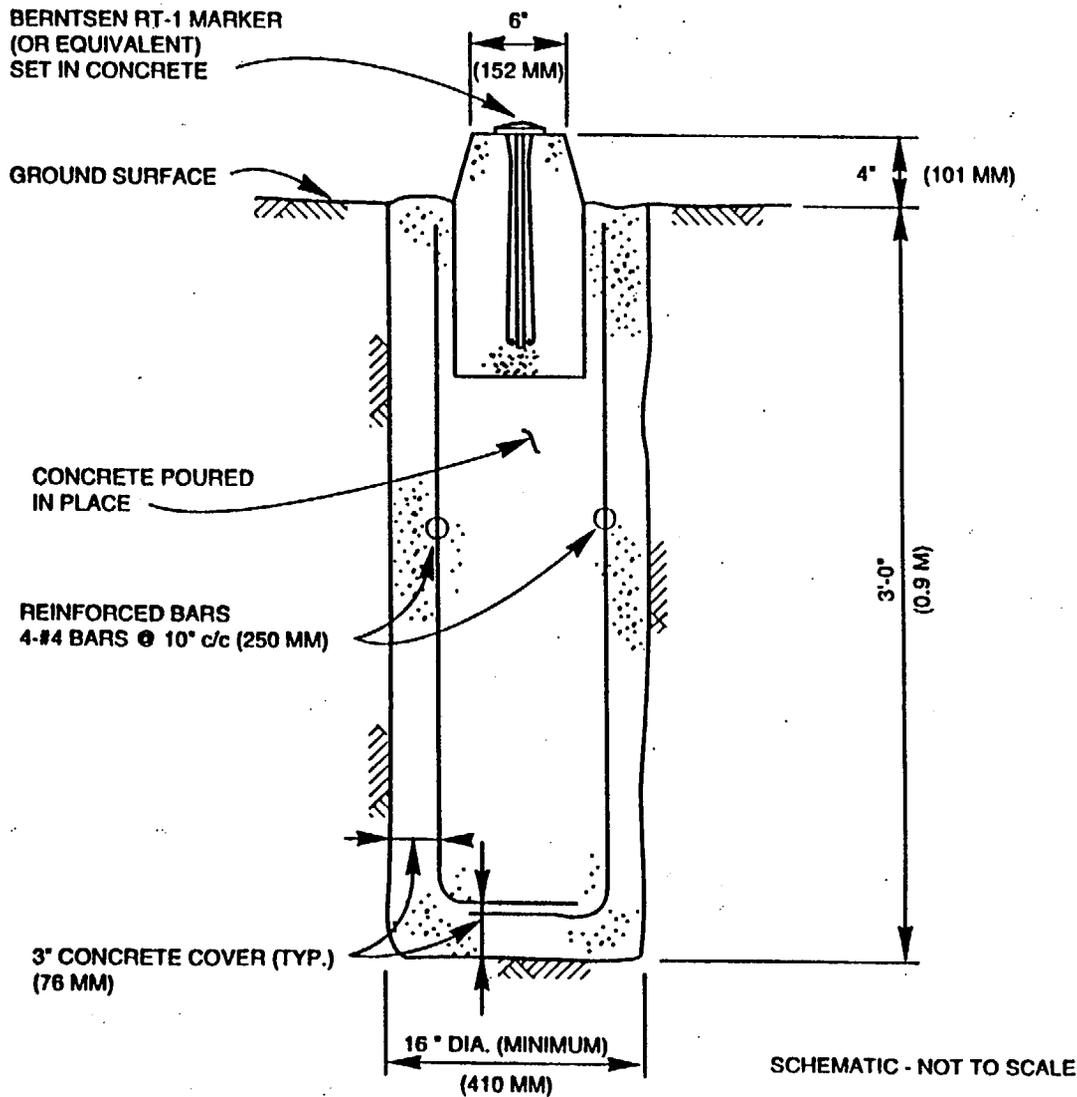
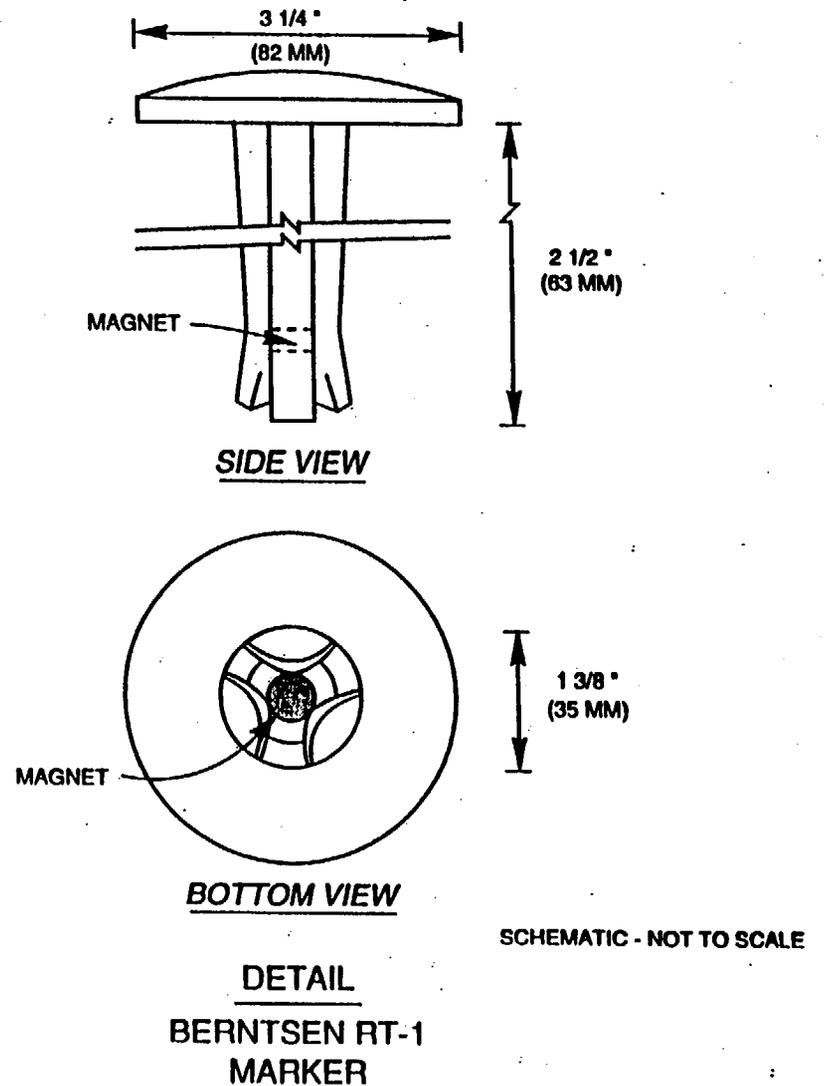
FIGURE 4.1  
UMTRA PROJECT SURVEY MONUMENT  
BODO CANYON, COLORADO, DISPOSAL SITE

**BERNTSEN FEDERAL ALUMINUM SURVEY MONUMENT, MODEL A-1, STANDARD LOGO CAP**

SM-1 is in the northwest quadrant of the site, SM-2 is south of the disposal cell, and SM-3 and SM-4 are to the east (Plate 1). The monuments, Bernsten RT-1 metal markers, were set into the top of a truncated cone of reinforced concrete set in concrete. The design of the survey monuments is shown in Figure 4.1.

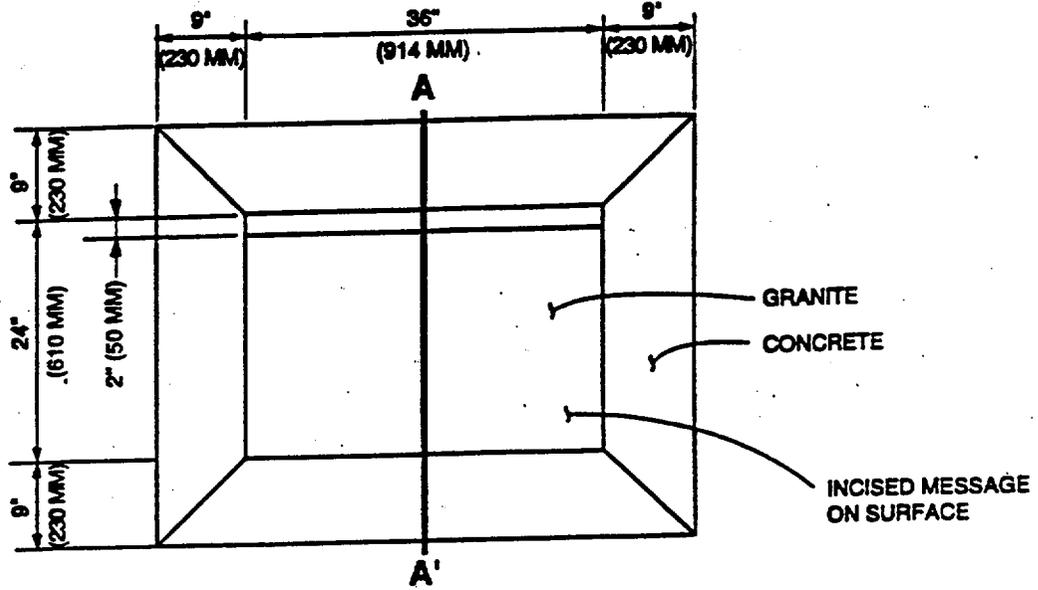
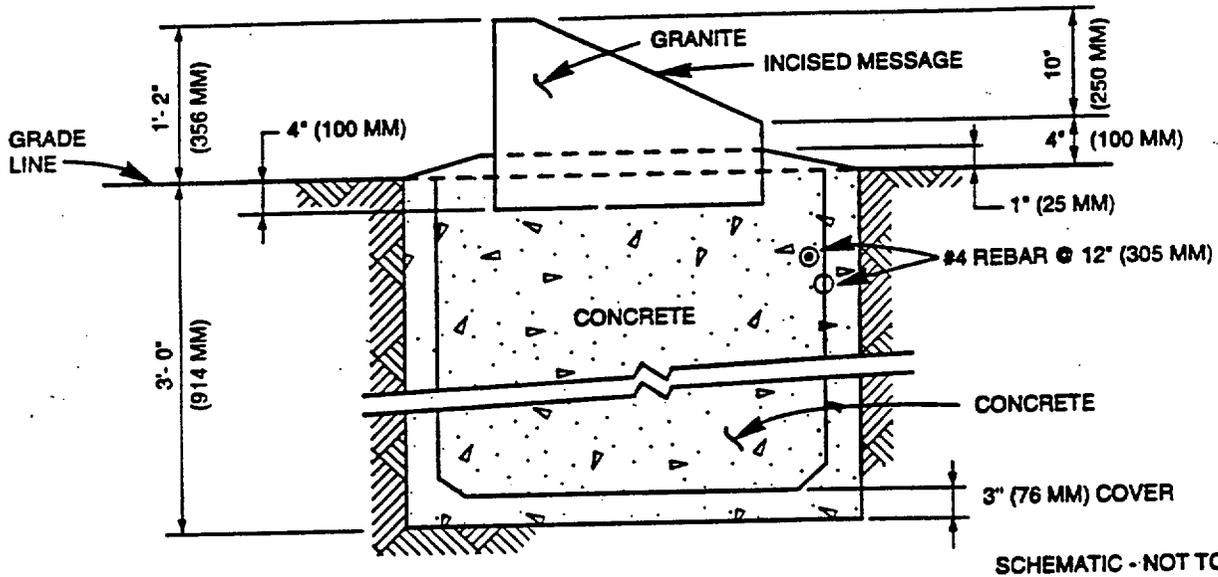
**FIGURE 4.3  
UMTRA PROJECT ENTRANCE SITE MARKER (SMK-1)  
BODO CANYON, COLORADO, DISPOSAL SITE**

PLAN VIEW

SECTION A - A'

Two unpolished granite site markers (SMK-1 and SMK-2) are within the restricted site boundary. SMK-1 is just inside the entrance gate. SMK-2 is on top of the disposal cell revegetated area. Site markers were constructed with the dimensions shown in Figures 4.3 and 4.4. The markers identify the disposal site, the general location of the disposal cell, the date of closure (3 August 1990), the dry tonnage of RRM (3,460,000 dry tons [3,140,000 tonnes]), and the curies of radioactivity (1400 curies, radium-226) (Figure 4.5).

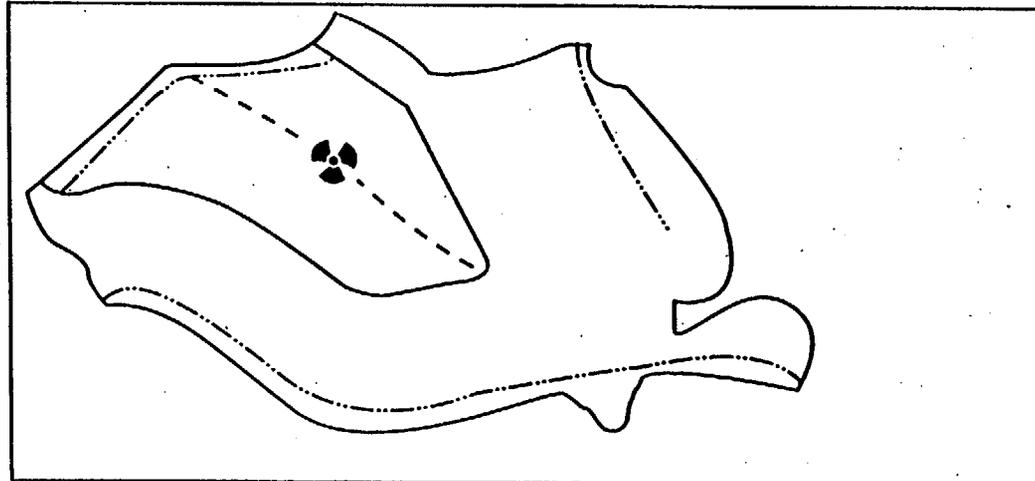
**FIGURE 4.5**  
**UMTRA PROJECT SITE MARKER INCISED MESSAGE**  
**BODO CANYON, COLORADO, DISPOSAL SITE**

<b>DATE OF CLOSURE:</b>	<b>AUGUST 3, 1990</b>
<b>DRY TONS OF TAILINGS:</b>	<b>3,460,000</b>
<b>RADIOACTIVITY:</b>	<b>1400 CURIES, RA-226</b>

INCISED MESSAGE

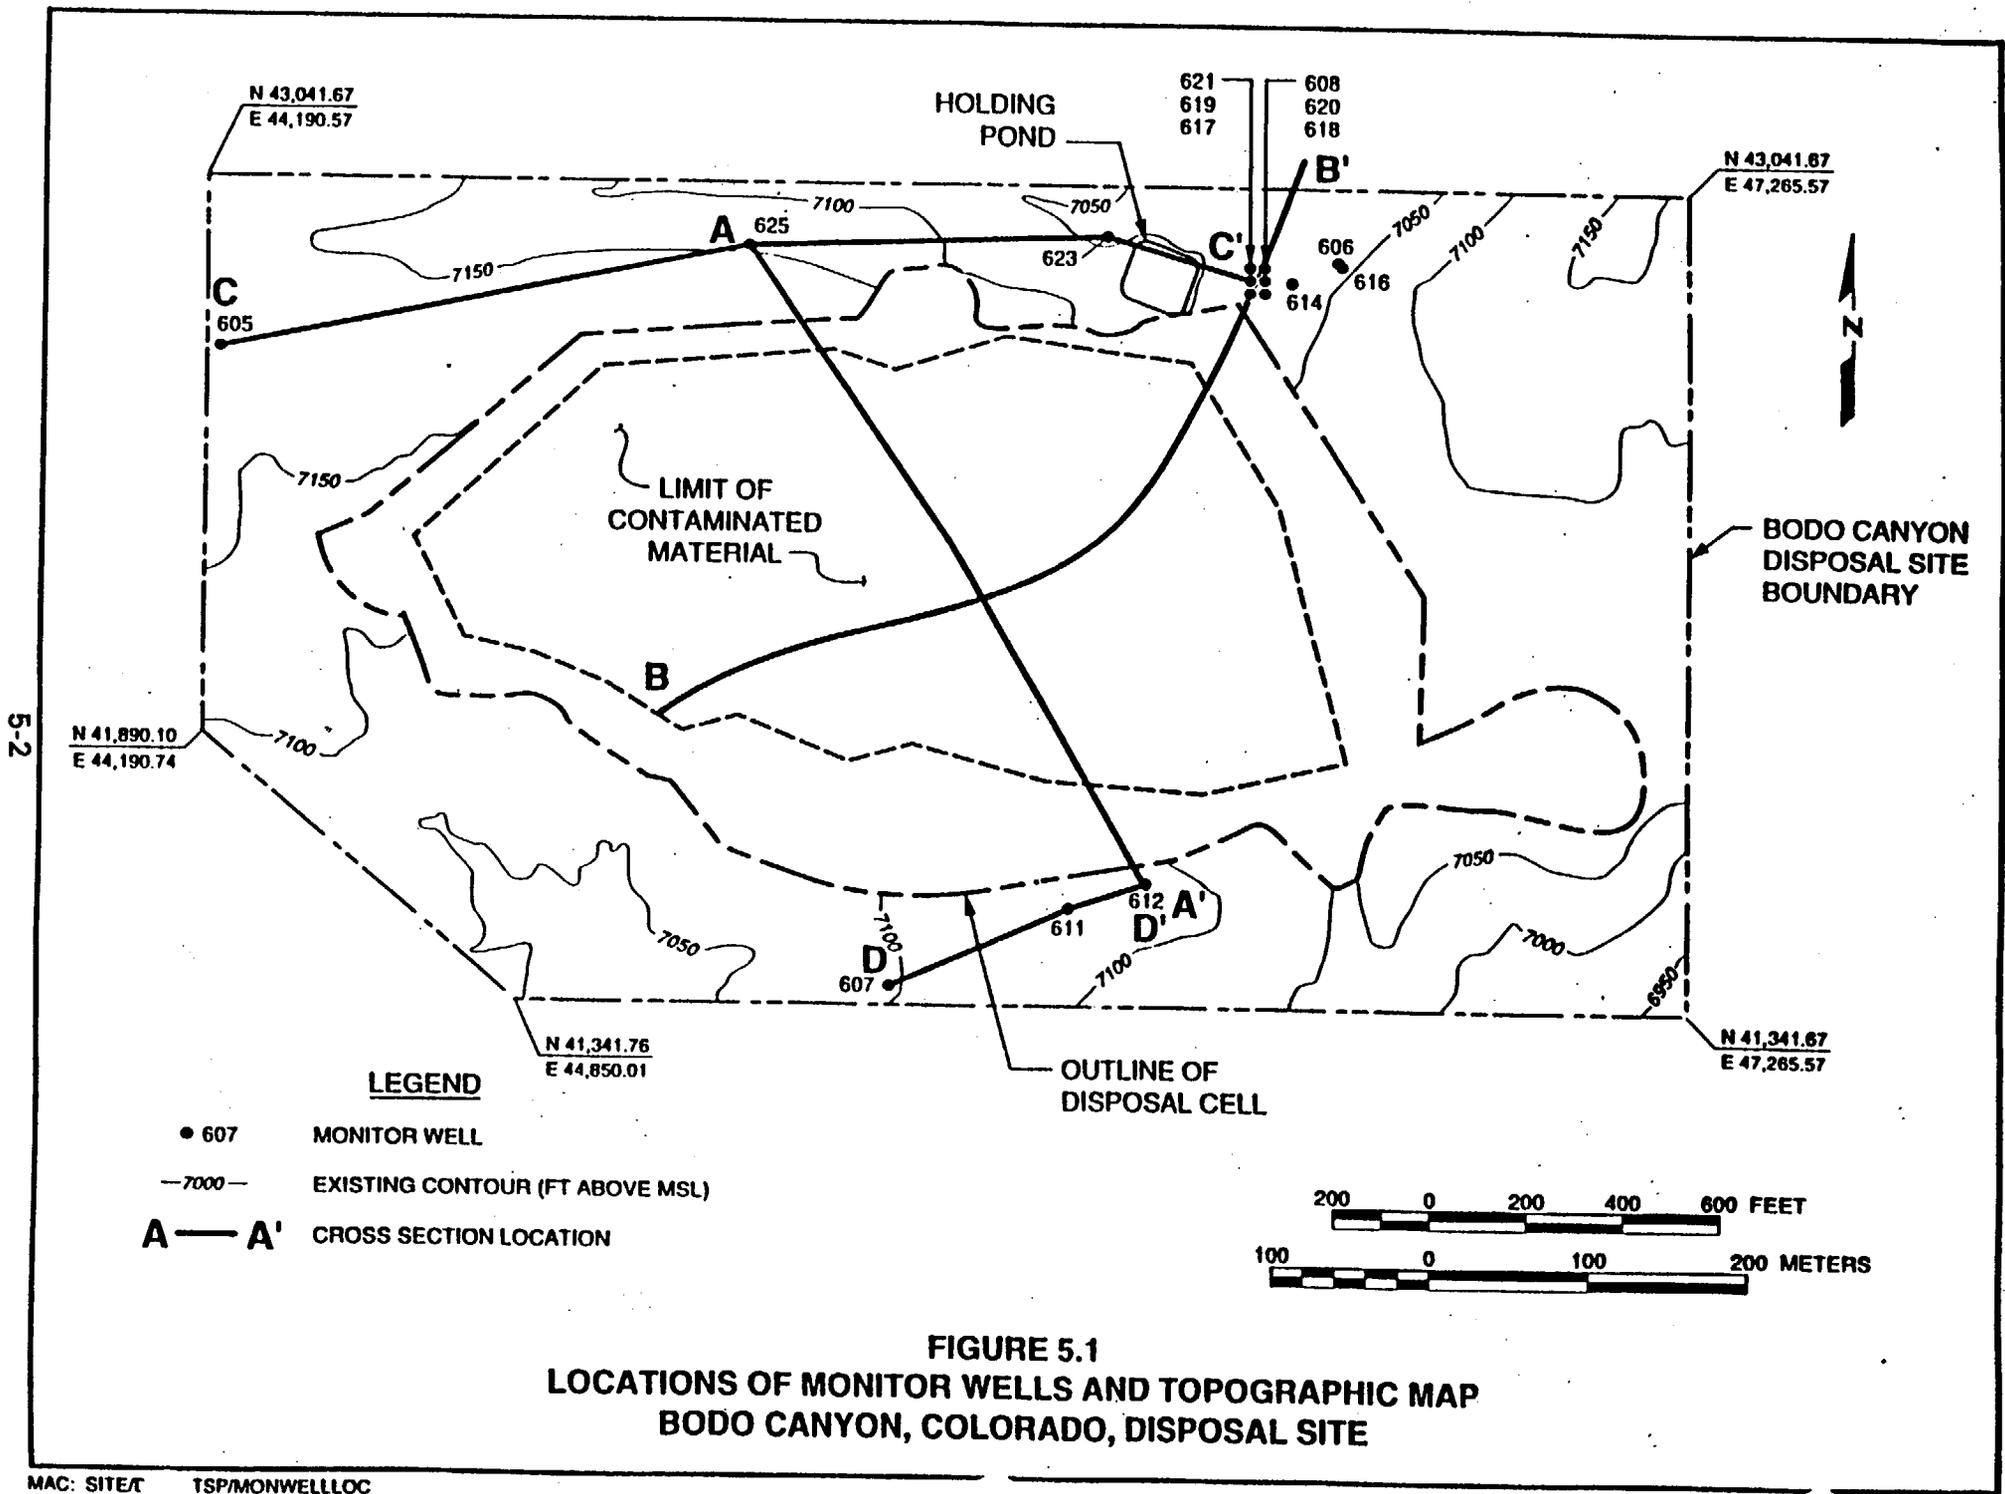
The disposal cell is in a valley that trends southwest-to-northeast. Prior to installation of the disposal cell, the valley elevation ranged from approximately 7190 ft (2190 m) above MSL near the western end of the property to about 6900 ft (2100 m) above MSL at the extreme southeastern corner of the site. Figure 5.1 shows the topography of the surrounding area after the cell was

- 607 MONITOR WELL
- 7000— EXISTING CONTOUR (FT ABOVE MSL)
- A — A' CROSS SECTION LOCATION

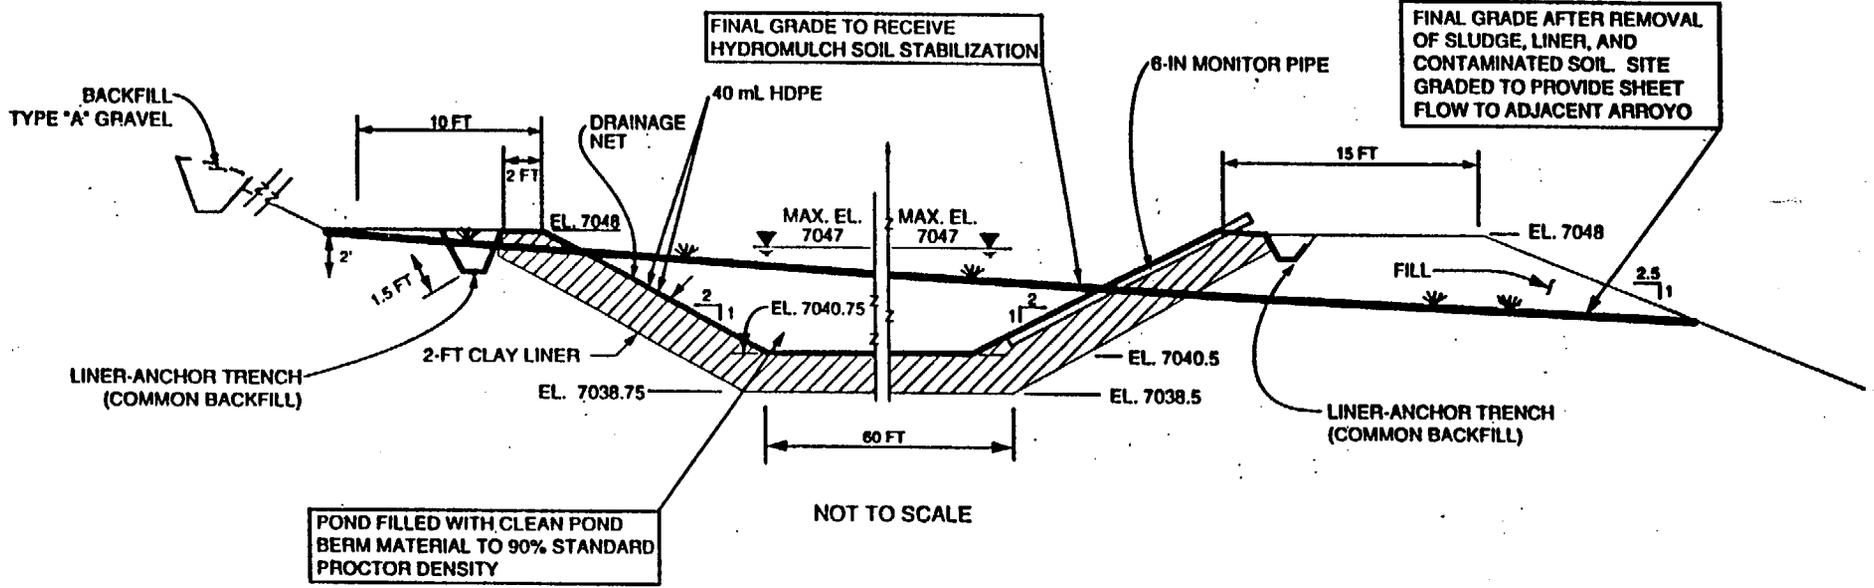
**FIGURE A3.4  
HOLDING POND - SITE RESTORATION  
BODO CANYON, COLORADO, SITE**

NOTE: BOXED NOTES ARE HOLDING POND DECOMMISSIONING PLAN REQUIREMENTS.

After all sludge and contaminated materials are removed from the holding pond area of the disposal site, the remaining soil berm of the holding pond will be regraded to permit proper drainage and to minimize the development of high velocity or concentrated flows. The holding pond site receives sheet flow runoff from the northeast face of the disposal cell and will be regraded to allow the sheet flow to drain naturally to the north and east, into the adjacent arroyo and outfall structure of ditch no. 1. Specifications require compacting the fill material to 90 percent Standard Proctor Density (American Society for Testing and Materials [ASTM] D698) (ASTM, 1988).
